Condit Hydroelectric Project Decommissioning

FERC Project No. 2342

PRELIMINARY SEDIMENT BEHAVIOR REPORT

December 18, 2011

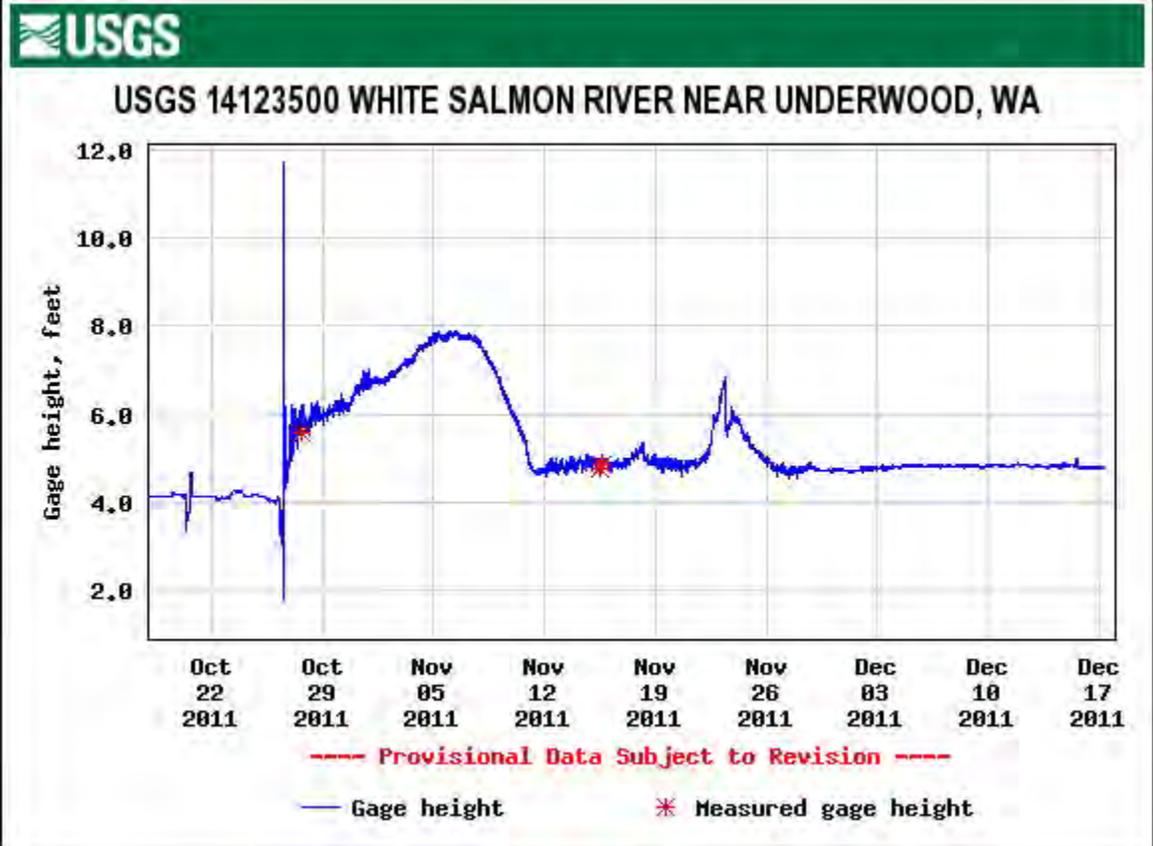
Bedload concentrations certainly increased in the days after the breach event, as high volumes of sand-size particles were mobilized from the reservoir area. Field observations at the Powerhouse showed the water surface rising daily for the first 10-11 days post breach. It is believed that this rise in water surface was due to a rising channel bed: sand-size sediments temporarily filling up the bottom of the channel. Anecdotal observations at a staff gage upstream of the reservoir suggest that water flow in the river did not change substantially during this 10-day period, remaining at around 700 cubic feet per second (CFS). Direct measurement of water surface (stage) has been recorded continuously at the USGS stream gage (USGS Gage No. 14123500) in the lower White Salmon River. Assuming the water flow in the river remained consistent during the first two weeks post breach, then the USGS stage data is analogous to the changes in river bed elevation from temporary sand deposits. During this two-week period, sediment supply to the canyon reach exceeded the sediment transport capacity of the river, allowing the excess sediments to be deposited in the riverbed. Beginning on approximately November 8, 2011, the sediment supply began to decrease, the sediment transport capacity of the river exceeded the supply, and channel bed elevations began to decrease. By November 12, 2011, (approximately) the river bed had returned to an elevation close to the pre-breach grade, and water stage readings stabilized.

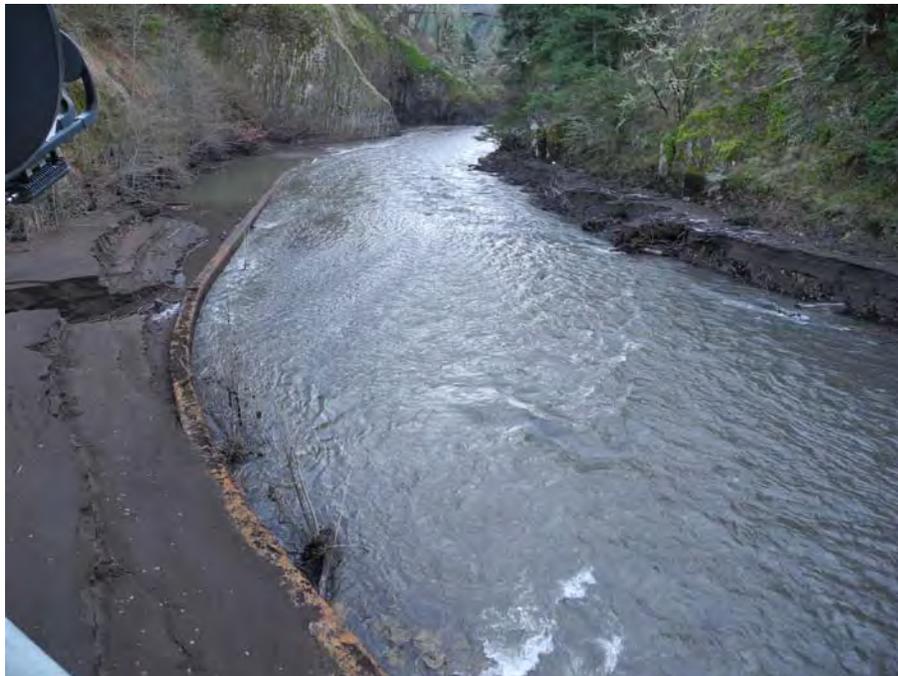
As the water levels dropped at the Powerhouse, the level of temporary sediment filling of the channel bed could be seen. The photograph below shows what is left of the temporary channel bed fill, with the sediment drape line on river right (view is looking downstream).

White Salmon River at the powerhouse. View downstream. Temporary bed sediment levels can be inferred from the deposition on river right. On river left the powerhouse tailrace is presently filled with sediment. 12-7-2011.

Powerhouse: *From 11/3/2011 to 11/10/2011 there was approximately 3 ft of down-cutting through riverbed sediment deposits and the river channel had narrowed by approximately 6 ft. From 11/10/2011 to 11/17/2011 approximately 3 ft of the sediment deposit on river right was removed. All sediment on river right was removed by 11/30/2011. No changes in conditions were observed from 11/30/2011 to 12/8/2011.*

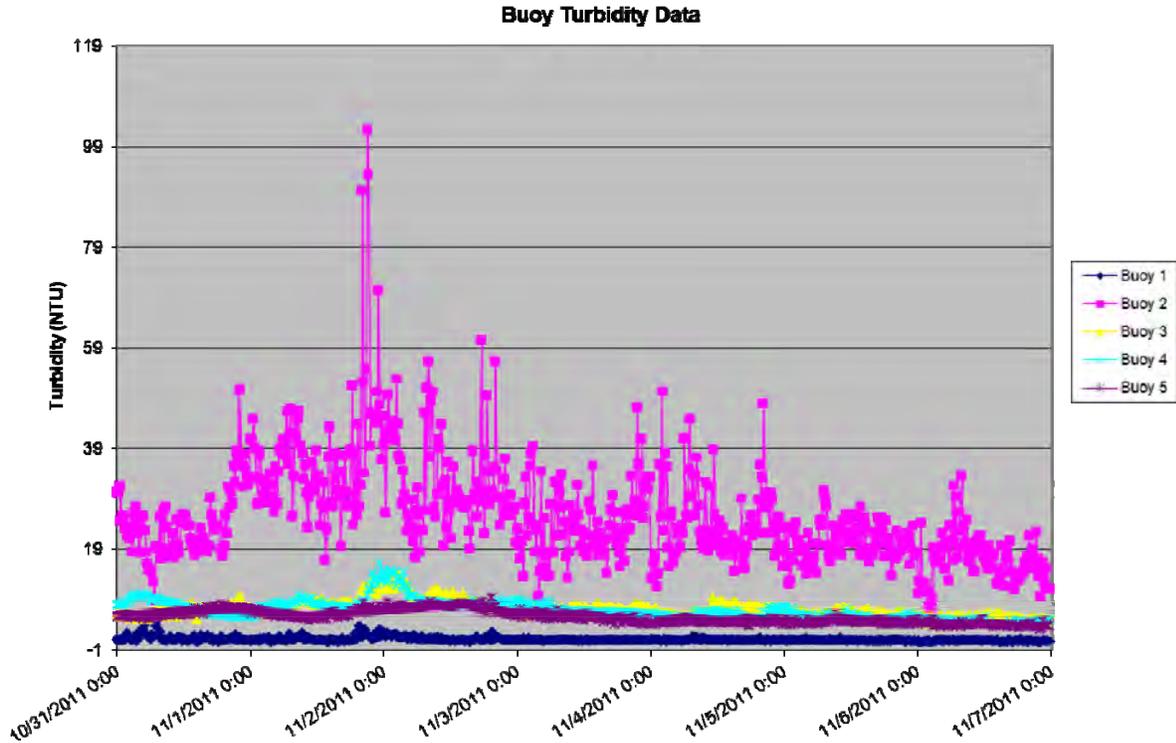
Visible evidence of turbidity on the surface of the Columbia River was notably absent during the first four weeks post breach. It is believed that the majority of the sediment discharged to the Columbia River was sand-size particles, moving as fluid bed sediment. On breach day the USGS attempted to measure discharge from the White Salmon River under the railroad bridge at the confluence with the Columbia River. Verbal accounts say that this measurement effort was abandoned when it was determined that the majority of surface water was flowing in an upstream direction. This suggests a powerful current flowing along the bed of the White Salmon River out into the Columbia River, consistent with a high bedload concentration and a density greater than that of clear water.

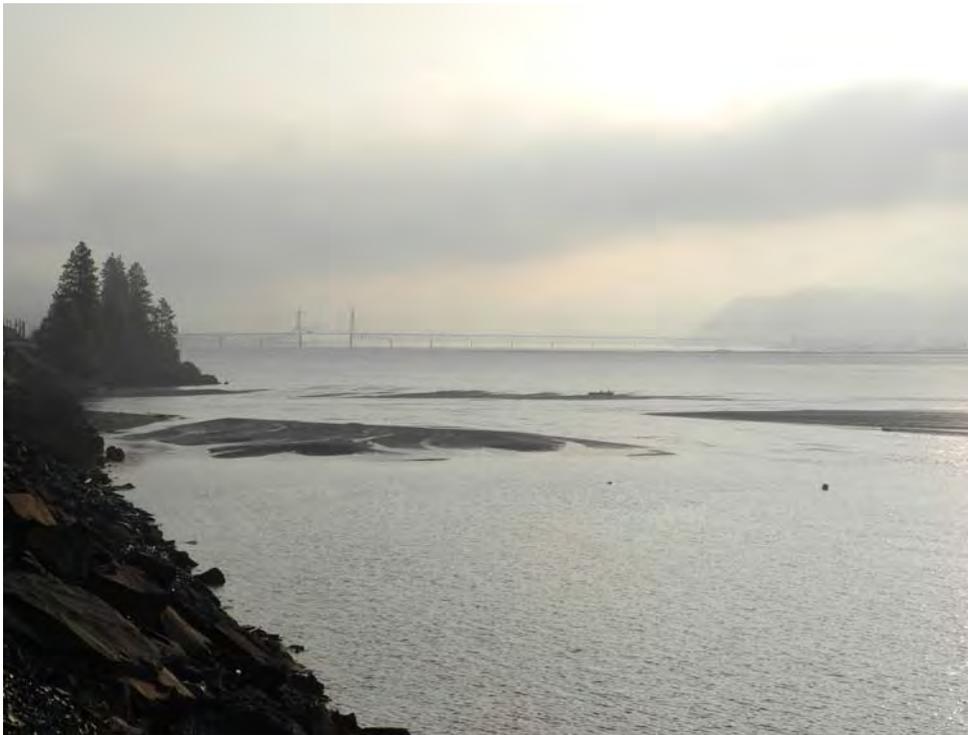
post breach before sand deposits were visible on the surface of the Columbia River at the mouth of the White Salmon River.

Columbia River at the mouth of the White Salmon River. Sand bars visible. 12-8-2011.

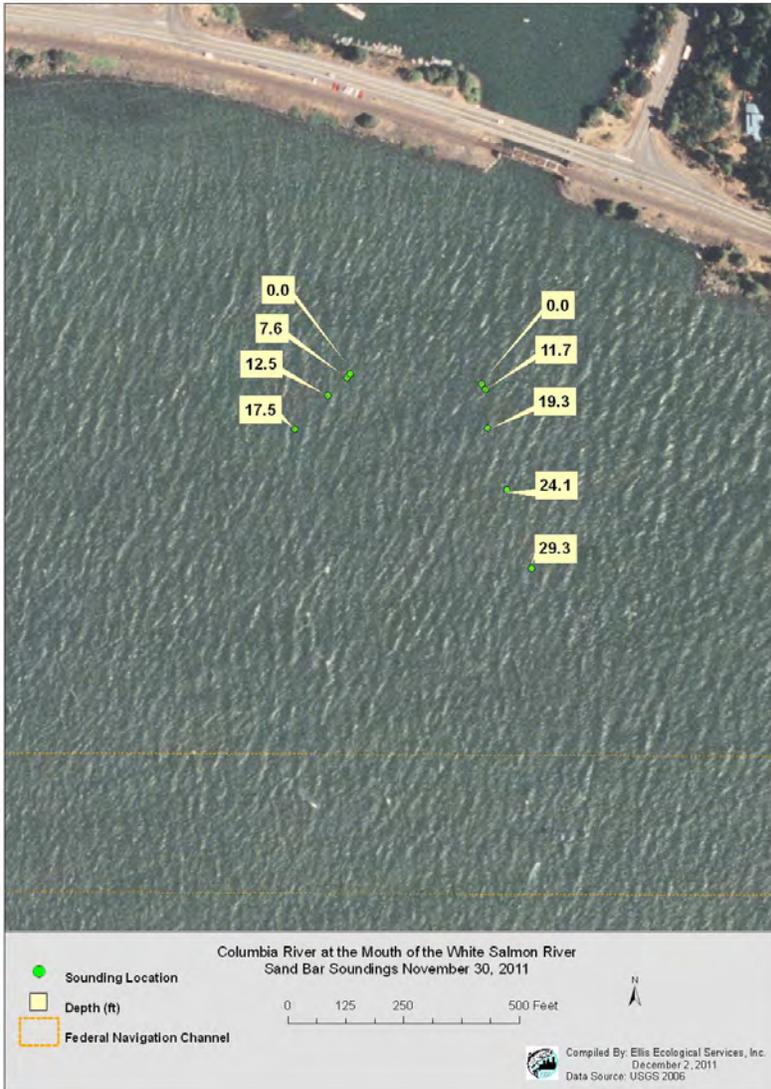
Bathymetric surveys conducted in the Columbia River at the mouth of the White Salmon River in the first week post breach revealed approximately 433,000 cubic yards deposited. It is apparent that the bulk of the bedload sediment volume had taken weeks rather than days to reach the Columbia River. A limited number of sediment depth data points were collected on November 30, 2011. These data points and depth are shown on the figure below, as is the commercial navigation channel (faint yellow line). The Coast Guard has placed a lighted, warning buoy at the outer extent off the sediment deposition area to prevent small craft from running aground.

Columbia River at the mouth of the White Salmon River. Depth to sediment surface, measurements taken on 11-30-2011. Note: photography is from an earlier date.
