Condit Hydroelectric Project Decommissioning

FERC Project No. 2342

PRELIMINARY SEDIMENT BEHAVIOR REPORT

December 18, 2011

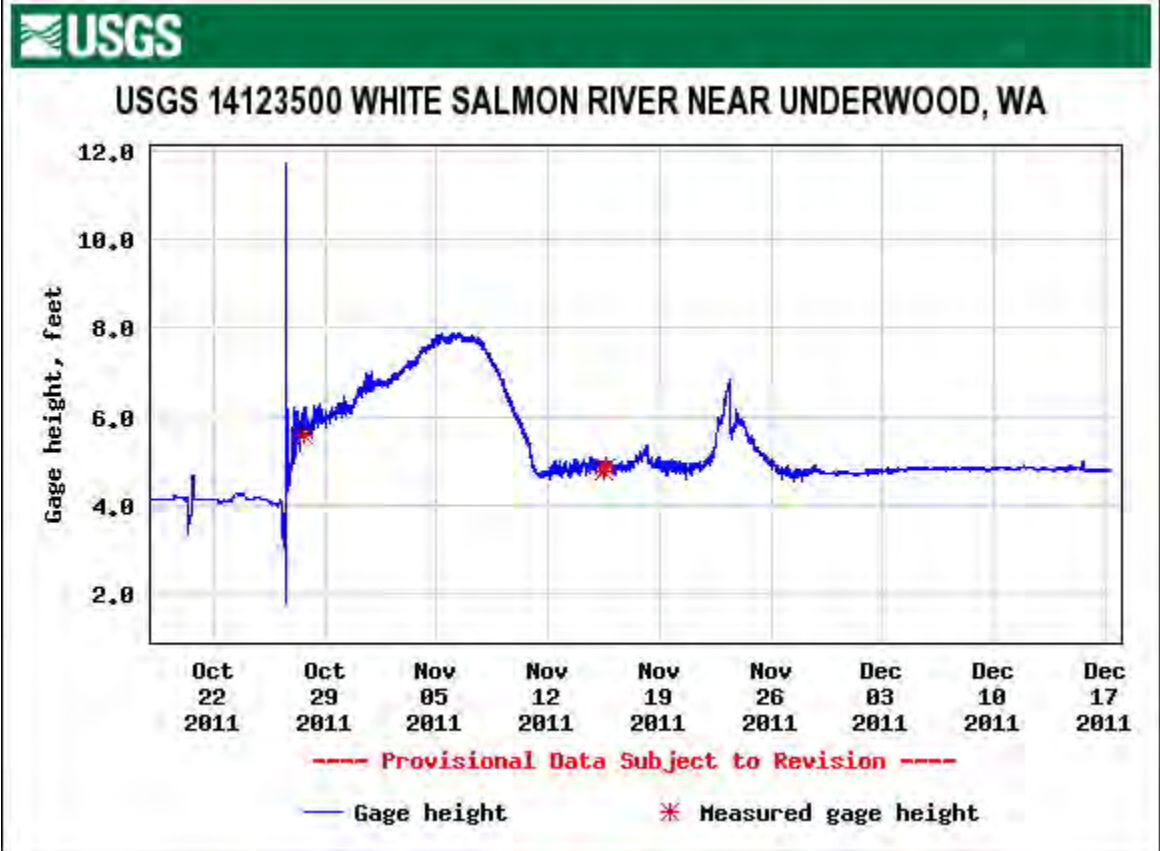
Bedload concentrations certainly increased in the days after the breach event, as high volumes of sand-size particles were mobilized from the reservoir area. Field observations at the Powerhouse showed the water surface rising daily for the first 10-11 days post breach. It is believed that this rise in water surface was due to a rising channel bed: sand-size sediments temporarily filling up the bottom of the channel. Anecdotal observations at a staff gage upstream of the reservoir suggest that water flow in the river did not change substantially during this 10-day period, remaining at around 700 cubic feet per second (CFS). Direct measurement of water surface (stage) has been recorded continuously at the USGS stream gage (USGS Gage No. 14123500) in the lower White Salmon River. Assuming the water flow in the river remained consistent during the first two weeks post breach, then the USGS stage data is analogous to the changes in river bed elevation from temporary sand deposits. During this two-week period, sediment supply to the canyon reach exceeded the sediment transport capacity of the river, allowing the excess sediments to be deposited in the riverbed. Beginning on approximately November 8, 2011, the sediment supply began to decrease, the sediment transport capacity of the river exceeded the supply, and channel bed elevations began to decrease. By November 12, 2011, (approximately) the river bed had returned to an elevation close to the pre-breach grade, and water stage readings stabilized.

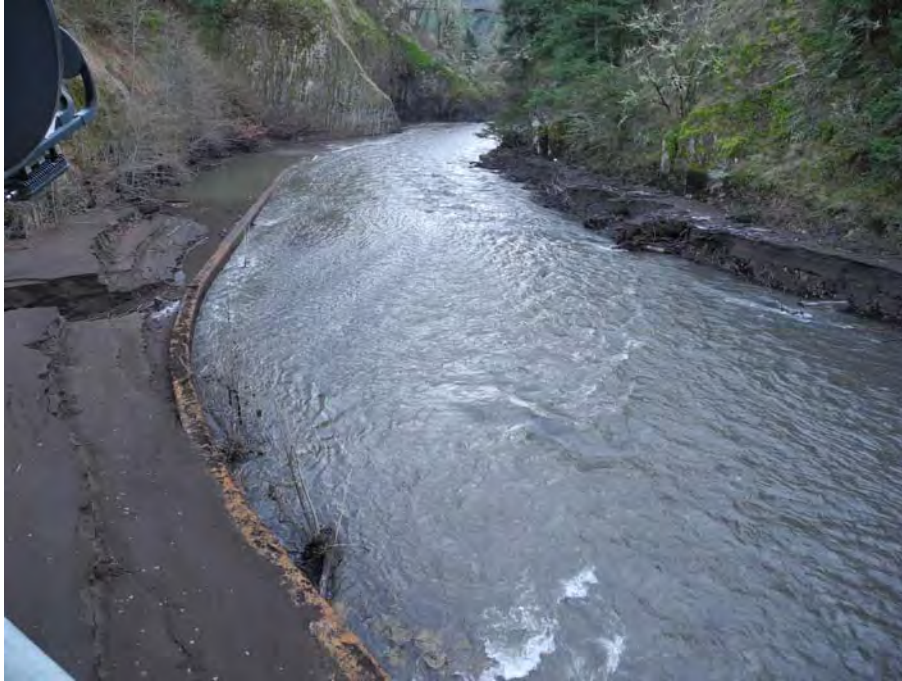
As the water levels dropped at the Powerhouse, the level of temporary sediment filling of the channel bed could be seen. The photograph below shows what is left of the temporary channel bed fill, with the sediment drape line on river right (view is looking downstream).

White Salmon River at the powerhouse. View downstream. Temporary bed sediment levels can be inferred from the deposition on river right. On river left the powerhouse tailrace is presently filled with sediment. 12-7-2011.

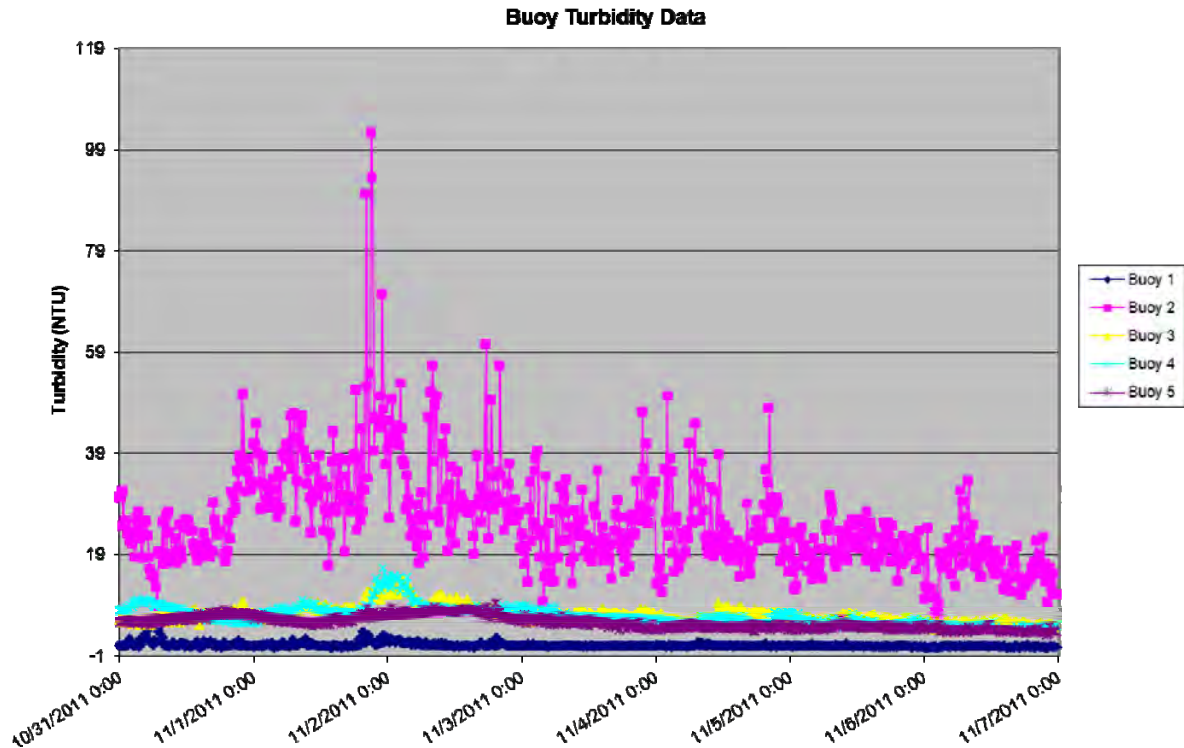
The dam breach event had an estimated peak flow rate of approximately 14,000 CFS, somewhat larger than the pre-breach estimate discharge of 10,000 - 11,000 CFS. Flows throughout the first week had significant suspended sediment concentrations (see Section 2.5). On the afternoon of October 26, 2011, a plume of muddy water was visible flowing out of the White Salmon River mouth and into the Columbia River. Increases in turbidity measured at buoys anchored in the Columbia River showed the progression of turbid water westward from the White Salmon River. The graph below shows the head of the suspended sediment plume reaching the Bonneville dam locks approximately seven days after the breach. The turbidity data collected at the buoys shows a general pattern of dilution as the sediment plume moved down the Columbia River. Buoy No. 2 is at the mouth of the White Salmon River, and buoys Nos. 3, 4, and 5 are progressively further downstream. Buoy No. 1 is also in the Columbia River, but it is upstream of the White Salmon River confluence.

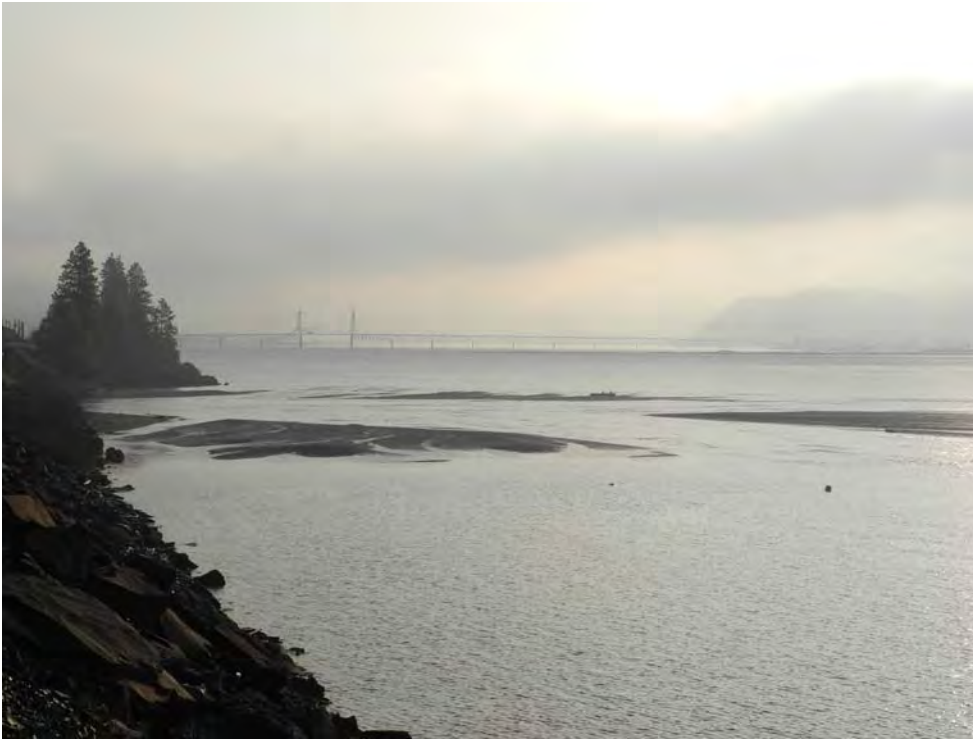
post breach before sand deposits were visible on the surface of the Columbia River at the mouth of the White Salmon River.

Columbia River at the mouth of the White Salmon River. Sand bars visible. 12-8-2011.

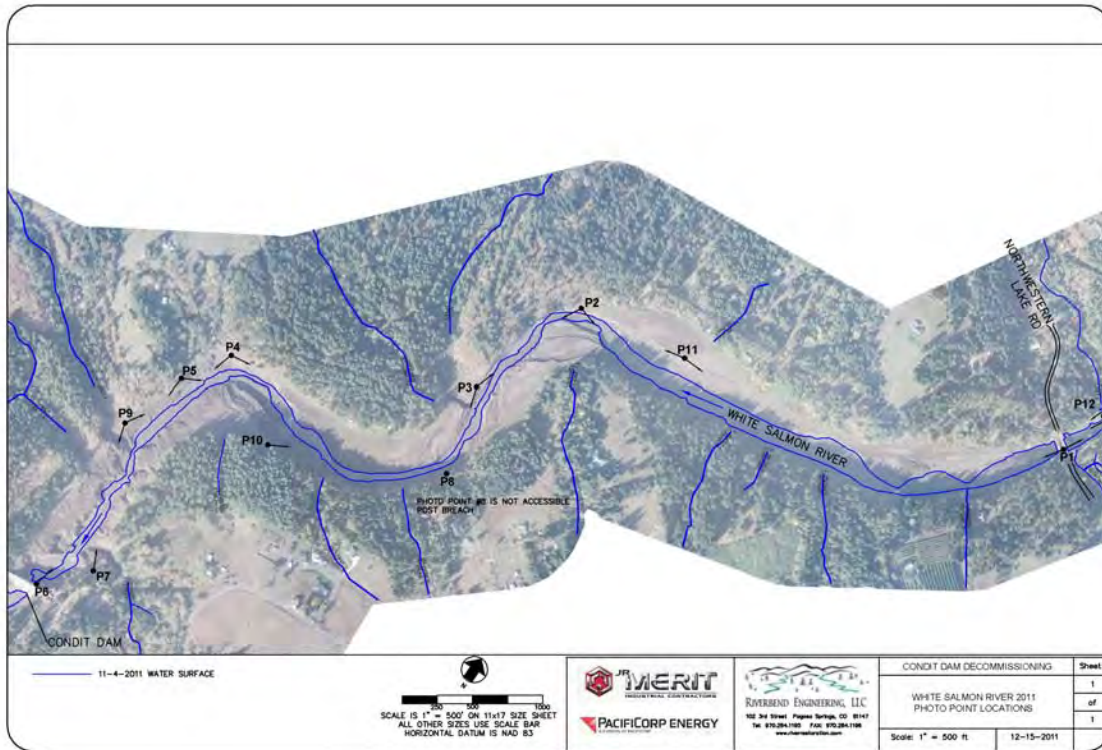
sequences are provided in Appendix A. Each photo sequence in the Appendix was continued until visible changes to the reservoir sediments were no longer evident. Data from Photo point No. 8 had to be terminated when the soil at that location collapsed into the river. Data from Photo point No. 12 commenced once the headcutting and erosion had moved upstream past Northwestern Lake Bridge.
