# Condit Hydroelectric Project Decommissioning

FERC Project No. 2342

## PRELIMINARY SEDIMENT BEHAVIOR REPORT

December 18, 2011

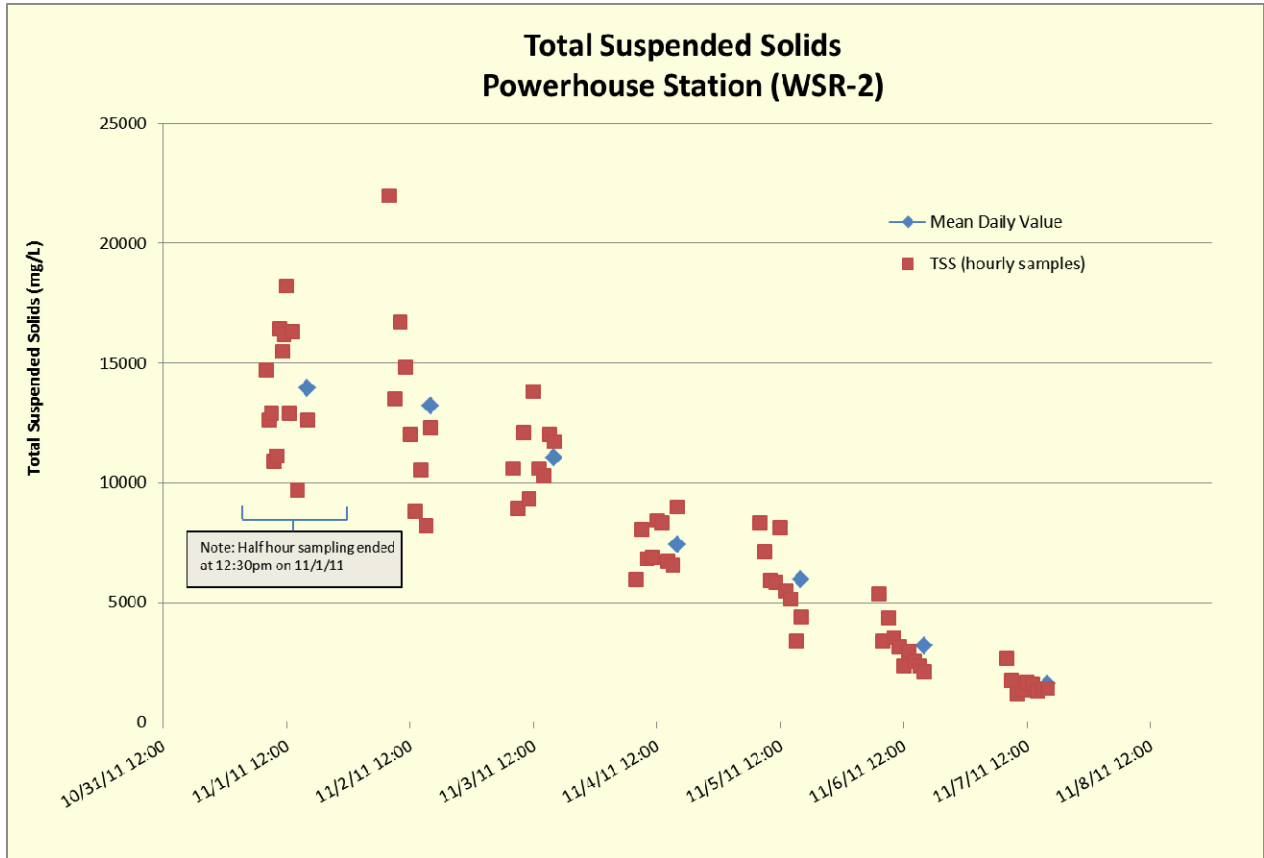
Sediment concentrations in the White Salmon River proved to be consistently larger than predicted in the Sediment Assessment, Stability and Management Plan (PacifiCorp Energy, 2011). The initial flood wave had a high concentration of suspended sediments (primarily silt size material) which quickly exceeded the upper limits for detection in the turbidity probes installed in the river. The probes had an upper limit for detection of 4,000 Nephelometric Turbidity Units (NTUs). Manual collection of water and suspended sediment samples were commenced immediately and continued for the following two weeks, until the concentrations came down enough to be detected by the 4,000 NTU turbidity probe. Suspended sediment samples collected manually were tested in the laboratory for Total Suspended Solids (TSS). Measured data points are shown in the figure below. The TSS fraction of the total sediment load was significant, but indirect observations suggest that a large amount of bedload sediment transport was occurring simultaneously. Bedload sampling was not performed during or after the breach event, so there is no quantitative means to estimate the peak concentration of total sediment load in the White Salmon River. Based on field observations, it is possible that the peak sediment load was in the range of 50,000 - 100,000 parts per million (PPM).

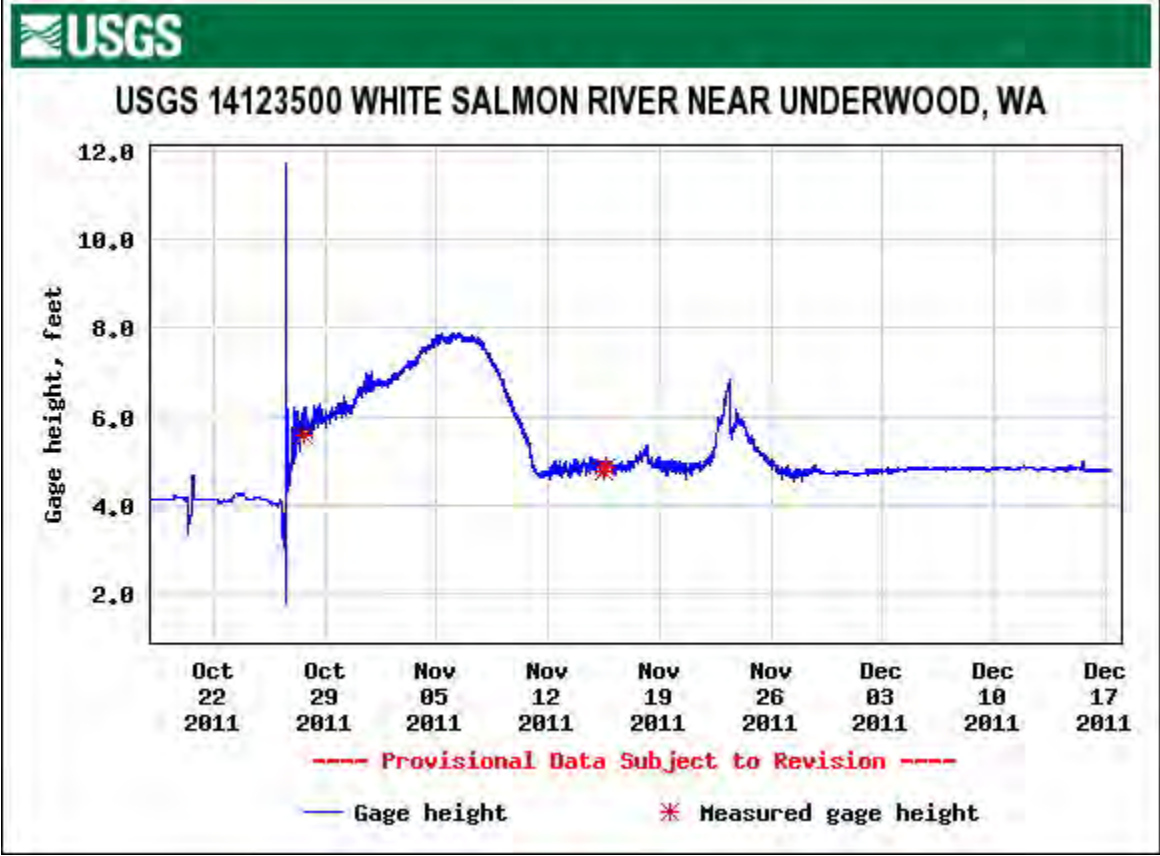
Bedload concentrations certainly increased in the days after the breach event, as high volumes of sand-size particles were mobilized from the reservoir area. Field observations at the Powerhouse showed the water surface rising daily for the first 10-11 days post breach. It is believed that this rise in water surface was due to a rising channel bed: sand-size sediments temporarily filling up the bottom of the channel. Anecdotal observations at a staff gage upstream of the reservoir suggest that water flow in the river did not change substantially during this 10-day period, remaining at around 700 cubic feet per second (CFS). Direct measurement of water surface (stage) has been recorded continuously at the USGS stream gage (USGS Gage No. 14123500) in the lower White Salmon River. Assuming the water flow in the river remained consistent during the first two weeks post breach, then the USGS stage data is analogous to the changes in river bed elevation from temporary sand deposits. During this two-week period, sediment supply to the canyon reach exceeded the sediment transport capacity of the river, allowing the excess sediments to be deposited in the riverbed. Beginning on approximately November 8, 2011, the sediment supply began to decrease, the sediment transport capacity of the river exceeded the supply, and channel bed elevations began to decrease. By November 12, 2011, (approximately) the river bed had returned to an elevation close to the pre-breach grade, and water stage readings stabilized.

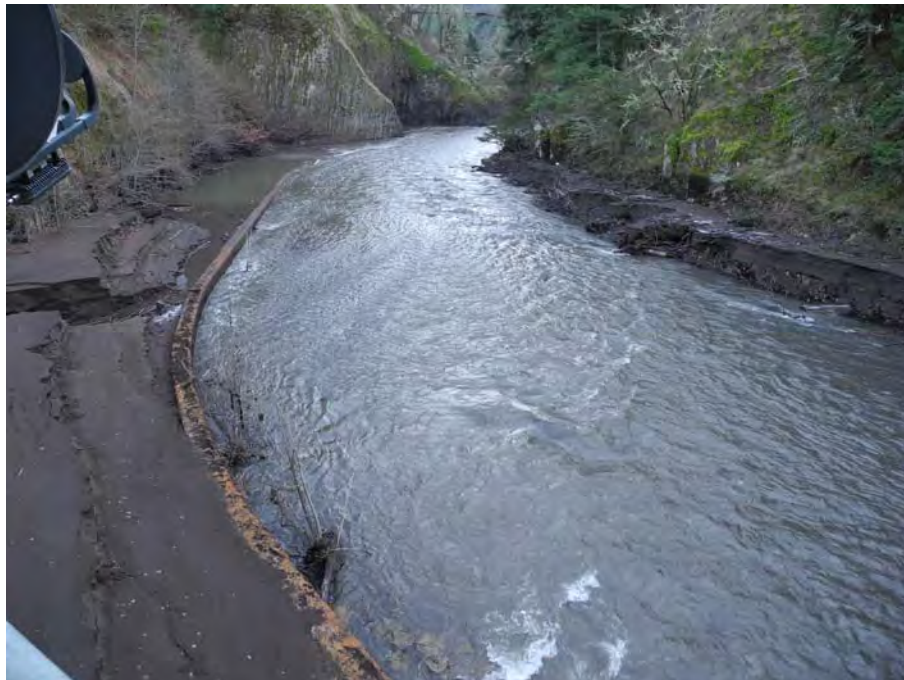
As the water levels dropped at the Powerhouse, the level of temporary sediment filling of the channel bed could be seen. The photograph below shows what is left of the temporary channel bed fill, with the sediment drape line on river right (view is looking downstream).

*White Salmon River at the powerhouse. View downstream. Temporary bed sediment levels can be inferred from the deposition on river right. On river left the powerhouse tailrace is presently filled with sediment. 12-7-2011.*

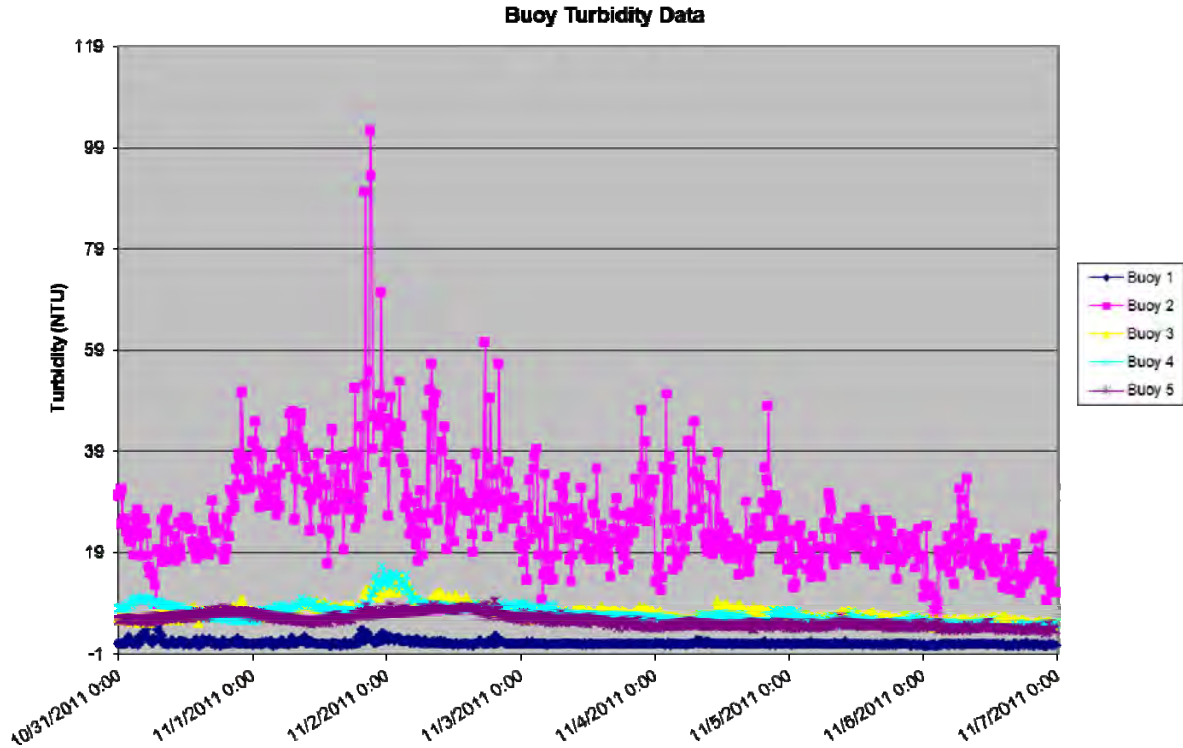
The dam breach event had an estimated peak flow rate of approximately 14,000 CFS, somewhat larger than the pre-breach estimate discharge of 10,000 - 11,000 CFS. Flows throughout the first week had significant suspended sediment concentrations (see Section 2.5). On the afternoon of October 26, 2011, a plume of muddy water was visible flowing out of the White Salmon River mouth and into the Columbia River. Increases in turbidity measured at buoys anchored in the Columbia River showed the progression of turbid water westward from the White Salmon River. The graph below shows the head of the suspended sediment plume reaching the Bonneville dam locks approximately seven days after the breach. The turbidity data collected at the buoys shows a general pattern of dilution as the sediment plume moved down the Columbia River. Buoy No. 2 is at the mouth of the White Salmon River, and buoys Nos. 3, 4, and 5 are progressively further downstream. Buoy No. 1 is also in the Columbia River, but it is upstream of the White Salmon River confluence.

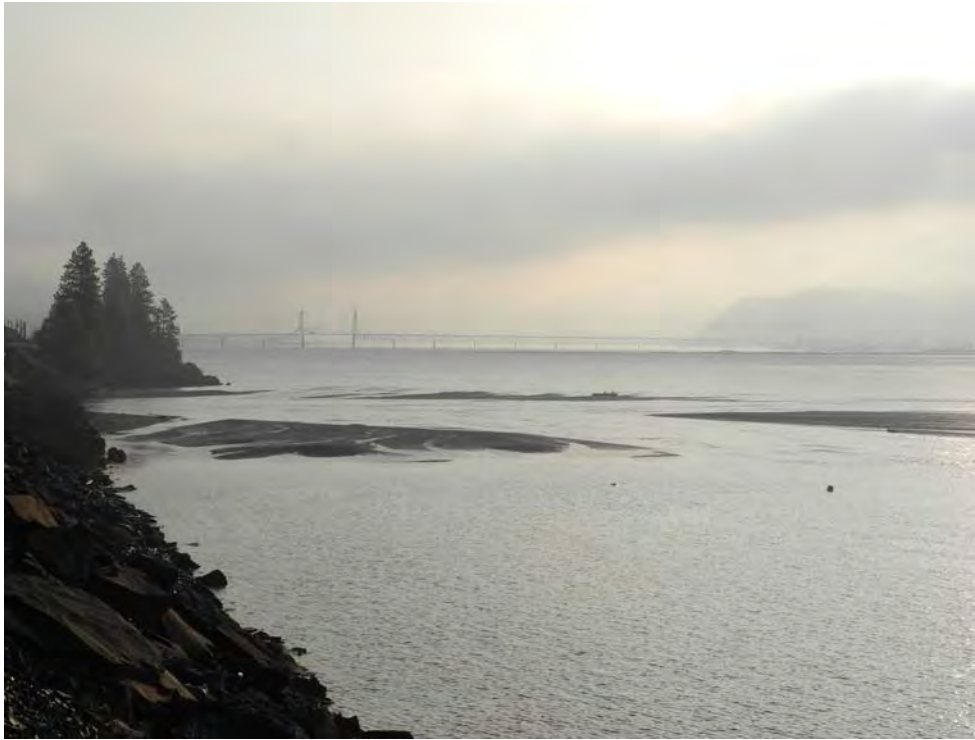
post breach before sand deposits were visible on the surface of the Columbia River at the mouth of the White Salmon River.

*Columbia River at the mouth of the White Salmon River. Sand bars visible. 12-8-2011.*

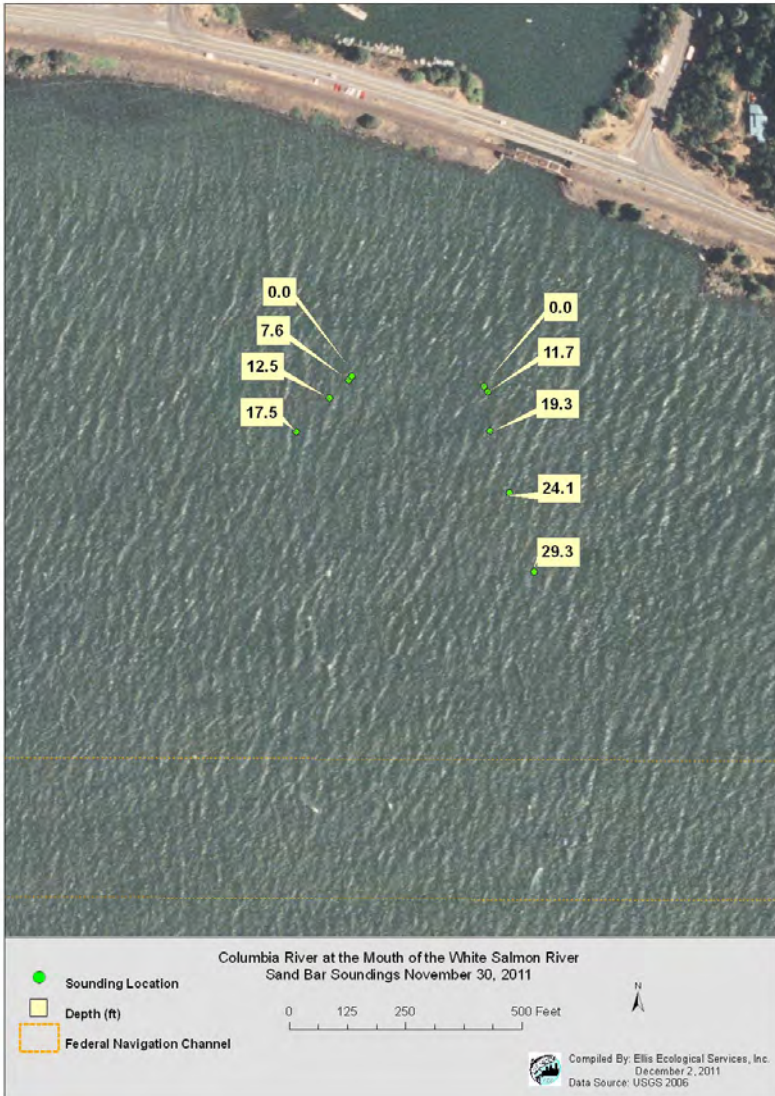
Bathymetric surveys conducted in the Columbia River at the mouth of the White Salmon River in the first week post breach revealed approximately 433,000 cubic yards deposited. It is apparent that the bulk of the bedload sediment volume had taken weeks rather than days to reach the Columbia River. A limited number of sediment depth data points were collected on November 30, 2011. These data points and depth are shown on the figure below, as is the commercial navigation channel (faint yellow line). The Coast Guard has placed a lighted, warning buoy at the outer extent off the sediment deposition area to prevent small craft from running aground.

*Columbia River at the mouth of the White Salmon River. Depth to sediment surface, measurements taken on 11-30-2011. Note: photography is from an earlier date.*
