# Condit Hydroelectric Project Decommissioning

FERC Project No. 2342

## PRELIMINARY SEDIMENT BEHAVIOR REPORT

December 18, 2011

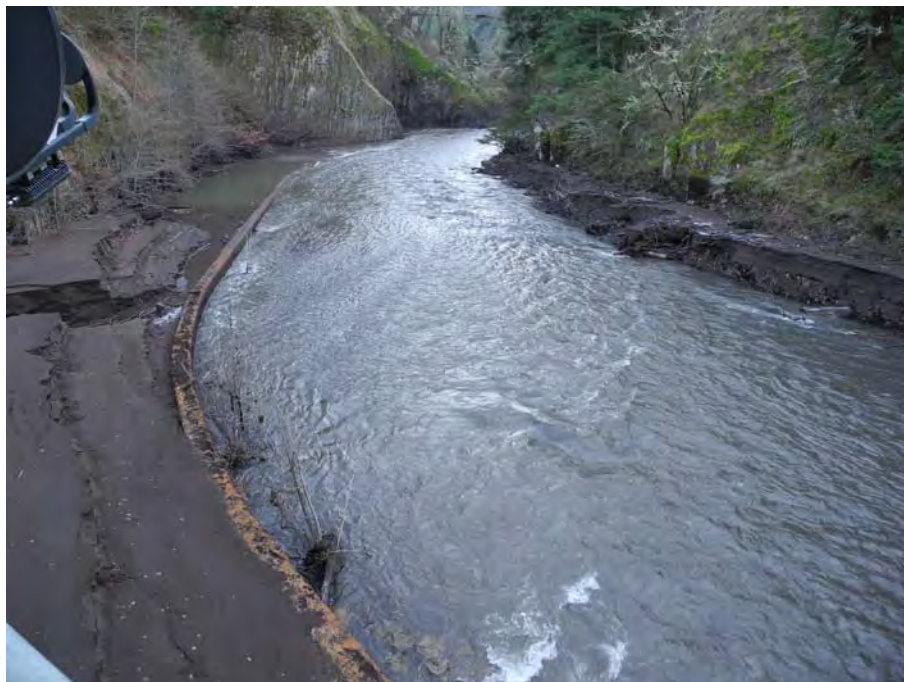
As the water levels dropped at the Powerhouse, the level of temporary sediment filling of the channel bed could be seen. The photograph below shows what is left of the temporary channel bed fill, with the sediment drape line on river right (view is looking downstream).

*White Salmon River at the powerhouse. View downstream. Temporary bed sediment levels can be inferred from the deposition on river right. On river left the powerhouse tailrace is presently filled with sediment. 12-7-2011.*
