2016 Coal Combustion Residuals Annual Inspection

Dave Johnston Power Plant *Industrial Landfill*

Prepared for
PacifiCorp
North Temple Office
1407 West North Temple
Salt Lake City, Utah 84116

November 23, 2016

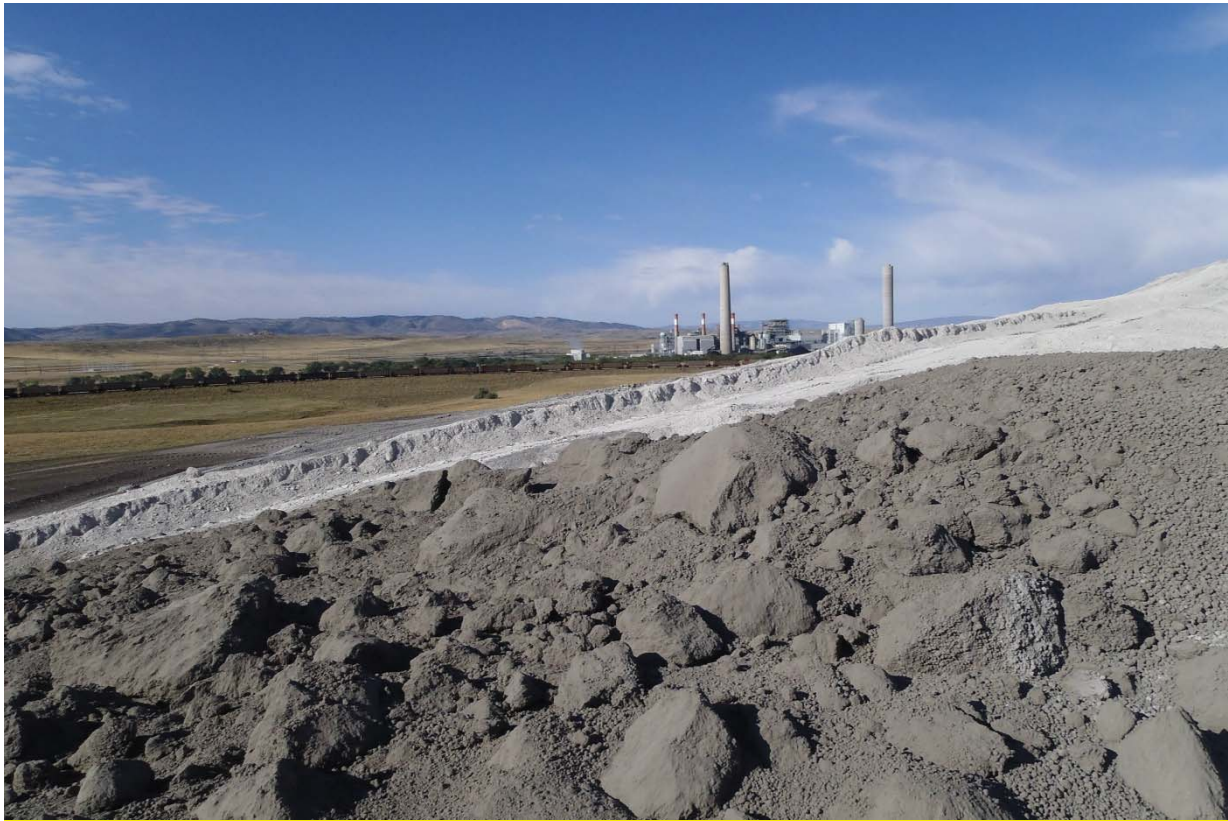
Photograph No. 1 View of stage 2 of the expansion landfill looking west.

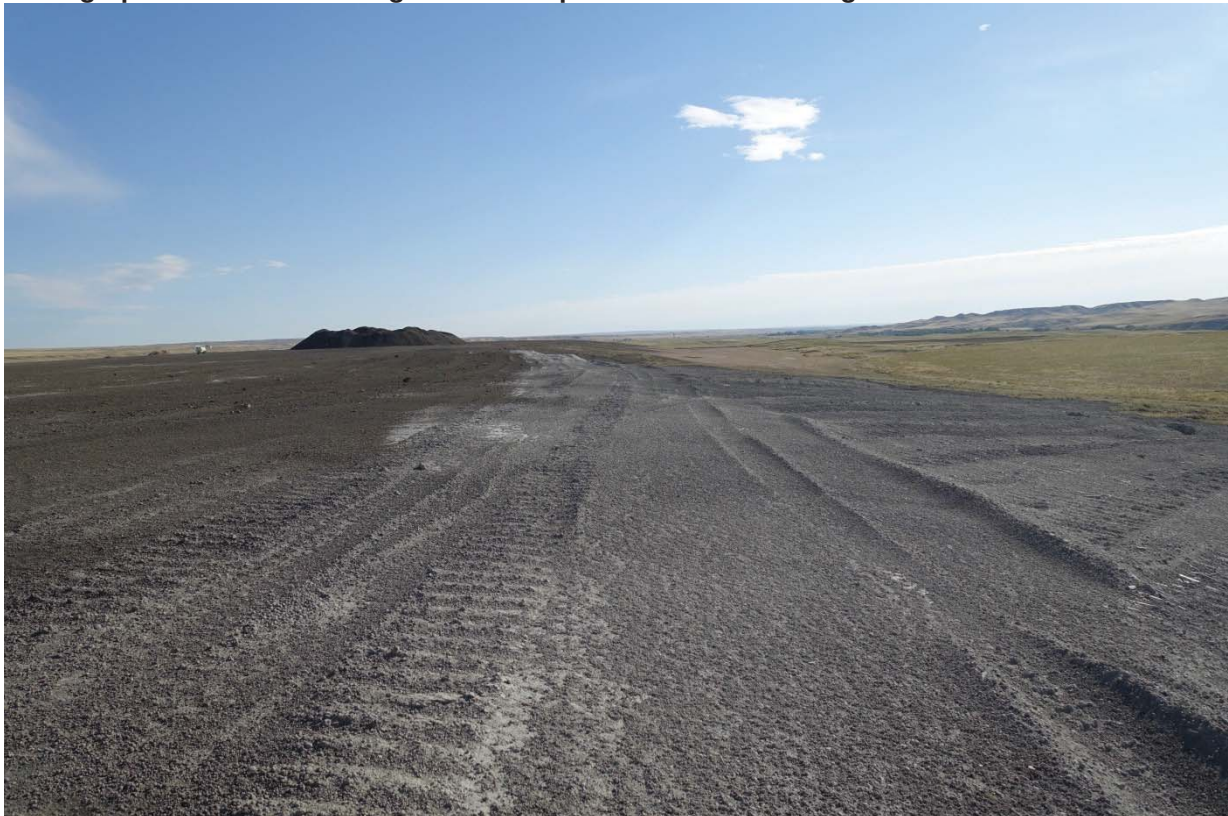
Photograph No. 2 View of stage 2 of the expansion landfill looking east.

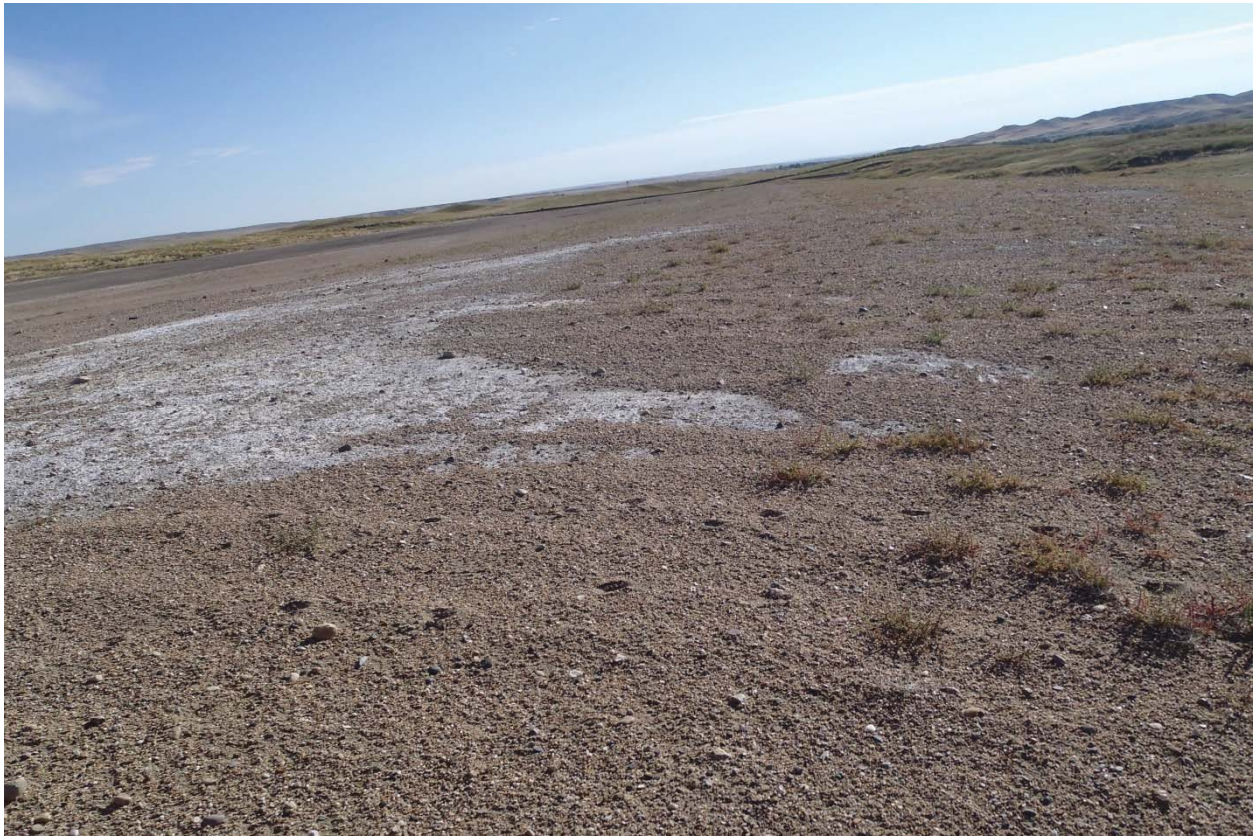
Photograph No. 3 View of stage 3 of the landfill looking west.

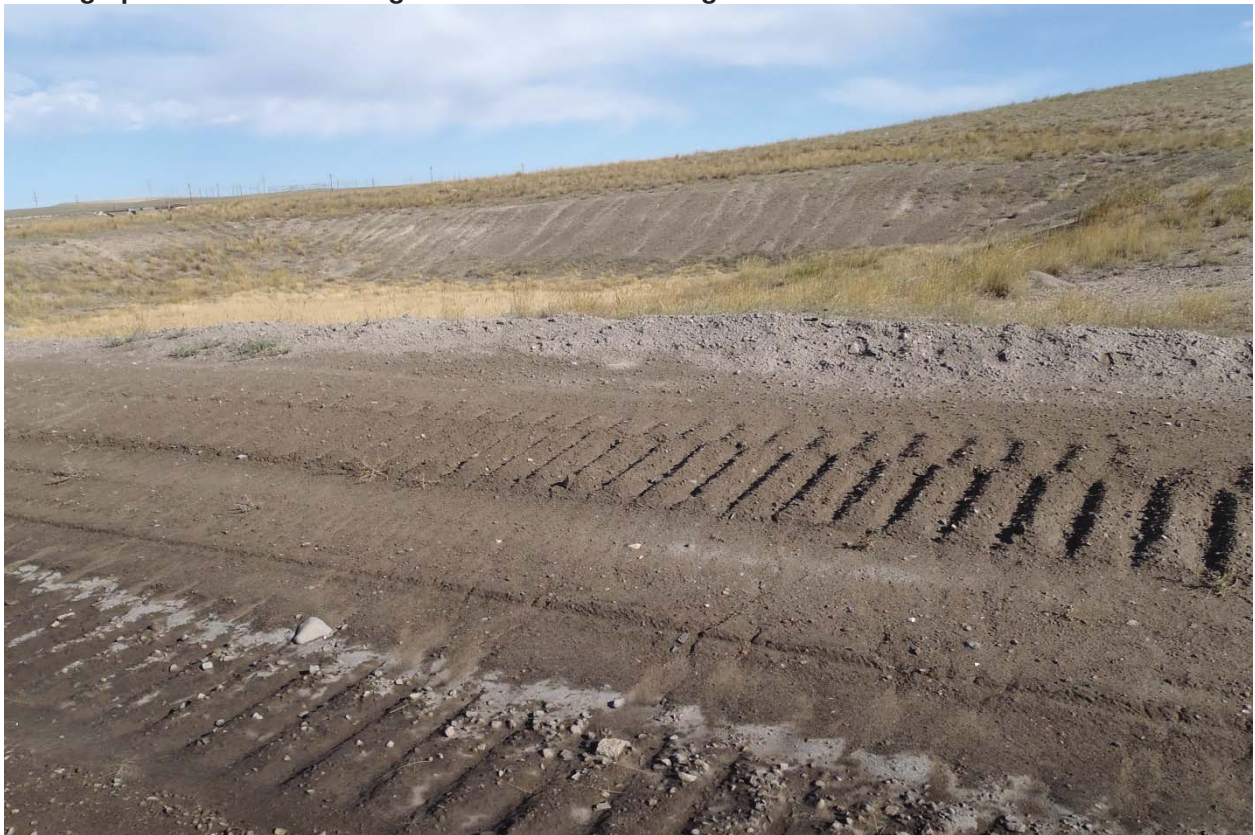
Photograph No. 4 View of landfill western retention basin.

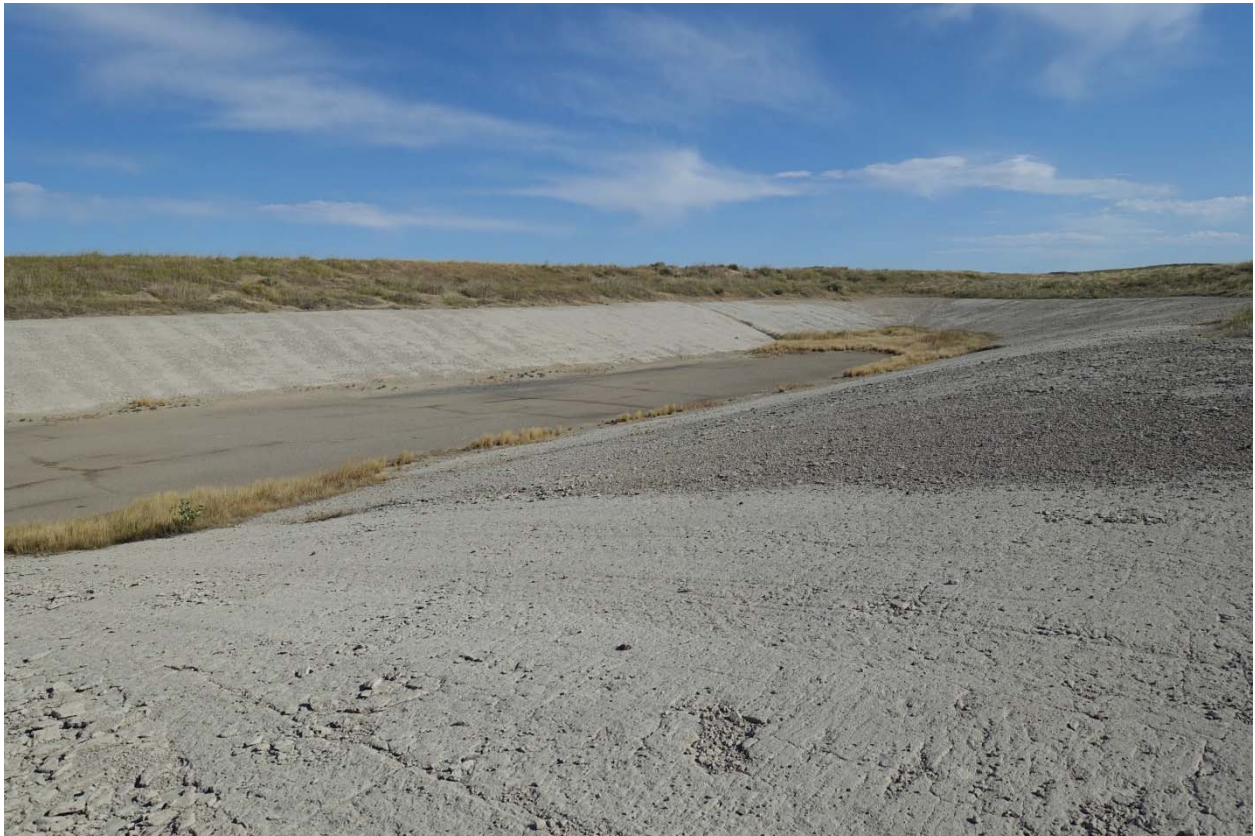
Photograph No. 5 View of landfill eastern retention basin.

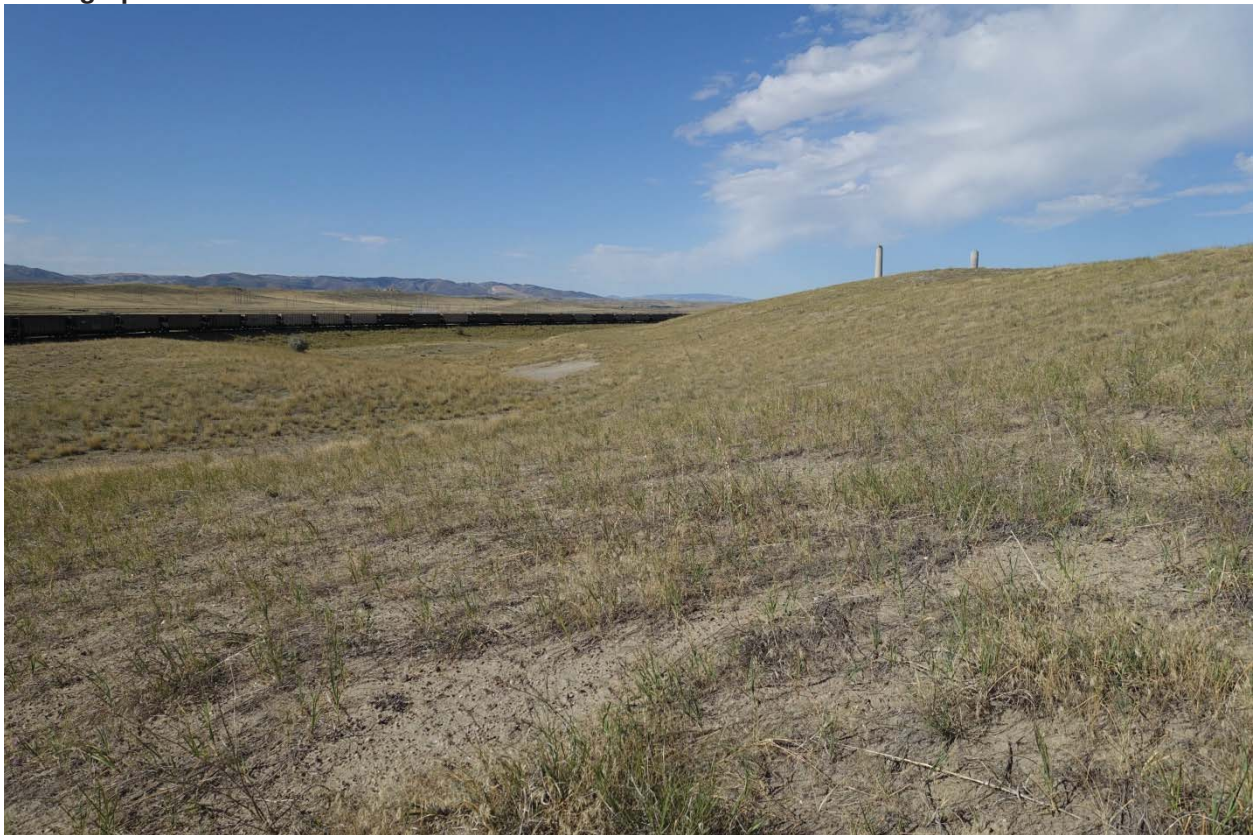
Photograph No. 6 View of closed area of landfill looking west.

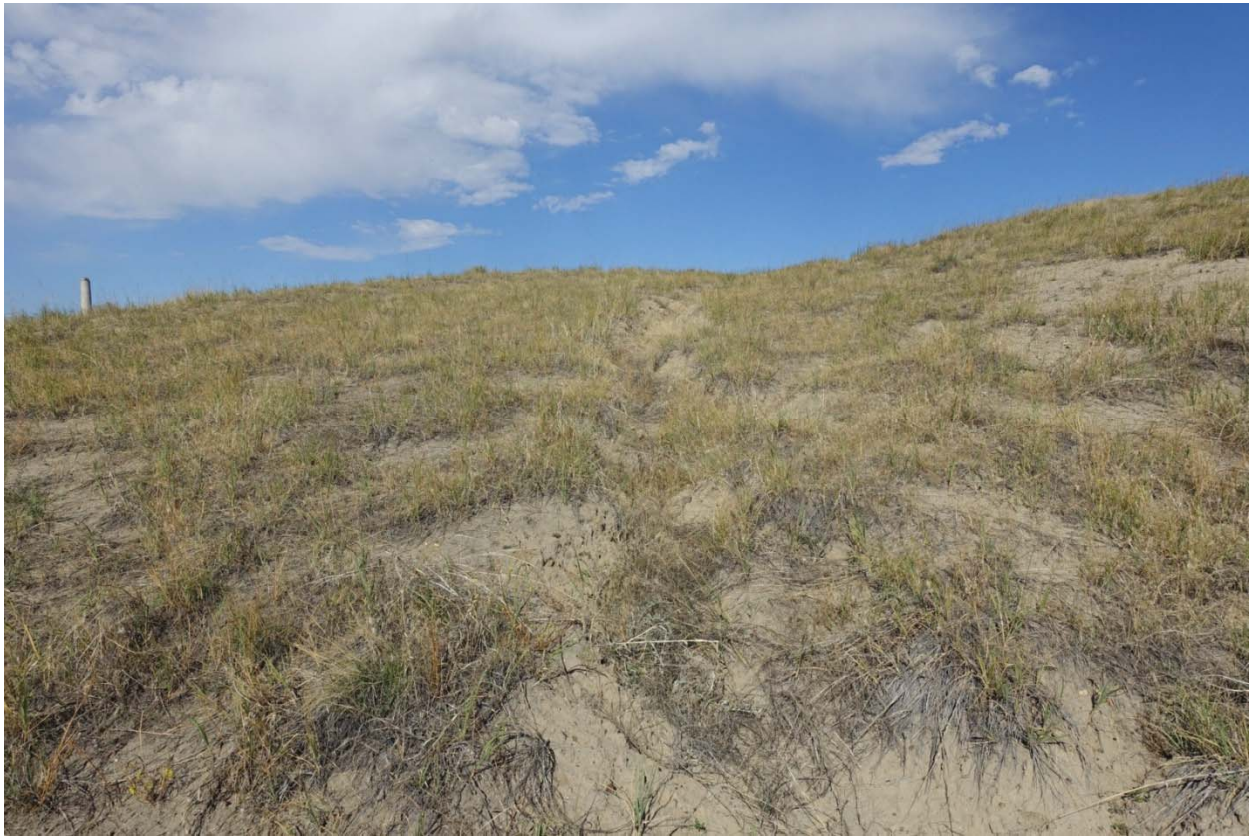
There are no reported incidences of slope failure or movement of the landfill embankment in the record files. There has been some minor erosion of the final cover on the south face of Stage 1. Refer to Photos 7 and 8, Appendix A.

Photograph No. 7 View of erosion rill on south face of stage 1.

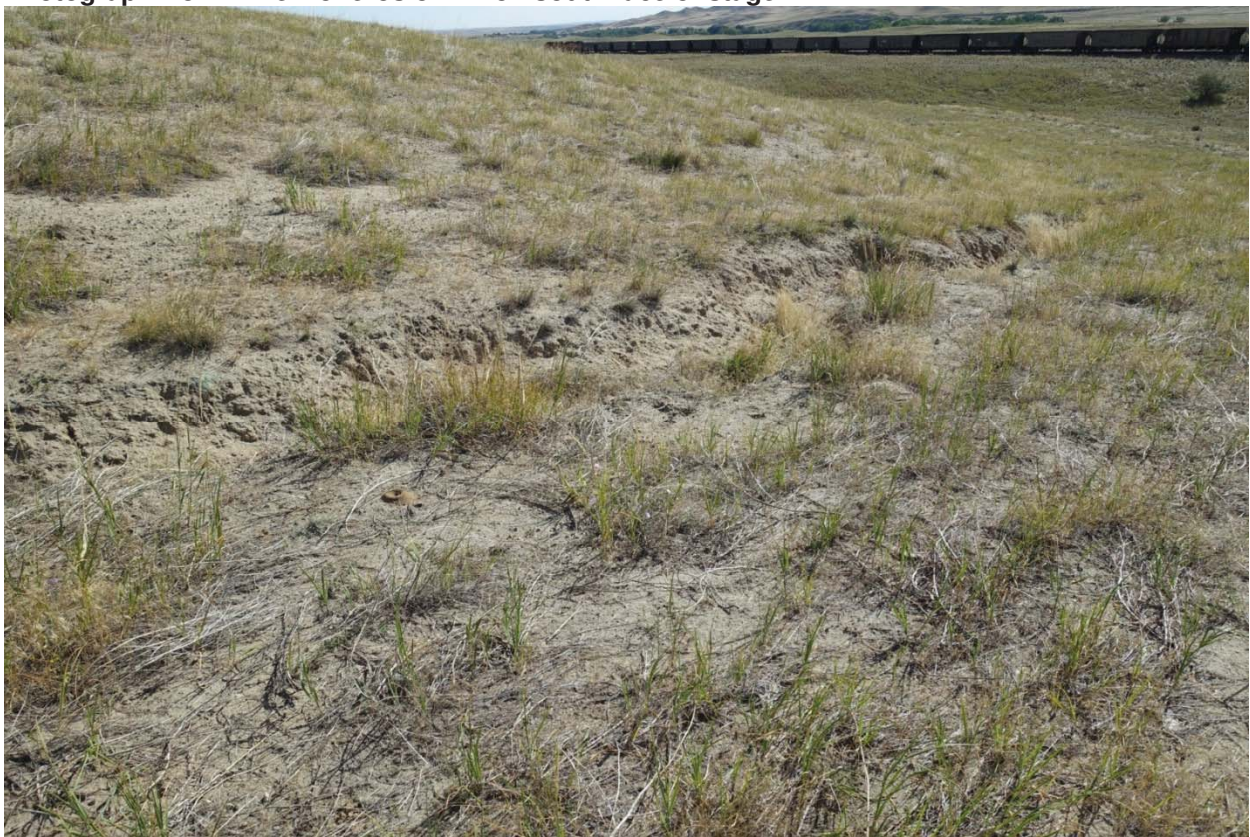
Photograph No. 8 View of erosion rill.

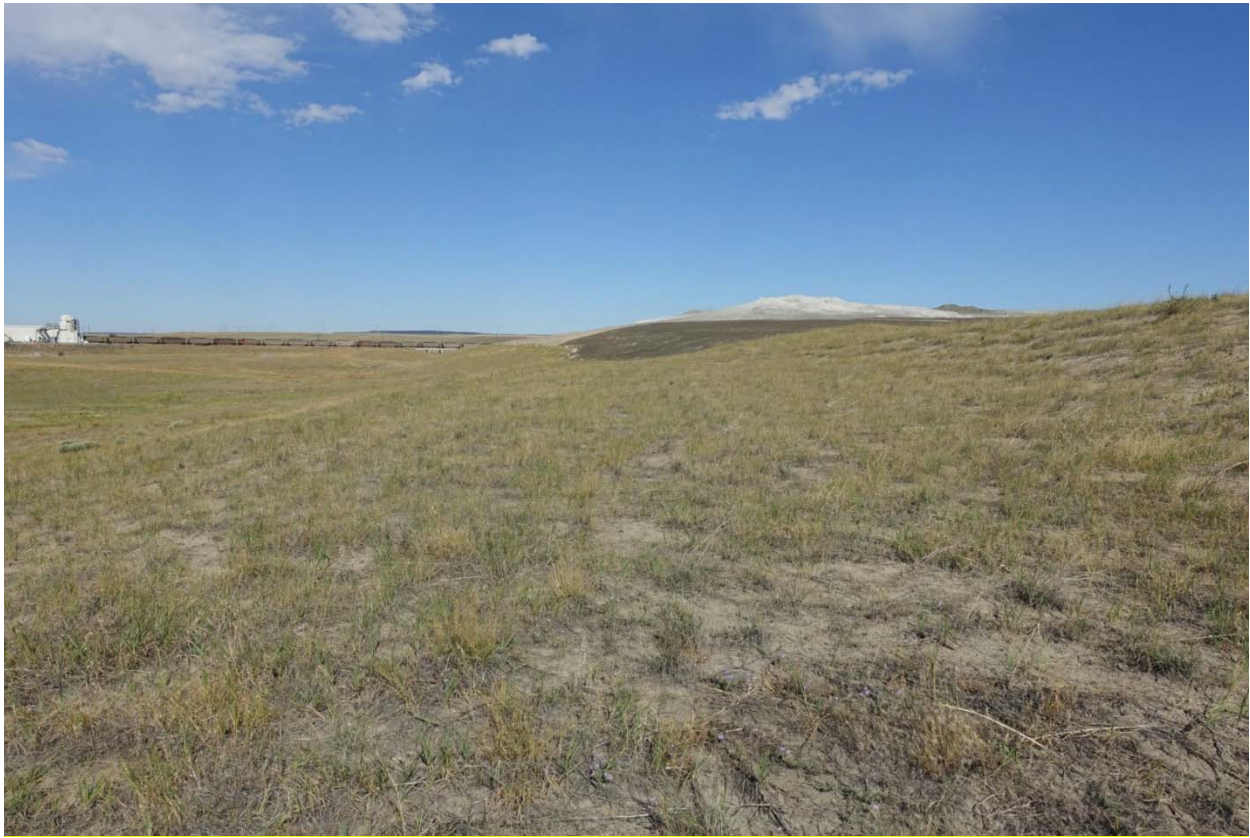
Photograph No. 9 View of stage 2 of the expansion landfill.
