# 2016 Coal Combustion Residuals Annual Inspection

## Hunter Power Plant

### *Hunter CCR Landfill*

November 29, 2016

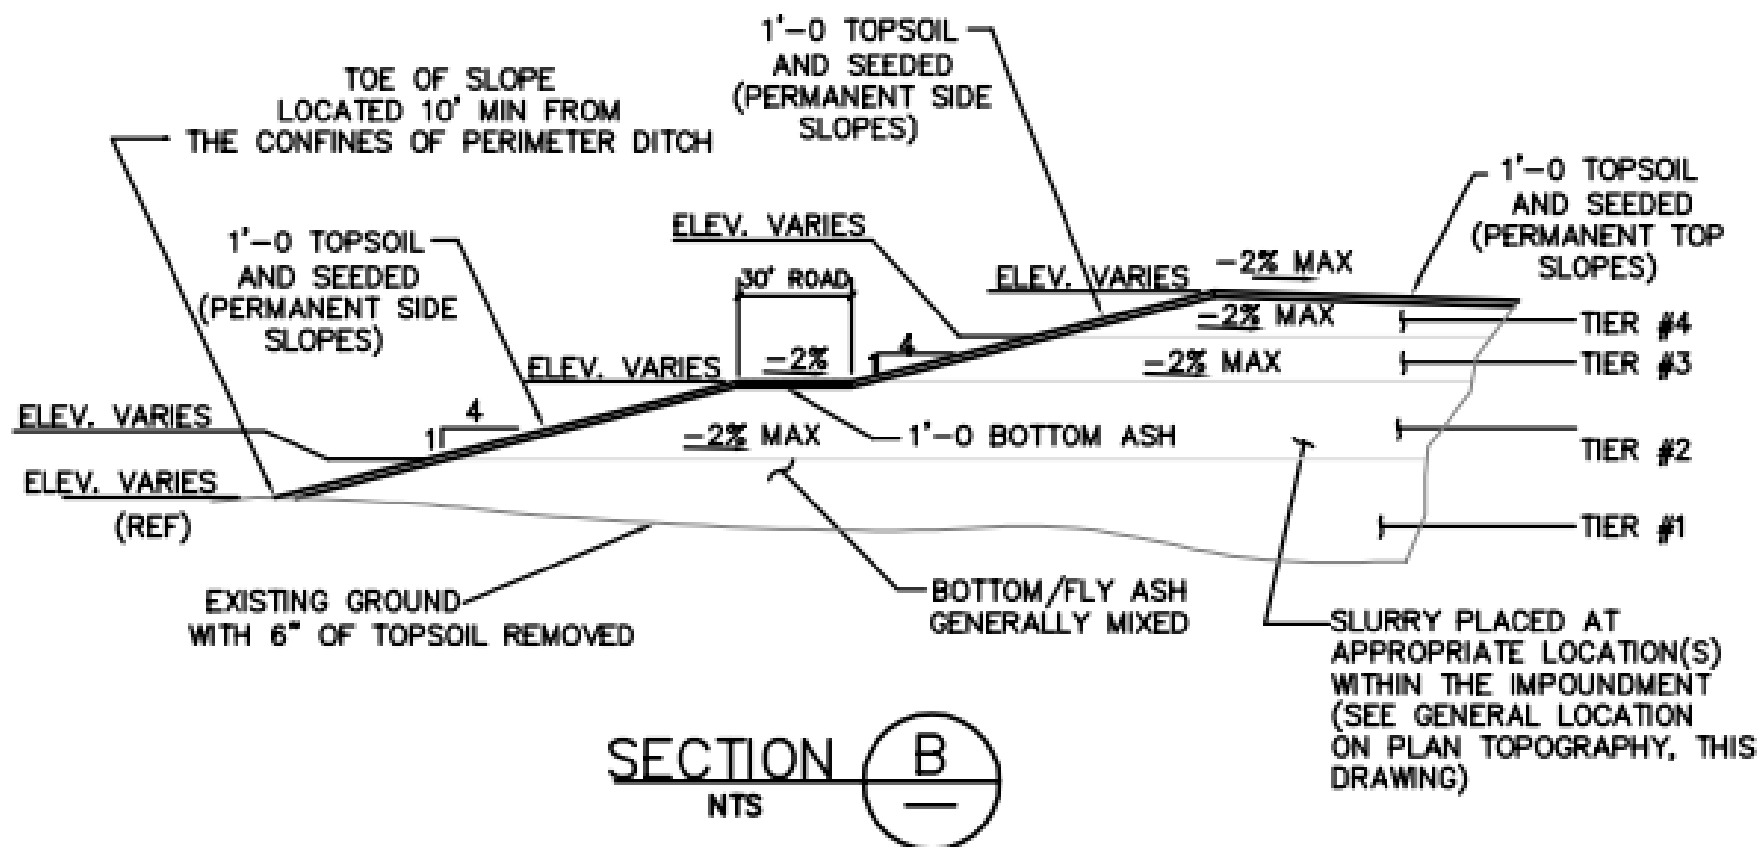
Figure 3-1. Section of South Face of Hunter Landfill [5]

Figure 3-1 shows a cross section of the embankment slope on the south face of the landfill. This section is found in the Industrial Landfill Renewal Application, June 27, 2006, Plan Sheet 3 and is typical of the other landfill faces. The slopes are a maximum of 4 horizontal to 1 vertical.

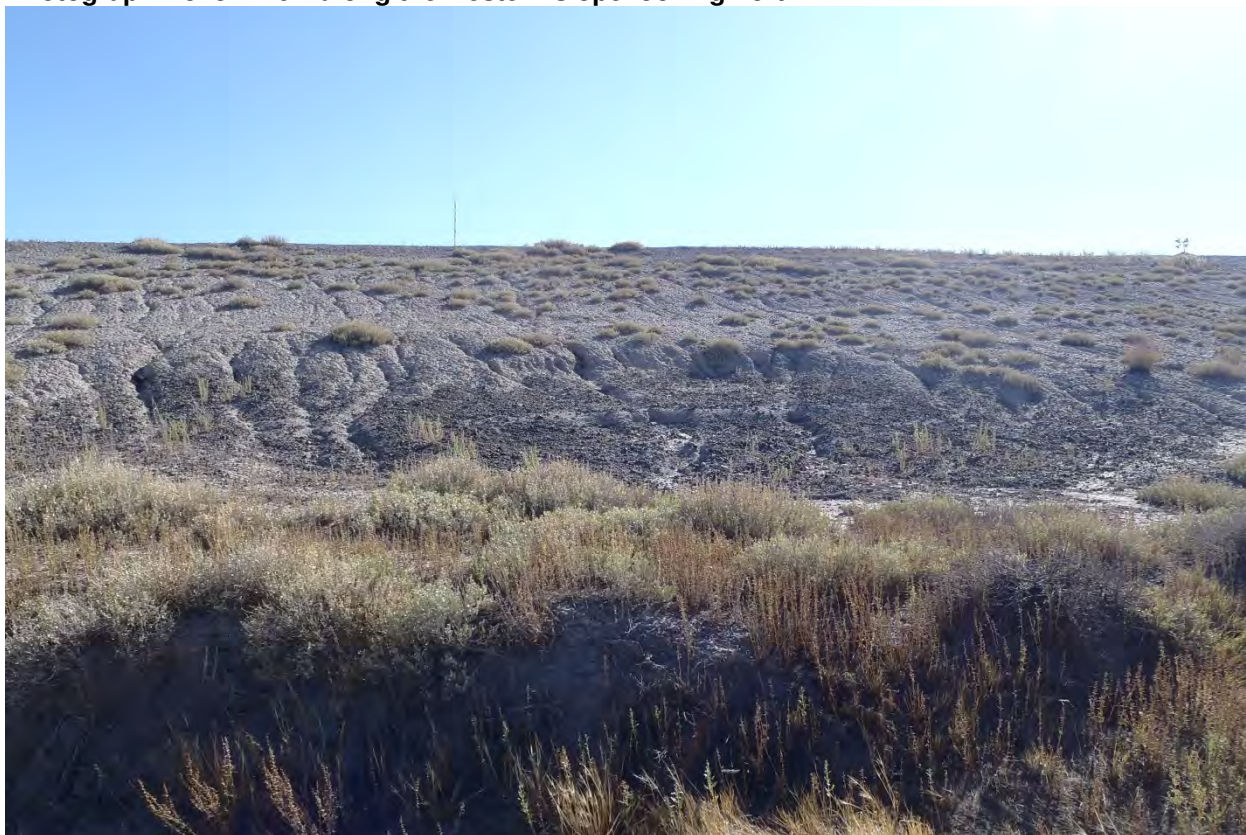
1. Observation of minor erosion rills and shallow gullies. Refer to photograph 4 and 9 in Appendix A. These rills and gullies have not increased in size since the 2015 inspection and do not represent a threat to the integrity of the slopes. The eroded material has been retained at the toe of the embankment and there is no potential for it to move off site. This erosion is superficial and will be covered with closure of the slopes.

**Photograph No. 4 View of minor erosion rills along southern slope.**

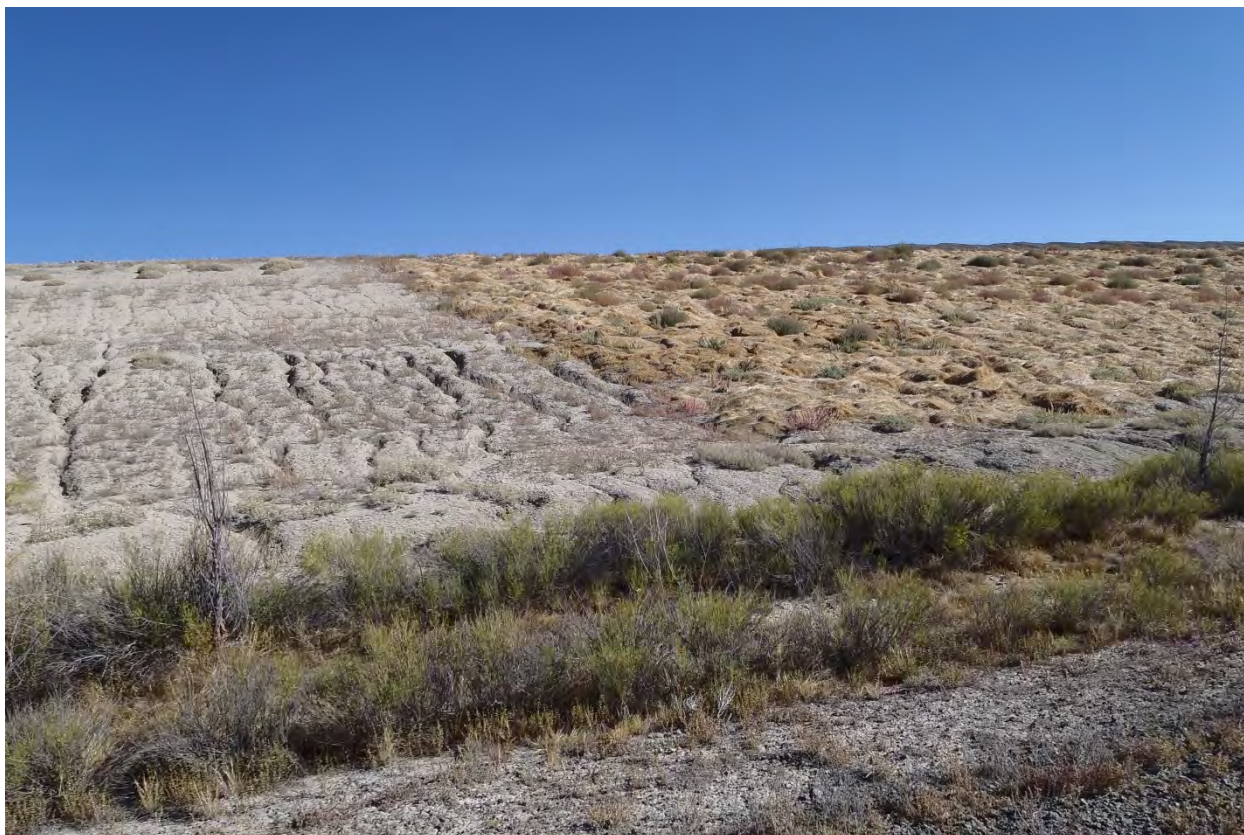
1. Vegetation is established on the south and southeast slopes of the landfill amended with hay. There was no topsoil on the upper half of this area. The lower half has topsoil. Photographs 9, 10, and 11
2. The permanent survey monument outside the landfill used for aerial photography and the associated target is in good condition. Only one observed, photograph 23.

**Photograph No. 9 View of erosion control along eastern slope. Notice vegetation difference.**

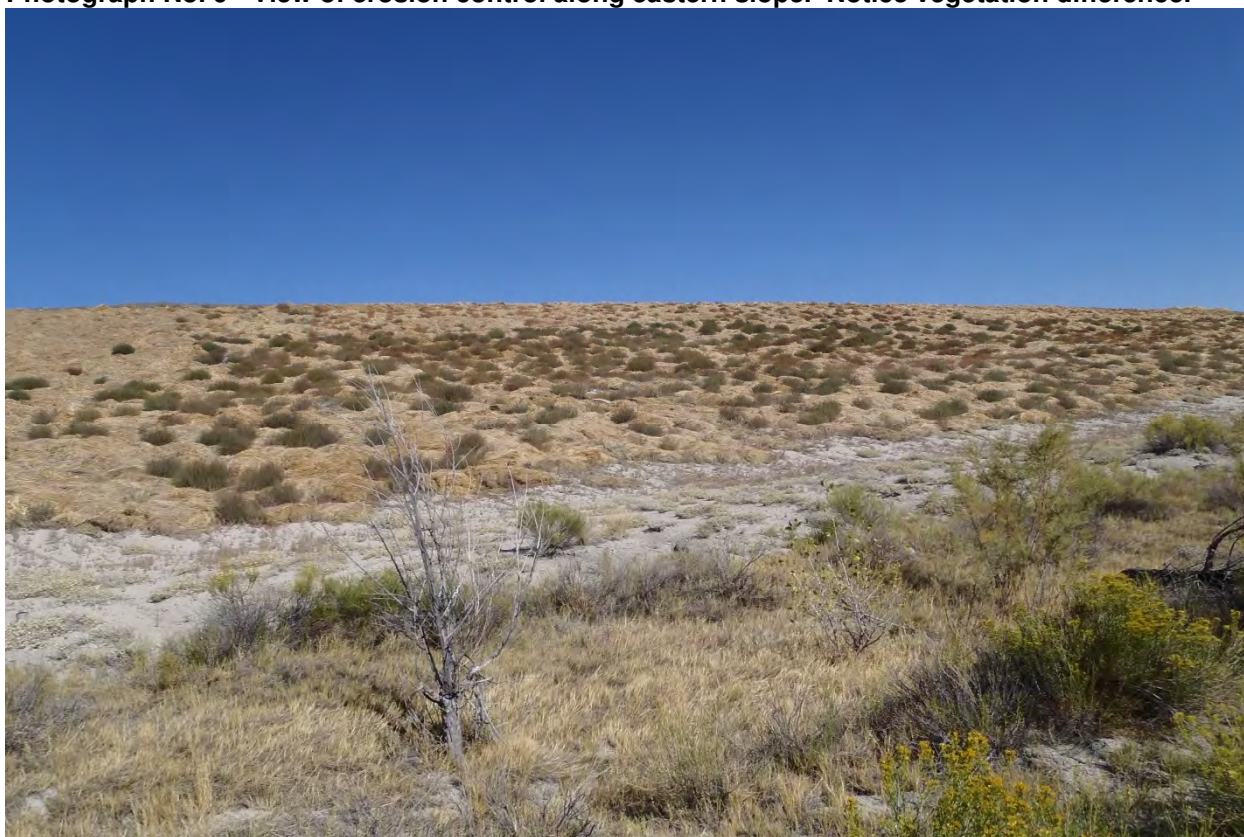
**Photograph No. 10 View of erosion control along eastern slope.**

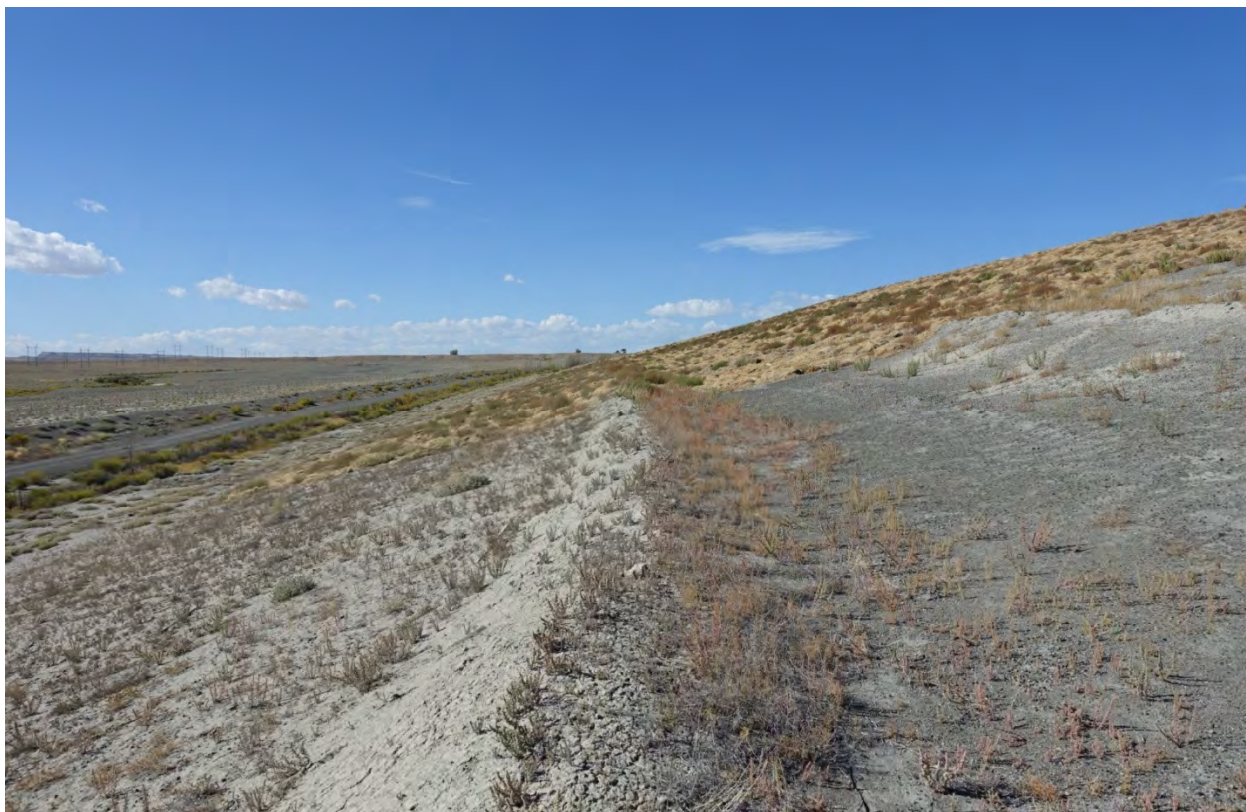
**Photograph No. 11 View of erosion control along eastern slope looking south.**

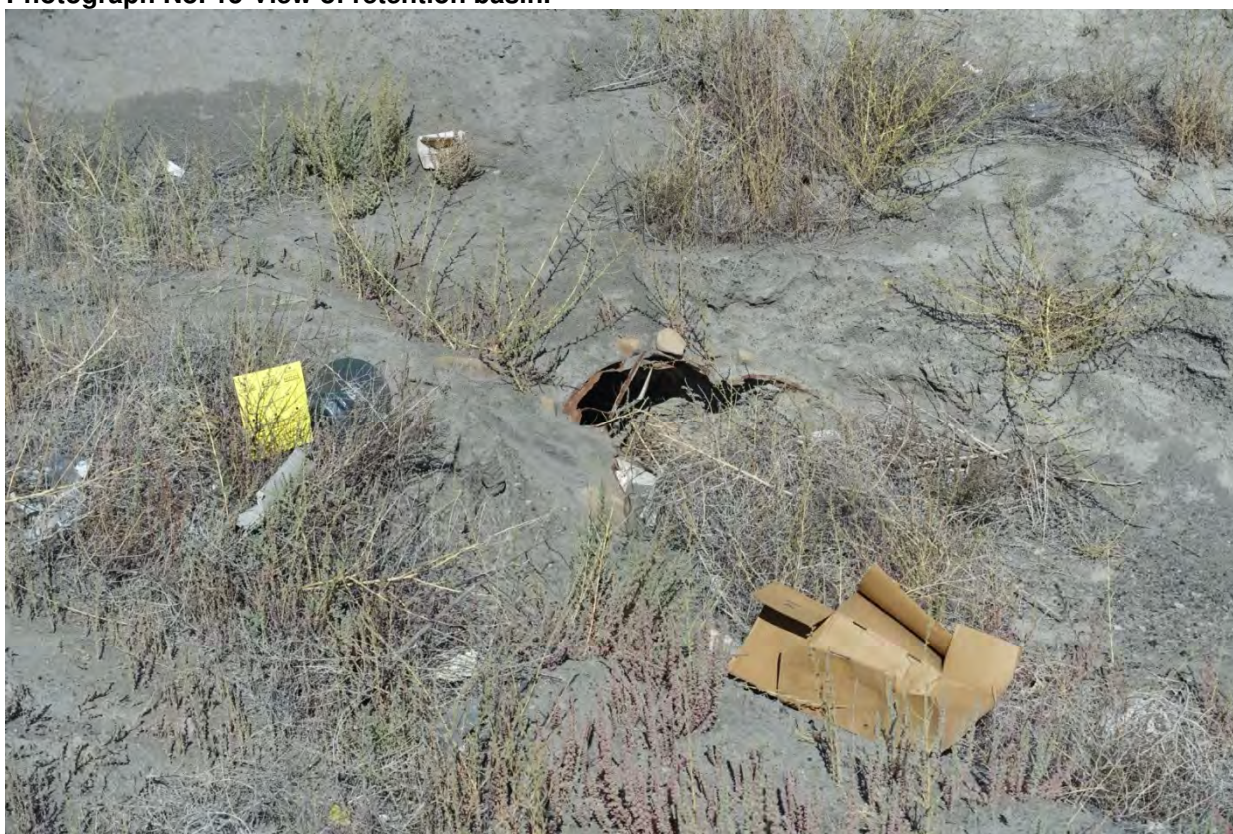
**Photograph No. 16 View of plugged culvert along northern slope. West side of road.**

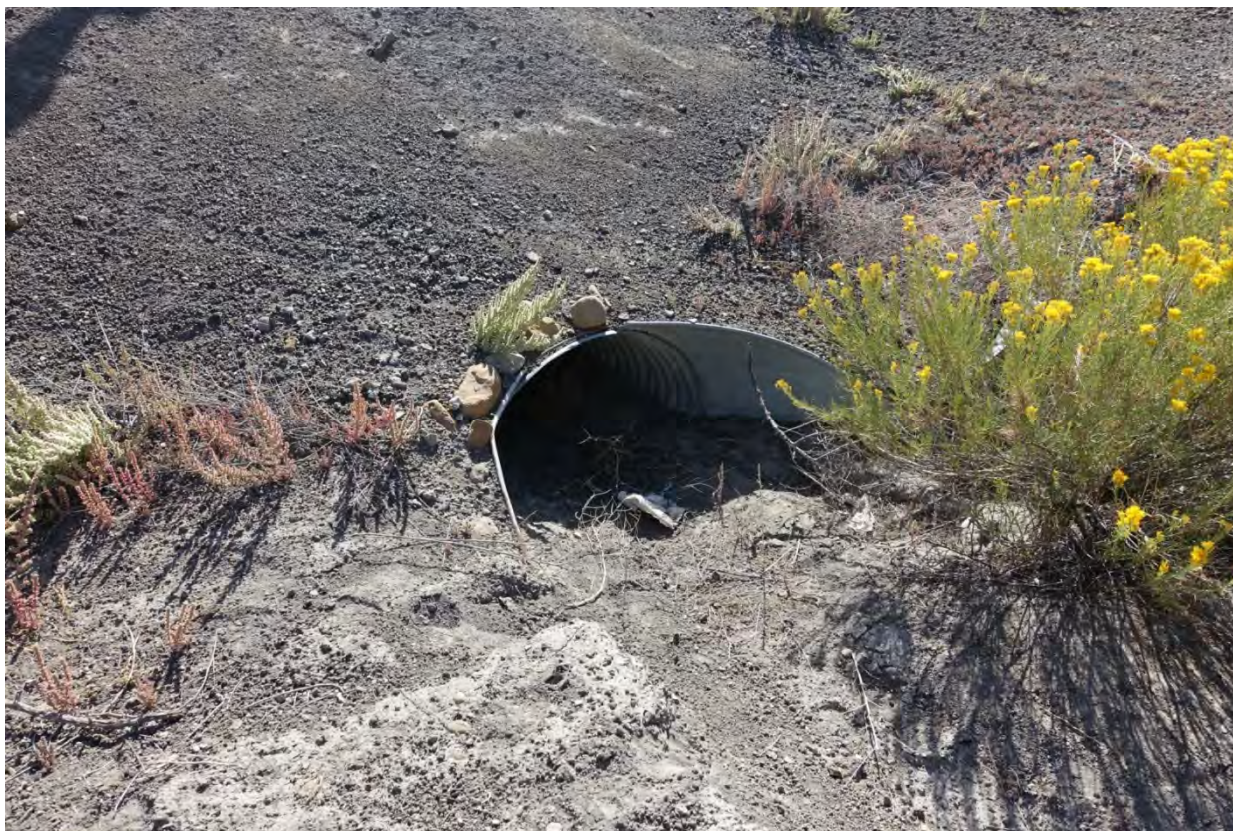
**Photograph No. 17 View of plugged culvert along northern slope. East side of road.**

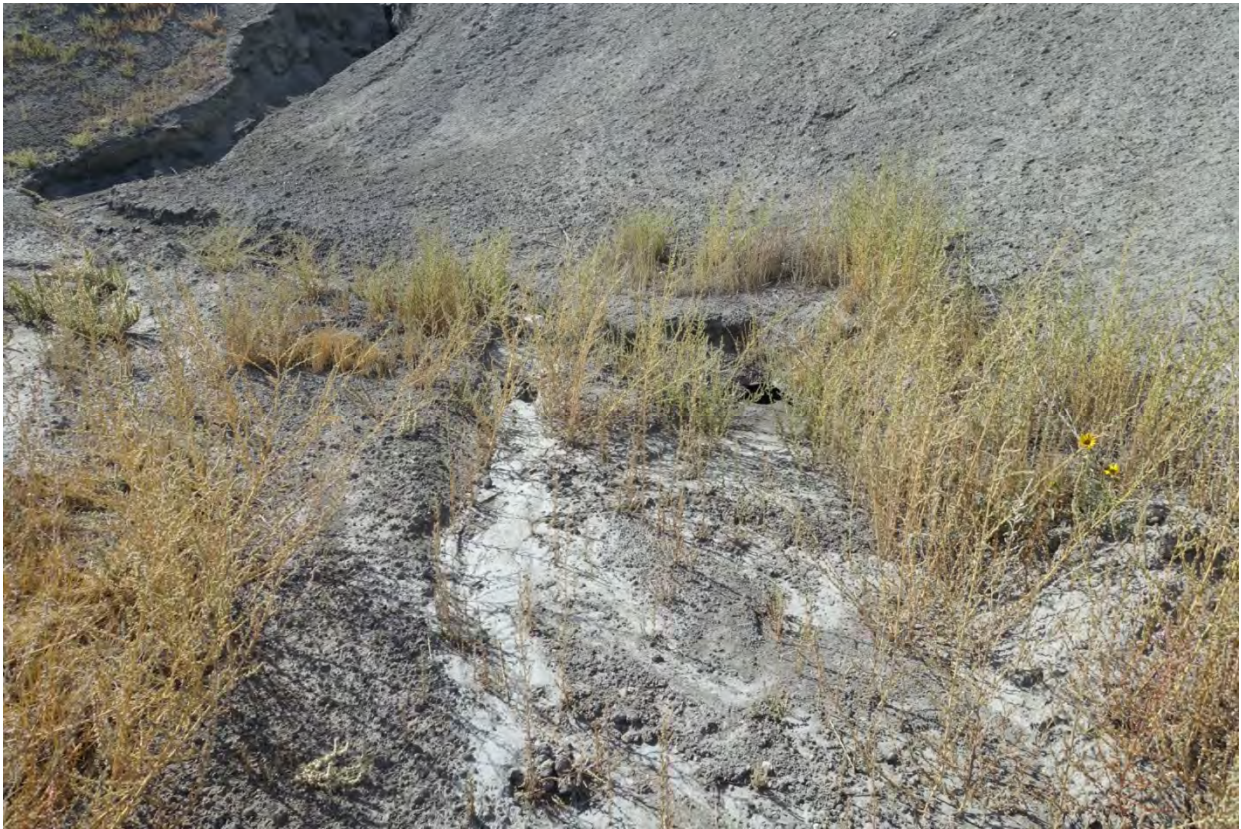
2. Possible blockage of a culvert (or non-existing culvert) in the perimeter drainage ditch at the haul road crossing. This is the same location as an erosional cut in the haul road. Refer to photograph 19 and 20 in Appendix A.

2. Possible blockage of a culvert (or non-existing culvert) in the perimeter drainage ditch at the haul road crossing. This is the same location as an erosional cut in the haul road. Refer to photograph 19 and 20 in Appendix A. The blockage was observed in 2015 and the erosion is new for 2016.

**Photograph No. 19 View of plugged culvert on north side of haul road.**

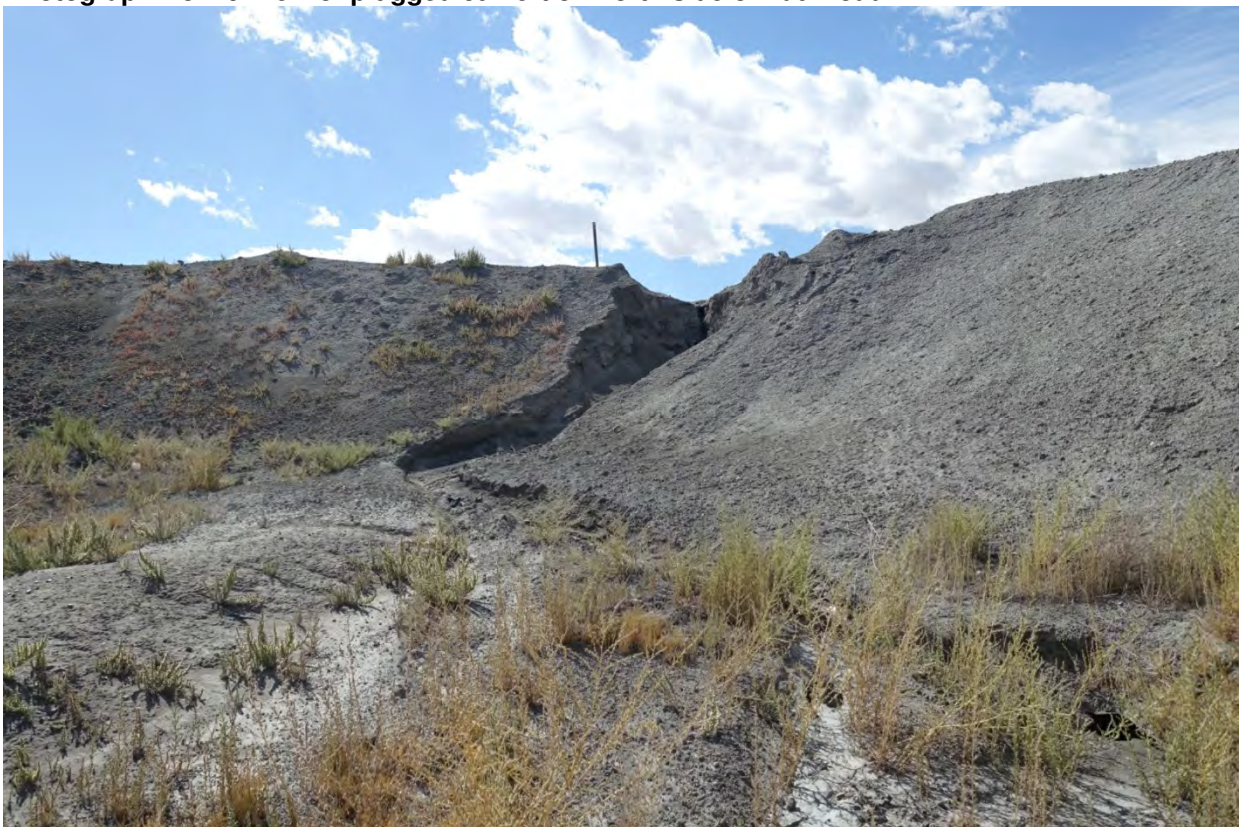
**Photograph No. 20 View of erosion rill on north side of haul road.**

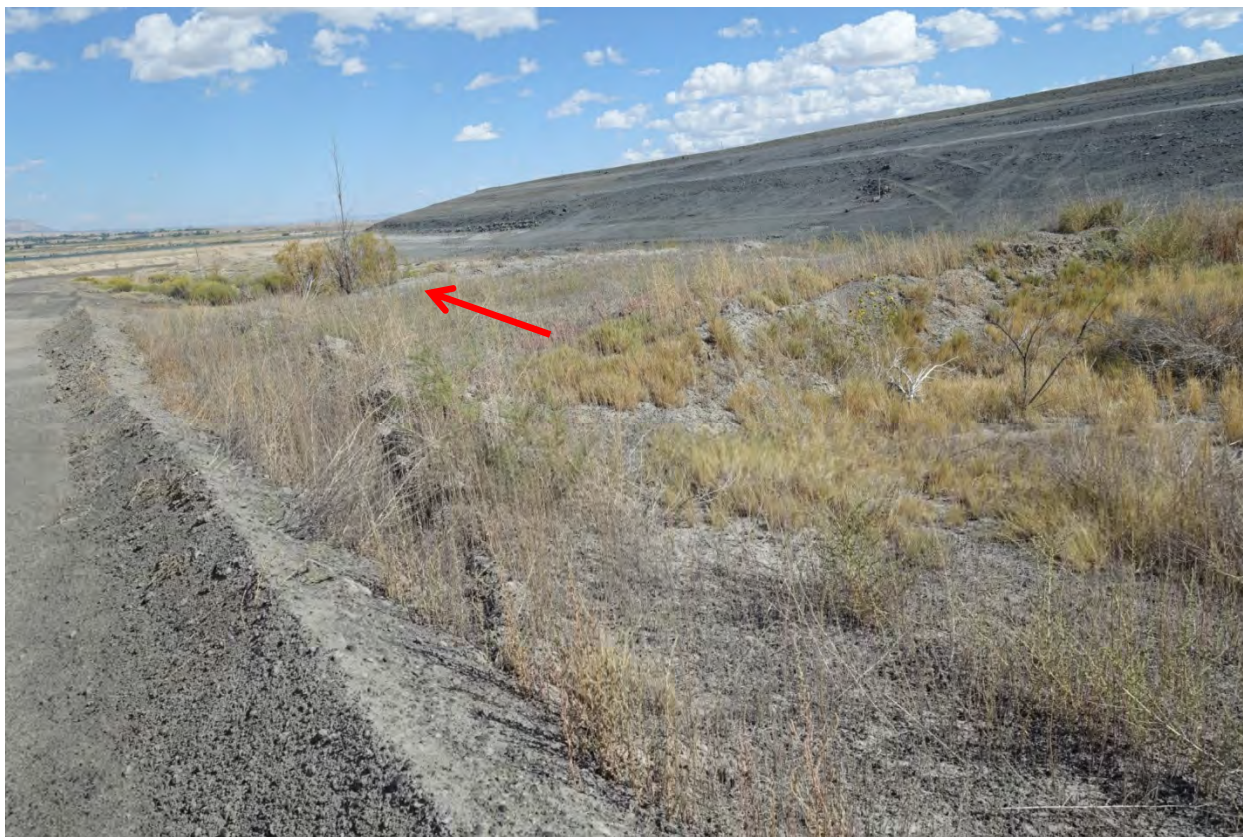
3. Blockage of the perimeter drainage ditch on the west side of the landfill. Refer to photograph 21 in Appendix A.
4. Blockage of the perimeter drainage ditch at the outfall of the horizontal drains. Refer to photograph 22 in Appendix A. This condition was necessary because of the lack of elevation to drain water from the horizontal drains. No corrective action recommended. The no action consequence is that the collection box might be inundated.

3. Blockage of the drainage ditch on the west side of the landfill. Refer to photograph 21 in Appendix A. The blockage is from a temporary road crossing. This crossing is to be removed when no longer needed.

**Photograph No. 21 View temporary “bridge.” Preventing proper ditch drainage.**

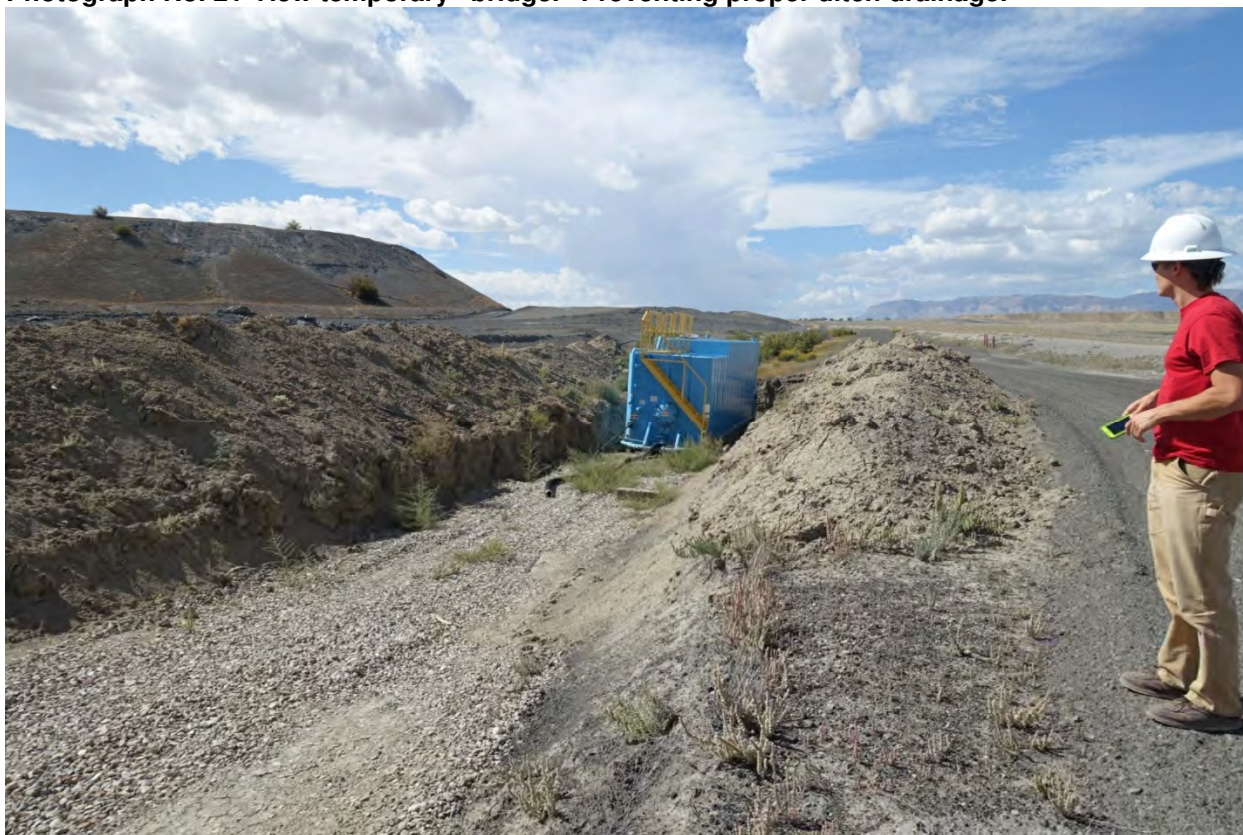
4. Blockage of the perimeter drainage ditch at the outfall of the horizontal drains. Refer to photograph 22 in Appendix A. This condition was necessary because of the lack of elevation to drain water from the horizontal drains. No corrective action recommended. The consequences are that the collection box might be inundated.

**Photograph No. 22 View of frac tank. Installed in perimeter ditch.**

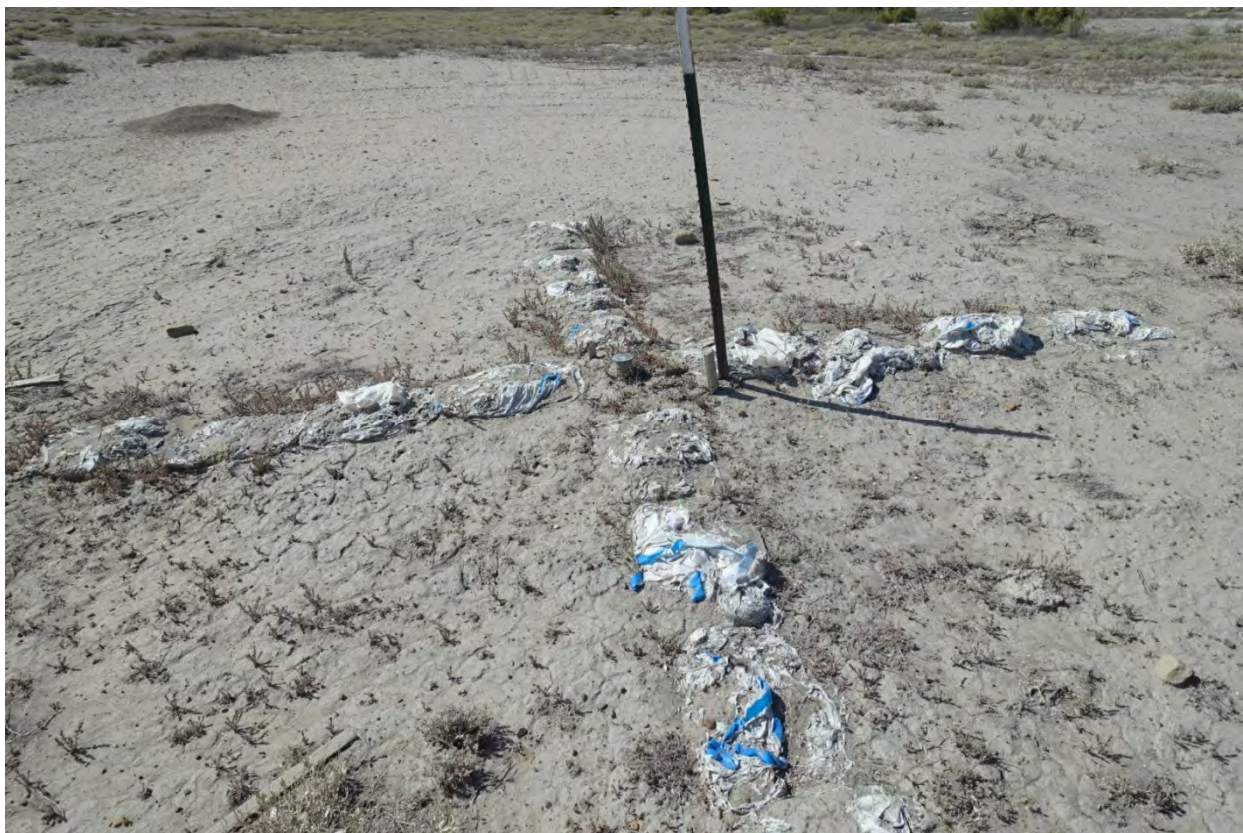
**Photograph No. 23 View of landfill survey monument.**
