# 2017 Coal Combustion Residuals Annual Inspection

## Hunter Power Plant

### *Hunter CCR Landfill*

November 30, 2017

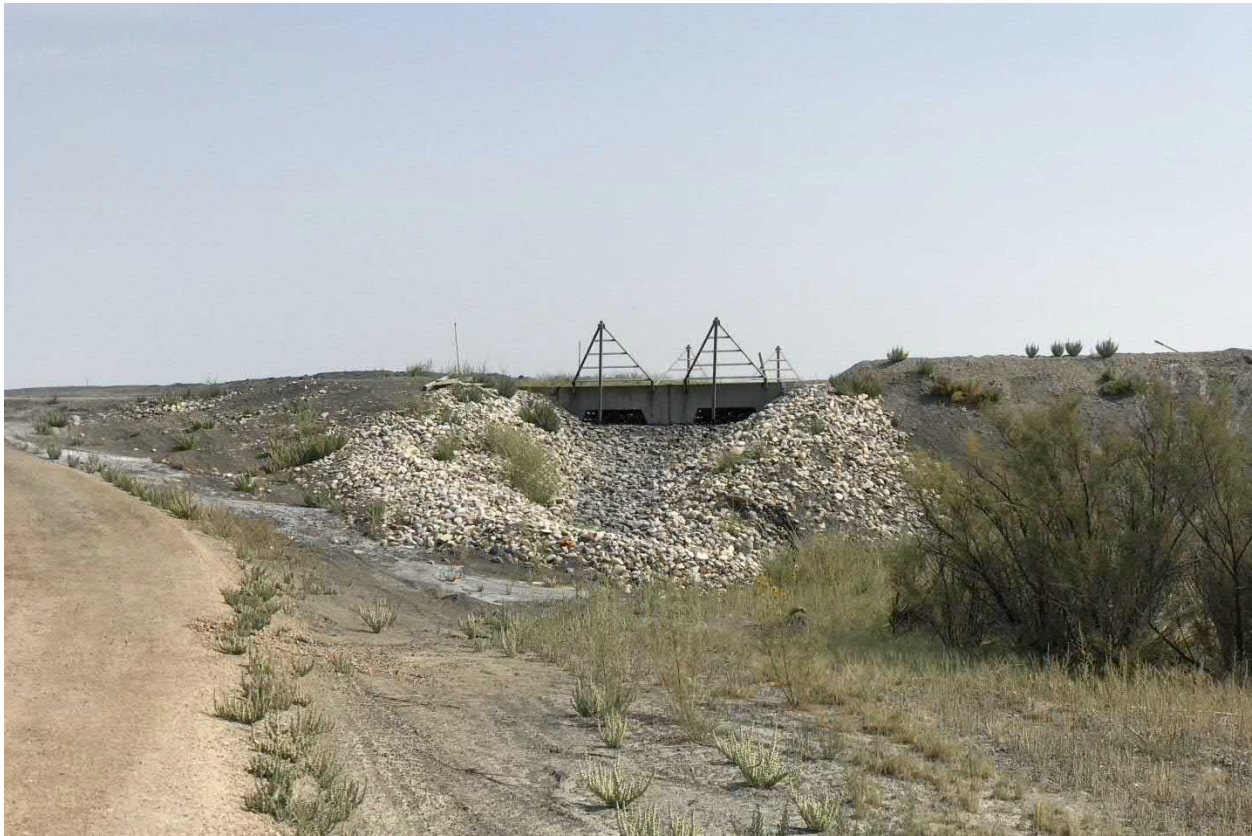
4. A rumble rack was installed as a tire clean-off and runoff break on the main haul road at the entrance to the CCR Landfill. Refer to photos 1, 3, and 5, Appendix A.
5. Additional segments of the exterior slopes have been partially covered with straw. These segments include the west exterior slopes, south of the haul road, and the east exterior slopes above the retention pond. Vegetation continues to improve on straw-covered slopes observed in 2016 inspection [2]. Refer to photos 6, 7, 23, 28, and 29, Appendix A.

**Photograph No. 1** View of rumble rack as tire cleanout and runoff break at entrance/exit to CCR Landfill on south haul road, looking northeast. Note armored ditch for runoff.

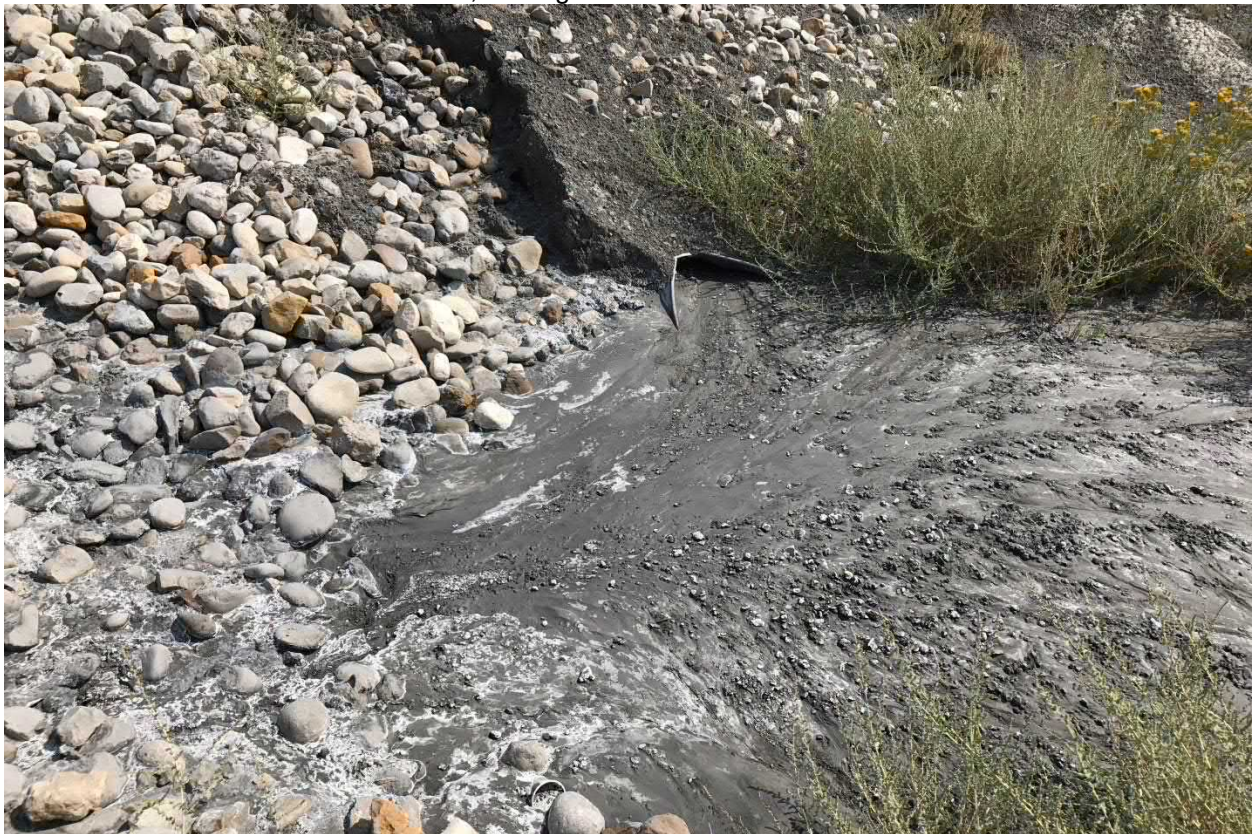
1. Obstruction of culverts in the perimeter drainage ditch at south haul road crossing and north access road crossing. The obstructions in both culverts are the result of eroded sediment similar to the condition observed in the 2016 inspection report [2]. Refer to photos 2, 4, 5, 33, 34, and 35, Appendix A.

2. Obstruction of culverts in the perimeter drainage ditch at south haul road crossing and north access road crossing. The obstructions in both culverts are the result of eroded sediment similar to the condition observed in the 2016 inspection report [2]. Refer to photos 2, 4, 5, 33, 34, and 35, Appendix A.

**Photograph No. 2** View of pipe culvert (upstream side), which was almost completely blocked, under south haul road, looking southeast.

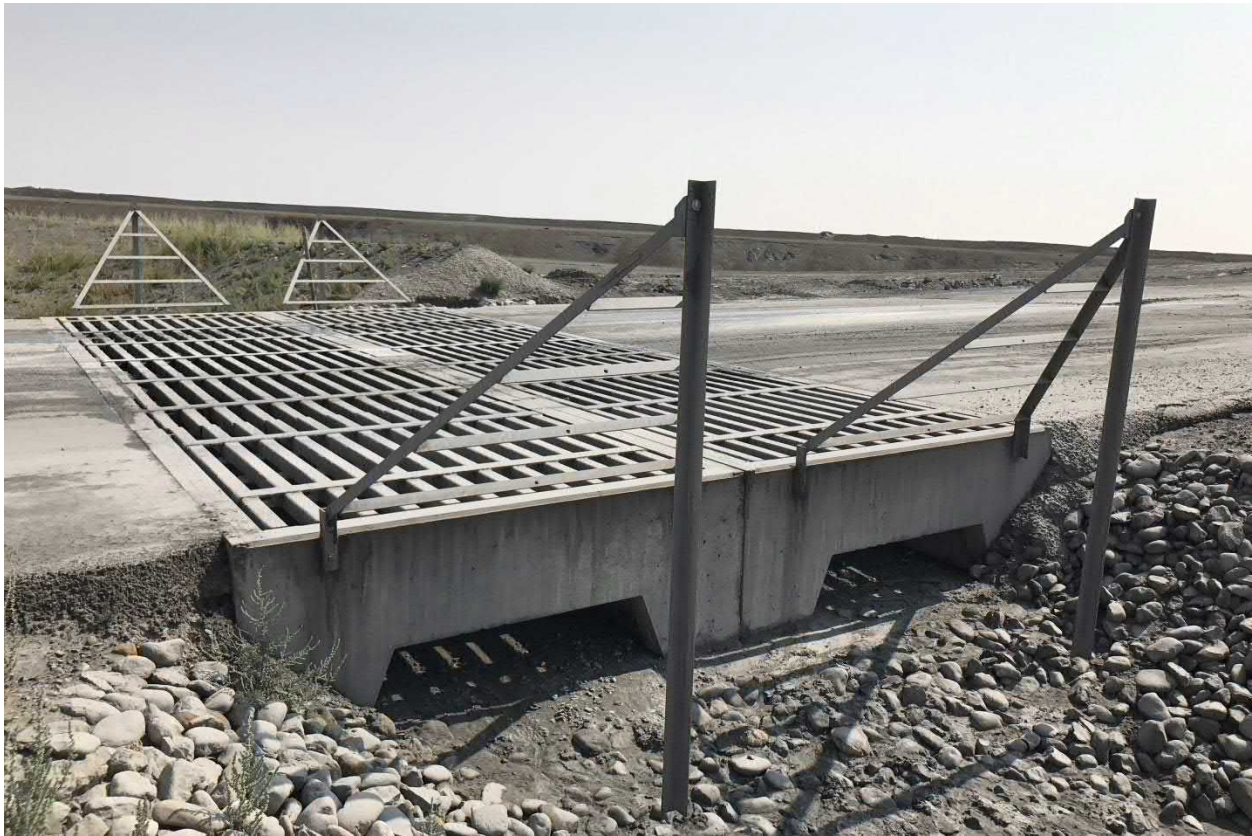
**Photograph No. 3** View of rumble rack as tire cleanout and runoff break at entrance/exit to CCR Landfill on south haul road, looking northeast.

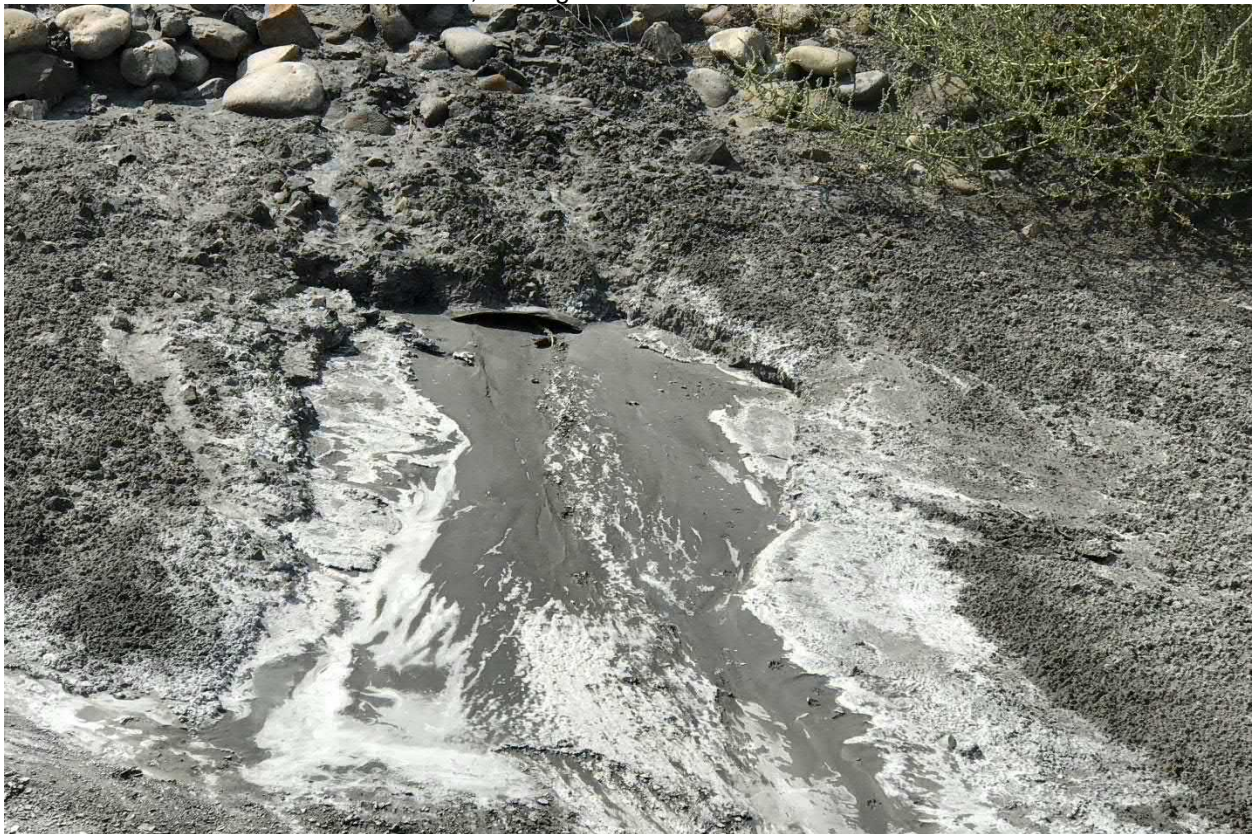
**Photograph No. 4** View of pipe culvert (downstream side), which was almost completely blocked, under south haul road, looking southwest.

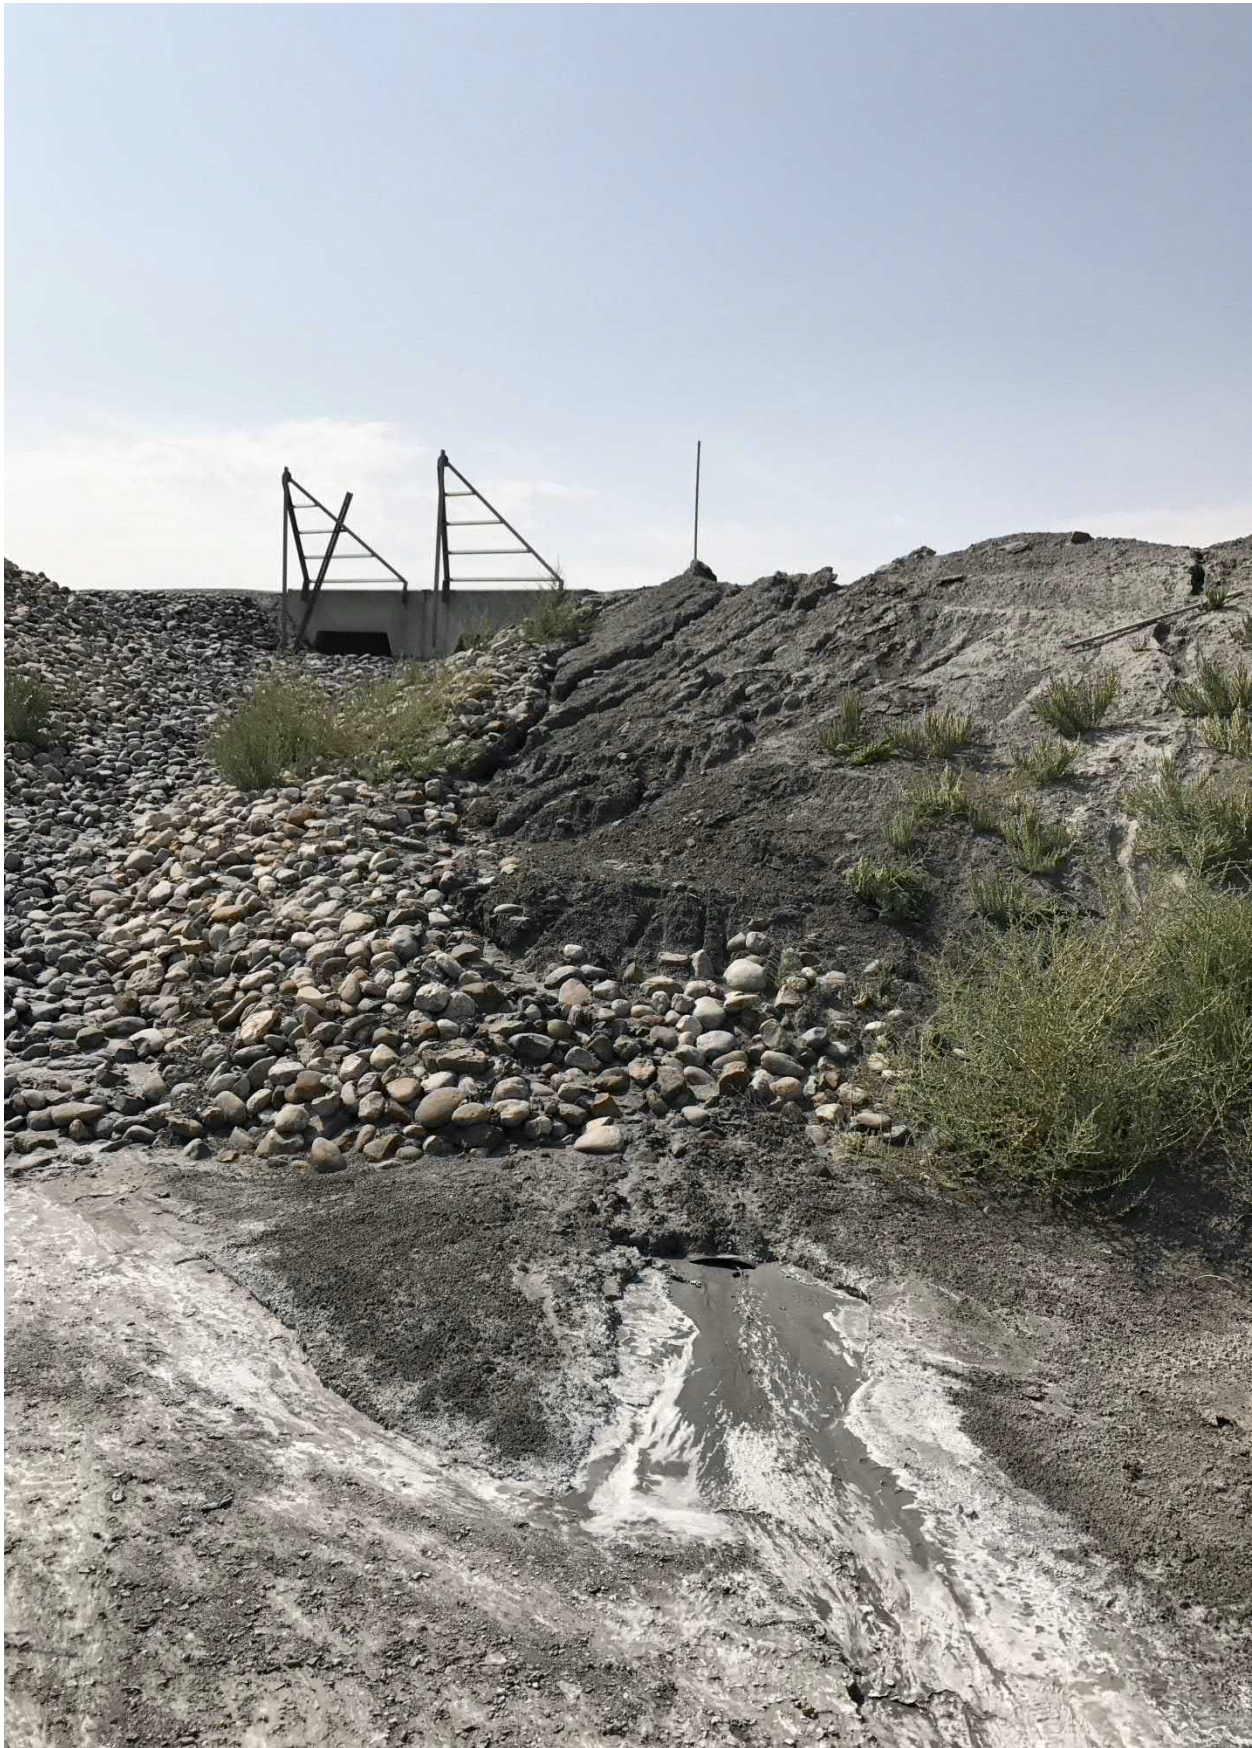
**Photograph No. 5** View of rumble rack as tire cleanout and runoff break at entrance/exit to CCR Landfill on south haul road, looking southwest. Note armored ditch for runoff.

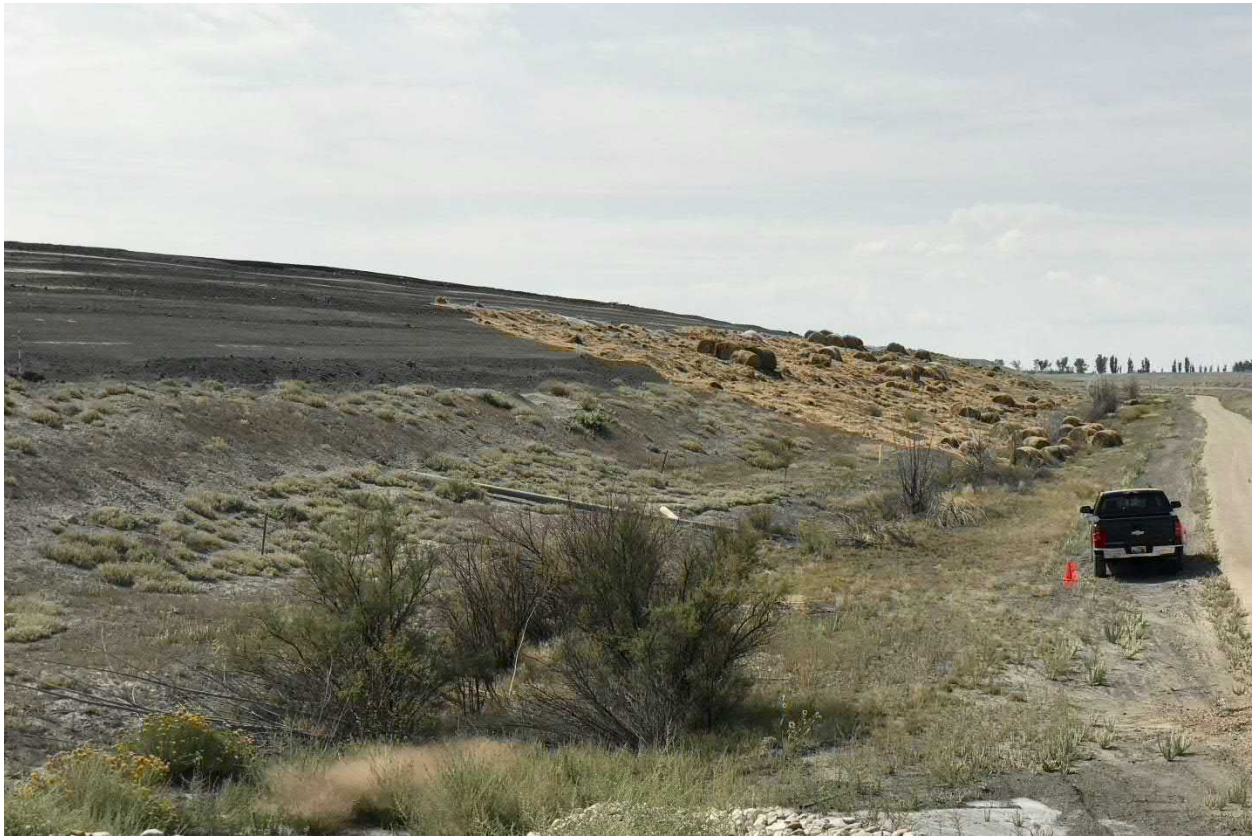
5. Additional segments of the exterior slopes have partially been covered with straw. These segments include the west exterior slopes, south of the haul road, and the east exterior slopes above the retention pond. Vegetation continues to improve on straw-covered slopes observed in 2016 inspection [2]. Refer to photos 6, 7, 23, 28, and 29, Appendix A.

**Photograph No. 6** View of west slope, looking south-southwest. Some vegetation is visible on lower ash slopes.

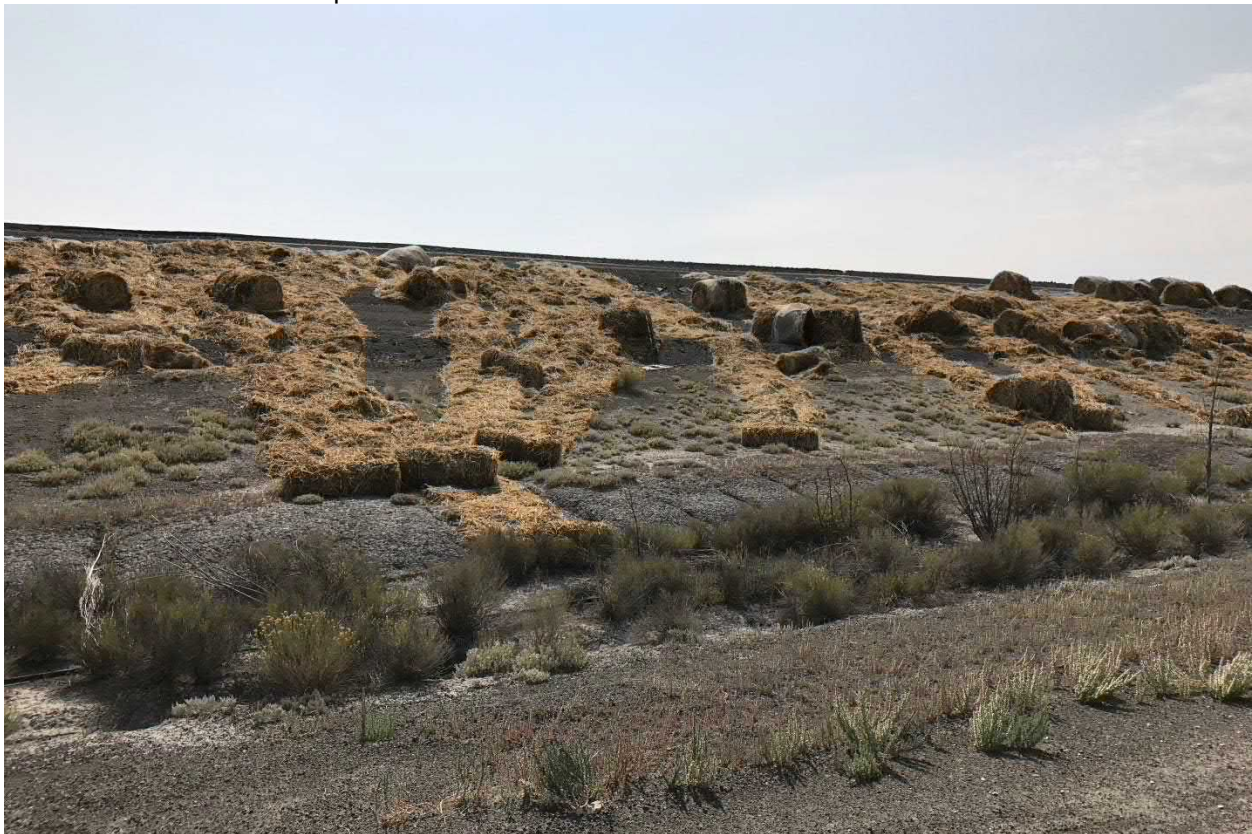
**Photograph No. 7** View of straw on west ash slope to help with erosion control and establishment of vegetation, looking approximately south.

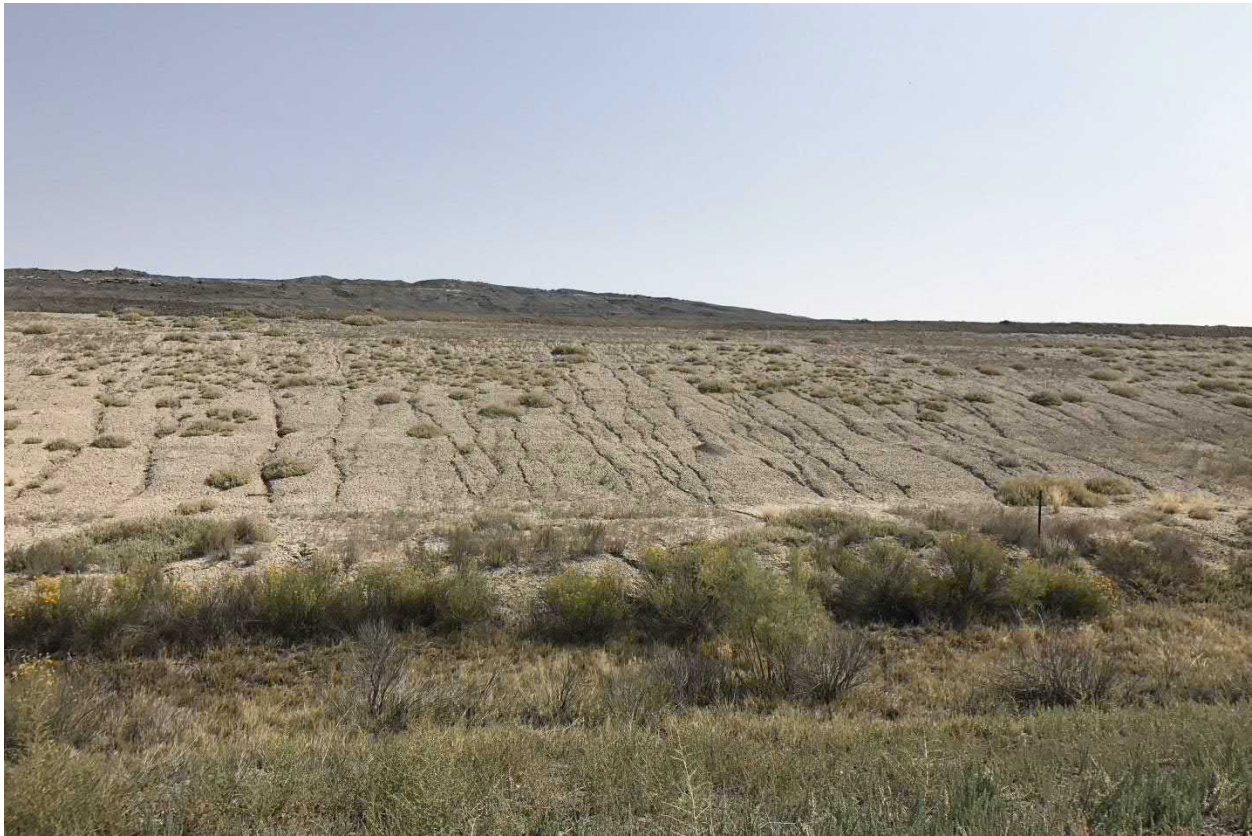
3. Observation of minor erosion rills and shallow gullies. Refer to photos 10, 13, and 15, Appendix A. These rills and gullies are typical of the exterior slopes of the landfill and have not changed significantly since the 2016 inspection. These do not represent a threat to safety or the integrity of the slopes. The eroded material has been retained at the toe of the embankment and there is no potential for it to move off site. This erosion is superficial and will be covered with closure of the slopes.

**Photograph No. 10** View of typical west exterior slope with sparse vegetation, widespread erosional rills, and thicker vegetation beneath the toe of the slope, looking approximately northeast.

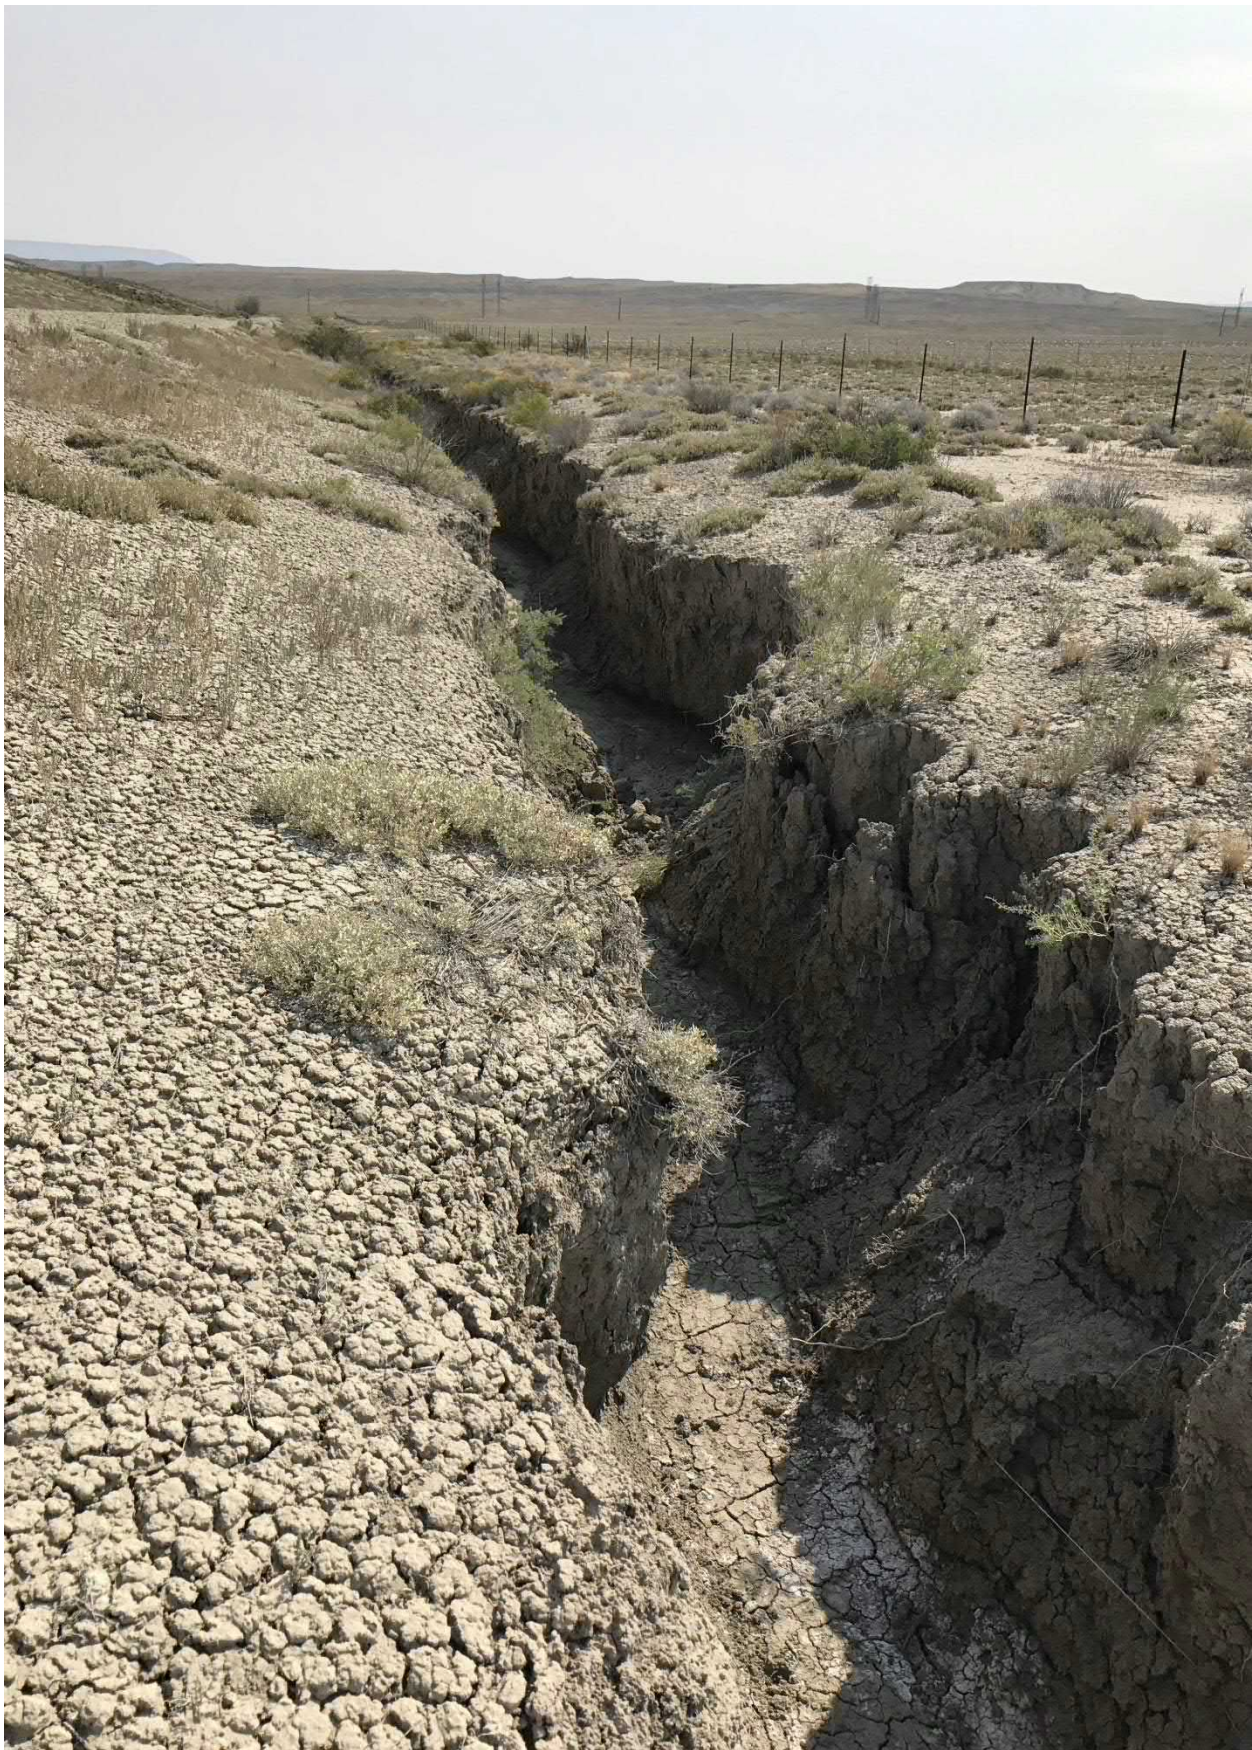
**Photograph No. 12** View of drainage ditch diverting offsite runoff around permitted CCR Landfill, looking east. Note erosion and steepened earthen sides of the channel.

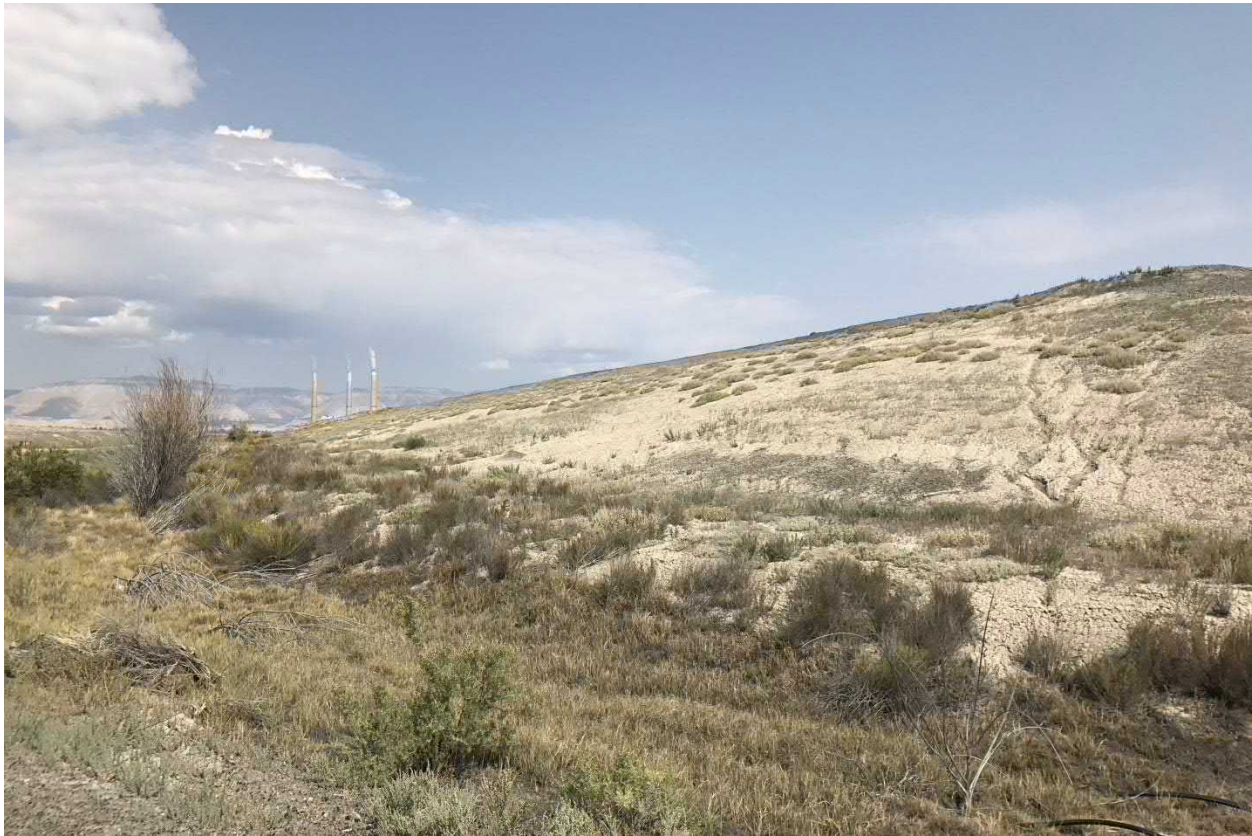
**Photograph No. 13** View of southwest ash slope and onsite runoff collection ditch running along the toe of the slope, looking northwest.

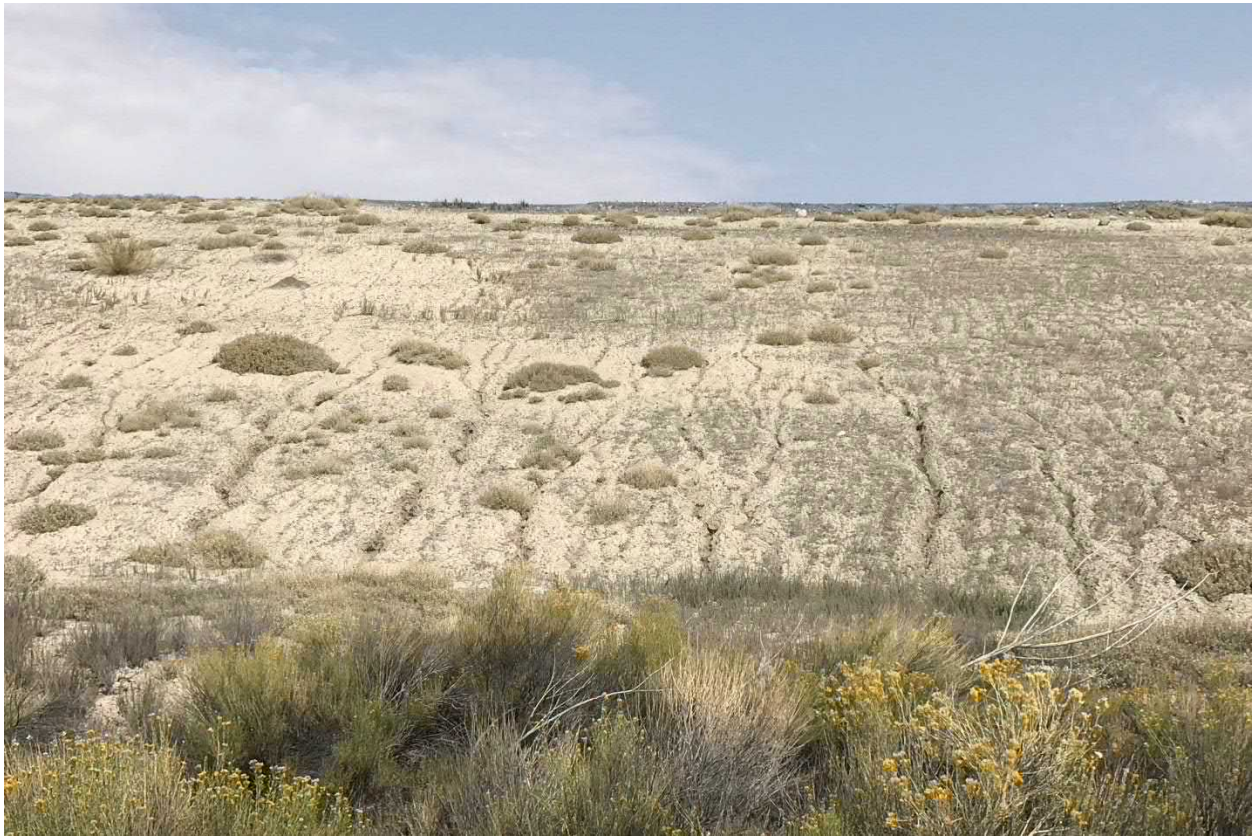
**Photograph No. 15** View of typical south exterior slope with sparse vegetation, widespread erosional rills, and thicker vegetation beneath the toe of the slope, looking approximately north.

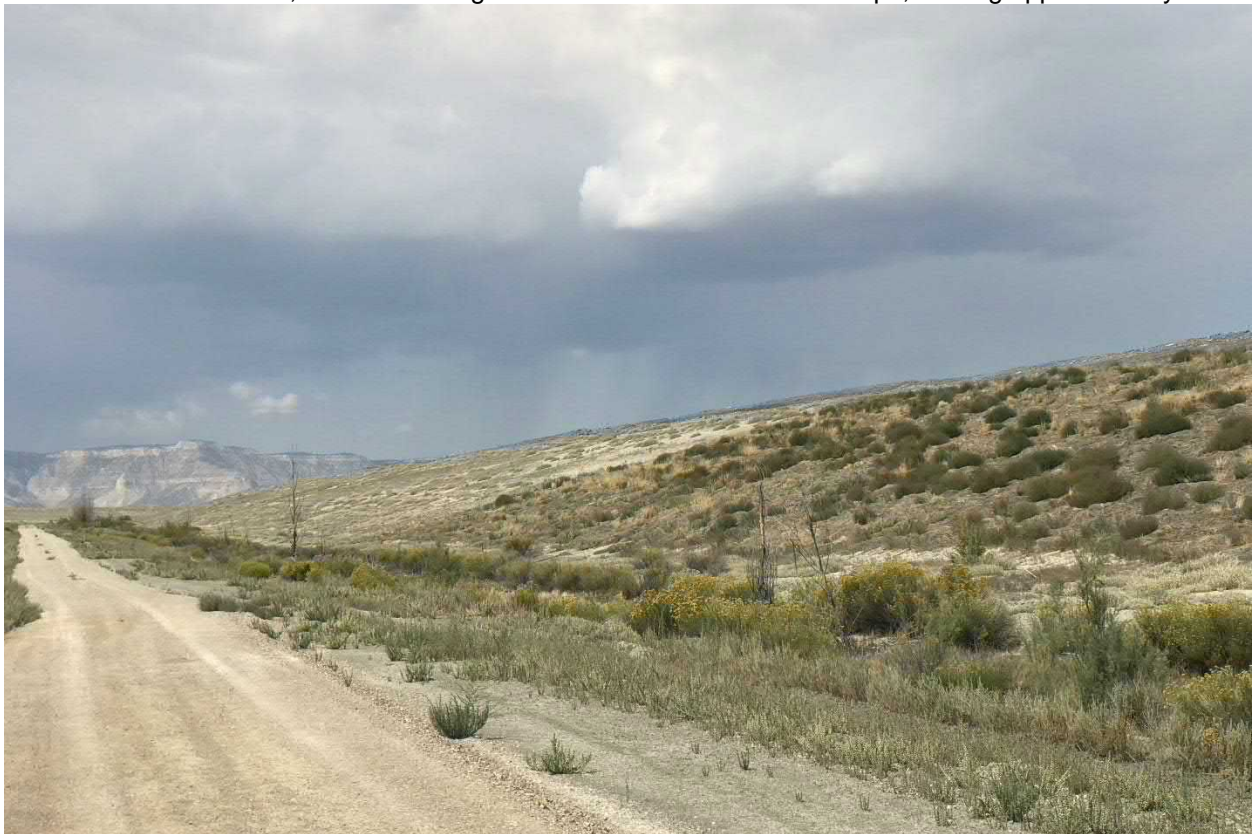
**Photograph No. 16** View of south exterior slope of landfill. Note vegetation growth on straw-treated slope compared with untreated slope.

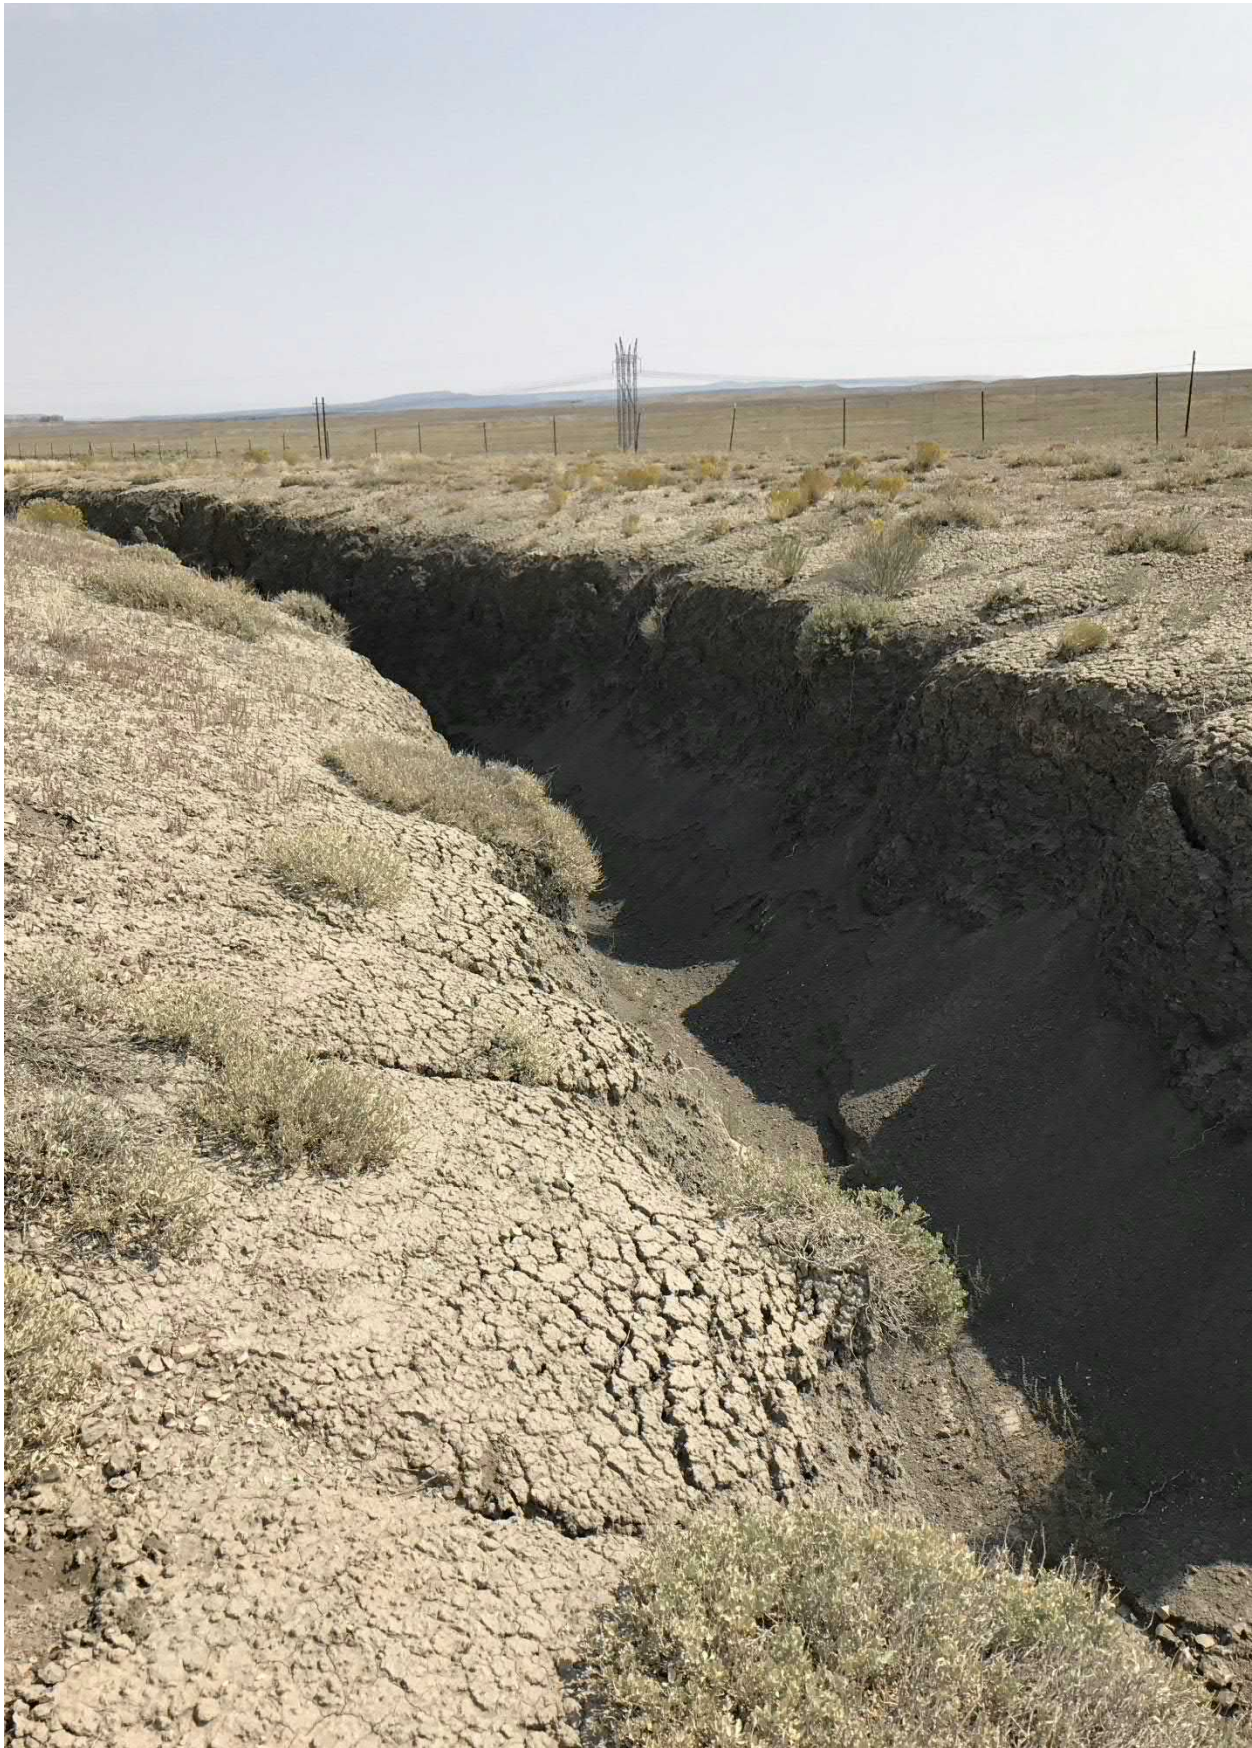
**Photograph No. 19** View of drainage ditch diverting offsite runoff around permitted CCR Landfill, looking approximately east. Note erosion and steepened earthen sides of the channel.

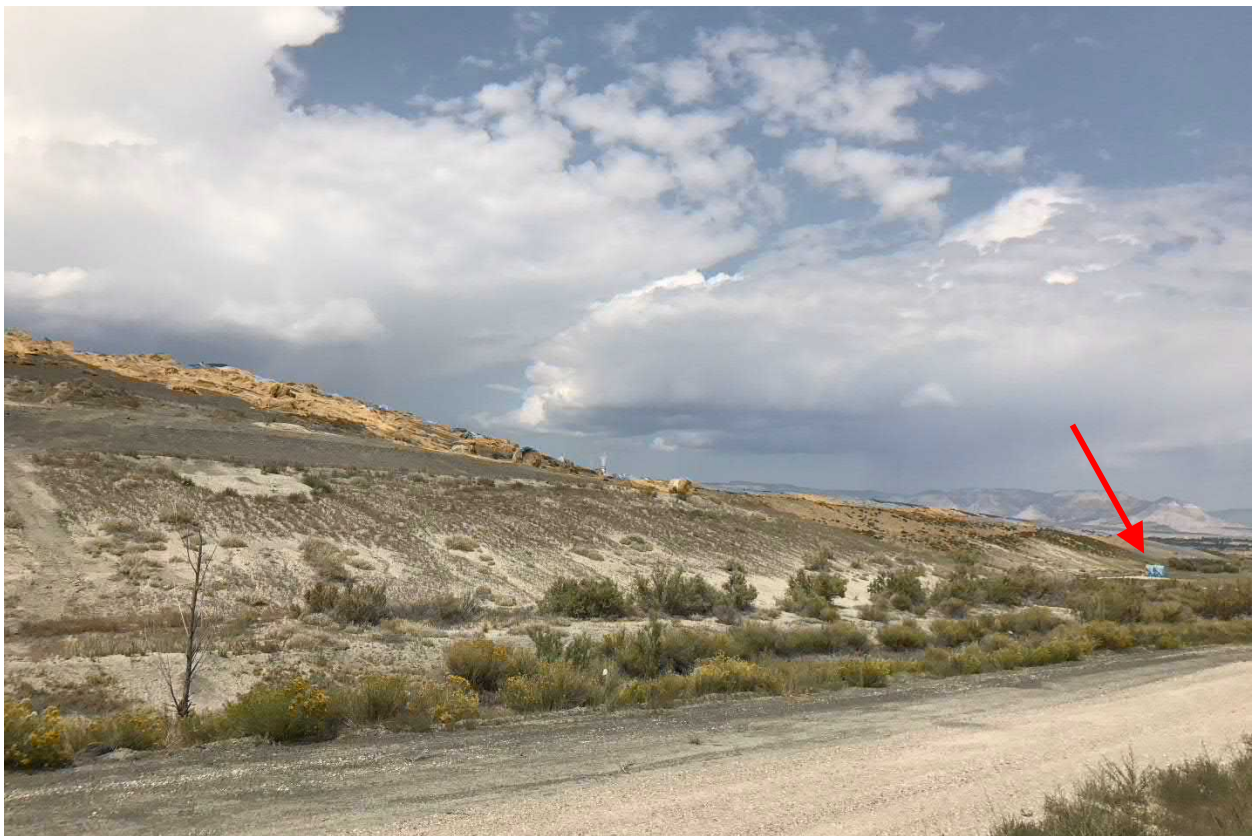
**Photograph No. 23** View of east ash slope of landfill. Some portions of the slope were straw treated, looking north-northwest. Frac tank used for underdrain water storage is also shown.

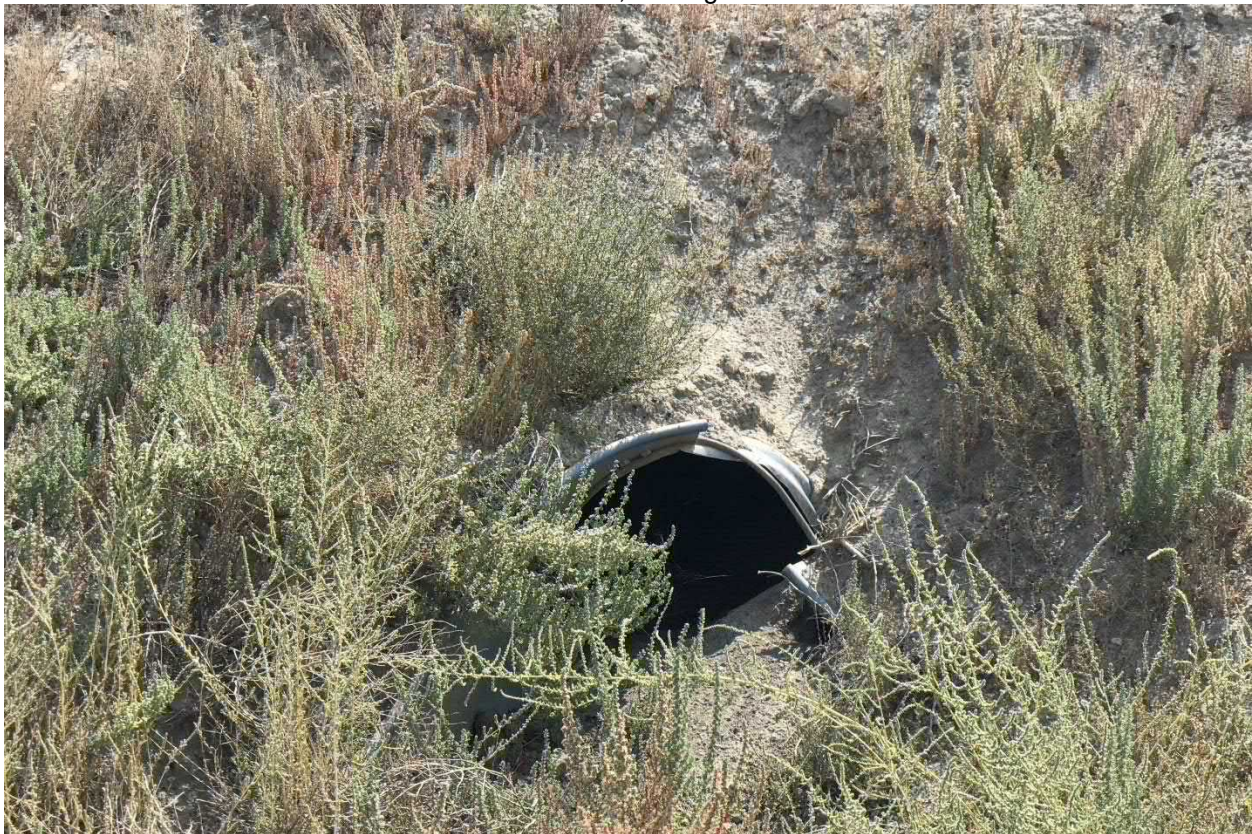
2. Partial obstruction of inlet culvert at the south end of the retention basin located east of the CCR Landfill. The obstruction is composed of eroded sediment at the downstream end of the culvert. Refer to photo 25, Appendix A.

**Photograph No. 25** View of south retention basin inlet pipe (downstream end). Pipe culvert was partially obstructed at this end, looking southeast.

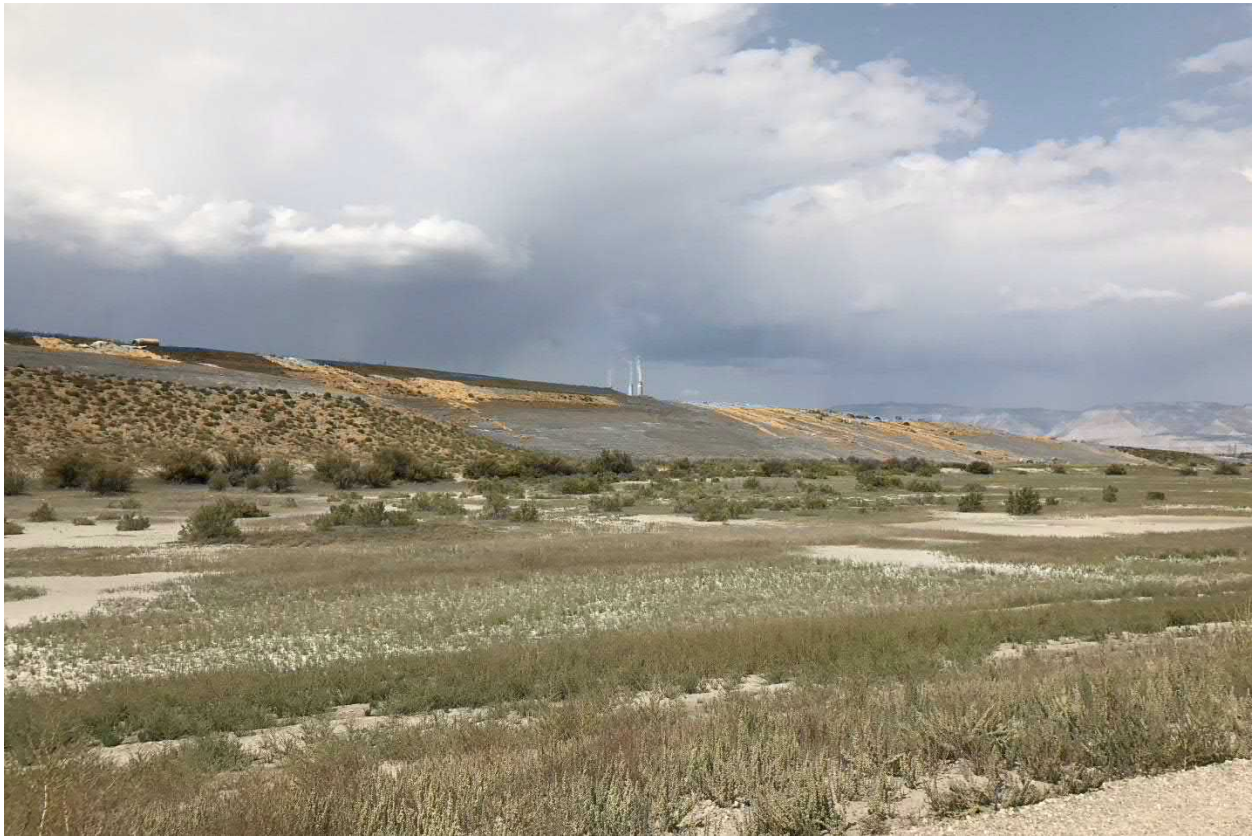
**Photograph No. 28** View of east slope with straw treatment for erosion control, looking northwest. Retention basin is also shown.

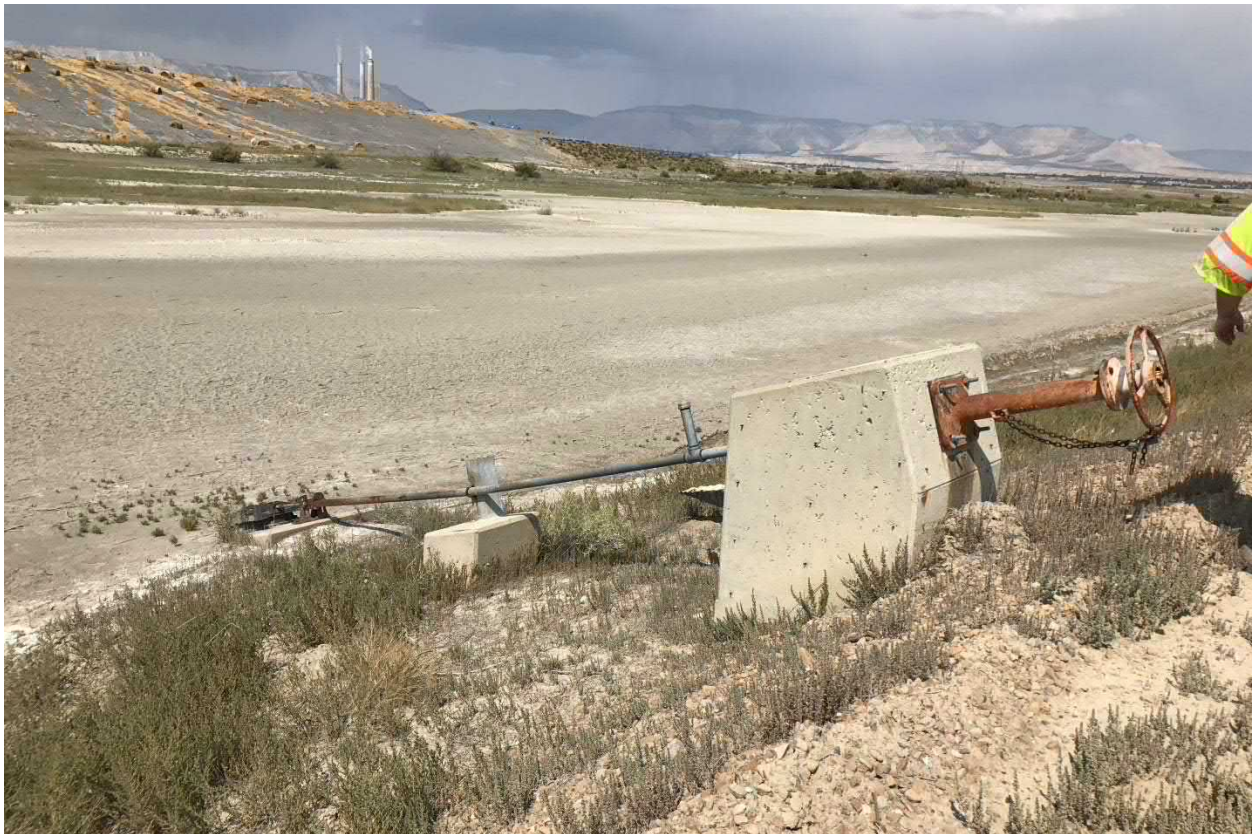
**Photograph No. 29** View of outlet gate and gate control, looking northwest. This facility is a zero-discharge facility and gate remains closed.
