# 2017 Coal Combustion Residuals Annual Inspection

## Hunter Power Plant

### *Hunter CCR Landfill*

November 30, 2017

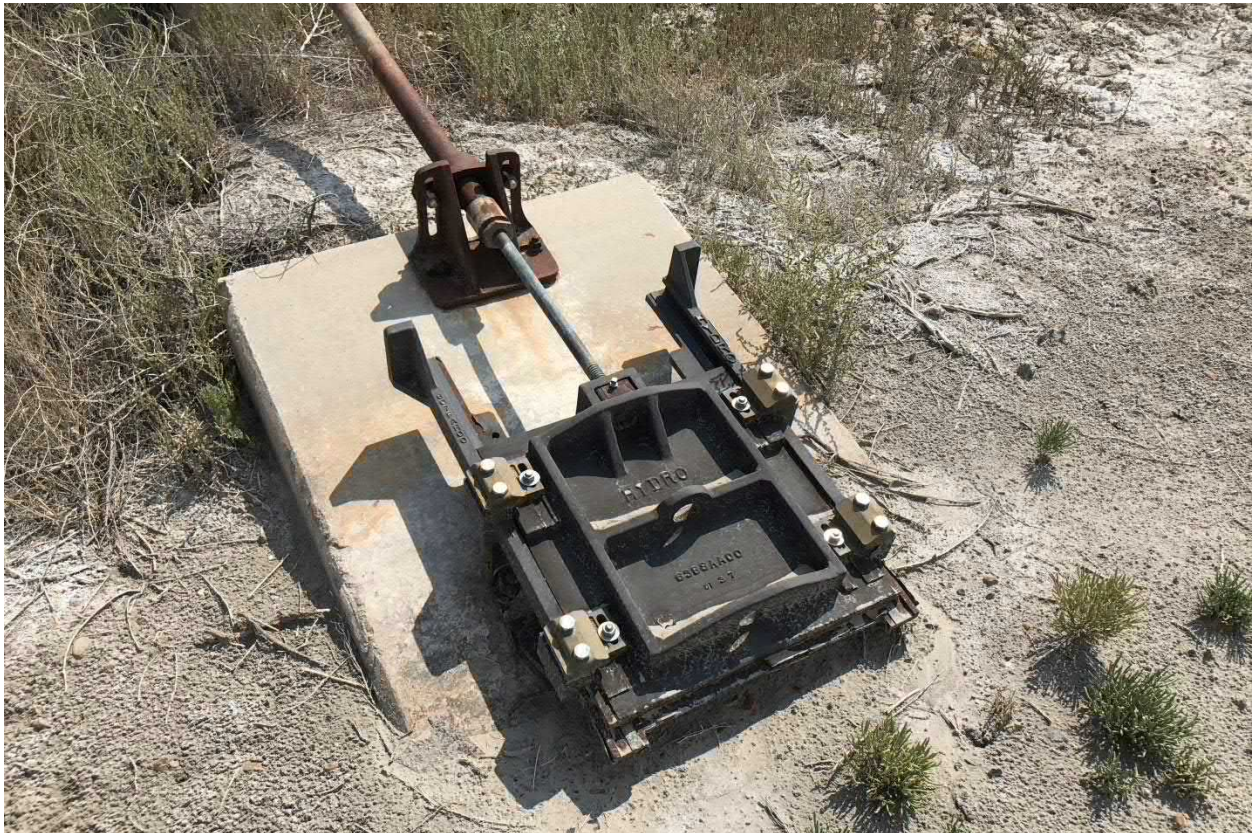
**Photograph No. 30** View of outlet slide gate and outlet pipe structure, looking southeast. The slide gate appeared to be in good condition.

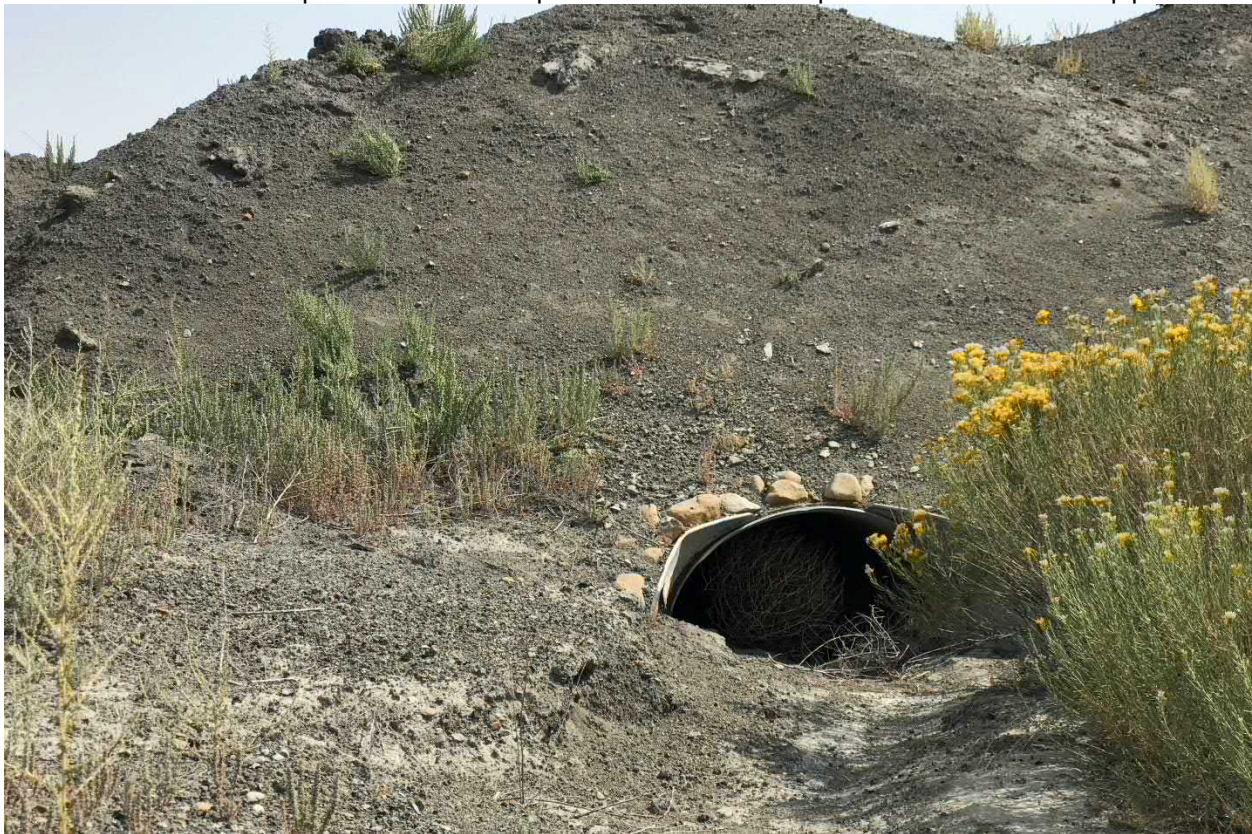
1. Obstruction of culverts in the perimeter drainage ditch at south haul road crossing and north access road crossing. The obstructions in both culverts are the result of eroded sediment similar to the condition observed in the 2016 inspection report [2]. Refer to photos 2, 4, 5, 33, 34, and 35, Appendix A.

2. Obstruction of culverts in the perimeter drainage ditch at south haul road crossing and north access road crossing. The obstructions in both culverts are the result of eroded sediment similar to the condition observed in the 2016 inspection report [2]. Refer to photos 2, 4, 5, 33, 34, and 35, Appendix A.

**Photograph No. 33** View of retention basin north inlet pipe (upstream end), looking east-southeast. Pipe culvert was partially obstructed by soil and debris.

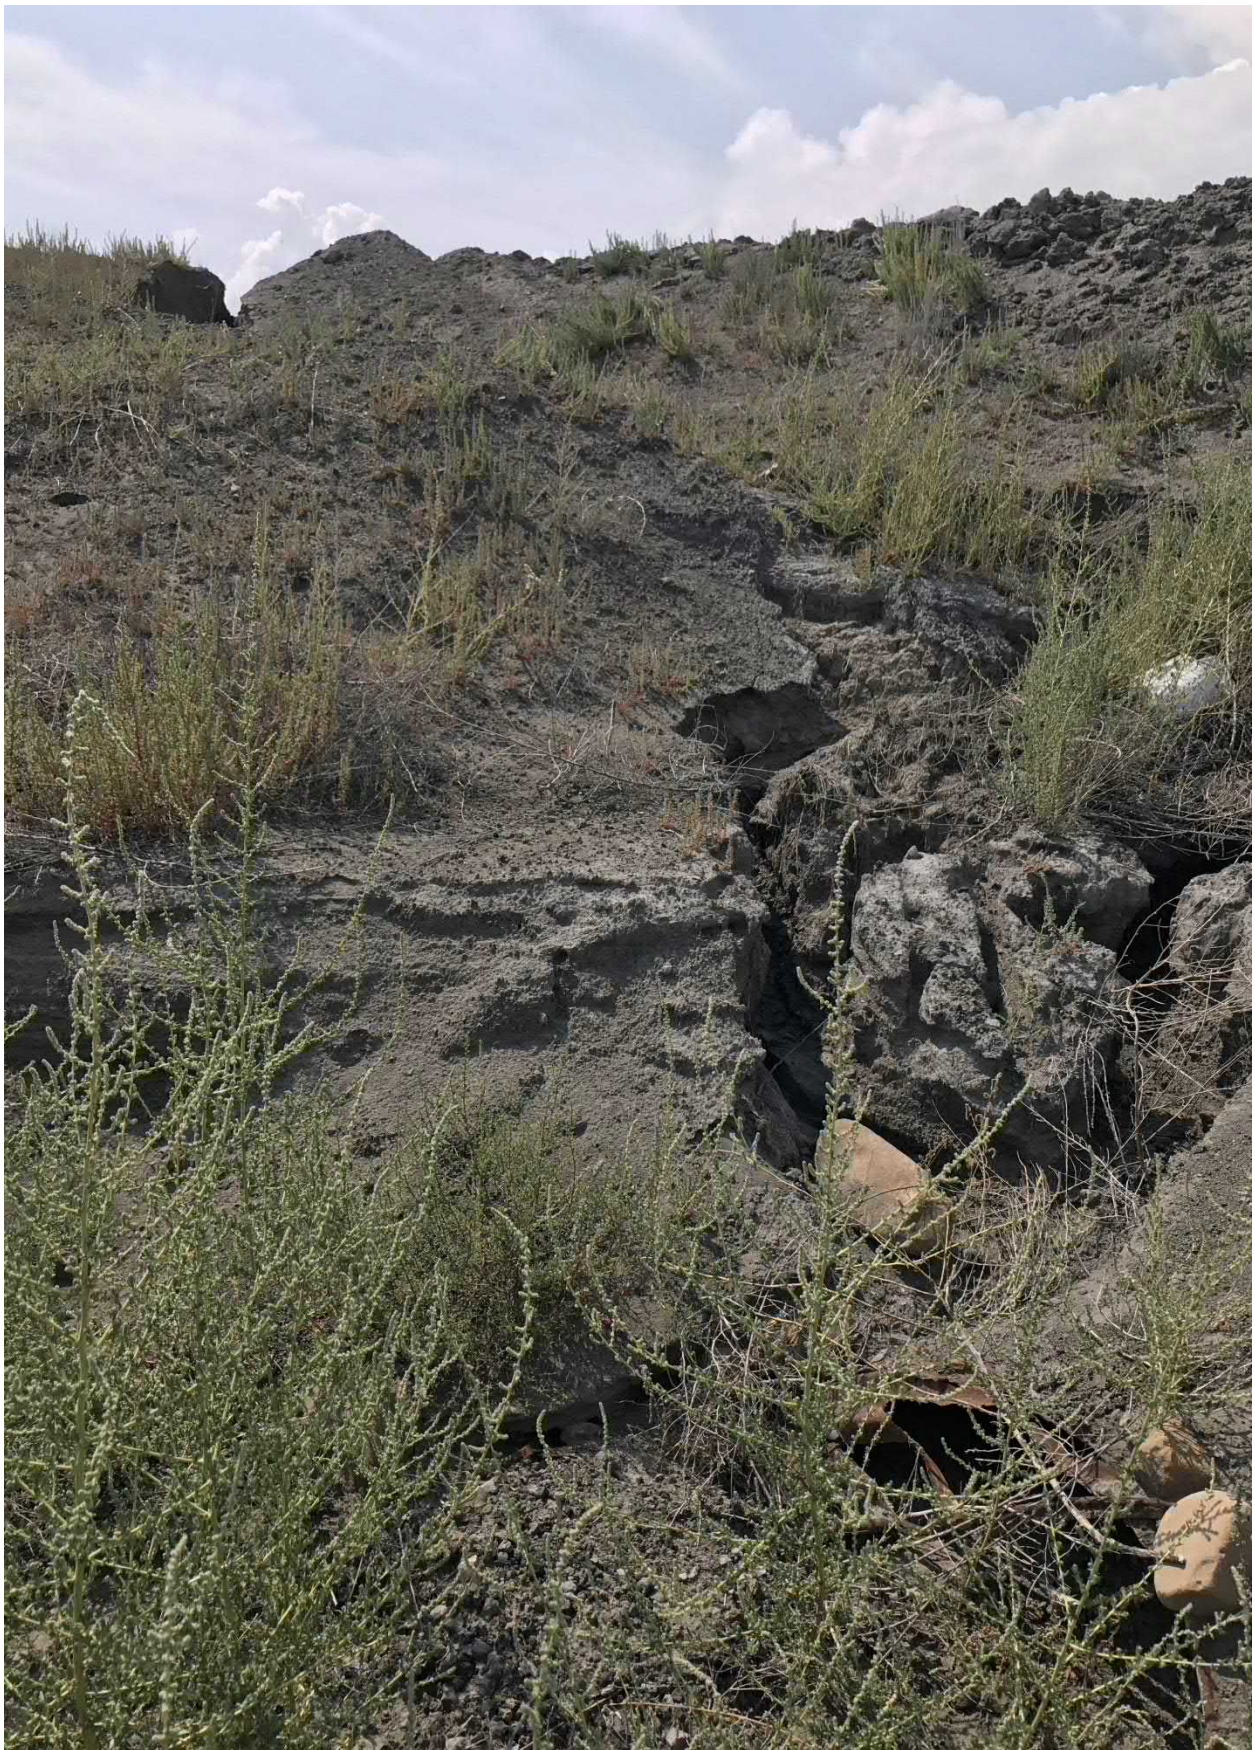
**Photograph No. 34** View of erosion from perimeter road above retention basin north inlet pipe (downstream end), looking approximately south-southwest.

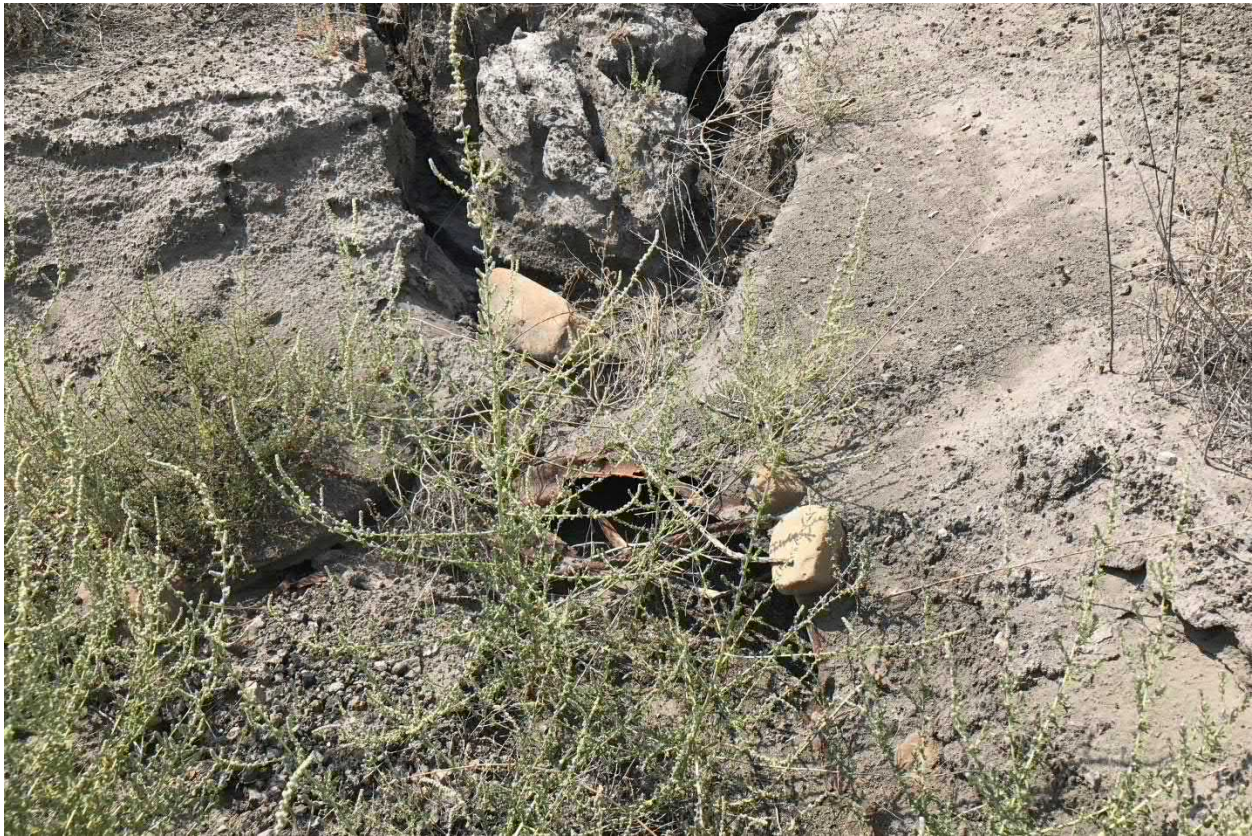
**Photograph No. 35** View of retention basin north inlet pipe (downstream end), looking southwest. Pipe culvert was almost completely obstructed by debris. Pipe outlet partially collapsed.
