# 2018 Coal Combustion Residuals Annual Inspection

## Hunter Power Plant

### *Hunter CCR Landfill*

FINAL December 11, 2018

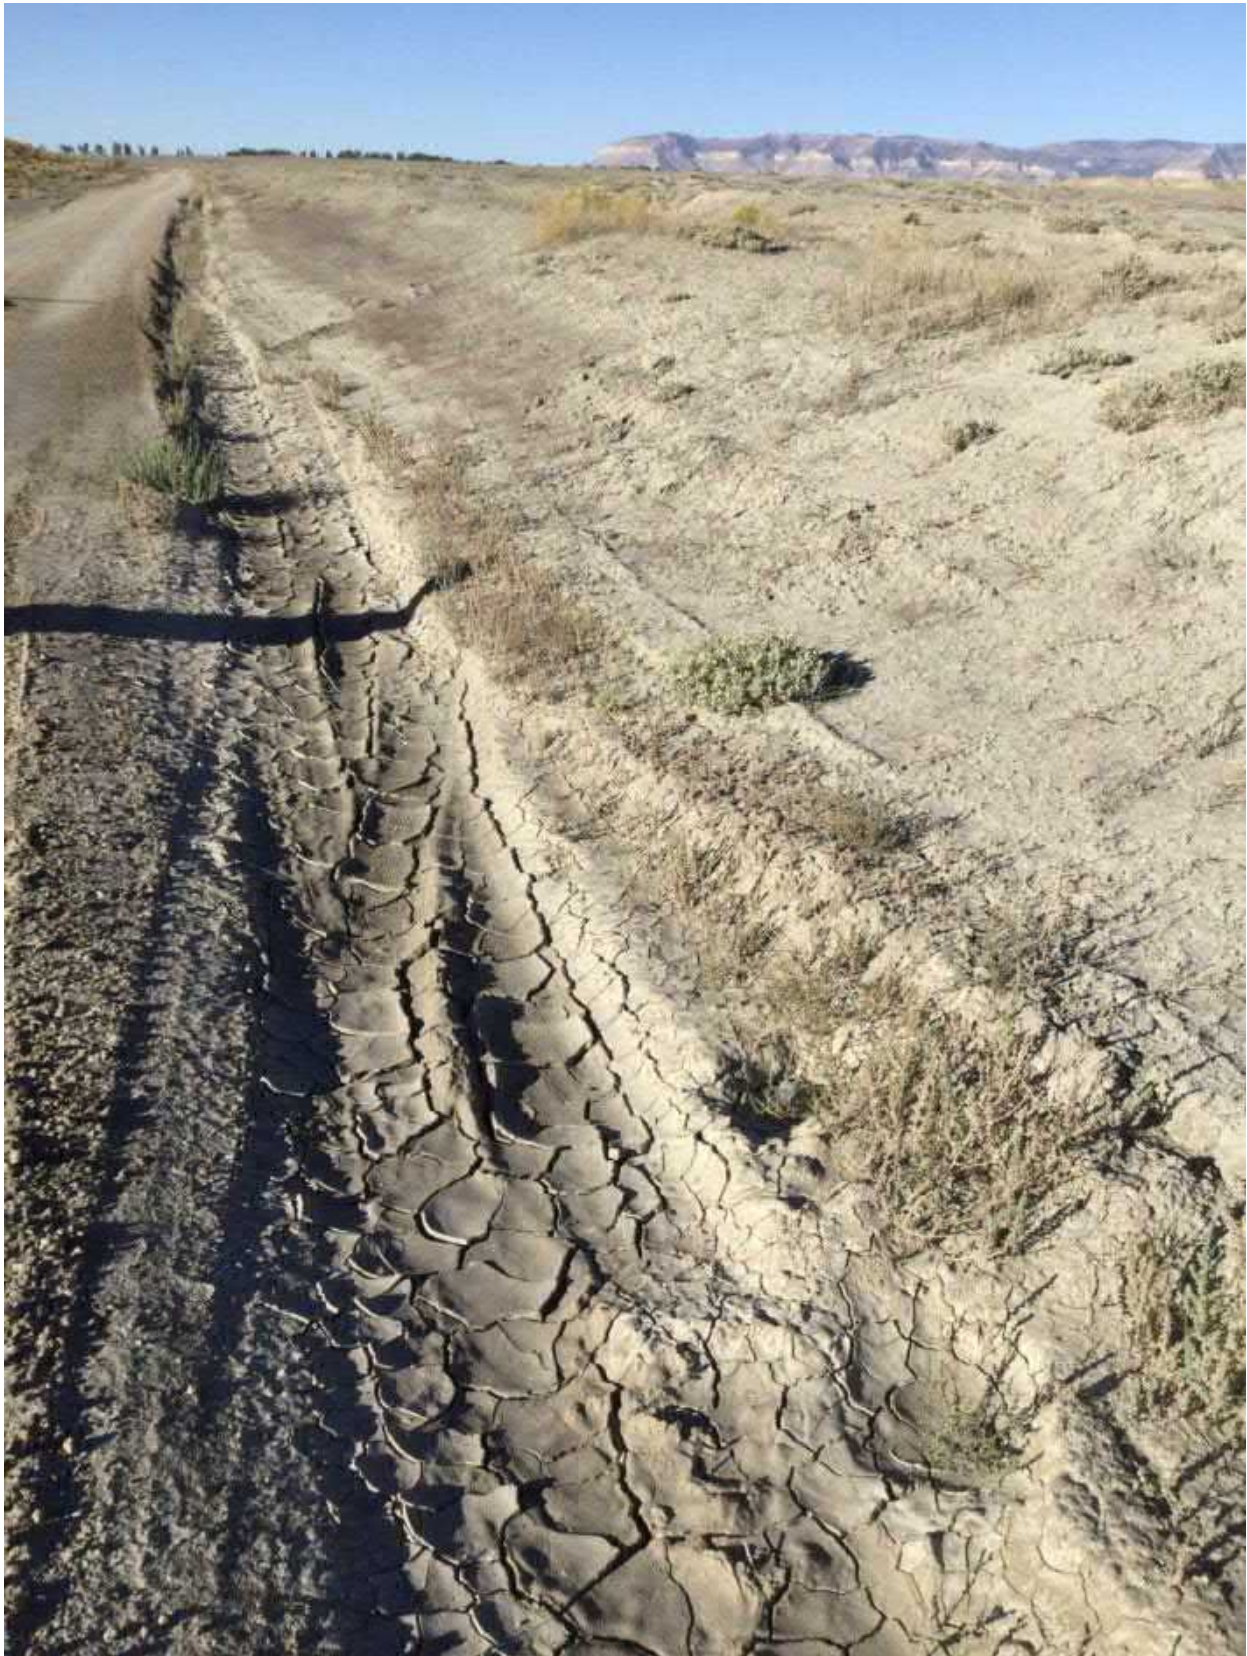
**Photograph No. 1** View of depression on outside edge of perimeter road south of main haul road entrance to CCR Landfill, looking south.

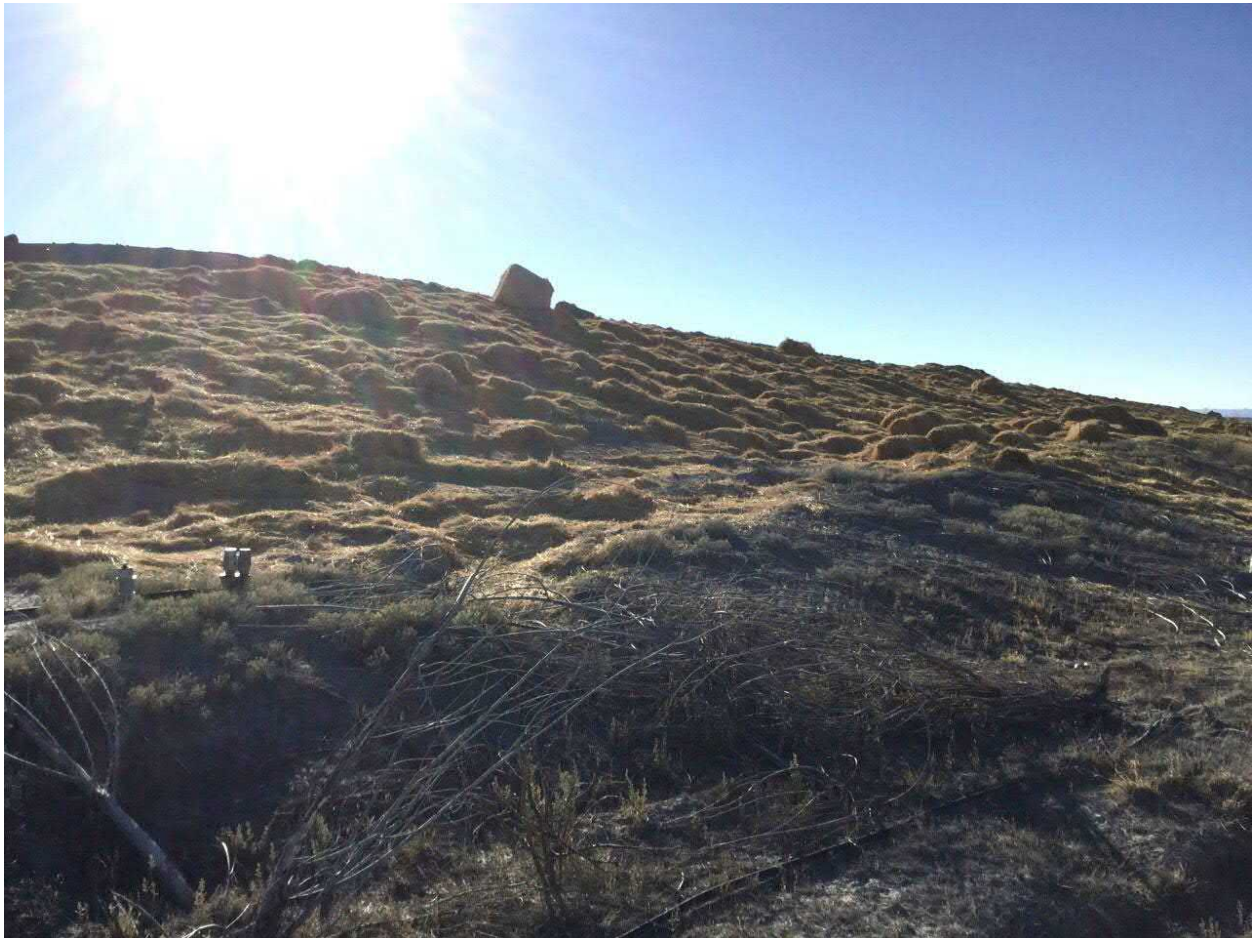
4. Additional segments of the exterior slopes have partially been covered with straw. These segments include the south and west exterior slopes, south of the haul road, and the east exterior slopes. Vegetation continues to improve on straw-covered slopes observed in the 2016 and 2017 inspections. Refer to photos 6, 9, 10, and 12, Appendix A.

**Photograph No. 6**      **View of southwest slope of CCR Landfill, looking east. Note hay placement on slope.**

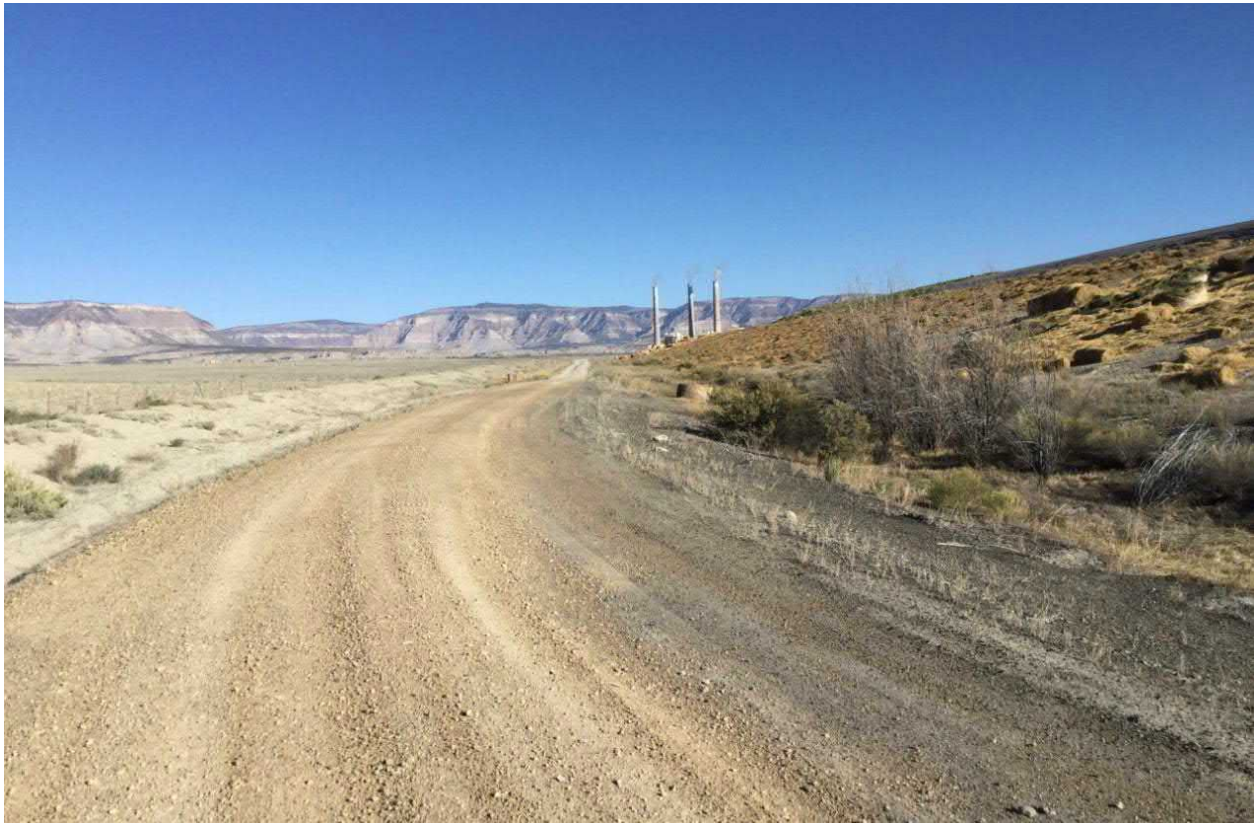
**Photograph No. 9** View of southwest slope of CCR Landfill, runoff collection ditch running along the toe of the slope, and perimeter road, looking northwest.

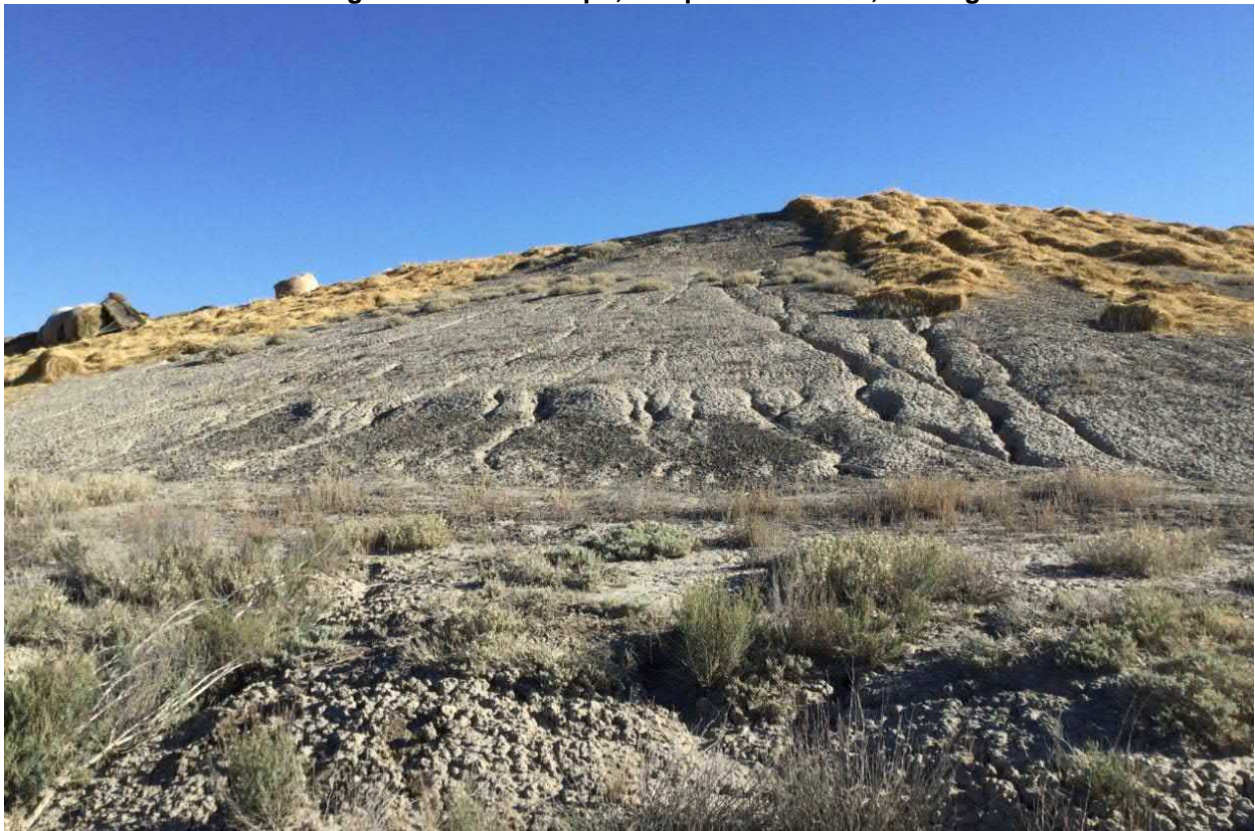
3. Observation of minor erosion rills and shallow gullies. Refer to photos 10, Appendix A. These rills and gullies are typical of the exterior slopes of the landfill and have not changed significantly since the 2017 inspection. These do not represent a threat to safety or the integrity of the slopes. The eroded material has been retained at the toe of the embankment and there is no potential for it to move off site. This erosion is superficial and will be covered with closure of the slopes.

**Photograph No. 10** View of southwest slope of CCR Landfill, looking northeast. Note erosion rills and hay placed on slope.

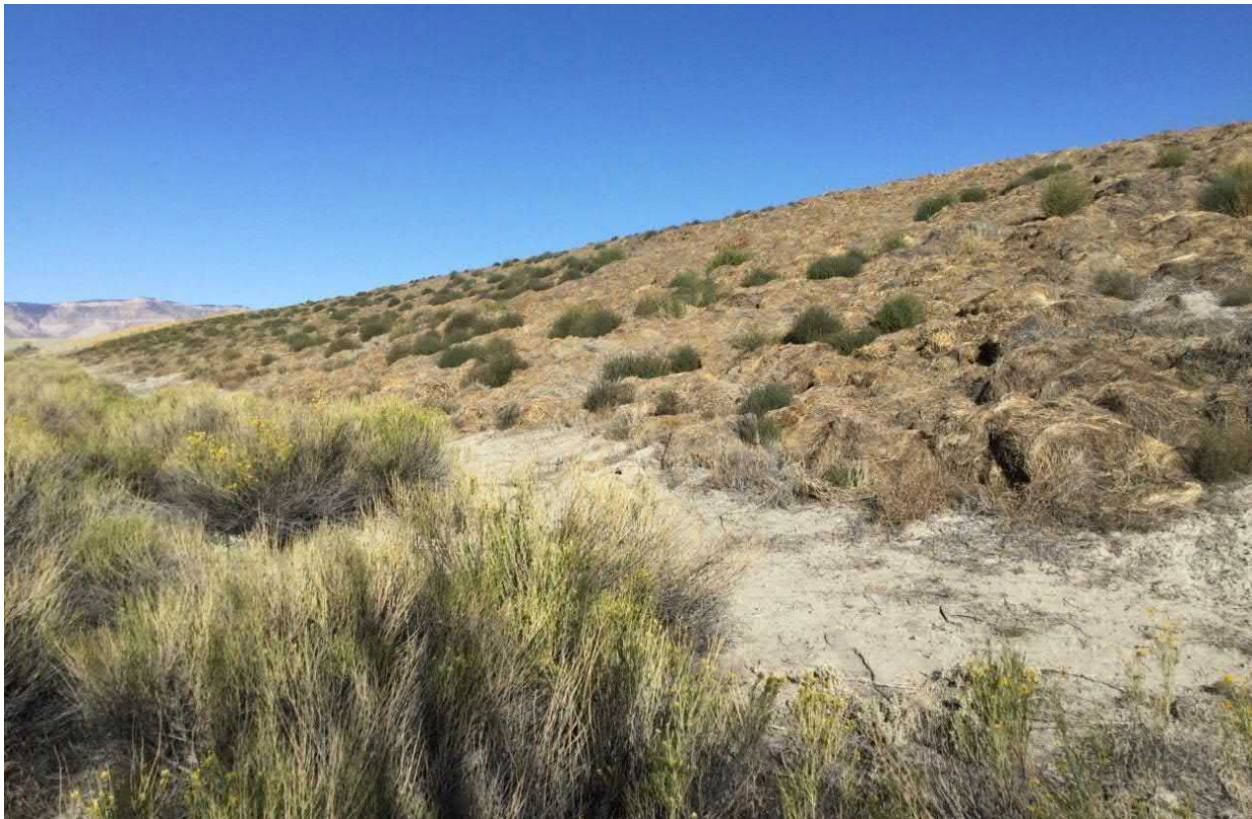
**Photograph No. 12** View of south slope of CCR Landfill, looking west. Note hay and increased vegetation on slope.

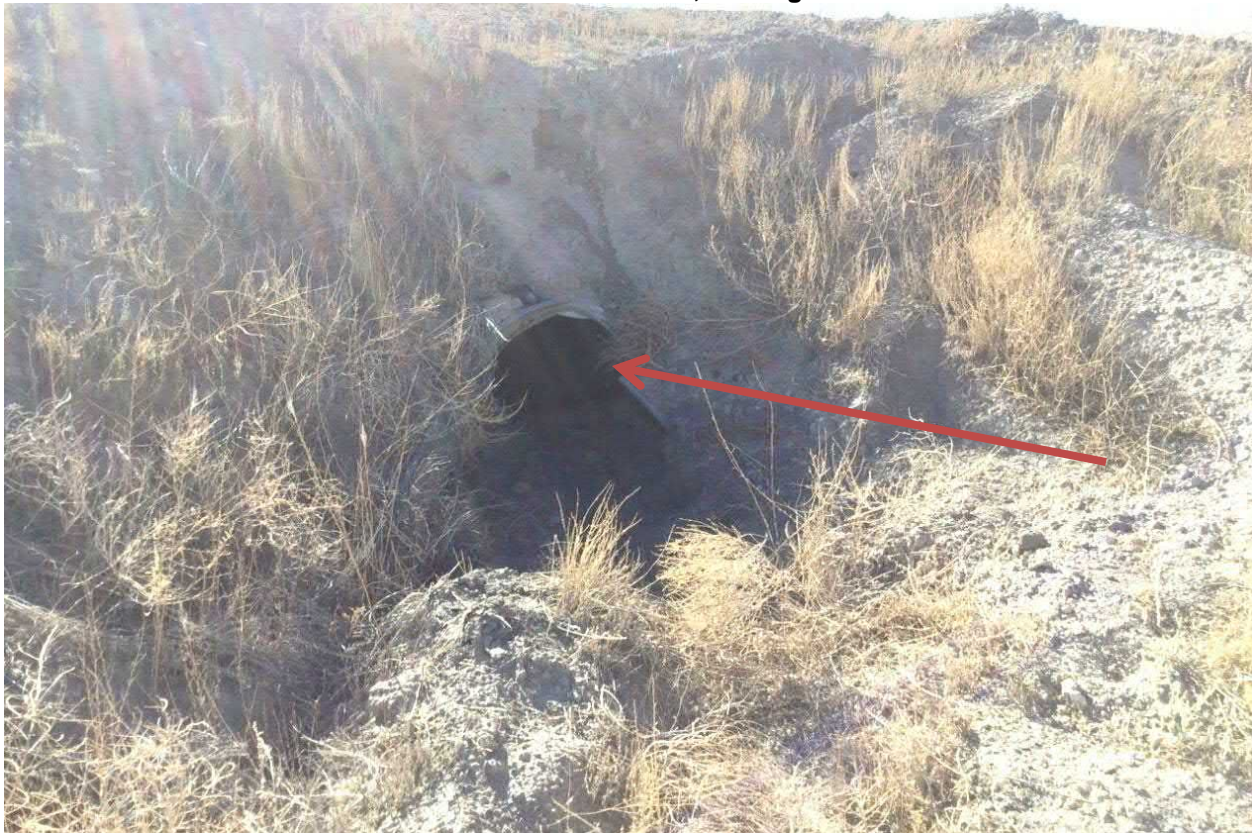
2. Partial obstruction of inlet culvert at the south end of the retention basin located east of the CCR Landfill. The obstruction is composed of eroded sediment at the downstream end of the culvert. Refer to photo 16, Appendix A. Obstruction of this culvert was addressed in recent maintenance and has been cleared since the inspection was completed.

**Photograph No. 16** View of south retention basin inlet pipe (downstream end). Pipe culvert was partially obstructed at this end at time of inspection, looking southeast.

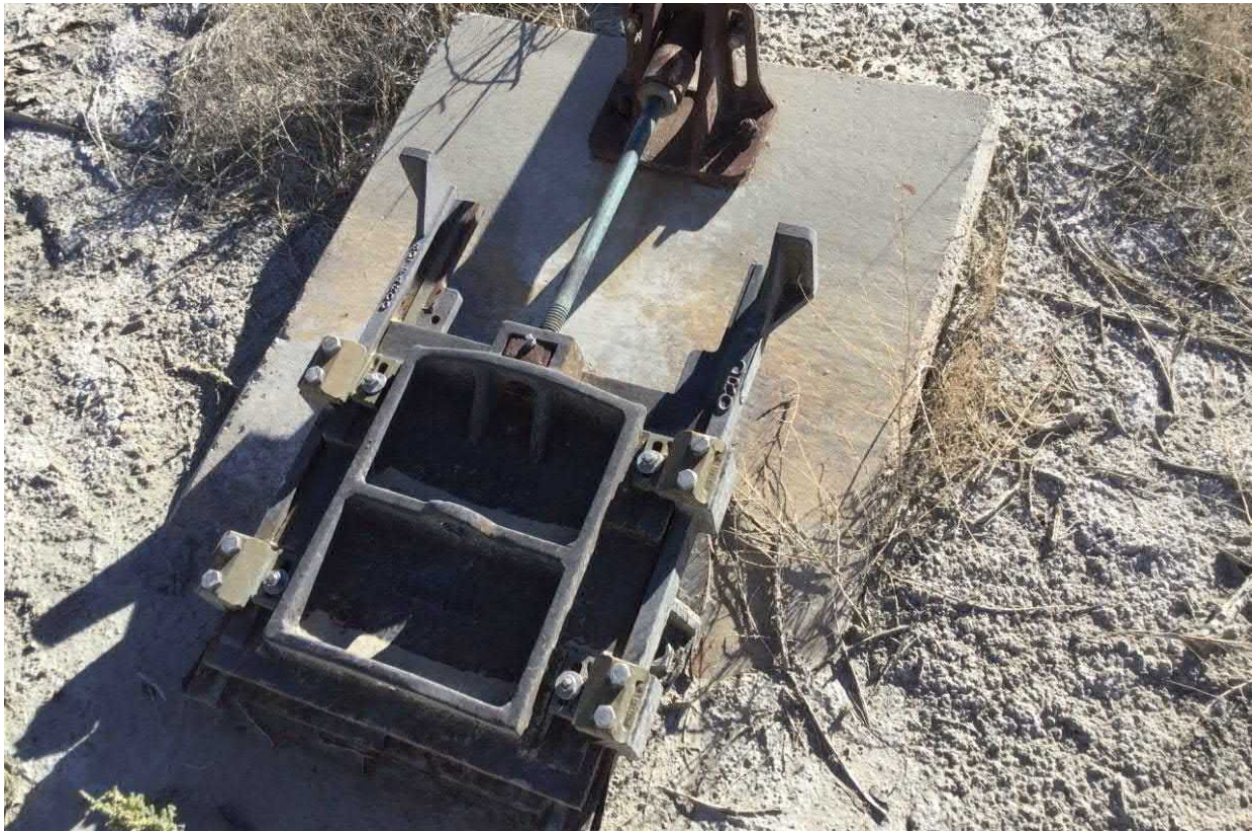
**Photograph No. 21** View of retention pond outlet and slide gate control structure (upstream end), looking east. The slide gate appeared to be in good condition.

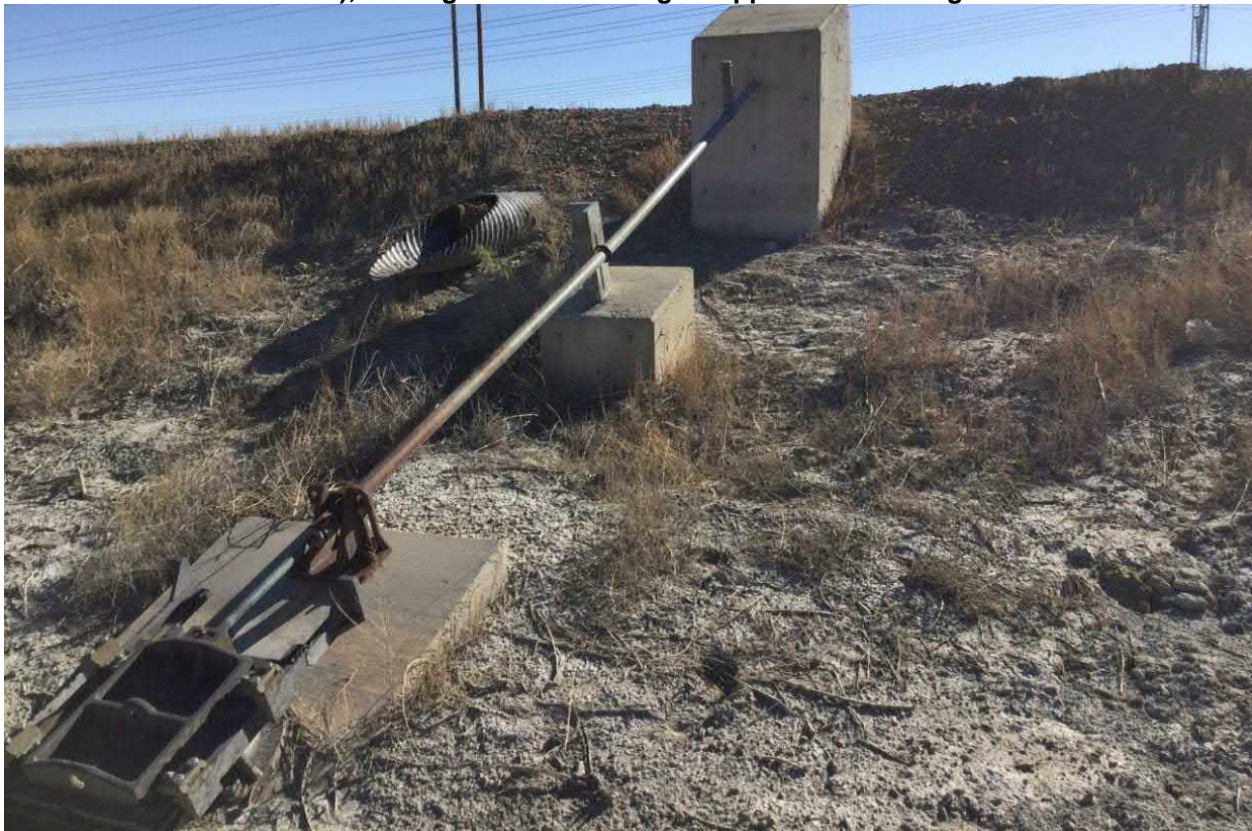
**Photograph No. 22** View of slide gate control and auxiliary outlet conduit, looking east. The slide gate control appeared to be straight and in good condition.

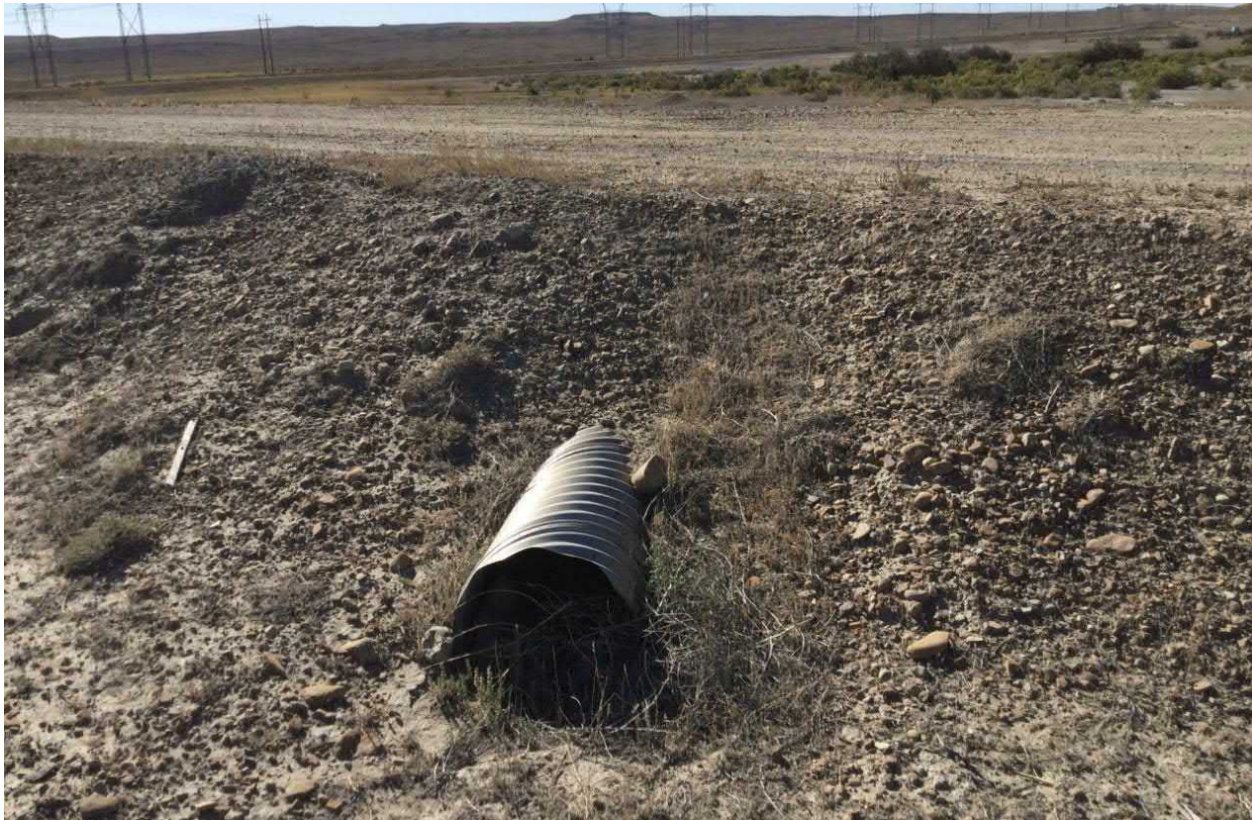
**Photograph No. 26** View of pipe culvert (upstream end) under perimeter road through retention pond embankment. The purpose of the pipe is unclear, but has since been removed.

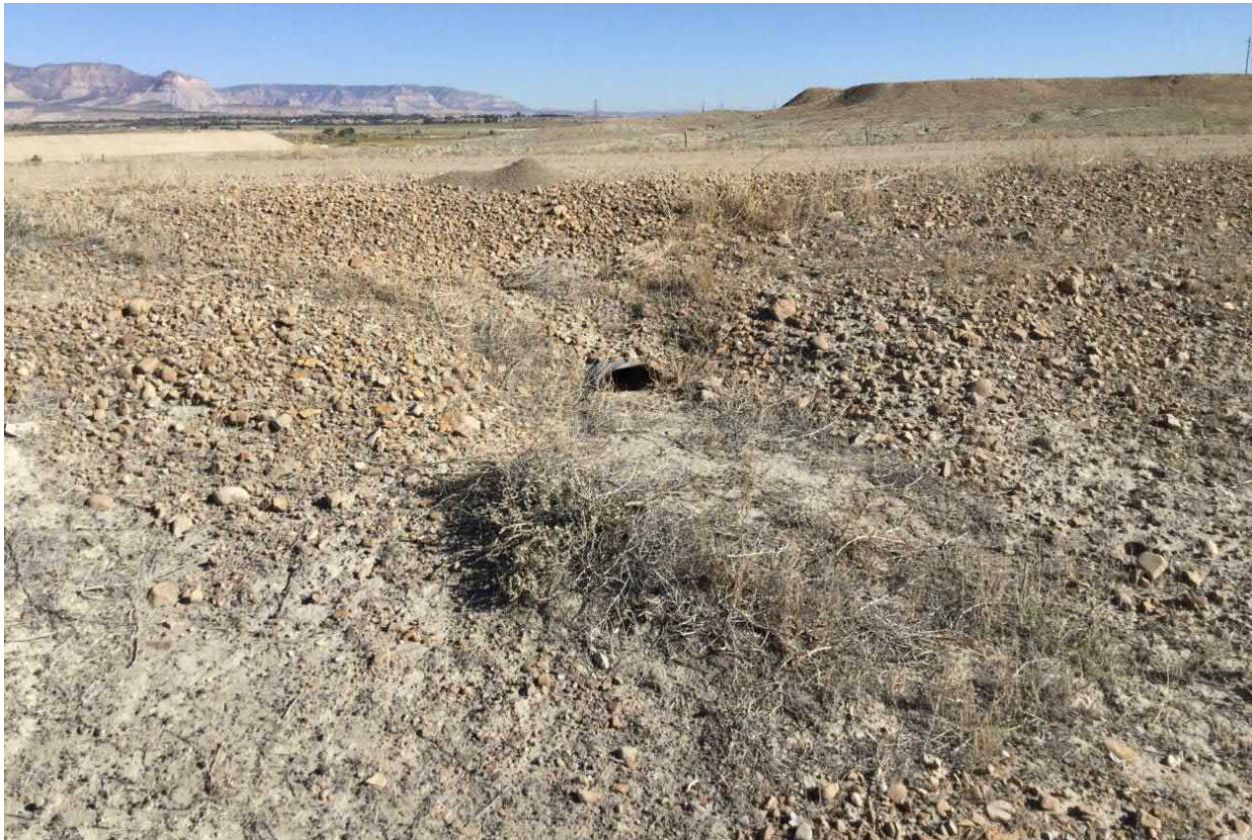
**Photograph No. 27** View of pipe culvert (downstream end) under perimeter road through retention pond embankment. The culvert has since been removed.

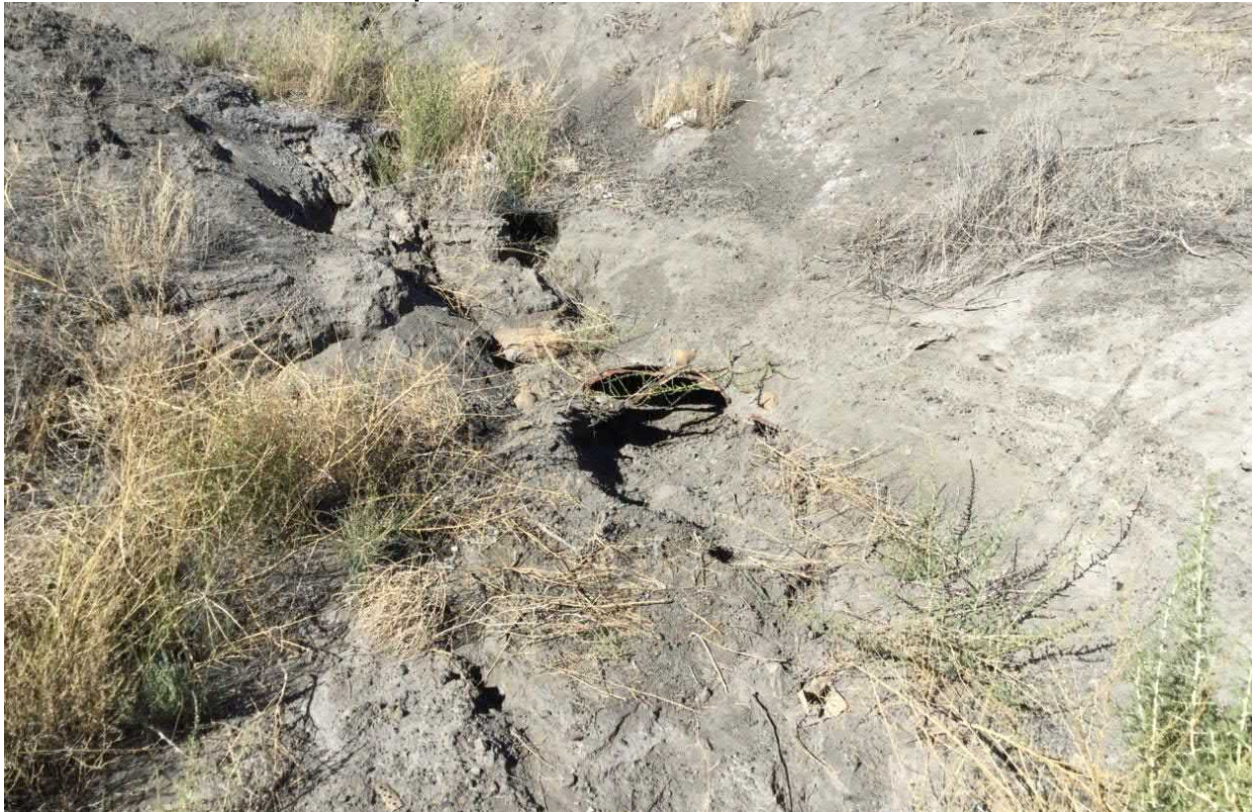
**Photograph No. 28** View of erosion gully above north inlet pipe (downstream end), looking approximately south-southwest. Pipe was partially obstructed, but has since been cleared.

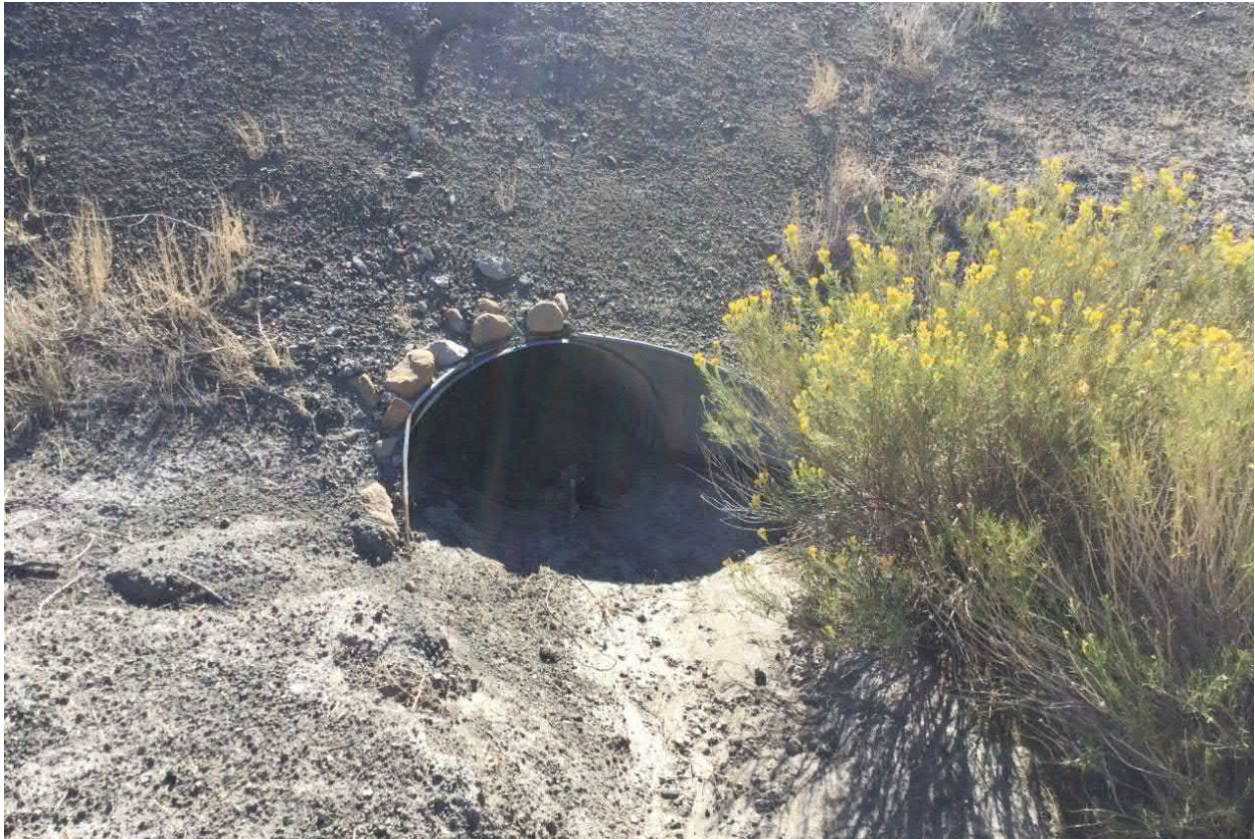
**Photograph No. 29** View of retention basin north inlet pipe (upstream end), looking east. Pipe culvert was partially obstructed, but has since been cleared.

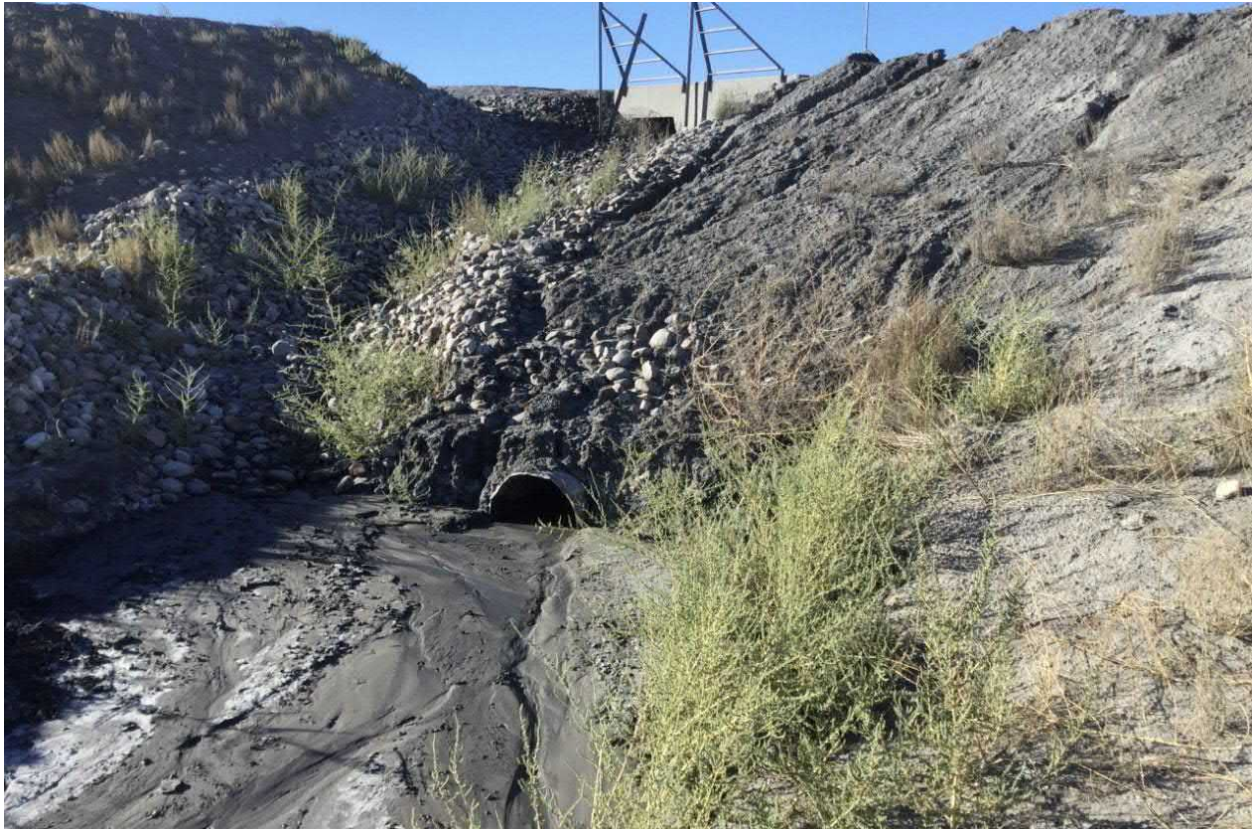
1. Obstruction of culverts in the perimeter drainage ditches at south haul road crossing and north access road. The obstructions in culverts are the result of eroded sediment similar to the condition observed in the 2016 and 2017 inspection reports [2], [3]. Refer to photos 28, 29, 33, and 34 Appendix A. These obstructions were addressed in recent maintenance and have been cleared since the inspection was completed.

**Photograph No. 33** View of pipe culvert (downstream end) under main haul road near entrance to CCR Landfill. Note rumble rack in the background. Culvert was partially obstructed by sediment, but has since been cleared.

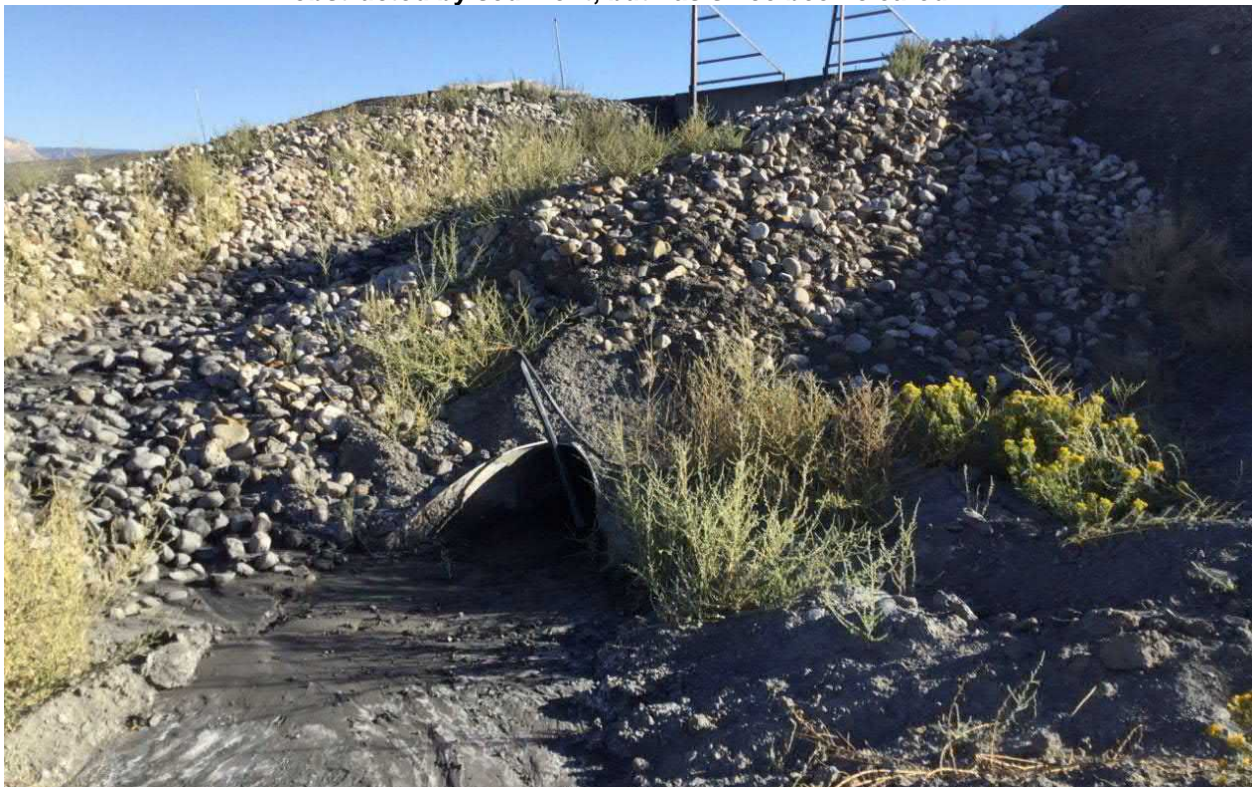
**Photograph No. 34** View of pipe culvert (upstream end) under main haul road near entrance to CCR Landfill. Culvert was partially obstructed, but has since been cleared.
