# 2019 Coal Combustion Residuals Annual Inspection

## Hunter Power Plant

### *Hunter CCR Landfill*

FINAL December 18, 2019

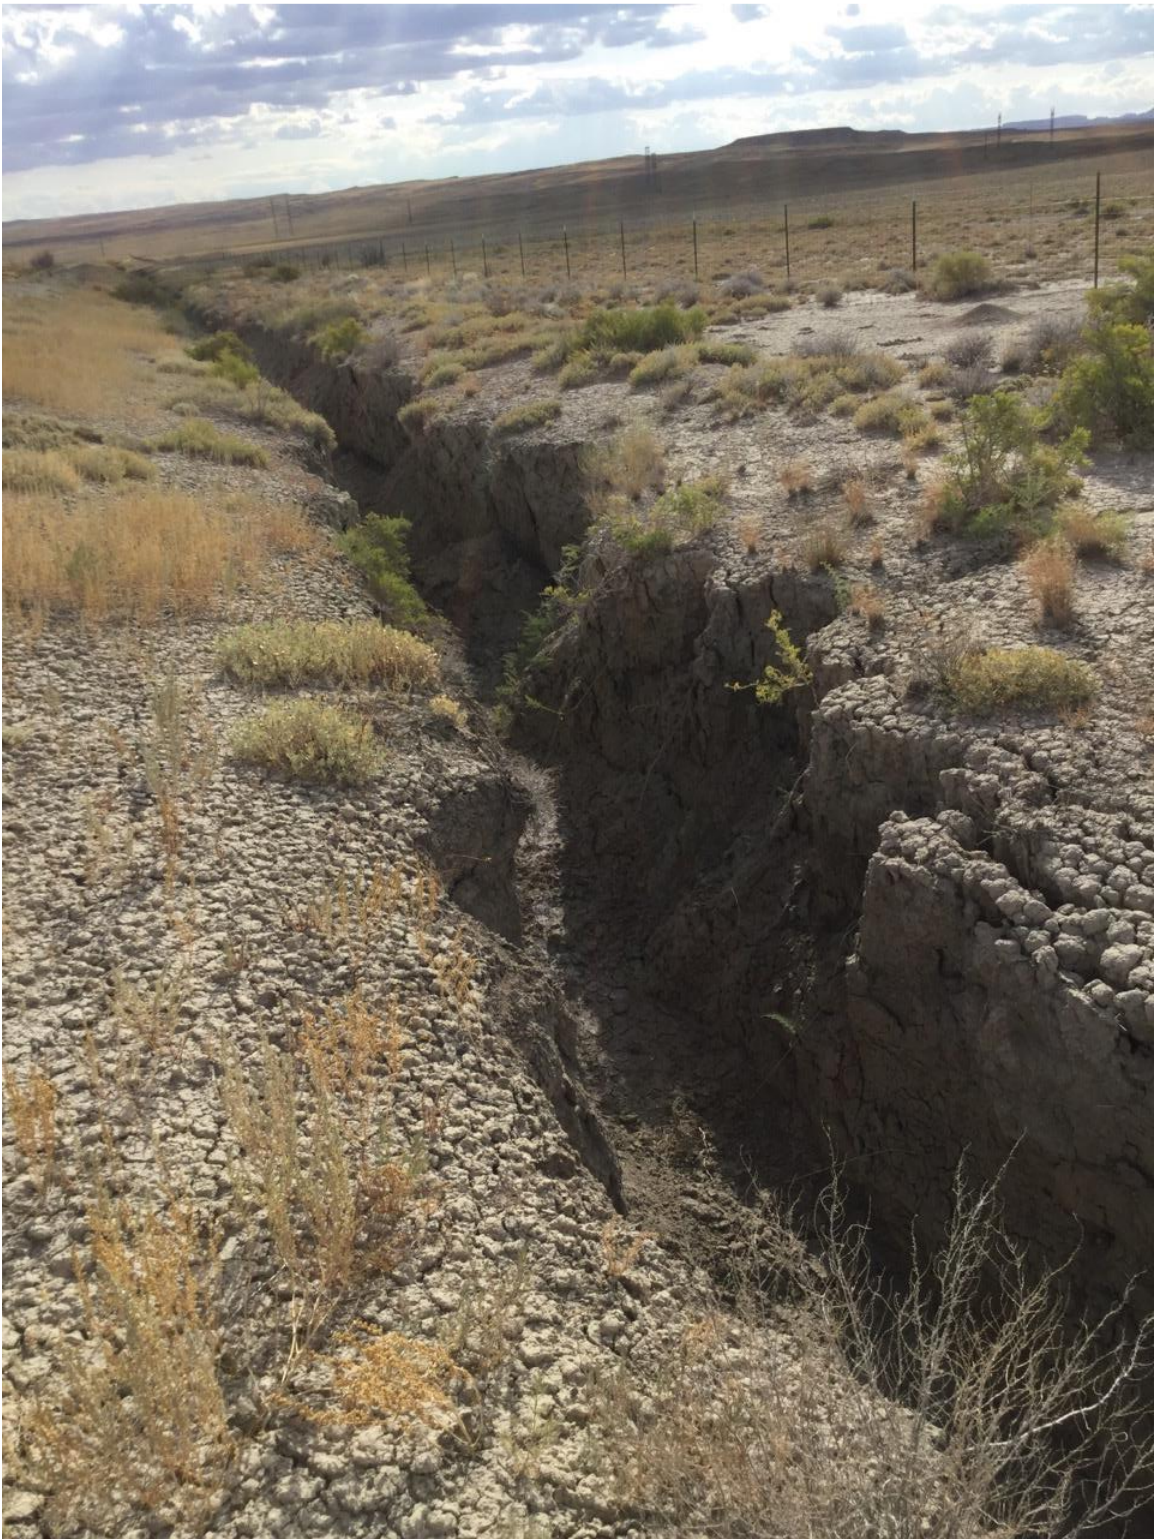
**Photograph No. 11** View of offsite diversion channel around permitted CCR Landfill, looking east. Channel is approximately 6 feet deep.

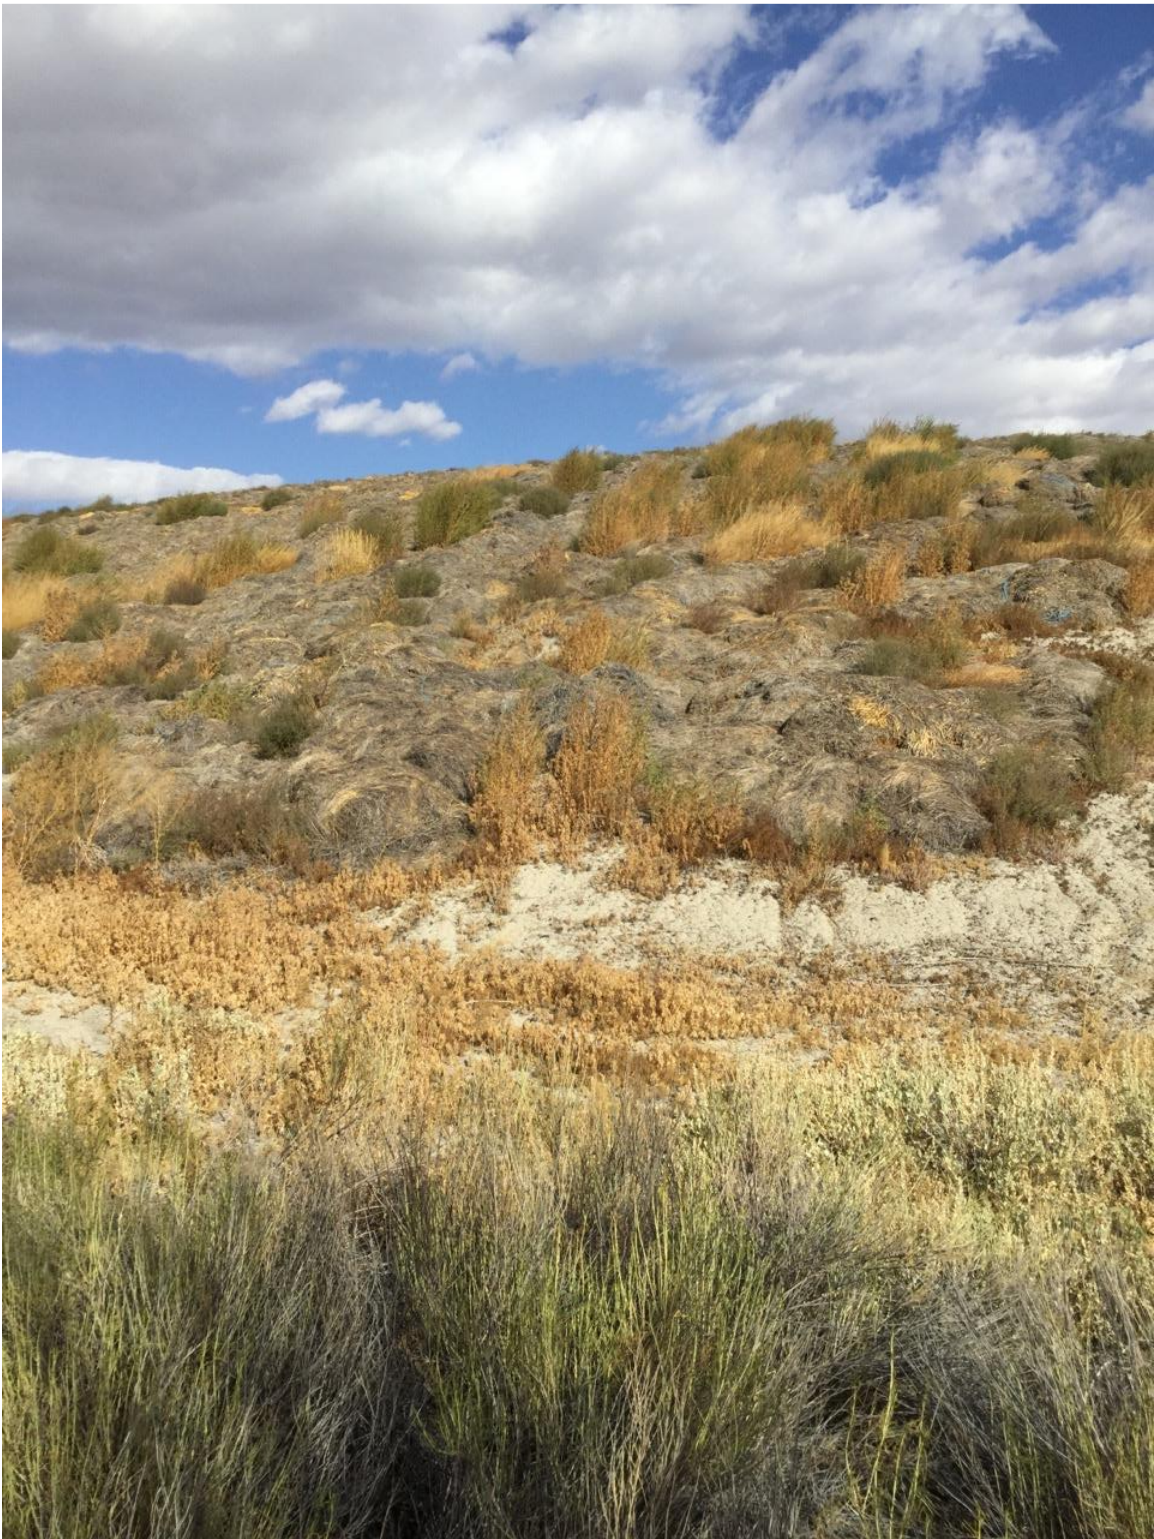
3. Additional segments of the exterior slopes have partially been covered with straw. These segments include the south and west exterior slopes, south of the haul road, and the east exterior slopes. Vegetation continues to improve on straw-covered slopes observed in previous inspections. Refer to photos 8, 9, 14, and 15, Appendix A.

**Photograph No. 14** View of southeast slope of CCR Landfill, looking northwest. Note hay and increased vegetation on slope.

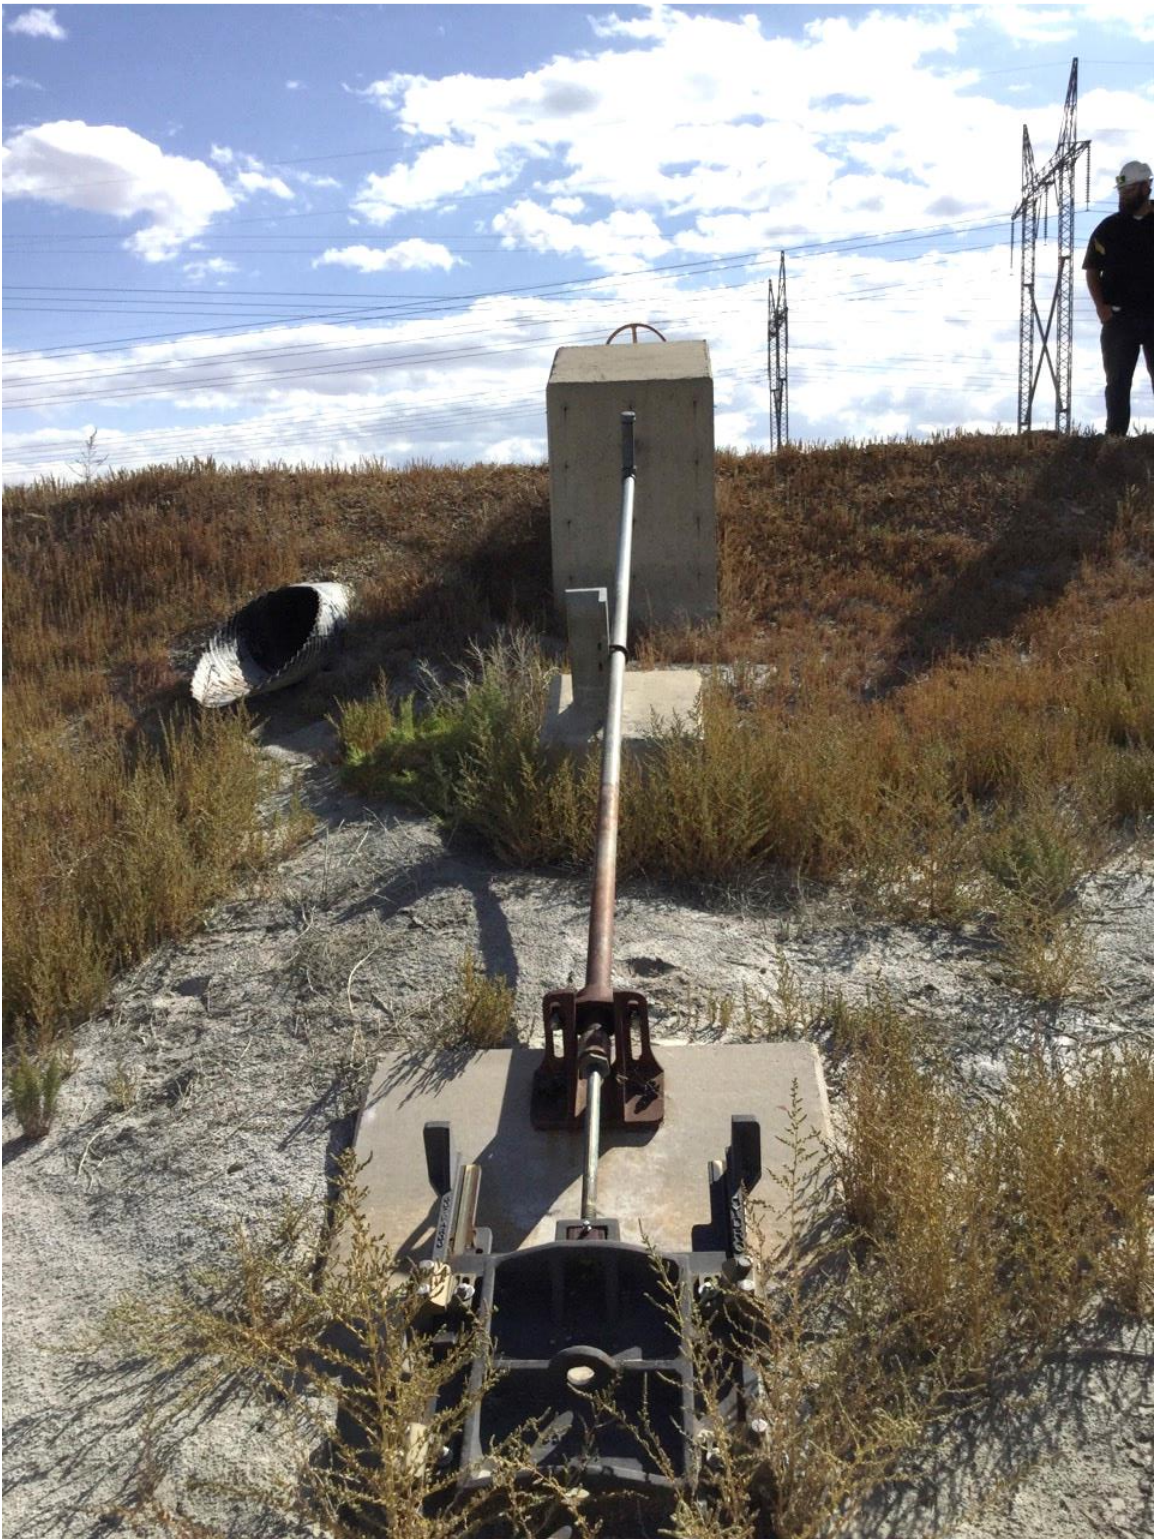
4. Energy dissipation structure at downstream end of retention pond outlet conduit has standing water despite dry conditions. No water was observed near the slide gate at the upstream end of conduit. The inspection team could not identify the source of the water. Refer to photos 22-26, Appendix A.

**Photograph No. 22** View of slide gate control and auxiliary outlet conduit, looking east. The slide gate control appeared to be straight and in good condition.

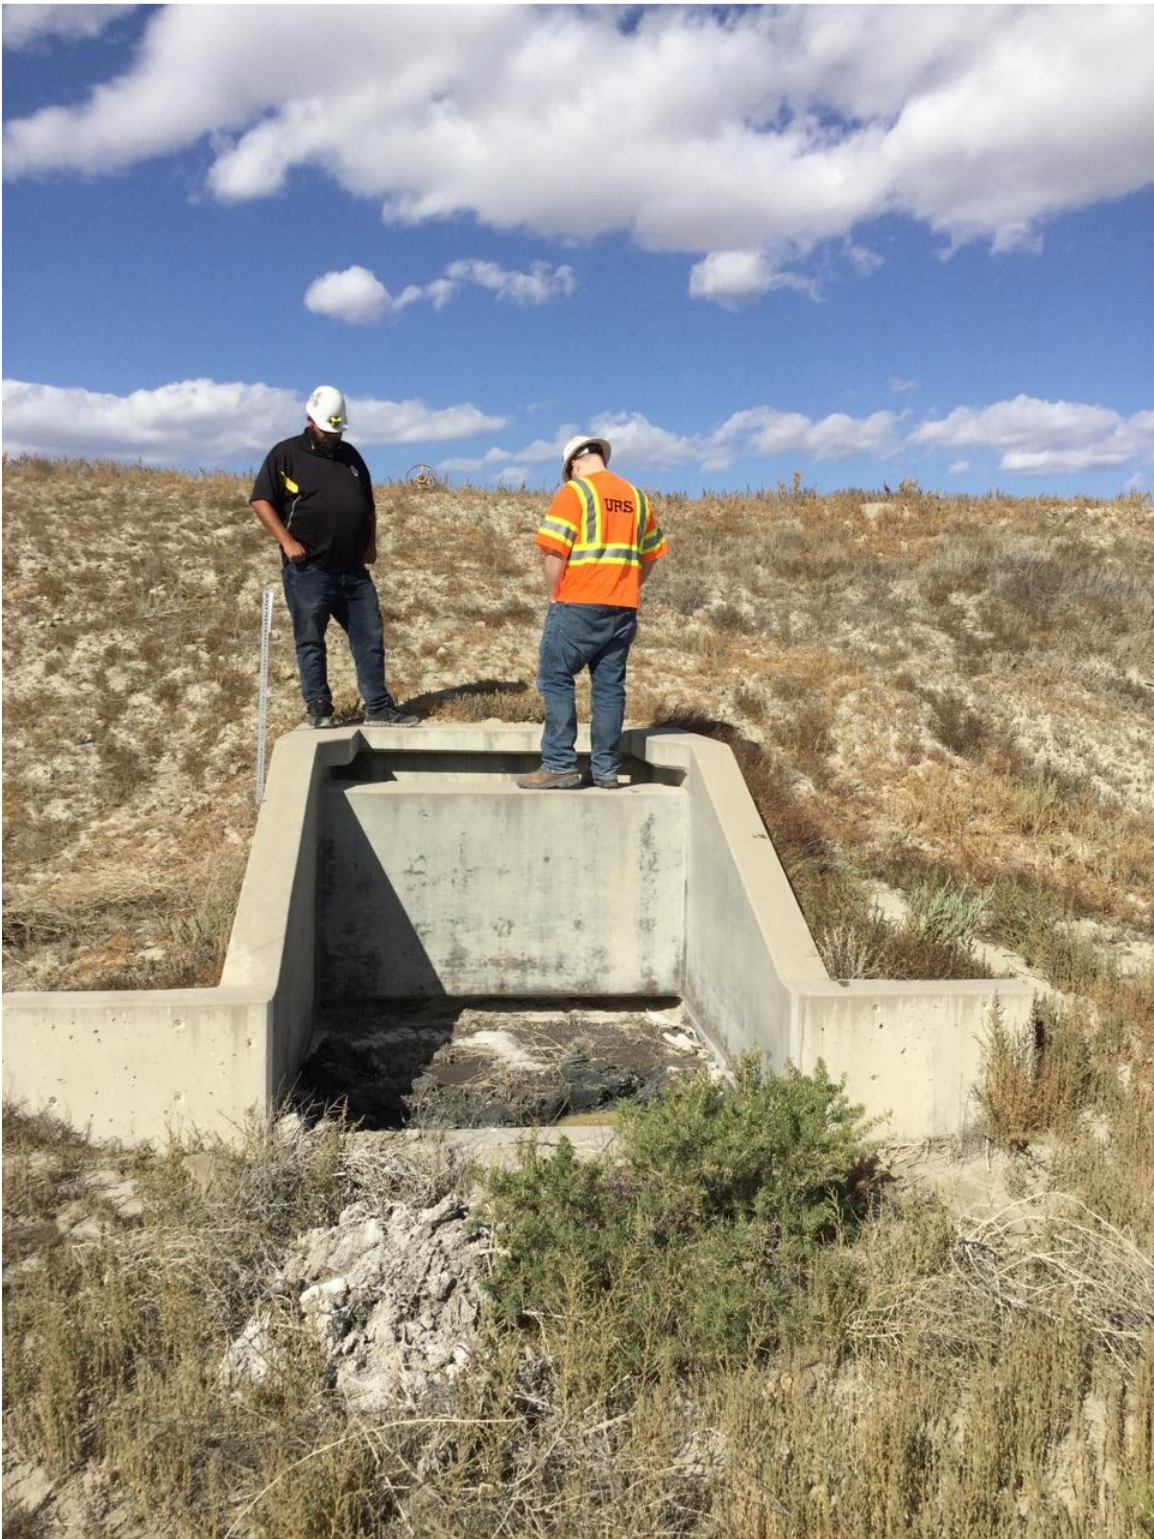
**Photograph No. 23** View of energy dissipation structure at downstream end of retention pond outlet conduit, looking west. This facility is a zero-discharge facility and gate remains closed.

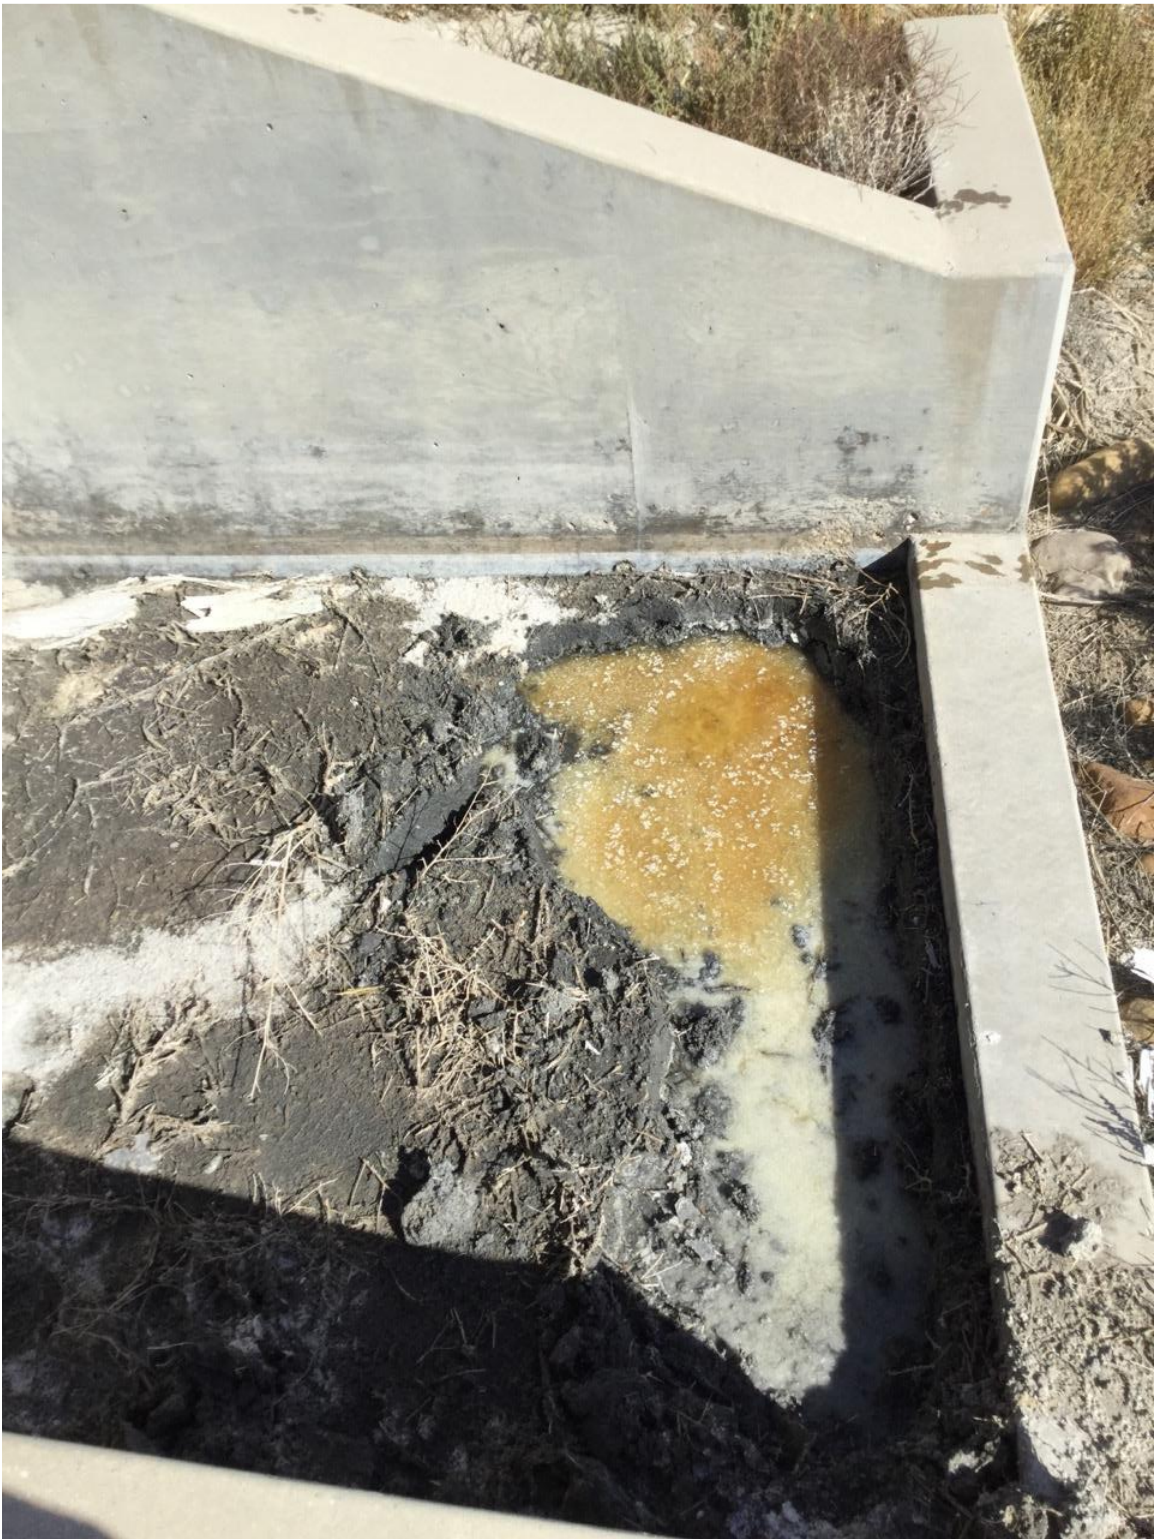
**Photograph No. 24** View of energy dissipation structure at downstream end of retention pond outlet conduit and downstream of baffle. Note ponding water despite no water present at upstream end.

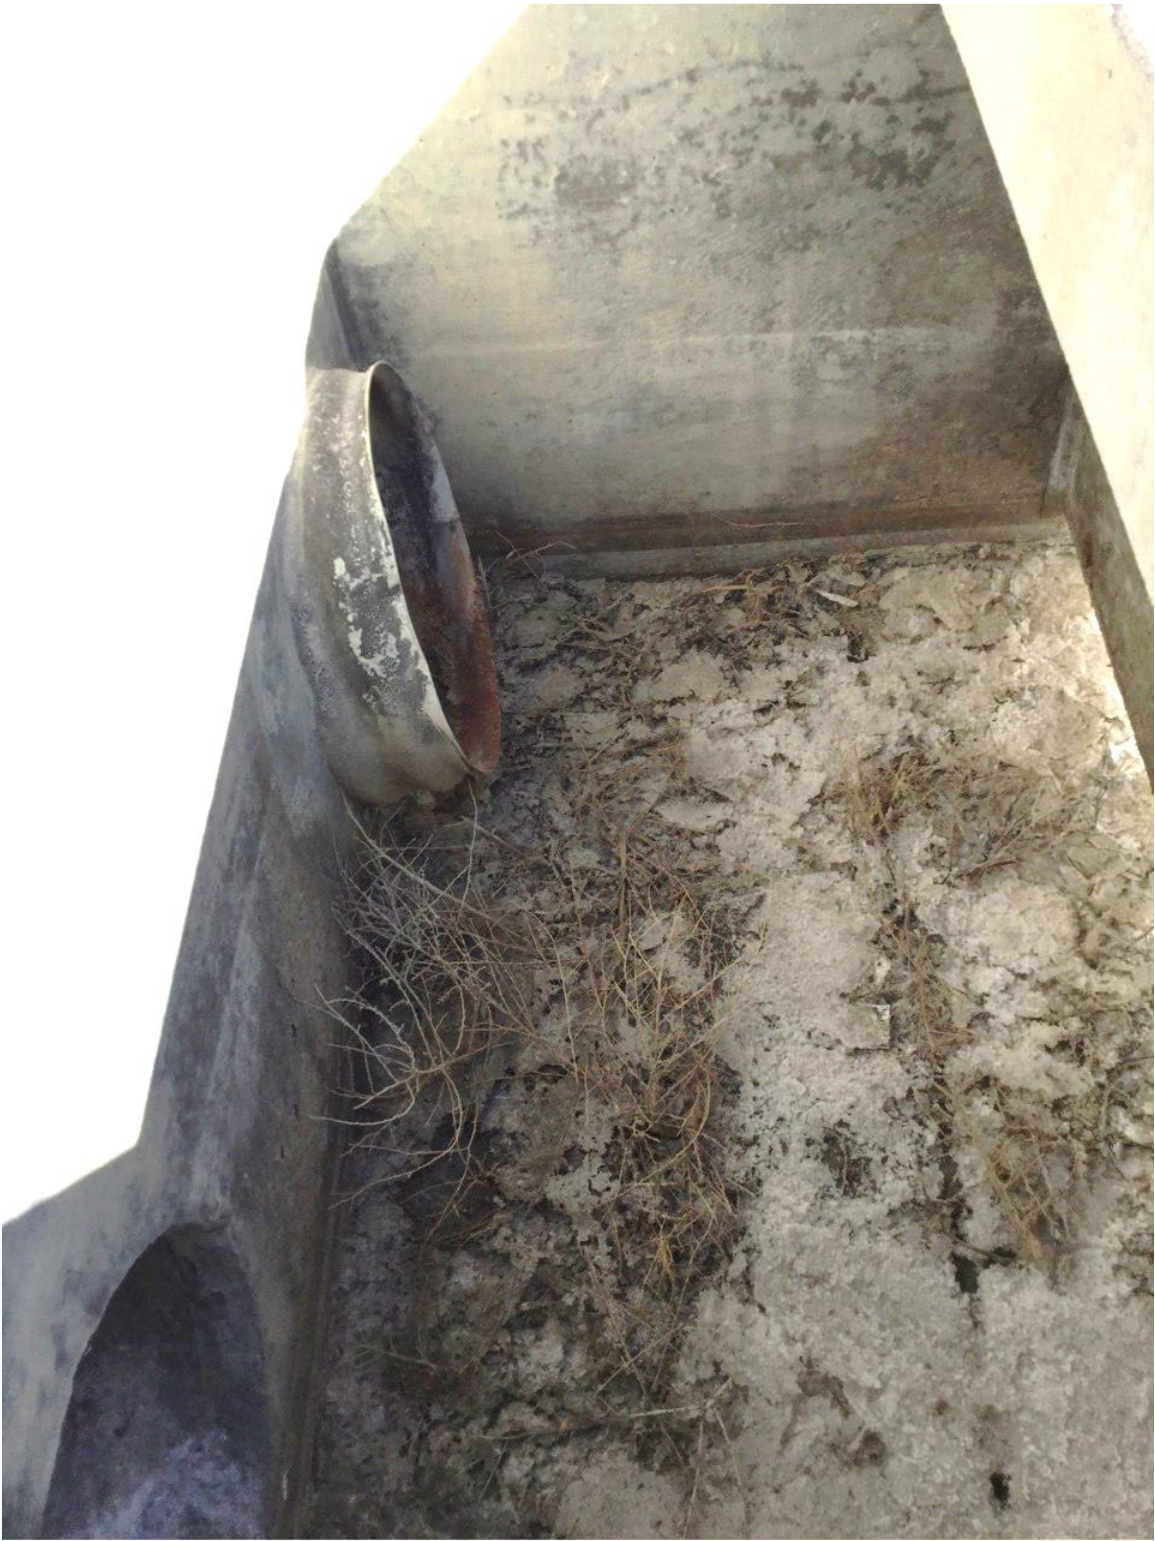
**Photograph No. 25** View of energy dissipation structure at downstream end of retention pond outlet conduit and upstream of baffle. Note discharge conduit from auxiliary spillway (top).

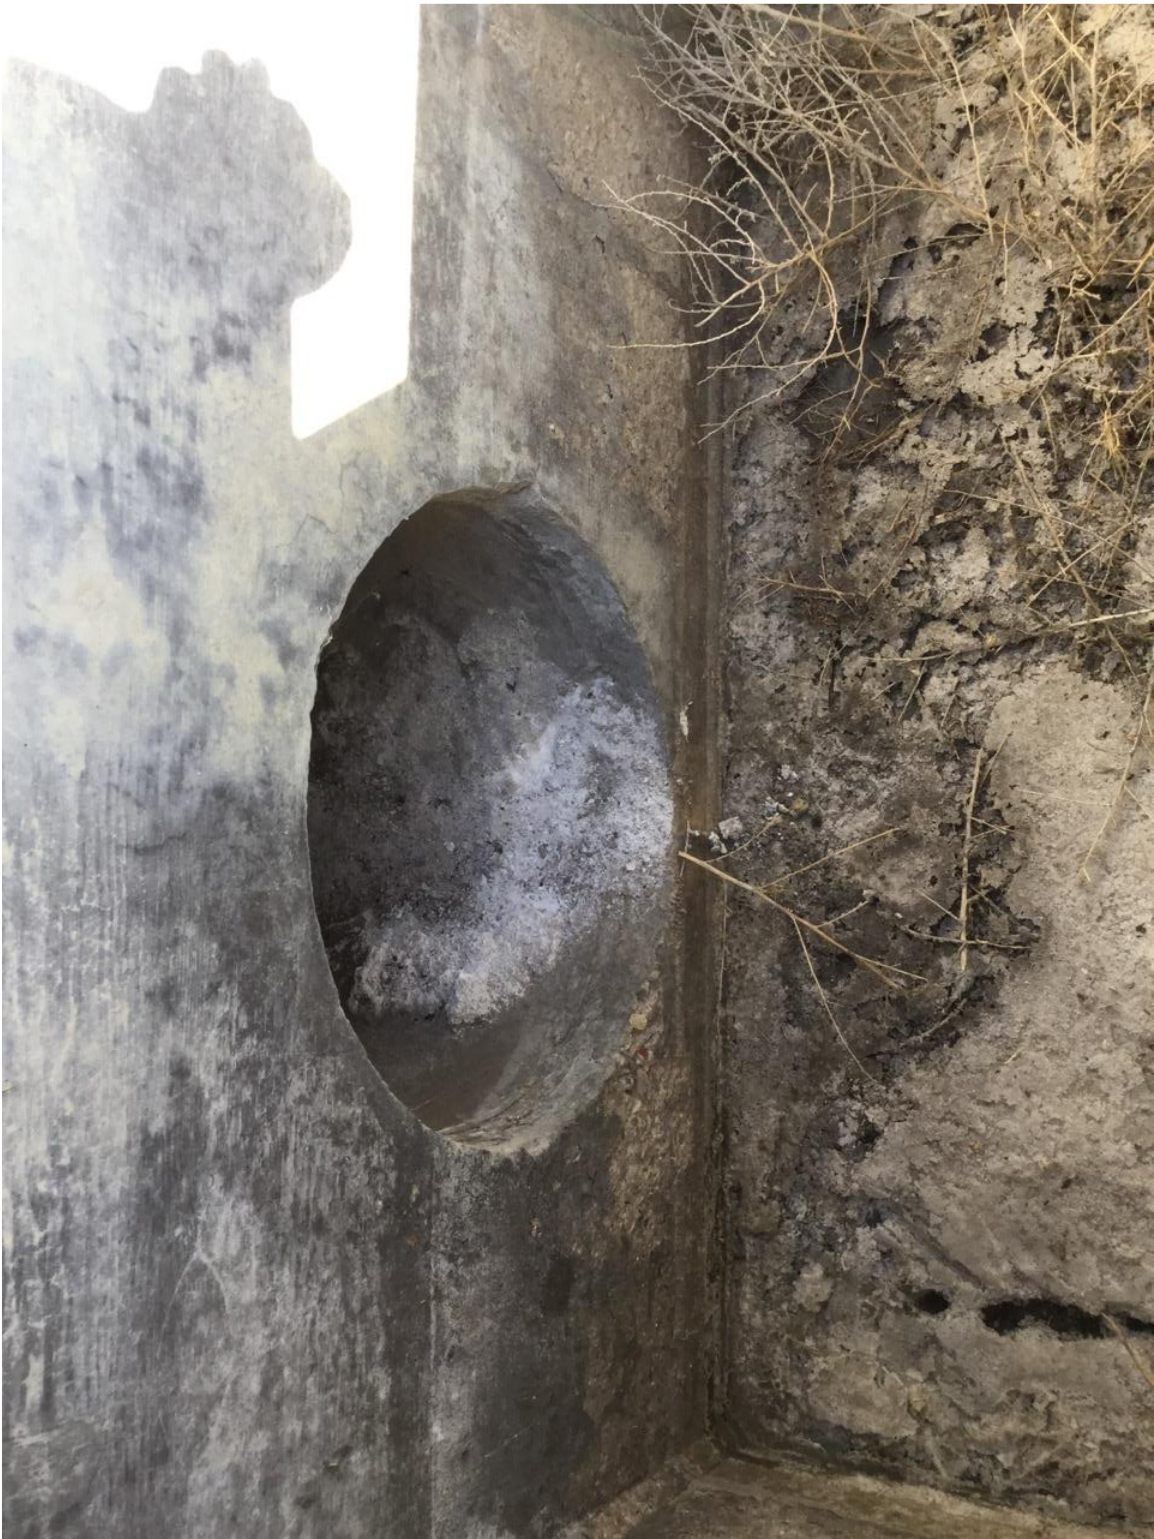
**Photograph No. 26** View of energy dissipation structure at downstream end of retention pond outlet conduit and upstream of baffle. Note dry material in outlet conduit.

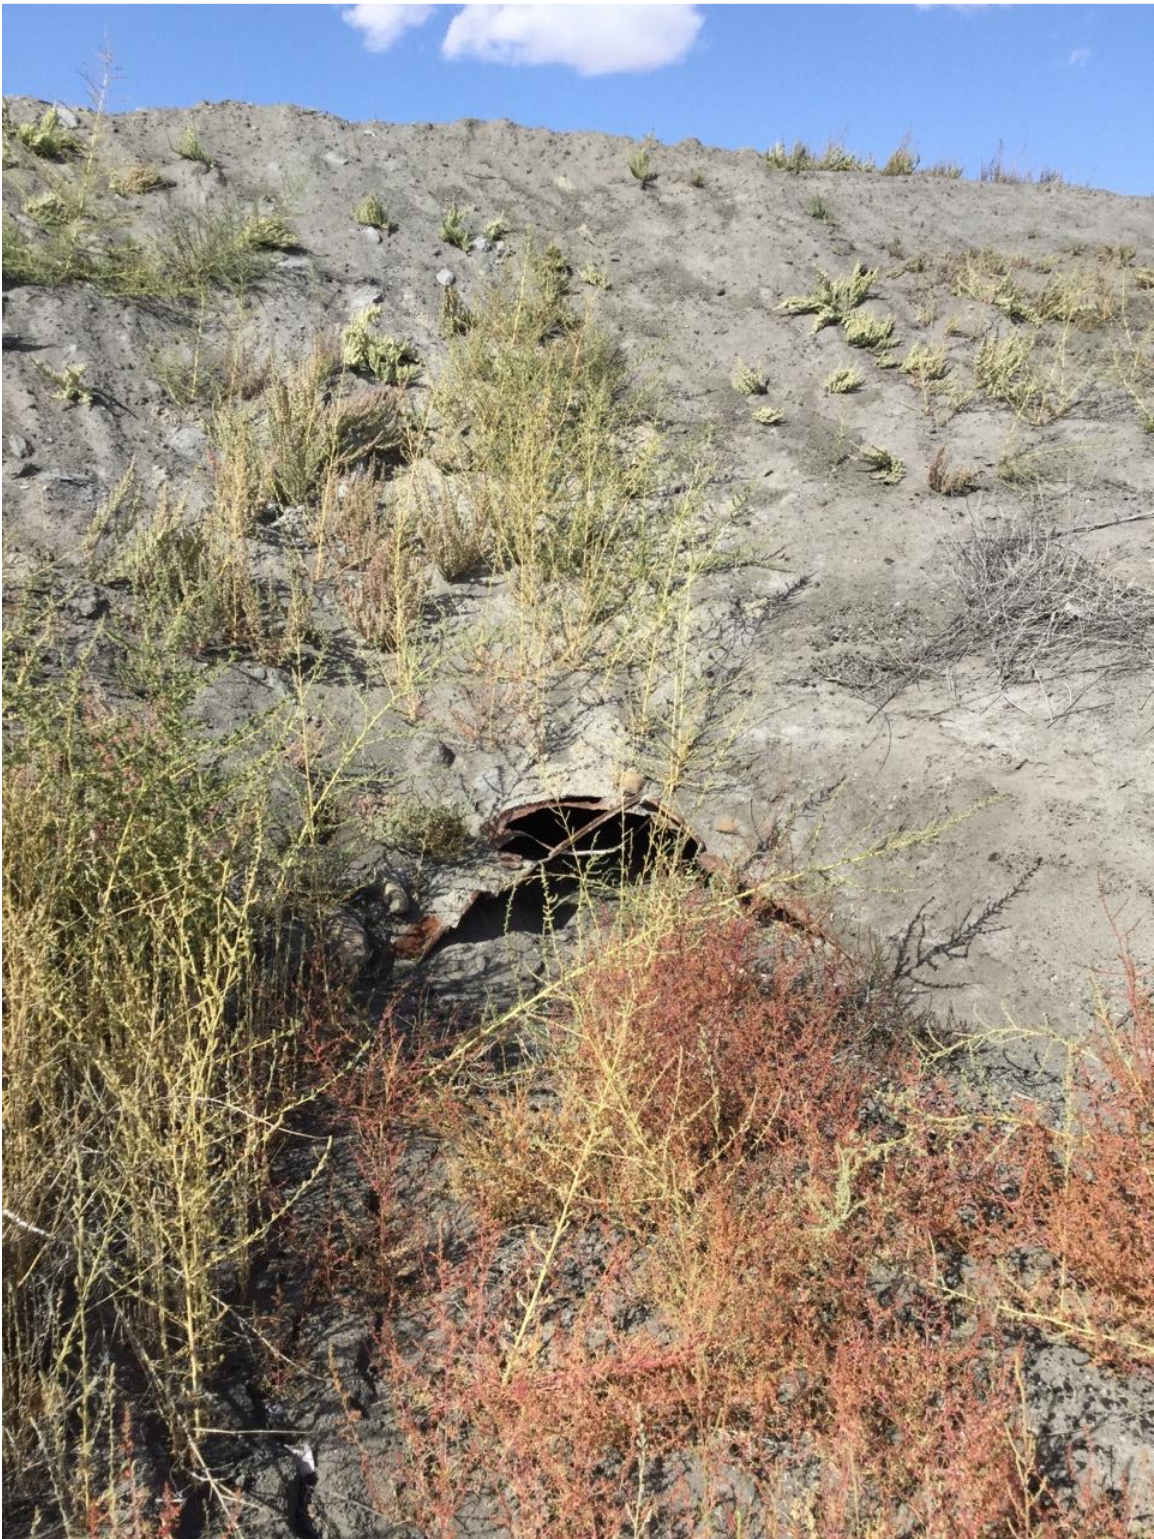
1. Obstruction of a culvert in the perimeter drainage ditches at the north access road. The obstructions in the culvert are the result of eroded sediment. Refer to photo 27, Appendix A.

1. Obstruction of culvert in the perimeter drainage ditch at the north access road. The obstructions in culverts are the result of eroded sediment. Refer to photo 27 Appendix A. Other obstructions were observed in the 2018 inspection report and all have been cleared.

**Photograph No. 27**    **View of north inlet pipe (downstream end), looking approximately south-southwest. Pipe was partially obstructed.**

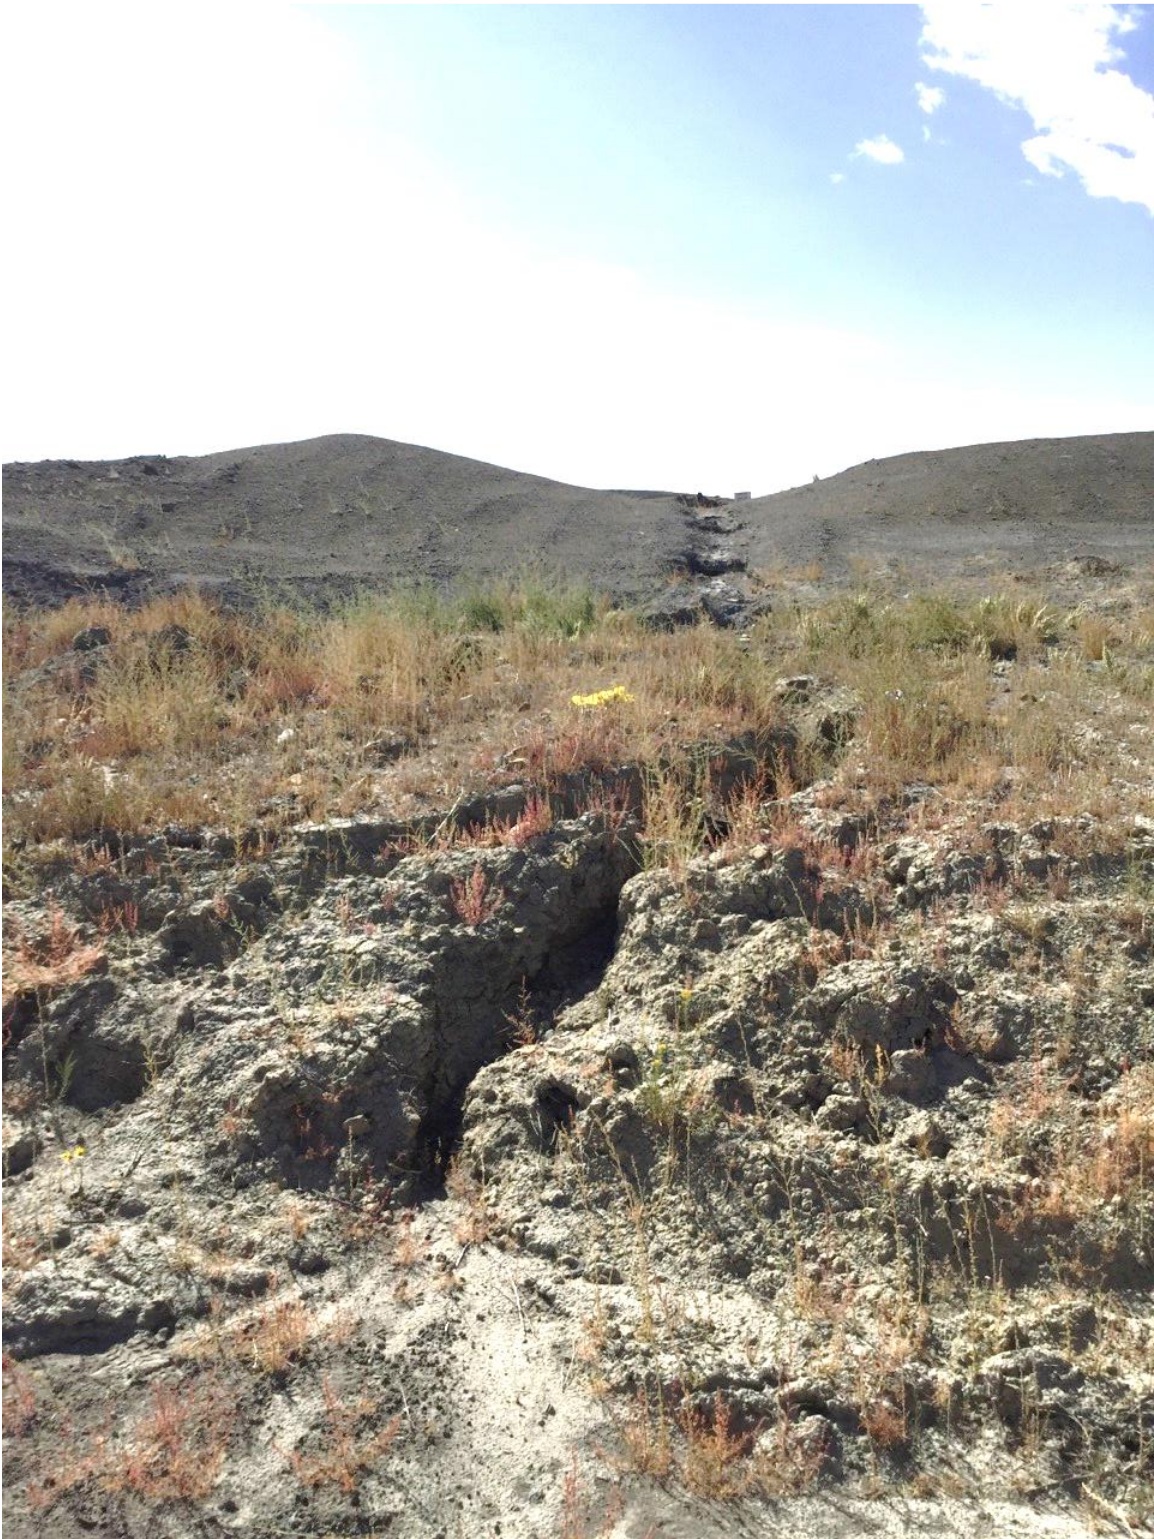
1. Observation of erosion rills and shallow gullies at the north access road. Refer to photo 29, Appendix A.
2. Additional segments of the exterior slopes have partially been covered with straw. Vegetation continues to improve on straw-covered slopes observed in previous inspections. Refer to photos 8, 9, 14, and 15, Appendix A.
3. Energy dissipation structure at downstream end of retention pond conduit has standing water despite dry conditions. Water did not reach the slide gate at the upstream end of conduit. Refer to photos 22-26, Appendix A.

2. Observation of erosion rills and shallow gullies at the north access road. Refer to photo 29, Appendix A. Operations personnel stated that these rills and gullies developed from snow melt this past spring. These do not represent a threat to safety or the integrity of the slopes. The eroded material has been retained at the toe of the embankment and runoff collection ditch and there is no potential for it to move off site.

**Photograph No. 29** View of erosion from snowmelt on north slope of CCR Landfill, looking southeast.
