2020 Coal Combustion Residuals Annual Inspection

Hunter Power Plant

Hunter CCR Landfill

FINAL December 15, 2020

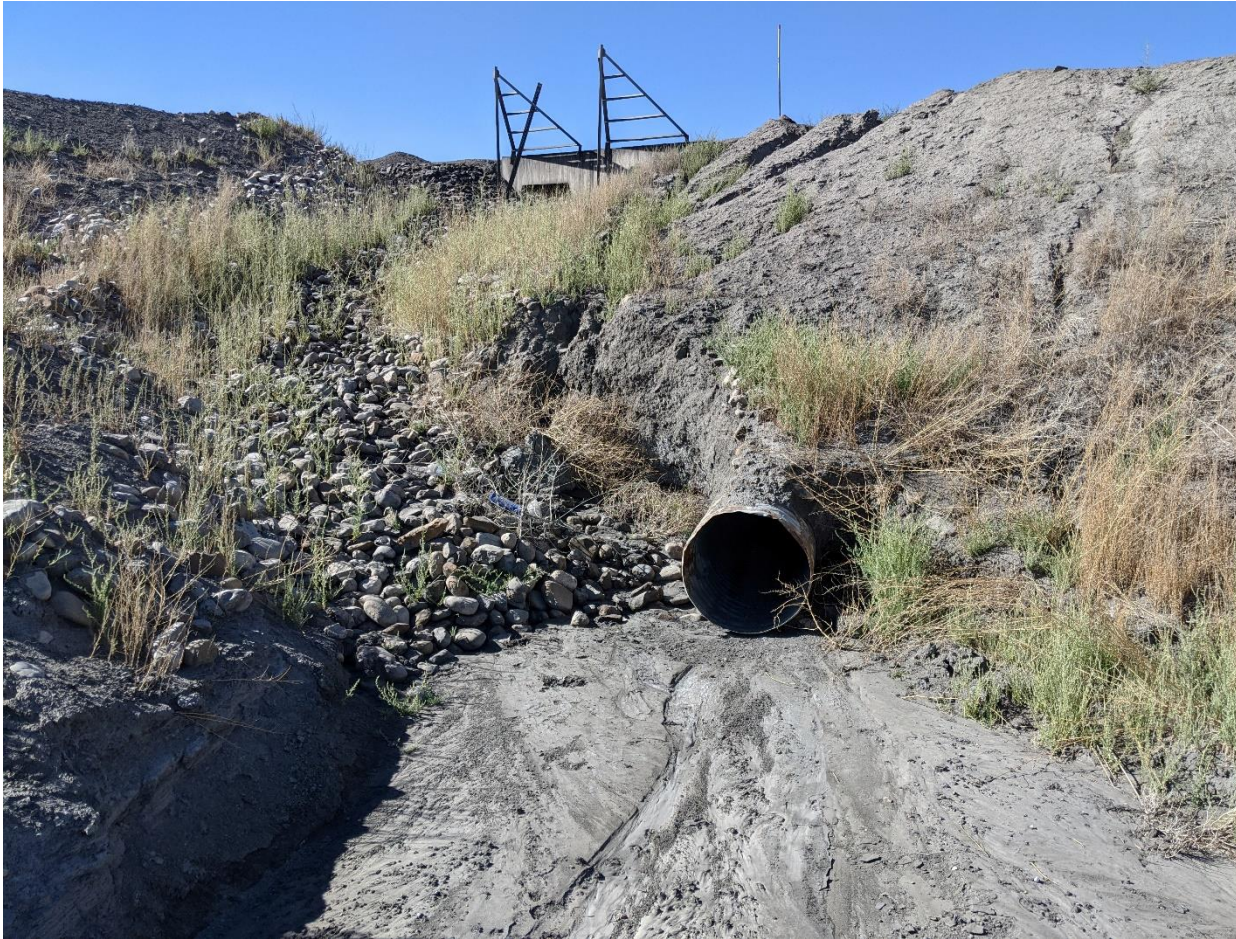
Photograph No. 1 **View of downstream end of culvert under main haul road and rumble rack, looking southwest. Culvert unobstructed, but moderate erosion observed adjacent to culvert (left) from water introduced into the rumble rack from snowmelt or for dust suppression and cleanout.**

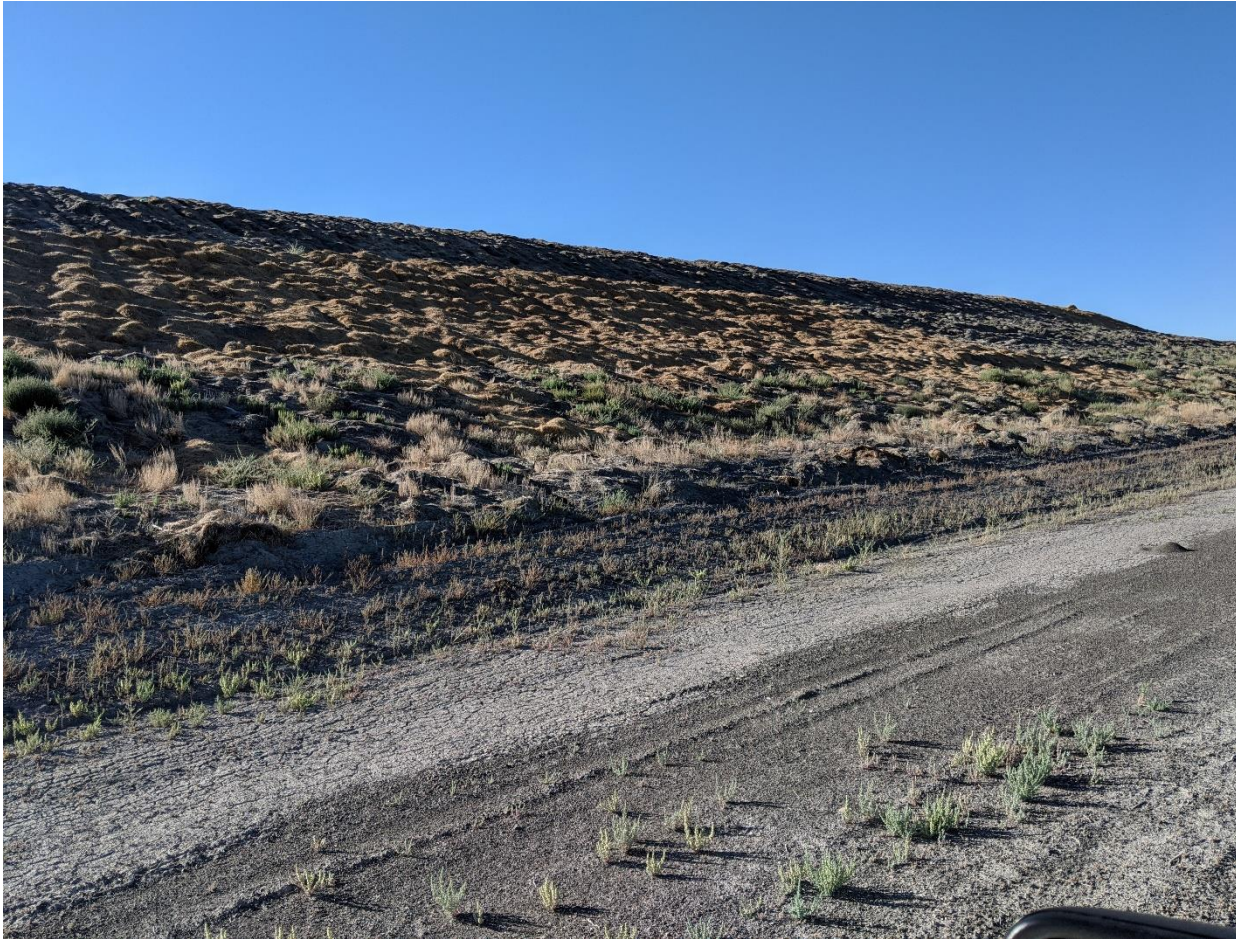
4. Additional segments of the exterior slopes have partially been covered with straw. Vegetation continues to improve on straw-covered slopes observed in previous inspections. Refer to Photos 3, 7, 11, 12, and 13, Appendix A.

Photograph No. 3 **View of western slope of CCR Landfill, looking south. Note vegetation and hay cover.**

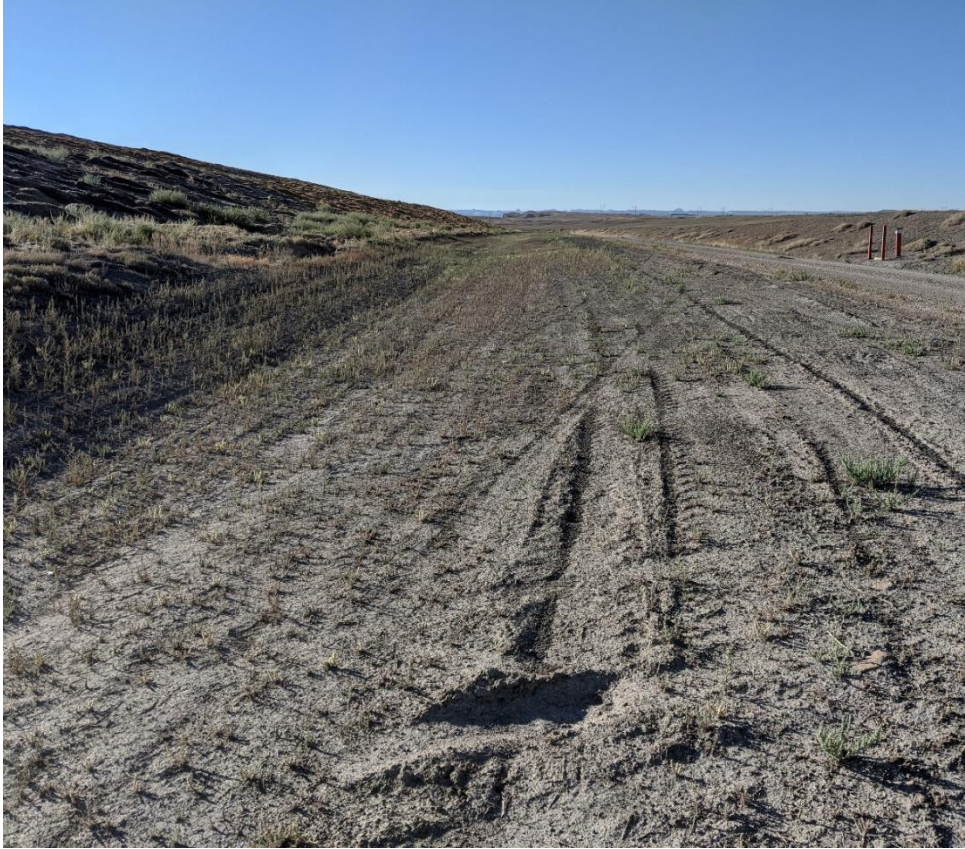
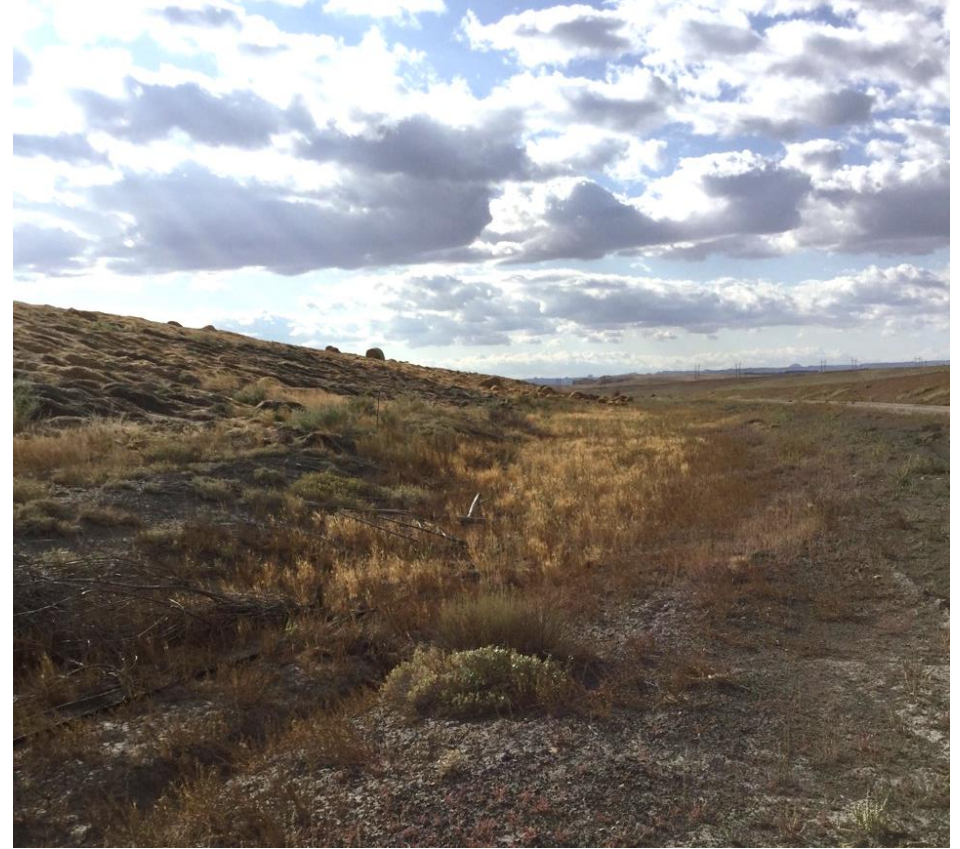
Photograph No. 4

1. Regrading and removal of brush has been performed near the toe of the slope along the perimeter ditch since the 2019 annual inspection [2].
2. Gullies on south end outside perimeter berm continue to develop. Desiccation cracks are visible, and there appear to be possible tension cracks near the downstream toe of the berm at the top of the gully's sidewall where continued erosion may be occurring. The function and integrity of the perimeter berm does not appear to be compromised at present, but AECOM recommends monitoring of this region. Refer to Photos 8 and 9, Appendix A.

Left: View of western face of CCR landfill showing recent regrading and removal of brush at the toe of the slope since the last annual inspection, looking southwest (photo from 2020 inspection).

Right: Photo from 2019 Inspection in approximately the same location prior to regrading and removal of brush at the toe of the slope.

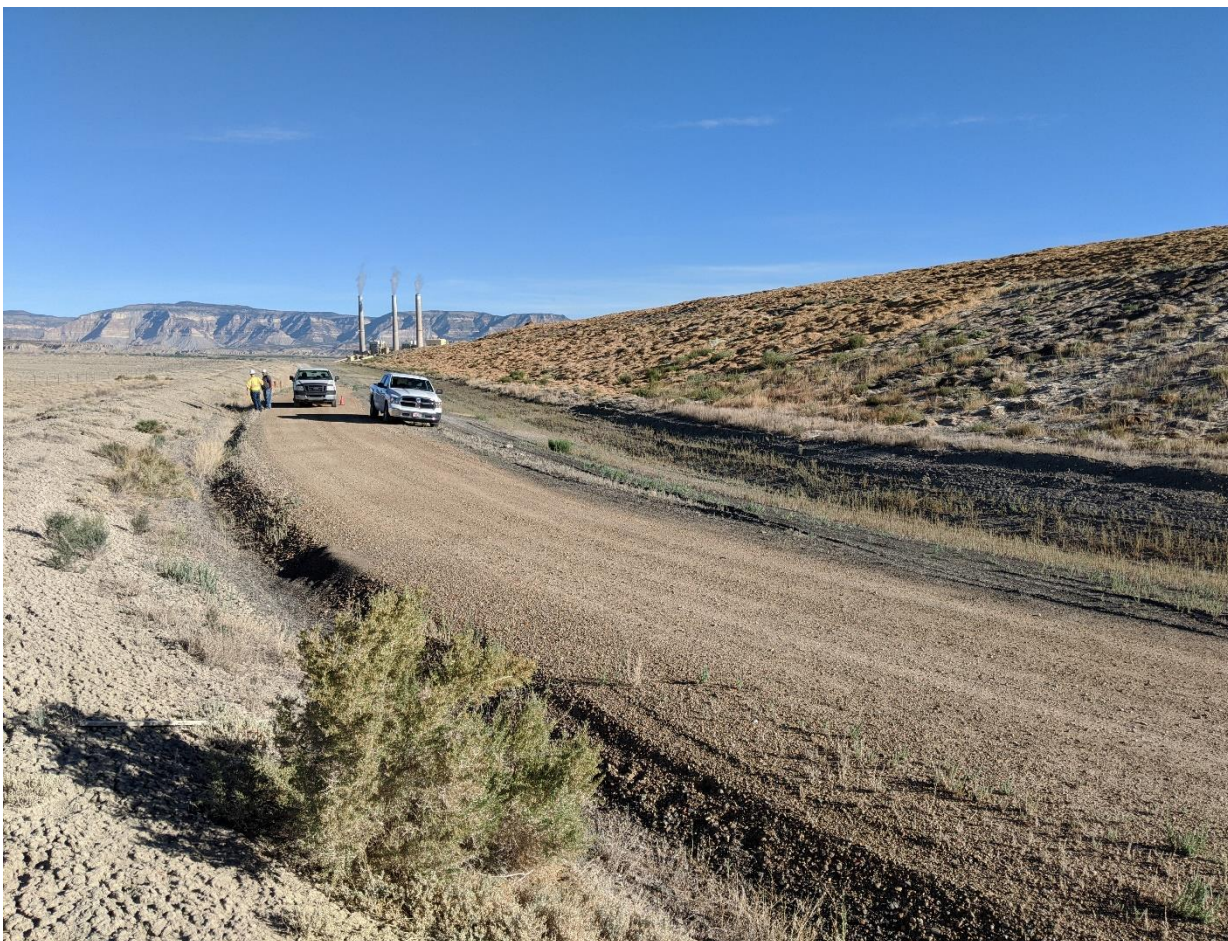
Photograph No. 7 **View of western slope of CCR landfill and perimeter berm, looking north. Note the recent regrading and removal of brush at the toe of the slope.**

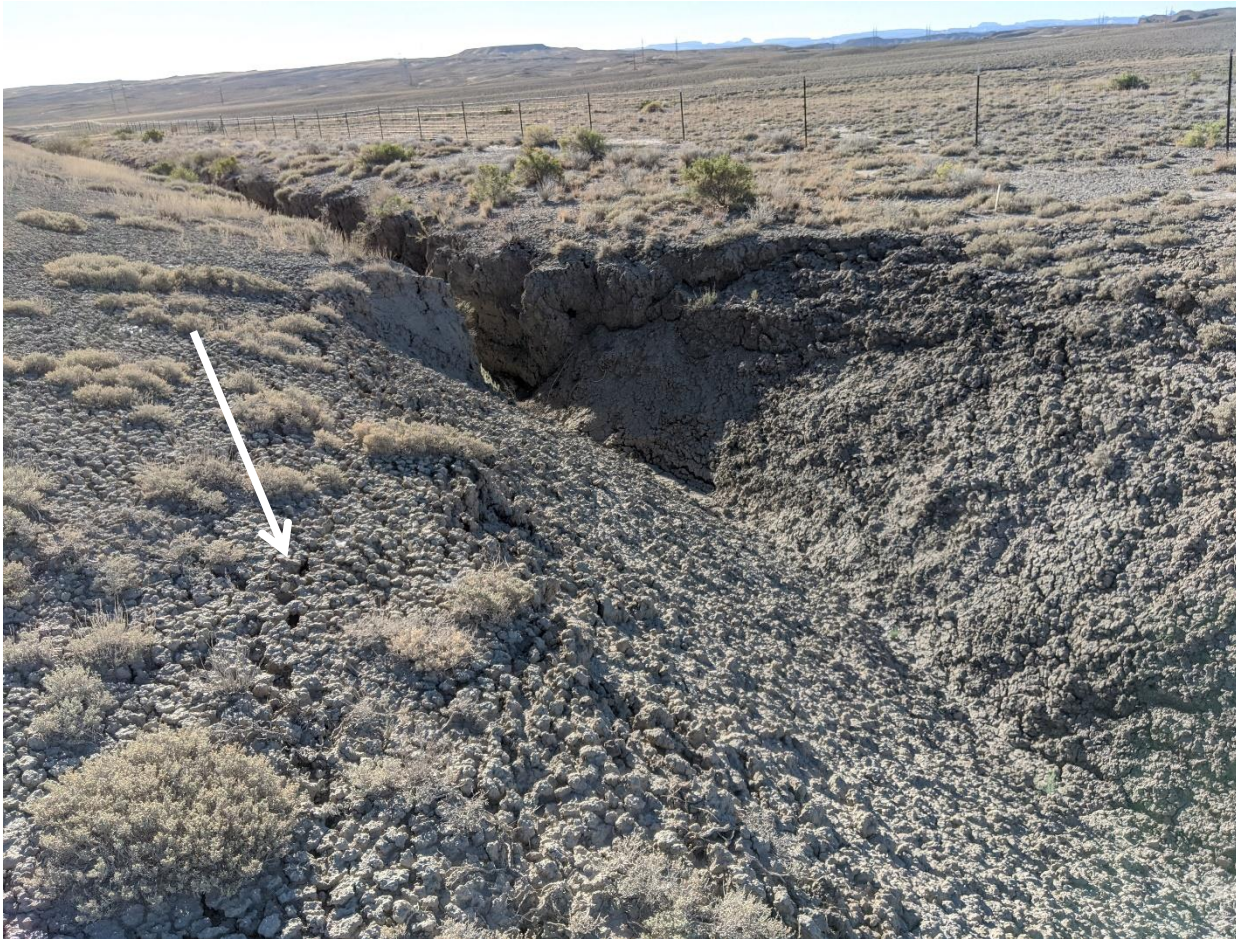
1. Regrading and removal of brush has been performed near the toe of the slope along the perimeter ditch since the 2019 annual inspection [2].
2. Gullies on south end outside perimeter berm continue to develop. Desiccation cracks are visible, and there appear to be possible tension cracks near the downstream toe of the berm at the top of the gully's sidewall and where continued erosion may be occurring. The function and integrity of the perimeter berm does not appear to be compromised at present, but AECOM recommends monitoring of this region. Refer to Photos 8 and 9, Appendix A.

Photograph No. 8 **View of erosion gully at outer slope of southwest perimeter berm, looking southeast. Note minor sloughing, desiccation, and possible tension cracking (arrow). The function and integrity of the diversion berm does not appear to be compromised at present.**

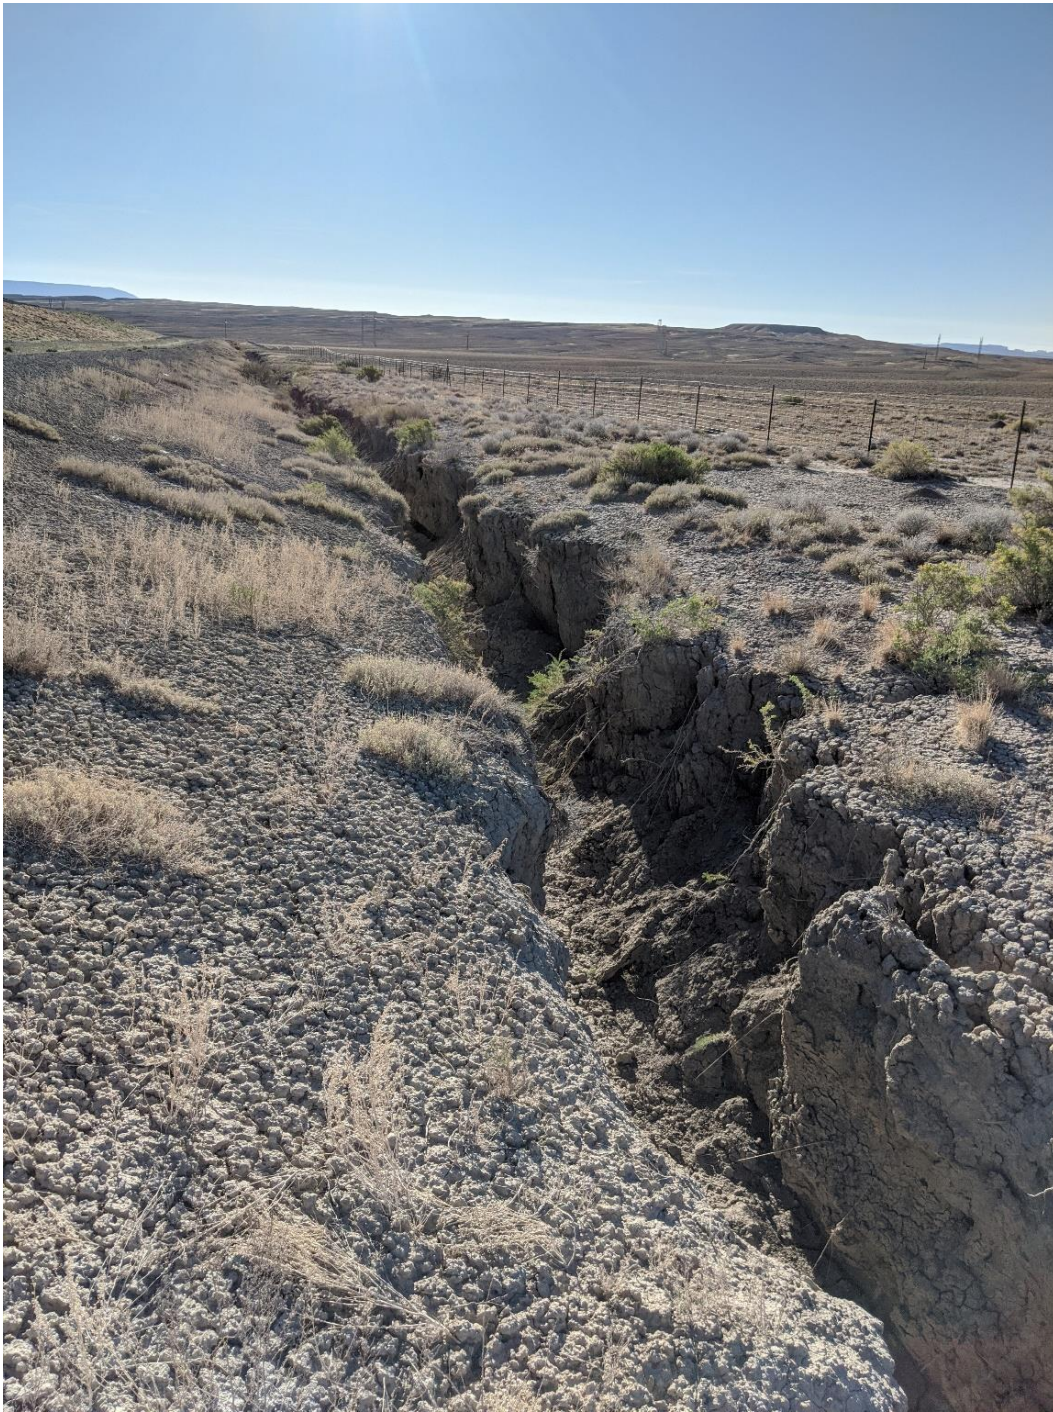
Photograph No. 9

View of erosion gully at outer slope of southern perimeter berm, looking east.

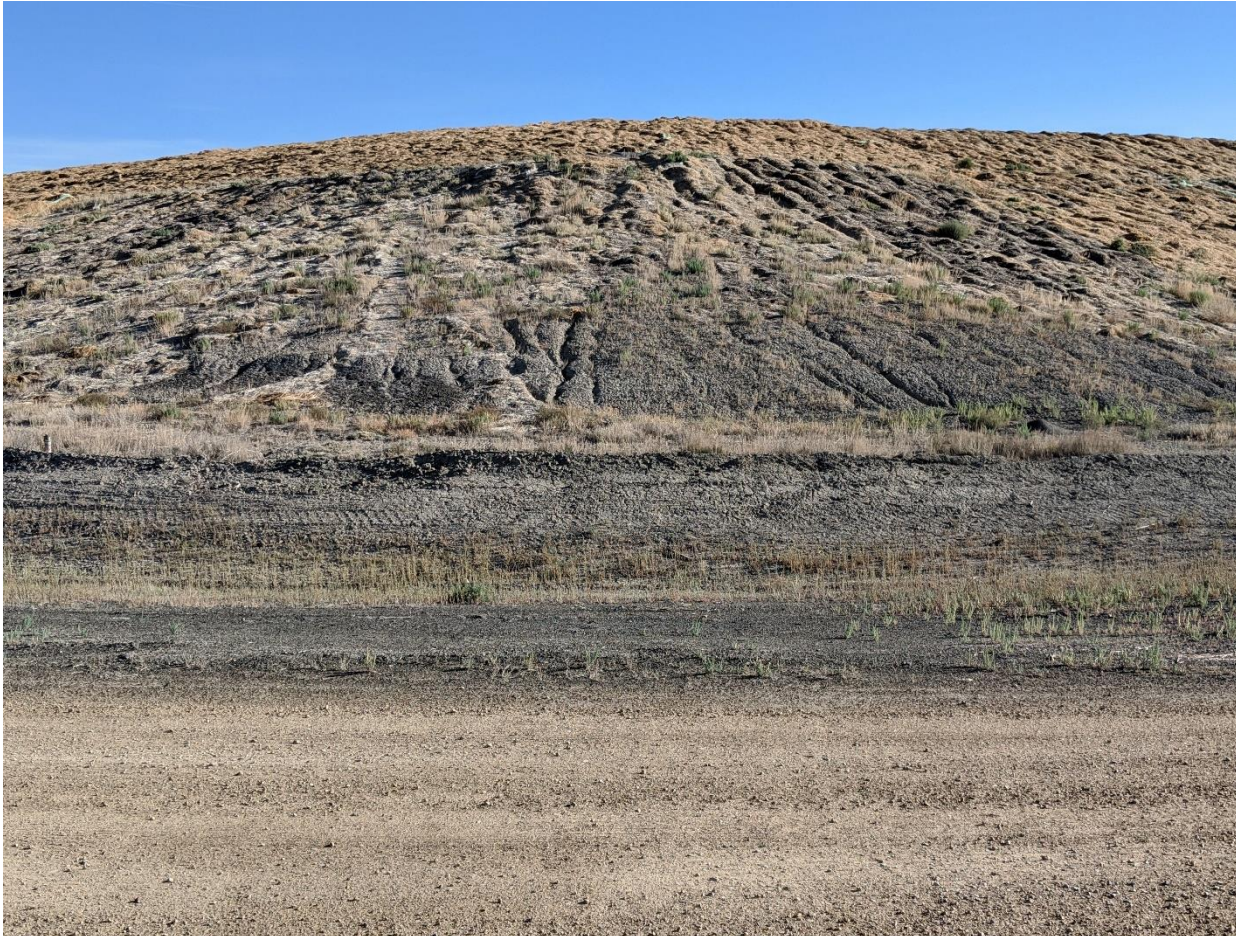
3. Observation of mild erosion and rills on bare soil cover of some slopes of CCR landfill (hay and vegetation obstructed view of possible erosion and rills beneath). Refer to Photo 10, Appendix A.

Photograph No. 10 **View of slope at southwest corner of CCR landfill showing minor erosion and rills, looking northeast.**

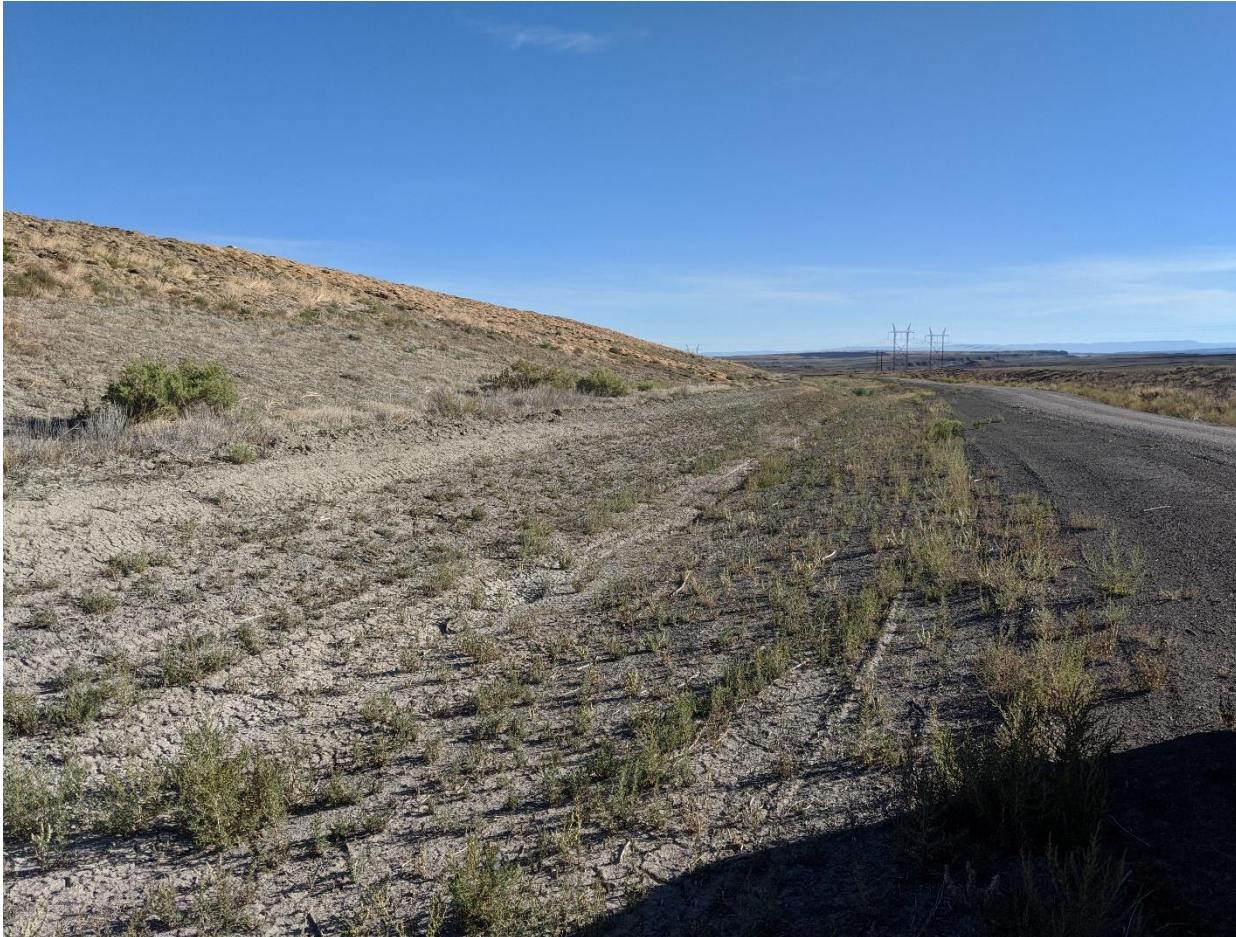
Photograph No. 13 **View of southeastern slope of CCR landfill, looking northeast. Note the recent regrading and removal of brush at the toe of the slope.**

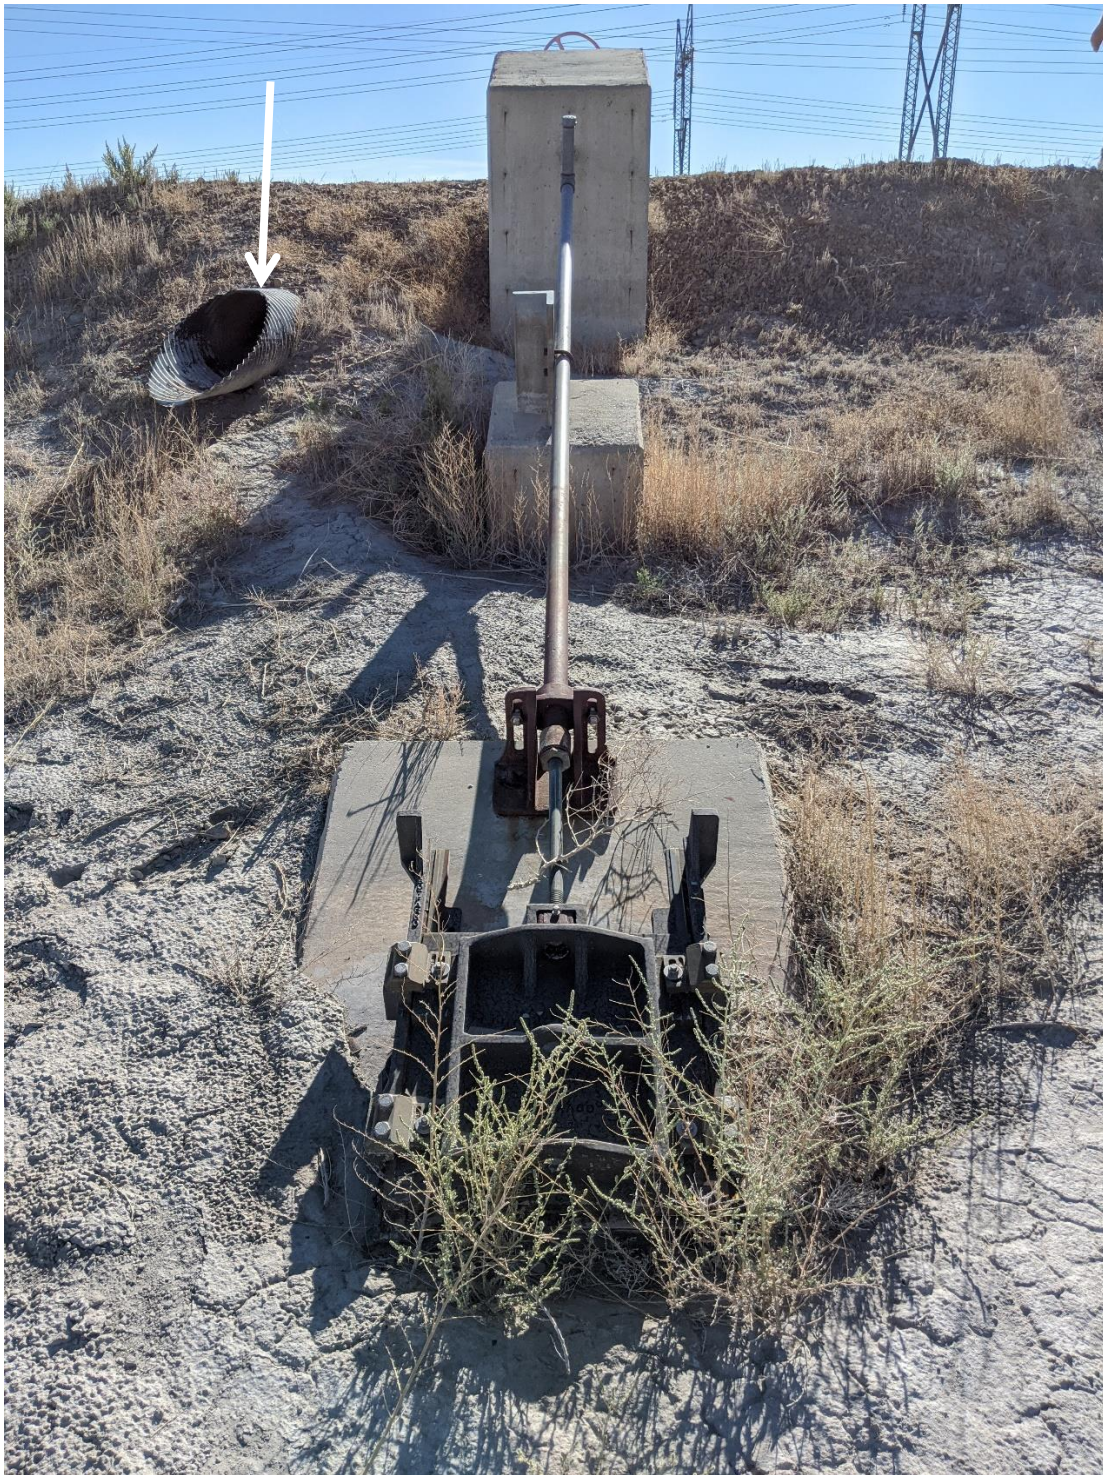
5. Energy dissipation structure at downstream end of retention pond conduit still has evidence of wetness despite dry conditions. Plant personnel reported that water did not reach the slide gate at the upstream end of conduit. Refer to Photos 21 and 22, Appendix A.

5. Energy dissipation structure at downstream end of retention pond conduit still has evidence of wetness despite dry conditions. Water did not reach the slide gate at the upstream end of conduit. Refer to Photos 21 and 22, Appendix A.

Photograph No. 21 **View of retention basin outlet slide gate and overflow conduit (arrow), looking east.**

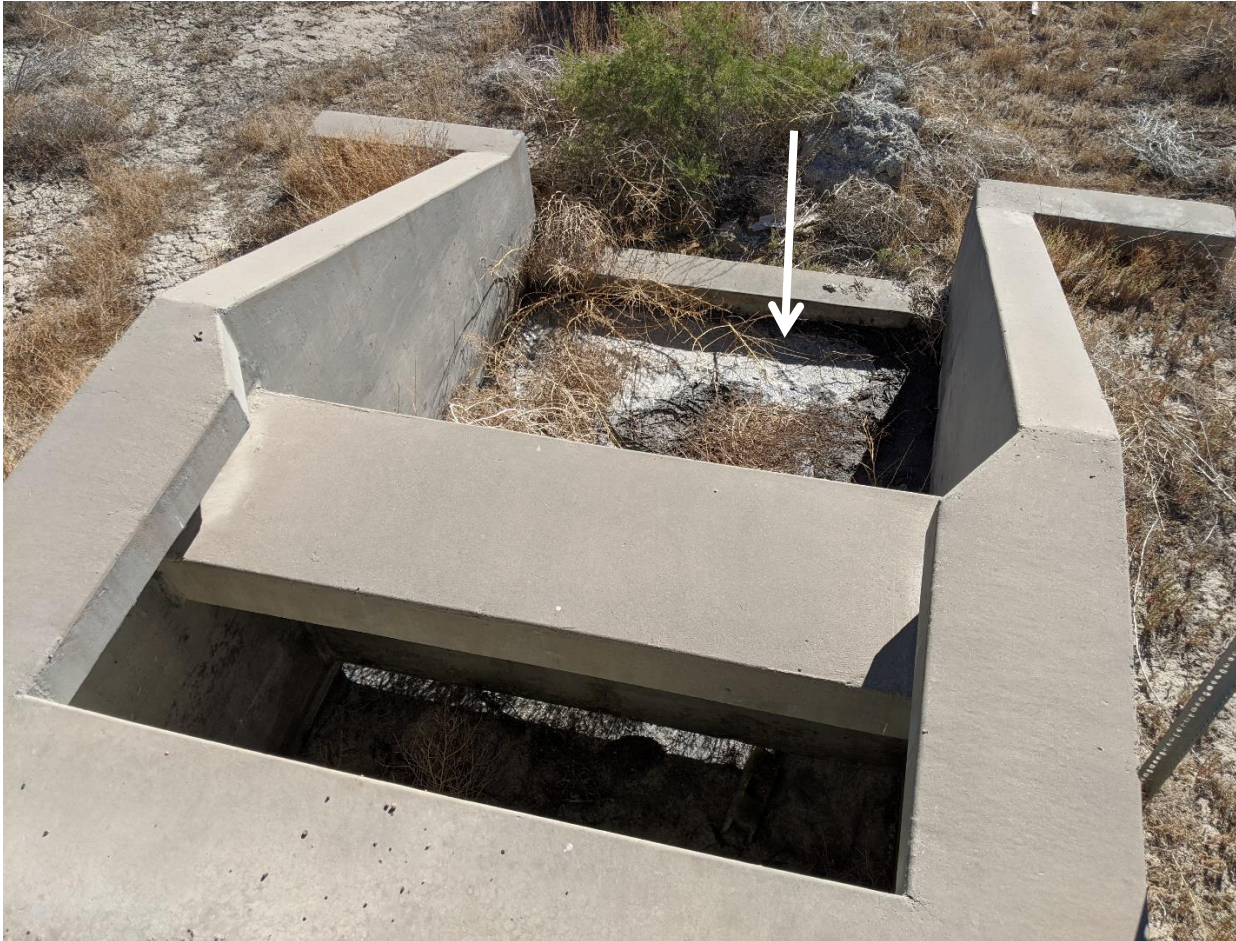
Photograph No. 22 **View of retention basin stilling basin, looking east. Note salt cap and apparent moisture (arrow).**

13. Other non-structural or non-emergency safety issues.	<input type="checkbox"/> Yes <input checked="" type="checkbox"/> No <input type="checkbox"/> N/A
Observations: Stagnant water/wetness observed in stilling basin, which may be coming from snowmelt and rainfall coming into diagonal cut in upstream inlet to spillway conduit. The water source is uncertain.		
Actions <input checked="" type="checkbox"/> None <input type="checkbox"/> Maintenance <input type="checkbox"/> Monitoring <input type="checkbox"/> Engineering Notification/Work Order#

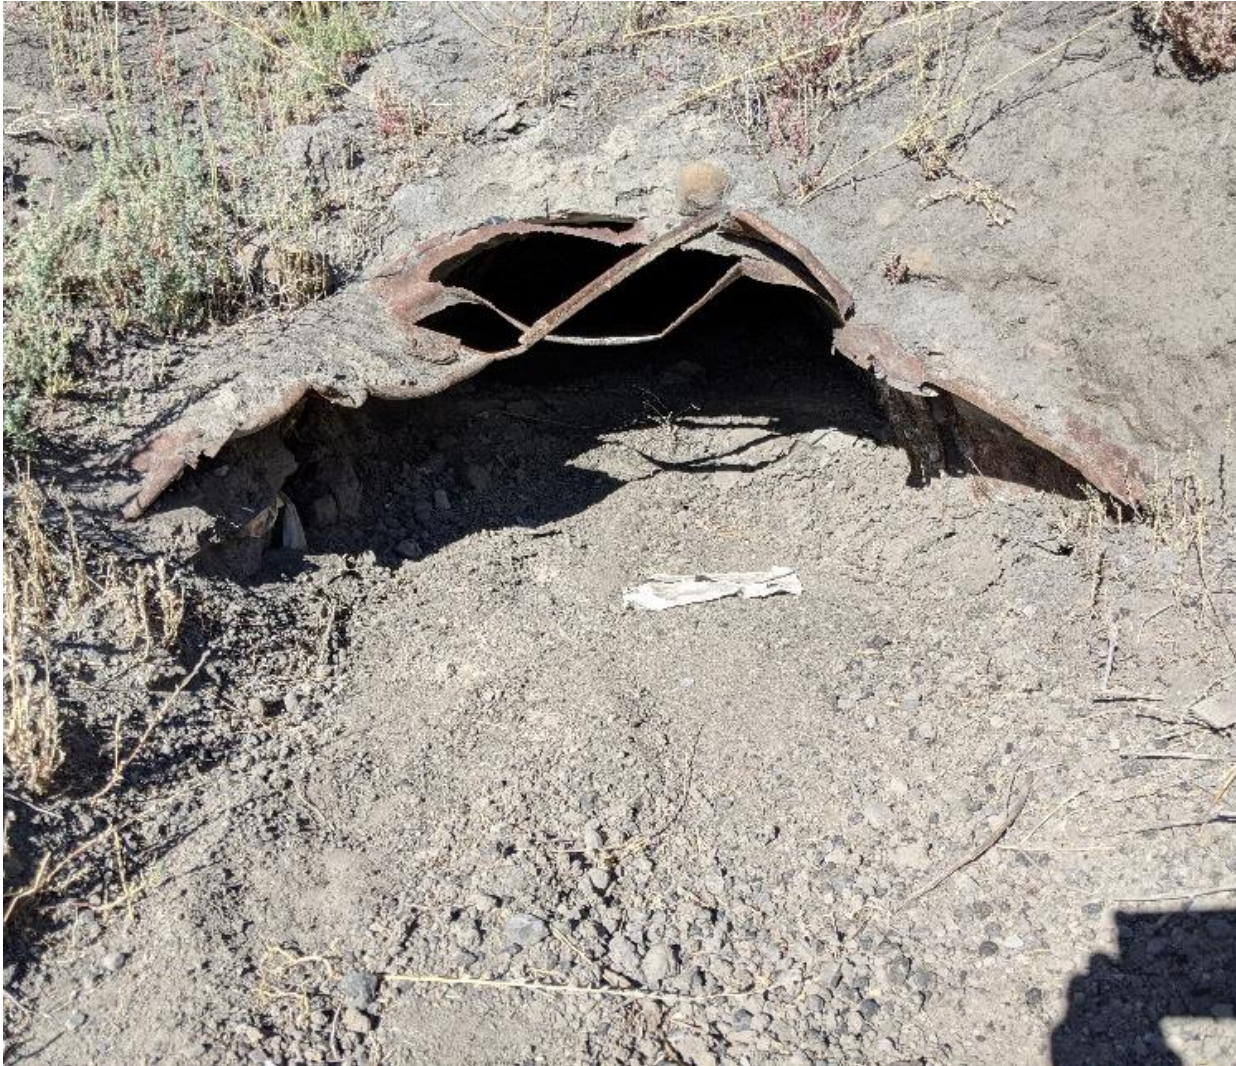
Photograph No. 24 View of downstream end of a culvert on the northern side of the CCR landfill, looking west. Note: The downstream end of the culvert appears to be partially obstructed.

6. The downstream end, particularly the middle to downstream of the culvert near the north access road, appears to be partially obstructed (30 percent or less). It appears that efforts had been made to remove sediment near the ends of the culvert. AECOM assumes that sediment within the culvert could scour out during a significant storm event because both ends of the culvert had been cleared of sediment. Refer to Photos 24 and 25, Appendix A.

7. The downstream end, particularly the middle to downstream end of the culvert near the north access road, appears to be partially obstructed (30 percent or less). It appears that efforts had been made to remove sediment near the ends of the culvert. AECOM assumes that sediment within the culvert could scour out during a significant storm event because both ends of the culvert had been cleared of sediment. Refer to Photos 24 and 25, Appendix A.

9. Perimeter run-on and run-off diversion ditches present and in good repair.				<input checked="" type="checkbox"/> Yes <input type="checkbox"/> No <input type="checkbox"/> NA	
Observations: A culvert on the north side of CCR Landfill had 6-8 inches of sediment (1/4 to 1/3 of culvert height) visible within a shovel length from the exit. Effort had been made to clean out the ends of the culvert, but AECOM recommends that additional maintenance be performed to better clear the culvert of sediment, particularly in the central portion of the culvert, between the upstream and downstream ends.					
Actions <input type="checkbox"/> None <input checked="" type="checkbox"/> Maintenance <input type="checkbox"/> Monitoring <input type="checkbox"/> Engineering Notification/Work Order#

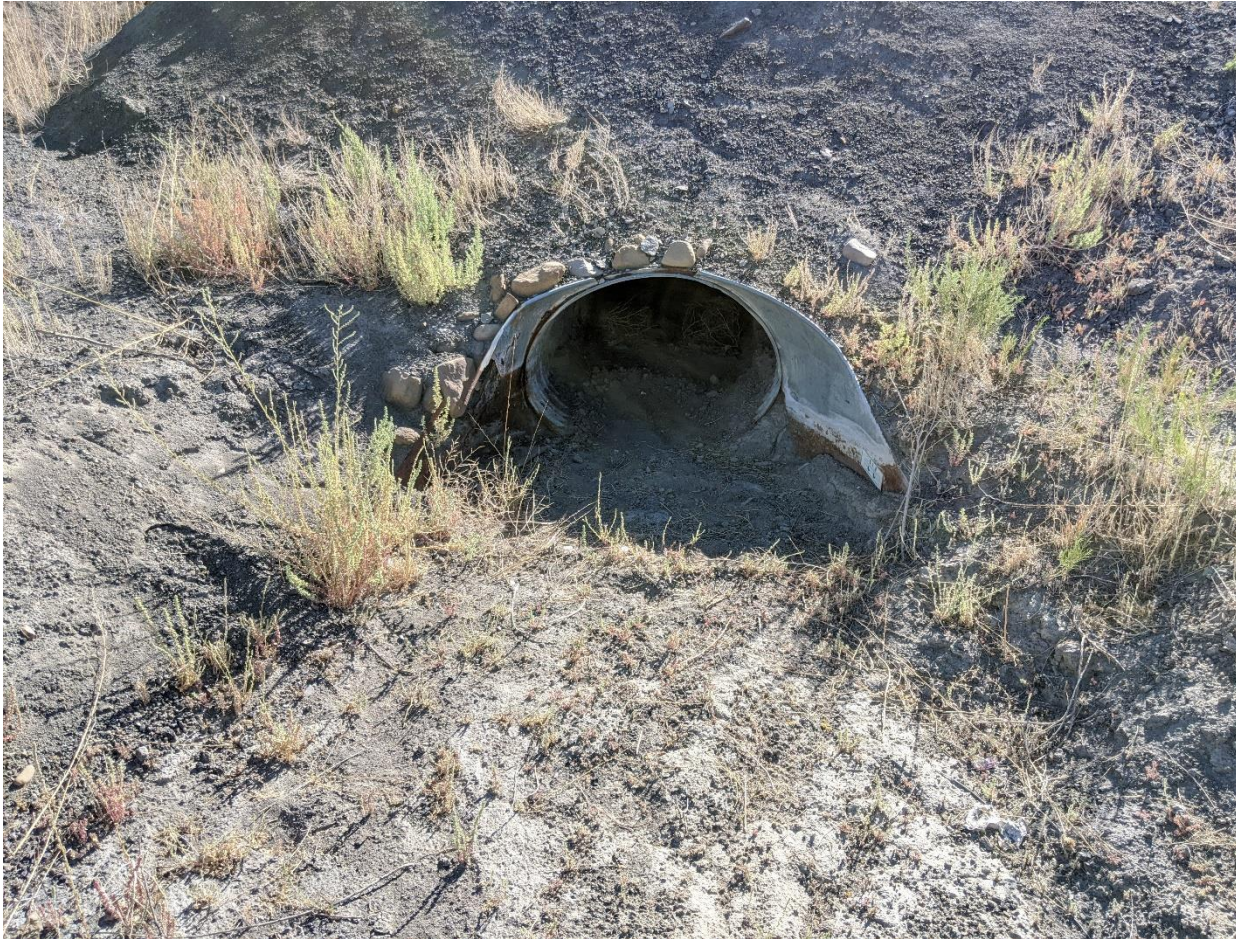
Photograph No. 25 **View of upstream end of a culvert on the northern side of the CCR landfill, looking east. Note: The upstream end of the culvert appears to be mostly unobstructed.**
