# **CCR Rule Operating Criteria §257.84(b)(1) Annual Inspection by A Qualified Engineer Final**

## **CCR Landfill Hunter Power Plant Castle Dale, Utah**

**December 16, 2021**

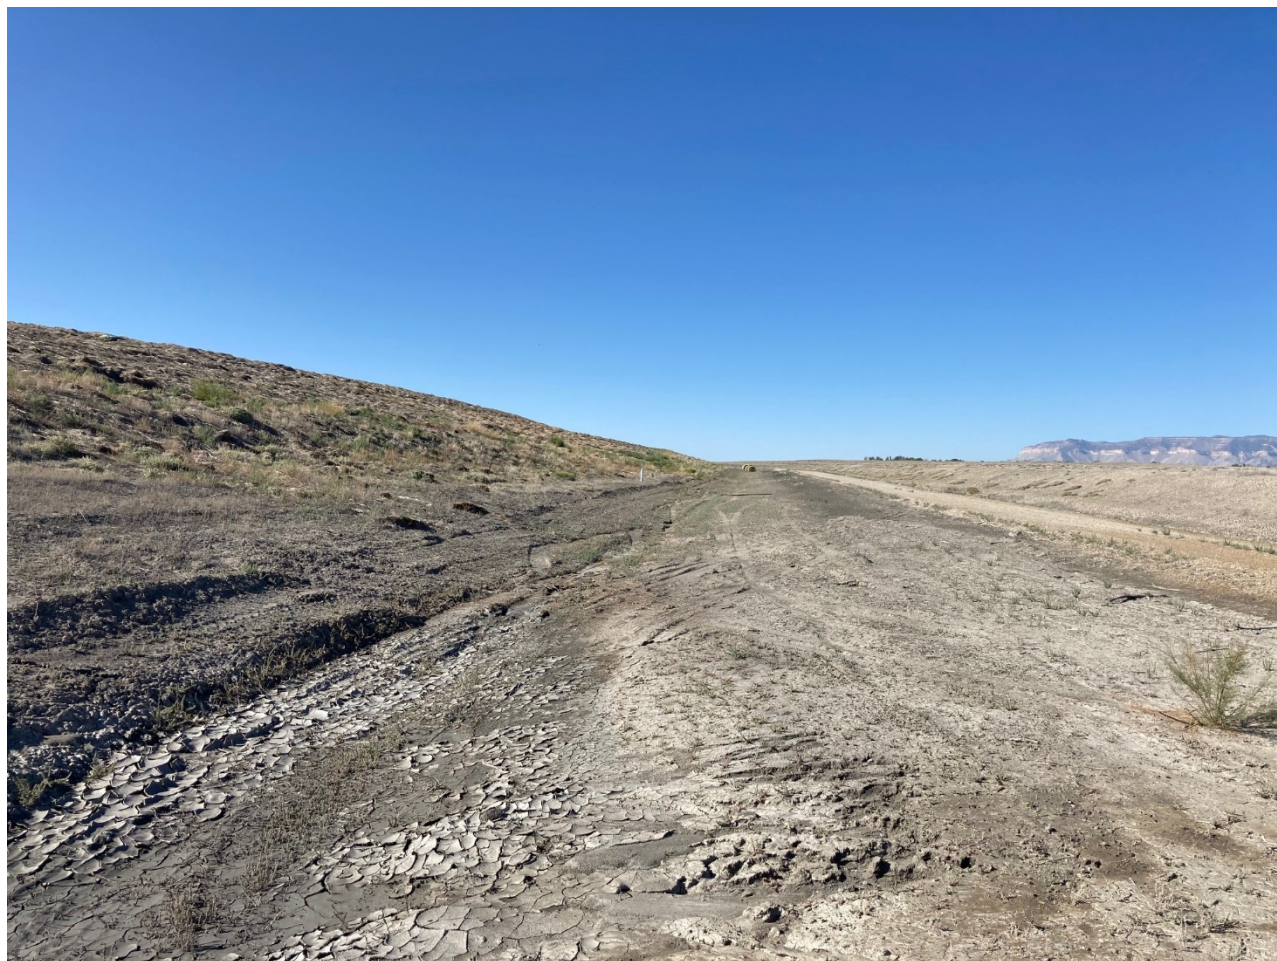
<b>Photo Number:</b> 1	<b>Date:</b> 8/24/2021 9:49 a.m.
<b>Location:</b> Hunter CCR Landfill	<b>Comments:</b> Looking south at inlet side of haul road culvert showing west ash slope, drainage ditch, and diversion berm (from left to right).

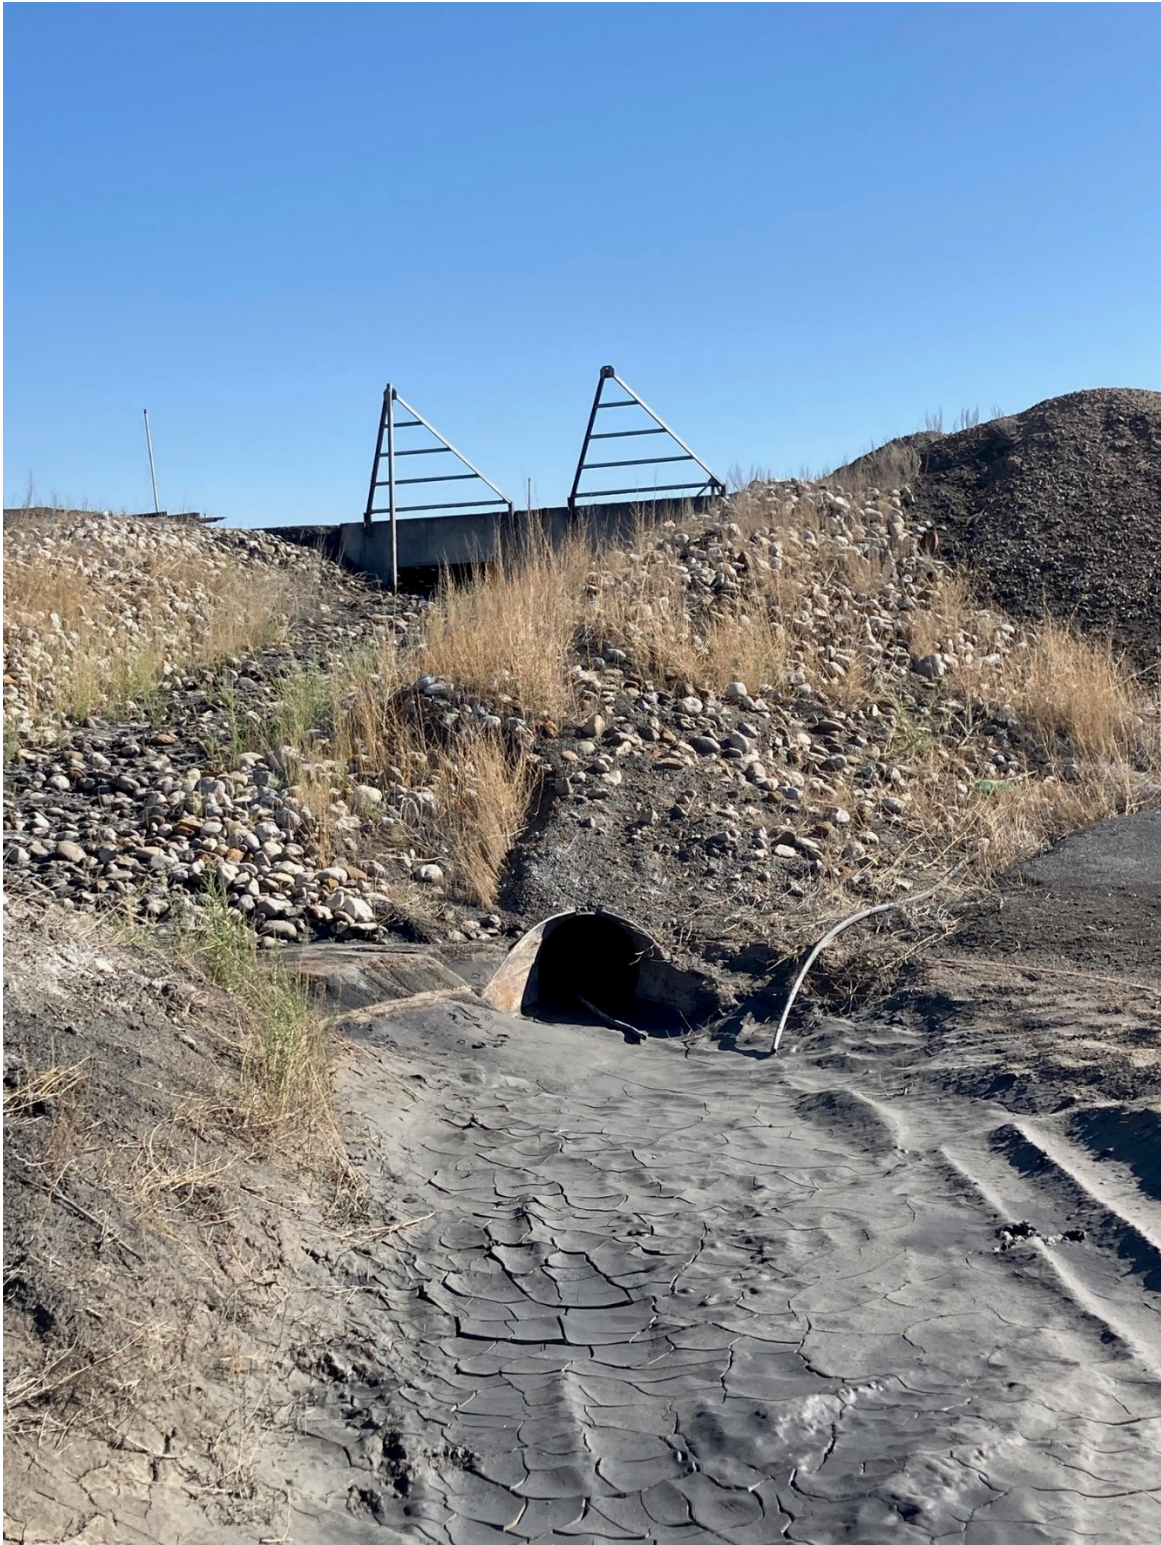
- Hay is being spread across the non-reclaimed ash slopes to minimize erosion and provide organic substrate for future cover. Vegetation is beginning to establish on non-reclaimed slopes.
- Culvert under access road to the Industrial Landfill had minor accumulation of ash.
- Head cutting of the run-on channel on the south side of the CCR landfill was observed.
- Standing water was observed on the downstream side of the stormwater basin discharge structure. Plant staff reported that the discharge structure did not operate during recent rains; therefore, the standing water was from direct precipitation.

<b>Photo Number:</b> 2	<b>Date:</b> 8/24/2021 9:52 a.m.
<b>Location:</b> Hunter CCR Landfill	<b>Comments:</b> Looking north at inlet side of culvert under haul road. Note some accumulation of ash at inlet.

- Clear inlet and outlet ends of culverts to preserve design flow capacity.
- Continue to monitor run-on ditch for undercutting of run-on berm on south side of CCR Landfill.

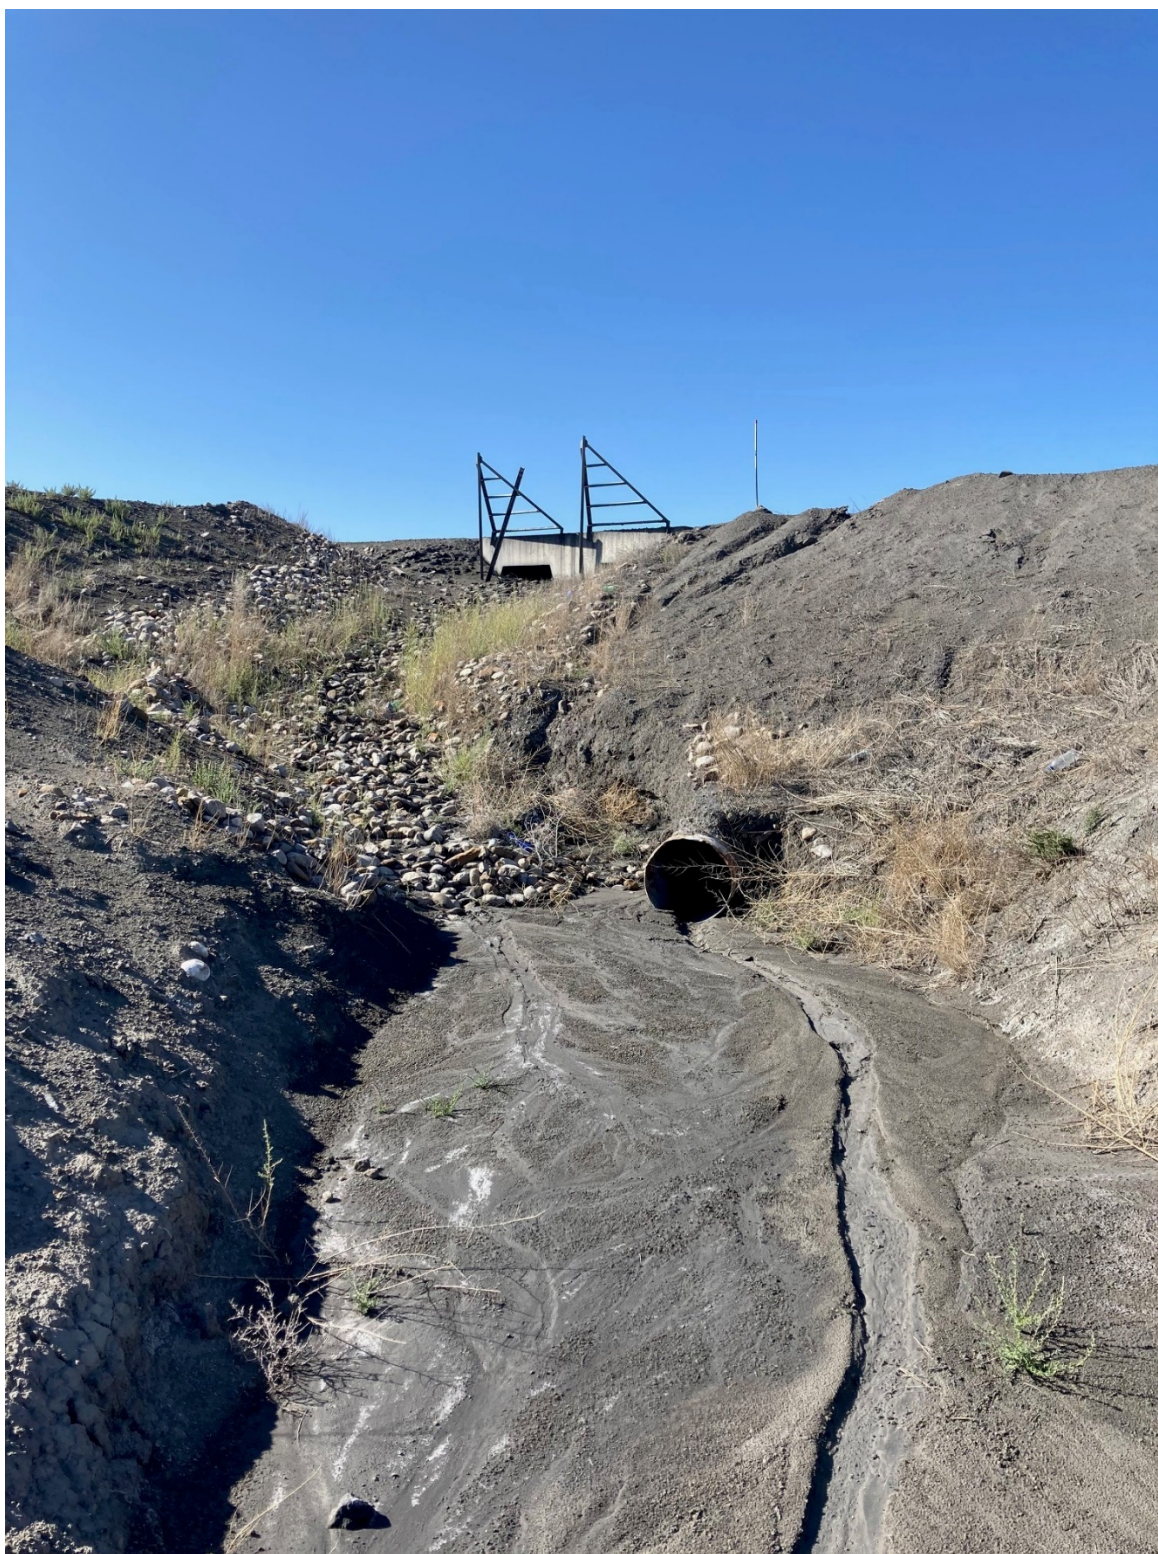
<b>Photo Number:</b> 3	<b>Date:</b> 8/24/2021 9:55 a.m.
<b>Location:</b> Hunter CCR Landfill	<b>Comments:</b> Looking south showing outlet side of culvert under ash haul road. Note no obstructions observed out outlet.

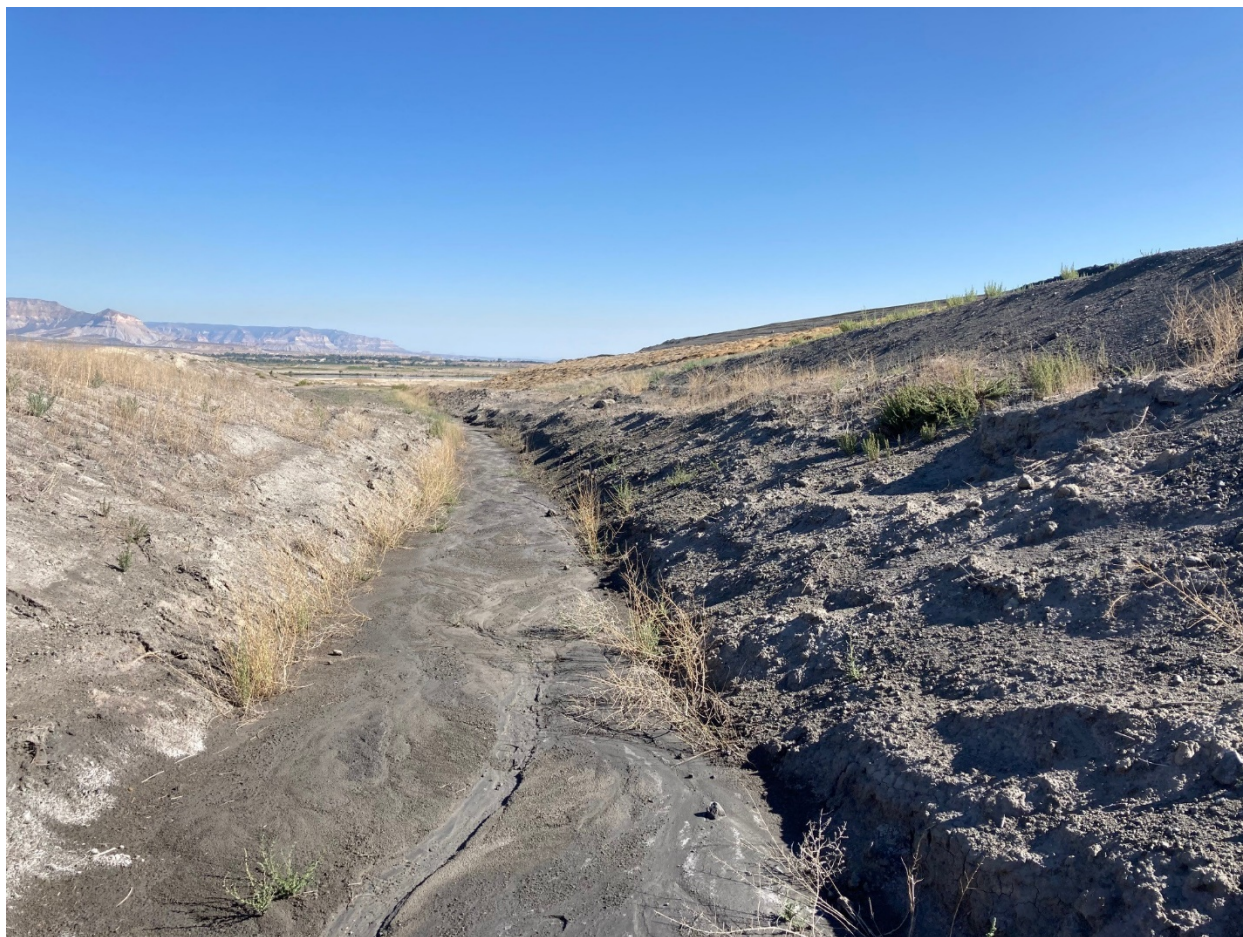
<b>Photo Number:</b> 4	<b>Date:</b> 8/24/2021 9:58 a.m.
<b>Location:</b> Hunter CCR Landfill	<b>Comments:</b> Looking north at outlet side of culvert under ash haul road showing runoff drainage ditch, which eventually discharges to sediment pond.

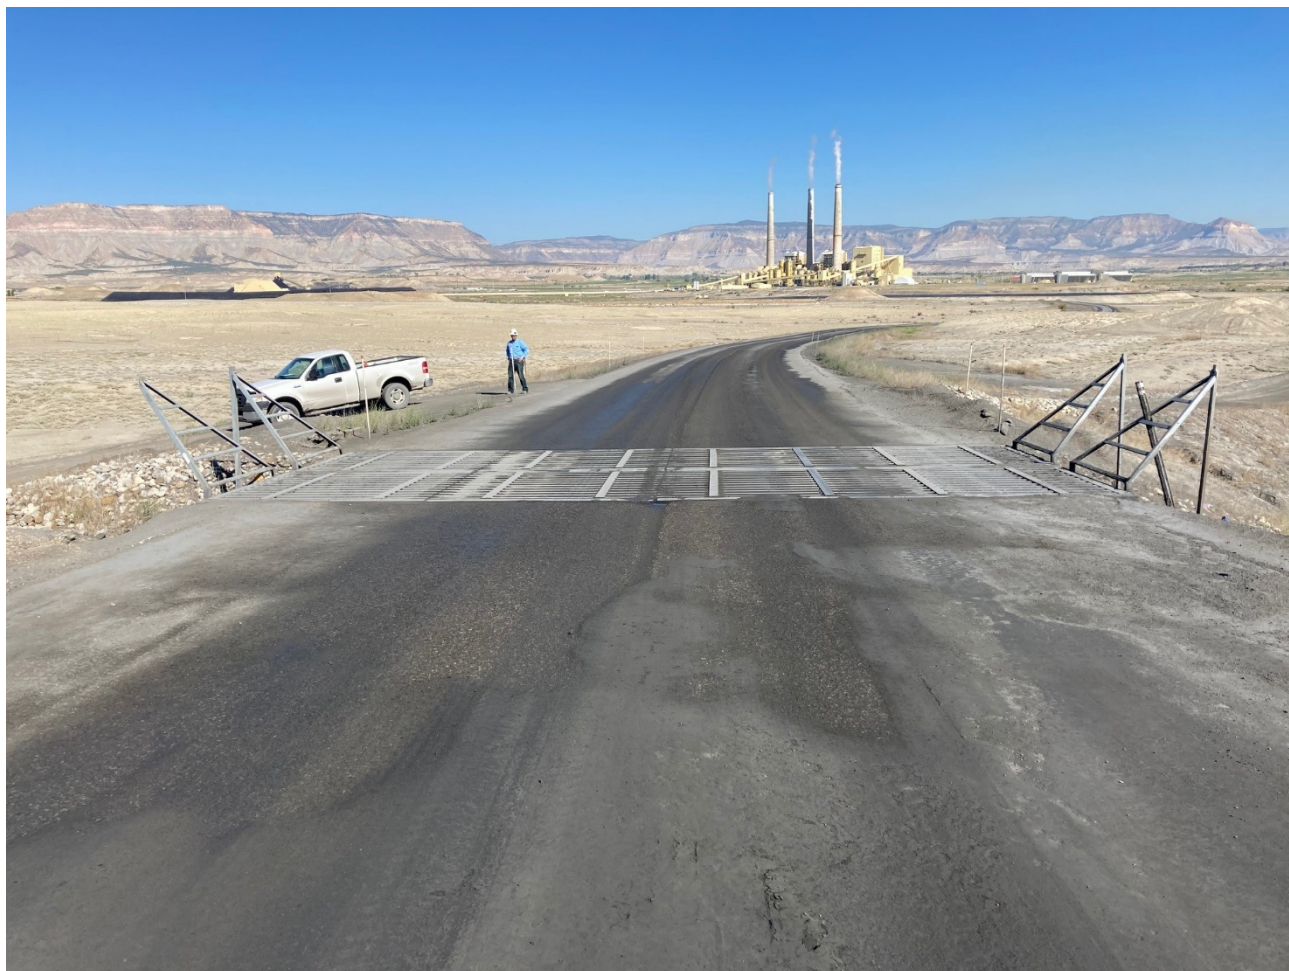
<b>Photo Number:</b> 5	<b>Date:</b> 8/24/2021 9:59 a.m.
<b>Location:</b> Hunter CCR Landfill	<b>Comments:</b> Looking northwest at grating installed in ash haul road to intercept runoff. Runoff discharges in run-off drainage channel shown in Photo 4.

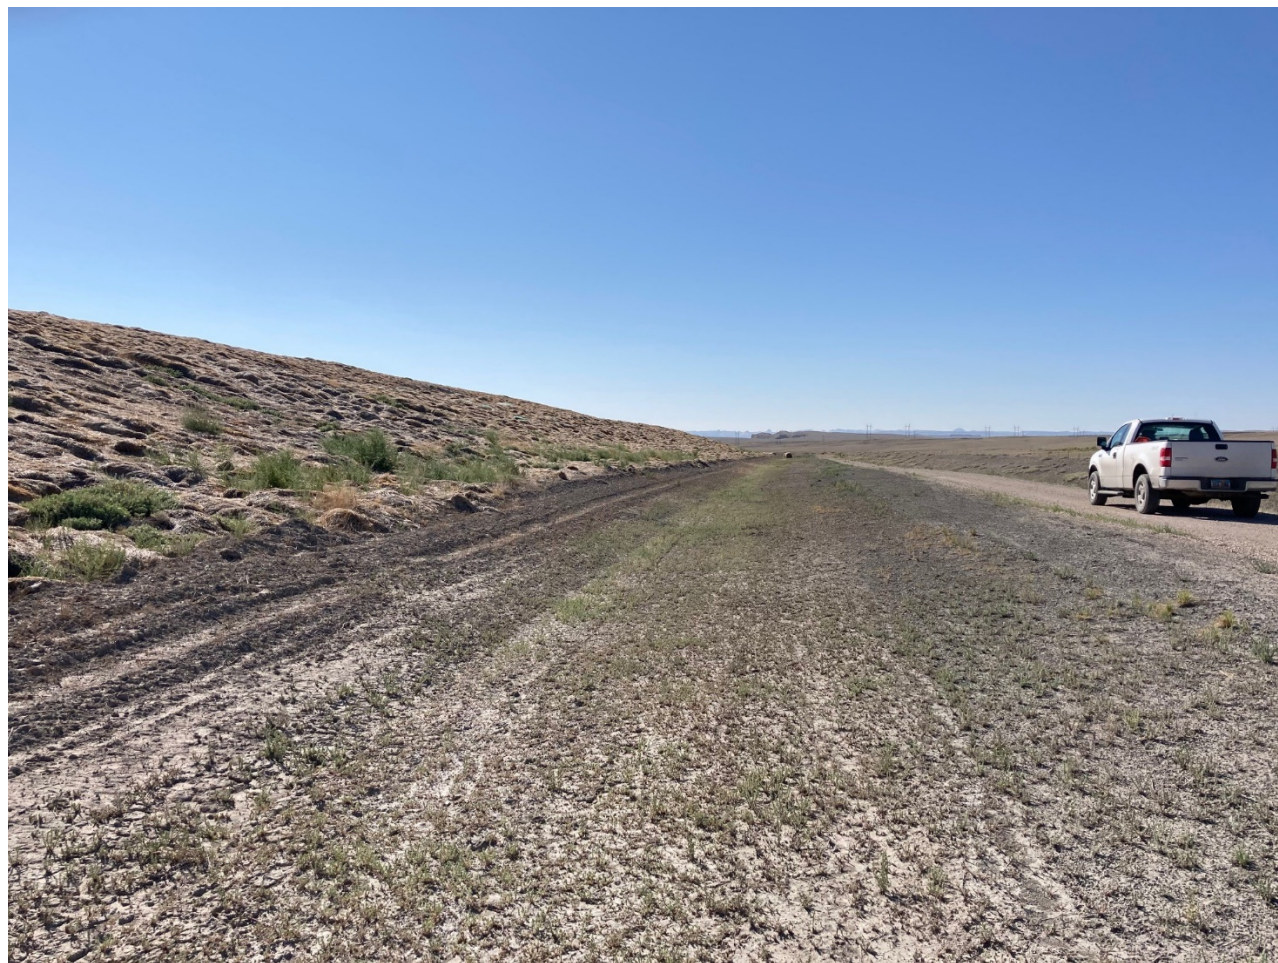
<b>Photo Number:</b> 6	<b>Date:</b> 8/24/2021 10:02 a.m.
<b>Location:</b> Hunter CCR Landfill	<b>Comments:</b> Looking southeast along south slope of ash landfill at high point in drainage channel.

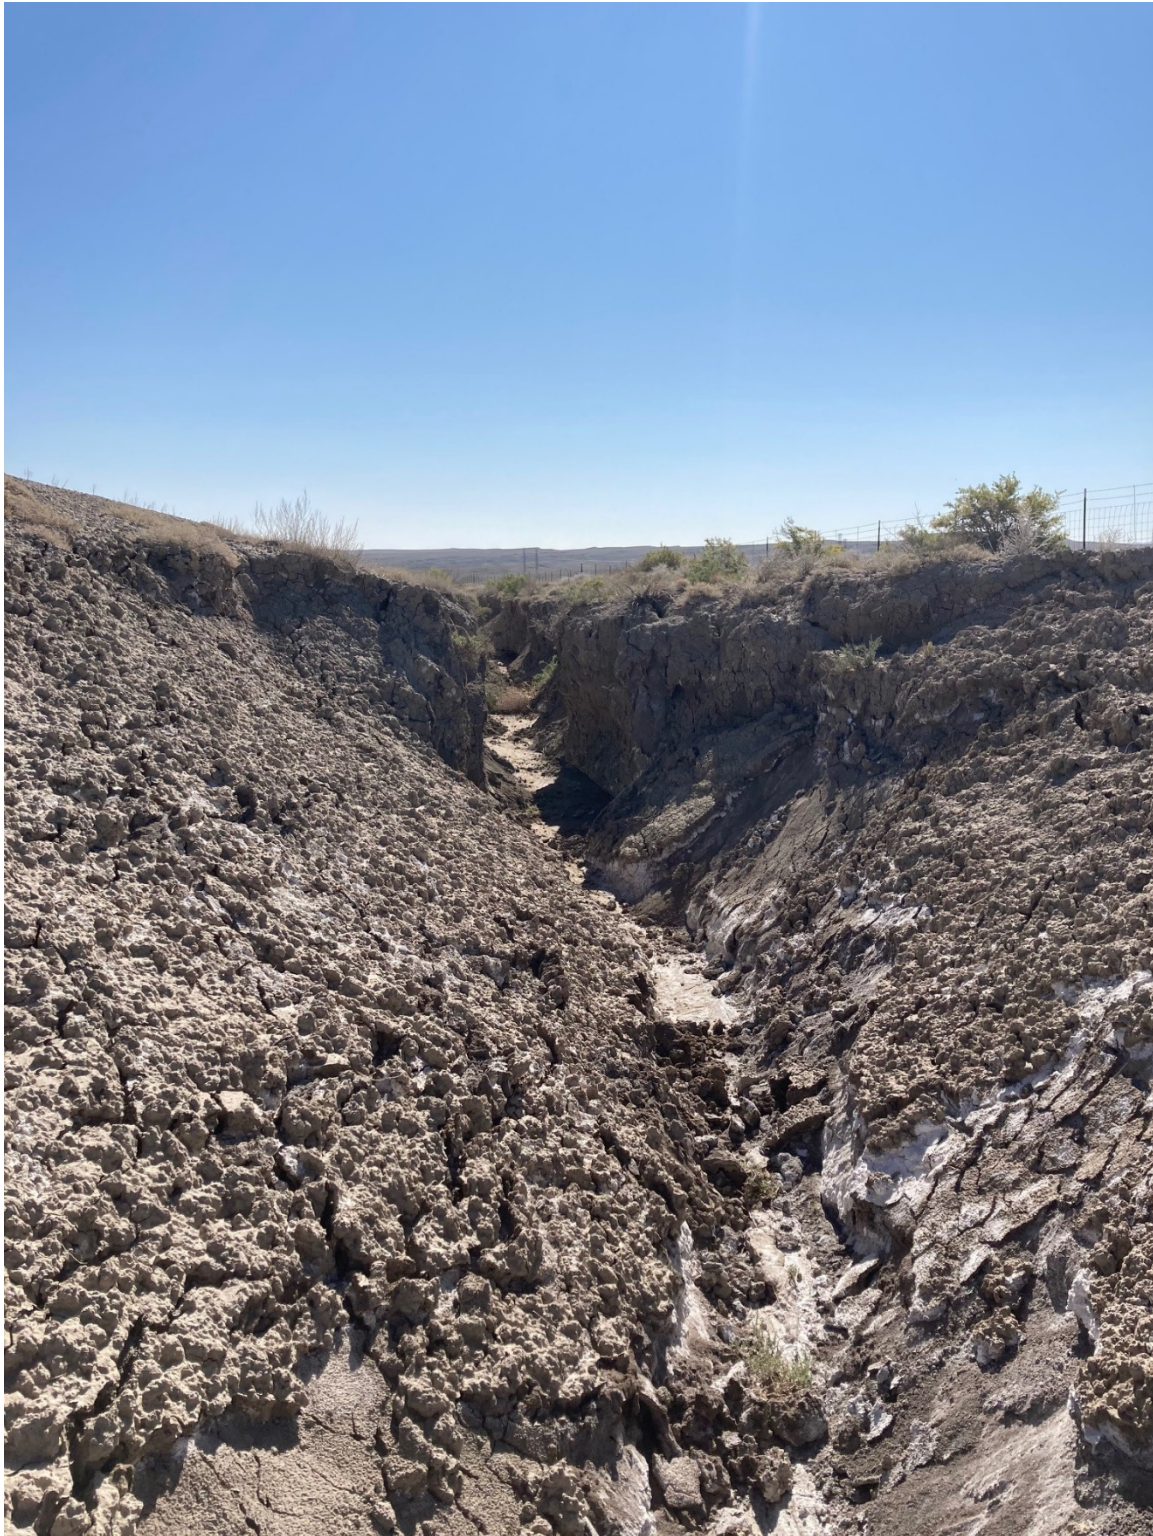
<b>Photo Number:</b> 7	<b>Date:</b> 8/24/2021 10:07 a.m.
<b>Location:</b> Hunter CCR Landfill	<b>Comments:</b> Looking east along run-on ditch.

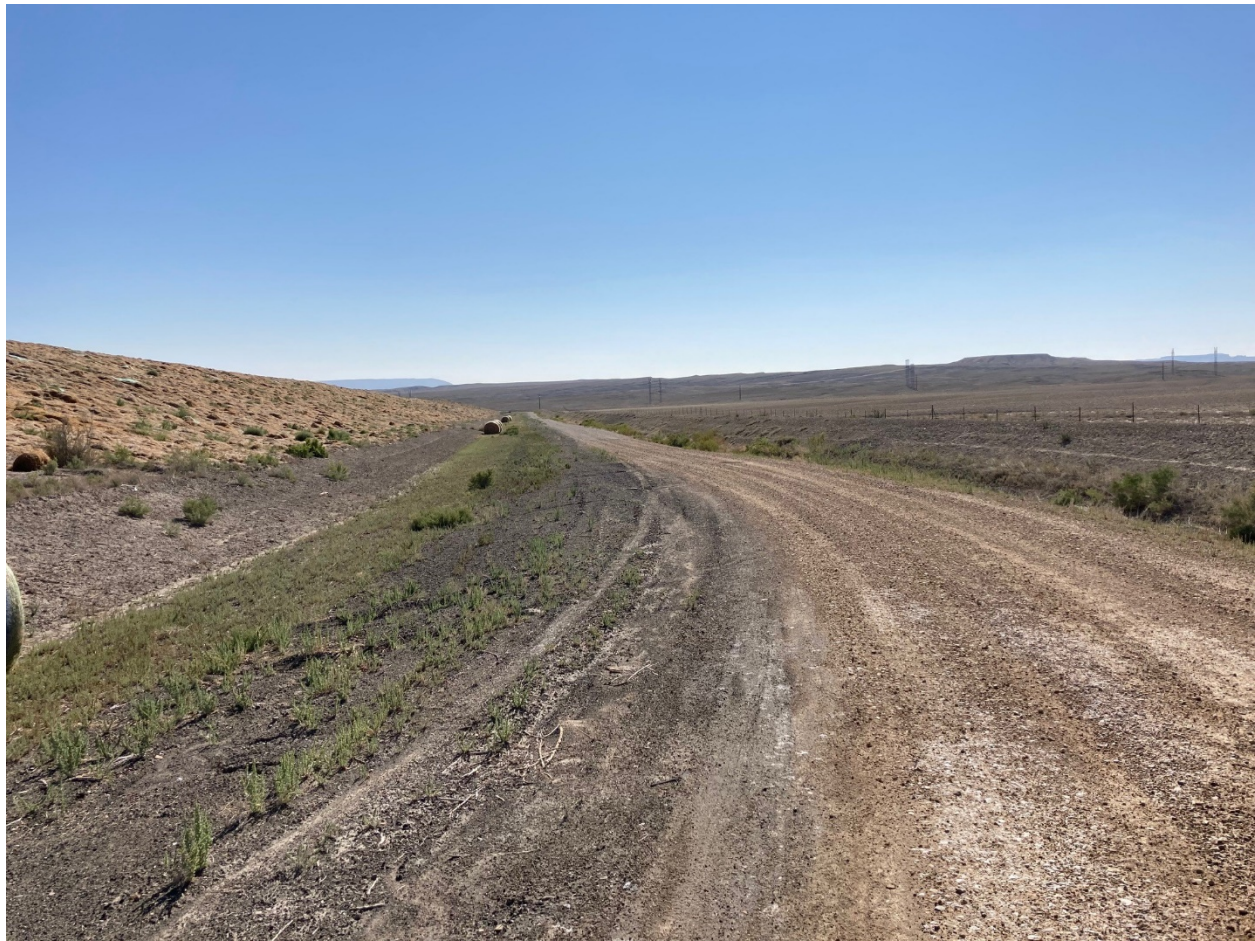
<b>Photo Number:</b> 8	<b>Date:</b> 8/24/2021 10:08 a.m.
<b>Location:</b> Hunter CCR Landfill	<b>Comments:</b> Looking northeast along southeast slope of ash landfill showing run-off ditch, perimeter road and run-on berm (from left to right).

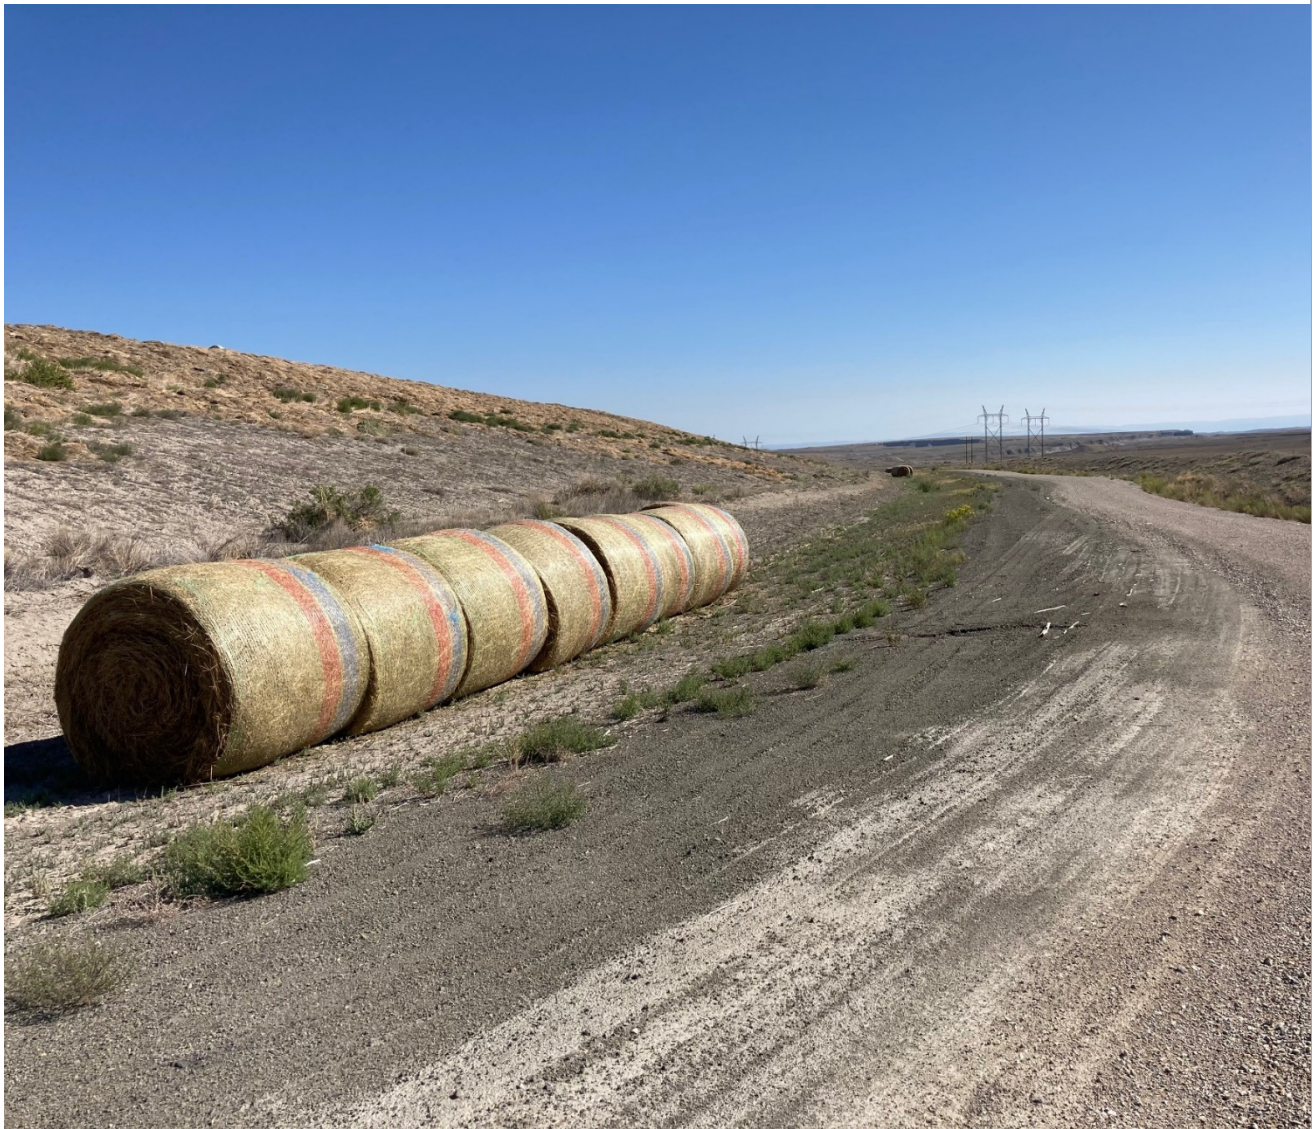
<b>Photo Number:</b> 9	<b>Date:</b> 8/24/2021 10:15 a.m.
<b>Location:</b> Hunter CCR Landfill	<b>Comments:</b> Looking north northeast

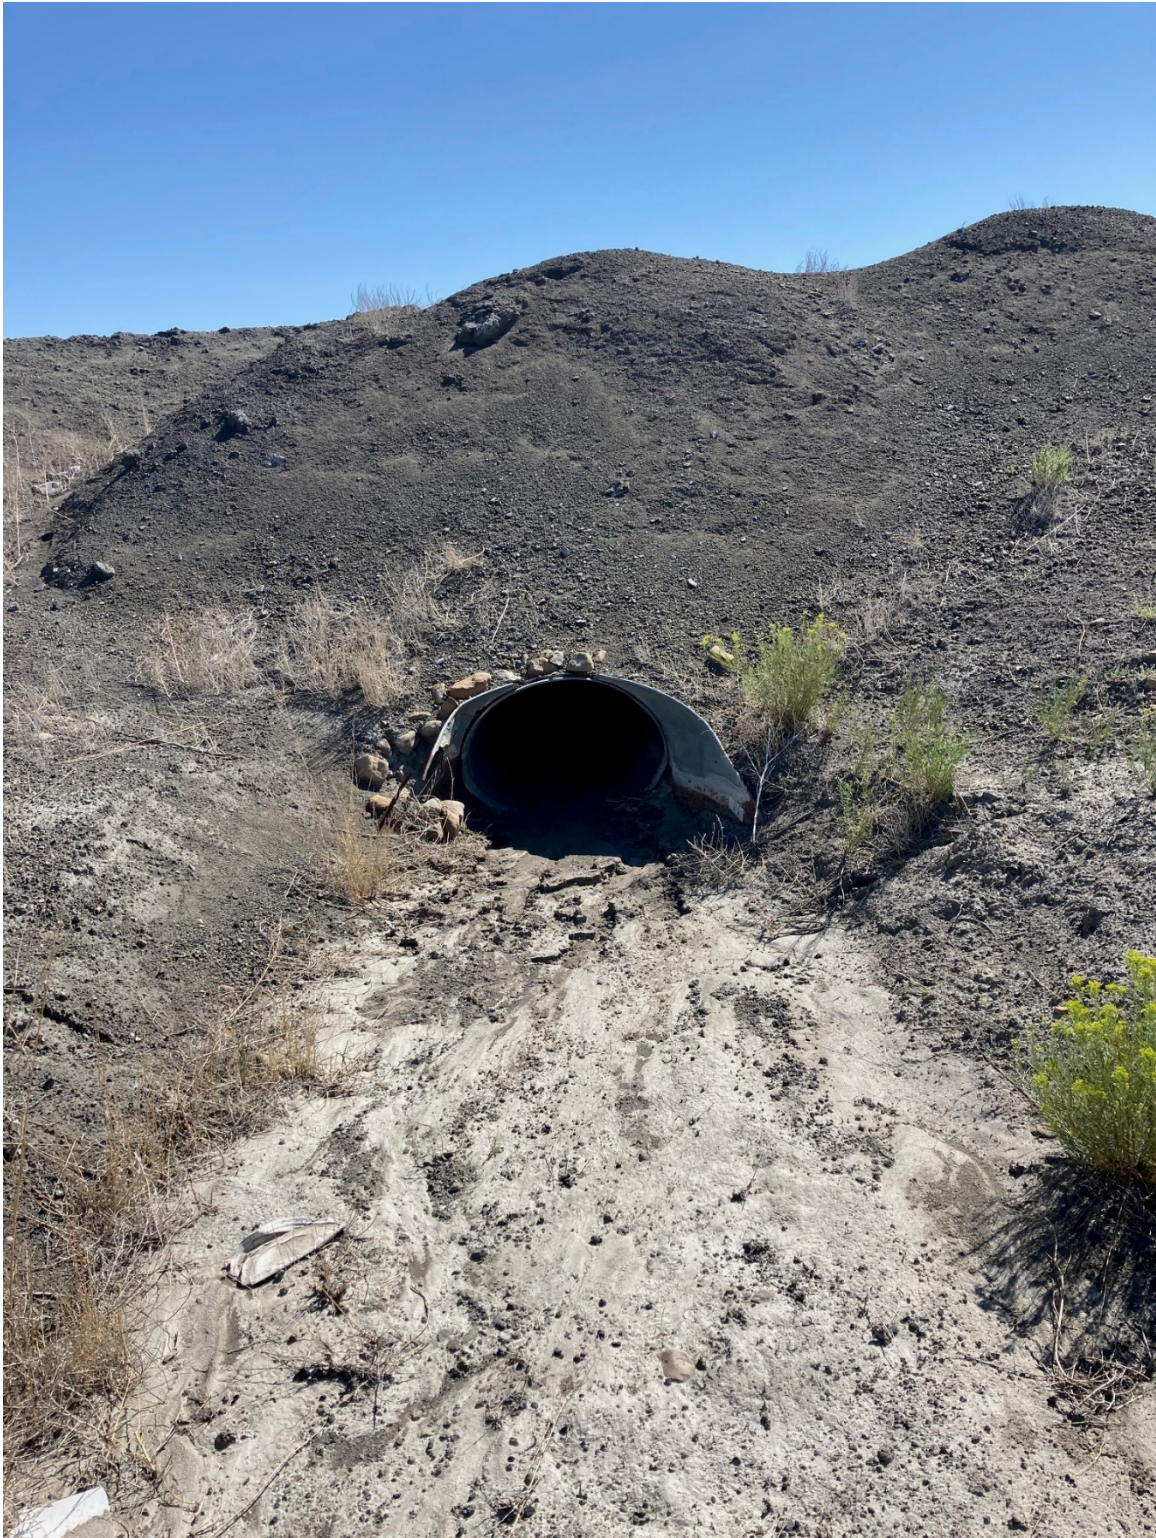
<b>Photo Number:</b> 10	<b>Date:</b> 8/24/2021 10:25 a.m.
<b>Location:</b> Hunter CCR Landfill	<b>Comments:</b> Looking northwest from upstream side of culvert that discharges run-off to sediment pond. Note minimal sediment accumulation.

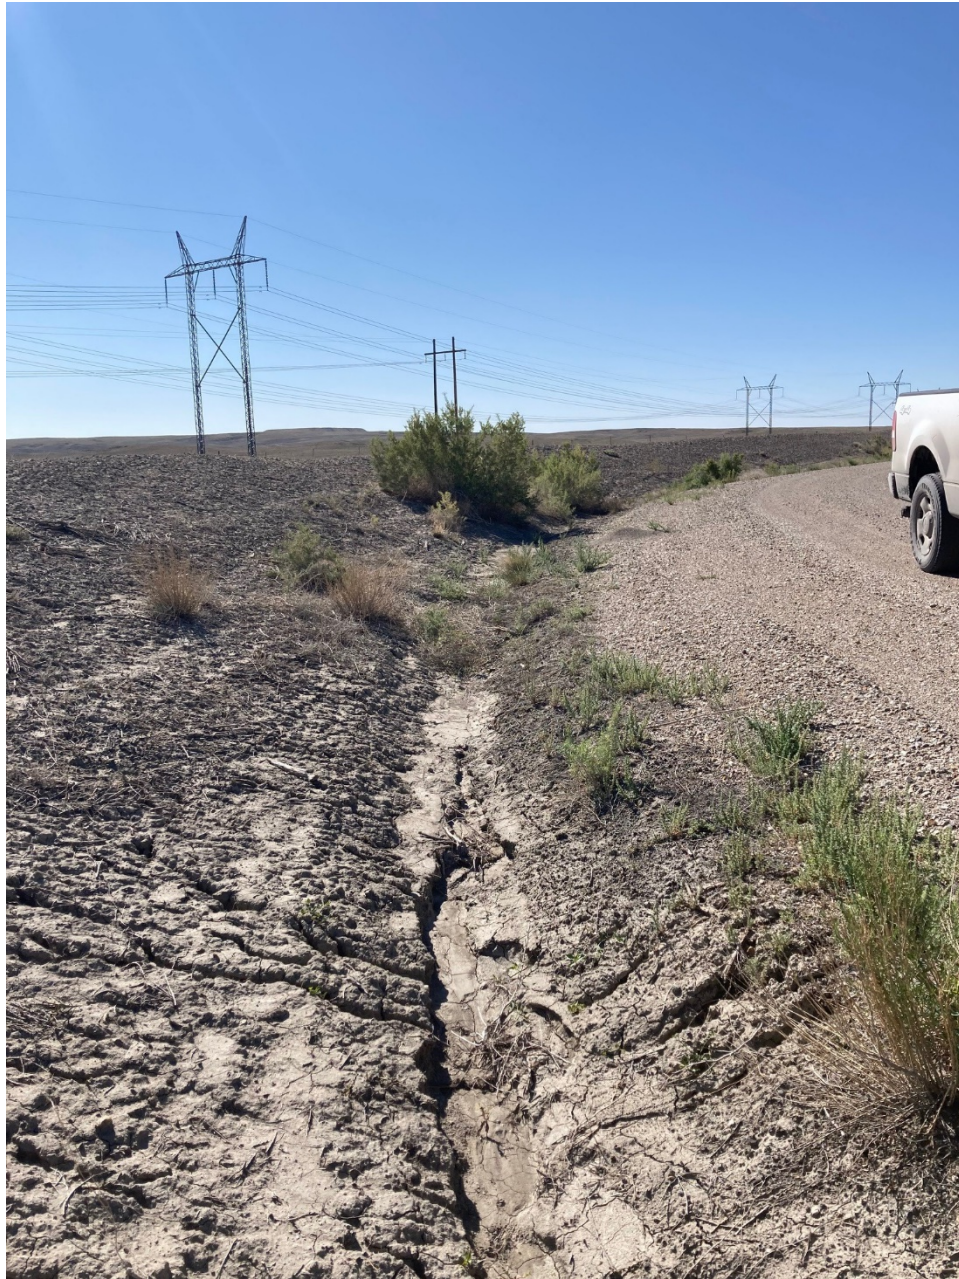
<b>Photo Number:</b> 11	<b>Date:</b> 8/24/2021 10:27 a.m.
<b>Location:</b> Hunter CCR Landfill	<b>Comments:</b> Looking southeast at drainage ditch between run-on berm and perimeter road.

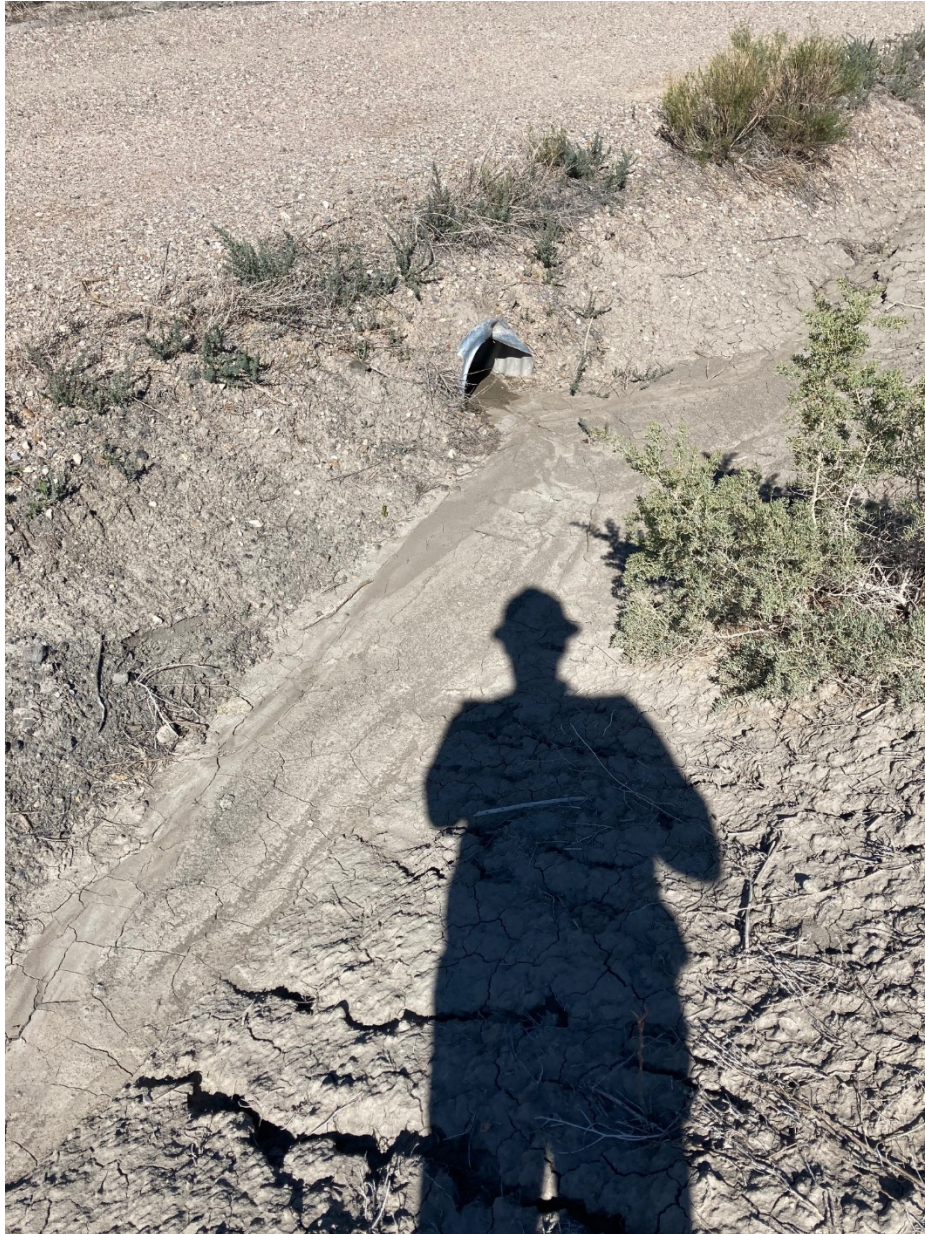
<b>Photo Number:</b> 12	<b>Date:</b> 8/24/2021 10:28 a.m.
<b>Location:</b> Hunter CCR Landfill	<b>Comments:</b> Looking northwest showing culvert draining roadside ditch between run-on berm and perimeter road.

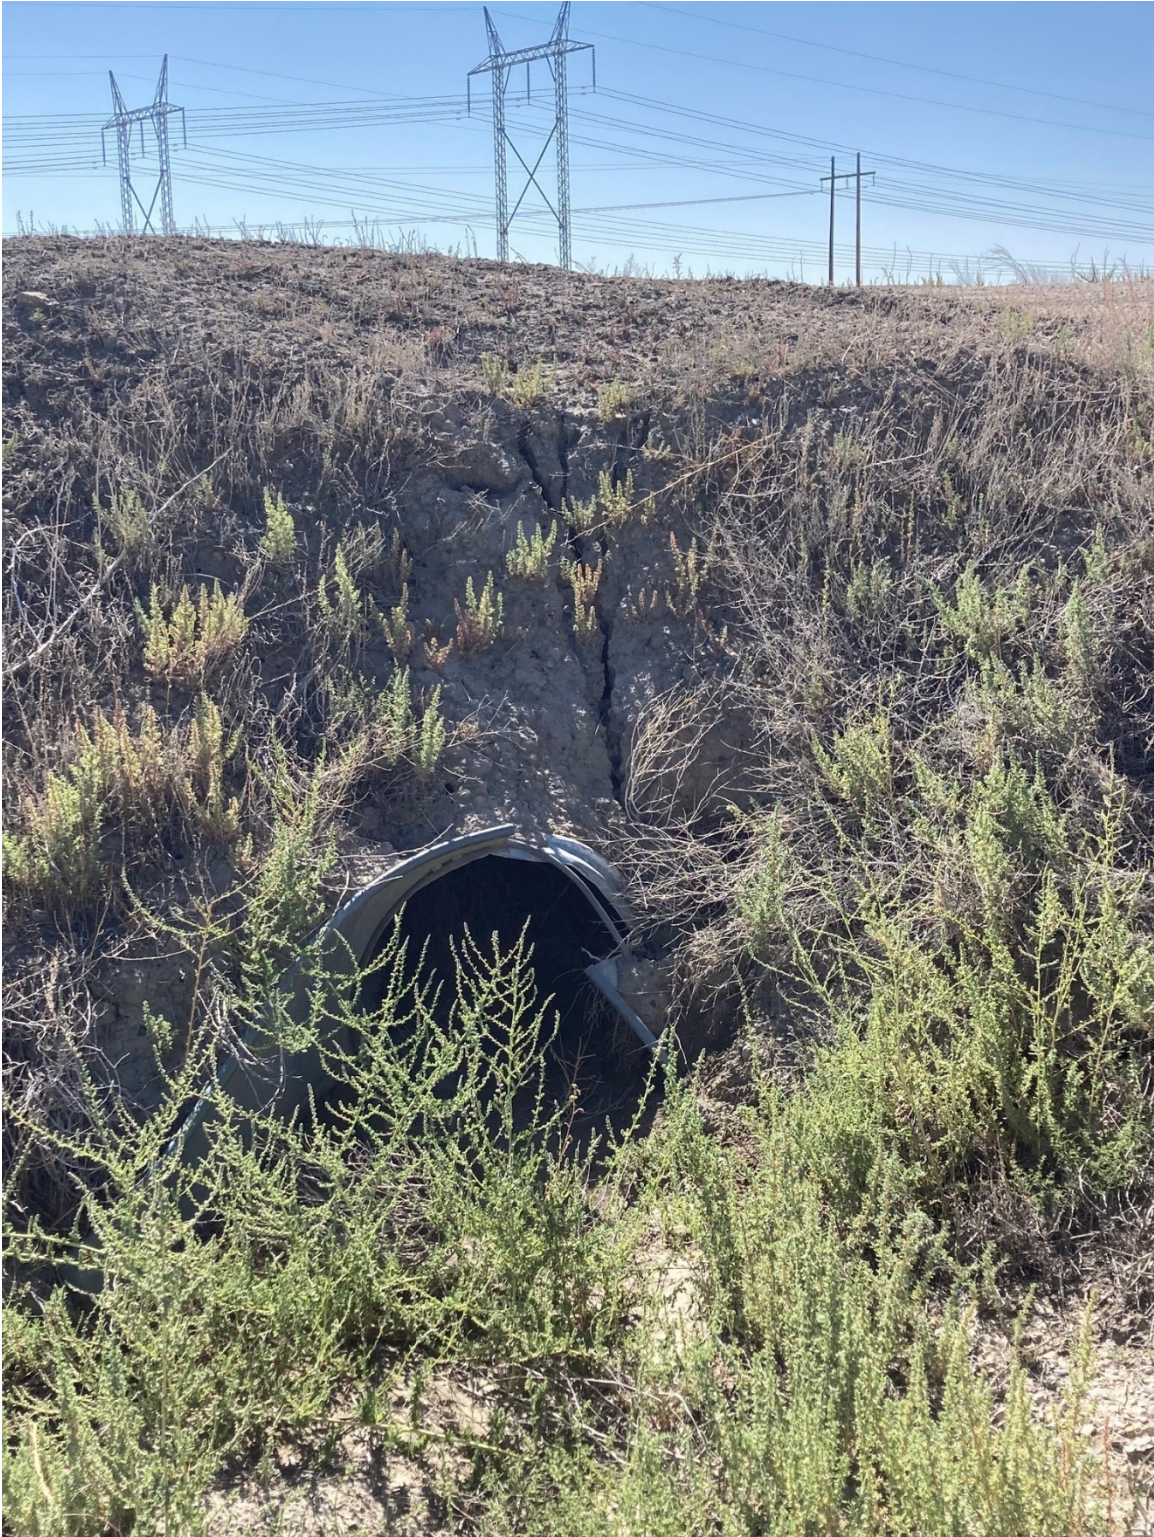
<b>Photo Number:</b> 13	<b>Date:</b> 8/24/2021 10:30 a.m.
<b>Location:</b> Hunter CCR Landfill	<b>Comments:</b> Looking southeast toward outlet end of culvert discharging to sedimentation pond.

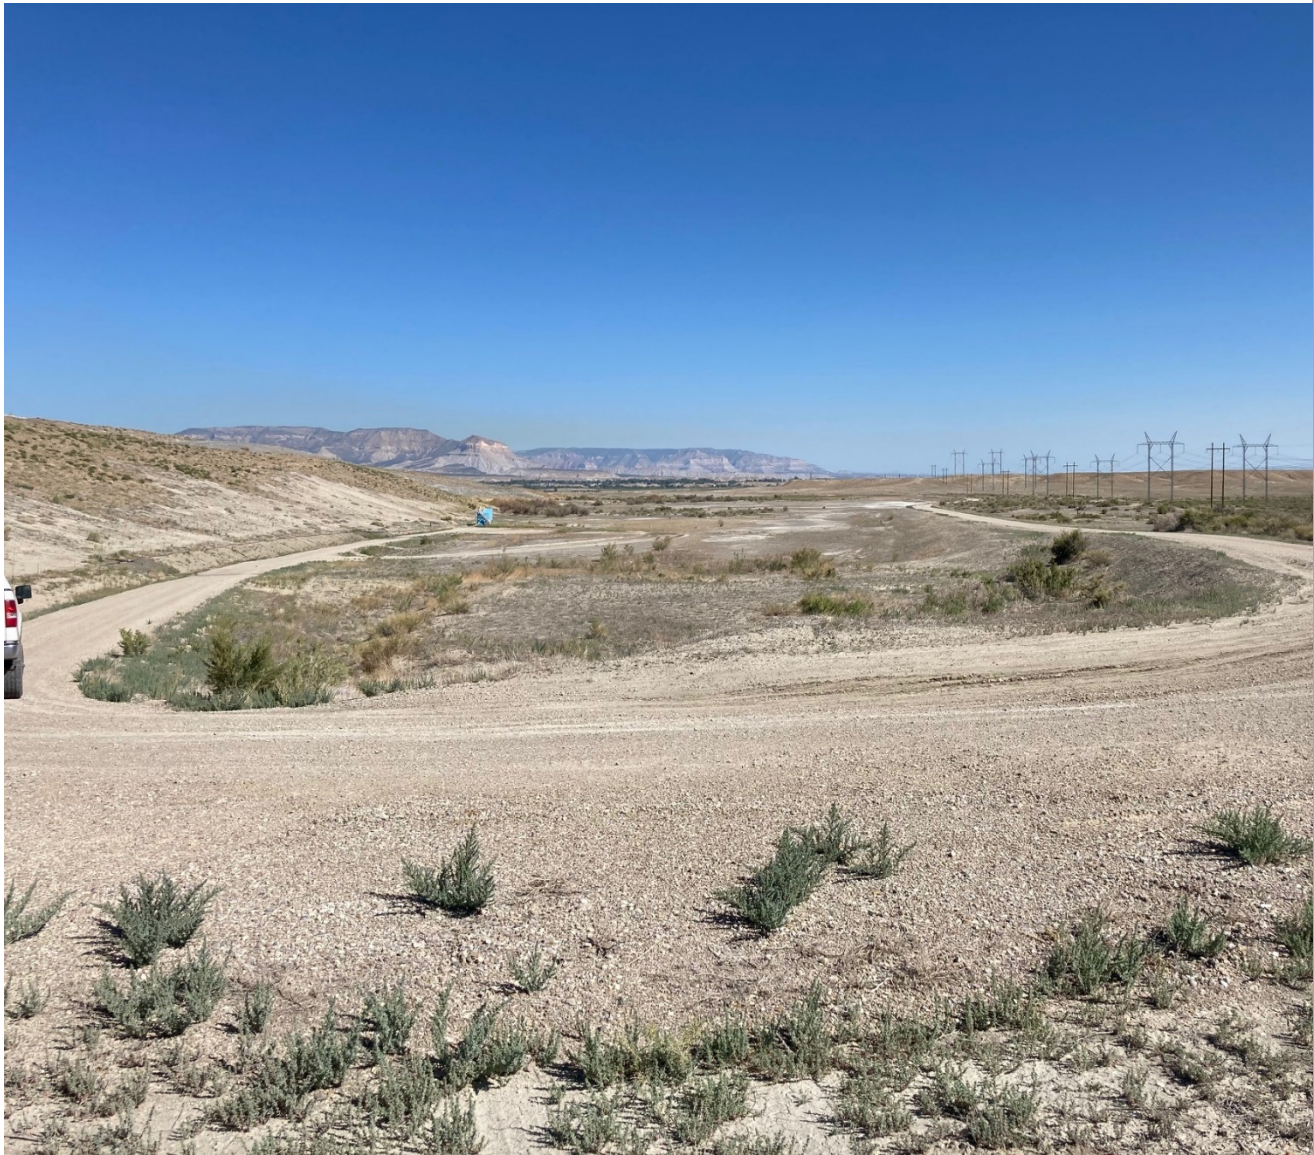
<b>Photo Number:</b> 14	<b>Date:</b> 8/24/2021 10:32 a.m.
<b>Location:</b> Hunter CCR Landfill	<b>Comments:</b> Looking northwest toward sedimentation pond. Note blue frac tank in background used to discharge water into from horizontal well dewatering system.

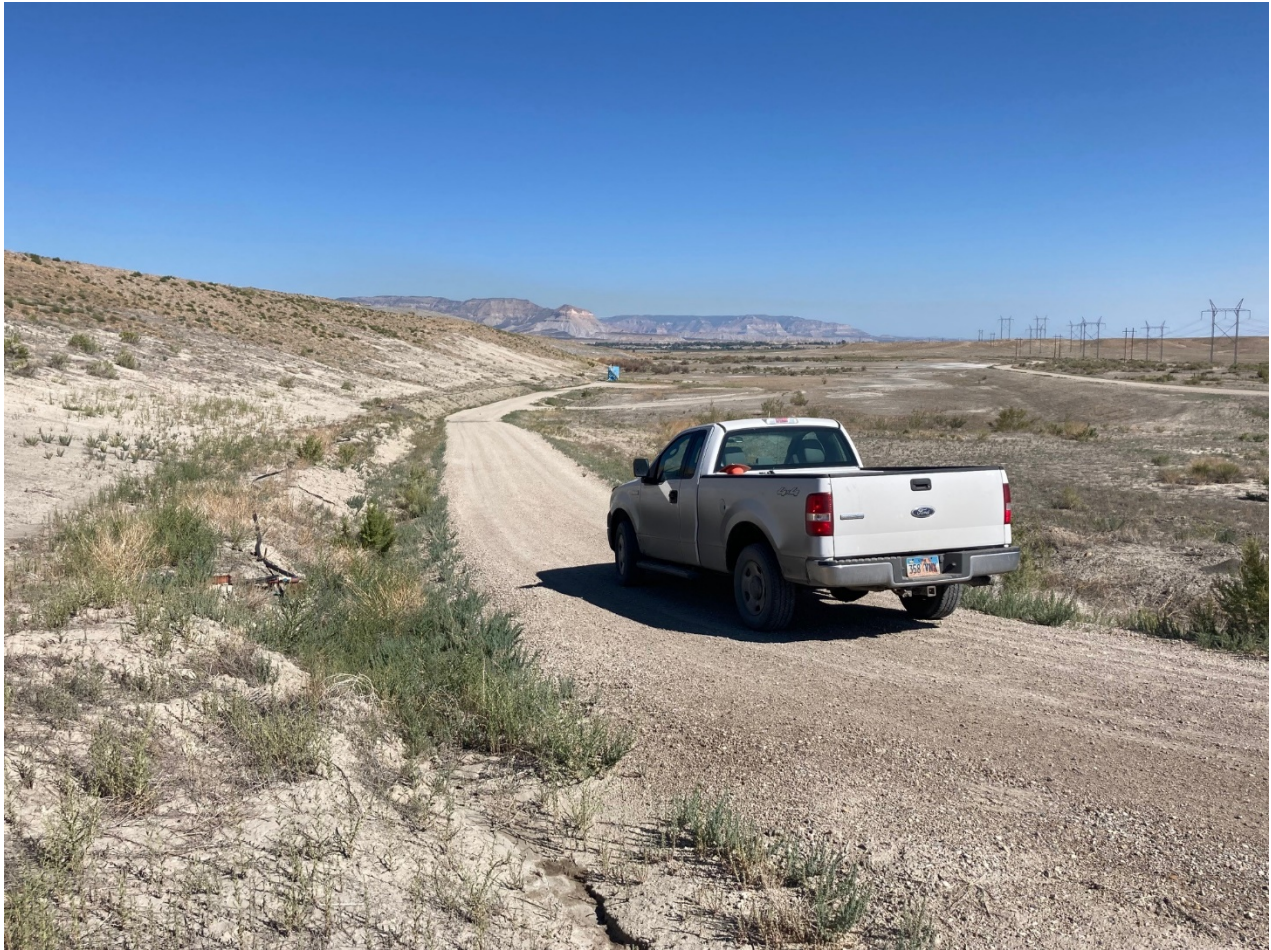
<b>Photo Number:</b> 15	<b>Date:</b> 8/24/2021 10:33 a.m.
<b>Location:</b> Hunter CCR Landfill	<b>Comments:</b> Looking northwest showing run-off ditch and perimeter road.
