# **CCR Rule Operating Criteria §257.84(b)(1) Annual Inspection by A Qualified Engineer Final**

## **CCR Landfill Hunter Power Plant Castle Dale, Utah**

**December 16, 2021**

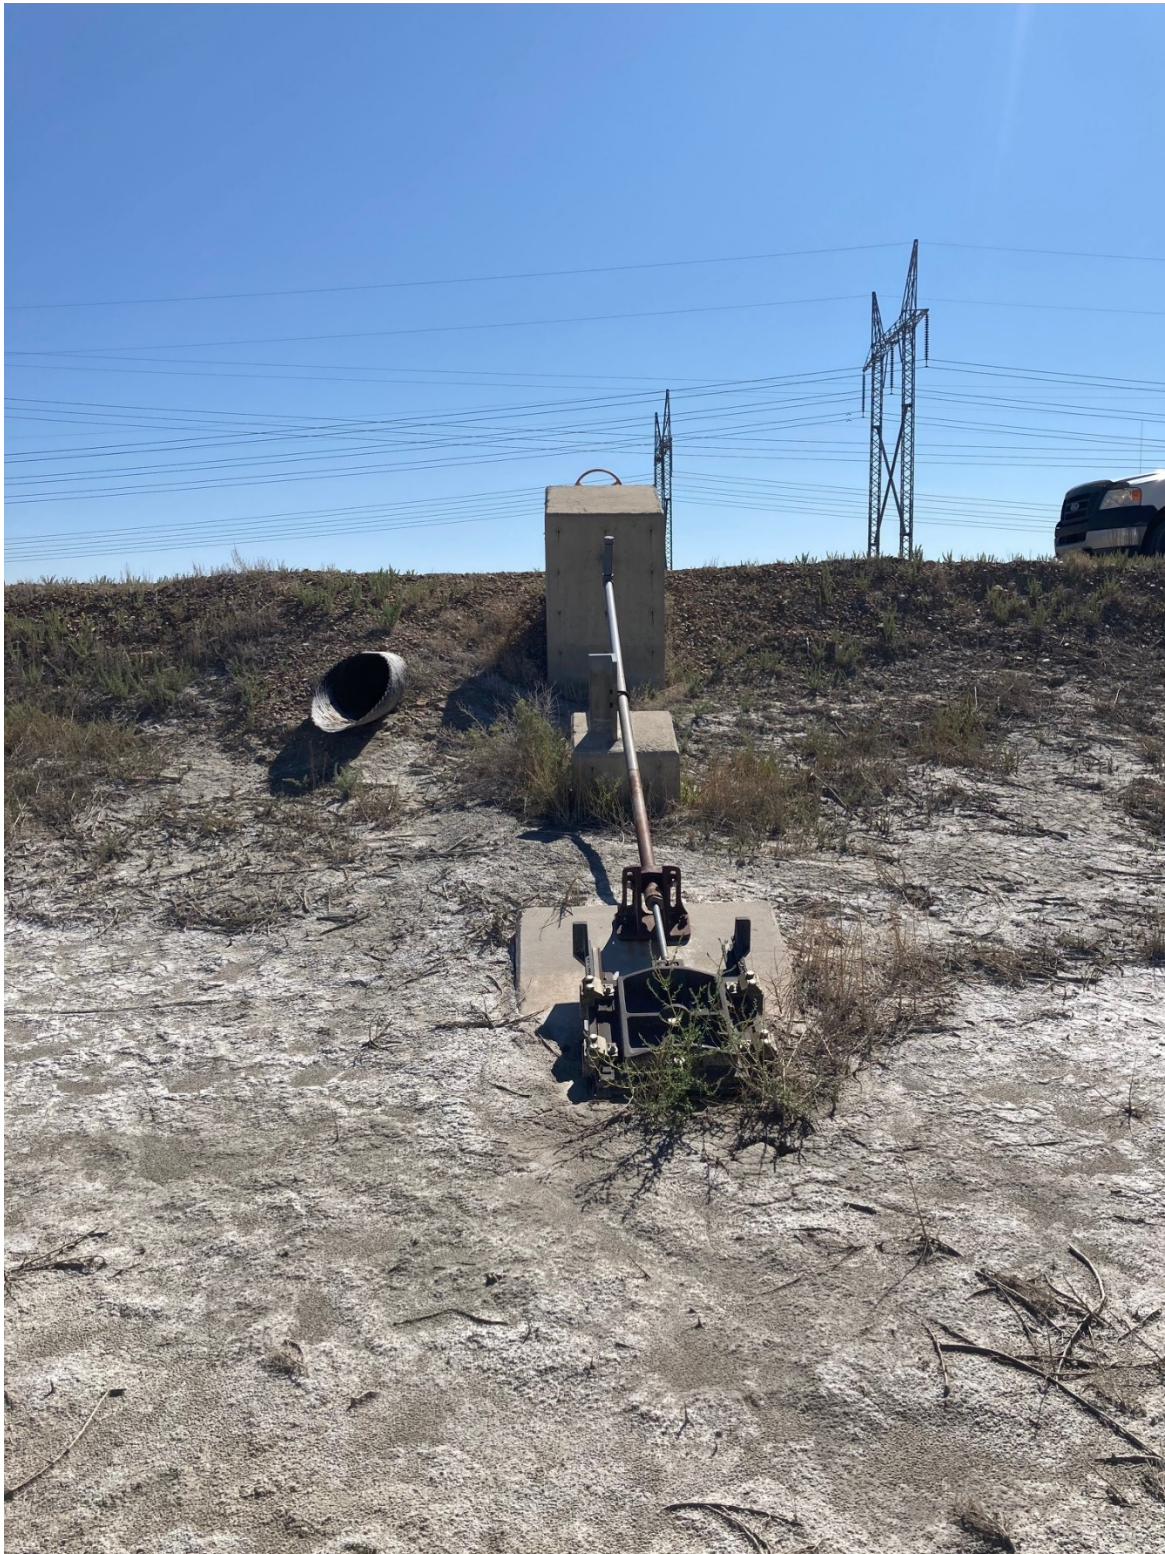
<b>Photo Number:</b> 16	<b>Date:</b> 8/24/2021 10:41 a.m.
<b>Location:</b> Hunter CCR Landfill	<b>Comments:</b> Looking east at upstream end of sedimentation basin discharge structure and overflow pipe. Based on discussions with PacifiCorp, the discharge structure has never operated.

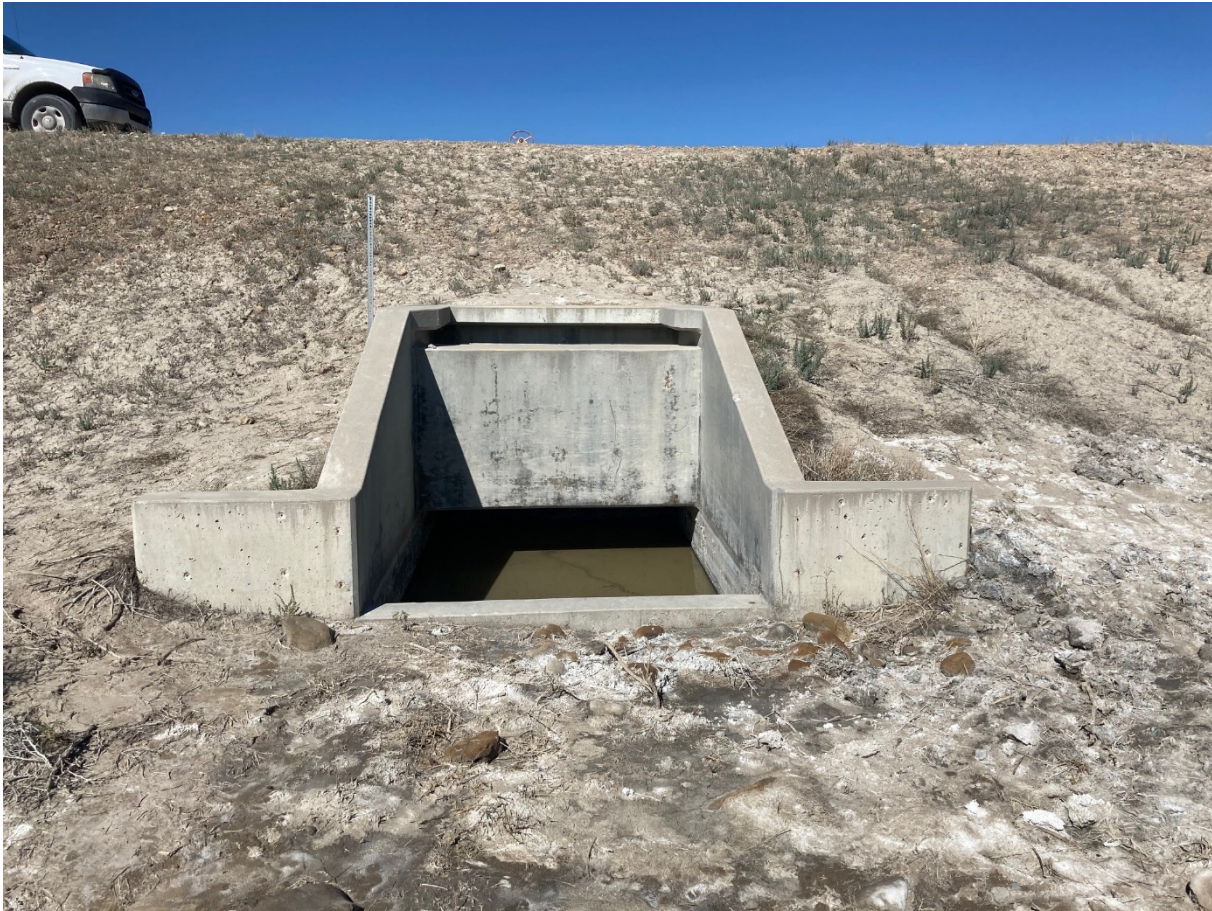
Energy dissipation structure at downstream end of retention pond conduit still has evidence of wetness despite dry conditions. Plant personnel reported that water did not reach the slide gate at the upstream end of conduit.	Water was observed in the downstream energy dissipation structure but was not due to discharge of water from the Stormwater Retention Basin as reported by plant personnel. Water was likely from direct precipitation.
The downstream end, particularly the middle to downstream of the culvert near the north access road, appears to be partially obstructed (30 percent or less). It appears that efforts had been made to remove sediment near the ends of the culvert. AECOM assumes that sediment within the culvert could scour out during a significant storm event because both ends of the culvert had been cleared of sediment.	Deposited sediment was still observed to be accumulated at outlet of culvert up to the mid-height of the culvert.

<b>Photo Number:</b> 17	<b>Date:</b> 8/24/2021 10:43 a.m.
<b>Location:</b> Hunter CCR Landfill	<b>Comments:</b> Looking west at downstream side of sedimentation pond outlet structure.

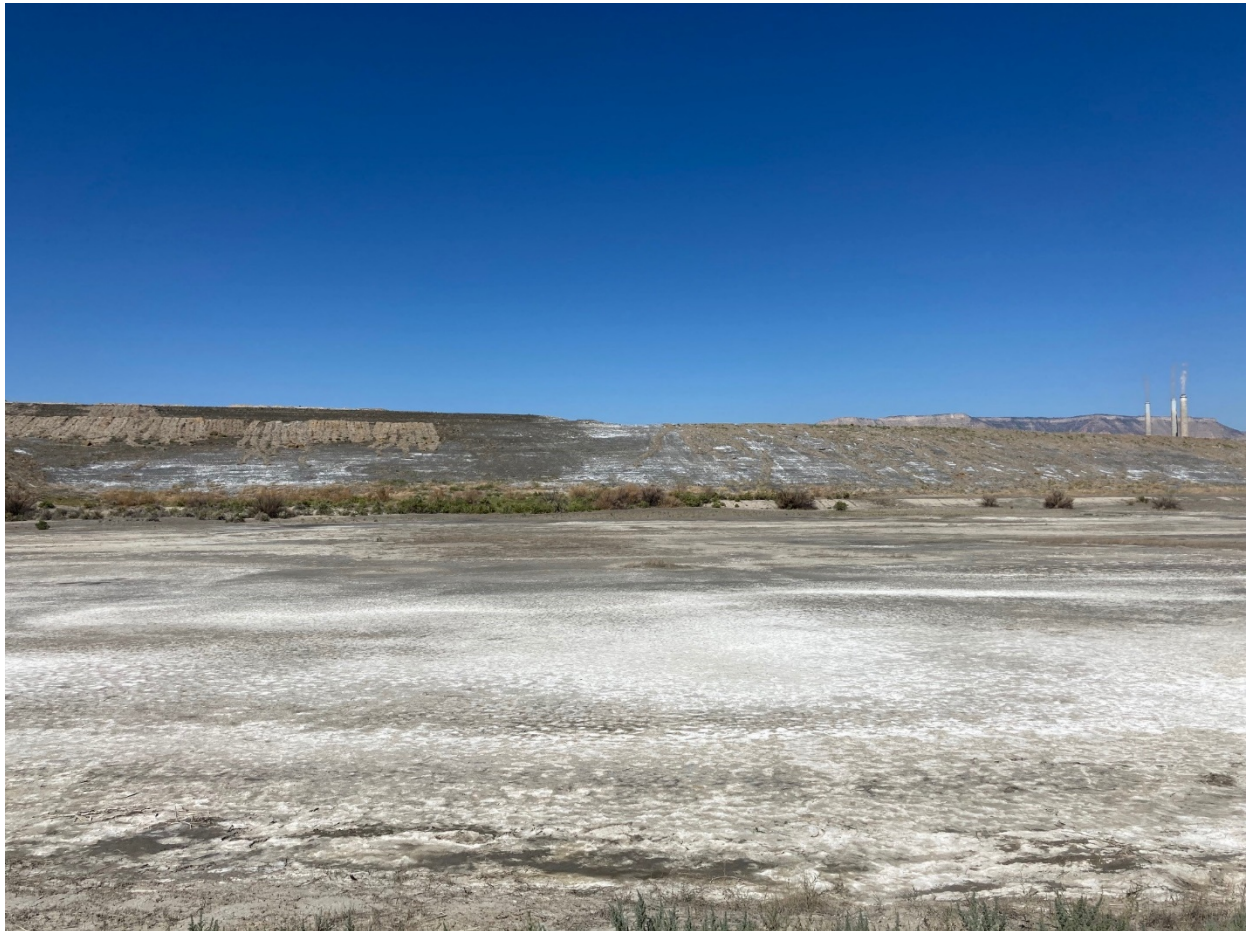
<b>Photo Number:</b> 18	<b>Date:</b> 8/24/2021 10:45 a.m.
<b>Location:</b> Hunter CCR Landfill	<b>Comments:</b> Looking west at middle portion of sedimentation basin. The site had received significant precipitation the prior week and the sedimentation pond had no standing water at the time of the inspection.

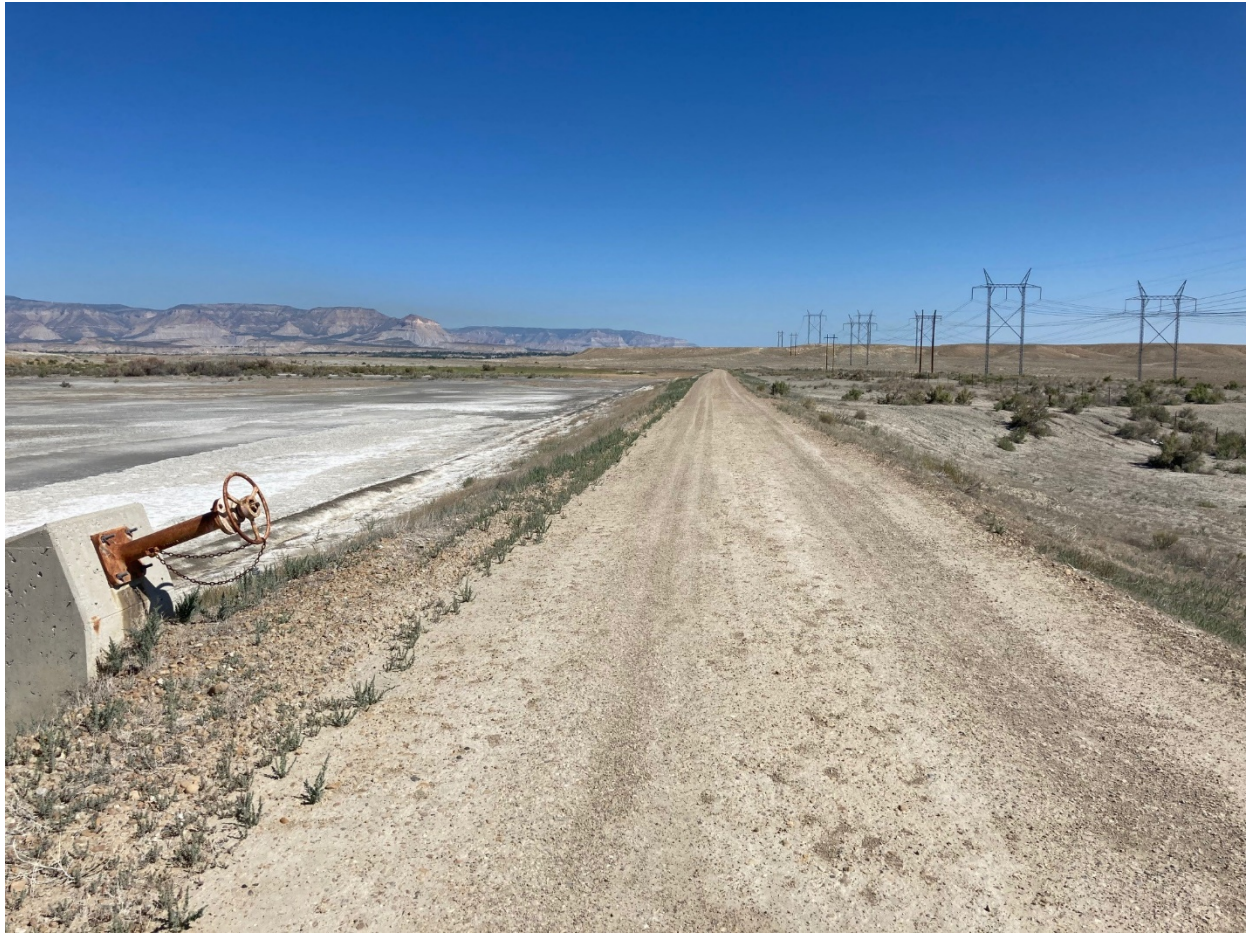
<b>Photo Number:</b> 19	<b>Date:</b> 8/24/2021 10:49 a.m.
<b>Location:</b> Hunter CCR Landfill	<b>Comments:</b> Looking northwest along crest of eastern embankment of sedimentation pond.

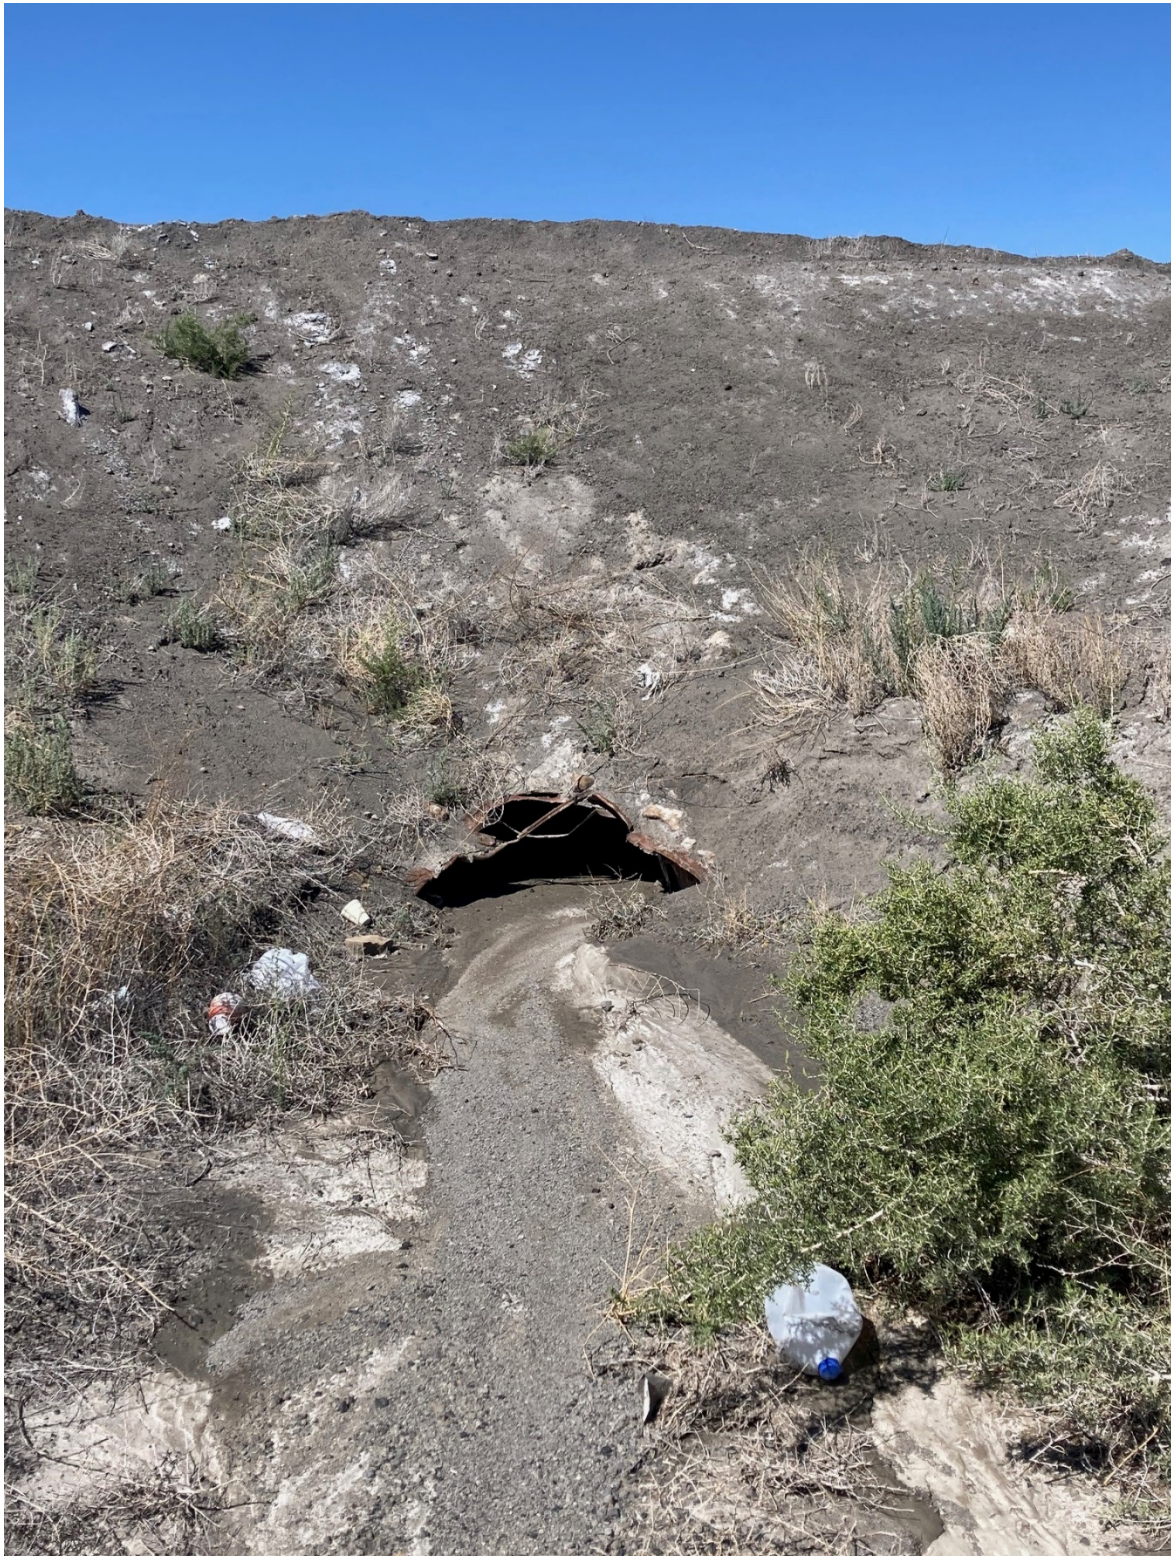
<b>Photo Number:</b> 20	<b>Date:</b> 8/24/2021 10:55 a.m.
<b>Location:</b> Hunter CCR Landfill	<b>Comments:</b> Looking west at downstream side of culvert on north end of pond that routes run-off under haul road to industrial landfill. Note accumulation of sediment up to approximately mid-height in the culvert.

- Clear inlet and outlet ends of culverts to preserve design flow capacity.
- Continue to monitor run-on ditch for undercutting of run-on berm on south side of CCR Landfill.

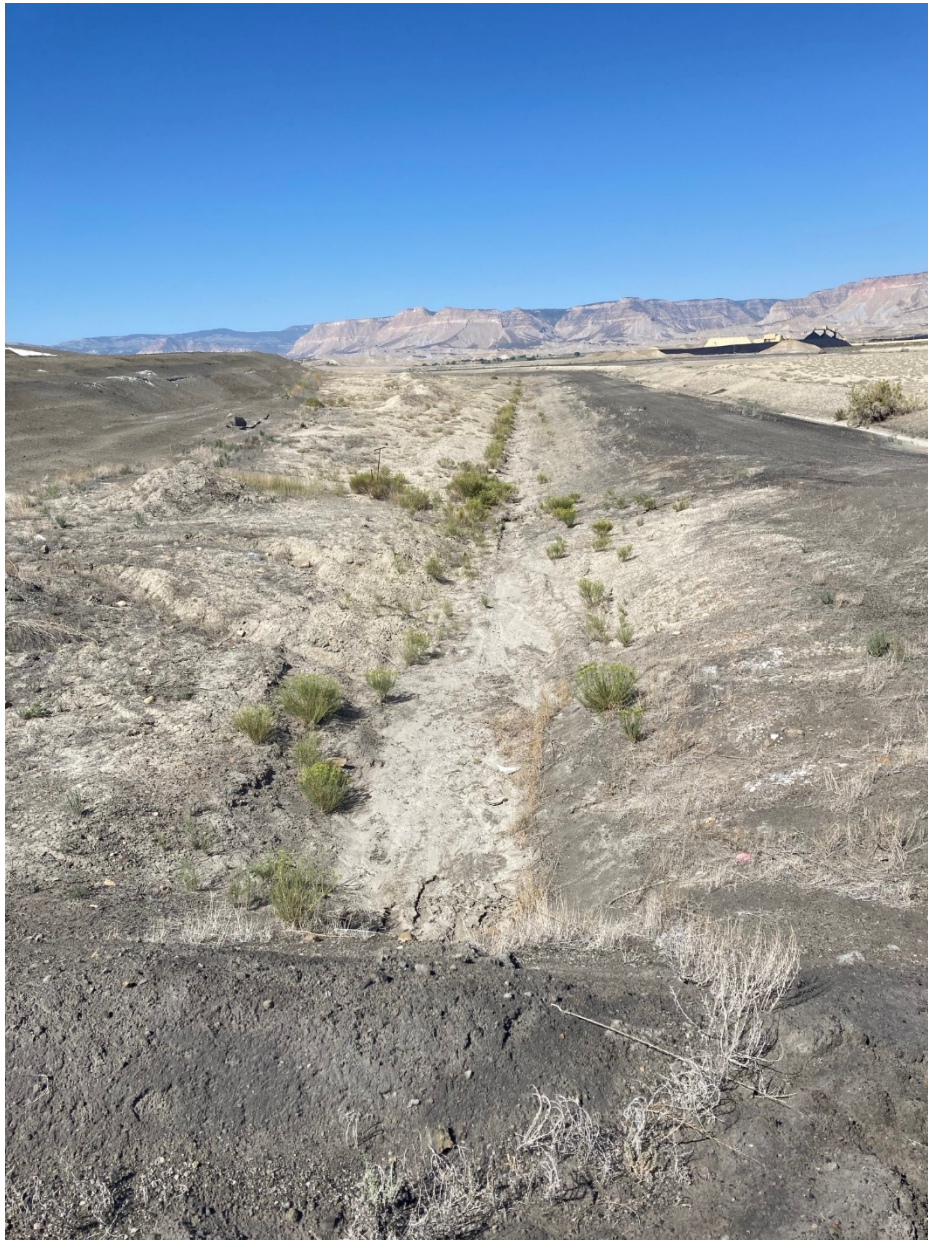
<b>Photo Number:</b> 21	<b>Date:</b> 8/24/2021 10:57 a.m.
<b>Location:</b> Hunter CCR Landfill	<b>Comments:</b> Looking southwest above culvert shown in Photo 20 showing run-off ditch.

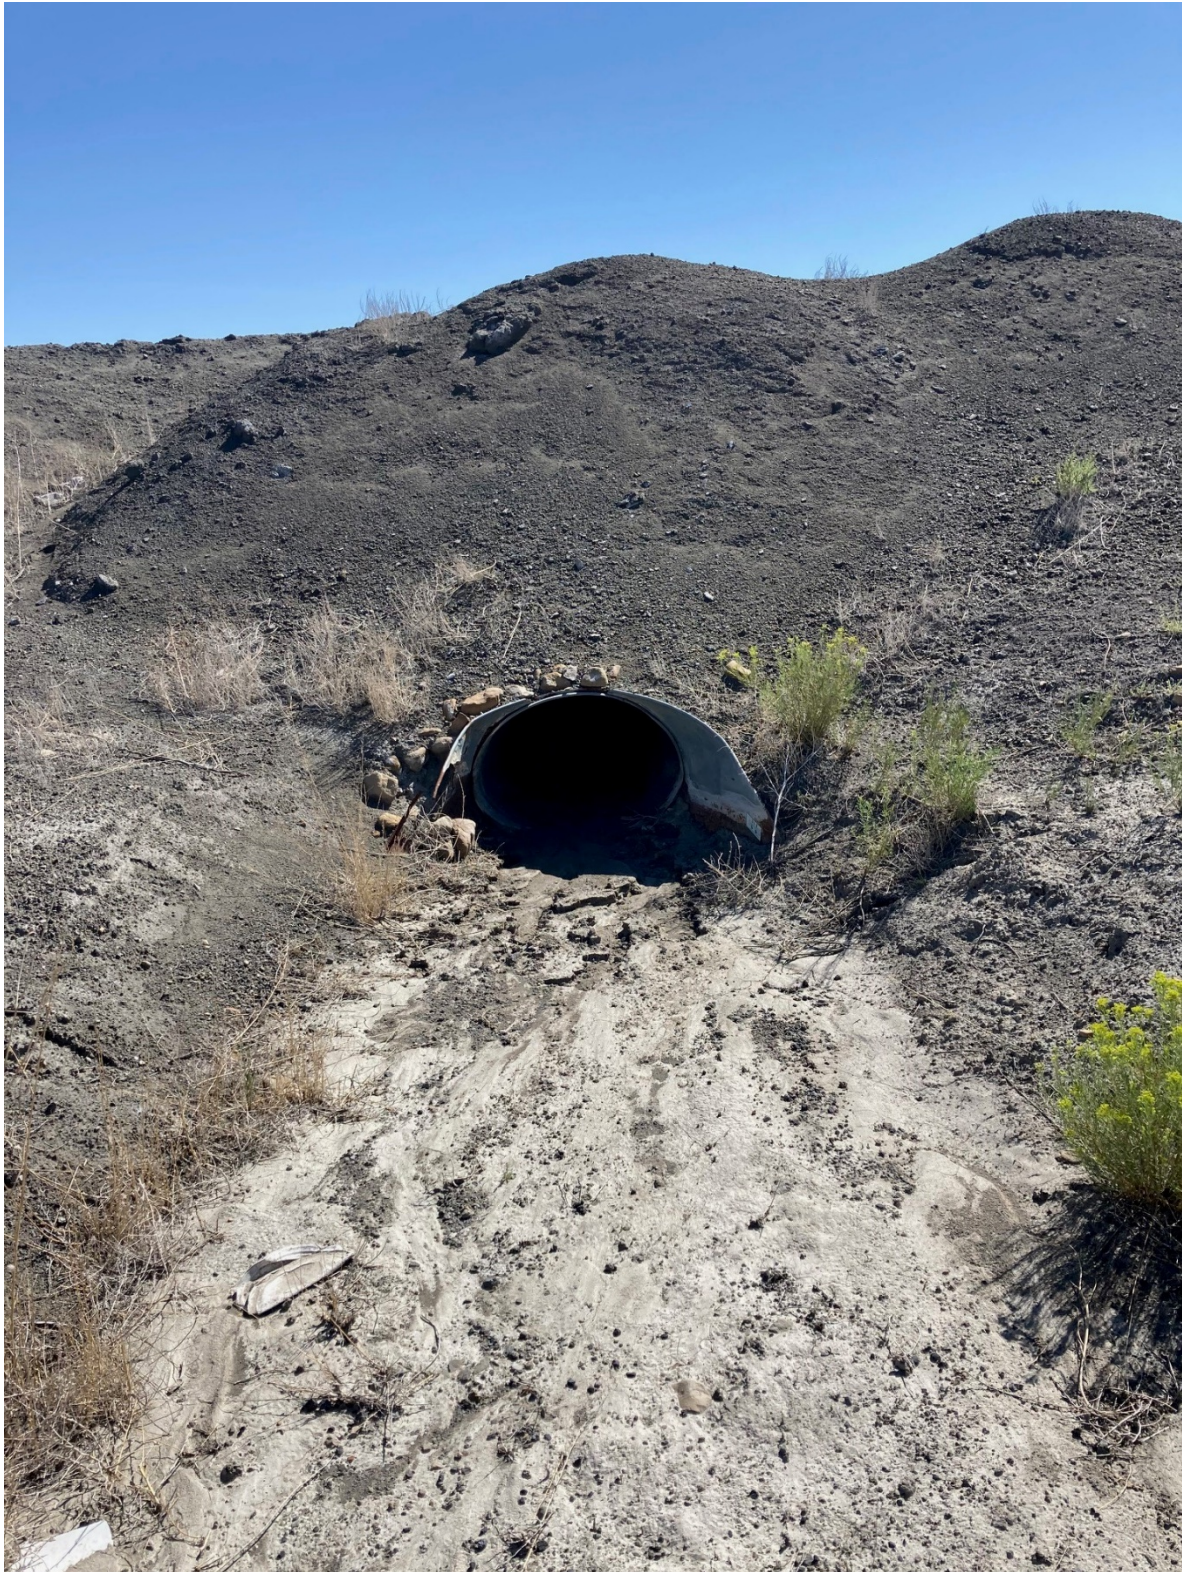
<b>Photo Number:</b> 22	<b>Date:</b> 8/24/2021 11:00 a.m.
<b>Location:</b> Hunter CCR Landfill	<b>Comments:</b> Looking northeast showing upstream end of culvert shown in Photo 20.
