# **CCR Rule Operating Criteria §257.84(b)(1) Annual Inspection by A Qualified Engineer Final**

## **CCR Landfill Hunter Power Plant Castle Dale, Utah**

**December 16, 2022**

**Tetra Tech**

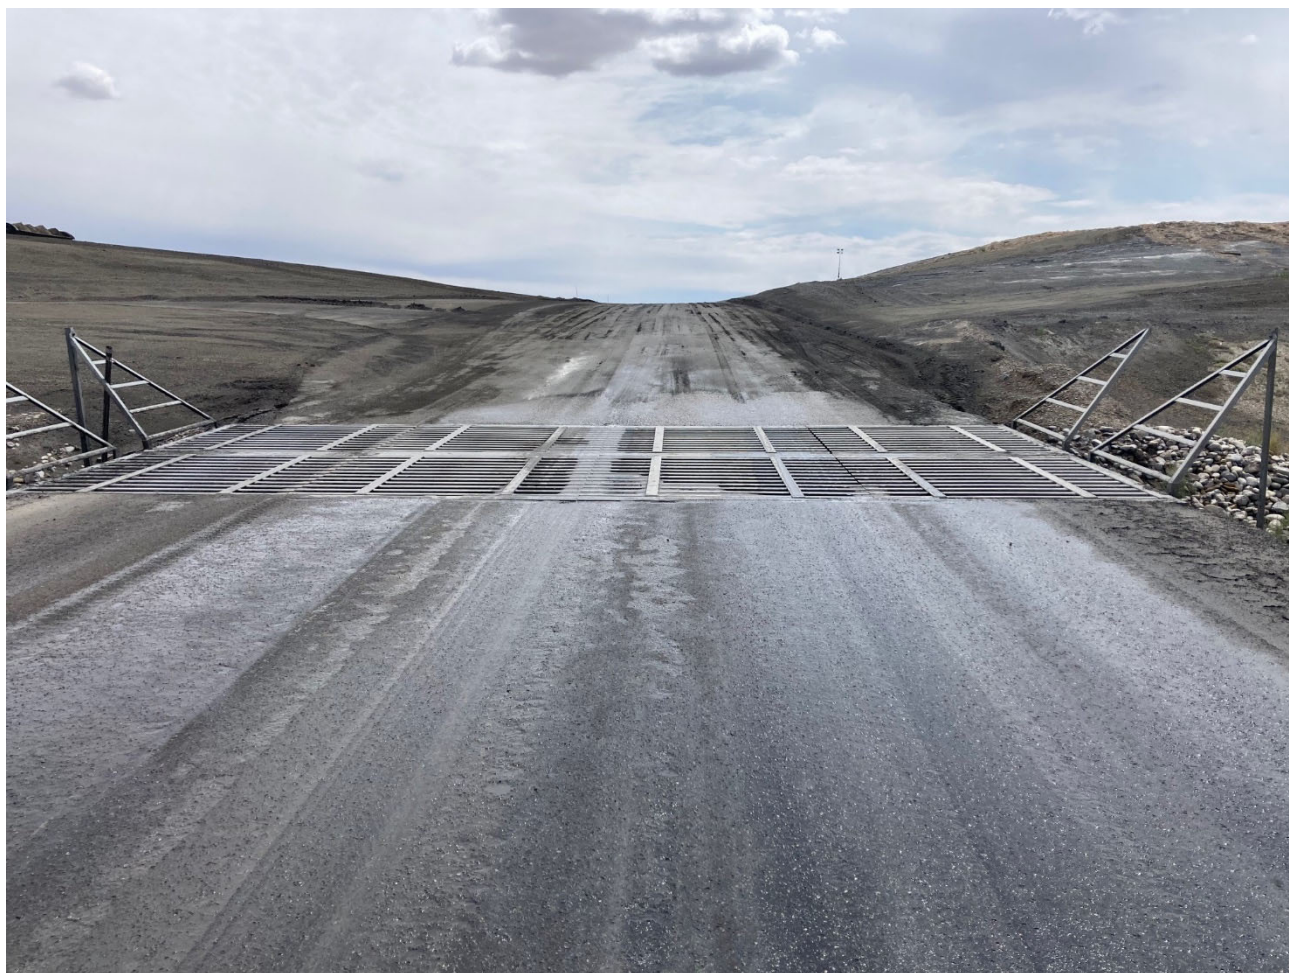
Photo Number: 1	Date: 8/25/2022 1:02 p.m.
Location: Hunter CCR Landfill	Comments: Looking southeast up at haul road grate. Road grate used to remove ash from tires and intercept stormwater running down haul road.

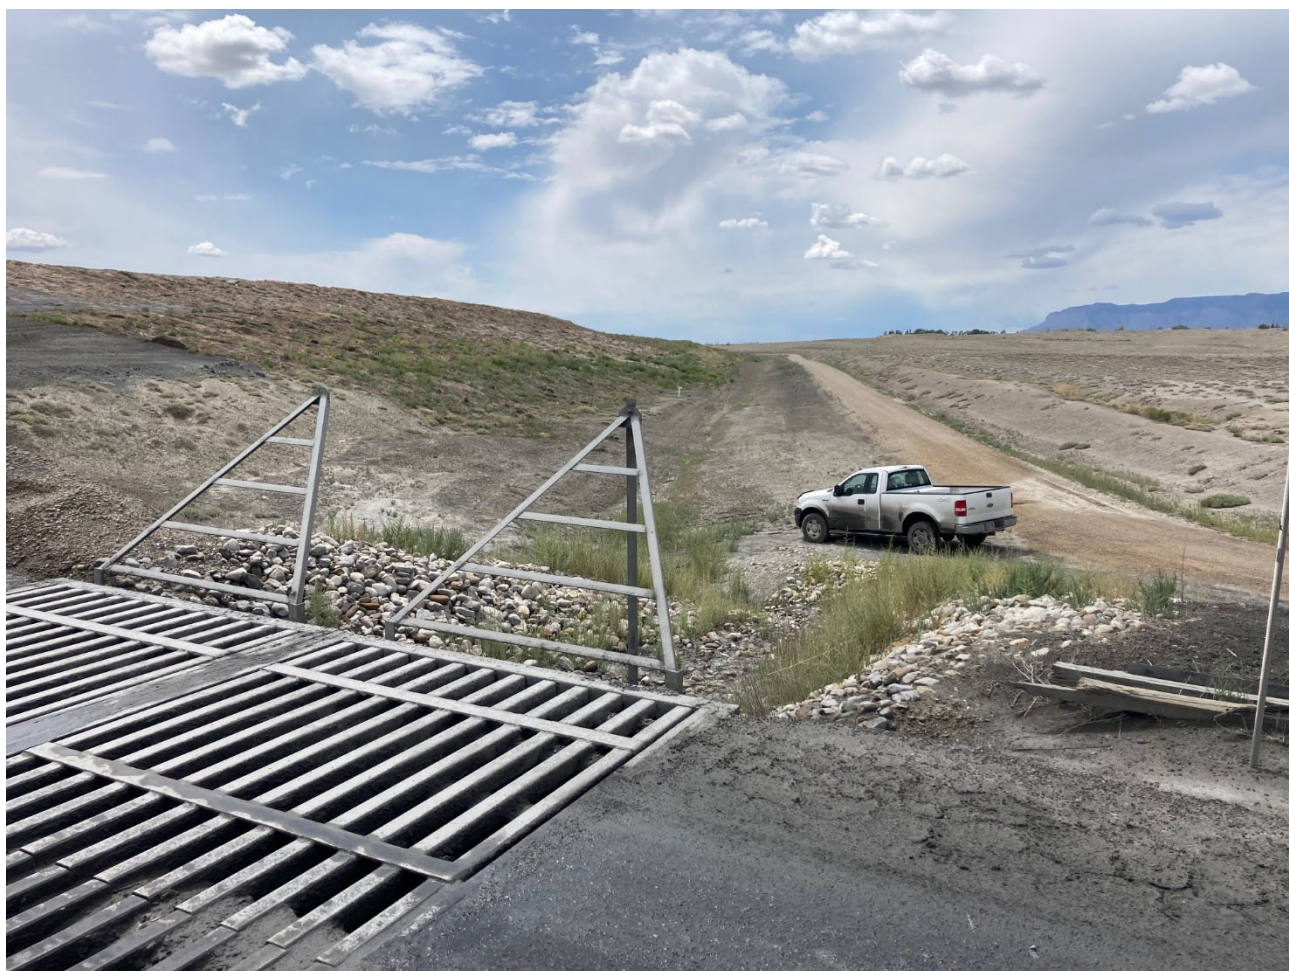
<b>Photo Number:</b> 2	<b>Date:</b> 8/25/2022 1:03 p.m.
<b>Location:</b> Hunter CCR Landfill	<b>Comments:</b> Looking southwest along northwest slope of landfill at run-off ditch and run-on berm..

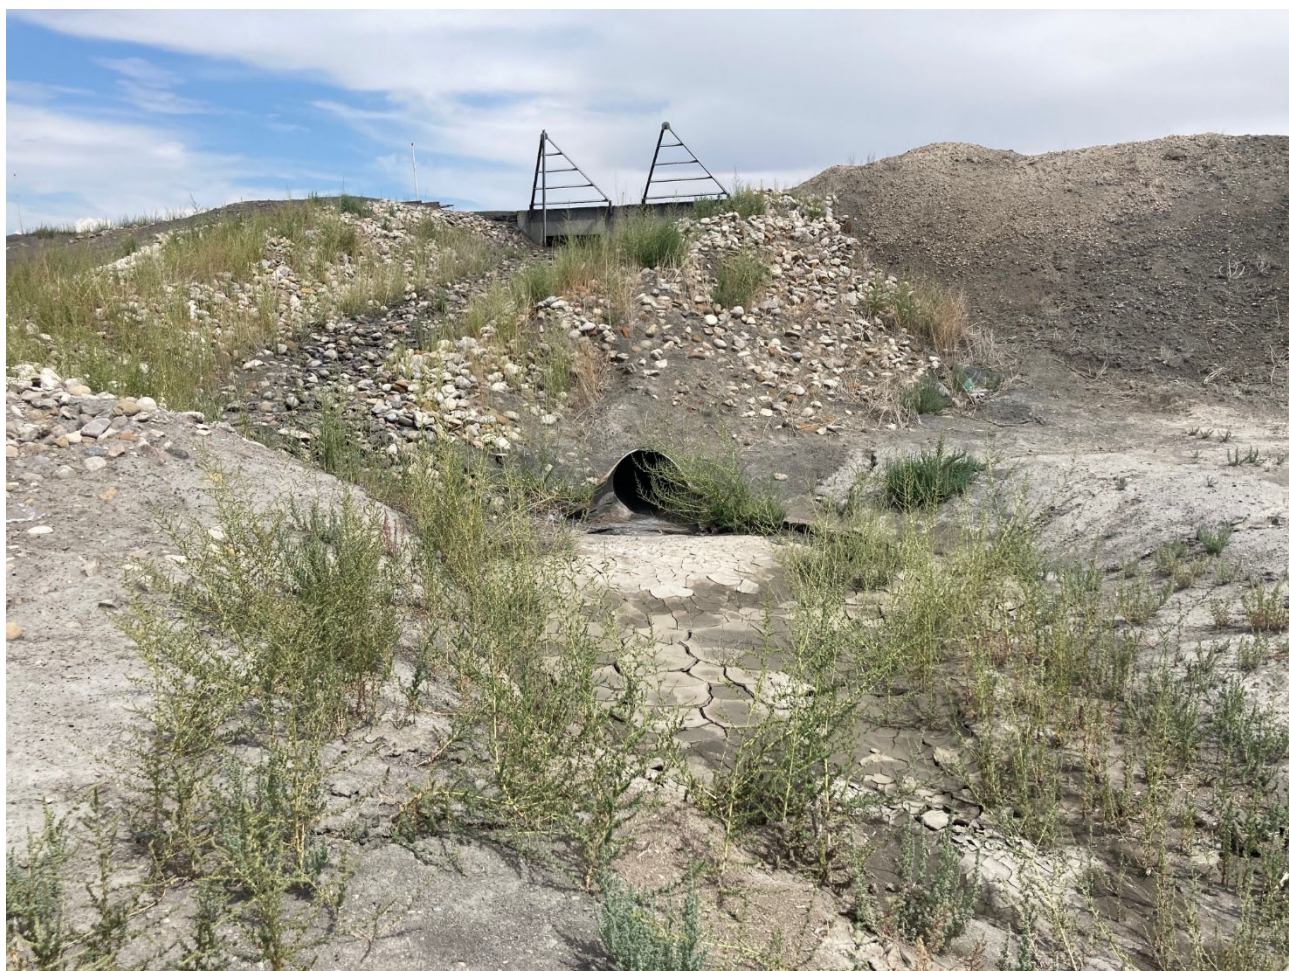
<b>Photo Number:</b> 3	<b>Date:</b> 8/25/2022 1:05 p.m.
<b>Location:</b> Hunter CCR Landfill	<b>Comments:</b> Looking north at inlet of culvert draining run-off channel shown in Photograph 2.

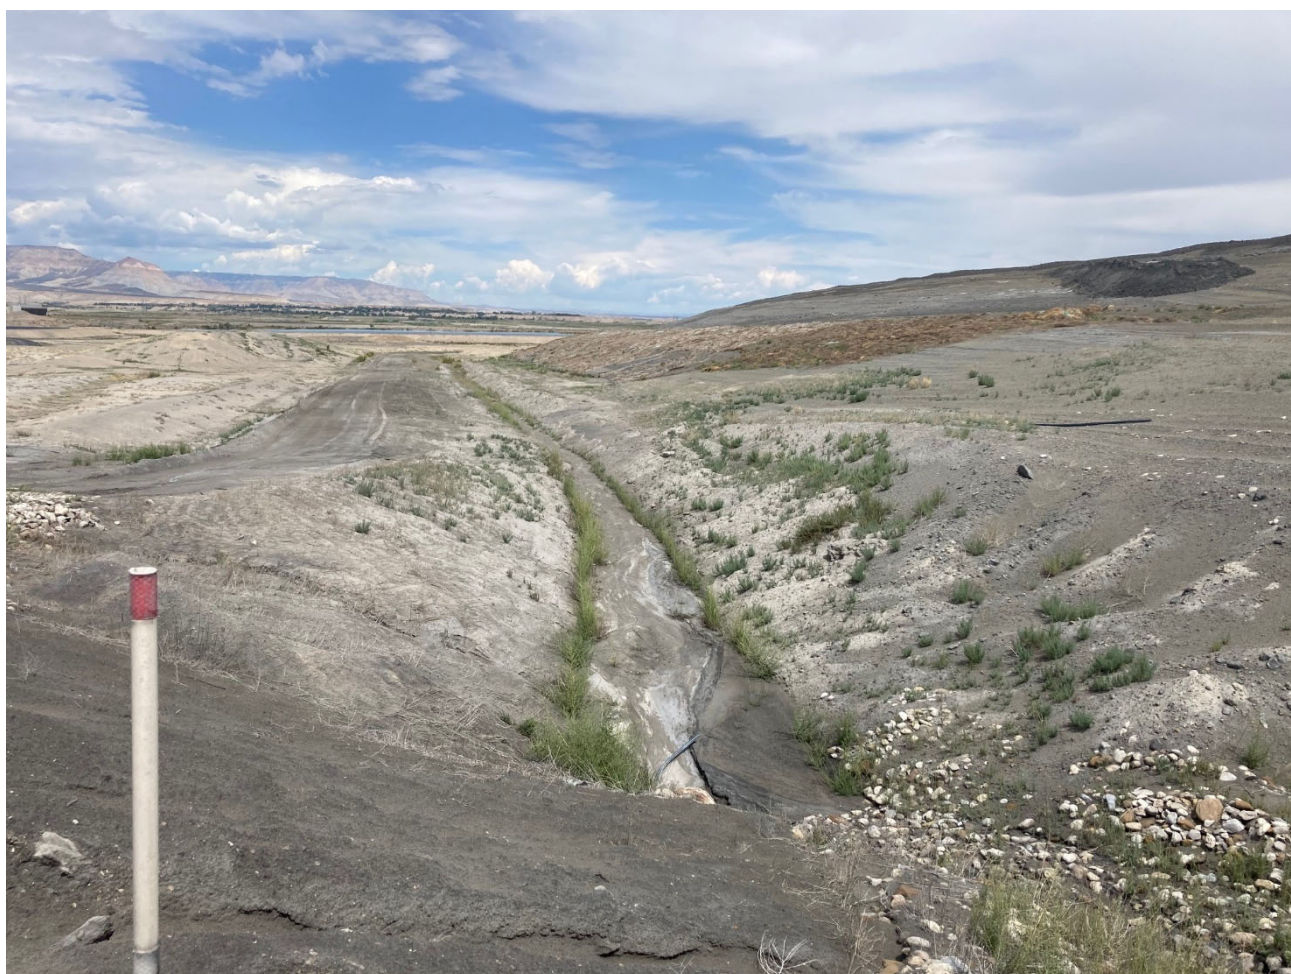
<b>Photo Number:</b> 4	<b>Date:</b> 8/25/2022 1:06 p.m.
<b>Location:</b> Hunter CCR Landfill	<b>Comments:</b> Looking north from ash haul road at discharge end of culvert and continuation of channel shown if Photographs 3 and 2, respectively.

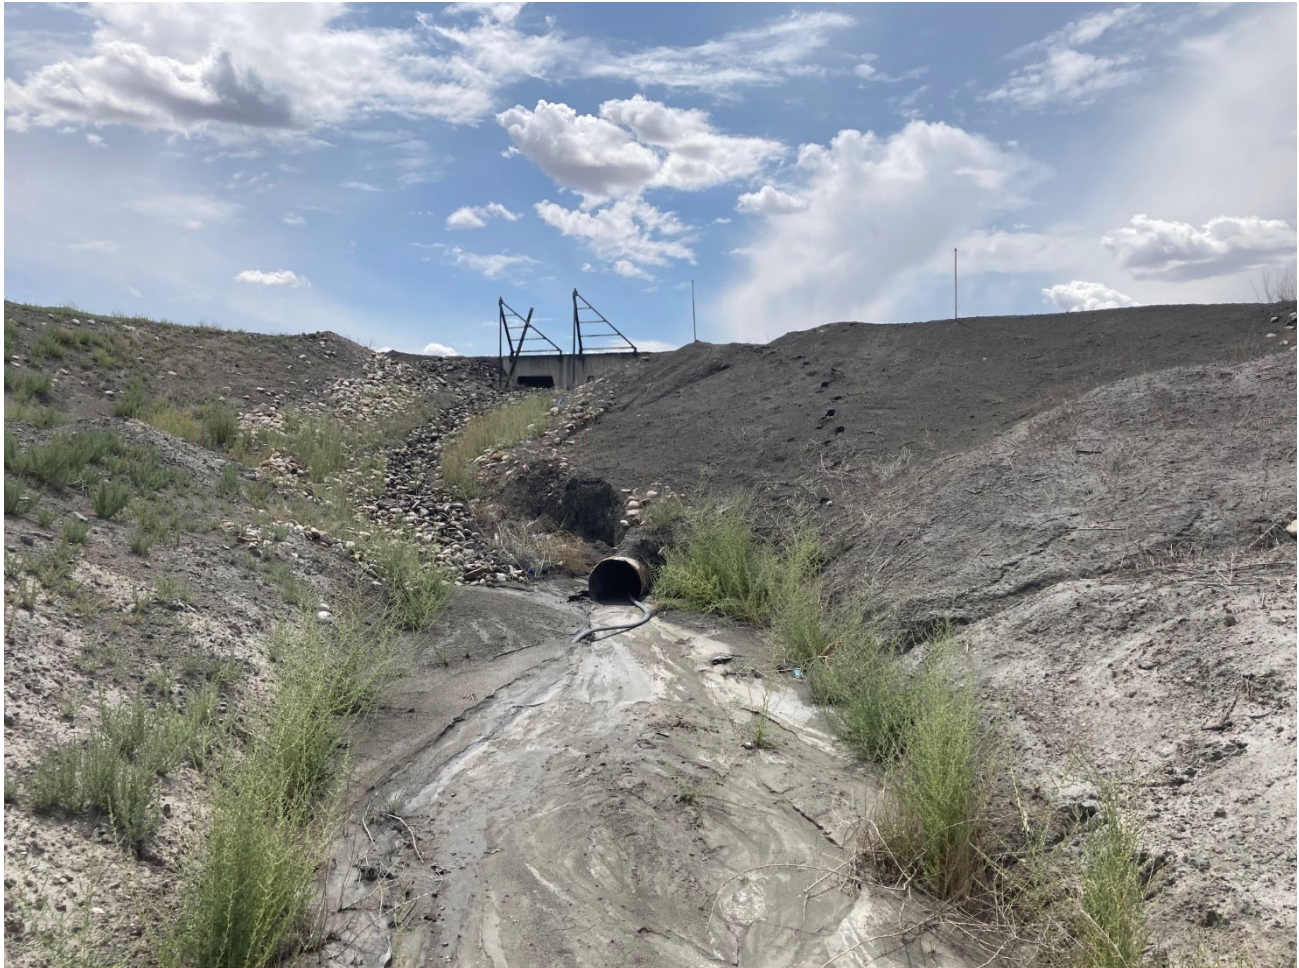
<b>Photo Number:</b> 5	<b>Date:</b> 8/25/2022 1:07 p.m.
<b>Location:</b> Hunter CCR Landfill	<b>Comments:</b> Looking south at discharge end of culver shown in Photograph 3.

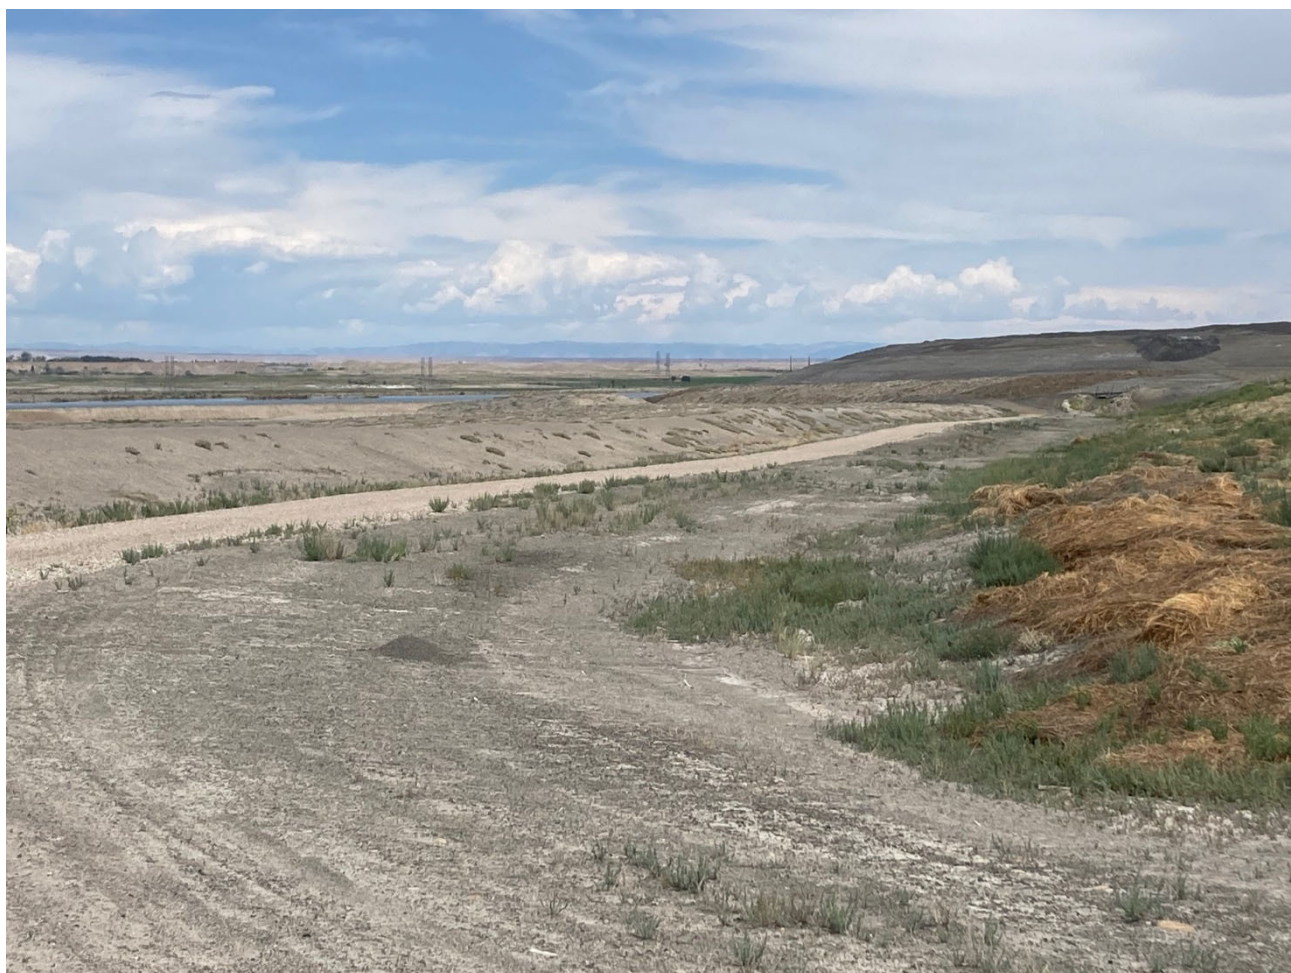
<b>Photo Number:</b> 6	<b>Date:</b> 8/25/2022 1:12 p.m.
<b>Location:</b> Hunter CCR Landfill	<b>Comments:</b> Looking north down run-off channel towards culvert shown in Photograph 2.

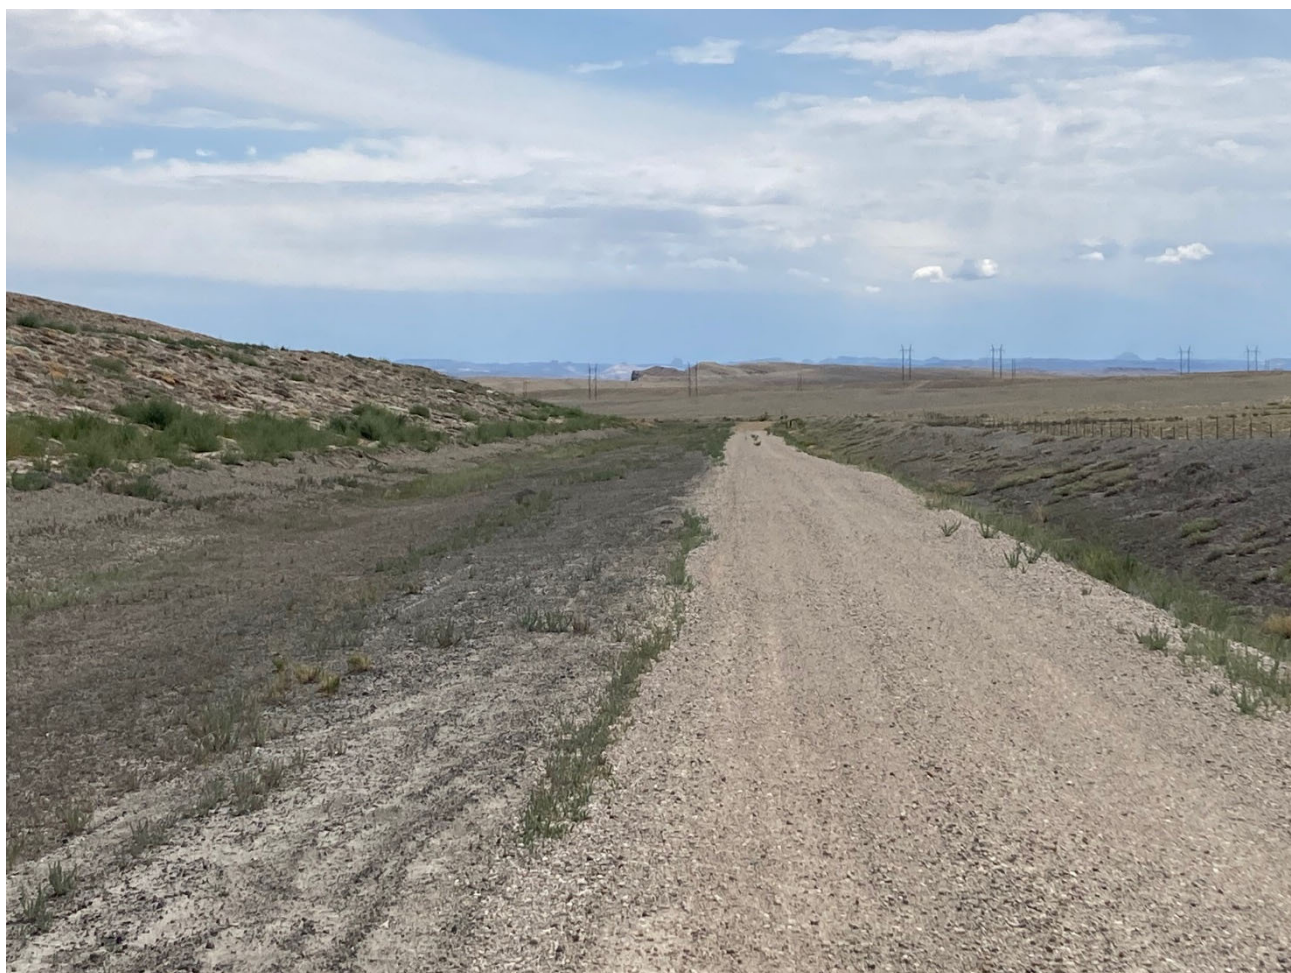
<b>Photo Number:</b> 7	<b>Date:</b> 8/25/2022 1:13 p.m.
<b>Location:</b> Hunter CCR Landfill	<b>Comments:</b> Looking southeast at high point (break in grade) of run-off channel.

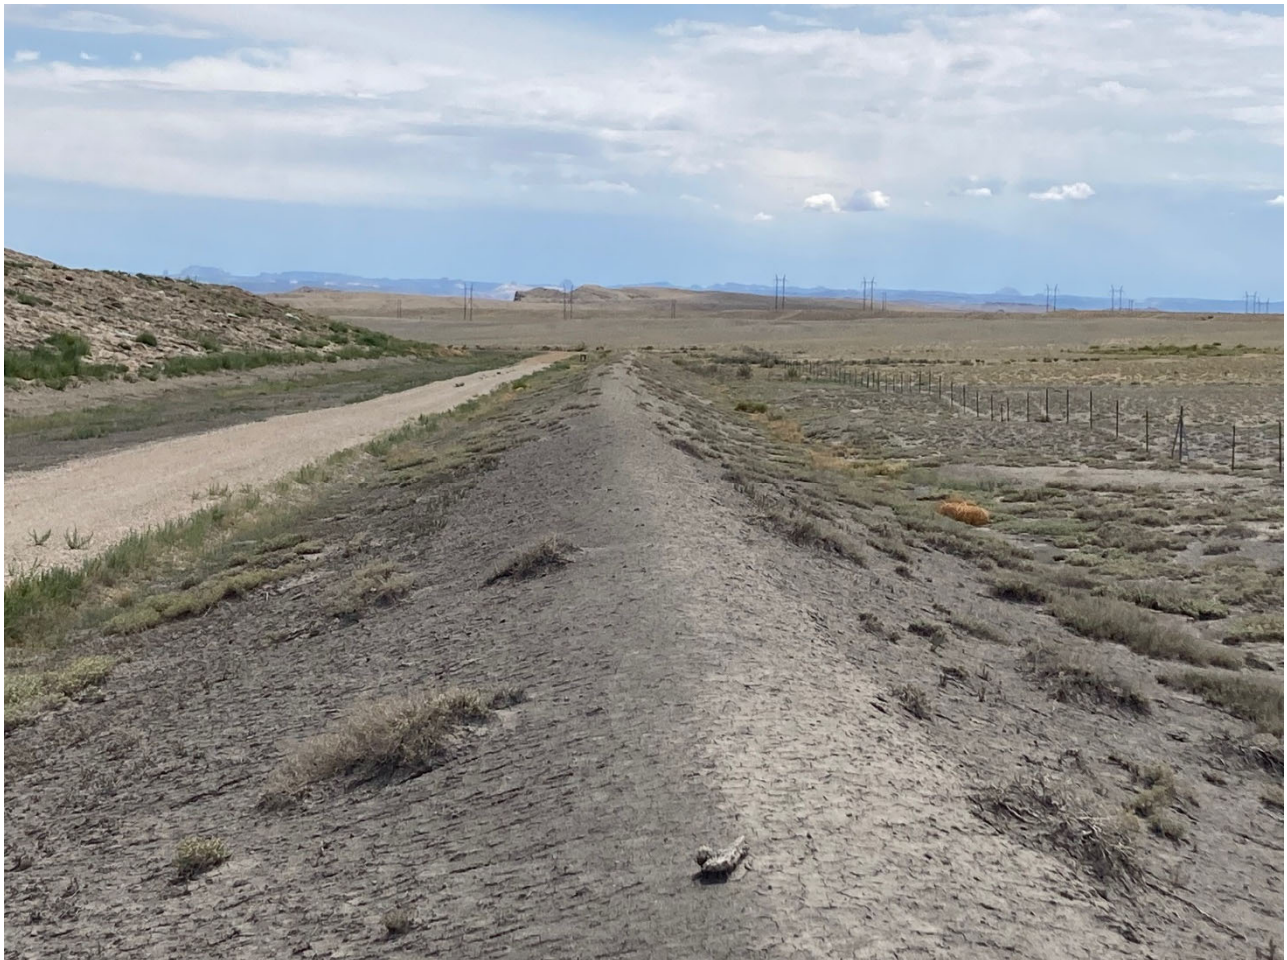
<b>Photo Number:</b> 8	<b>Date:</b> 8/25/2022 1:15 p.m.
<b>Location:</b> Hunter CCR Landfill	<b>Comments:</b> Looking southeast on top of run-on berm and perimeter road.

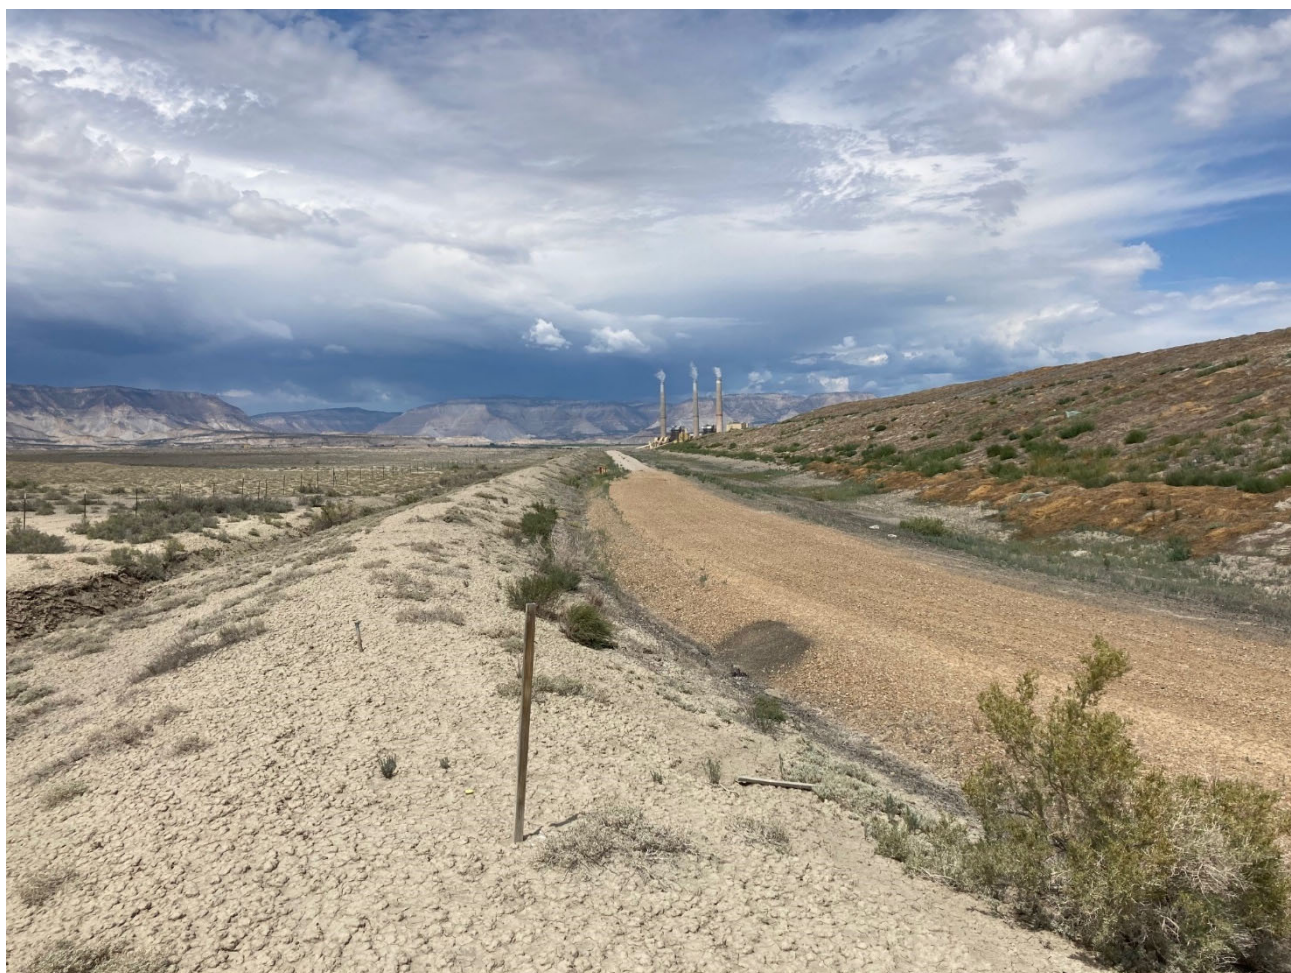
<b>Photo Number:</b> 9	<b>Date:</b> 8/25/2022 1:20 p.m.
<b>Location:</b> Hunter CCR Landfill	<b>Comments:</b> Looking north up run-on berm and perimeter road.

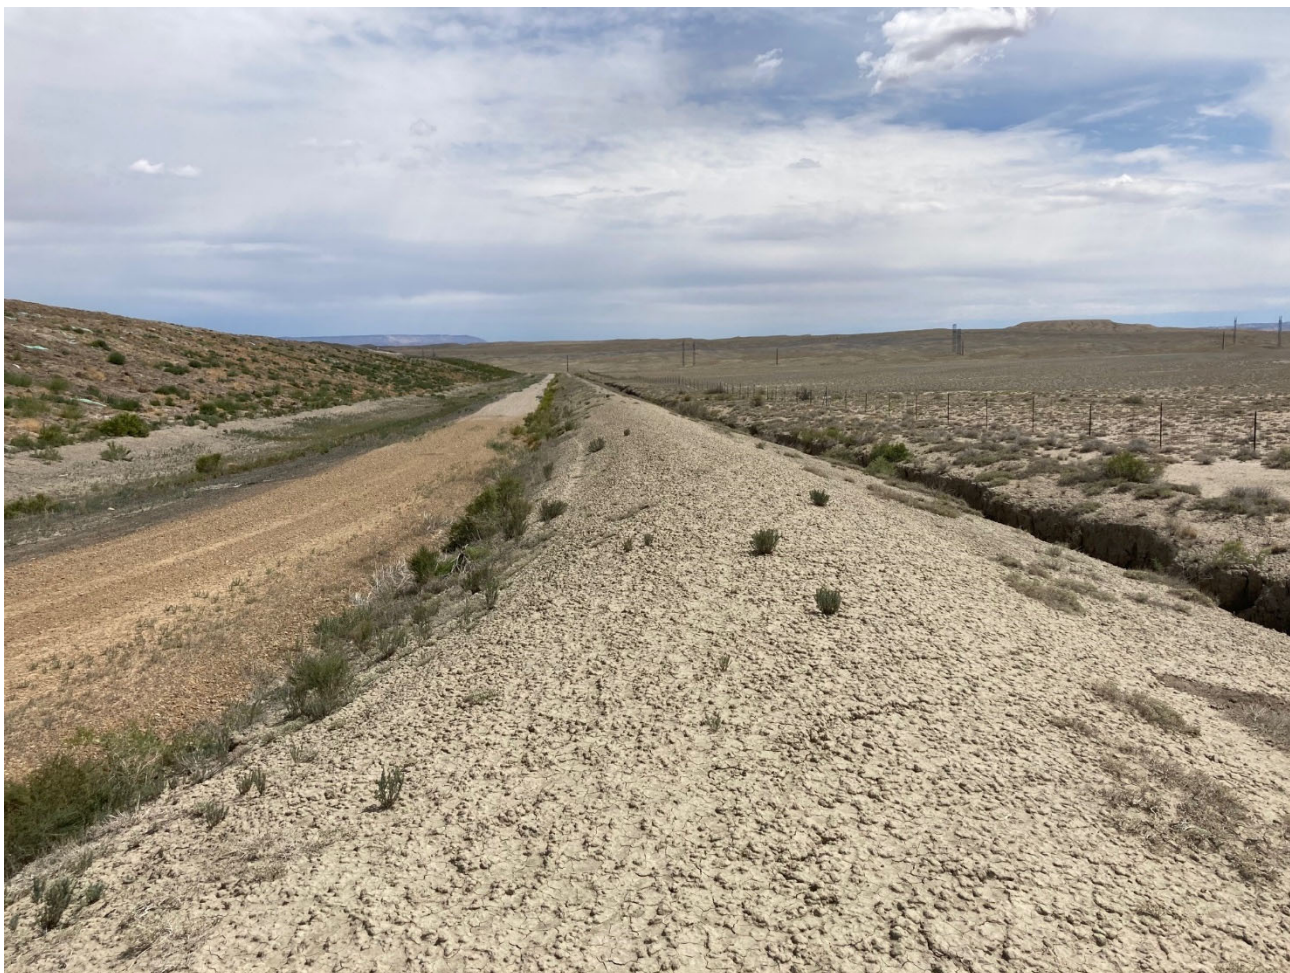
<b>Photo Number:</b> 10	<b>Date:</b> 8/25/2022 1:21 p.m.
<b>Location:</b> Hunter CCR Landfill	<b>Comments:</b> Looking east down run-on berm along southwest slope of landfill.

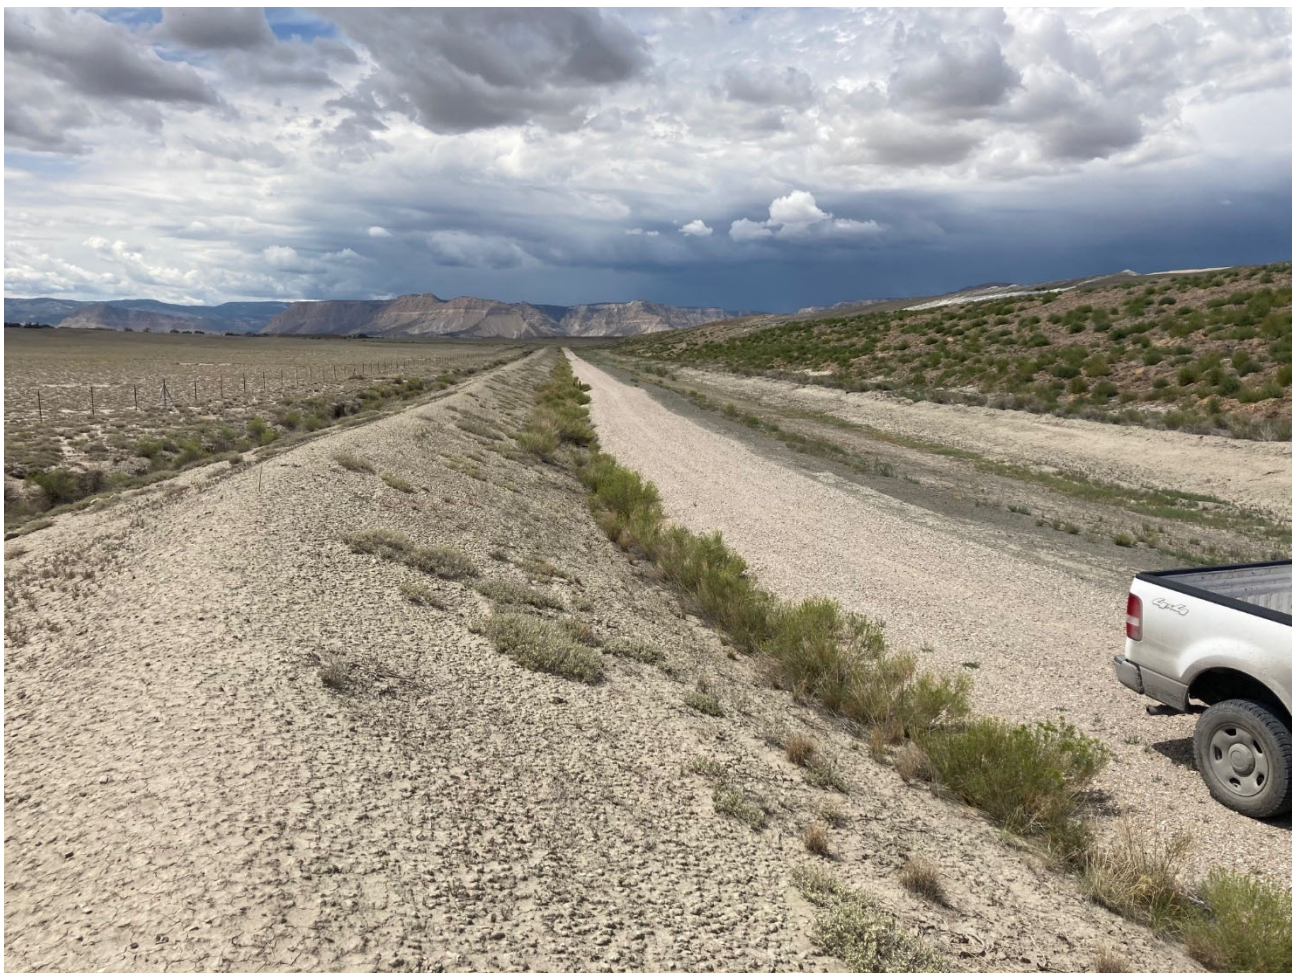
<b>Photo Number:</b> 11	<b>Date:</b> 8/25/2022 1:31 p.m.
<b>Location:</b> Hunter CCR Landfill	<b>Comments:</b> Looking west on top of run-on berm and run-on channel.

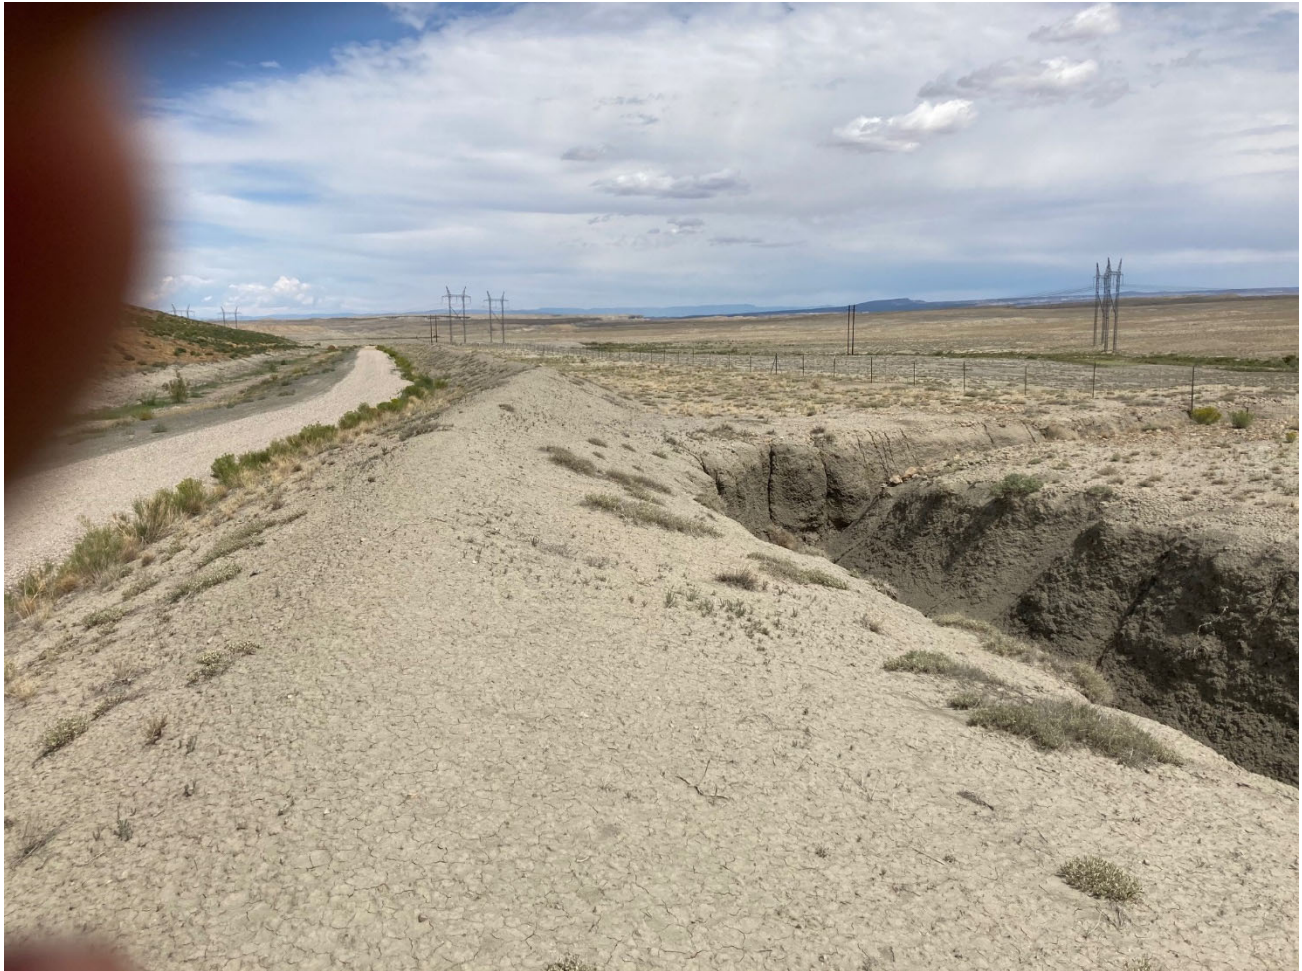
<b>Photo Number:</b> 12	<b>Date:</b> 8/25/2022 1:32 p.m.
<b>Location:</b> Hunter CCR Landfill	<b>Comments:</b> Looking northeast down run-on berm and end of run-on channel

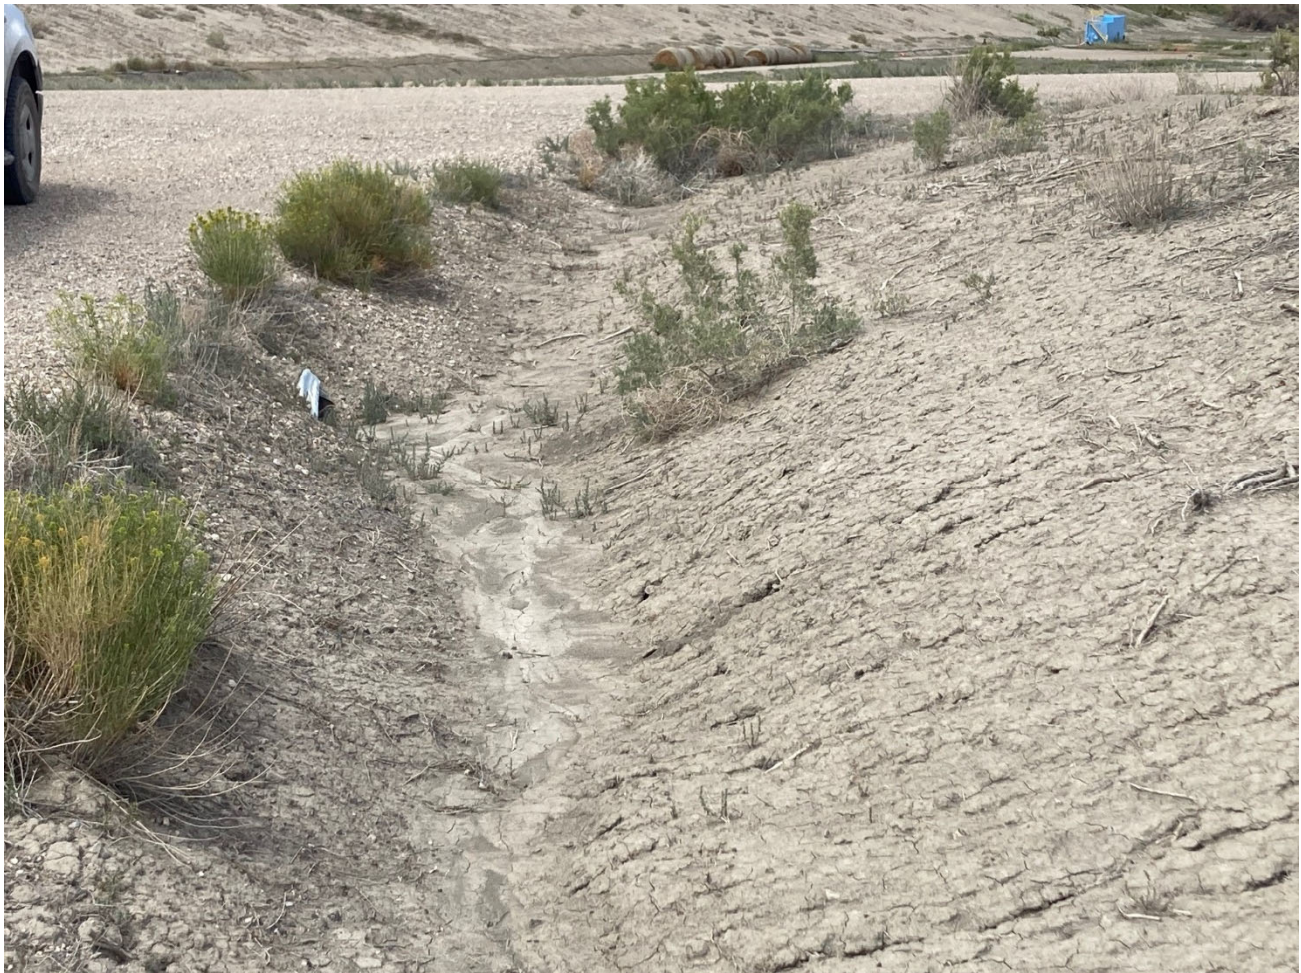
<b>Photo Number:</b> 13	<b>Date:</b> 8/25/2022 1:34 p.m.
<b>Location:</b> Hunter CCR Landfill	<b>Comments:</b> Looking north at inlet side of culvert draining run-off between perimeter road and run-on berm.

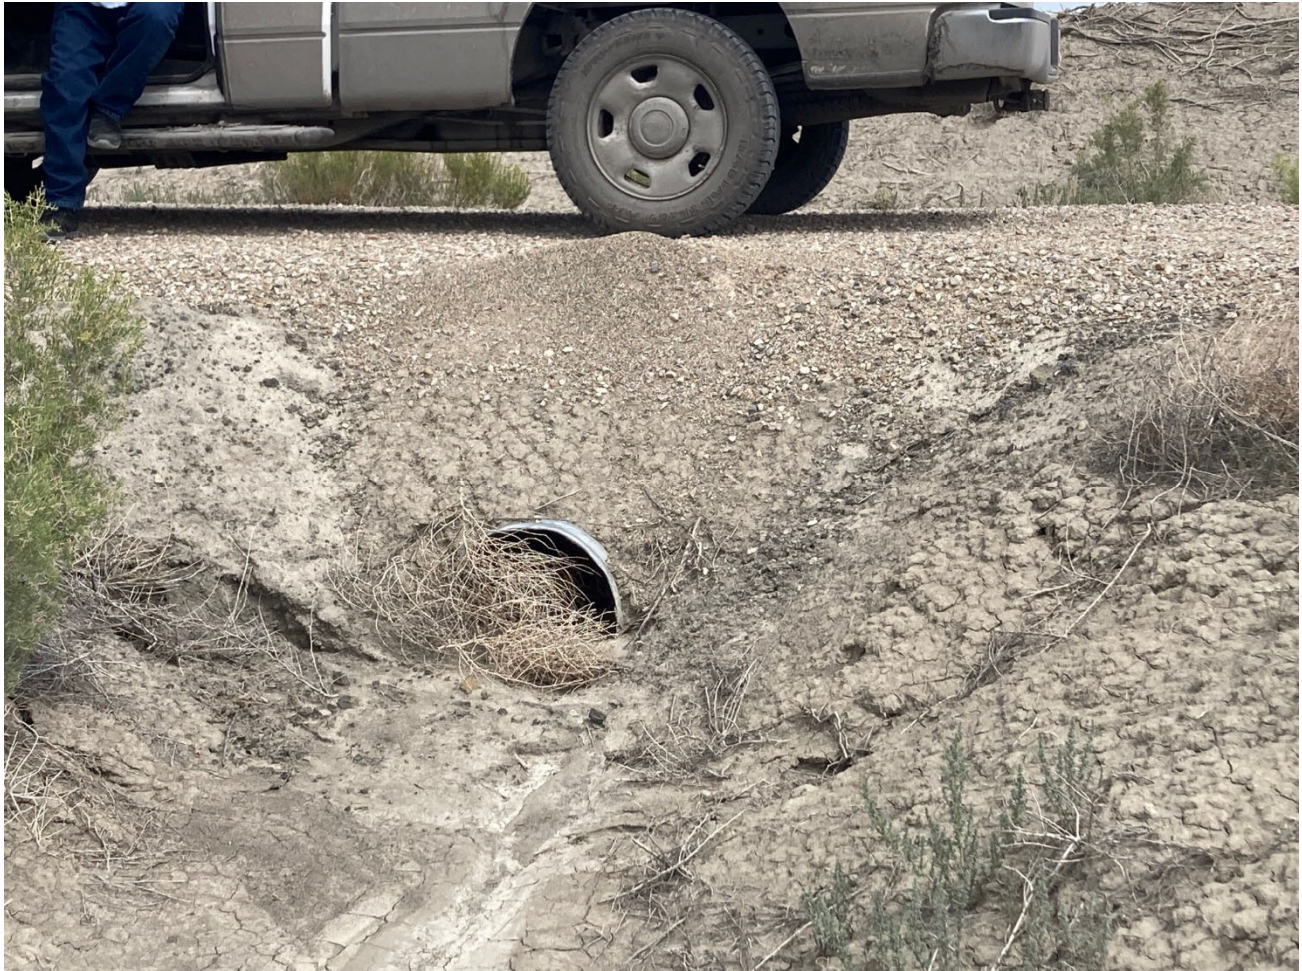
<b>Photo Number:</b> 14	<b>Date:</b> 8/25/2022 1:35 p.m.
<b>Location:</b> Hunter CCR Landfill	<b>Comments:</b> Looking northeast at discharge side of culvert shown in Photograph 13.

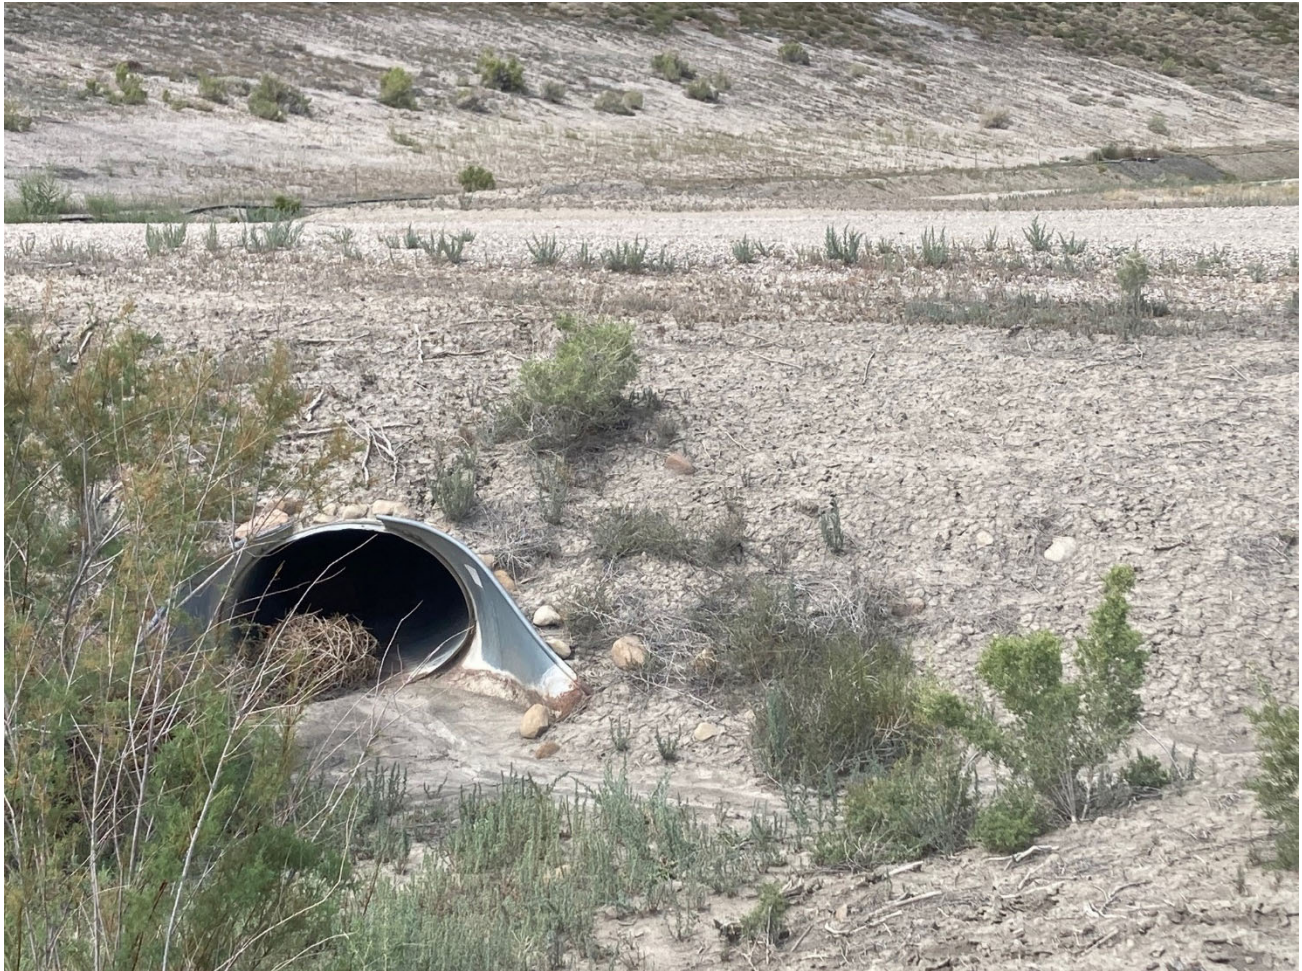
<b>Photo Number:</b> 15	<b>Date:</b> 8/25/2022 1:36 p.m.
<b>Location:</b> Hunter CCR Landfill	<b>Comments:</b> Looking northwest at inlet to culvert discharge to stormwater retention pond.

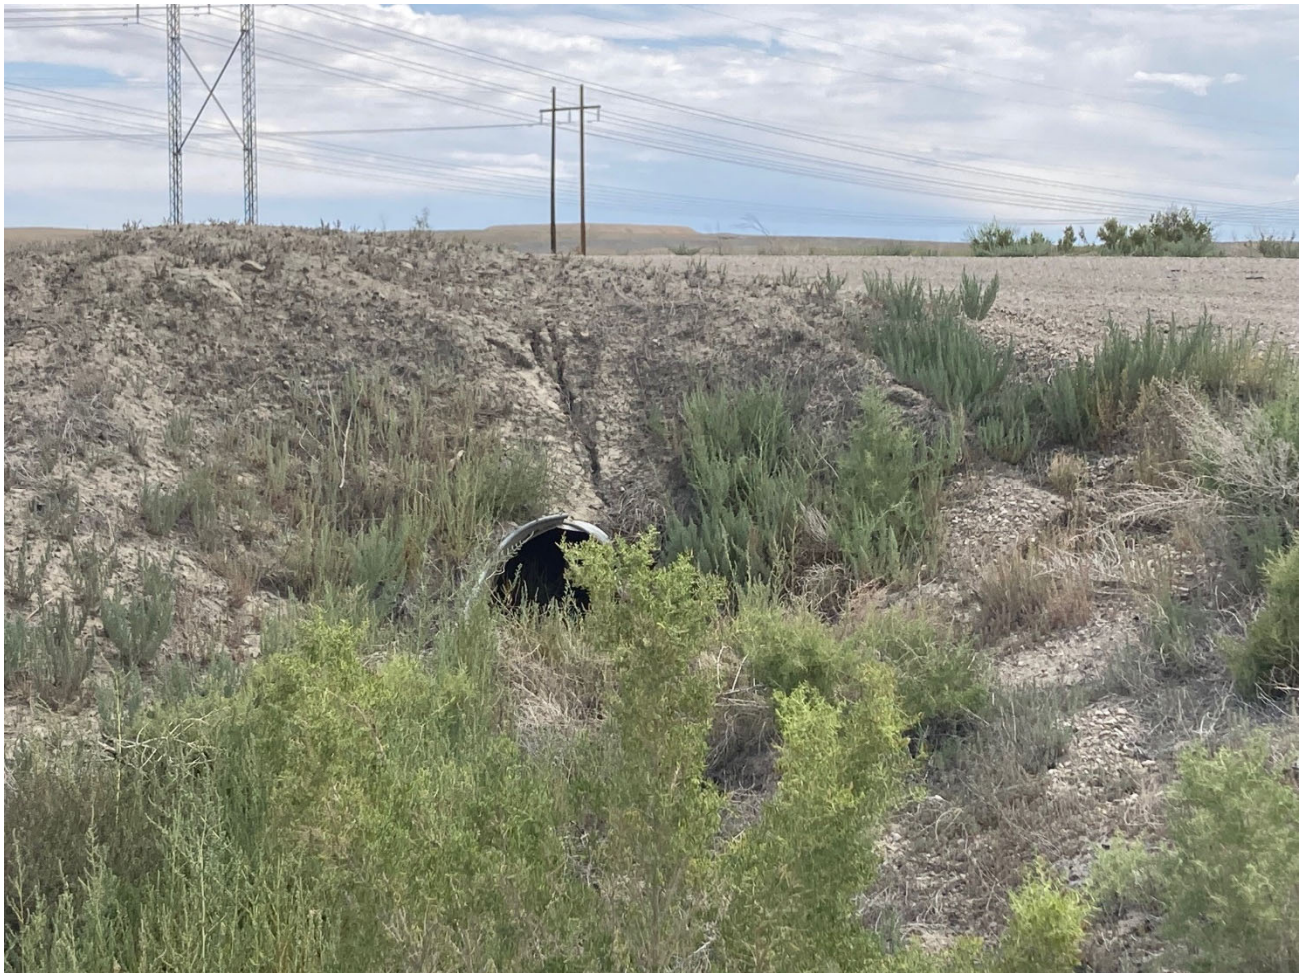
<b>Photo Number:</b> 16	<b>Date:</b> 8/25/2022 1:40 p.m.
<b>Location:</b> Hunter CCR Landfill	<b>Comments:</b> Looking southwest at discharge end of culvert shown in Photograph 15.

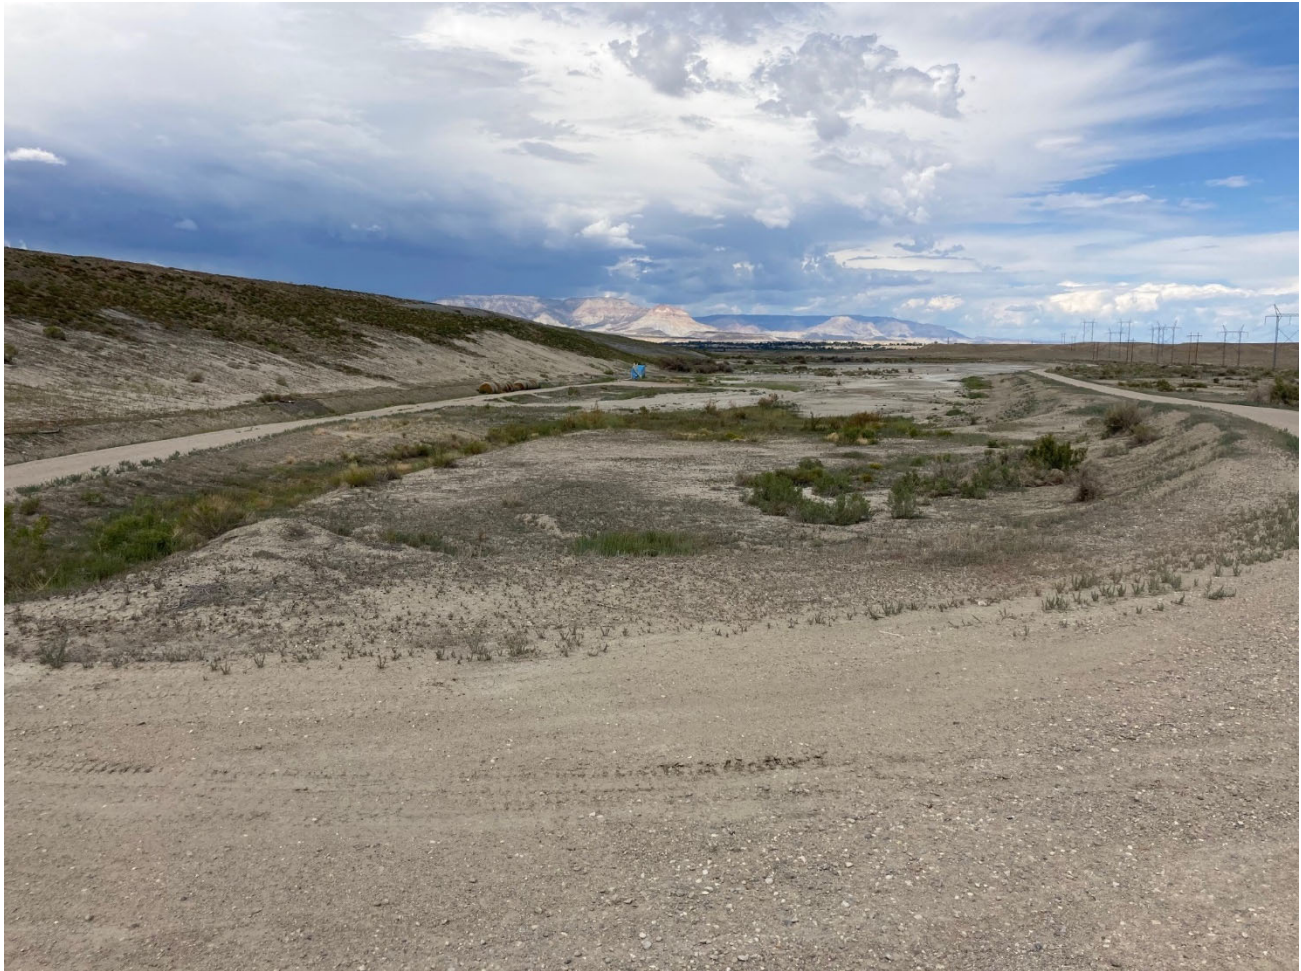
<b>Photo Number:</b> 17	<b>Date:</b> 8/25/2022 1:42 p.m.
<b>Location:</b> Hunter CCR Landfill	<b>Comments:</b> Looking north at stormwater retention pond.
