# **CCR Rule Operating Criteria §257.84(b)(1) Annual Inspection by A Qualified Engineer Final**

## **CCR Landfill Hunter Power Plant Castle Dale, Utah**

**December 16, 2022**

**Tetra Tech**

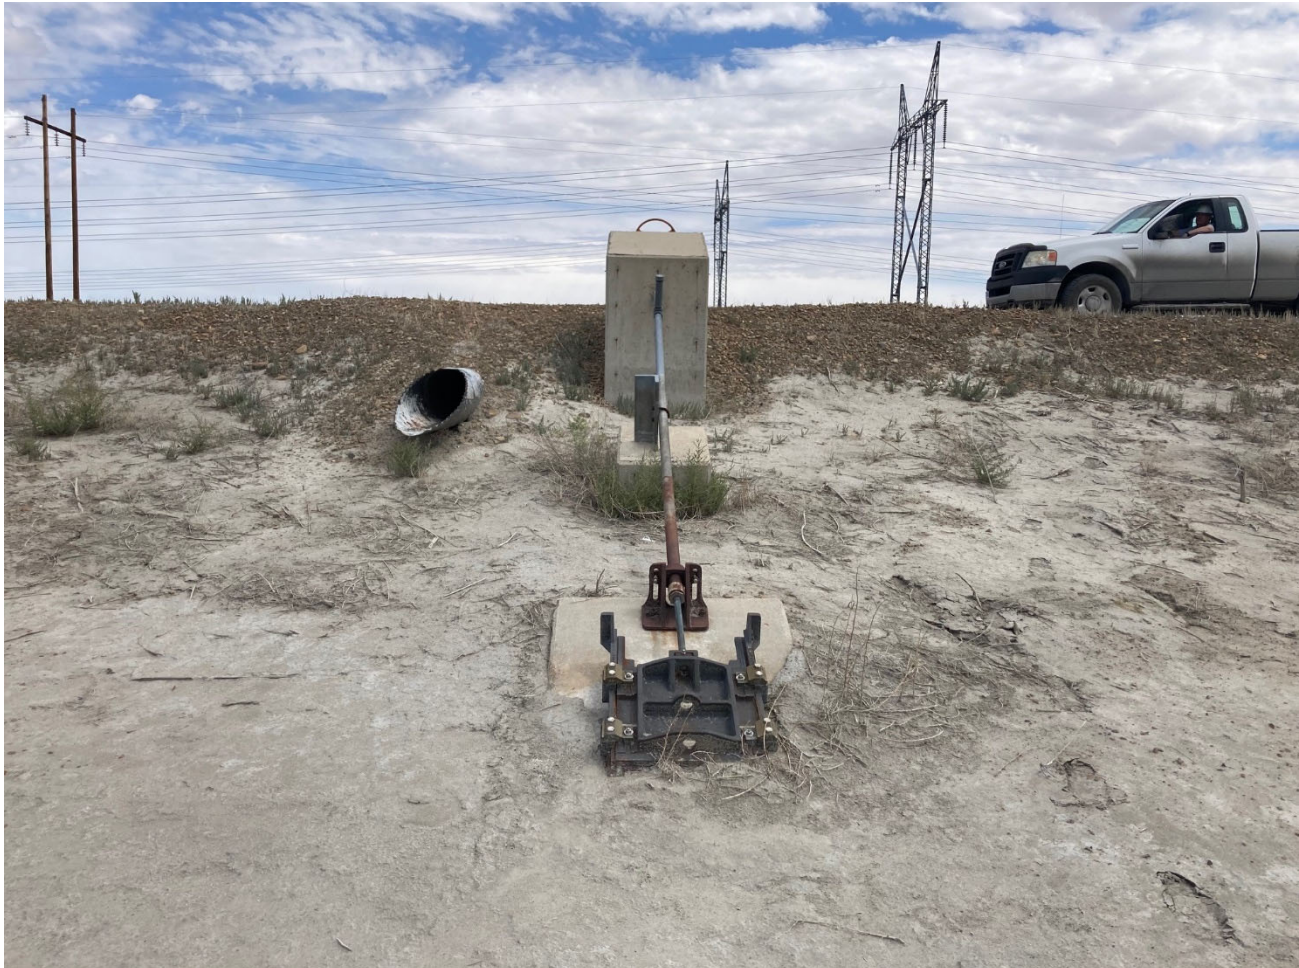
<b>Photo Number:</b> 18	<b>Date:</b> 8/25/2022 1:45 p.m.
<b>Location:</b> Hunter CCR Landfill	<b>Comments:</b> Looking east at inlet to stormwater retention pond overflow system.

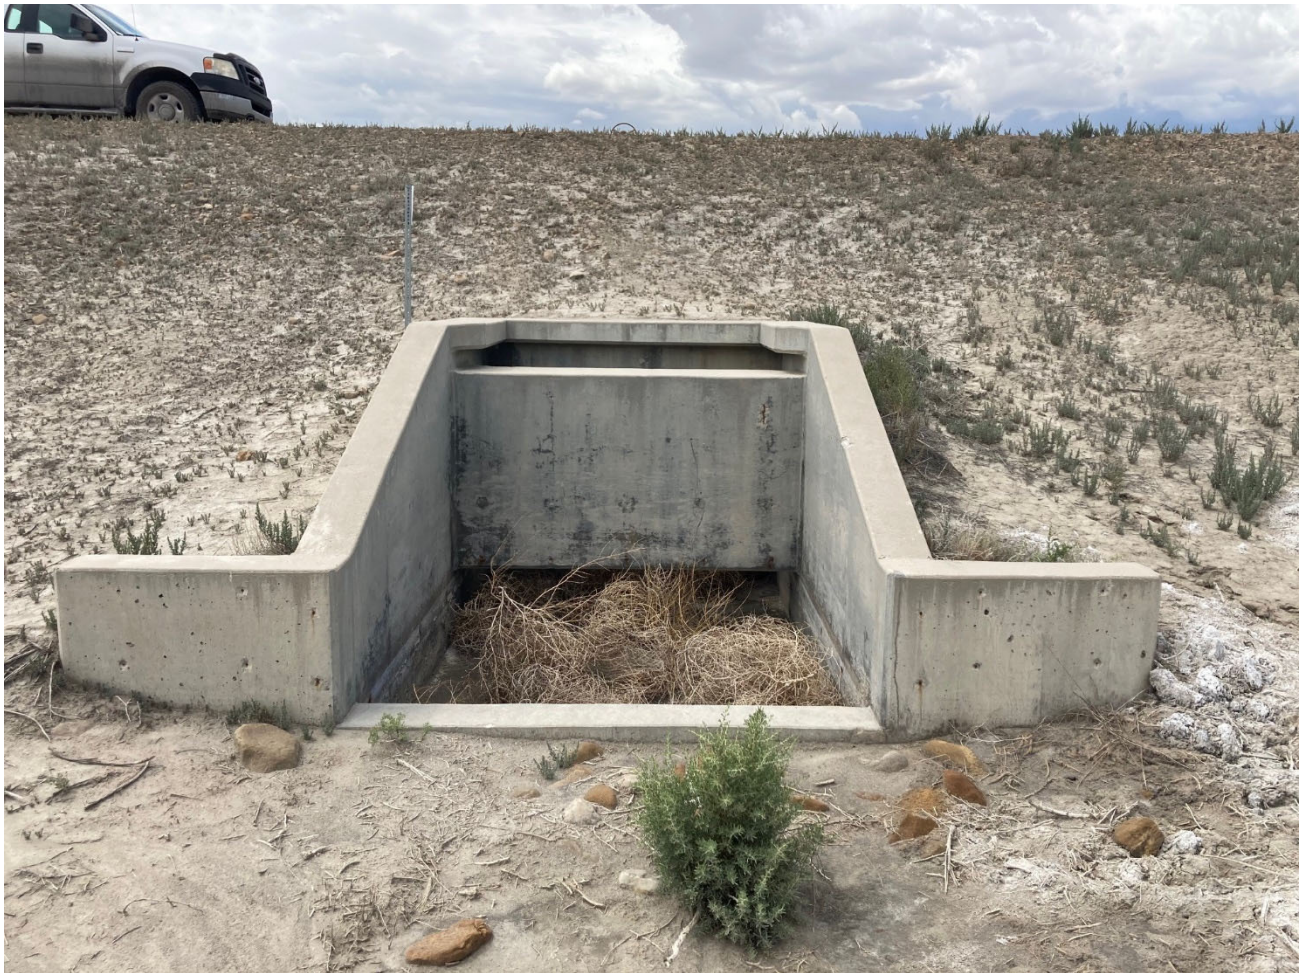
<b>Photo Number:</b> 19	<b>Date:</b> 8/25/2022 1:46 p.m.
<b>Location:</b> Hunter CCR Landfill	<b>Comments:</b> Looking west at outlet of stormwater retention pond outlet system.

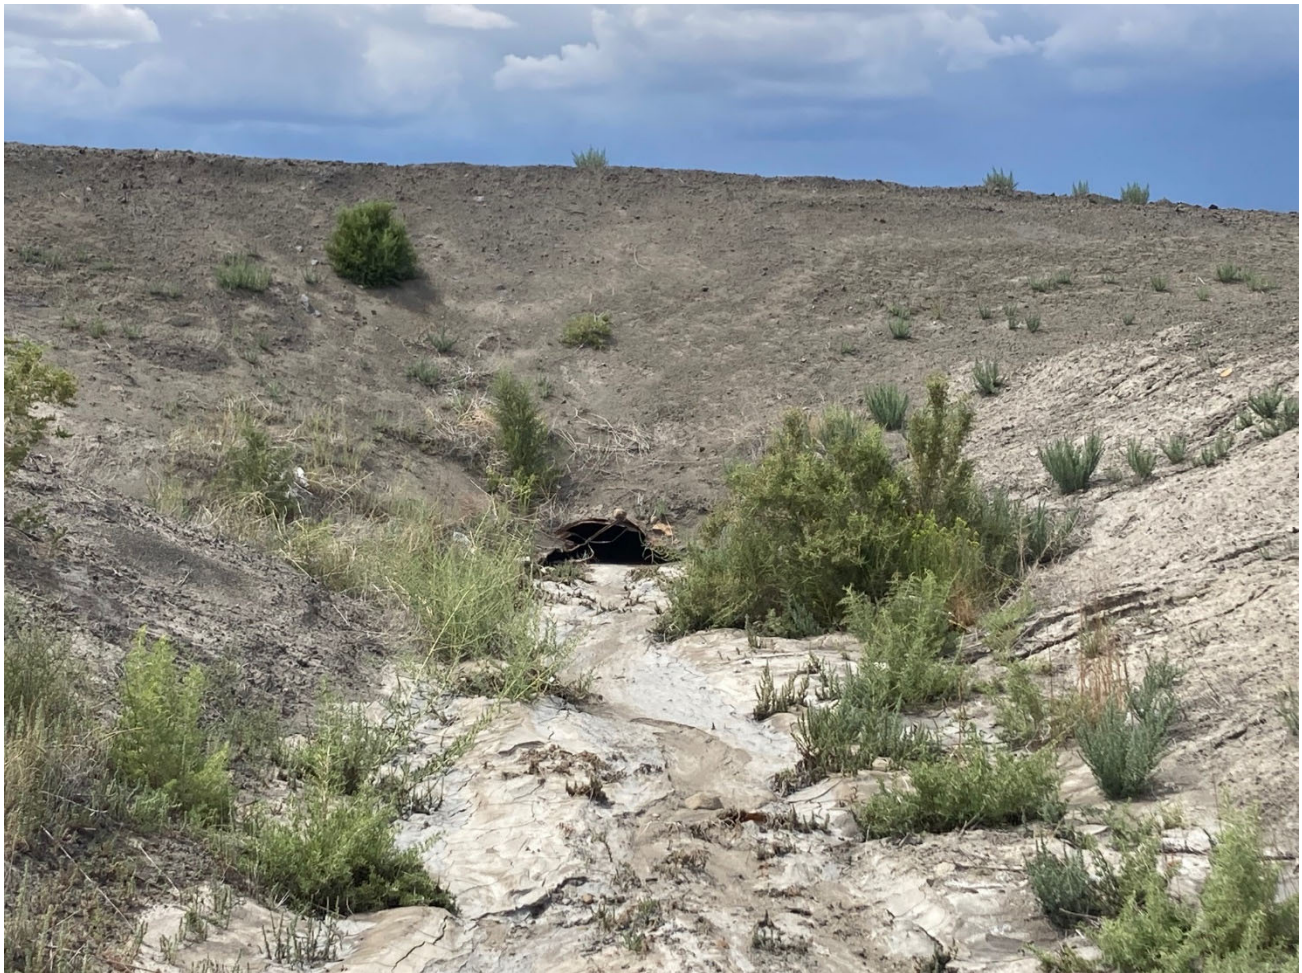
<b>Photo Number:</b> 20	<b>Date:</b> 8/25/2022 1:50 p.m.
<b>Location:</b> Hunter CCR Landfill	<b>Comments:</b> Looking southwest at discharge end of culvert passing road to industrial landfill. Note some accumulation of sediment.

- Clear inlet and outlet ends of culverts to preserve design flow capacity.
- Continue to monitor run-on ditch for undercutting of run-on berm on south side of CCR Landfill.

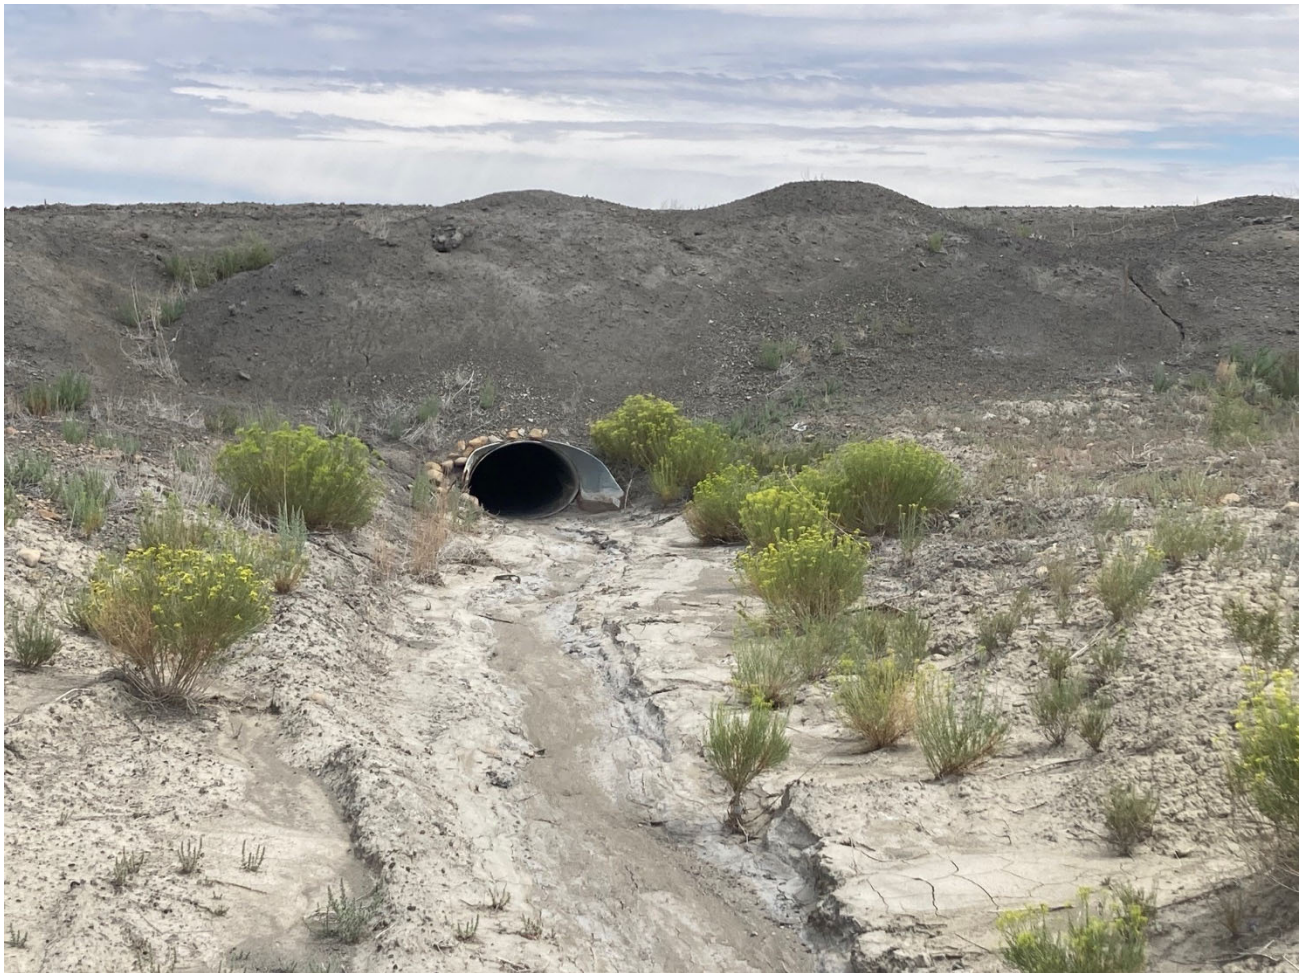
<b>Photo Number:</b> 21	<b>Date:</b> 8/25/2022 1:53 a.m.
<b>Location:</b> Hunter CCR Landfill	<b>Comments:</b> Looking northwest at inlet to culvert in Photograph 20. Discharge end of culvert recommended to be cleaned.
