CCR Rule Operating Criteria §257.84(b)(1) 2023 Annual Inspection by A Qualified Engineer Final

CCR Landfill Hunter Power Plant Castle Dale, Utah

December 15, 2023

Tetra Tech

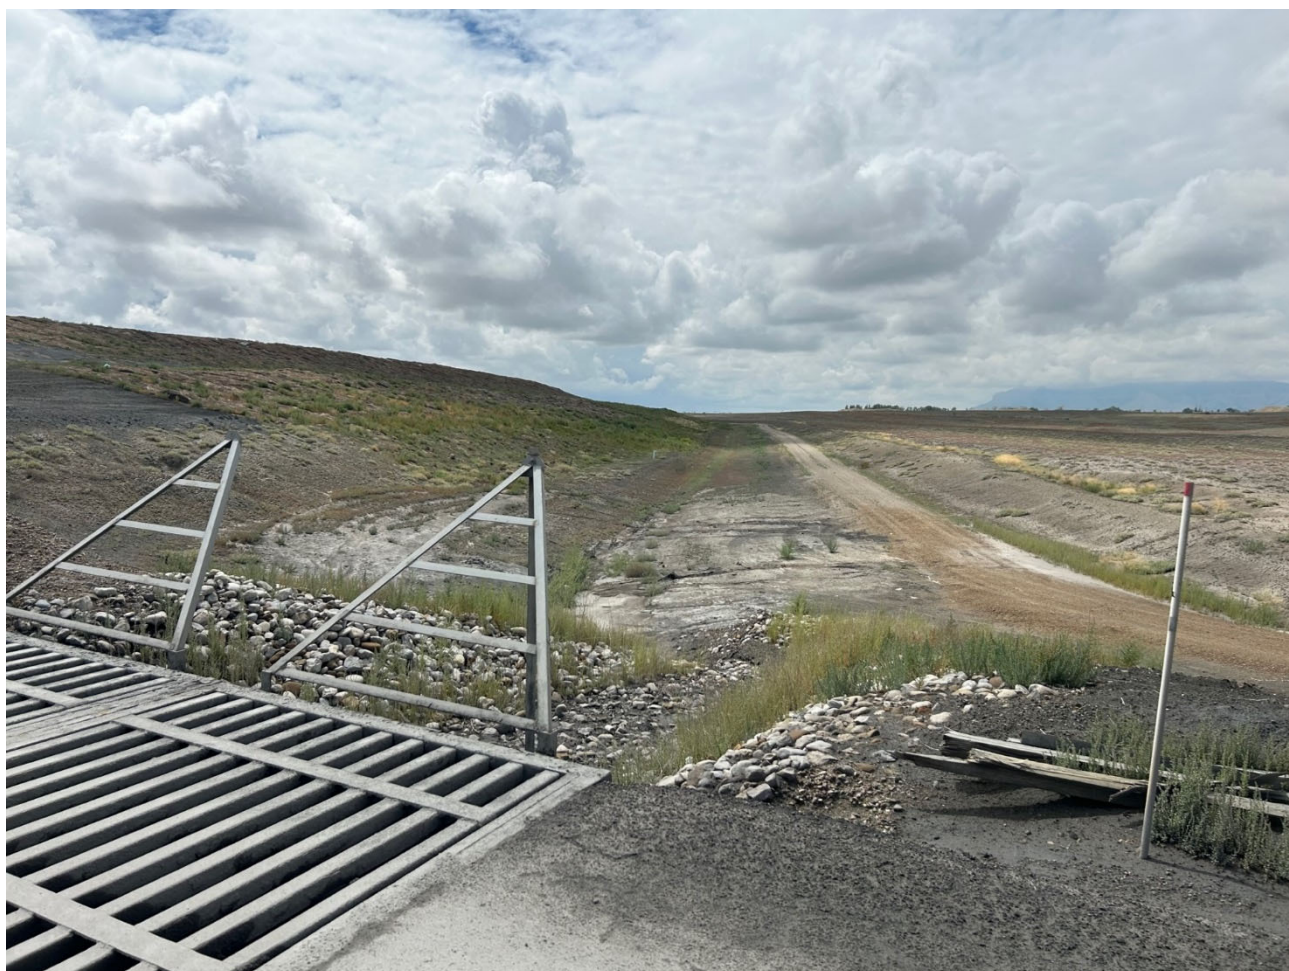
Photo Number: 2	Date: 8/24/2023 12:54 p.m.
Location: Hunter CCR Landfill	Comments: Looking southwest along northwest slope of landfill at run-off ditch and run-on berm.

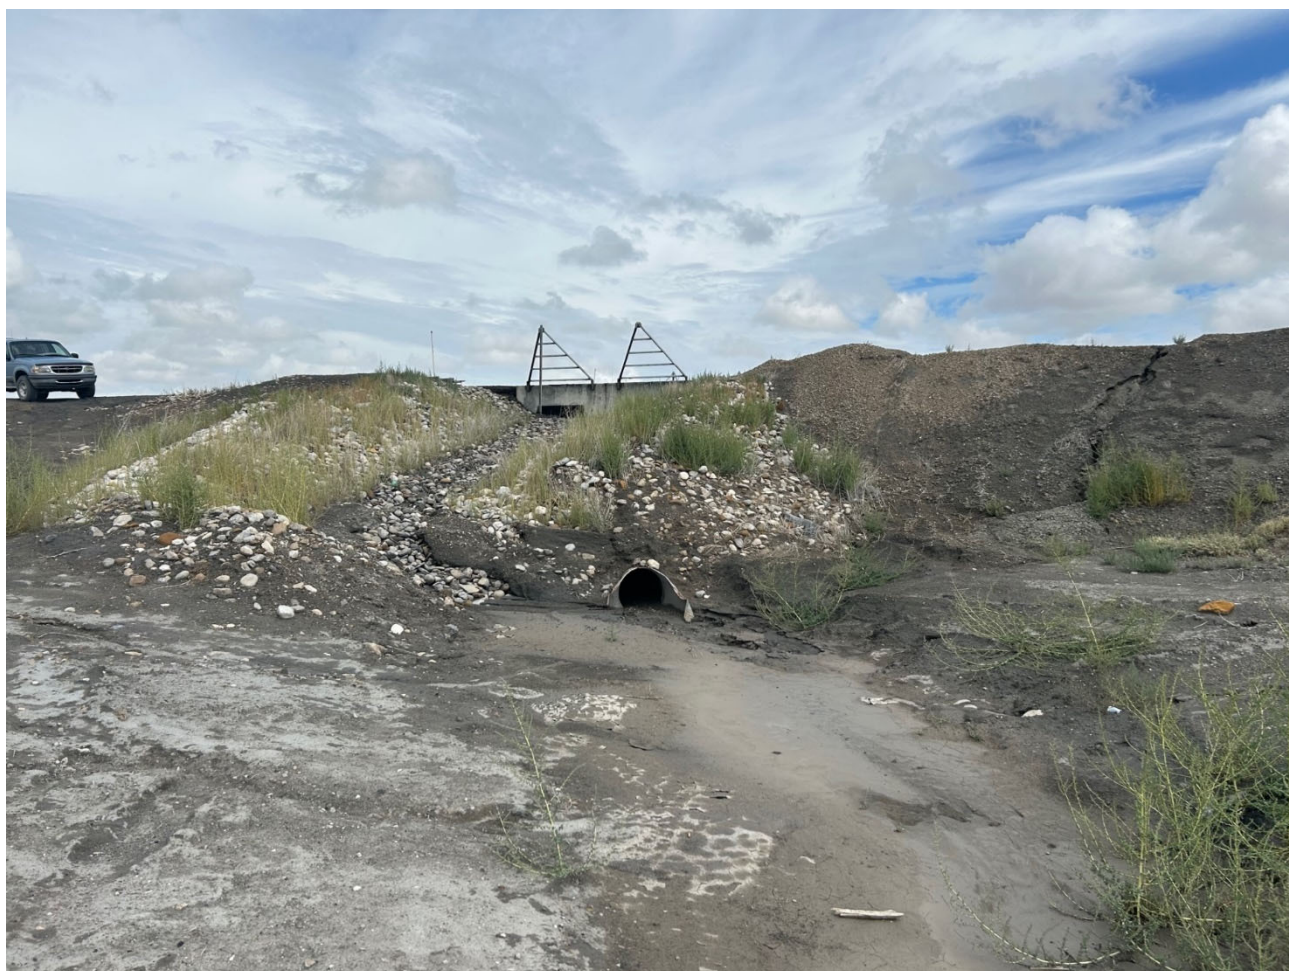
Photo Number: 3	Date: 8/24/2023 12:58 p.m.
Location: Hunter CCR Landfill	Comments: Looking north at inlet of culvert draining run-off channel shown in Photograph 2. Note minor amounts of ash deposited at inlet.

- Clear inlet and outlet ends of culverts to preserve design flow capacity.

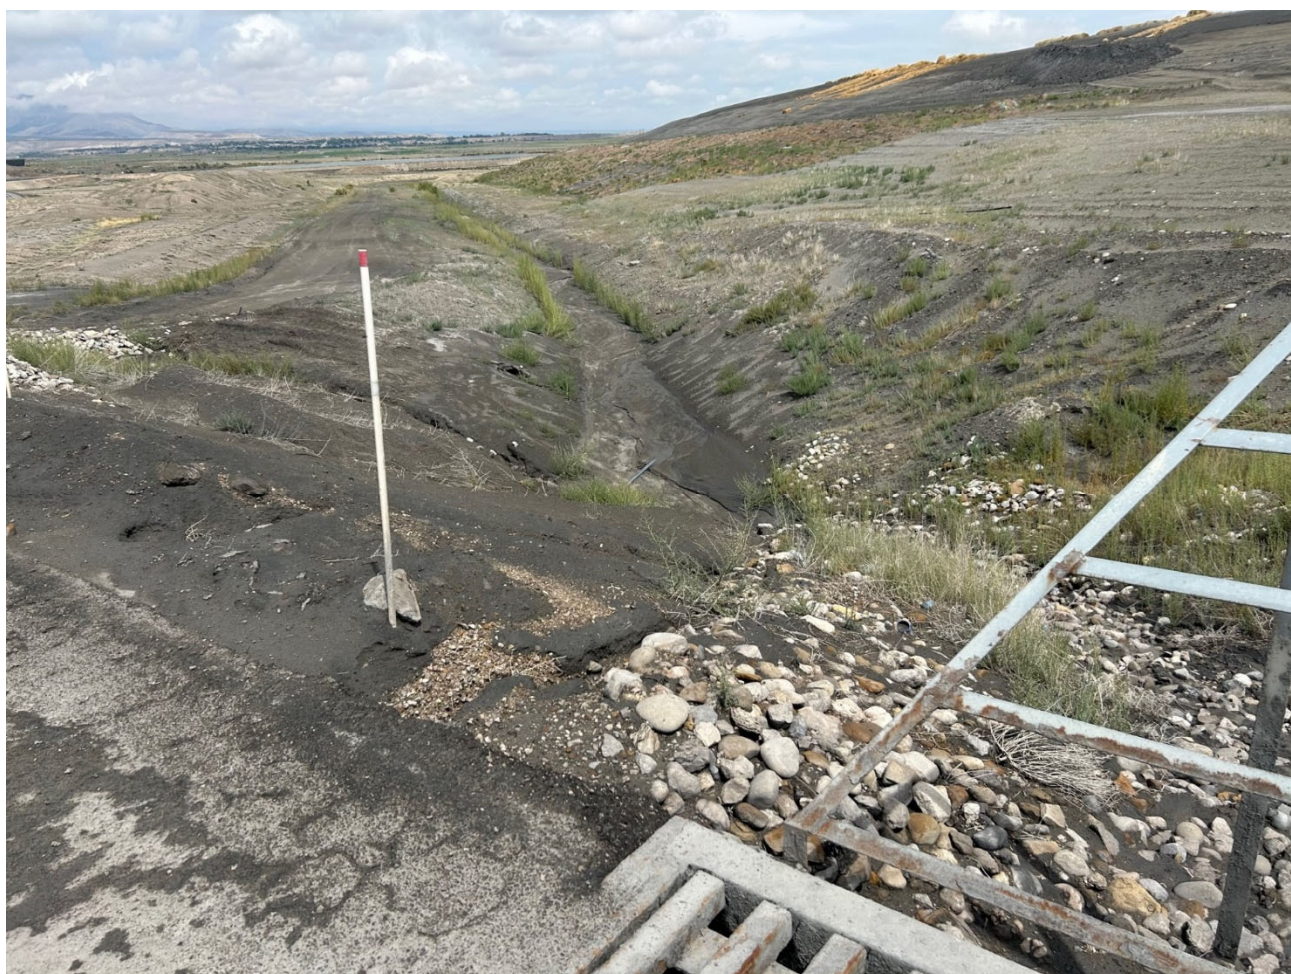
Photo Number: 4	Date: 8/24/2023 1:00 p.m.
Location: Hunter CCR Landfill	Comments: Looking north from ash haul road at discharge end of culvert and continuation of channel shown if Photographs 2 and 3.

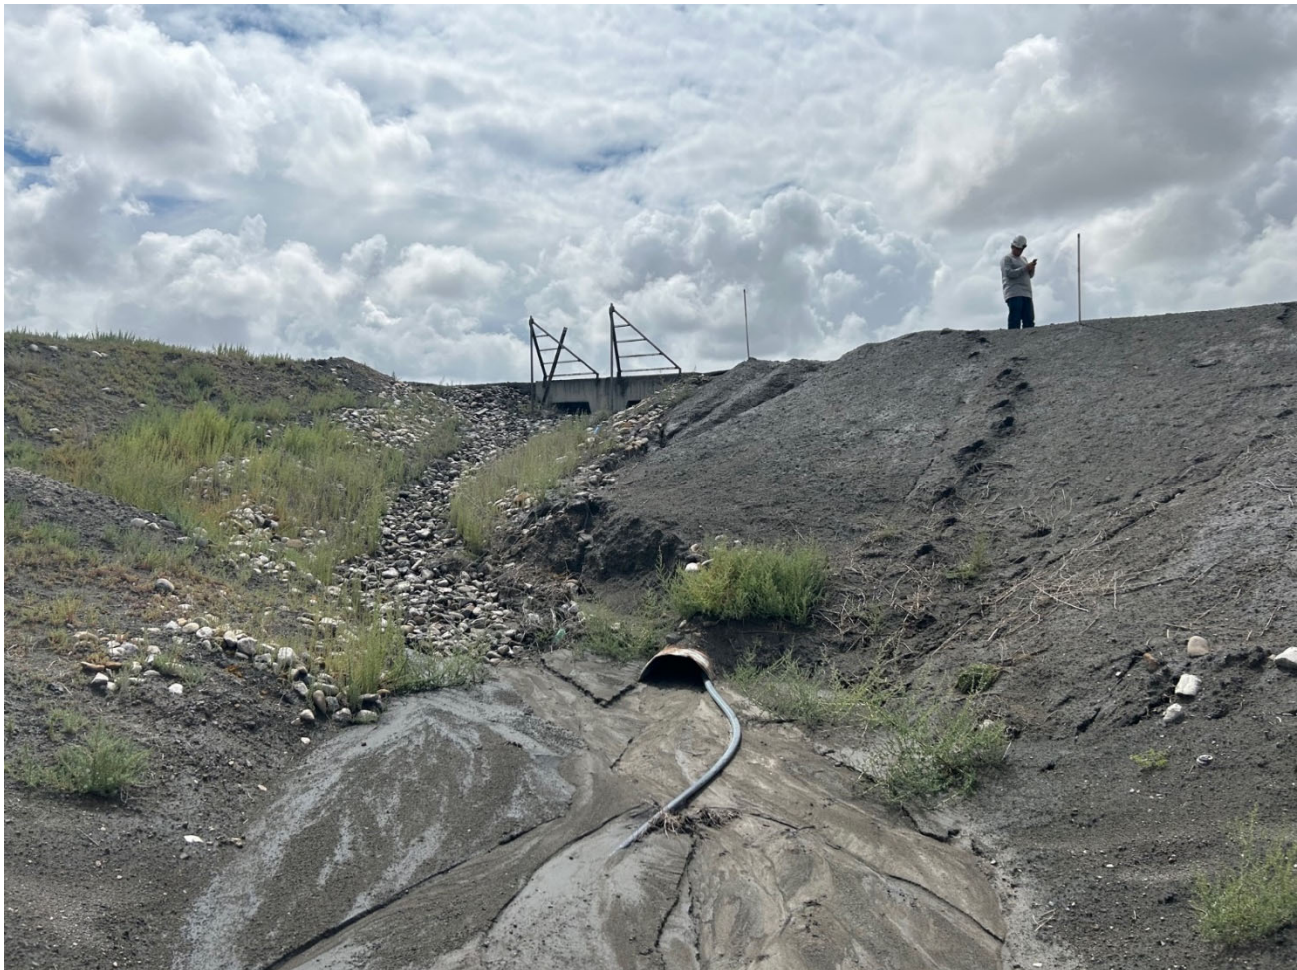
Photo Number: 5	Date: 8/24/2023 1:04 p.m.
Location: Hunter CCR Landfill	Comments: Looking south at discharge end of culvert shown in Photograph 3. Note accumulation of ash at discharge of culvert.

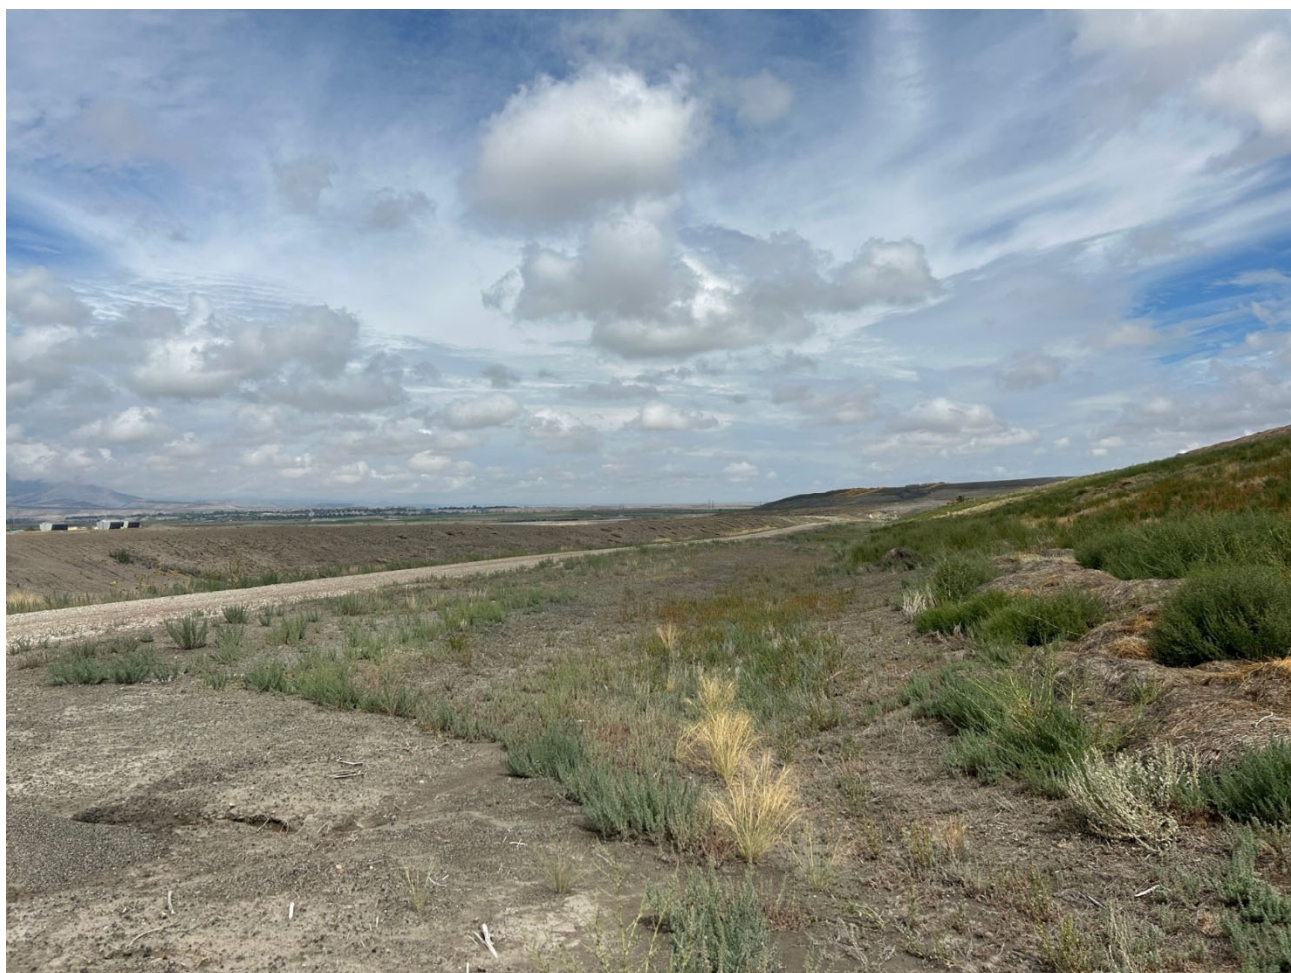
Photo Number: 6	Date: 8/24/2023 1:07 p.m.
Location: Hunter CCR Landfill	Comments: Looking north down run-off channel towards culvert shown in Photograph 2.

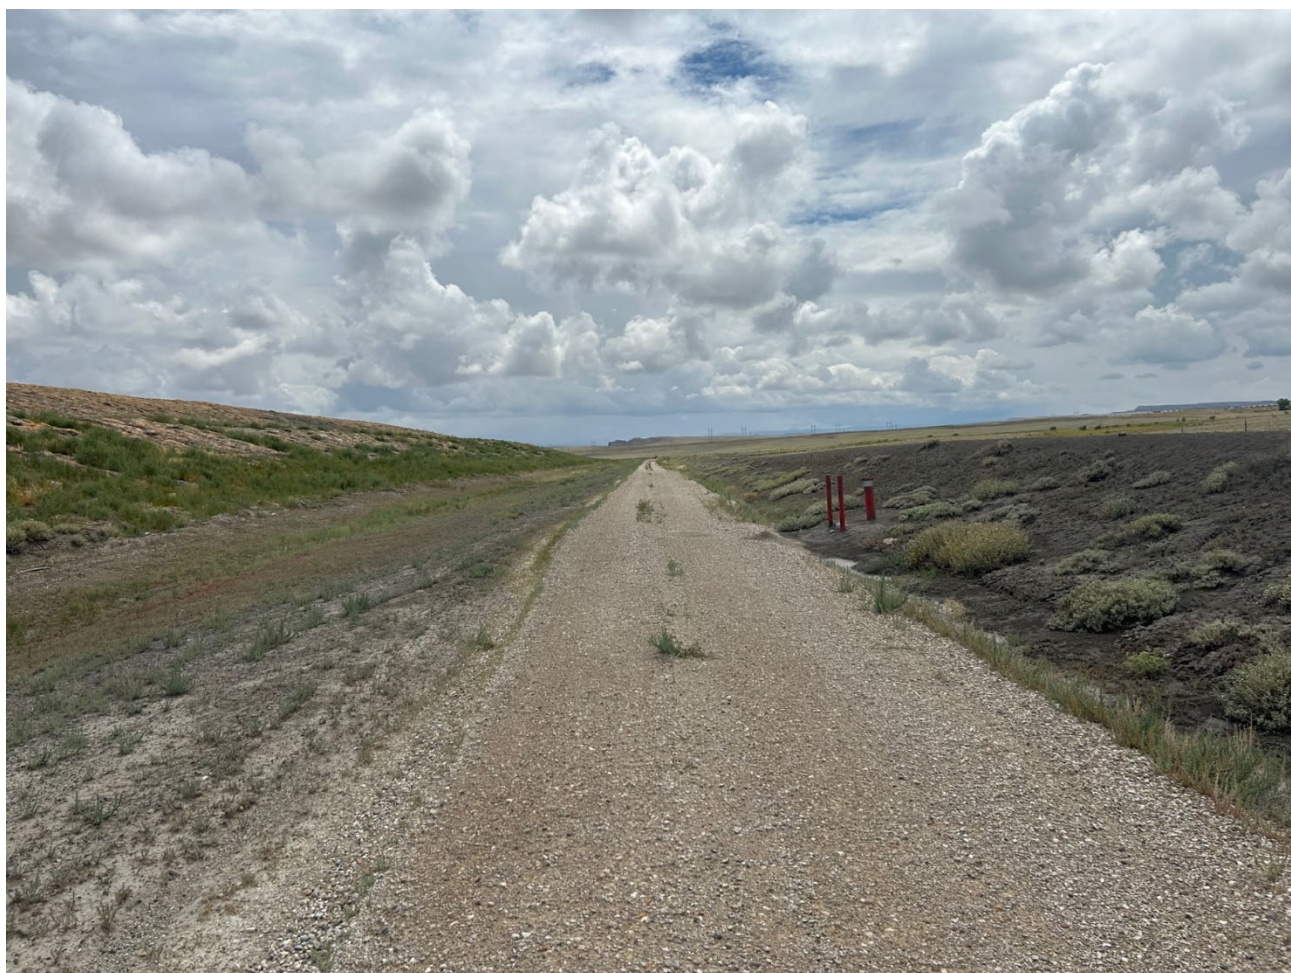
Photo Number: 7	Date: 8/24/2023 1:09 p.m.
Location: Hunter CCR Landfill	Comments: Looking southeast at high point (break in grade) of run-off channel.

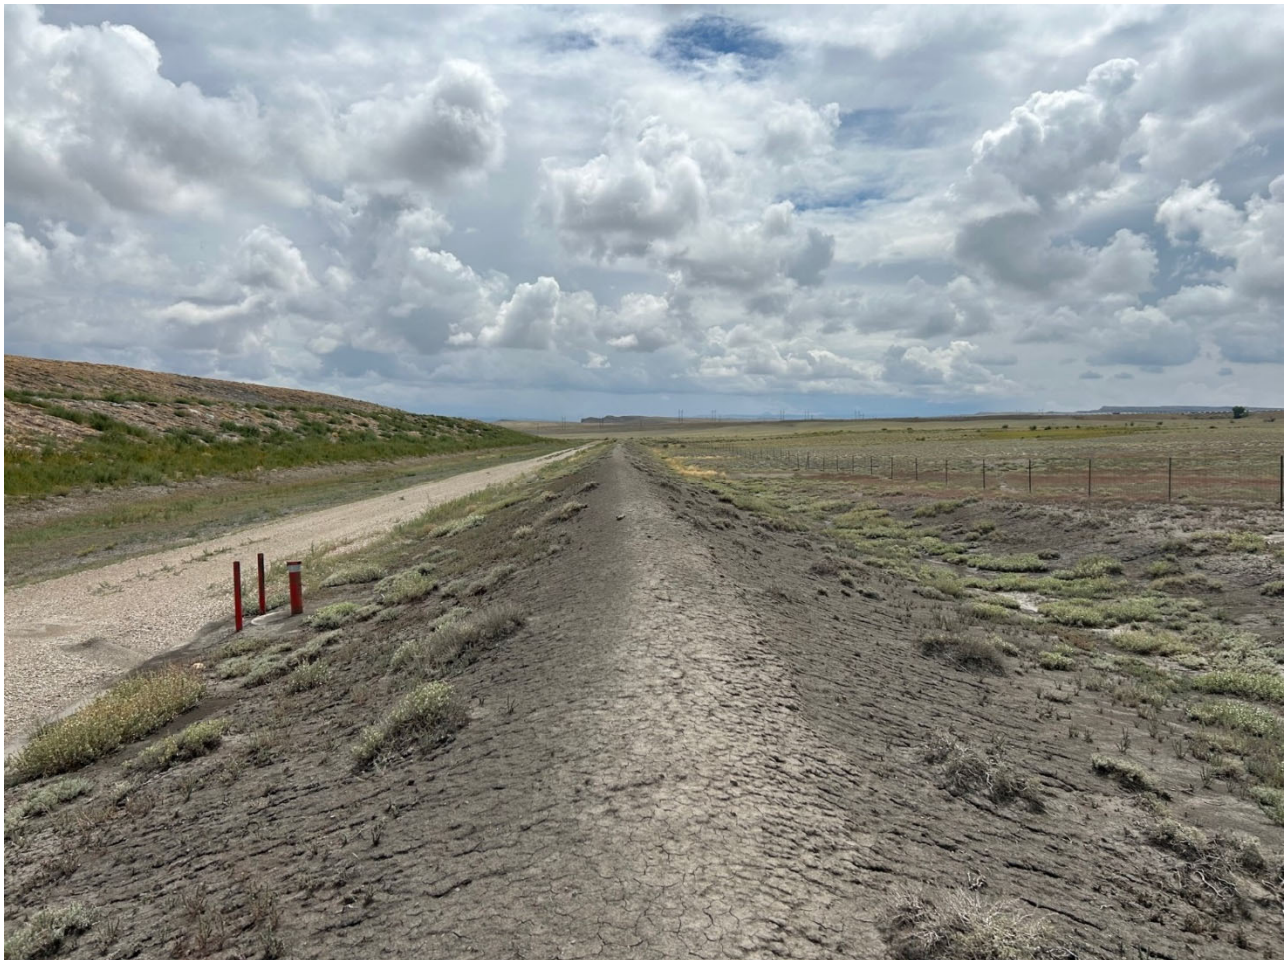
Photo Number: 8	Date: 8/24/2023 1:12 p.m.
Location: Hunter CCR Landfill	Comments: Looking southeast on top of run-on berm and perimeter road.

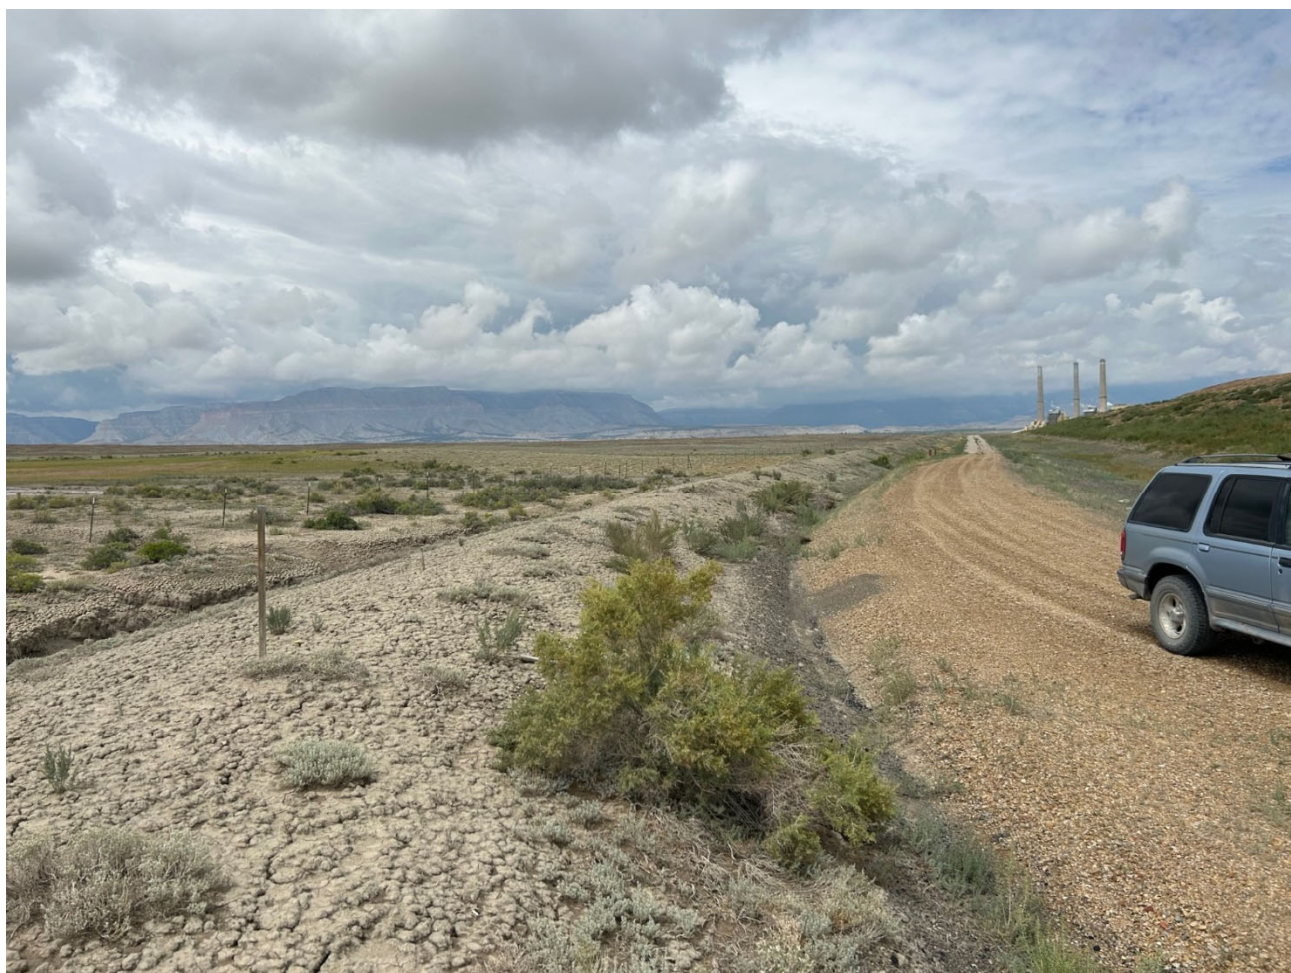
Photo Number: 9	Date: 8/24/2023 1:13 p.m.
Location: Hunter CCR Landfill	Comments: Looking north up run-on berm and perimeter road.

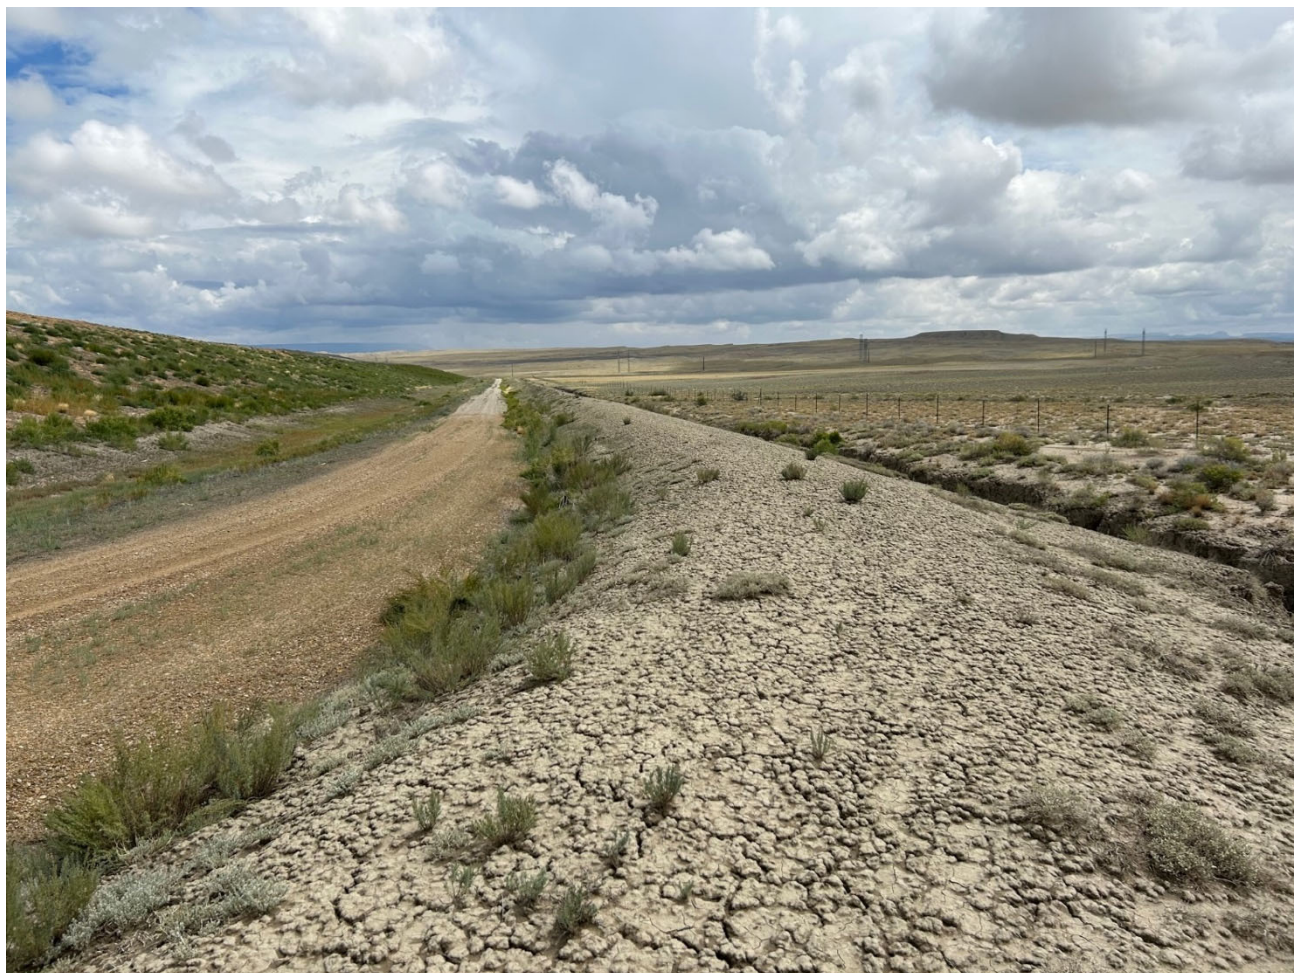
Photo Number: 10	Date: 8/24/2023 1:19 p.m.
Location: Hunter CCR Landfill	Comments: Looking east down run-on berm along southwest slope of landfill.

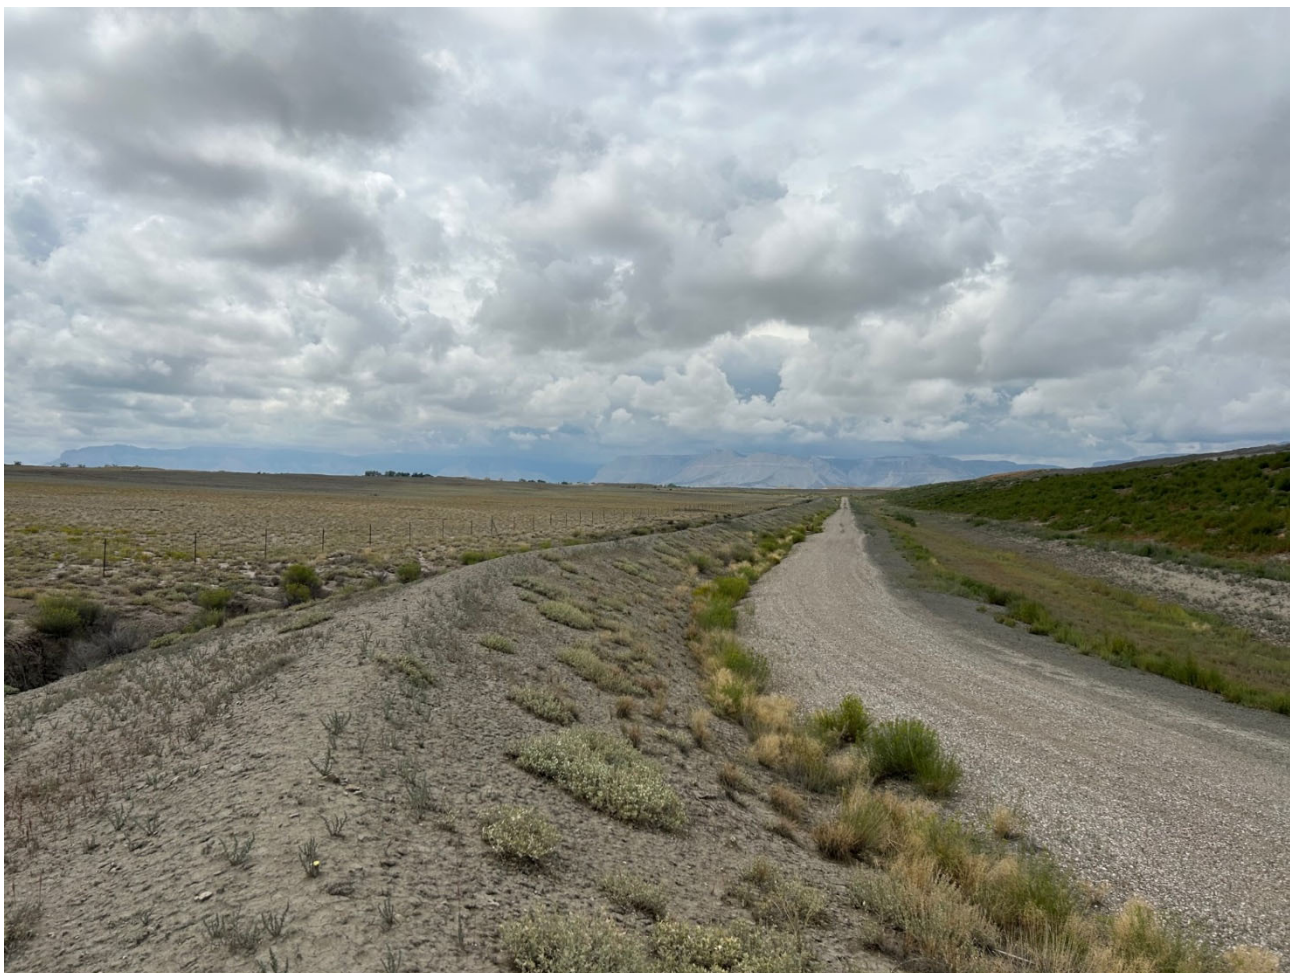
Photo Number: 11	Date: 8/24/2023 1:26 p.m.
Location: Hunter CCR Landfill	Comments: Looking west on top of run-on berm and run-on channel.

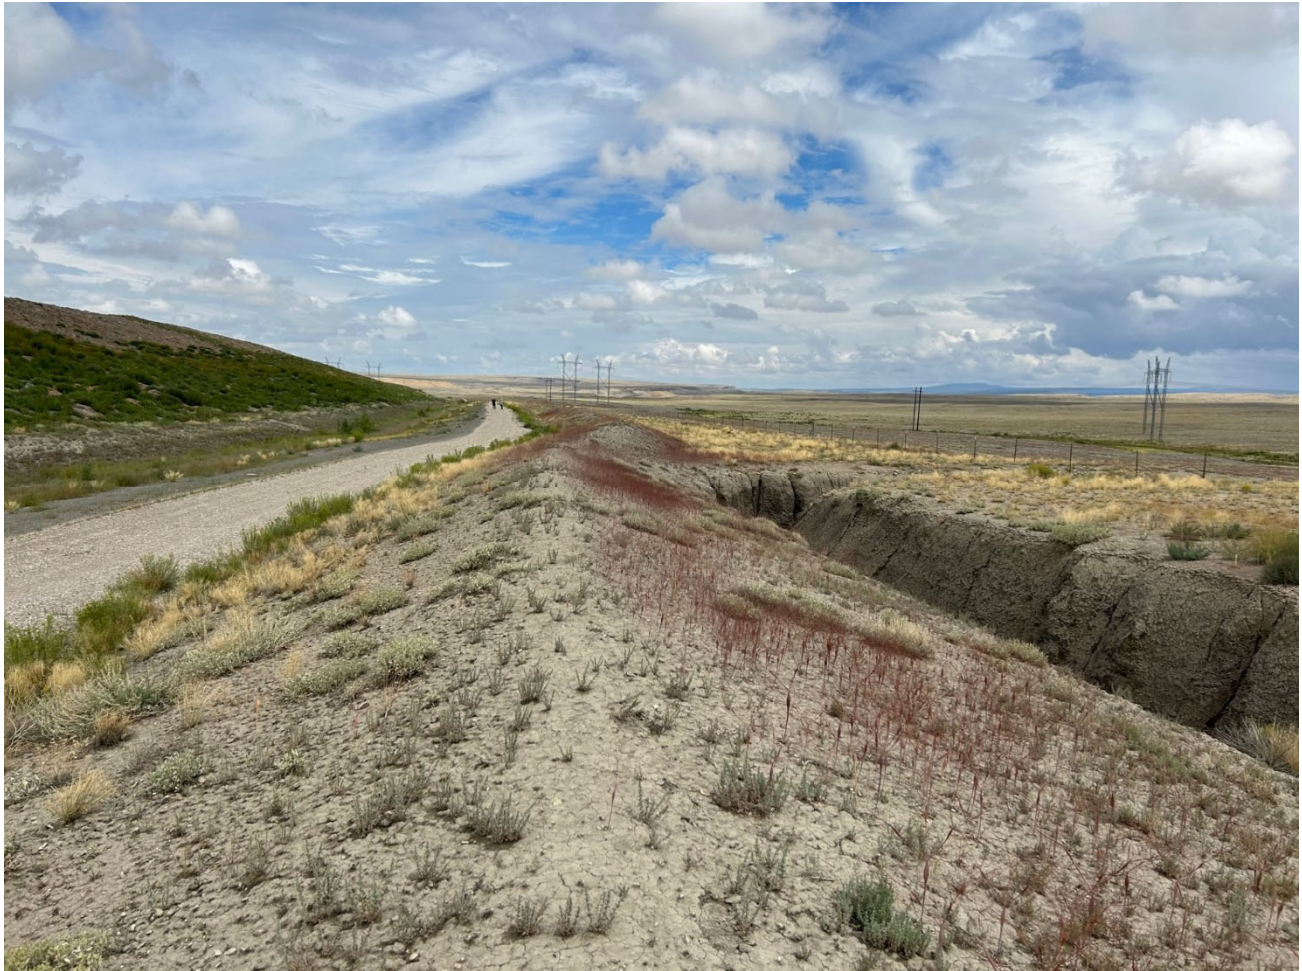
Photo Number: 12	Date: 8/24/2023 1:28 p.m.
Location: Hunter CCR Landfill	Comments: Looking northeast down run-on berm and end of run-on channel

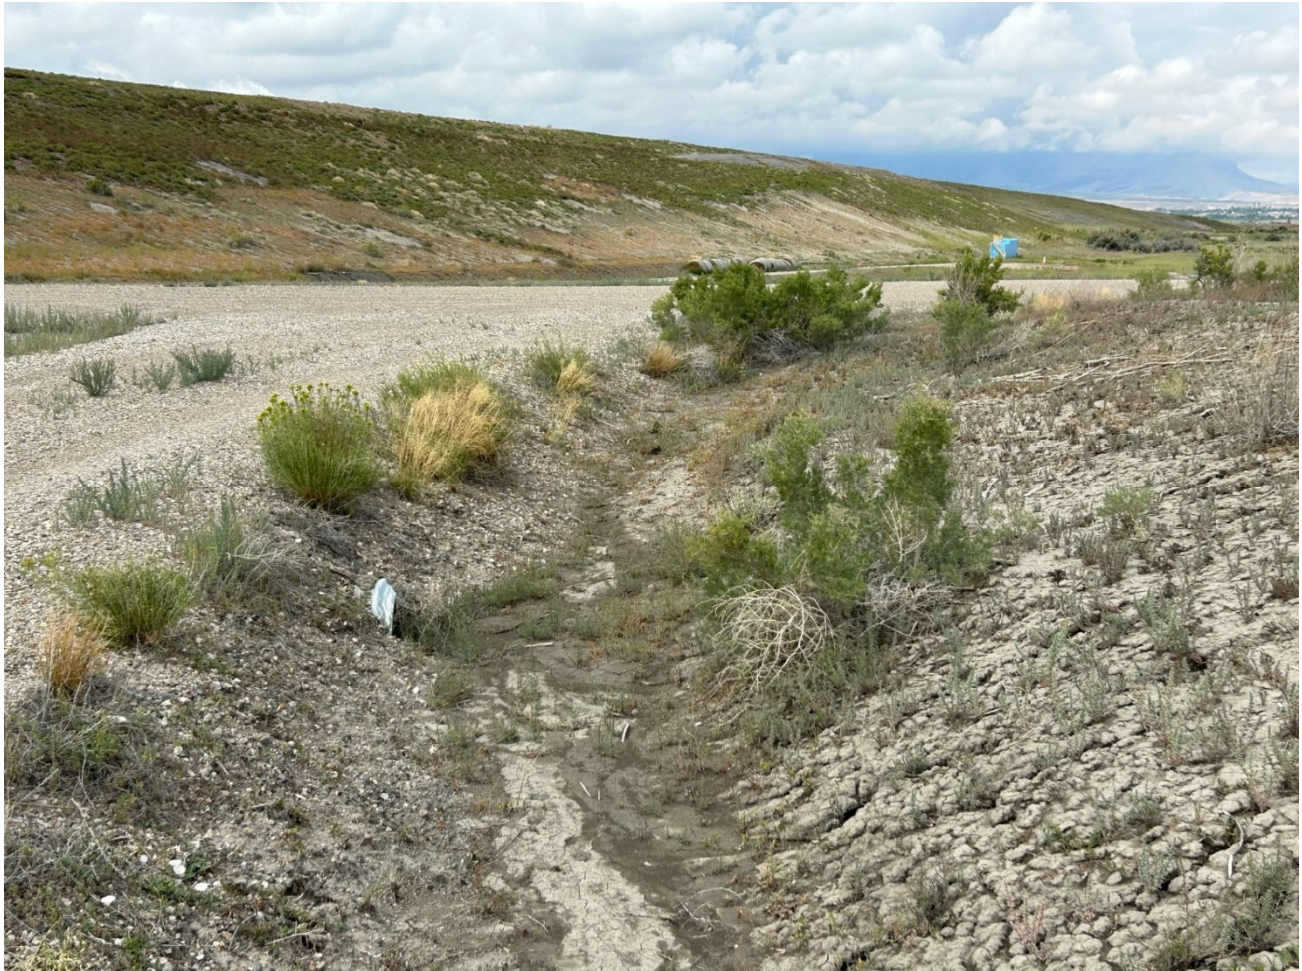
Photo Number: 13	Date: 8/24/2023 1:46 p.m.
Location: Hunter CCR Landfill	Comments: Looking north at inlet side of culvert draining run-off between perimeter road and run-on berm.

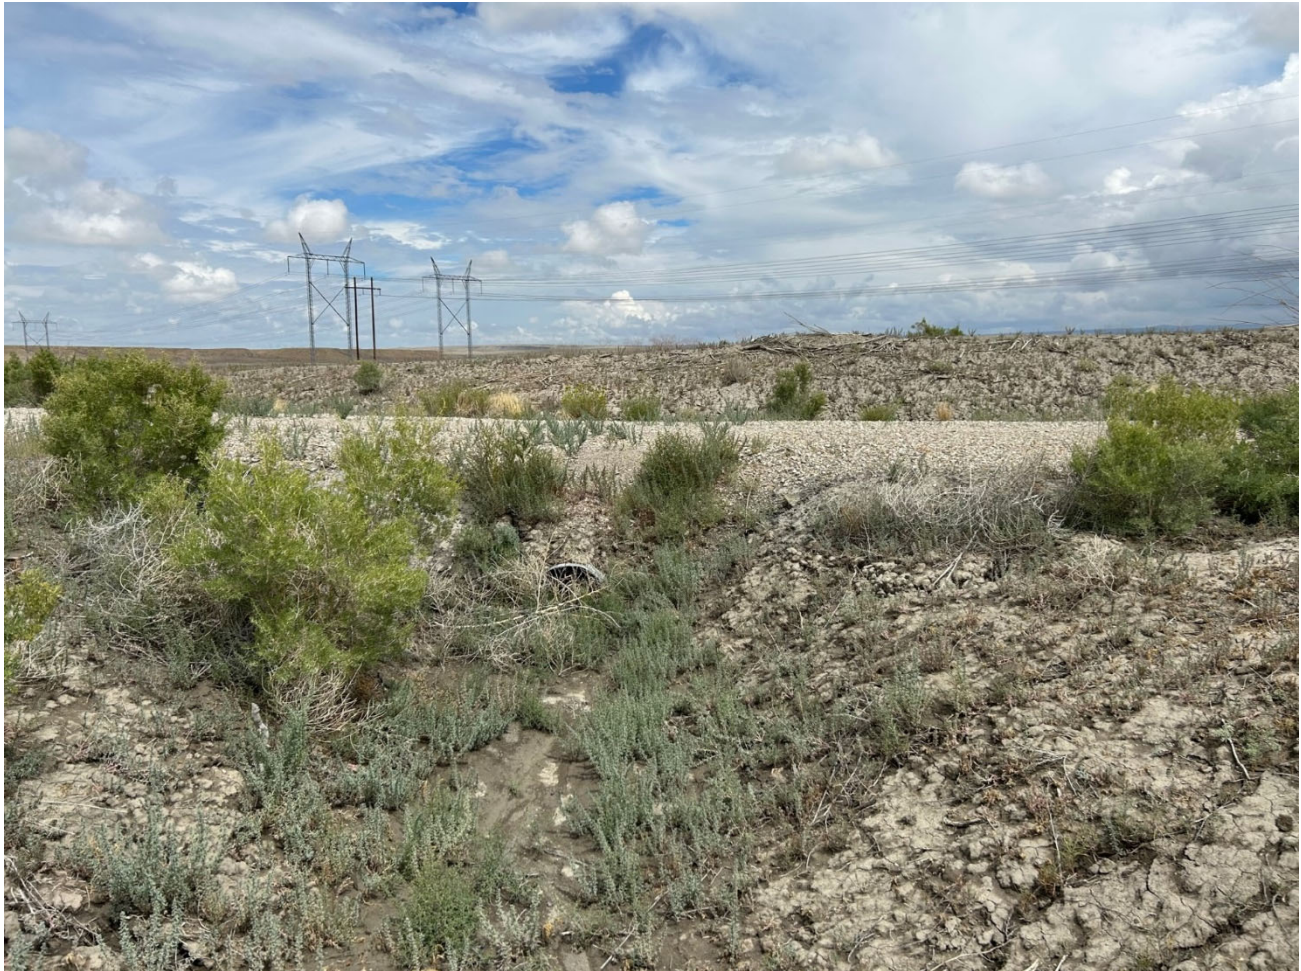
Photo Number: 14	Date: 8/24/2023 1:49 p.m.
Location: Hunter CCR Landfill	Comments: Looking northeast at discharge side of culvert shown in Photograph 13. Note accumulated brush and vegetation.

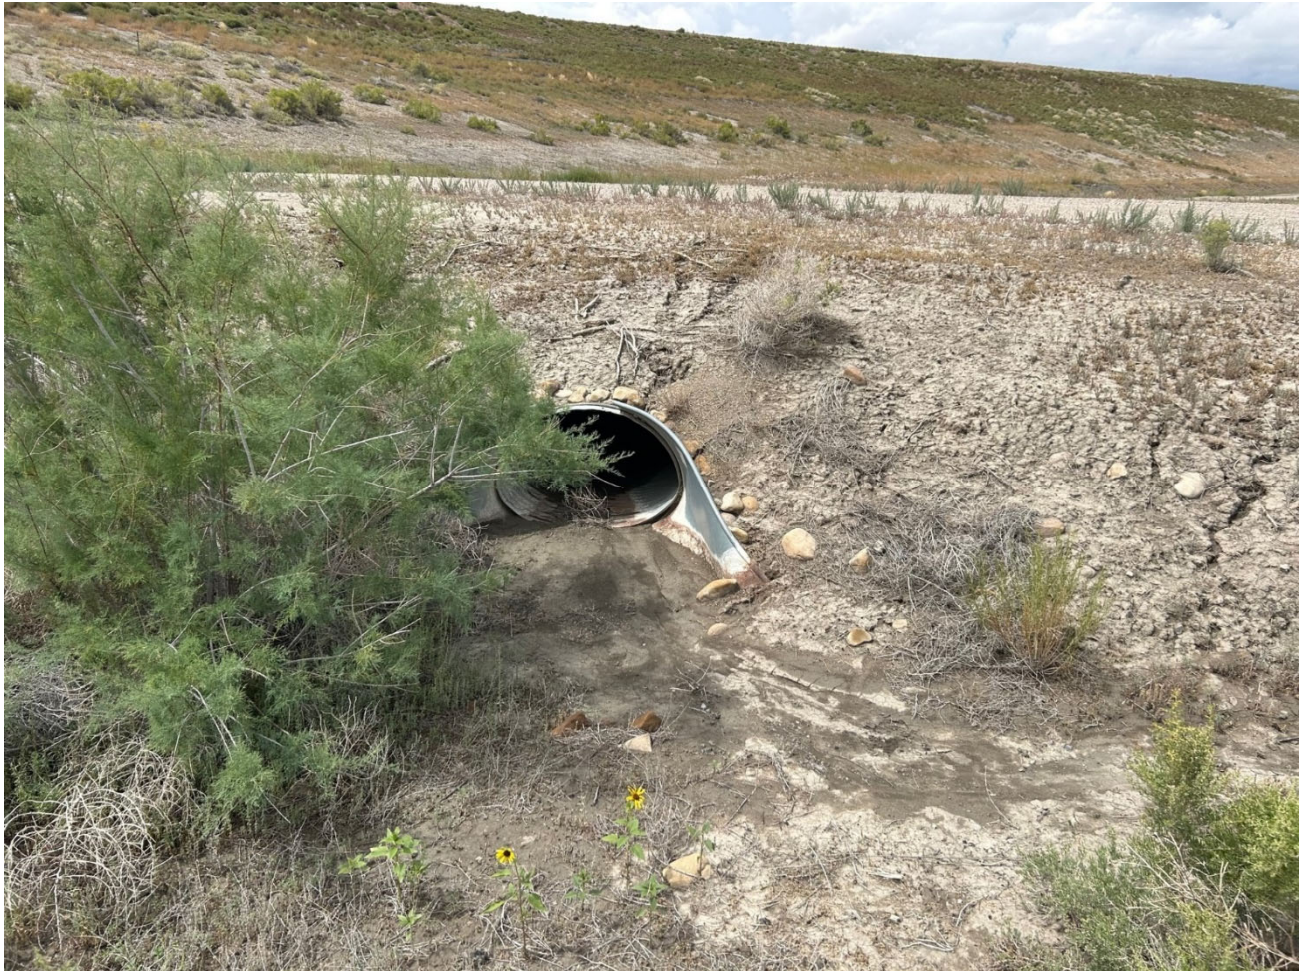
Photo Number: 15	Date: 8/24/2023 1:51 p.m.
Location: Hunter CCR Landfill	Comments: Looking northwest at inlet to culvert discharge to stormwater retention pond.

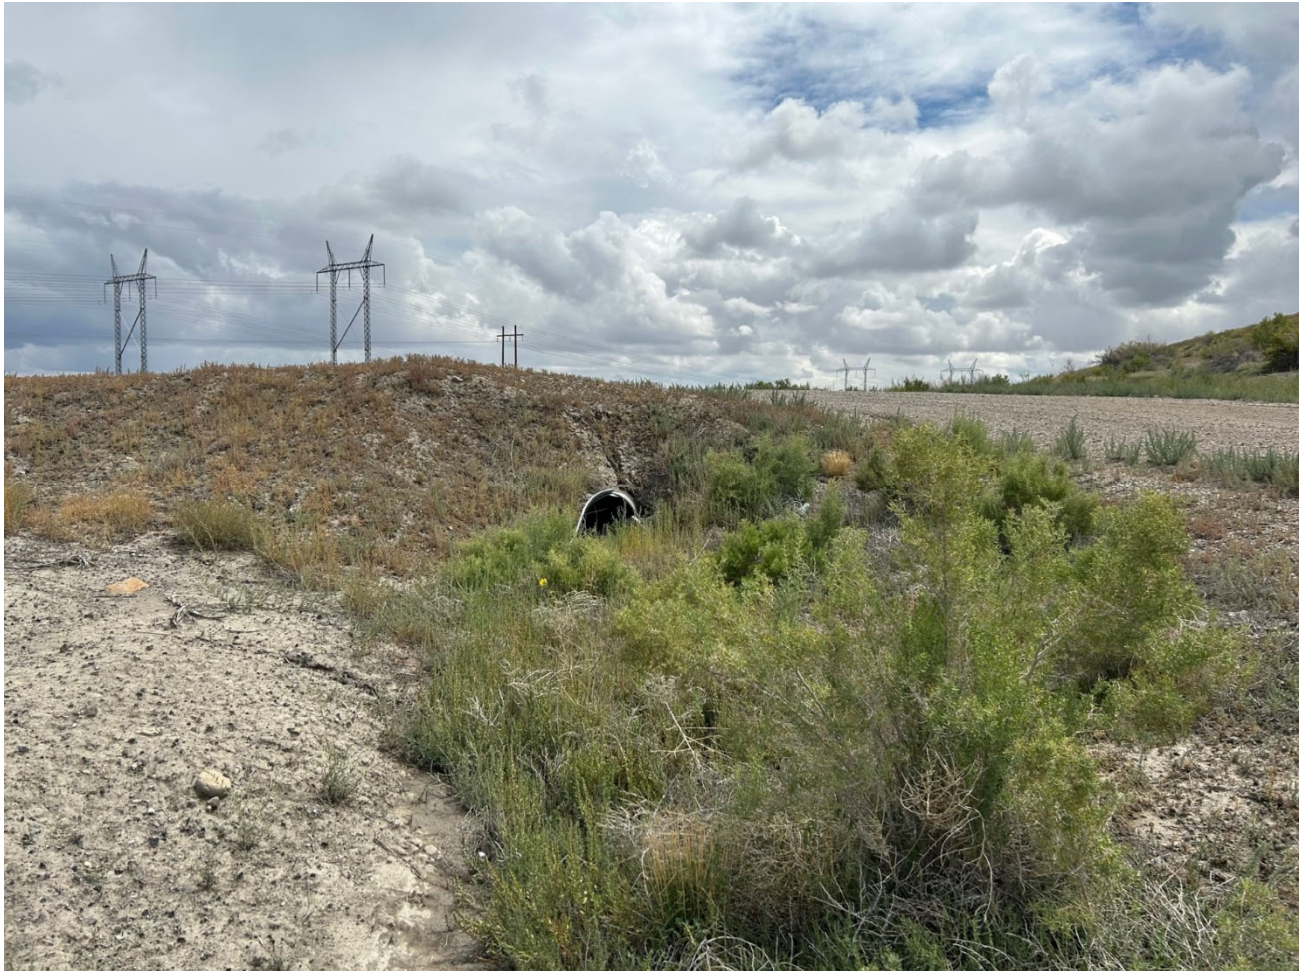
Photo Number: 16	Date: 8/24/2023 1:53 p.m.
Location: Hunter CCR Landfill	Comments: Looking southwest at discharge end of culvert shown in Photograph 15. Note vegetation beginning to obstruct discharge end of culvert.

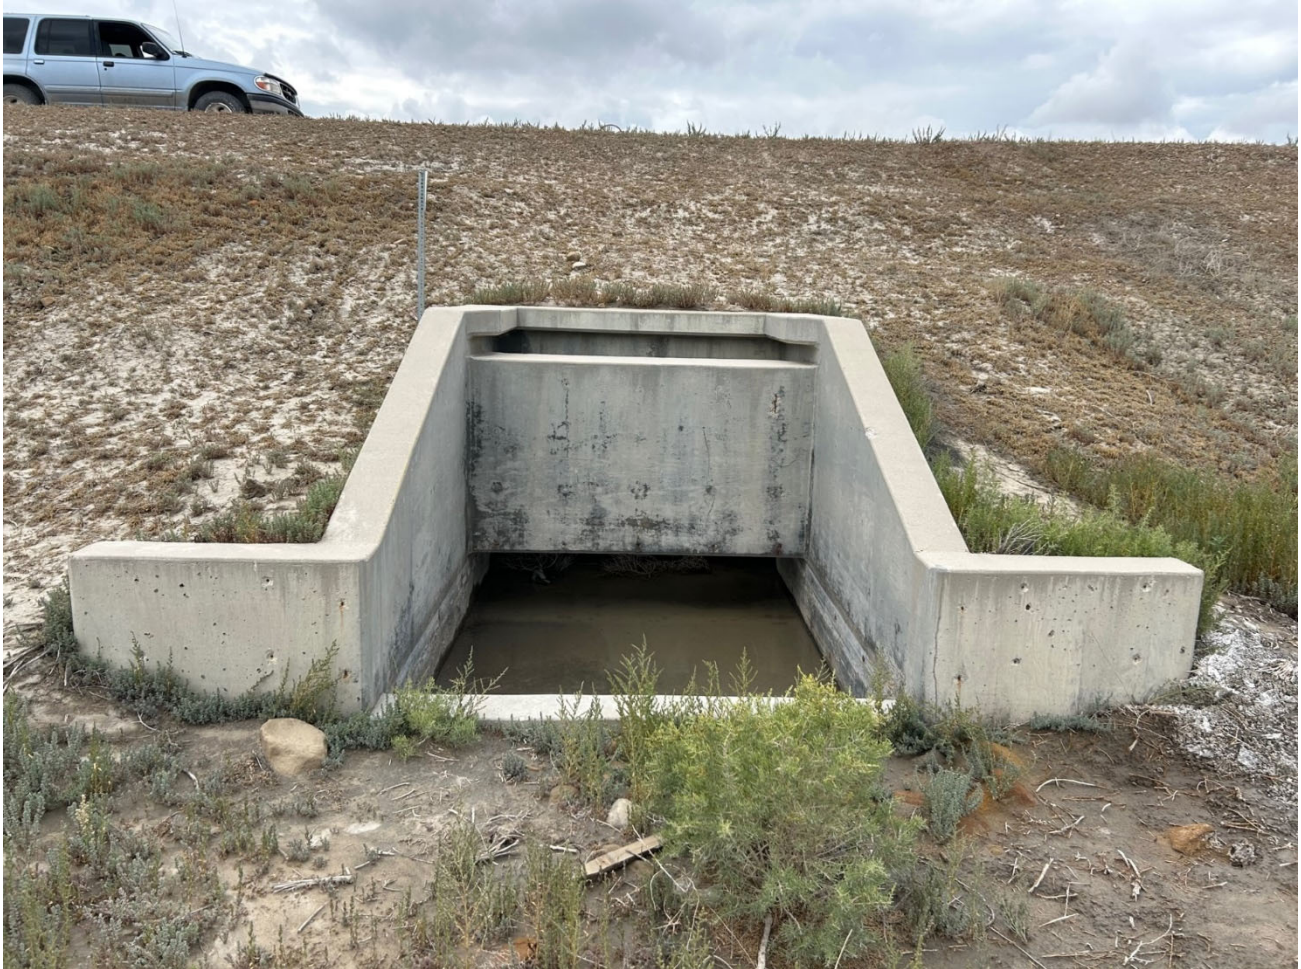
Photo Number: 17	Date: 8/24/2023 2:05 p.m.
Location: Hunter CCR Landfill	Comments: Looking west at outlet of stormwater retention pond outlet system.

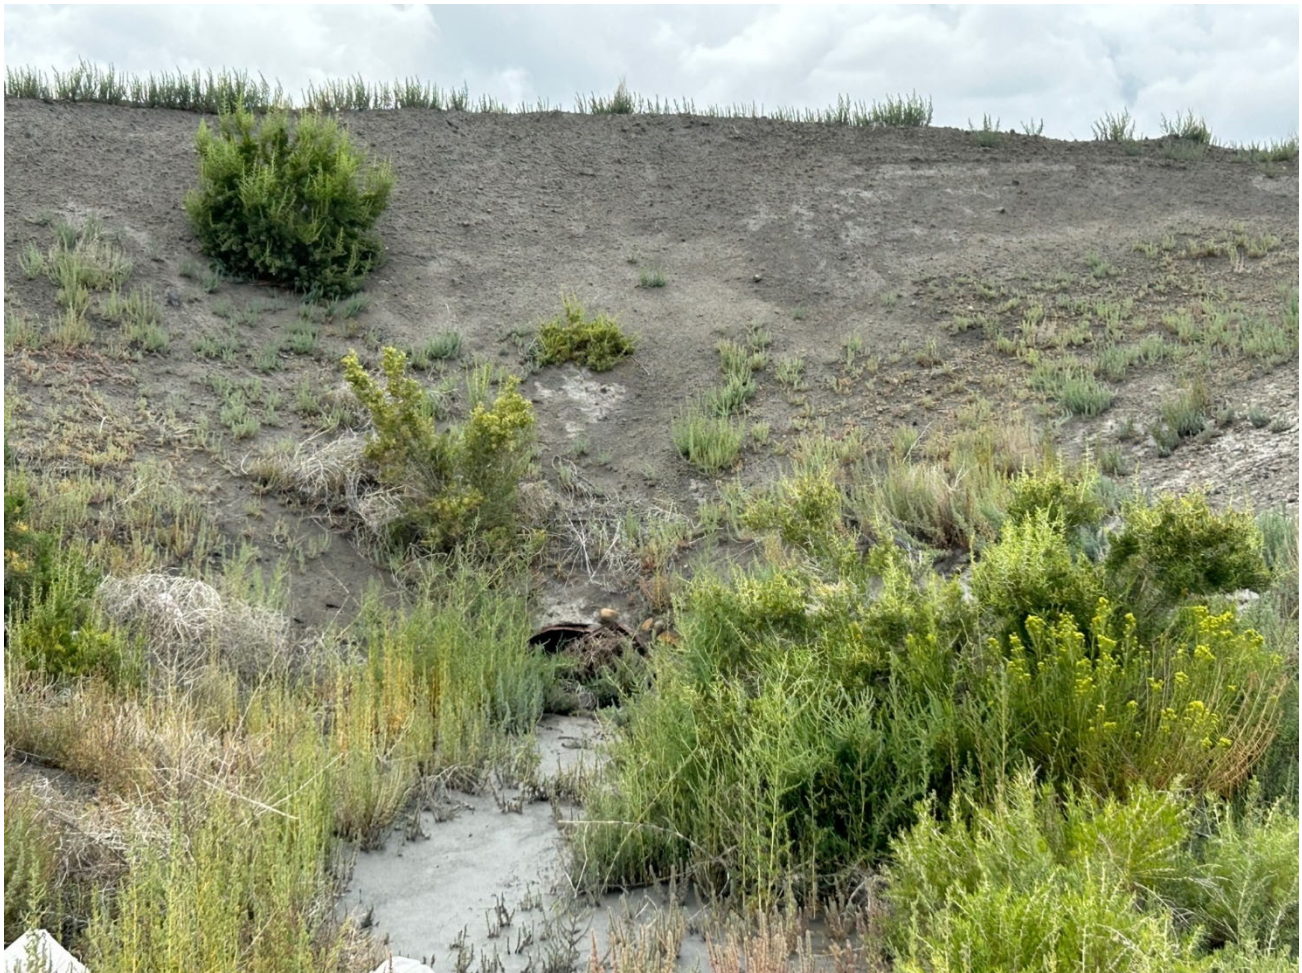
Photo Number: 18	Date: 8/24/2023 2:10 p.m.
Location: Hunter CCR Landfill	Comments: Looking southwest at discharge end of culvert passing road to industrial landfill. Note some accumulation of sediment and vegetation growth.
