CCR Rule Operating Criteria §257.84(b)(1) 2023 Annual Inspection by A Qualified Engineer Final

CCR Landfill Hunter Power Plant Castle Dale, Utah

December 15, 2023

Tetra Tech

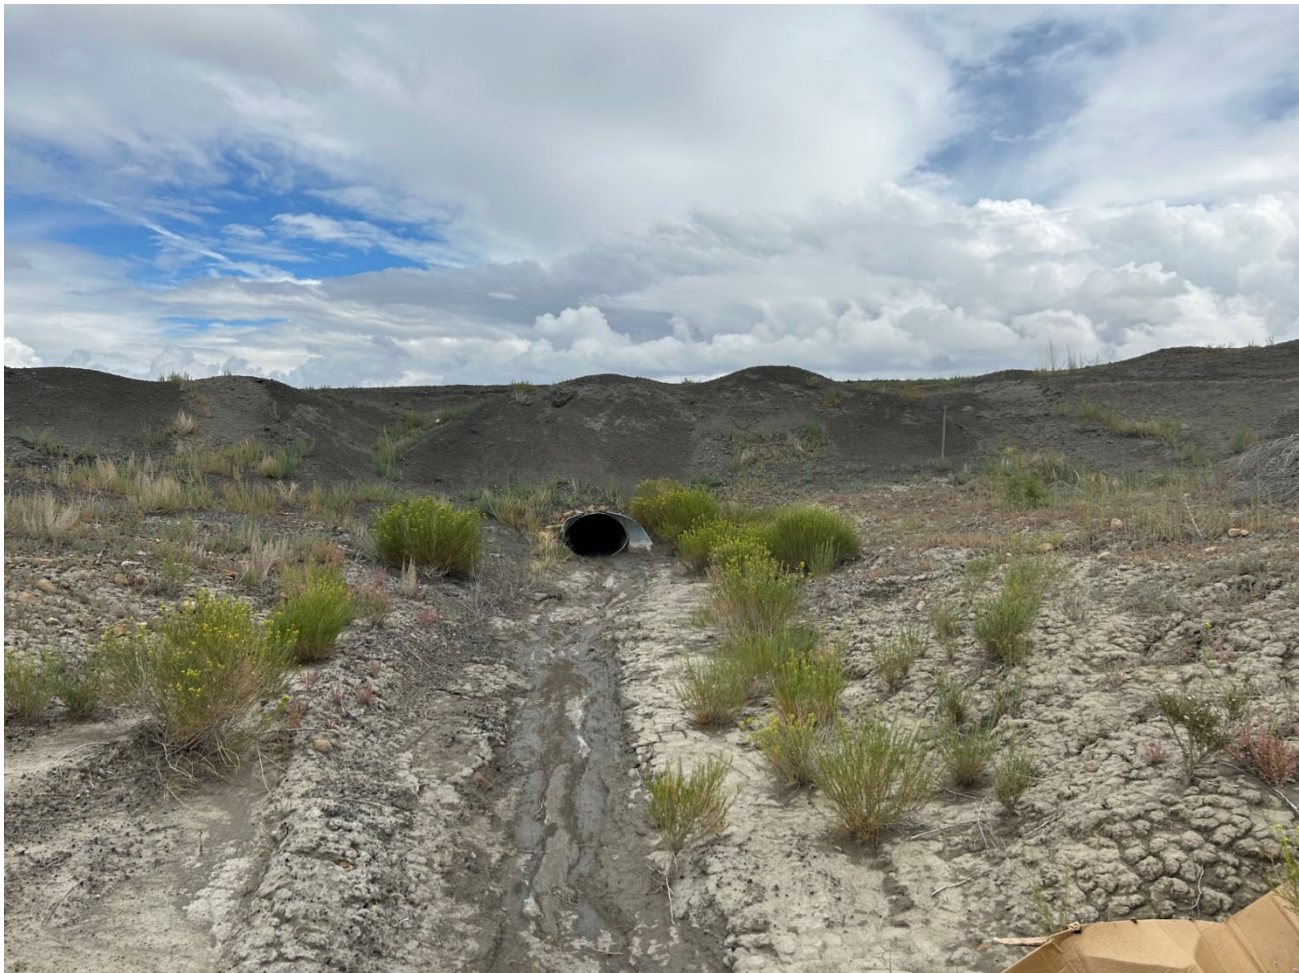
Photo Number: 19	Date: 8/24/2023 2:15 p.m.
Location: Hunter CCR Landfill	Comments: Looking northeast at inlet to culvert in Photograph 18. Discharge end of culvert recommended to be cleaned.

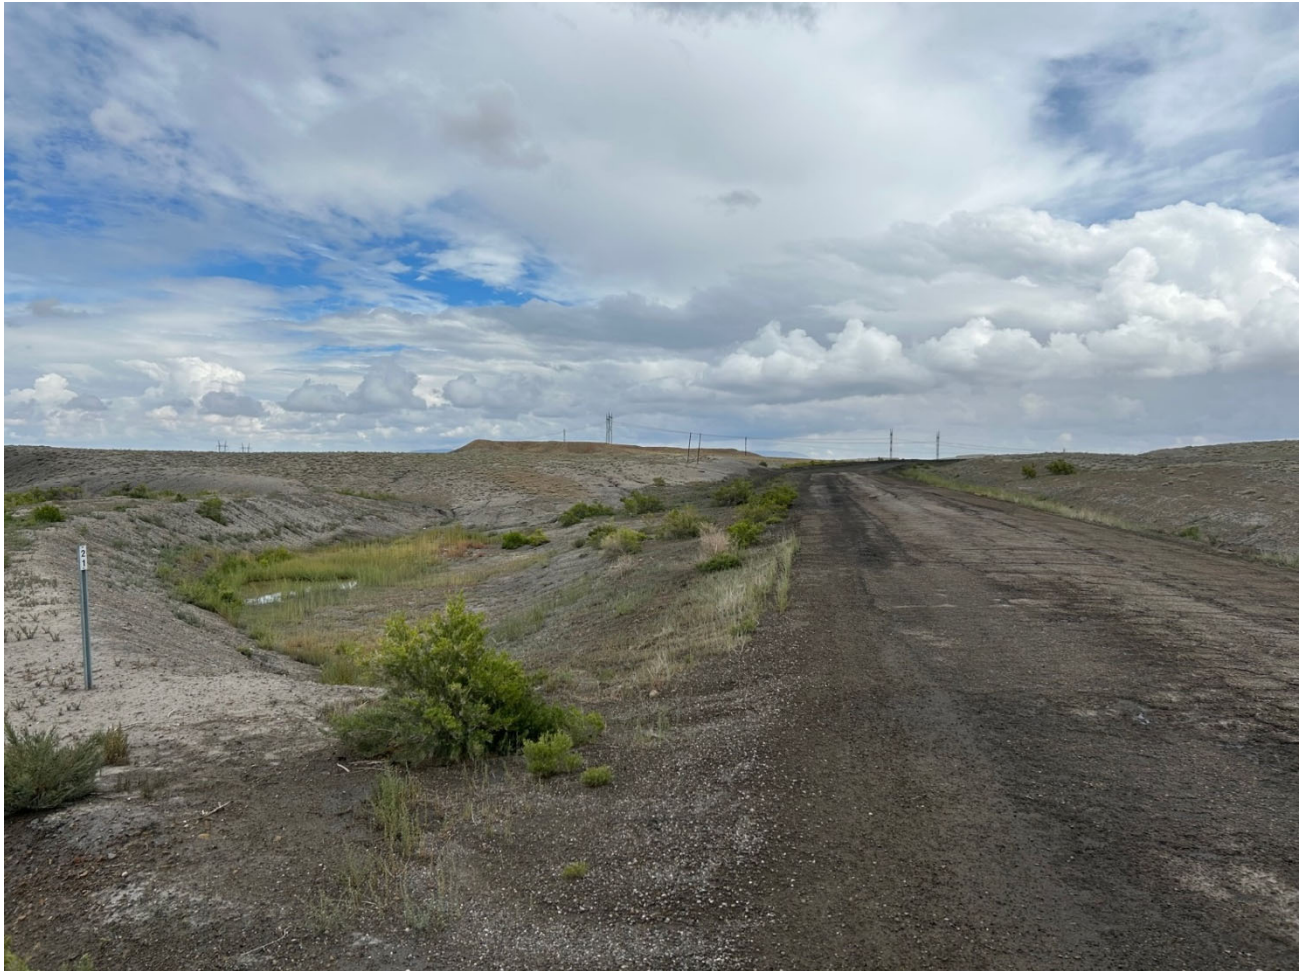
Photo Number: 20	Date: 8/24/2023 2:20 p.m.
Location: Hunter CCR Landfill	Comments: Looking southeast at depressed area used as detention area to capture run-off from northern portion of access road..

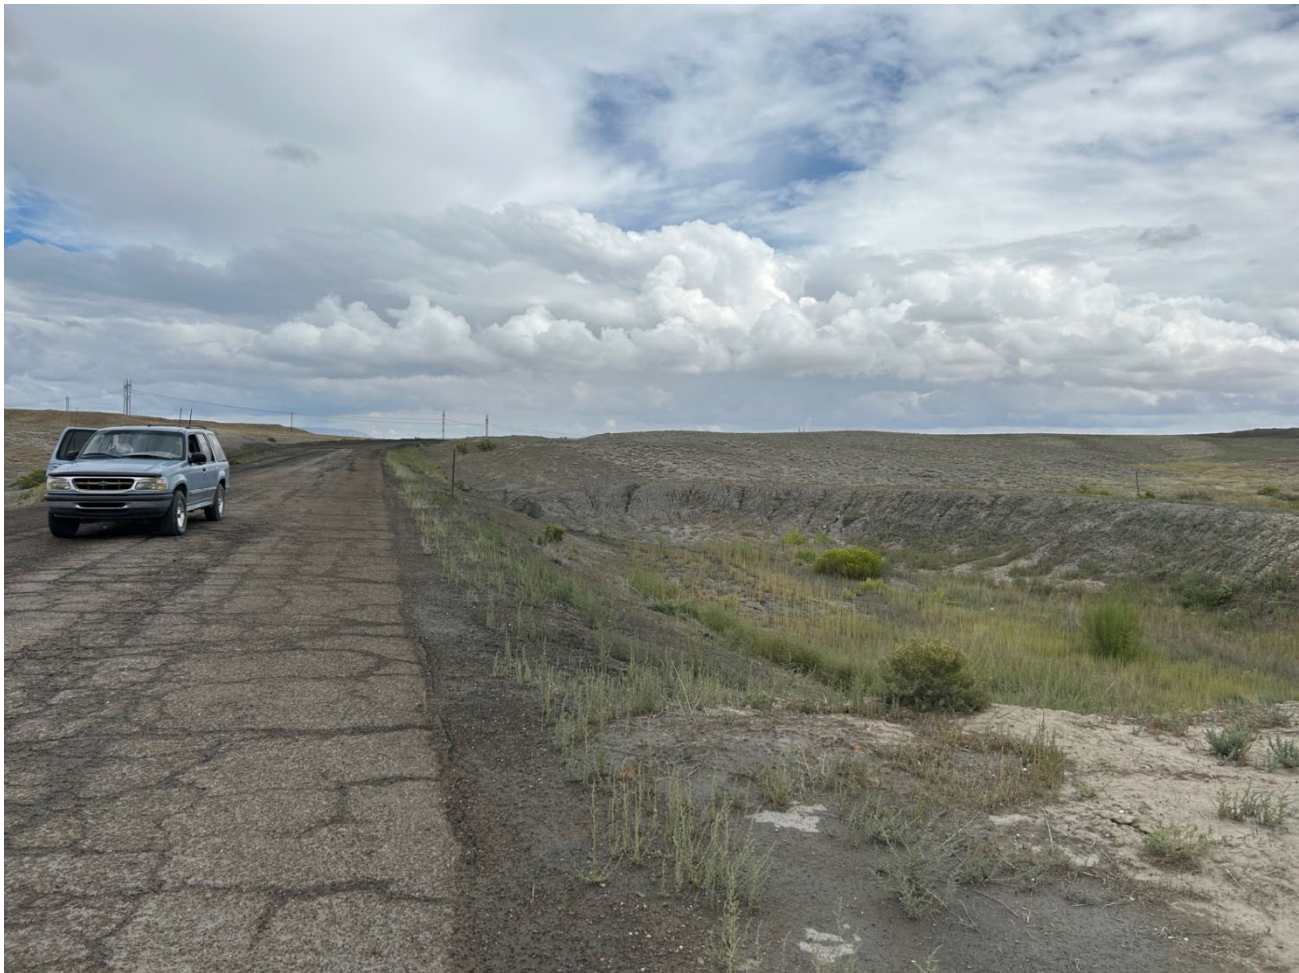
Photo Number: 21	Date: 8/24/2023 2:20 p.m.
Location: Hunter CCR Landfill	Comments: Looking southeast at depressed area used as detention area to capture run-off from southern portion of access road.
