CCR Rule Operating Criteria §257.84(b)(1) 2024 Annual Inspection by A Qualified Engineer Final

CCR Landfill Hunter Power Plant Castle Dale, Utah

December 13, 2024

Tetra Tech

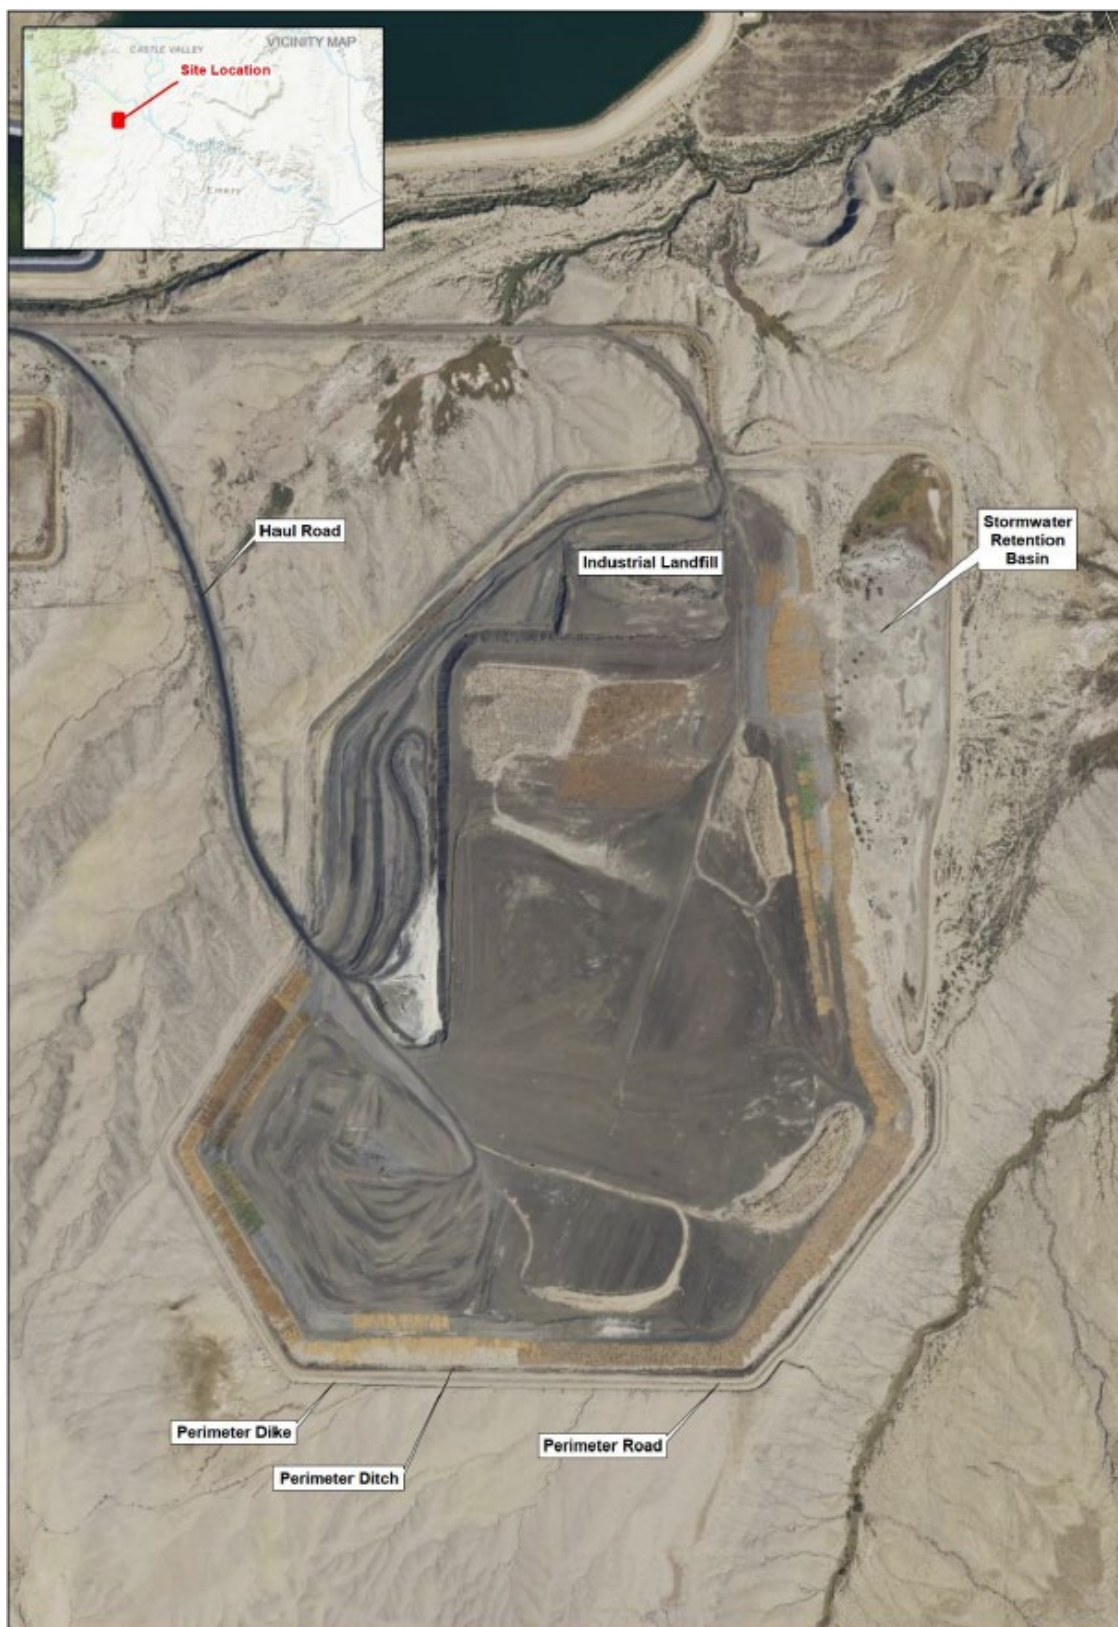
Figure 1 : Hunter CCR Landfill

The field inspection was performed on August 22, 2024 and found the principal project features of the Hunter CCR Landfill to be in satisfactory condition. Nothing was observed that would suggest an active or impending issue with stability of the landfill and the run-on and run-off control features were being maintained to preserve design capacity. The layout of the CCR Landfill is provided in **Figure 1**.

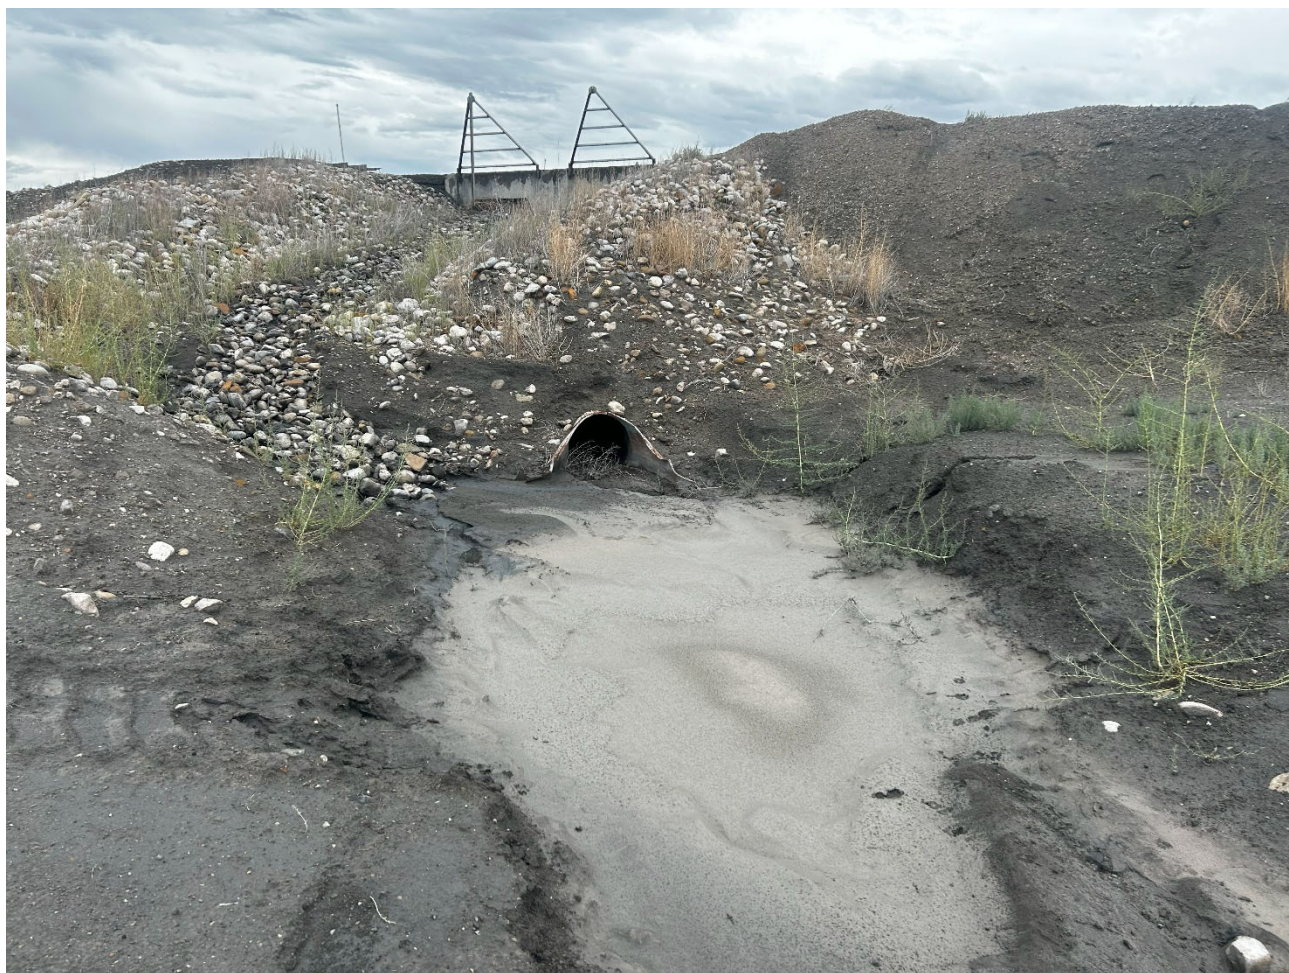
Photo Number: 1	Date: 8/22/2024 12:53 p.m.
Location: Hunter CCR Landfill	Comments: Looking north at inlet of culvert draining run-off channel shown in Photograph 2. Note minor amounts of ash deposited at inlet.

- Clear inlet and outlet ends of culverts to preserve design flow capacity.

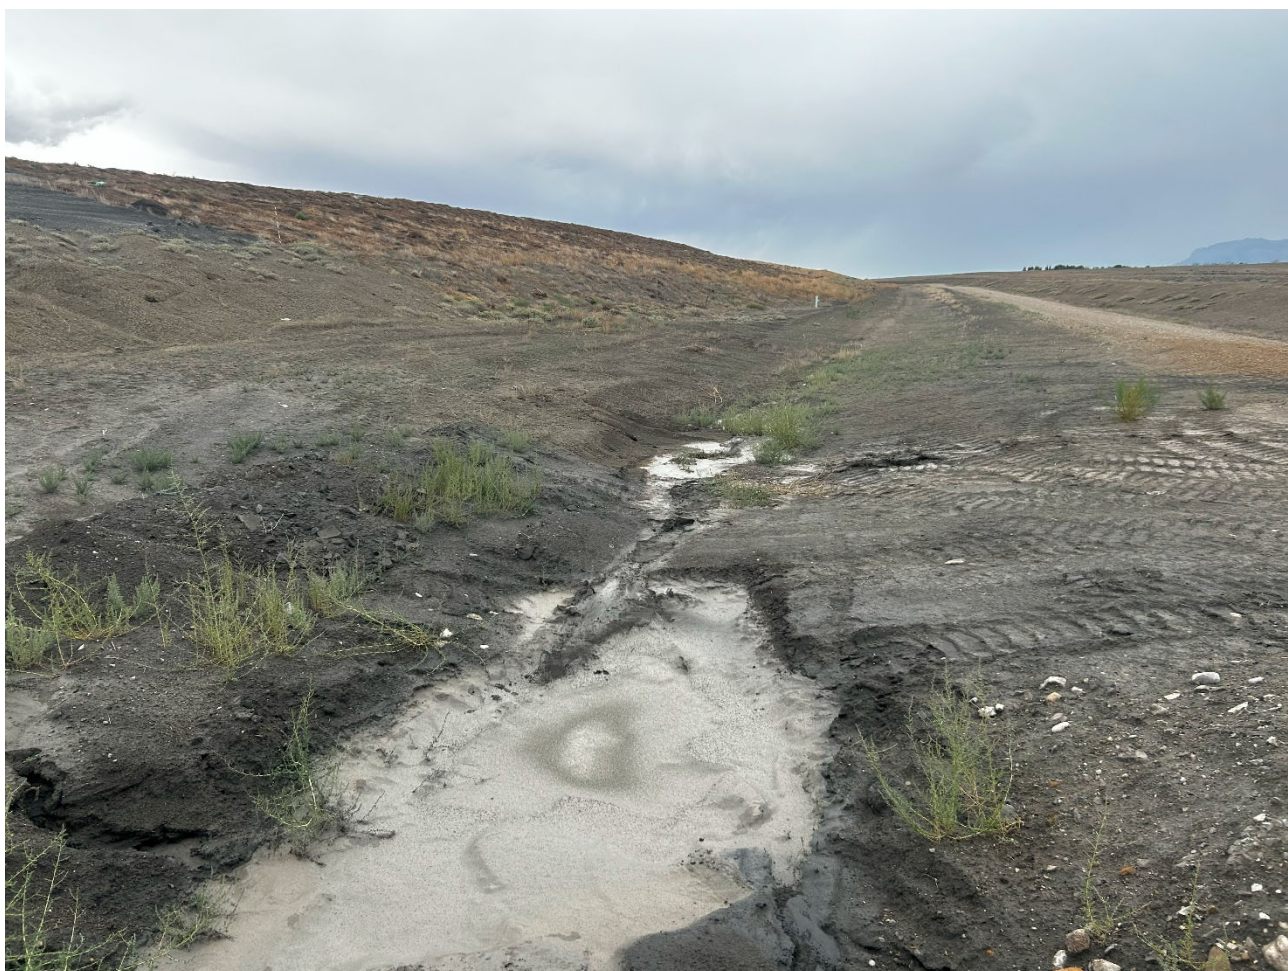
Photo Number: 2	Date: 8/22/2024 12:55 p.m.
Location: Hunter CCR Landfill	Comments: Looking southwest along northwest slope of landfill at run-off ditch and run-on berm.

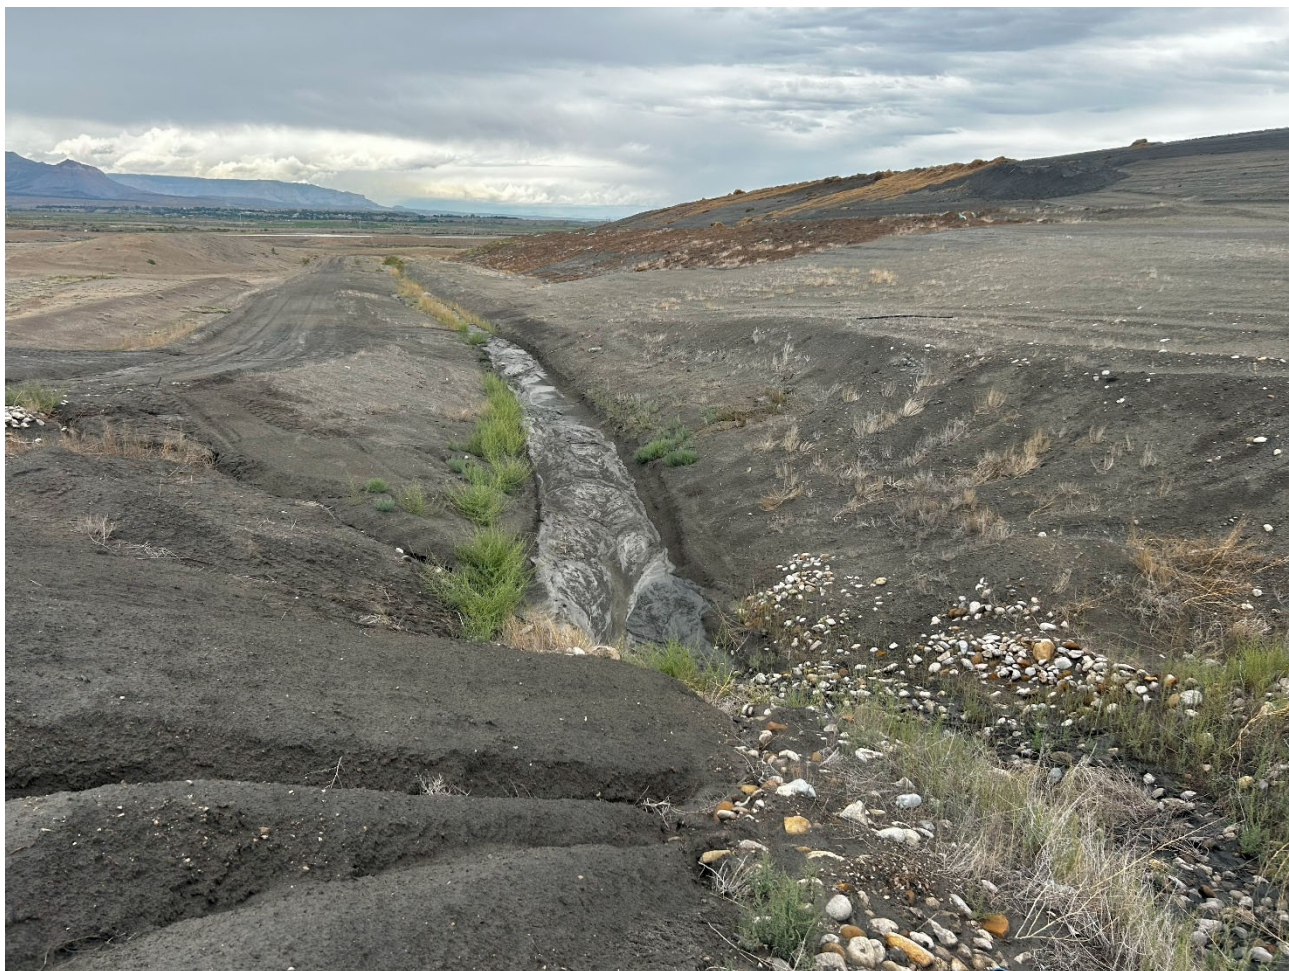
Photo Number: 3	Date: 8/22/2024 12:59 p.m.
Location: Hunter CCR Landfill	Comments: Looking north at outlet of culvert draining run-off channel shown in Photograph 2.

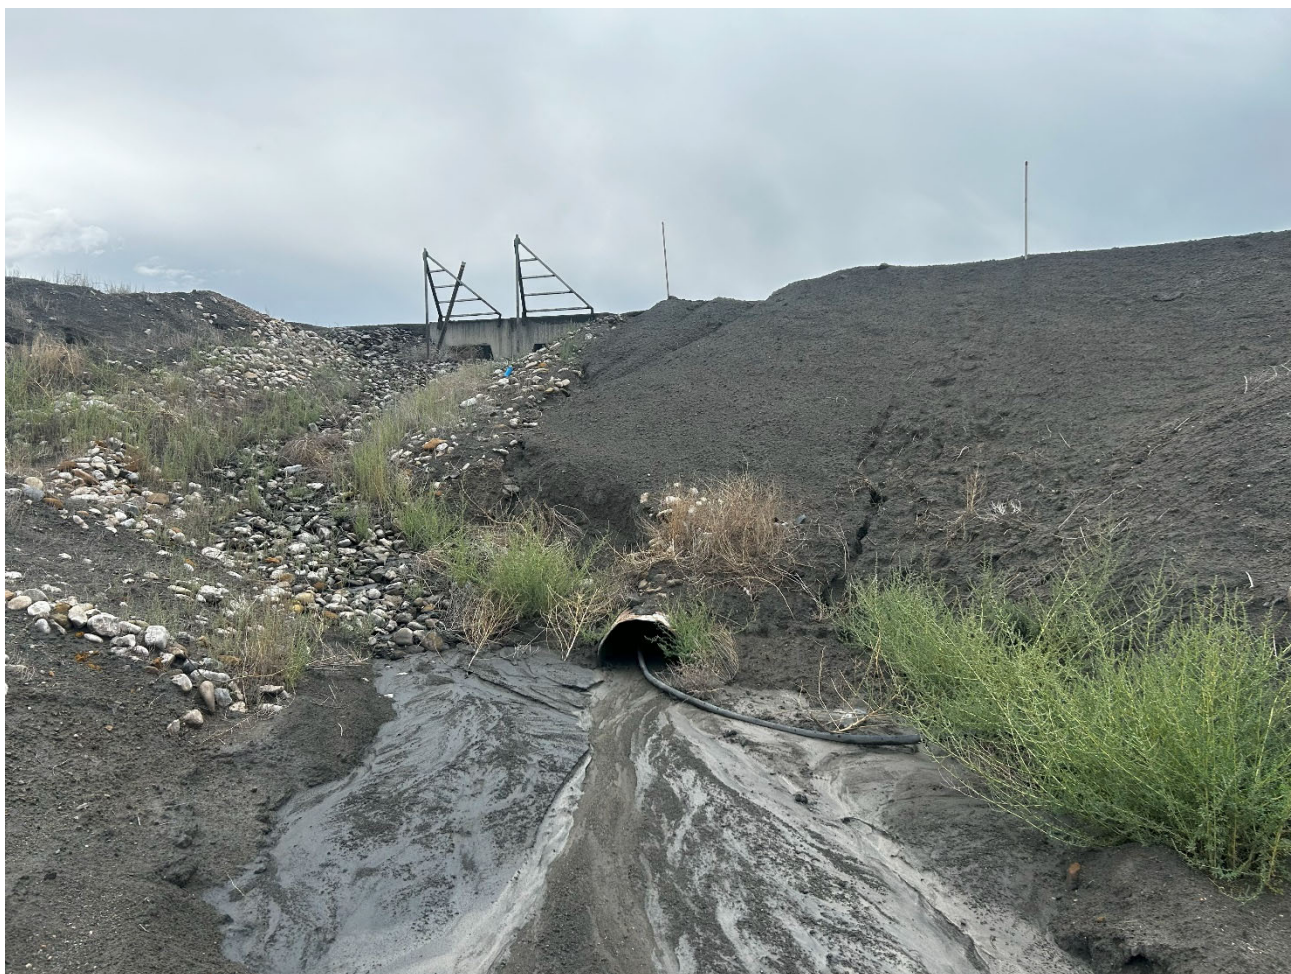
Photo Number: 4	Date: 8/22/2024 1:02 p.m.
Location: Hunter CCR Landfill	Comments: Looking south at outlet of culvert in Photograph 1. Note minor amounts of ash deposited at inlet.

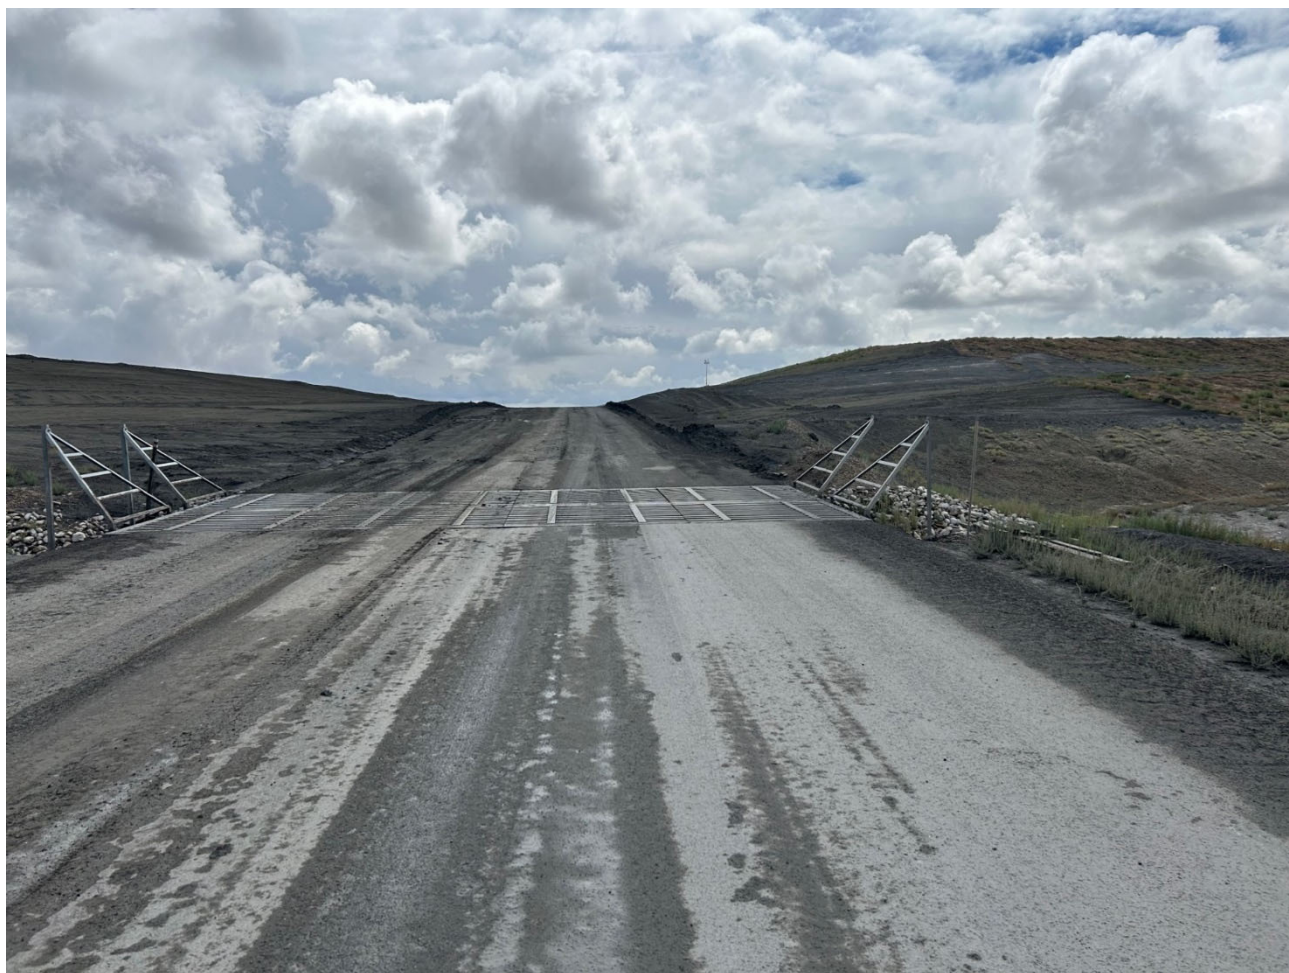
Photo Number: 5	Date: 8/22/2024 1:04 p.m.
Location: Hunter CCR Landfill	Comments: Looking southeast up at haul road grate. Road grate used to remove ash from tires and intercept stormwater running down haul road.

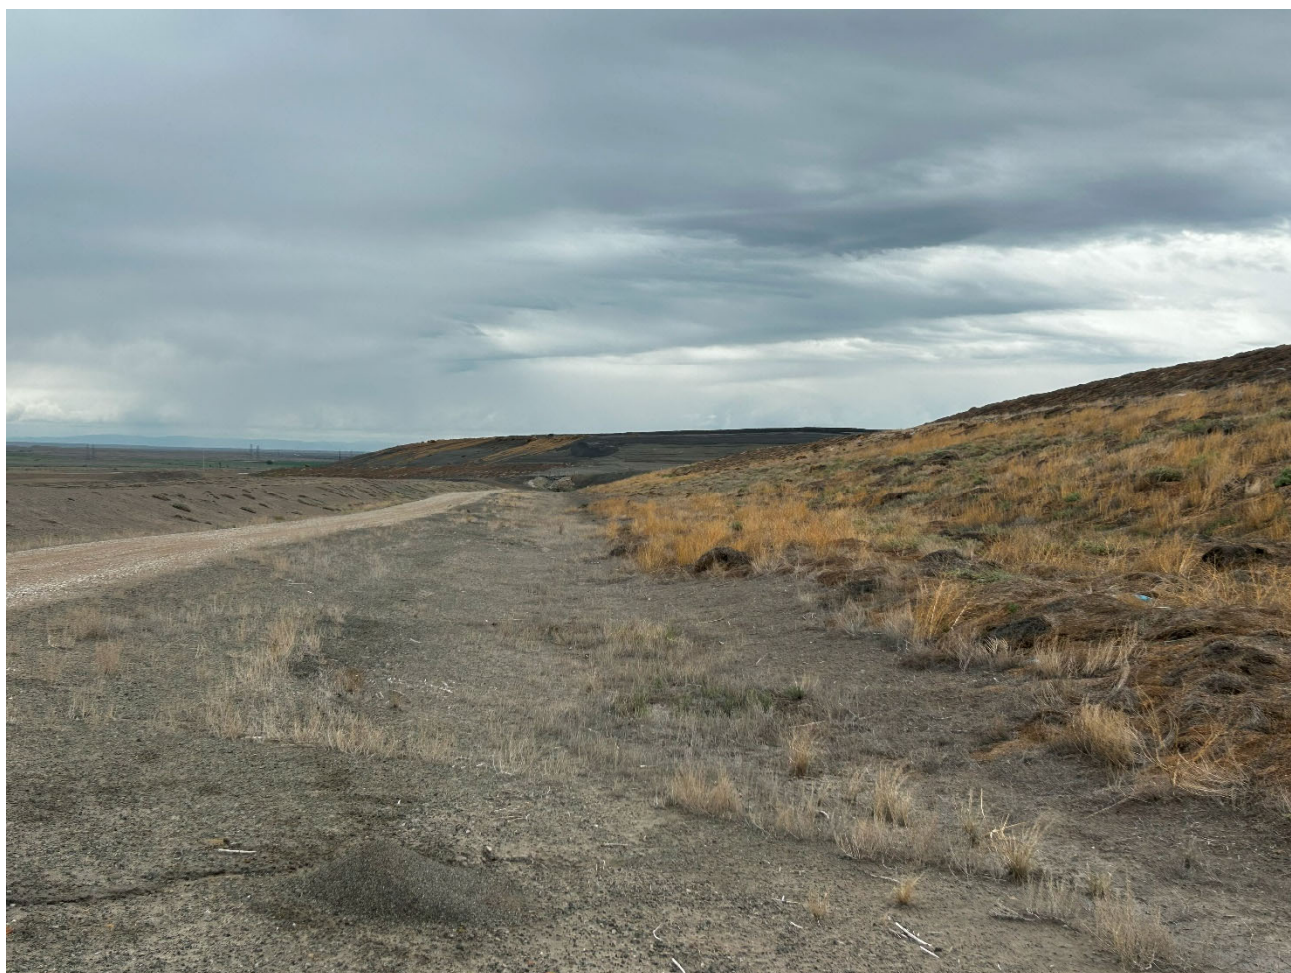
Photo Number: 6	Date: 8/22/2024 1:08 p.m.
Location: Hunter CCR Landfill	Comments: Looking north at along runoff channel draining into culvert shown on Photograph 1.

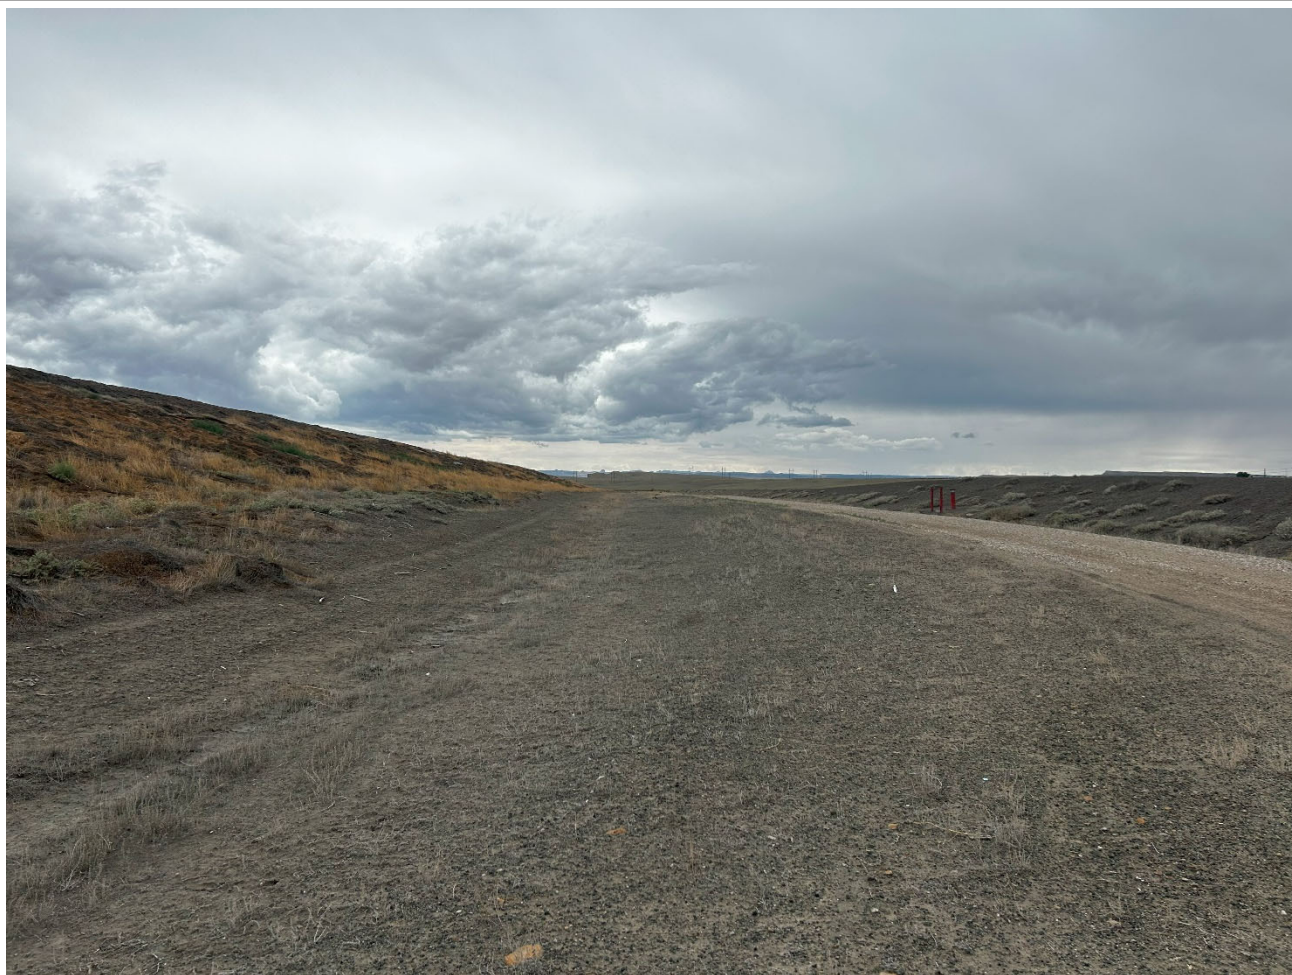
Photo Number: 7	Date: 8/22/2024 1:09 p.m.
Location: Hunter CCR Landfill	Comments: Looking southeast at high point of runoff ditch

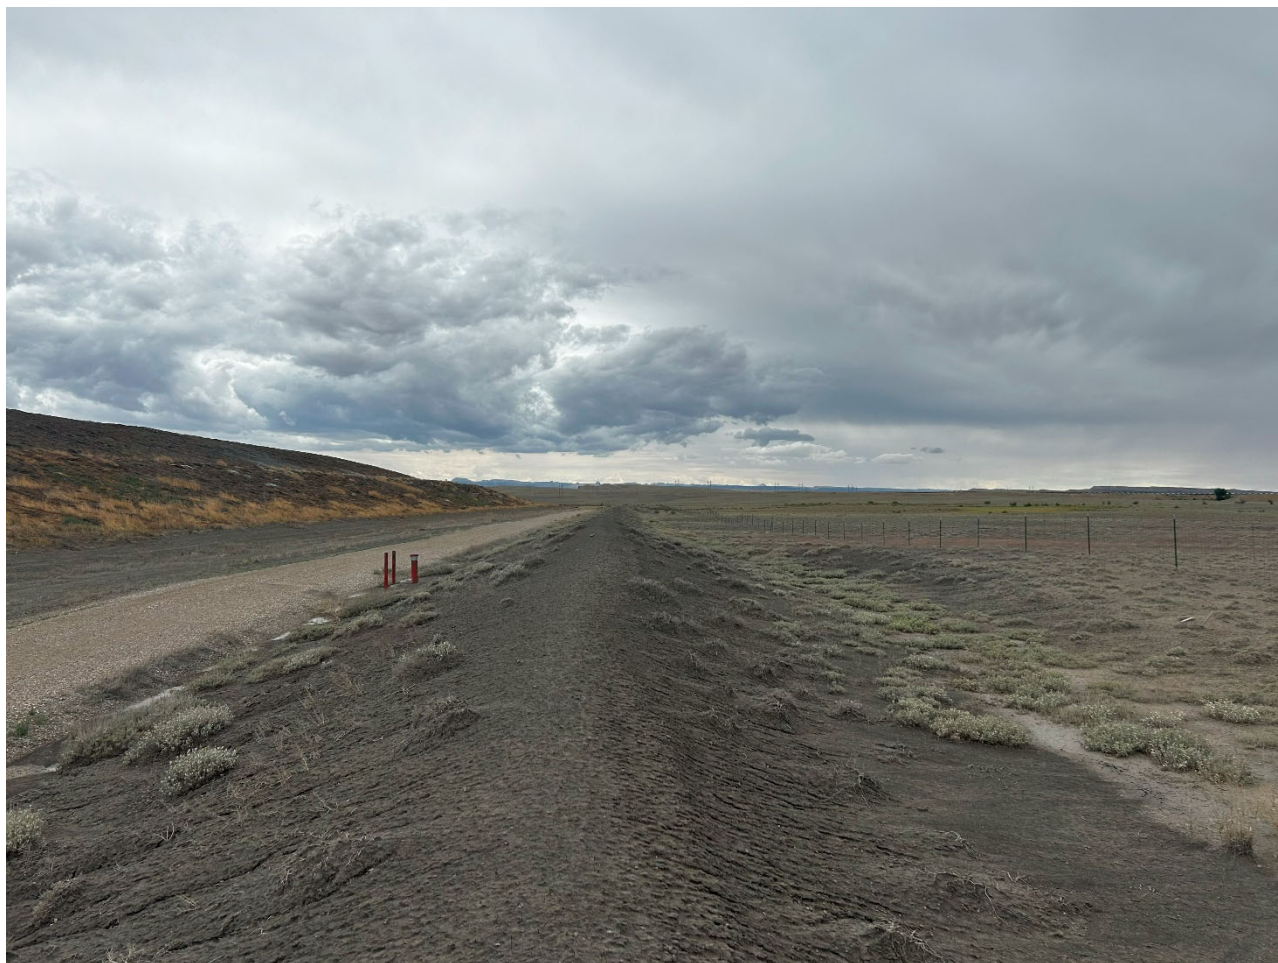
Photo Number: 8	Date: 8/22/2024 1:12 p.m.
Location: Hunter CCR Landfill	Comments: Looking southeast along run-on berm. Drainage ditch shown in Photograph 7 can be seen on the left side of the photograph.

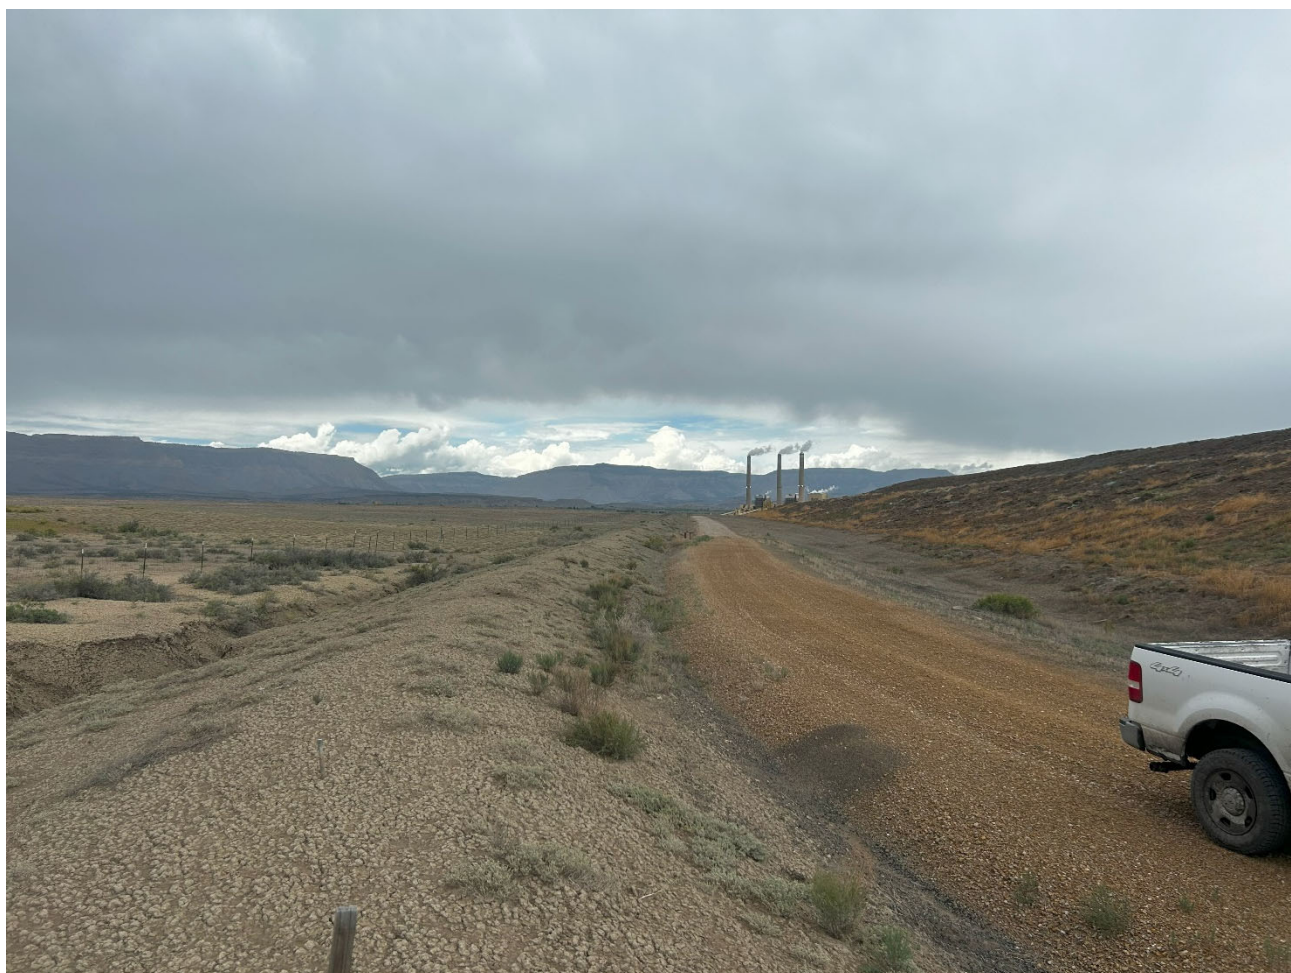
Photo Number: 9	Date: 8/22/2024 1:18 p.m.
Location: Hunter CCR Landfill	Comments: Looking northwest along run-on diversion berm.

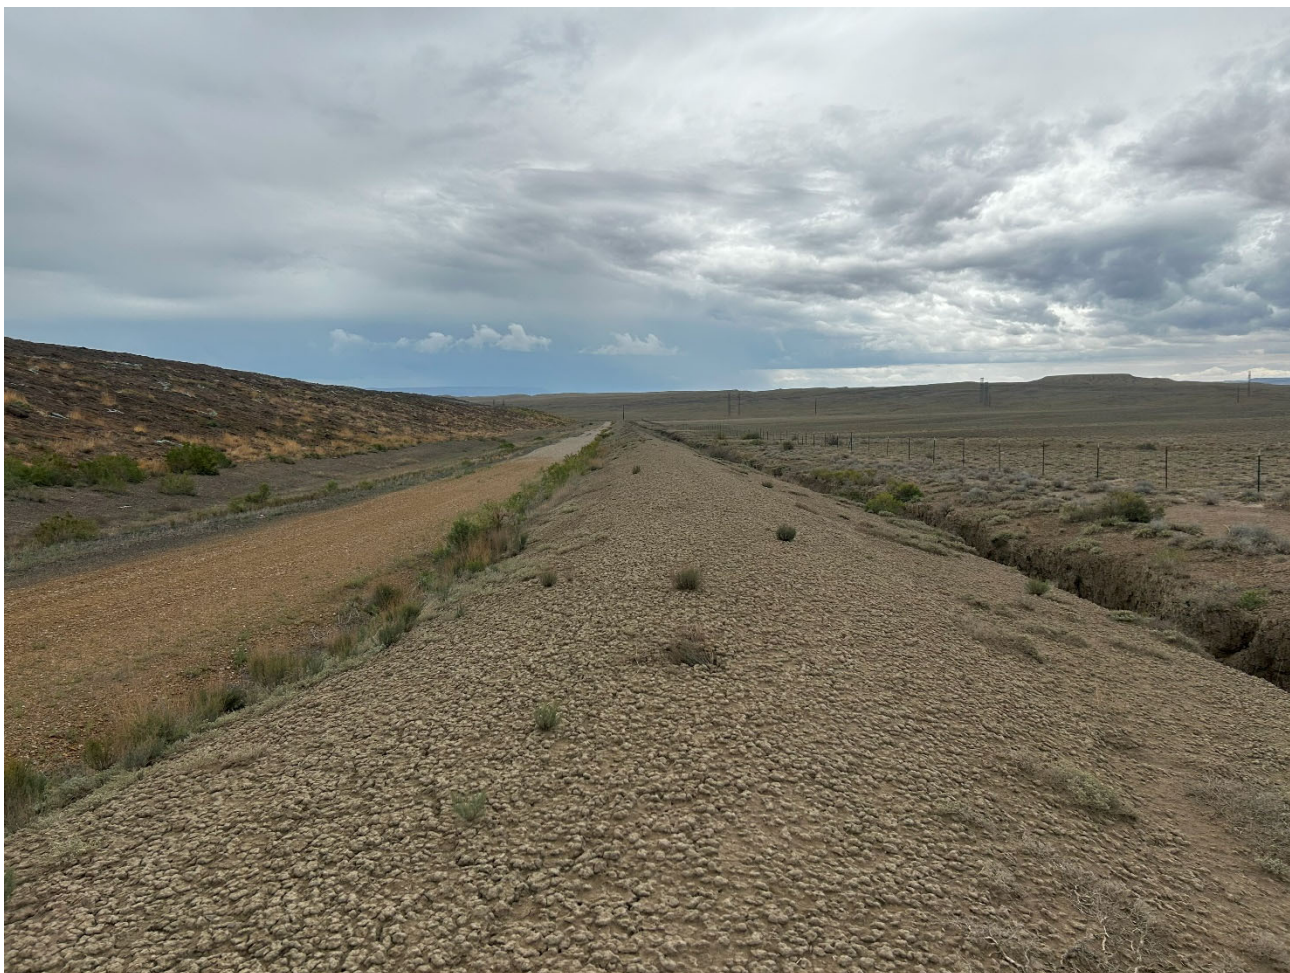
Photo Number: 10	Date: 8/22/2024 1:19 p.m.
Location: Hunter CCR Landfill	Comments: Looking east along run-on diversion berm. Not run-on ditch can be seen on the right side of the photograph.

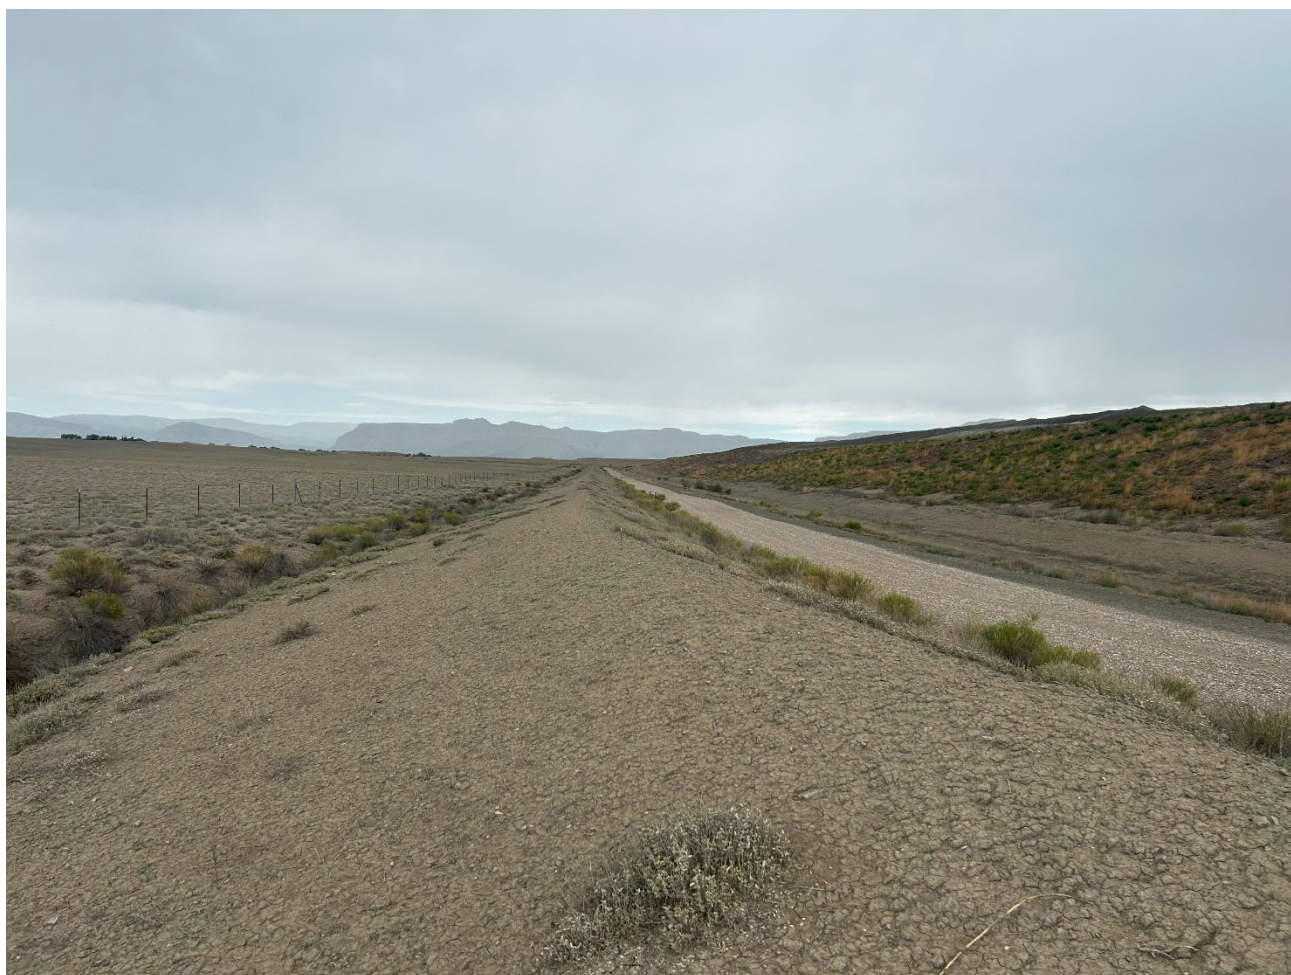
Photo Number: 11	Date: 8/22/2024 1:27 p.m.
Location: Hunter CCR Landfill	Comments: Looking west along run-on berm with run-on ditch and run-off ditch seen on the left and right sides of the photograph, respectively.

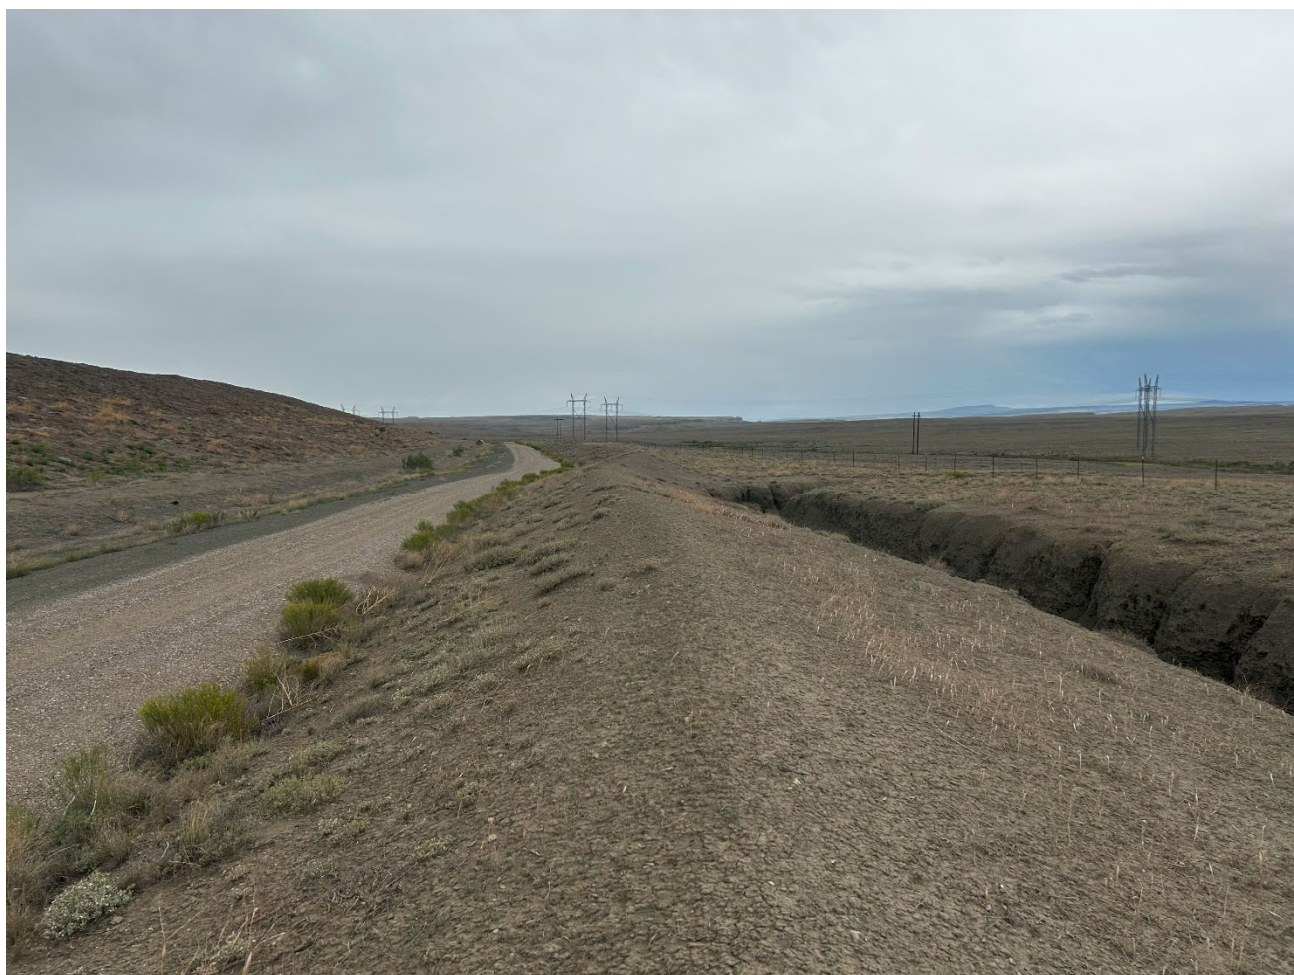
Photo Number: 12	Date: 8/22/2024 1:28 p.m.
Location: Hunter CCR Landfill	Comments: Looking northeast along run-on berm and termination of run-on ditch seen on the right side of the photograph.

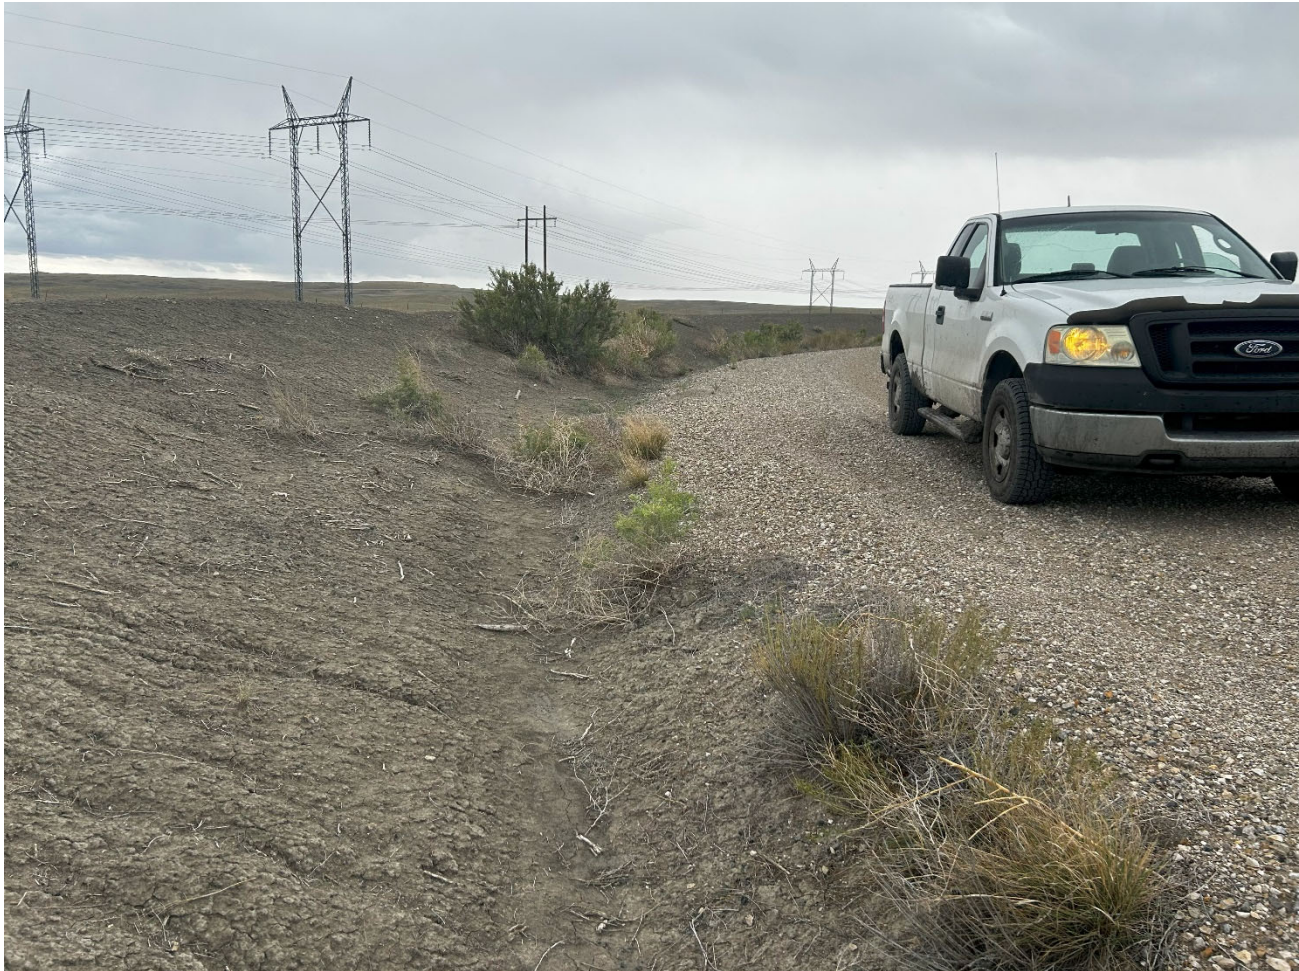
Photo Number: 13	Date: 8/22/2024 1:33 p.m.
Location: Hunter CCR Landfill	Comments: Looking south along channel created by perimeter road and run-on berm.

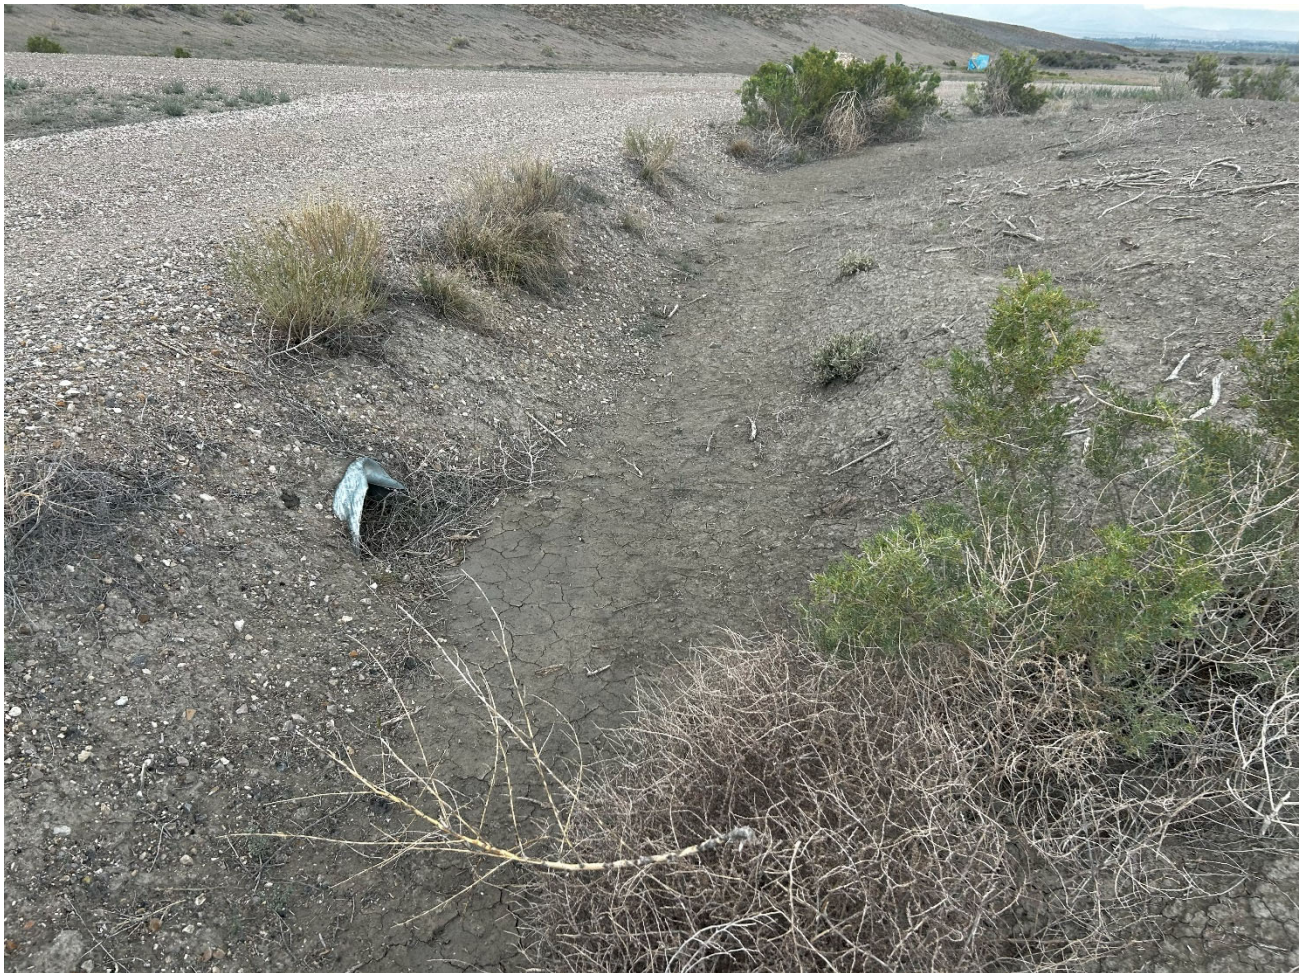
Photo Number: 14	Date: 8/22/2024 1:34 p.m.
Location: Hunter CCR Landfill	Comments: Looking north at inlet of culvert draining channel shown on Photograph 13.

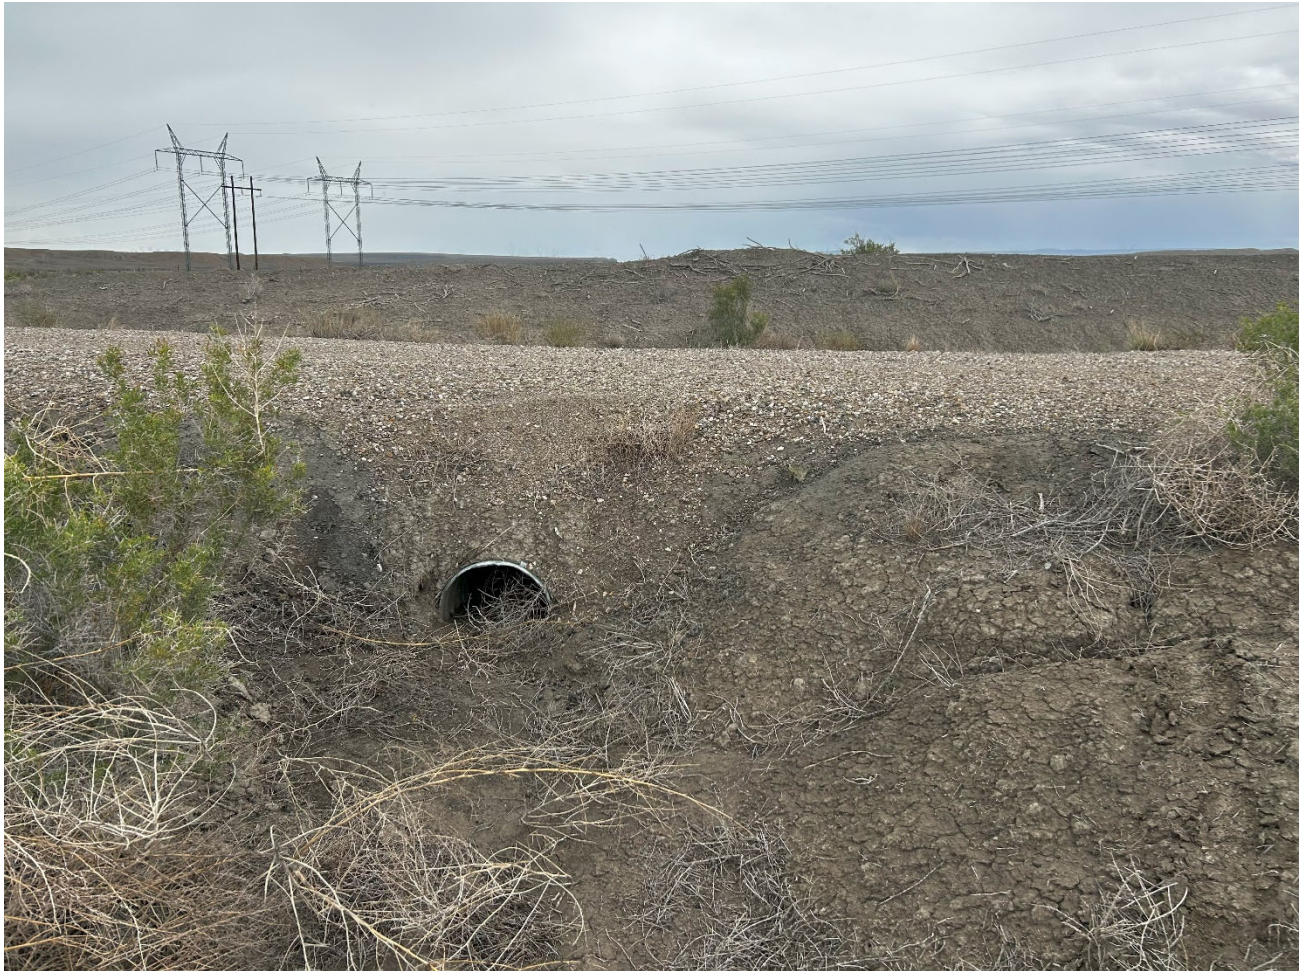
Photo Number: 15	Date: 8/22/2024 1:35 p.m.
Location: Hunter CCR Landfill	Comments: Looking east at outlet of culvert shown in Photograph 14. Minor vegetation observed and debris observed.

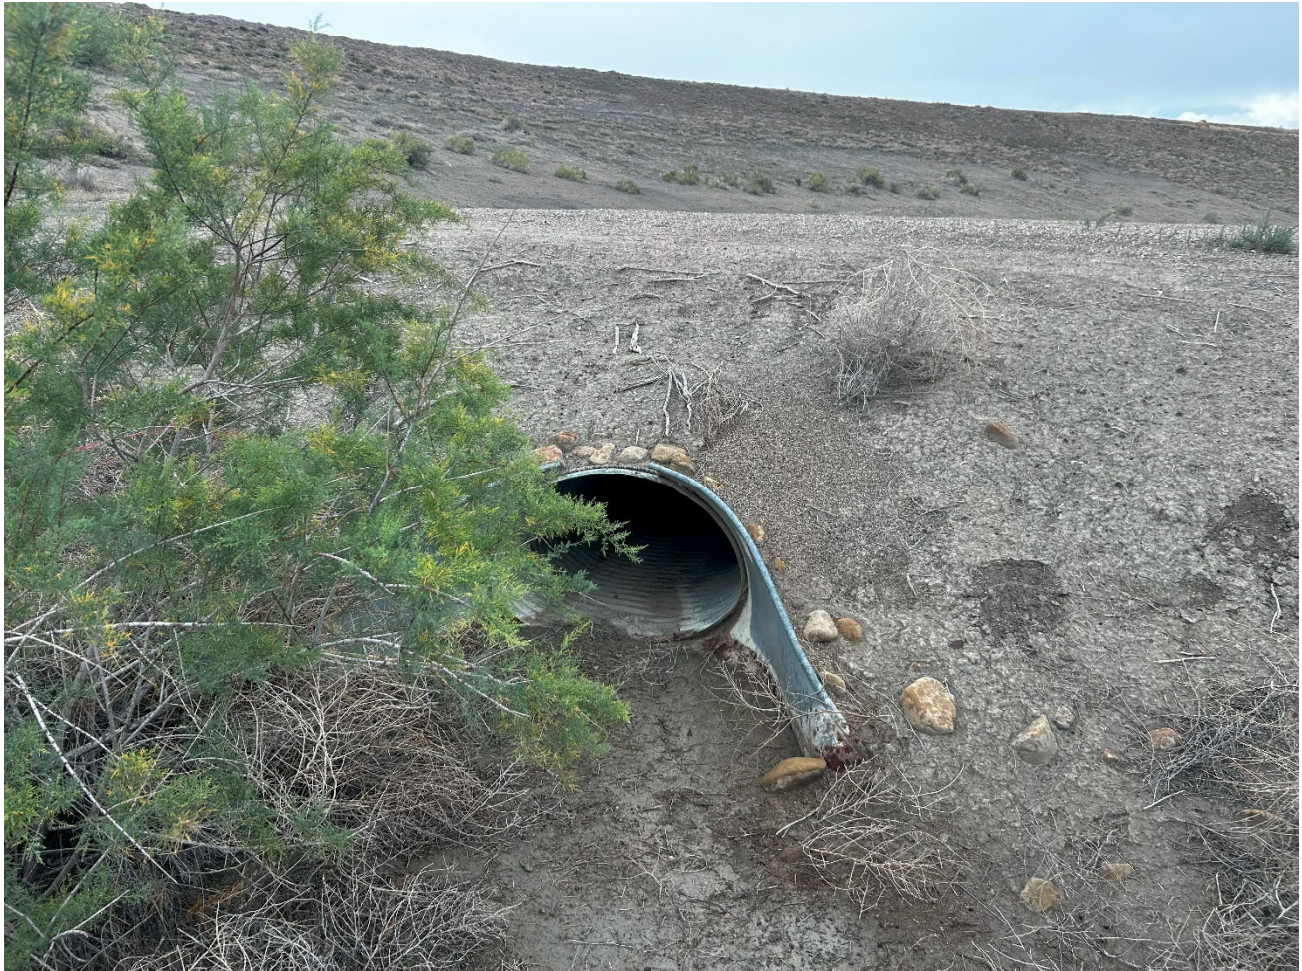
Photo Number: 16	Date: 8/22/2024 1:37 p.m.
Location: Hunter CCR Landfill	Comments: Looking north at inlet of culvert draining into Retention Basin. Inlet was observed to be free of debris and vegetation.
