CCR Rule Operating Criteria §257.84(b)(1) 2024 Annual Inspection by A Qualified Engineer Final

CCR Landfill Hunter Power Plant Castle Dale, Utah

December 13, 2024

Tetra Tech

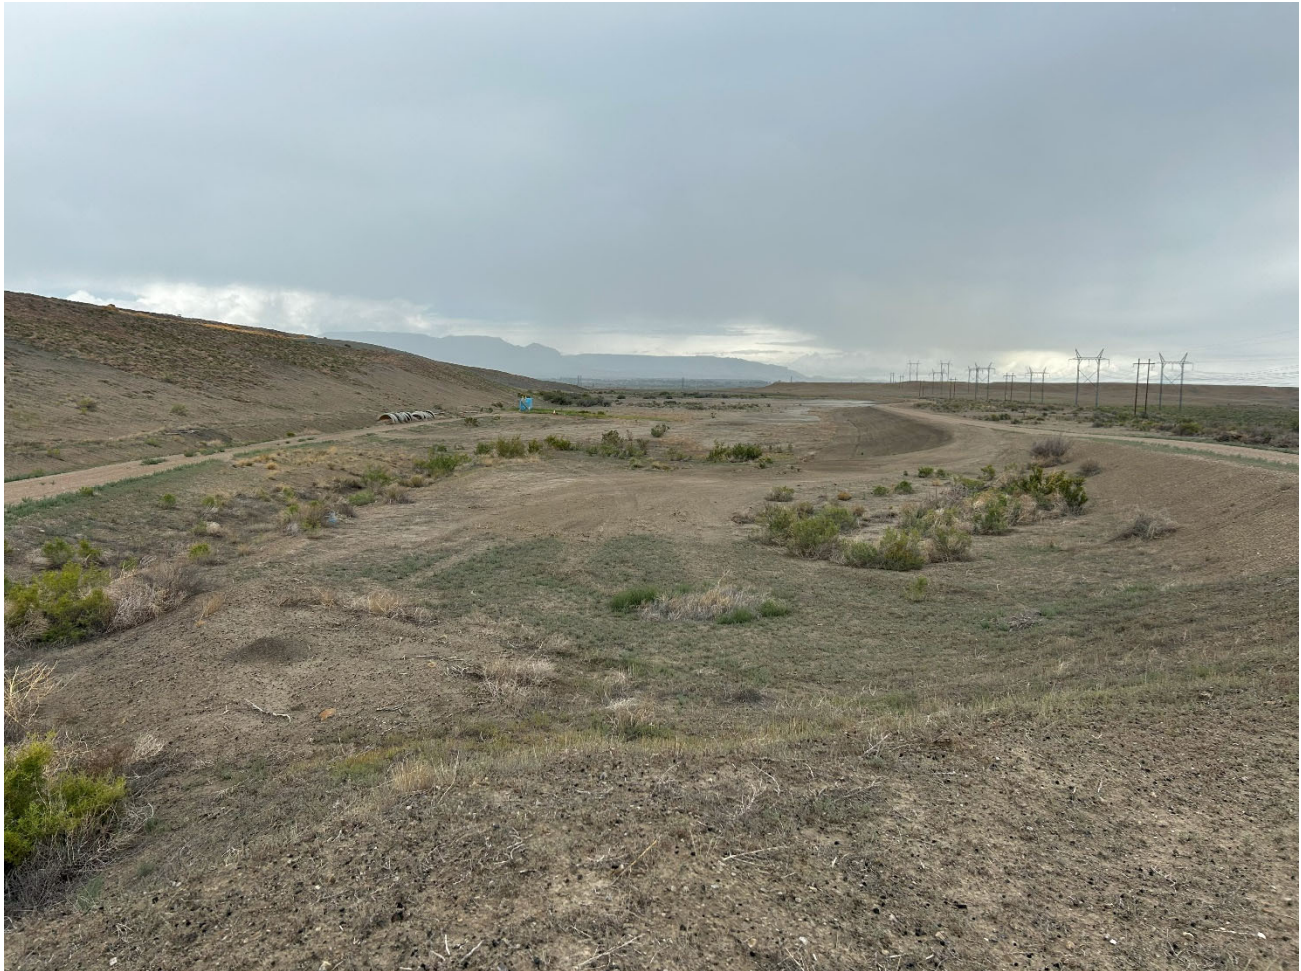
Photo Number: 17	Date: 8/22/2024 1:40 p.m.
Location: Hunter CCR Landfill	Comments: Looking north into Retention Basin from above outlet of culvert shown in Photograph 16.

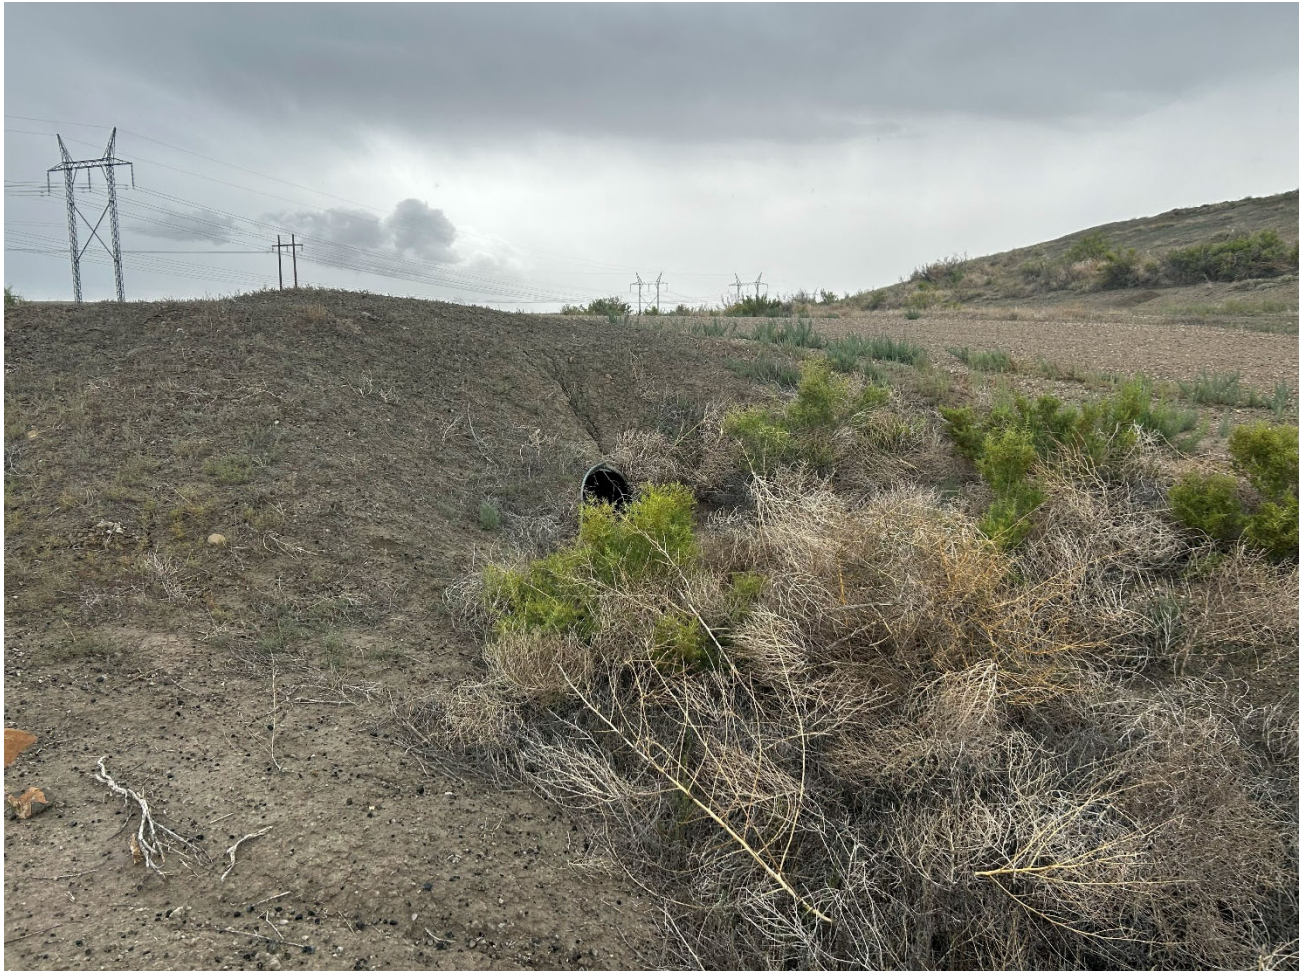
Photo Number: 18	Date: 8/22/2024 1:41 p.m.
Location: Hunter CCR Landfill	Comments: Looking south at outlet of culvert shown in Photograph 16. Accumulated vegetation observed.

- Clear inlet and outlet ends of culverts to preserve design flow capacity.

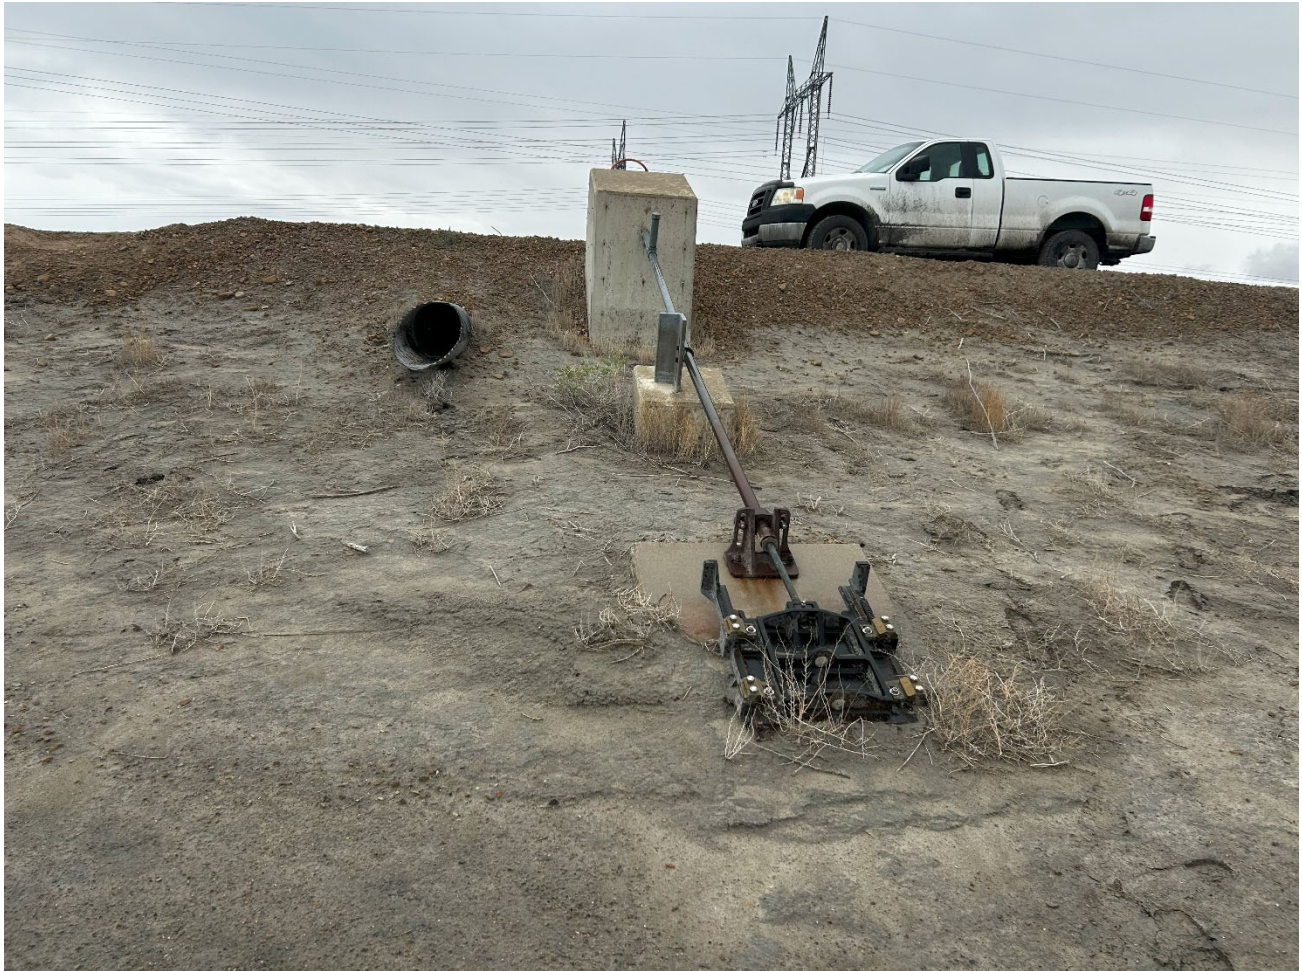
Photo Number: 19	Date: 8/22/2024 1:42 p.m.
Location: Hunter CCR Landfill	Comments: Looking east at outlet structure for Retention Basin.

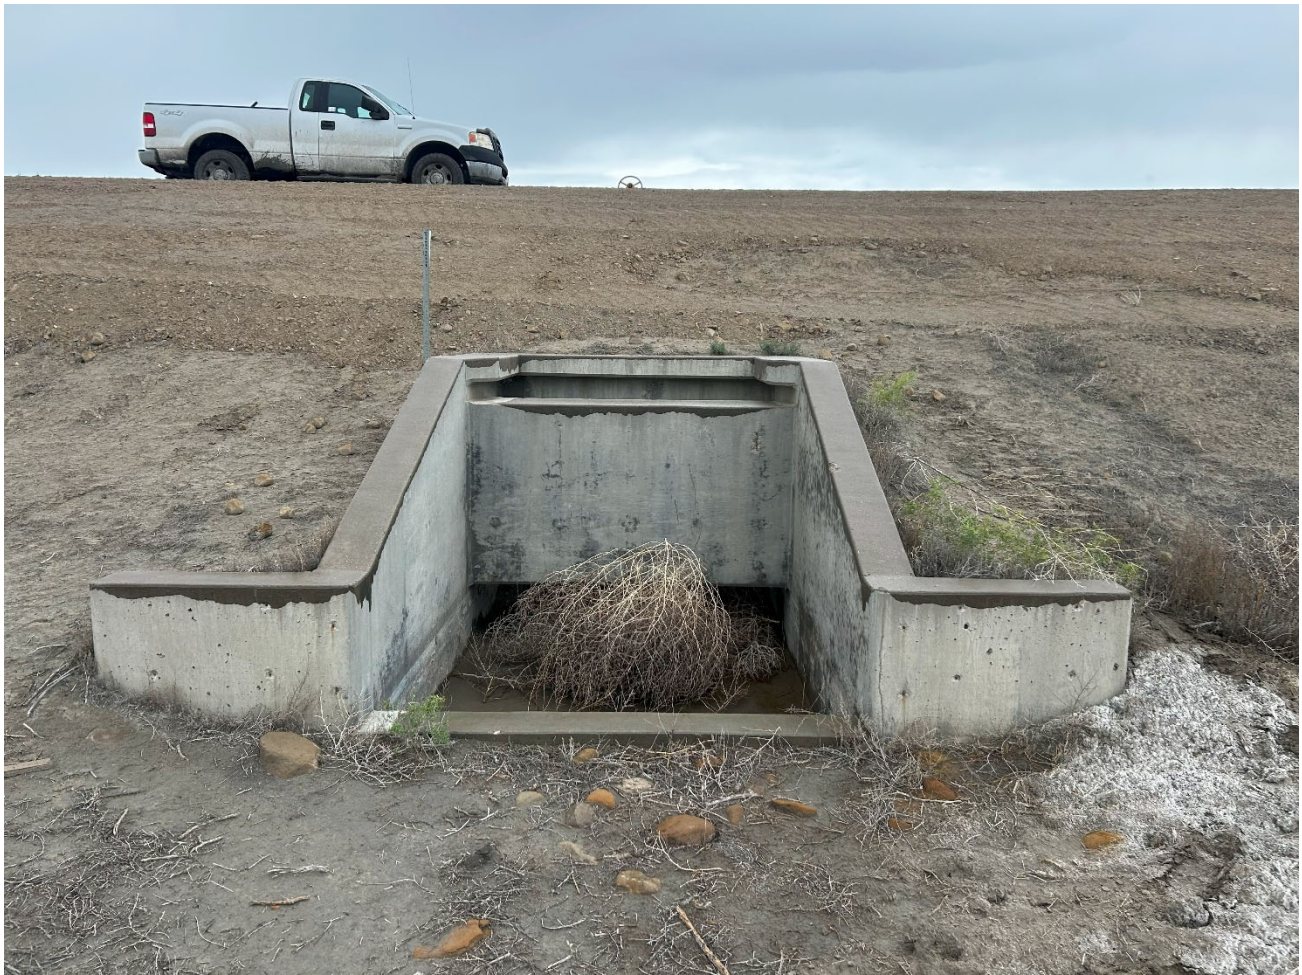
Photo Number: 20	Date: 8/22/2024 1:45 p.m.
Location: Hunter CCR Landfill	Comments: Looking west at outlet of discharge structure for Retention Basin.

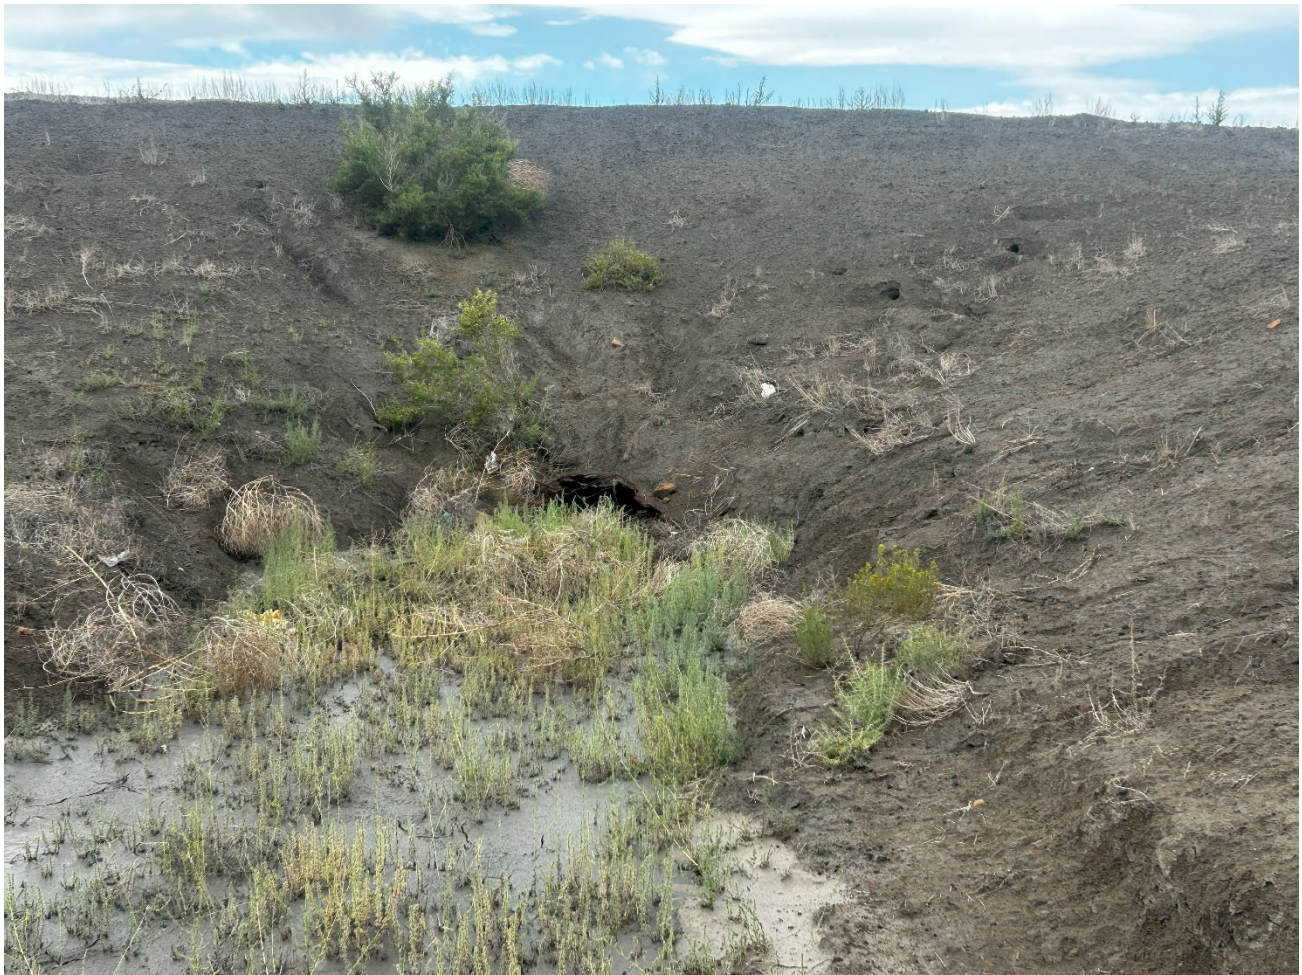
Photo Number: 21	Date: 8/22/2024 1:51 p.m.
Location: Hunter CCR Landfill	Comments: Looking west at outlet of culvert installed under road going to industrial landfill. Culvert was observed to mostly filled with sediment.

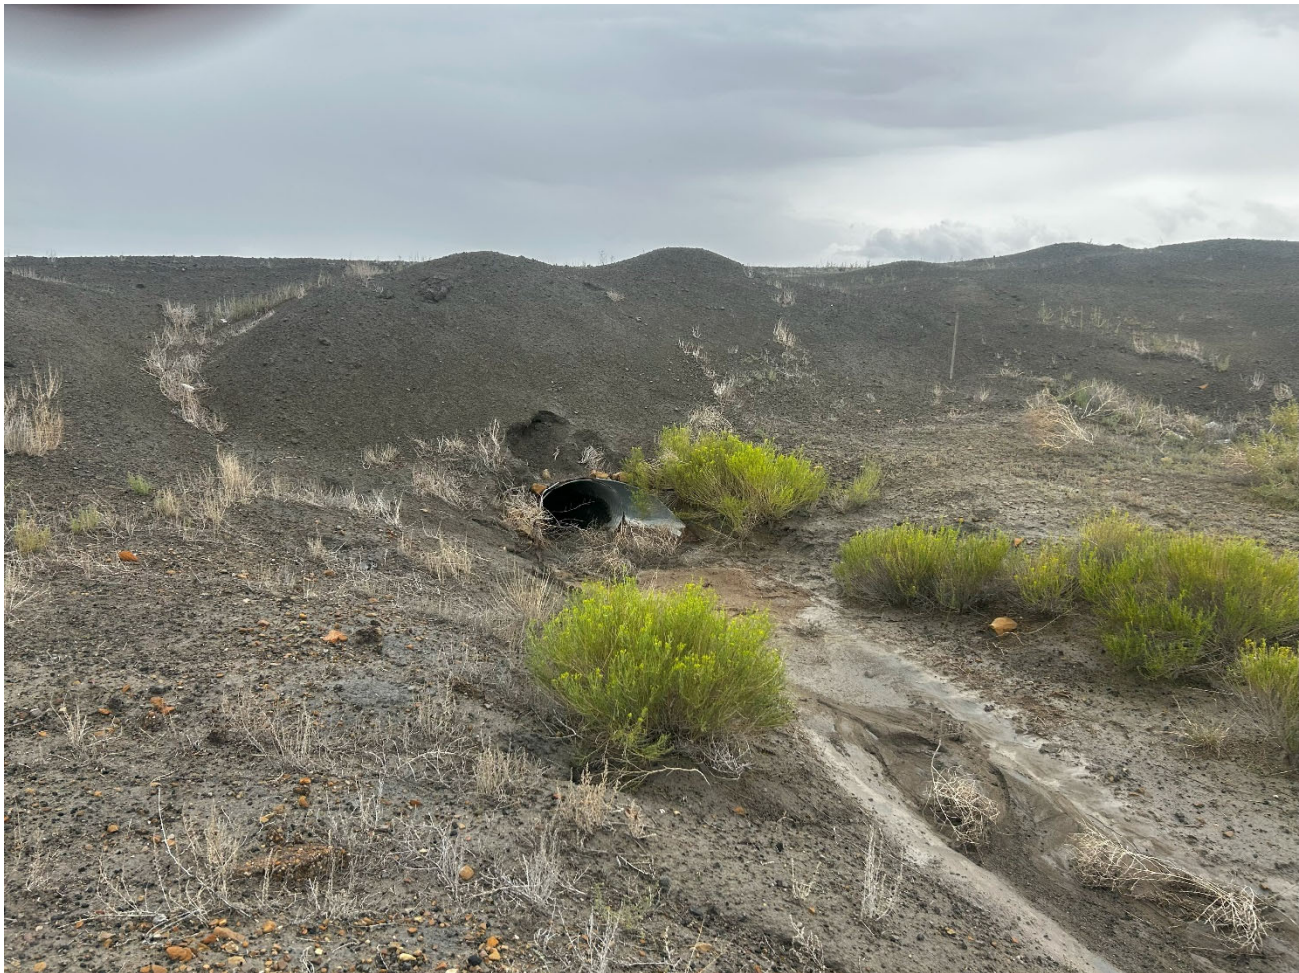
Photo Number: 22	Date: 8/22/2024 1:53 p.m.
Location: Hunter CCR Landfill	Comments: Looking east at inlet of culvert shown in Photograph 21. There was less sediment accumulation observed on inlet side then outlet side.

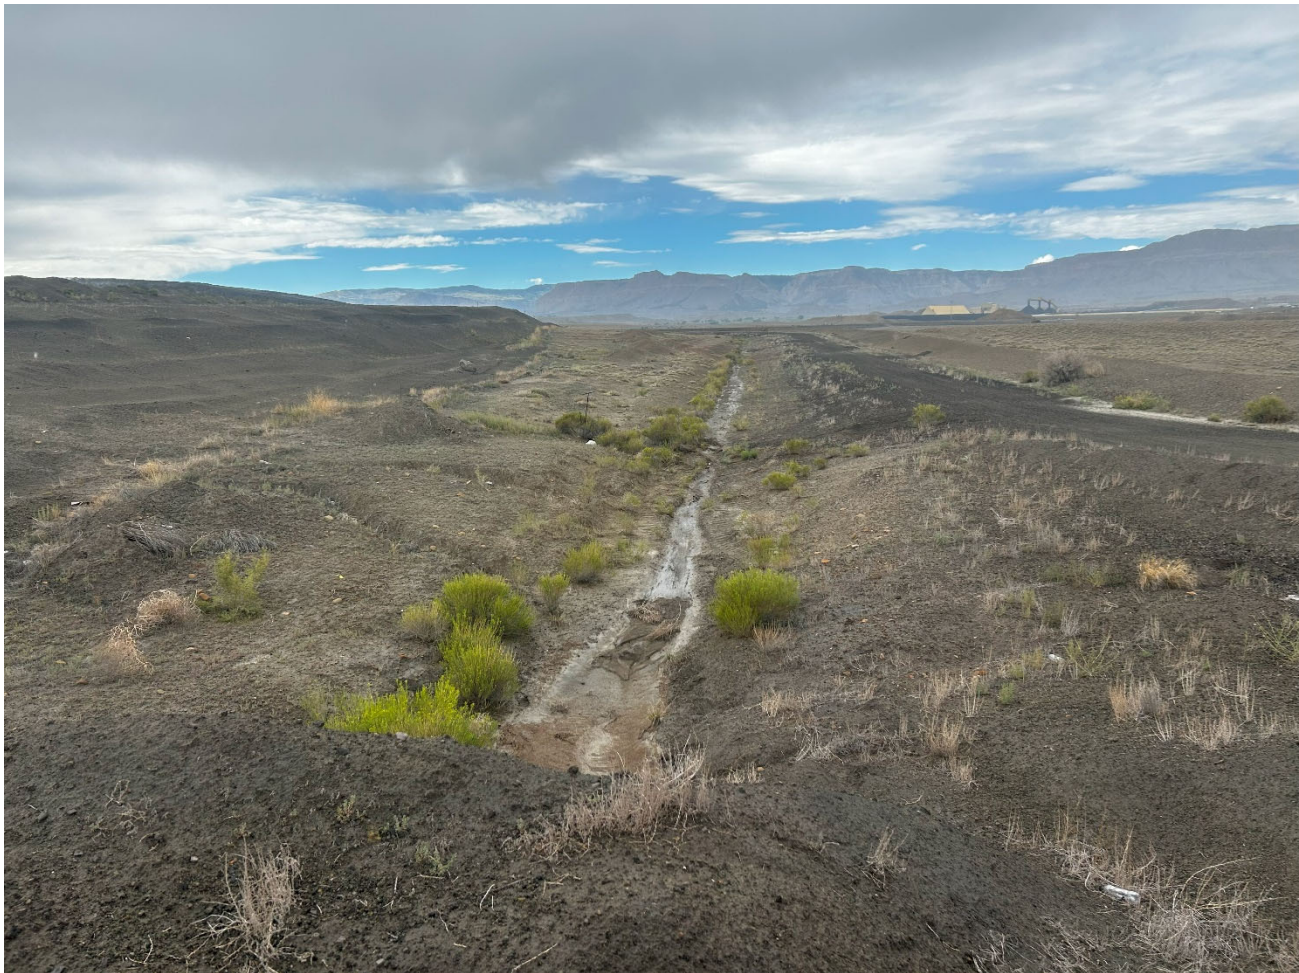
Photo Number: 23	Date: 8/22/2024 1:59 p.m.
Location: Hunter CCR Landfill	Comments: Looking west along drainage ditch discharging to culvert inlet shown in Photograph 22.

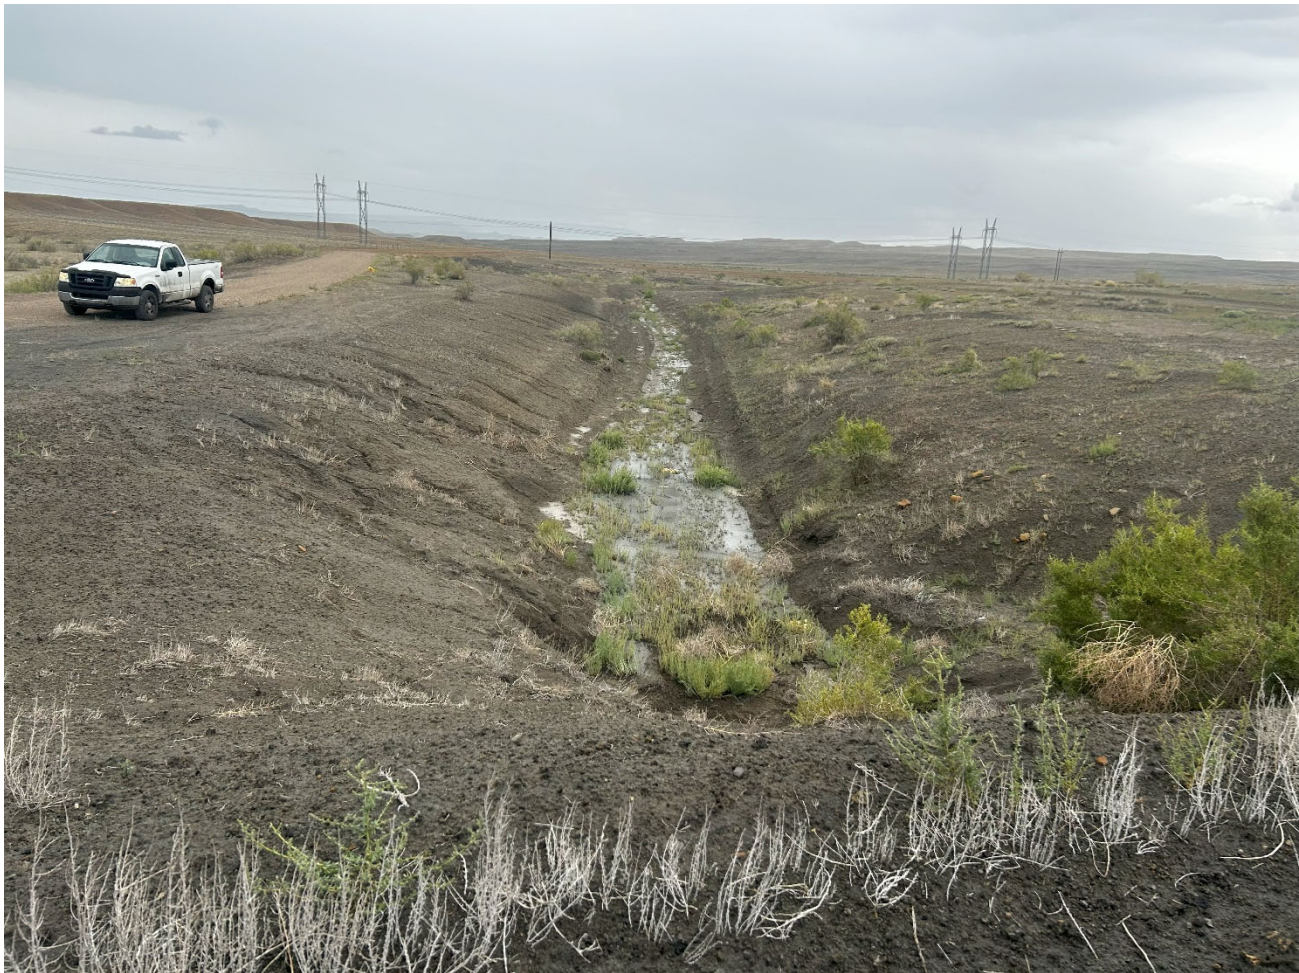
Photo Number: 24	Date: 8/22/2024 2:00 p.m.
Location: Hunter CCR Landfill	Comments: Looking east above outlet of culvert shown in Photograph 21 towards where drainage channel discharges to Retention Basin.

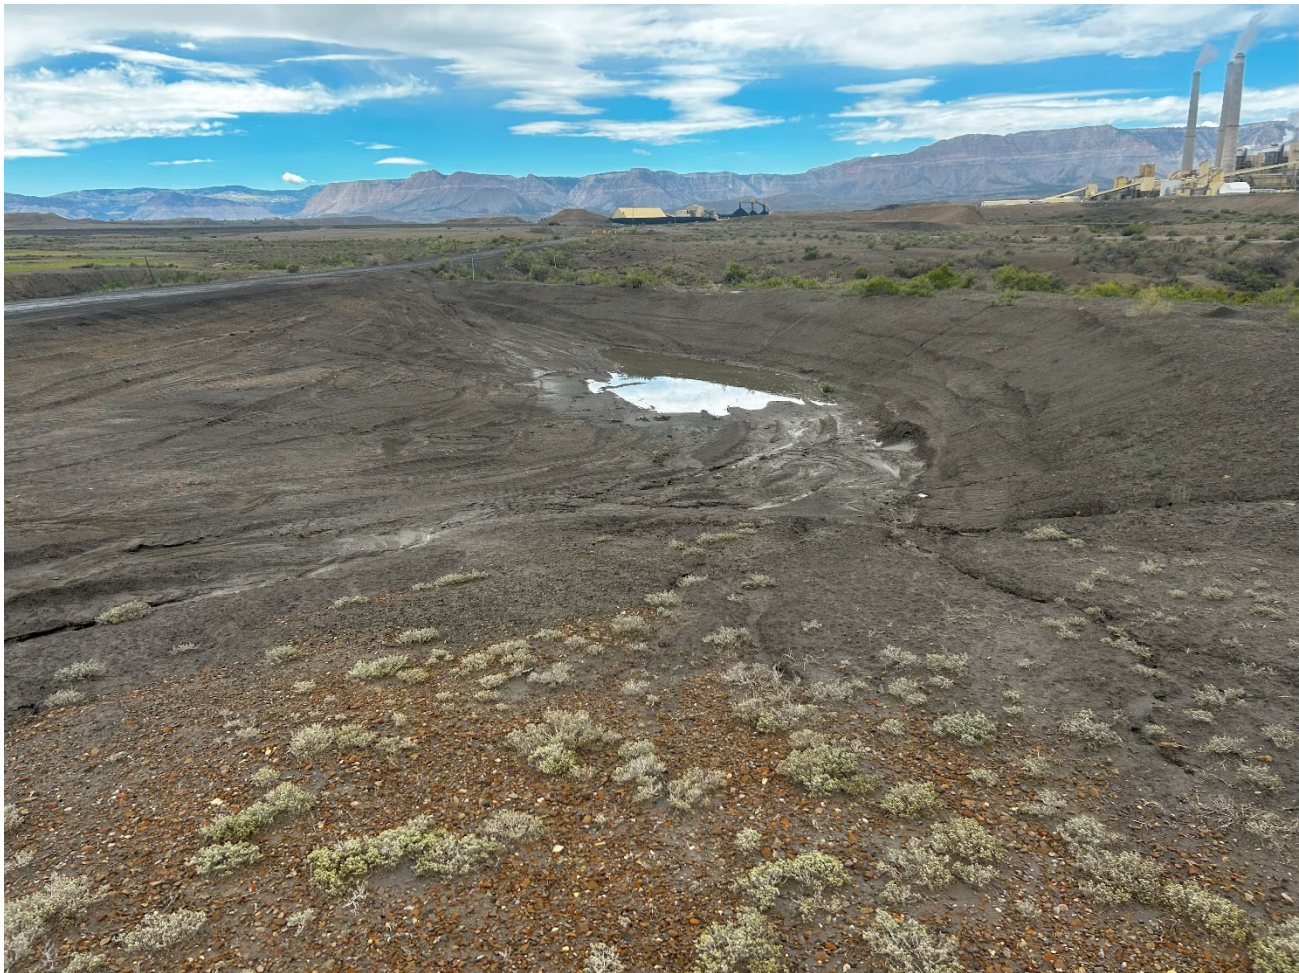
Photo Number: 25	Date: 8/22/2024 2:00 p.m.
Location: Hunter CCR Landfill	Comments: Looking east west at retention area on the right (north side) of the road. Retention area collect water from the right side of the road.

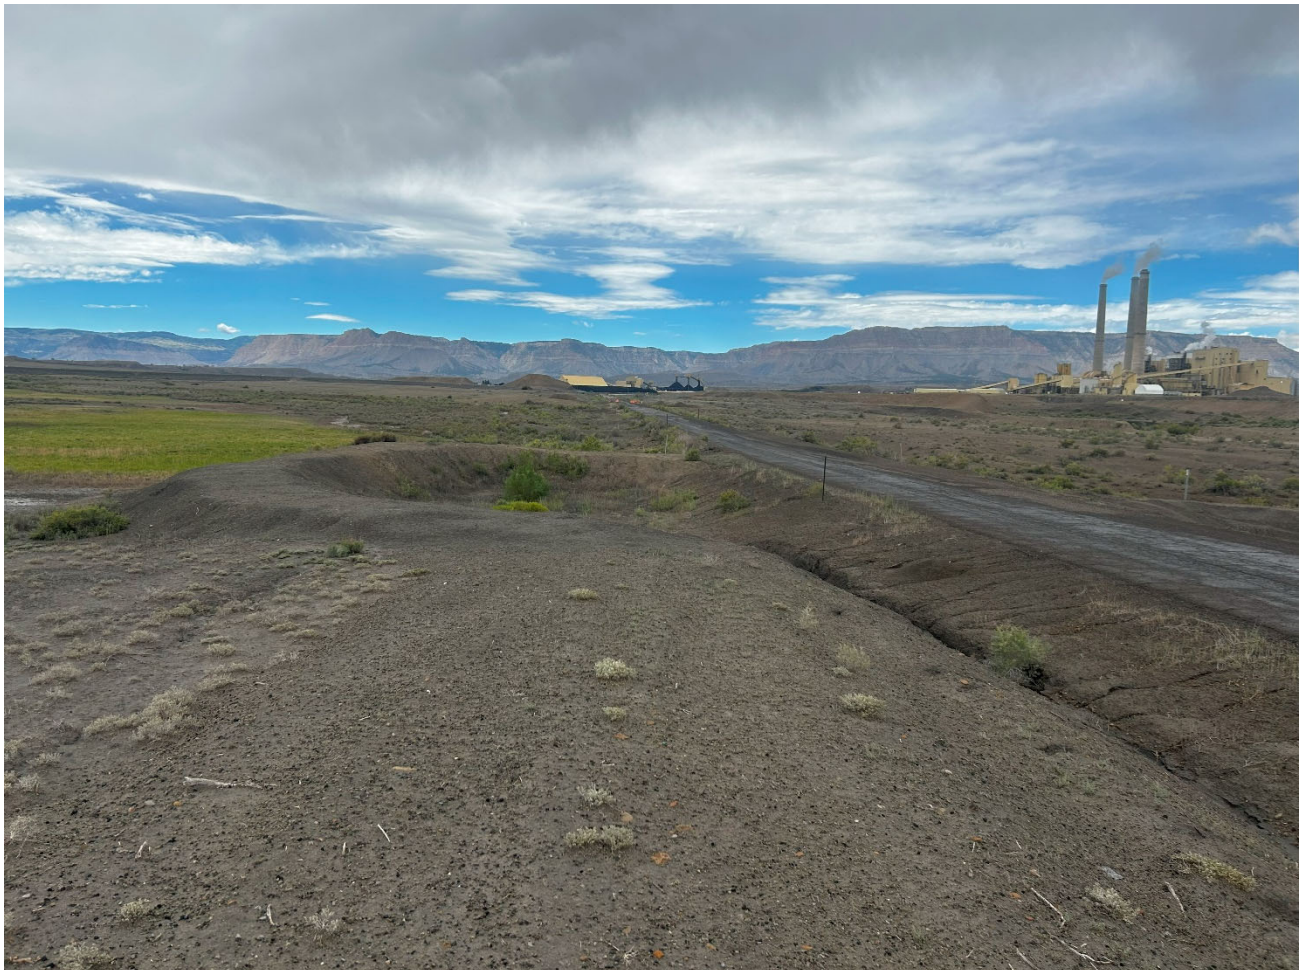
Photo Number: 26	Date: 8/22/2024 2:00 p.m.
Location: Hunter CCR Landfill	Comments: Looking east west at retention area on the left (south side) of the road. Retention area collect water from the left side of the road.
