2020 Coal Combustion Residuals Annual Inspection

Jim Bridger Power Plant *Industrial Landfill*

FINAL December 18, 2020

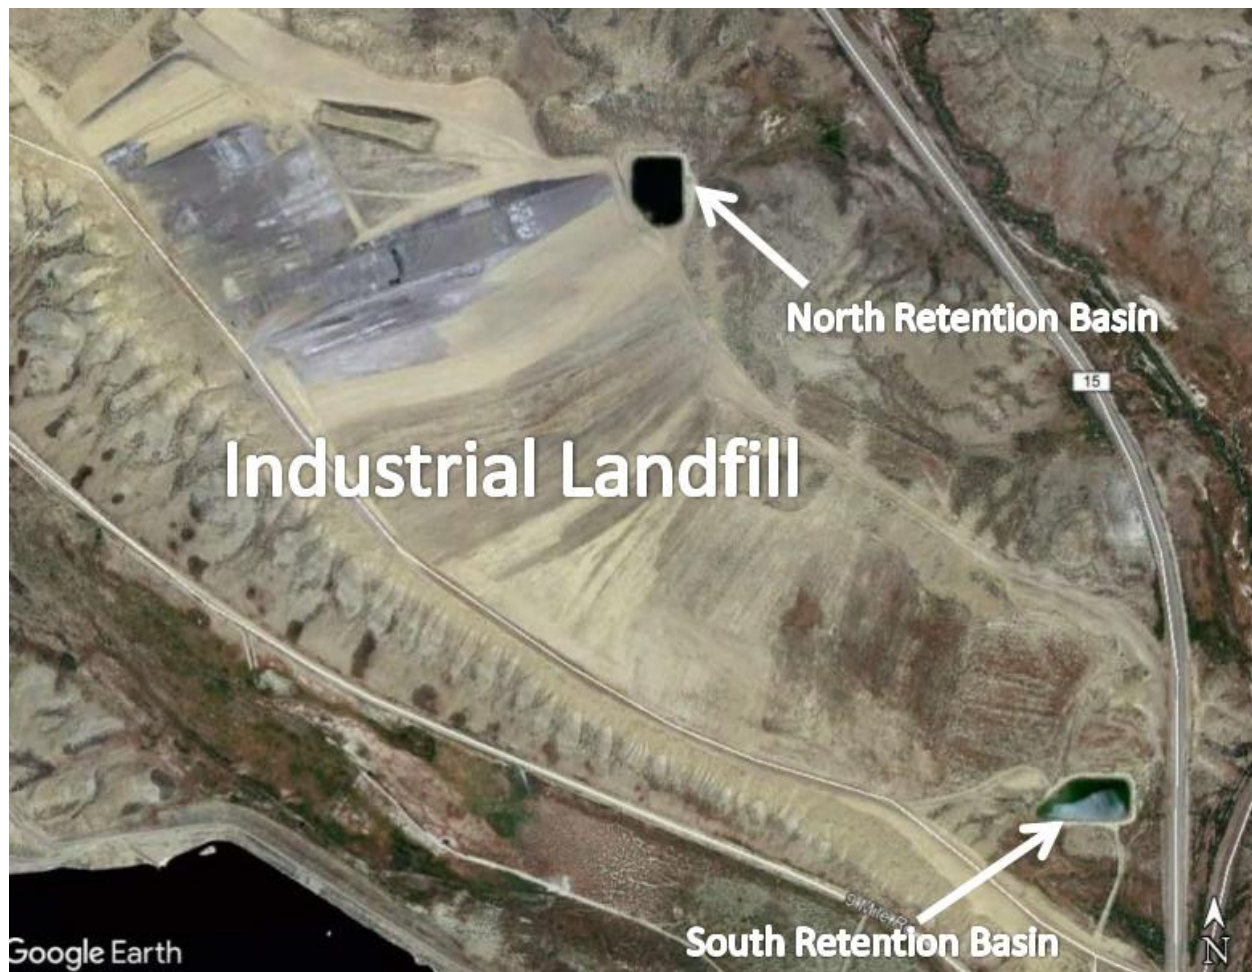
Figure 1-1. Jim Bridger Power Plant Industrial Landfill

AECOM found no observations that would indicate imminent failure of the landfill slopes for the Jim Bridger Power Plant Industrial Landfill. There is no indication of movement of the embankment. Figure 1-1 is an aerial photograph of the landfill and retention basins taken June 24, 2017.

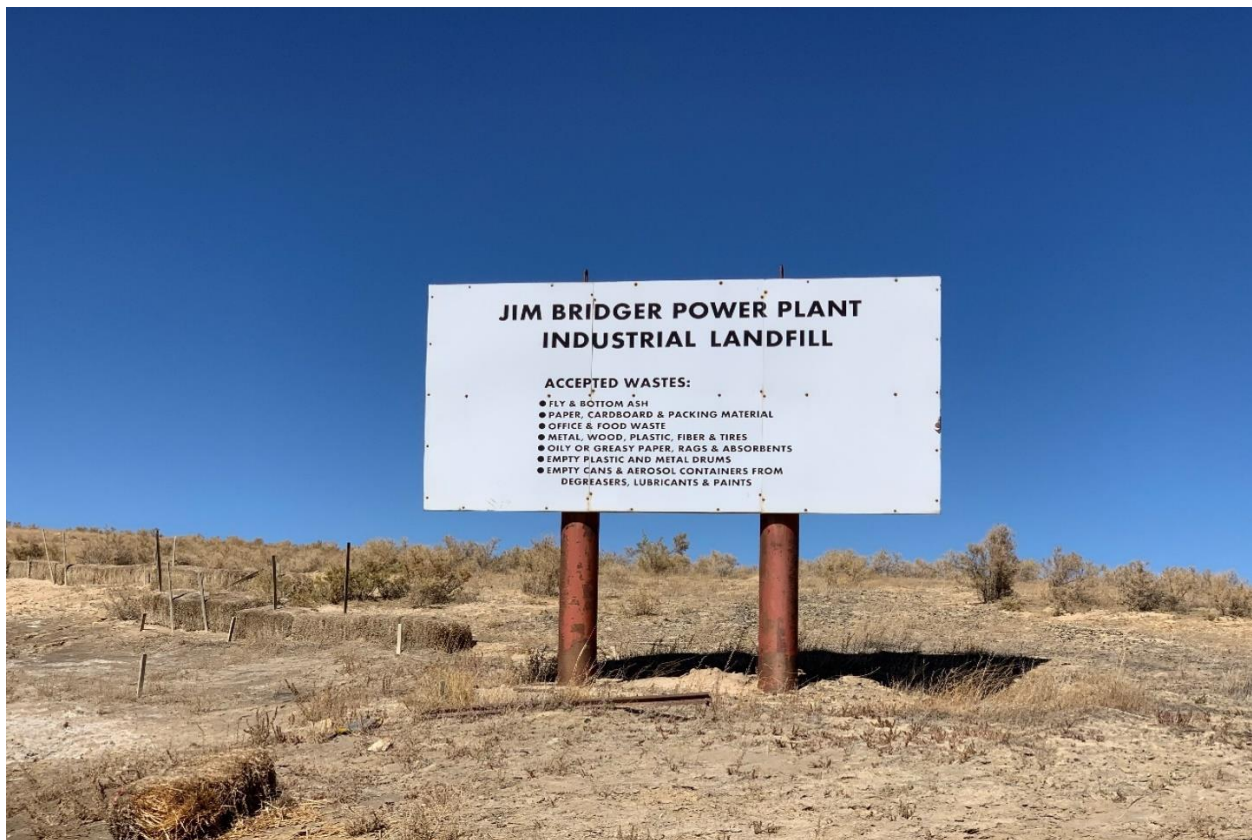
Photograph No. 1 View of industrial landfill signage indicating name and accepted wastes.

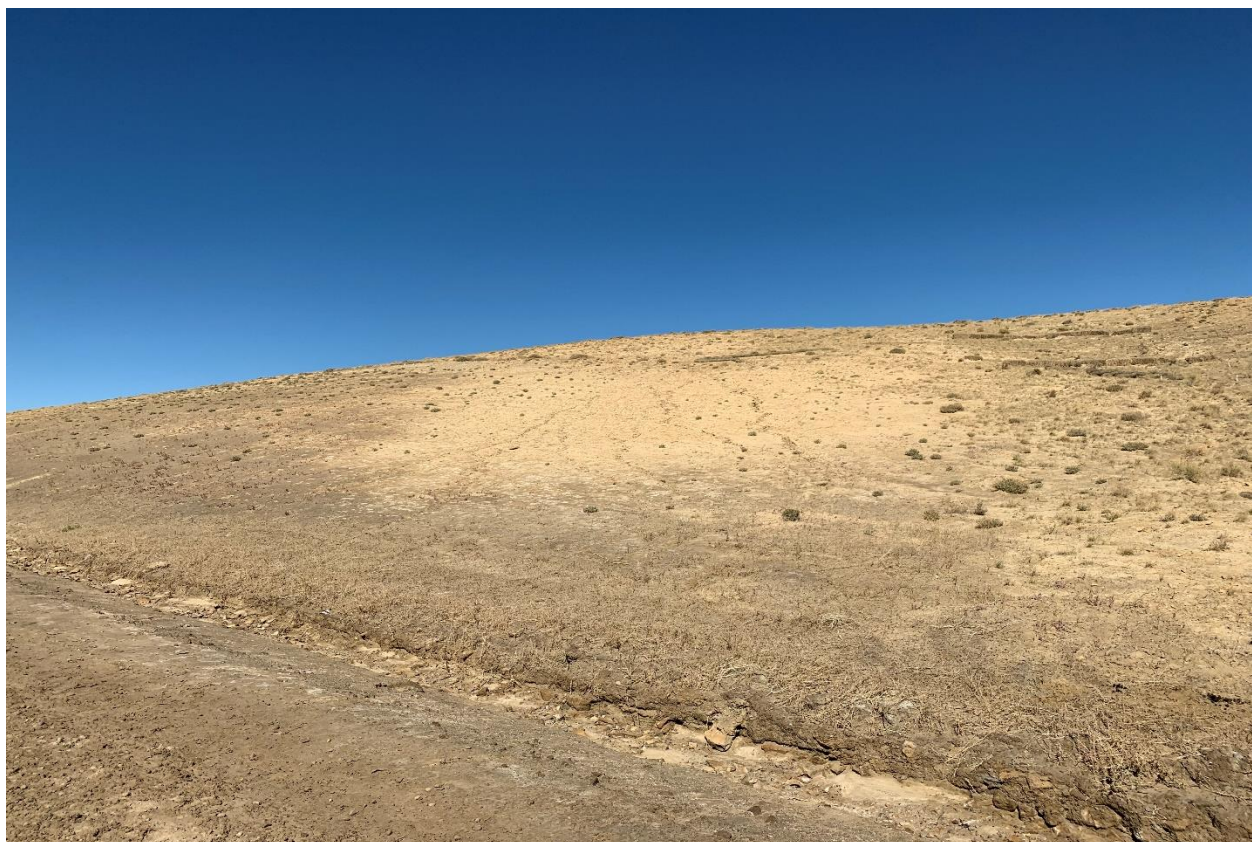
Observations from the 2020 inspection found areas of minor erosion of the final cover consistent with erosion observed in 2019 (refer to Photos 2, 3, and 4, Appendix A). There were no indications of movement of the embankments. The South Retention Basin was observed to have some water and approximately 10 feet of freeboard. The North Retention basin also had some water and approximately 10 feet of freeboard, providing storage capacity in both in the event of a high runoff (photos 9, 11, 12).

Photograph No. 2 View of minor erosional features of existing cap.

COVER	PROBLEMS				COVER
	<input type="checkbox"/> 1. None <input type="checkbox"/> 2. Animal burrows <input type="checkbox"/> 3. Animal damage <input type="checkbox"/> 4. Weeds & Brush	<input type="checkbox"/> 5. Vegetation >2" dia. <input type="checkbox"/> 6. Vegetation islands <input type="checkbox"/> 7. Poor grass cover <input type="checkbox"/> 8. Slope Stability	<input type="checkbox"/> 9. Settlement <input type="checkbox"/> 10. Cracks <input checked="" type="checkbox"/> 11. Erosion <input checked="" type="checkbox"/> 12. Rills	<input type="checkbox"/> 13. Seepage <input type="checkbox"/> 14. Ponding <input type="checkbox"/> 15. Other	<input checked="" type="checkbox"/> Vegetation <input type="checkbox"/> Gravel <input checked="" type="checkbox"/> Soil <input checked="" type="checkbox"/> Other Temp bottom ash
	Comments /Action Items : Minor erosion of placed cap. Photos 2, 3, and 4 of photo log.

Actions <input type="checkbox"/> None <input checked="" type="checkbox"/> Maintenance <input type="checkbox"/> Monitoring <input type="checkbox"/> Minor Repair <input type="checkbox"/> Engineering				
SLOPES & PERIMETER BERMS	PROBLEMS				COVER:
	<input checked="" type="checkbox"/> 1. None <input type="checkbox"/> 2. Animal burrows <input type="checkbox"/> 3. Animal damage <input type="checkbox"/> 4. Weeds & Brush	<input type="checkbox"/> 5. Vegetation >2" dia. <input type="checkbox"/> 6. Bare spots >25ft ² <input type="checkbox"/> 7. Poor grass cover <input type="checkbox"/> 8. Slope Stability	<input type="checkbox"/> 9. Settlement <input type="checkbox"/> 10. Cracks <input type="checkbox"/> 11. Erosion <input type="checkbox"/> 12. Rills	<input type="checkbox"/> 13. Seepage <input type="checkbox"/> 14. Ponding <input type="checkbox"/> 15. Other	<input type="checkbox"/> Vegetation <input type="checkbox"/> Gravel <input type="checkbox"/> Soil <input type="checkbox"/> Asphalt <input type="checkbox"/> Other

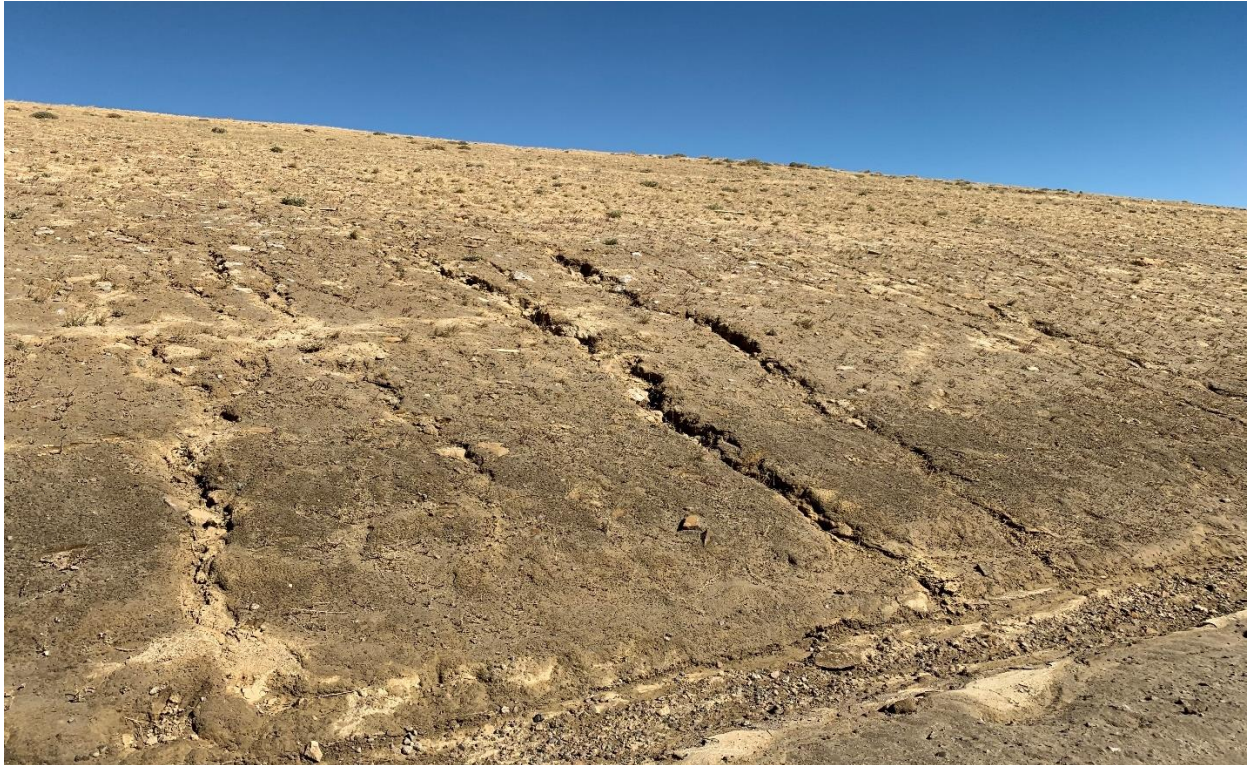
Photograph No. 3 View of minor erosional rill of existing cap.

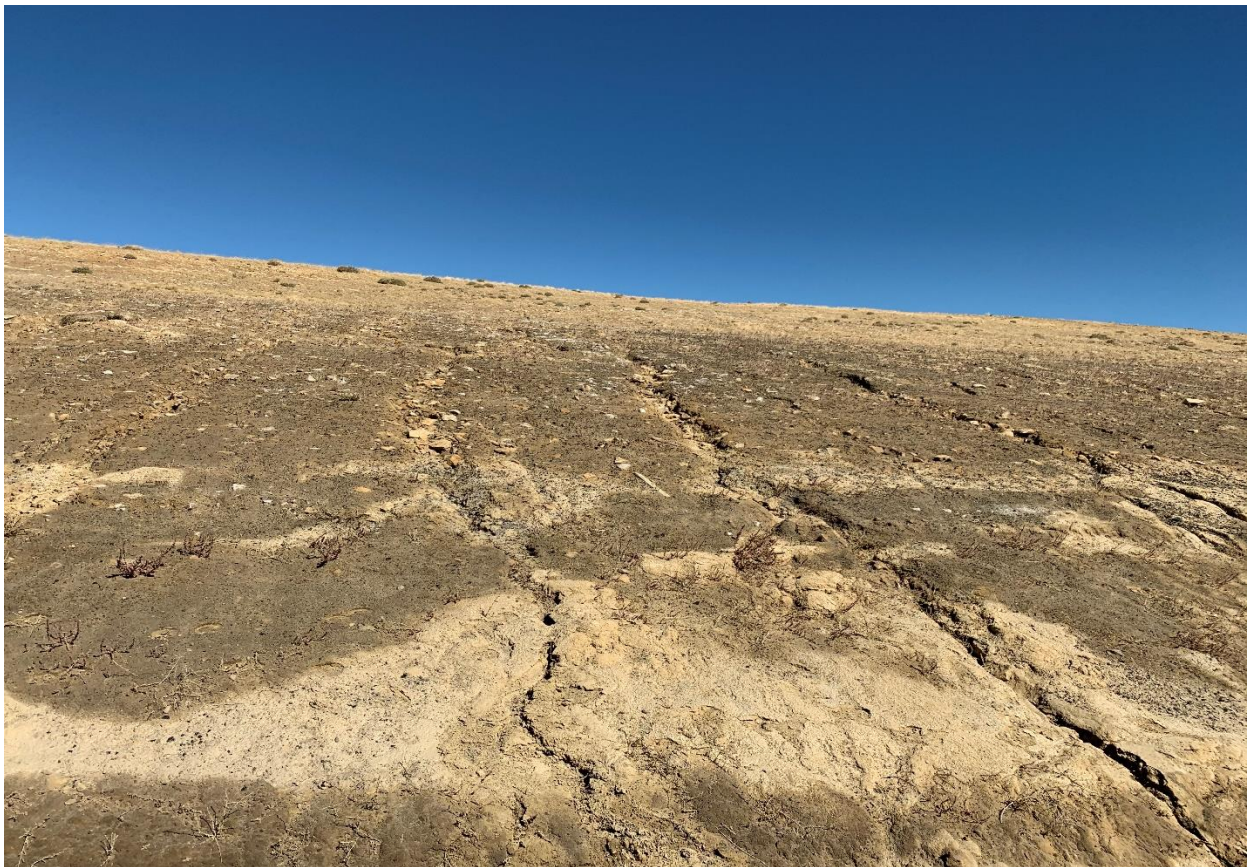
Photograph No. 4 View of minor erosional rill of existing cap.

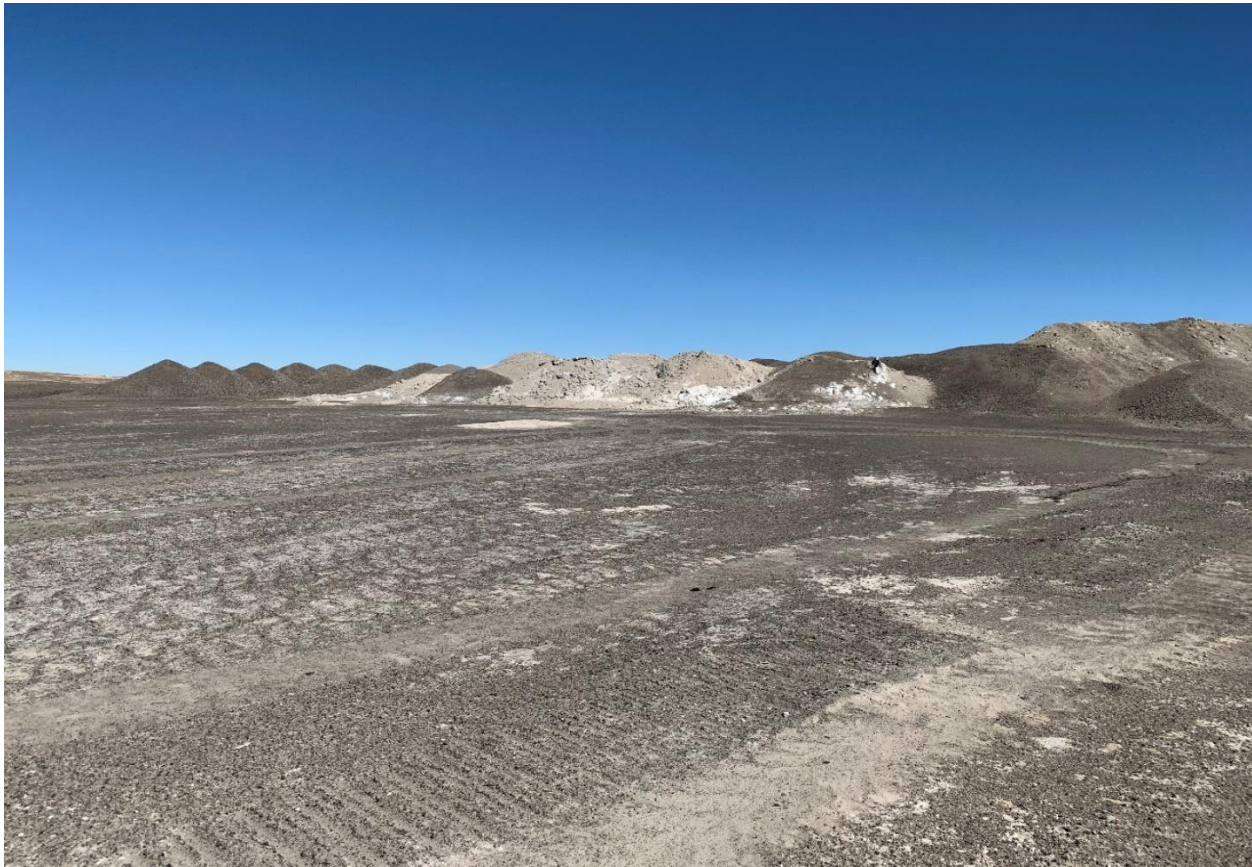
Photograph No. 5 View of active CCR placement area, looking northeast.

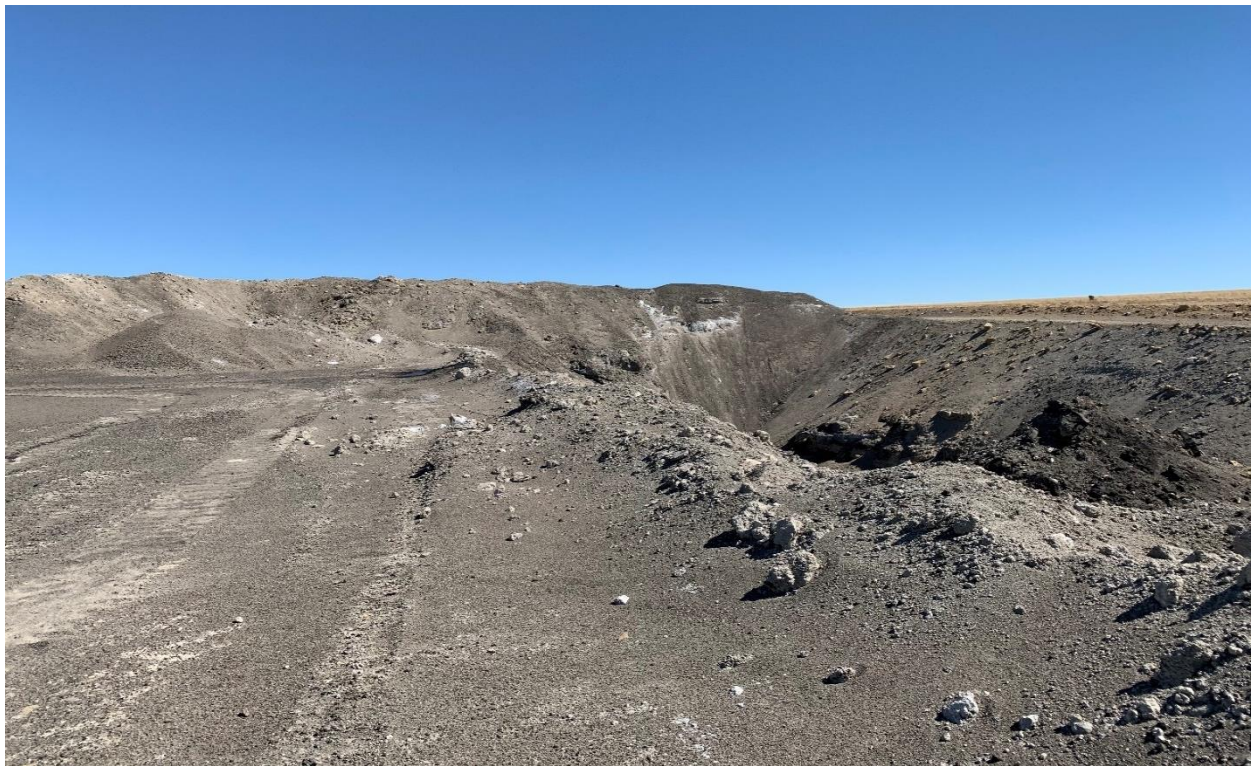
Photograph No. 6 View of active CCR placement area, looking east.

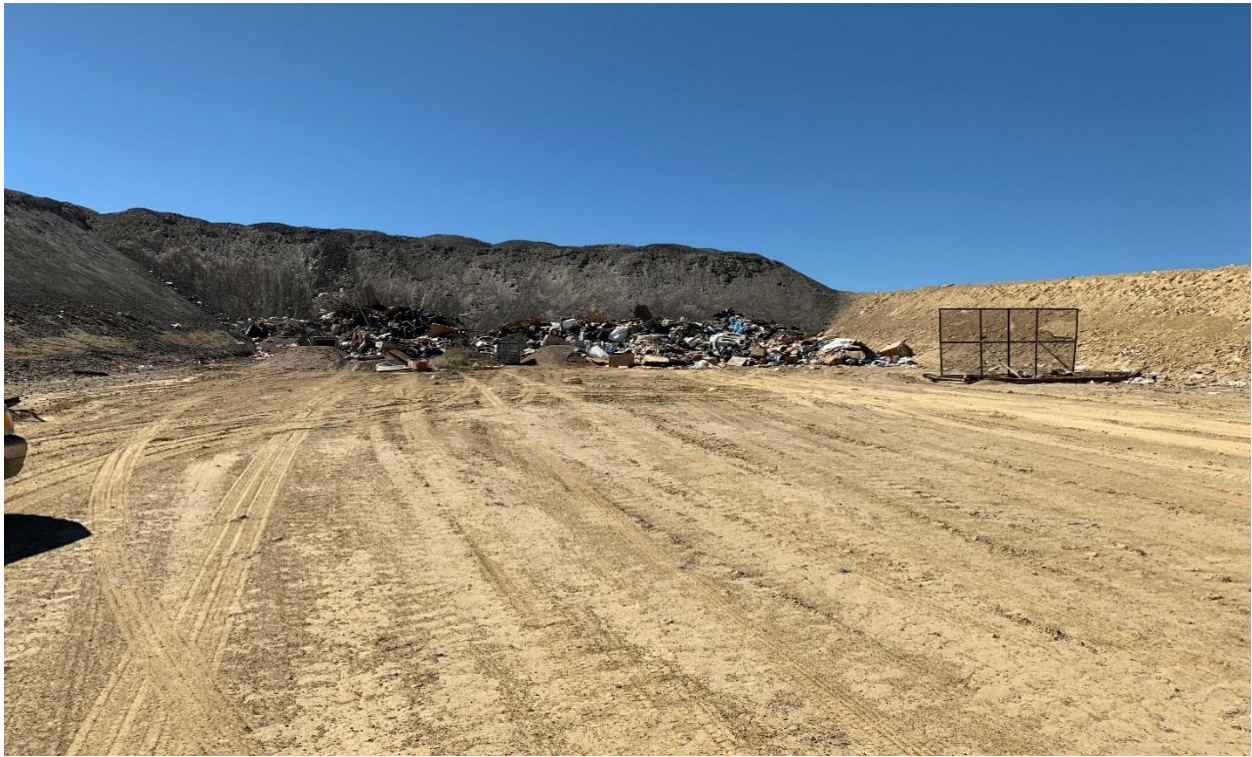
Photograph No. 7 View of industrial waste placement on northwest edge of ash, looking southwest.

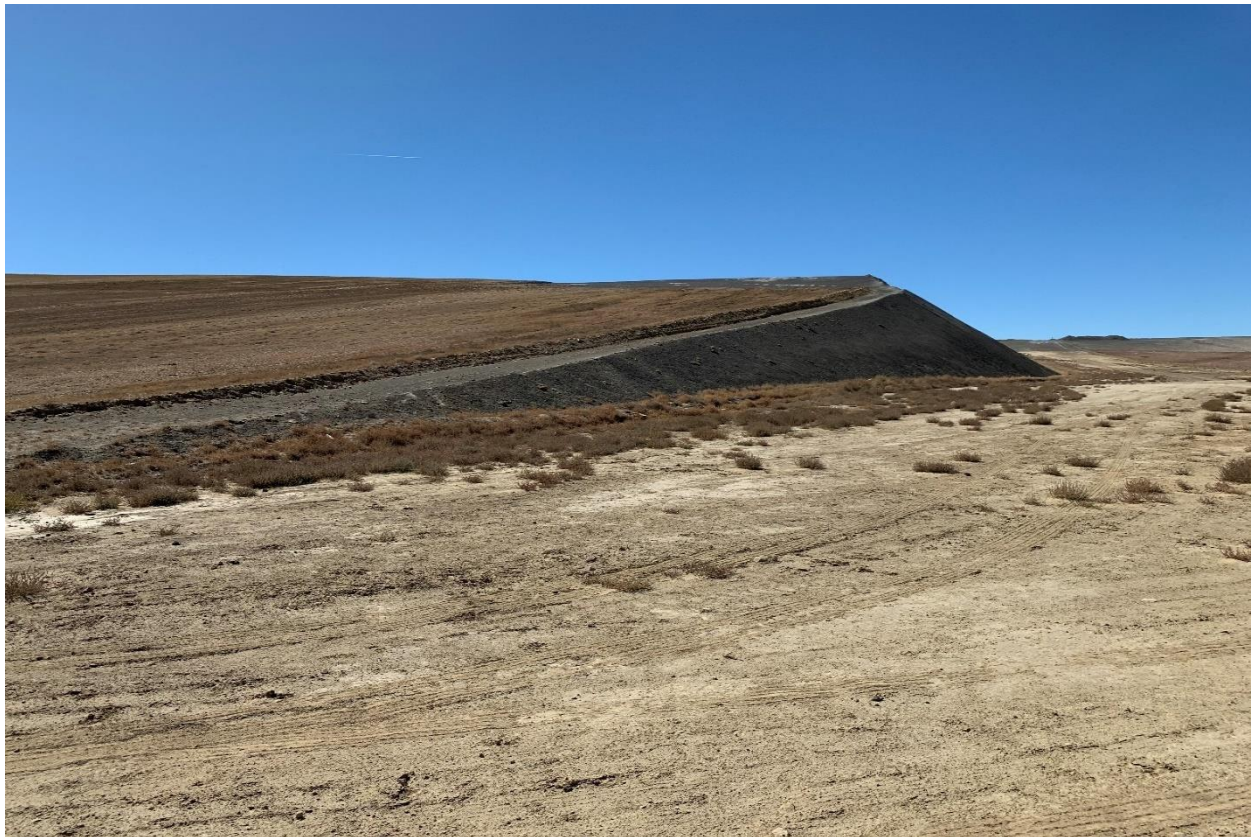
Photograph No. 8 View of edge of placement area, looking southwest.

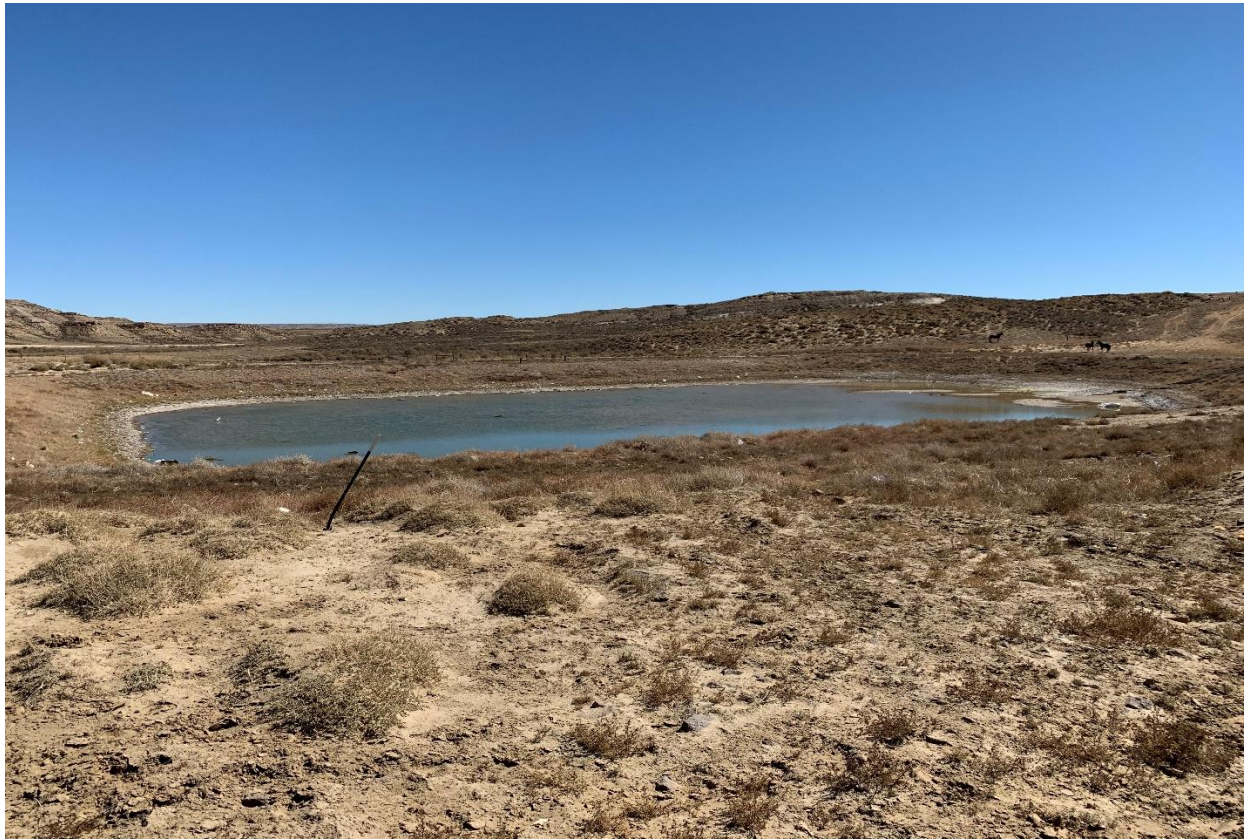
Photograph No. 9 View of Northern Retention Basin. Note wild horses at far edge. Looking east.

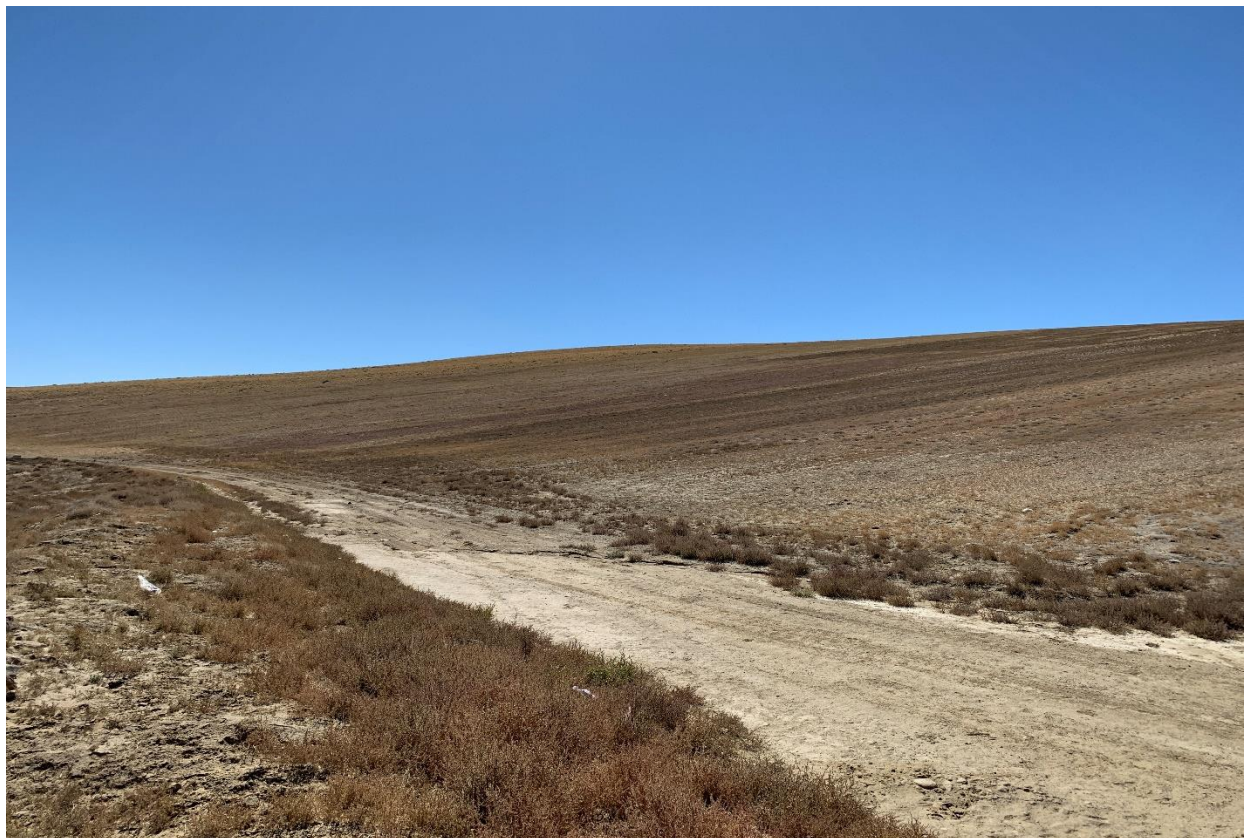
Photograph No. 10 View of final cap and sparse vegetation on eastern slope of landfill.

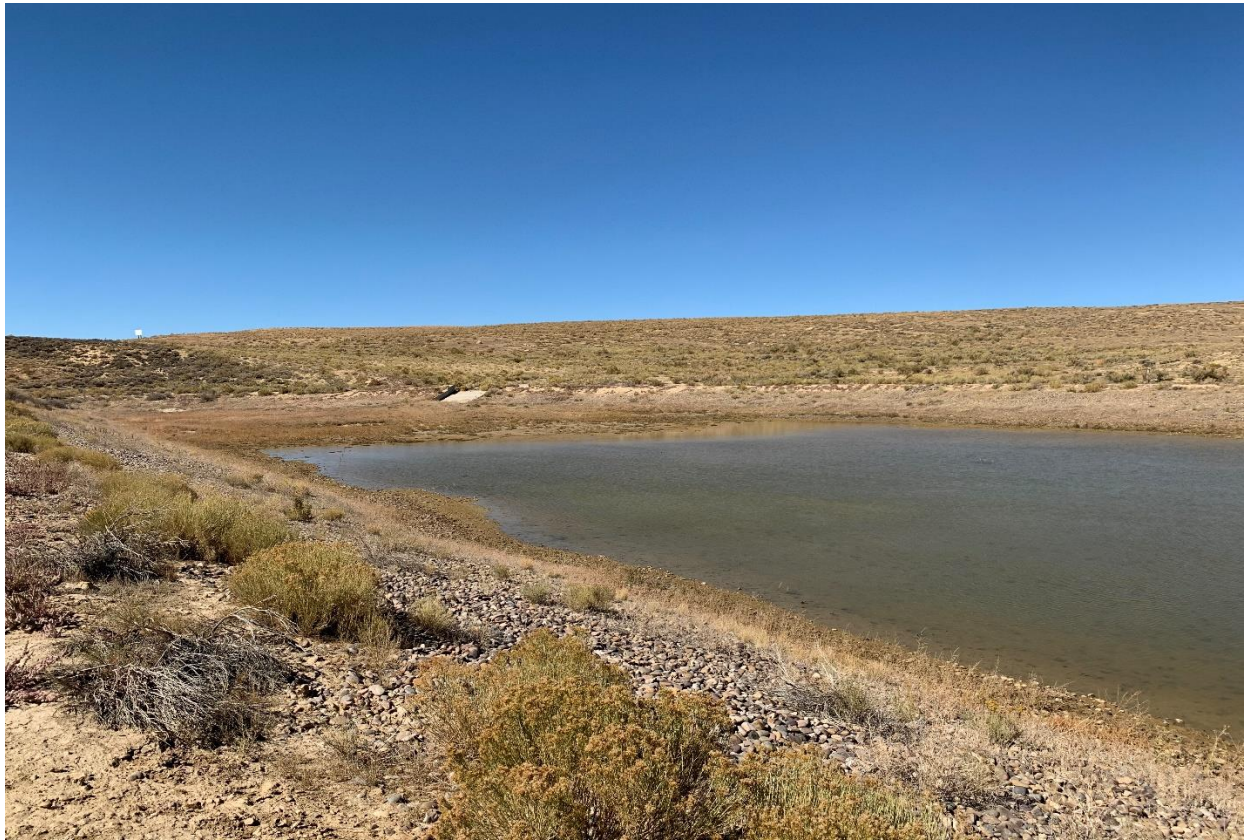
Photograph No. 11 View of South Retention Basin, looking northwest.

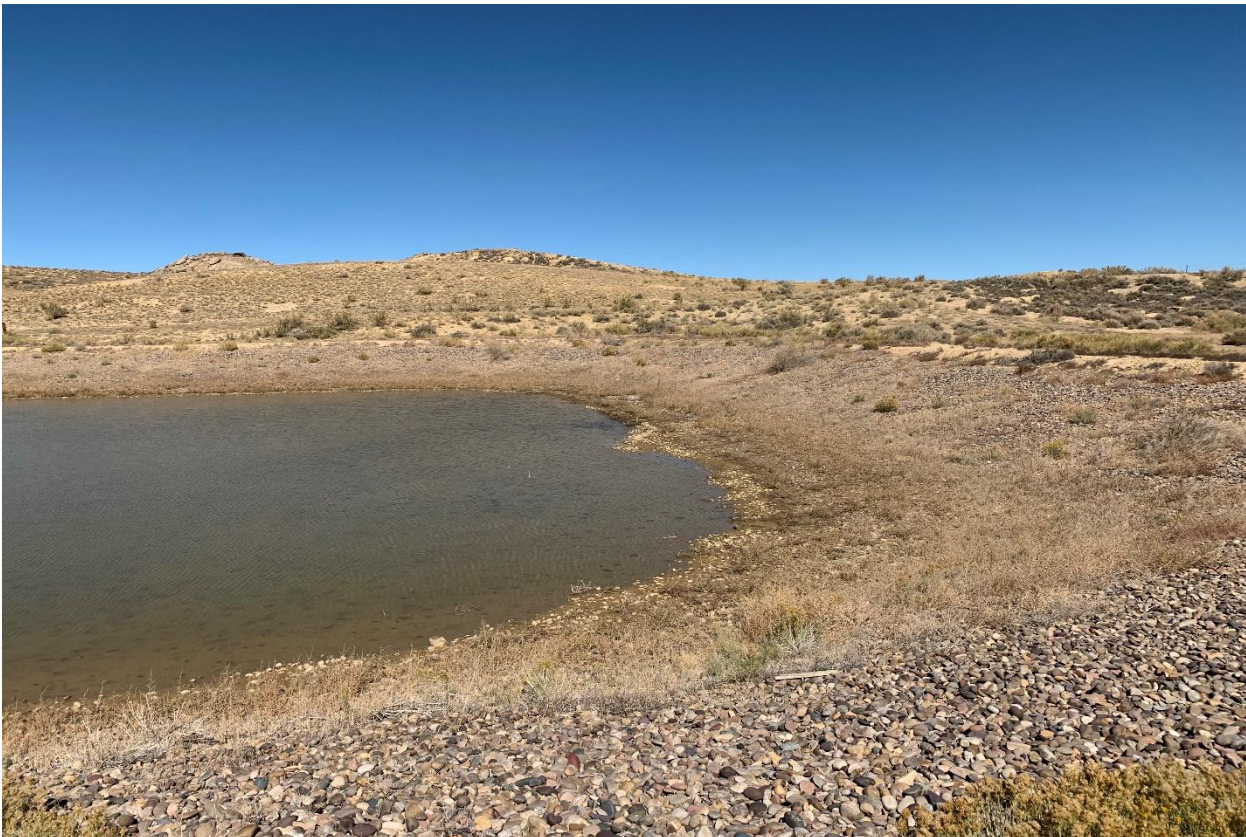
Photograph No. 11 View of South Retention Basin, looking northeast.
