# 2019 Coal Combustion Residuals Annual Inspection

## Naughton Power Plant

### *North Ash Pond*

November 21, 2019

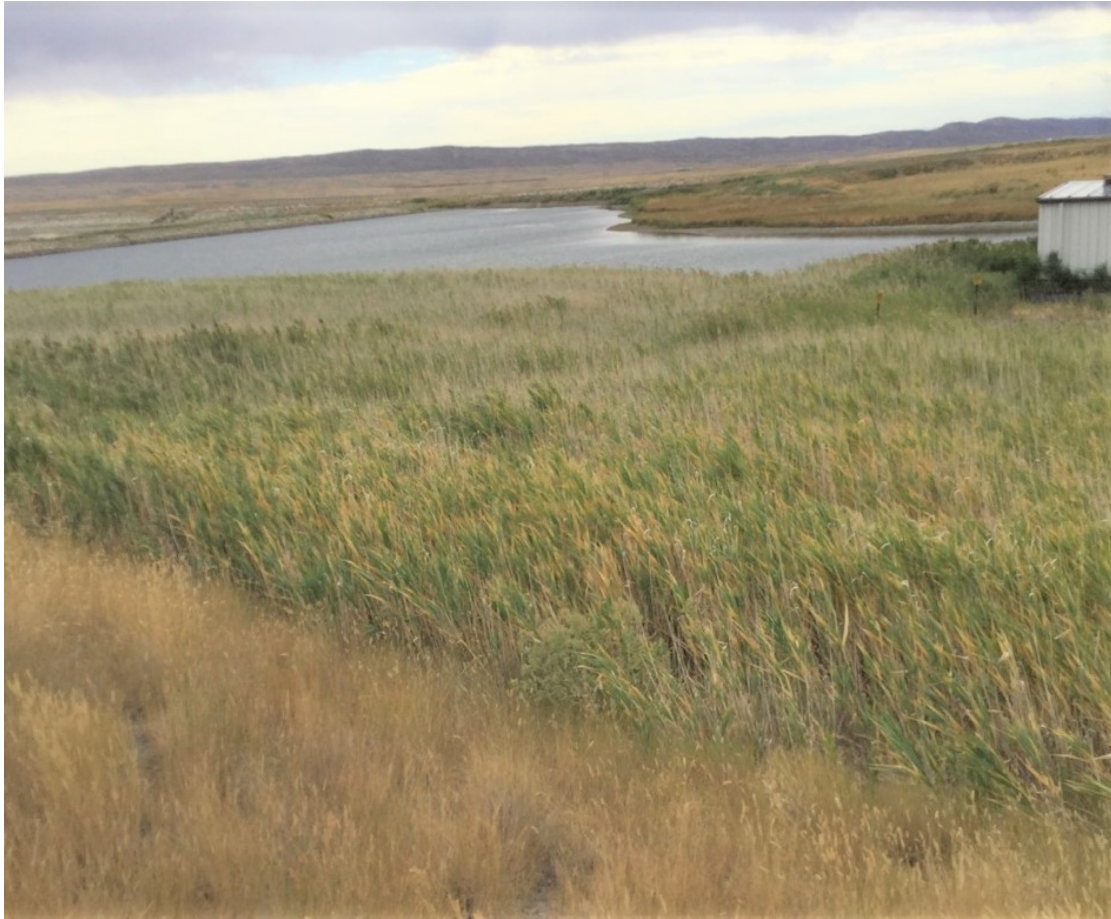
The CHA report [5] did not identify the wet area below the toe near the right abutment but the area is shown on photographs in the report. Refer to this report's Photo 1, Appendix A.

**Photograph No. 1 View of vegetation on downstream toe of southeast embankment.**

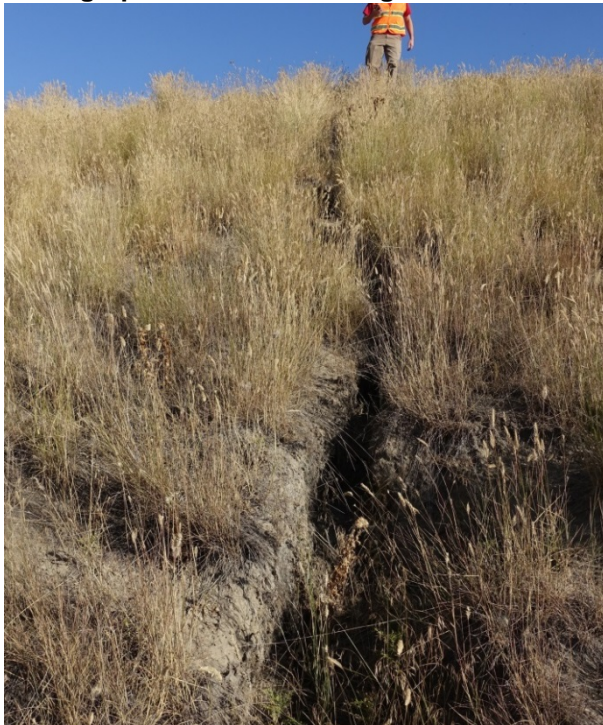
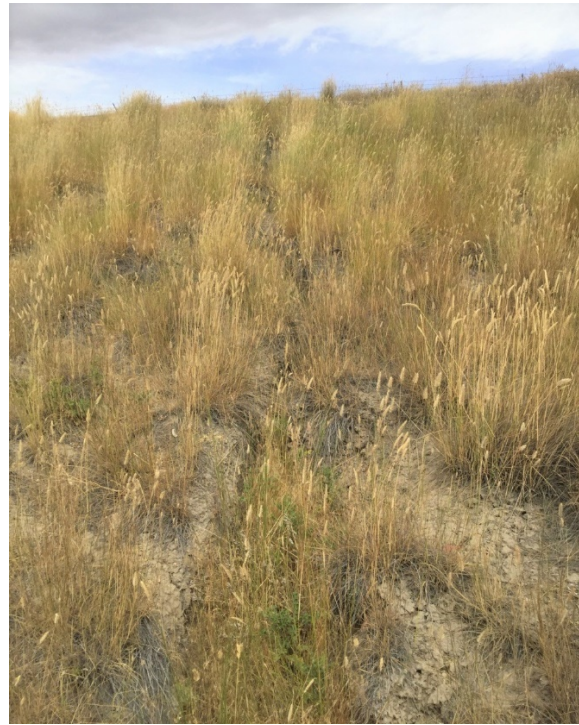
1. An erosion rill related to crest runoff that was also present in previous inspections (Photo 2, Appendix A). Incision appears to be less than prior inspections.
2. Erosion near outlet works (Photos 6 and 7, Appendix A).
3. Early growth woody vegetation (Photo 9, Appendix A).
4. Unusually accumulation of tumbleweeds. (Photo 10, Appendix A).
5. Animal burrows (Photos 11, 12 and 13, Appendix A).

**Photograph No. 2 Erosion gully on southeast embankment of North Ash Pond. Right photo is 2019. Compared to 2017 photo (left). It shows that this is nearly filled in with vegetation in 2019.**

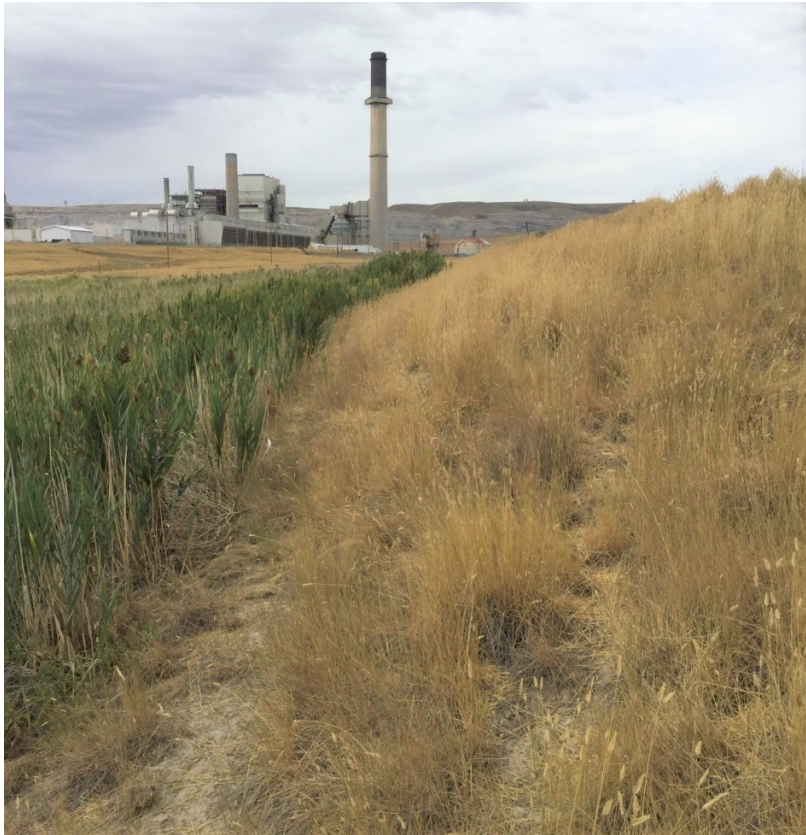
**Photograph No. 3 South-east embankment toe, view south-west.**

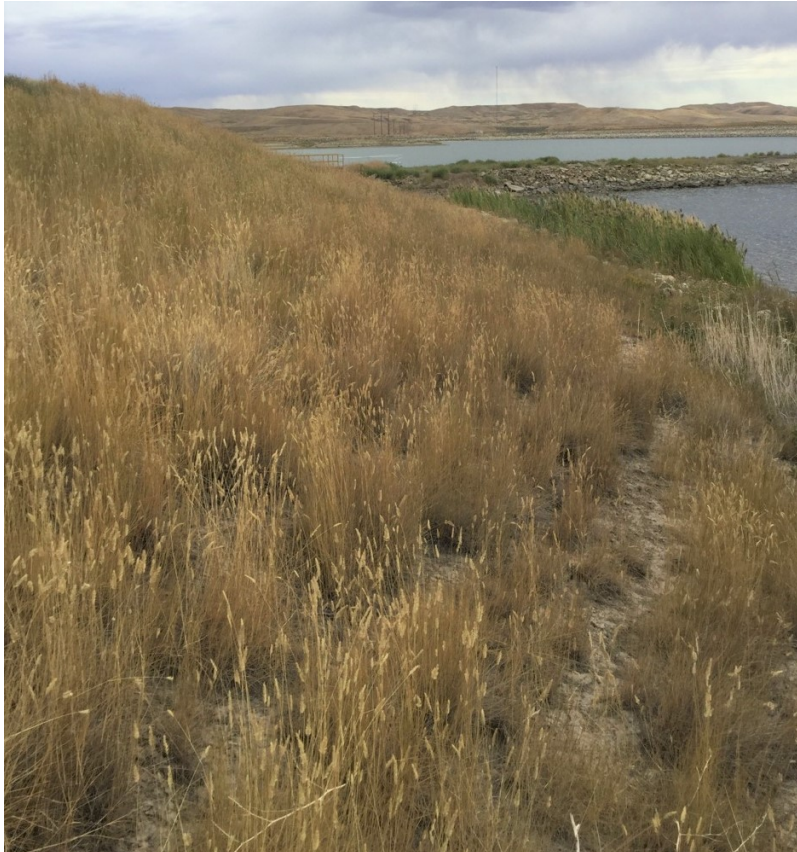
**Photograph No. 4 South-east embankment, view north-east.**

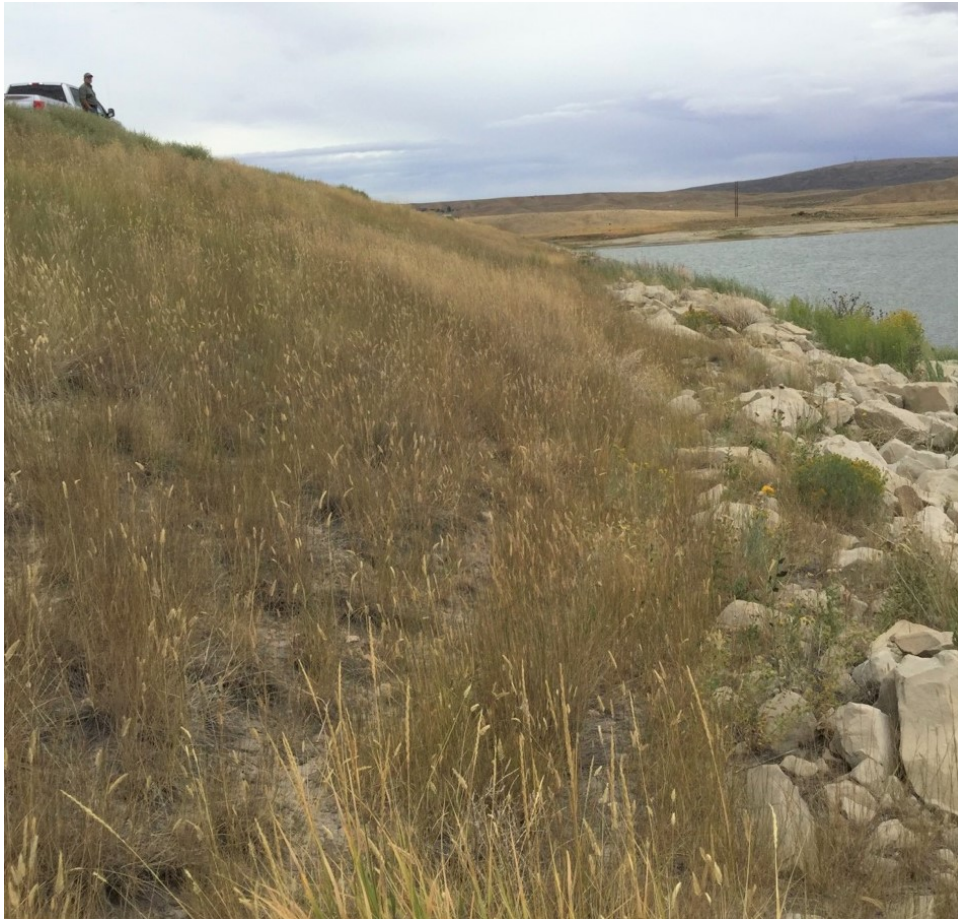
**Photograph No. 5 South-east Embankment, view north-east.**

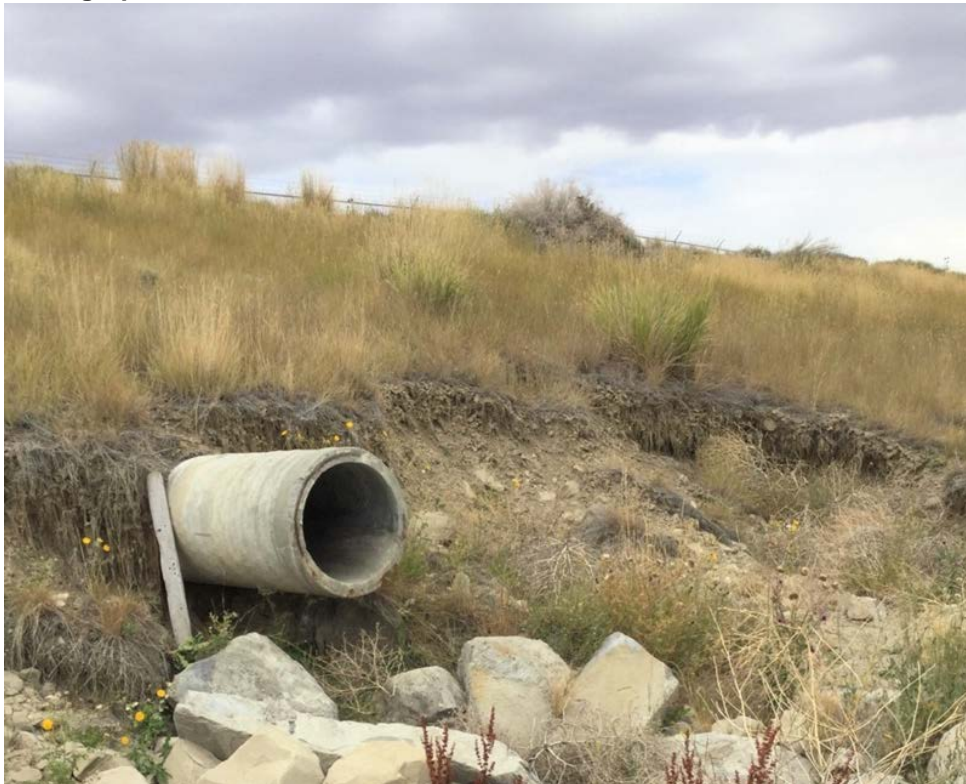
**Photograph No. 6 Erosion around outlet.**

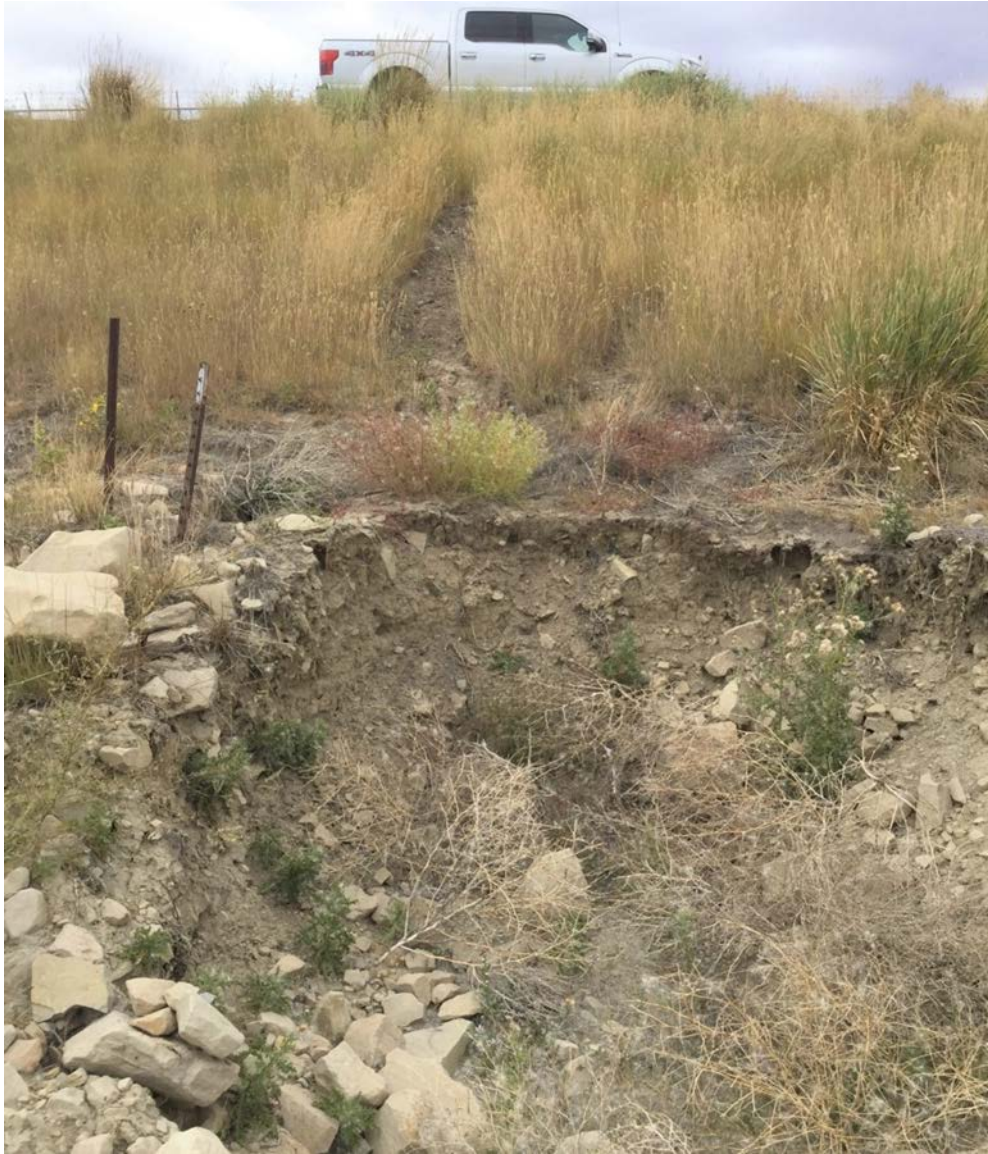
**Photograph No. 7 Erosion from prior pump discharge. No on-going pumping.**

| | Comments /Action Items : erosion caused by pumping from North Ash Pond to North Clear Pond still exists. | | | | |

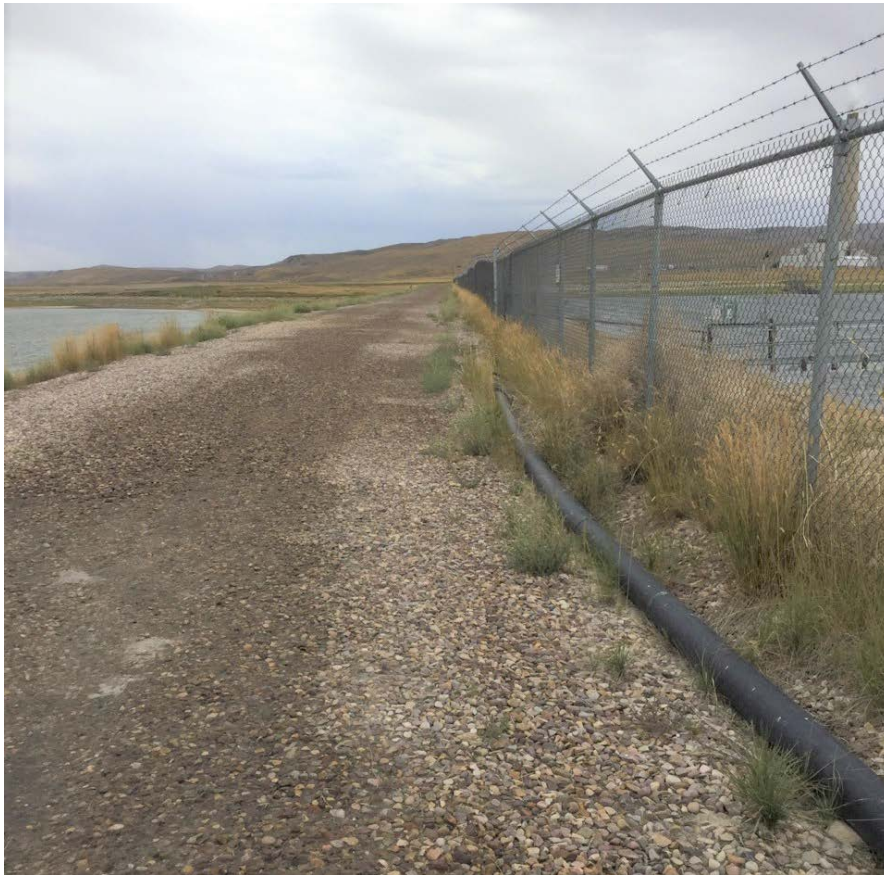
**Photograph No. 8 Crest of south embankment.**

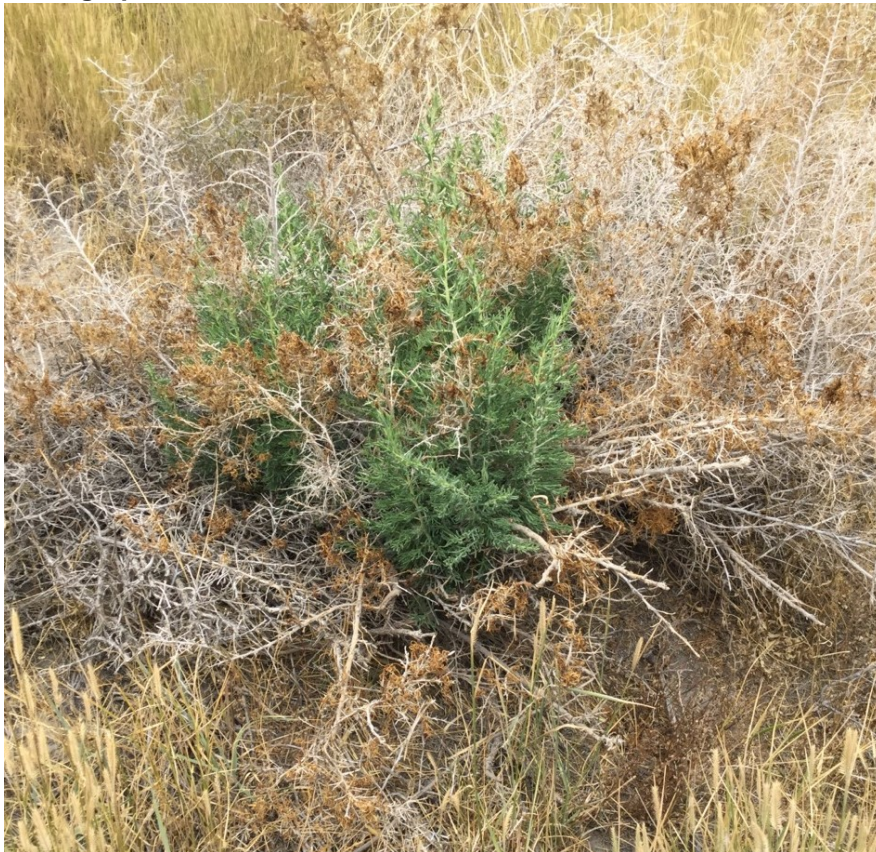
**Photograph No. 9 Early growth woody vegetation from sprayed out area.**

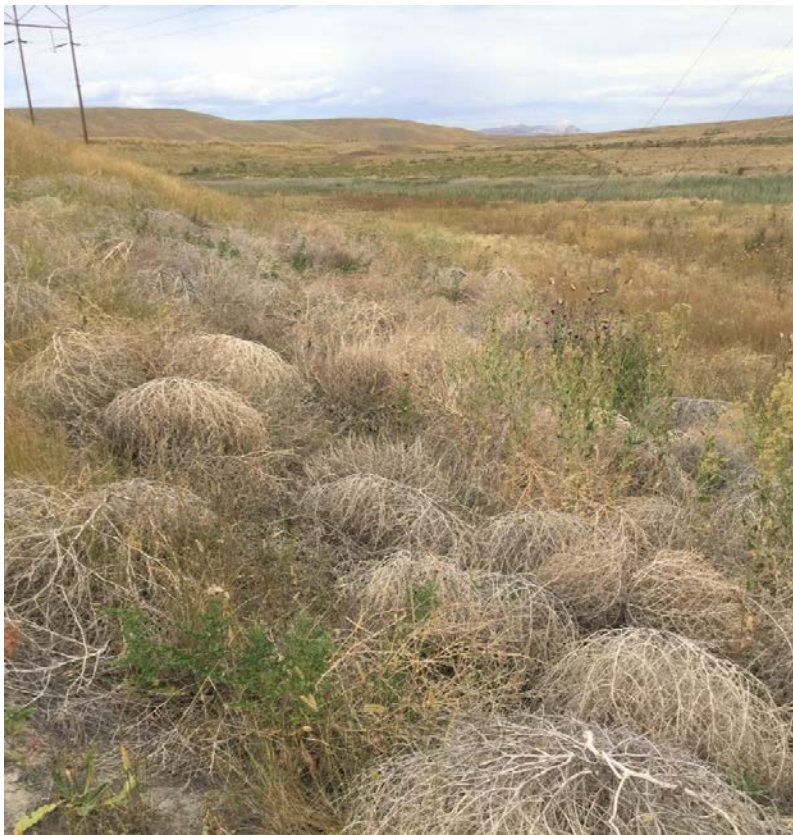
**Photograph No. 10** Unusual, large amount of tumbleweed collecting at toe of east embankment, view to north.

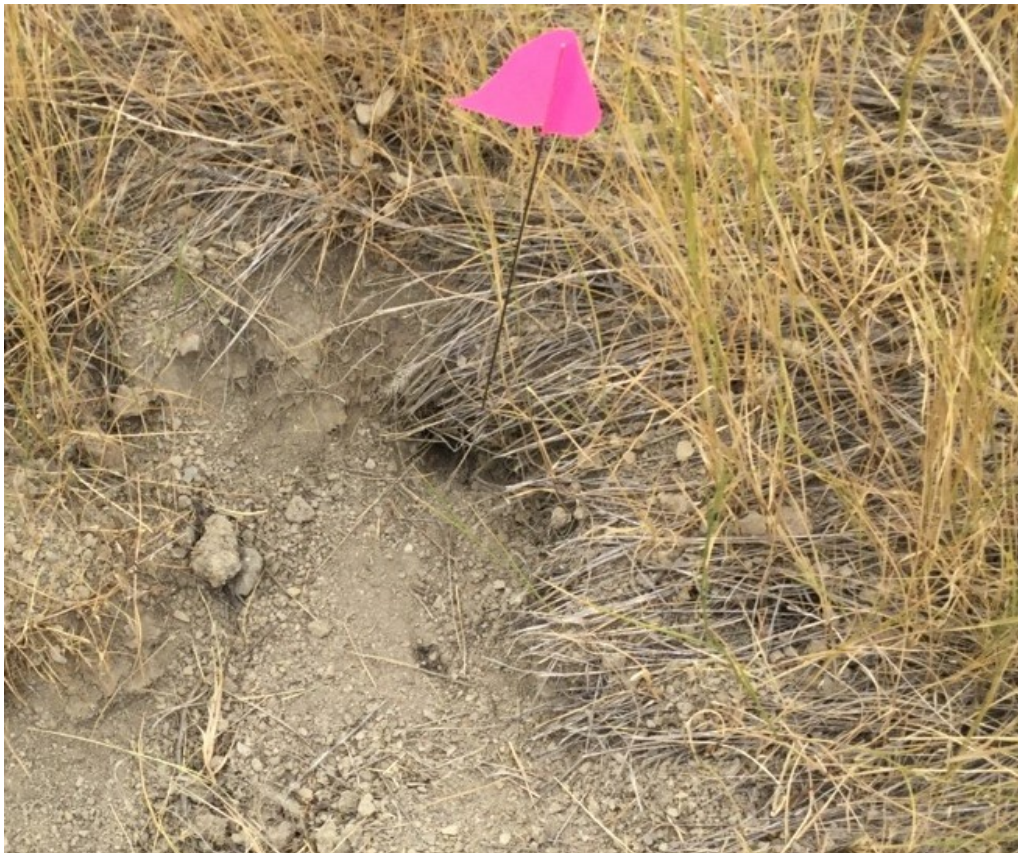
**Photograph No. 11** Rodent hole on east embankment.

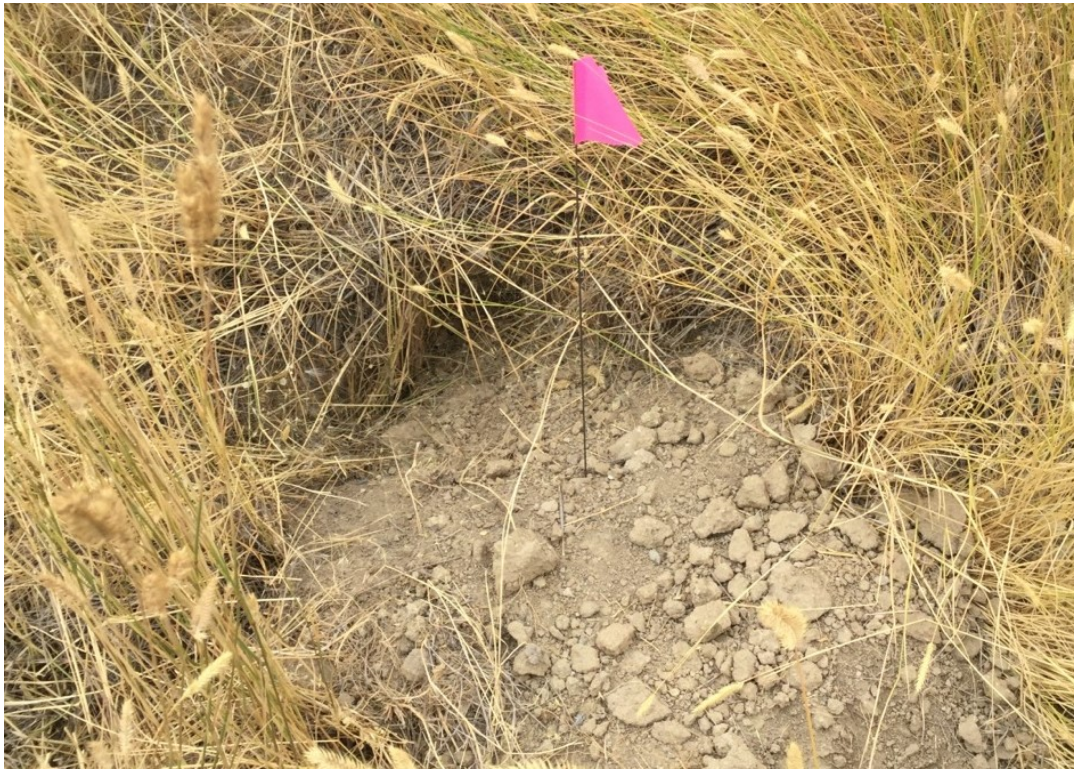
**Photograph No. 12 Second rodent hole on east embankment.**

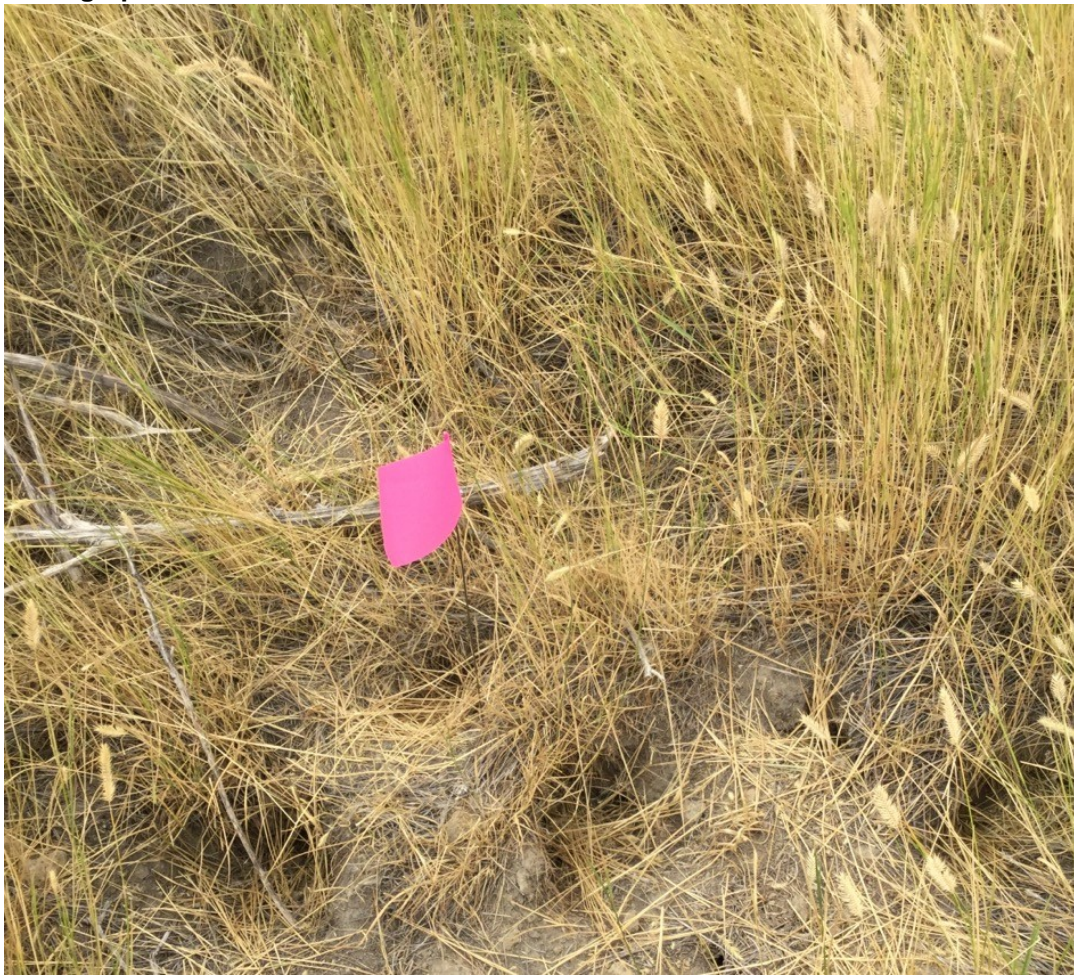
**Photograph No. 13 Third rodent hole on east embankment.**

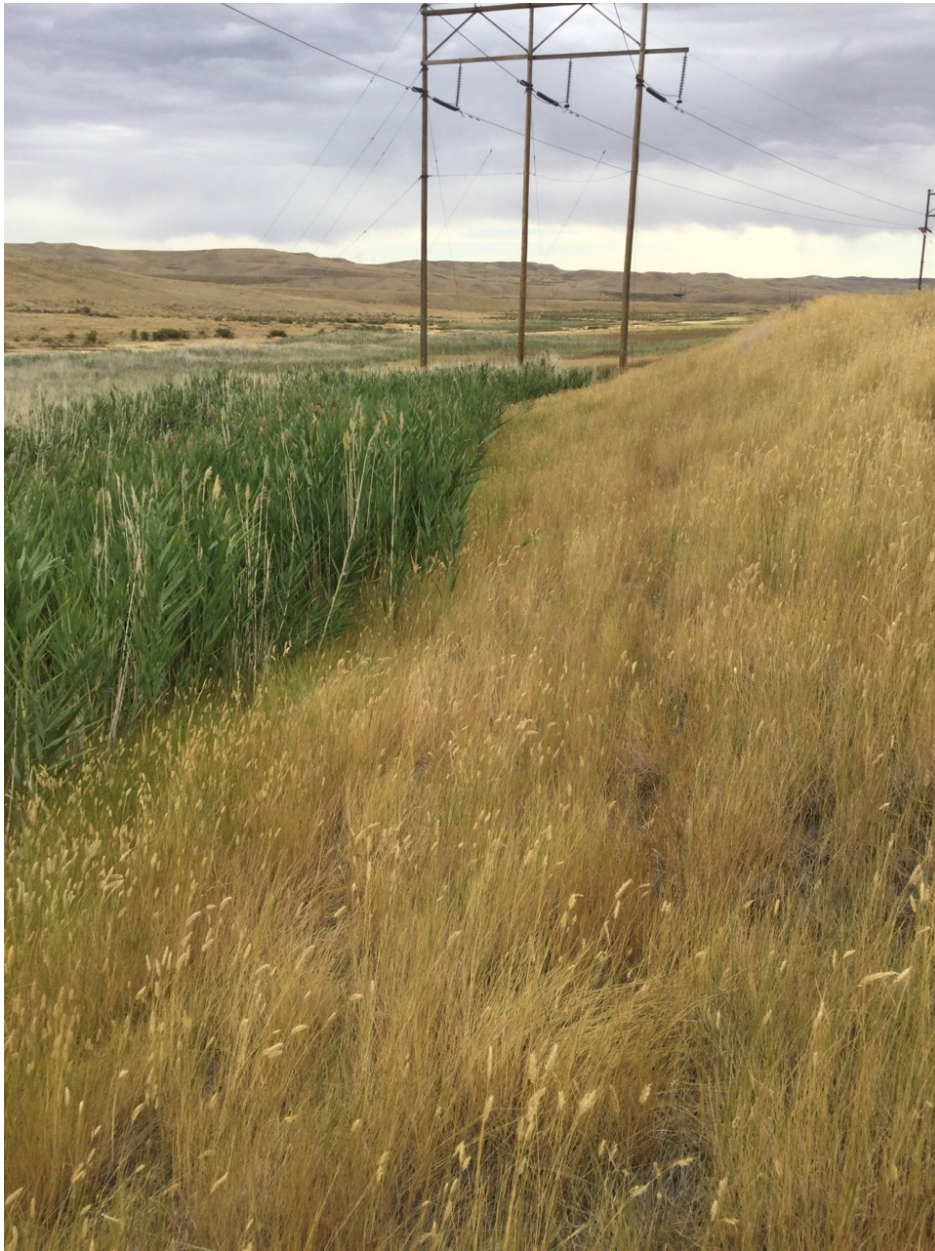
A wet area beyond the toe of the east embankment near the abutment was first documented by the 2009 Crank report [10]. The source of water was historically either FGD Pond #2 or the North Ash Pond

and was monitored. Refer to Photo 14, Appendix A. Water was historically pumped to FGD Pond 2 but during closure of FGD Pond 2, the water was pumped to FGD Ponds 4 and 5. It is no longer pumped. The vegetation appears to have receded from the 2016 inspection but not significantly since closure of FGD Pond 2.

**Photograph No.14** View of downstream slope of east embankment looking southeast.  
The vegetation appears to be approximately the same as 2017.
