**ENVIRONMENTAL INSPECTION REPORT  
(ELECTRONICALLY SUBMITTED)  
FEDERAL ENERGY REGULATORY COMMISSION**

**Region:** Portland **Inspection Date(s):** August 22, 2018

**Project:** Ashton Project **Project No.** 2381

**Licensee:** Pacificorp **Type:** Major

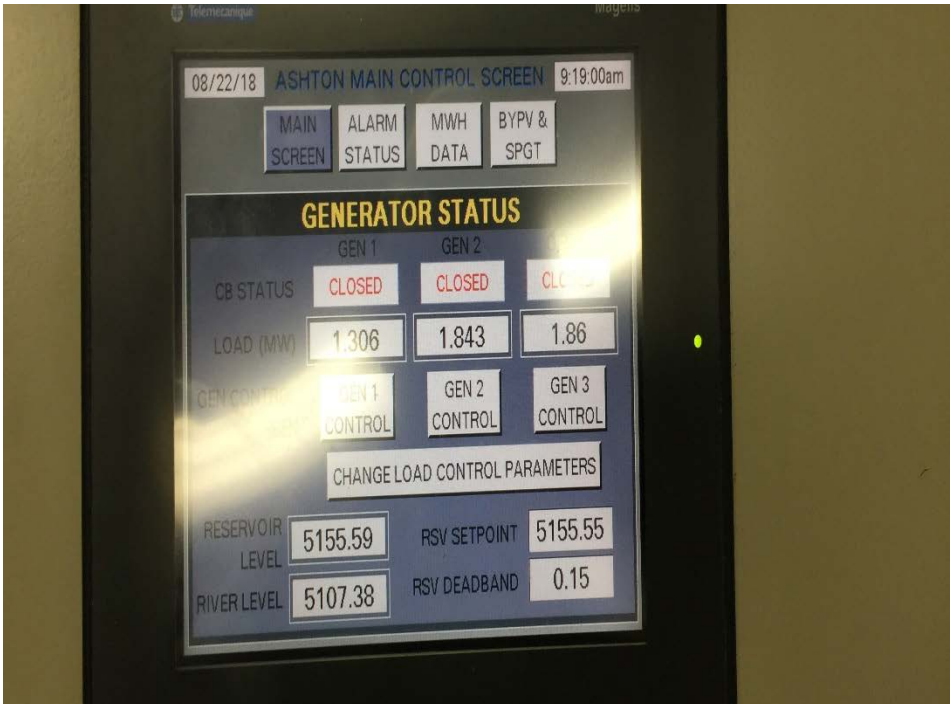
Pacificorp uses a Supervisory Control and Data Acquisition System (SCADA) and staff gages to monitor reservoir elevation and release flows (Photos 1-2). Run-of-river flows were in compliance the day of the inspection.

Photo 1. SCADA generator status and reservoir level reading 8-22-18.

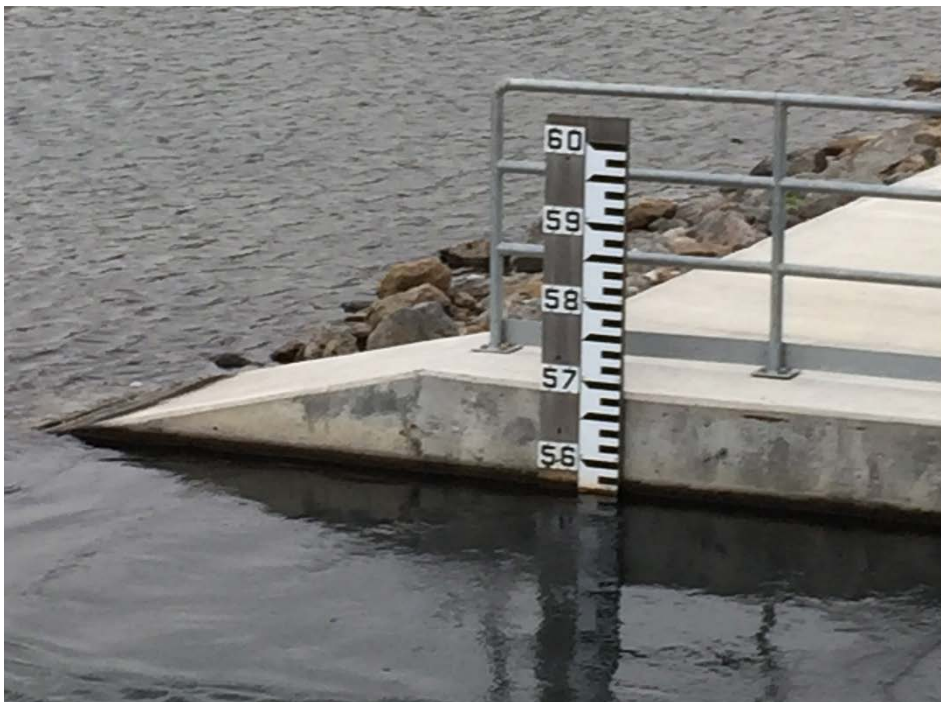
Photo 2. Staff gage at Ashton Reservoir Dam 8-22-18.

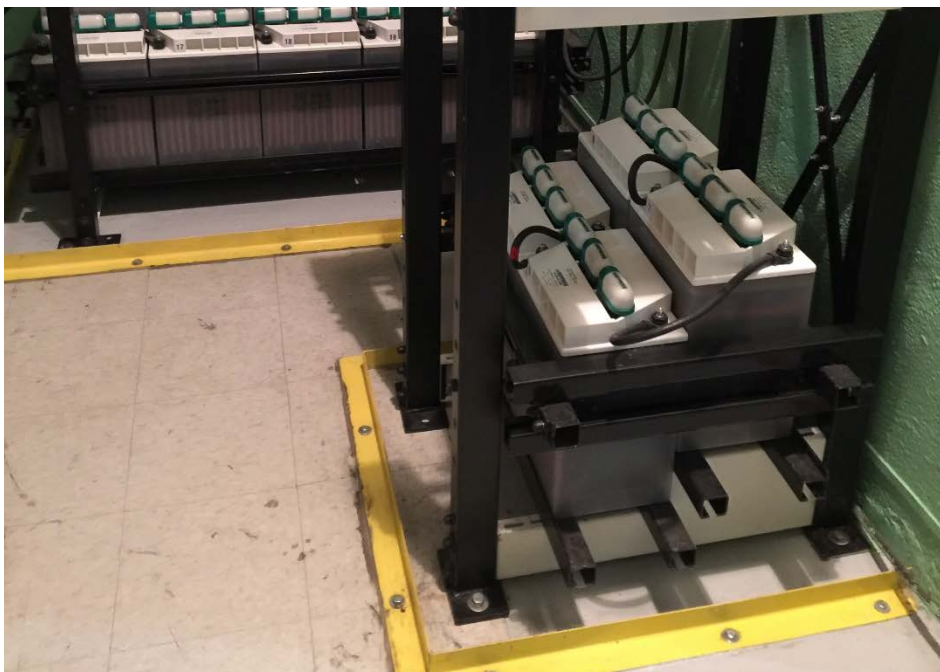
The Ashton Project has one powerhouse. The interior and exterior of the powerhouse had appropriate containment systems for hazardous materials the day of the inspection (Photos 3-5).

Photo 3. Battery bank with secondary containment in Ashton Powerhouse.

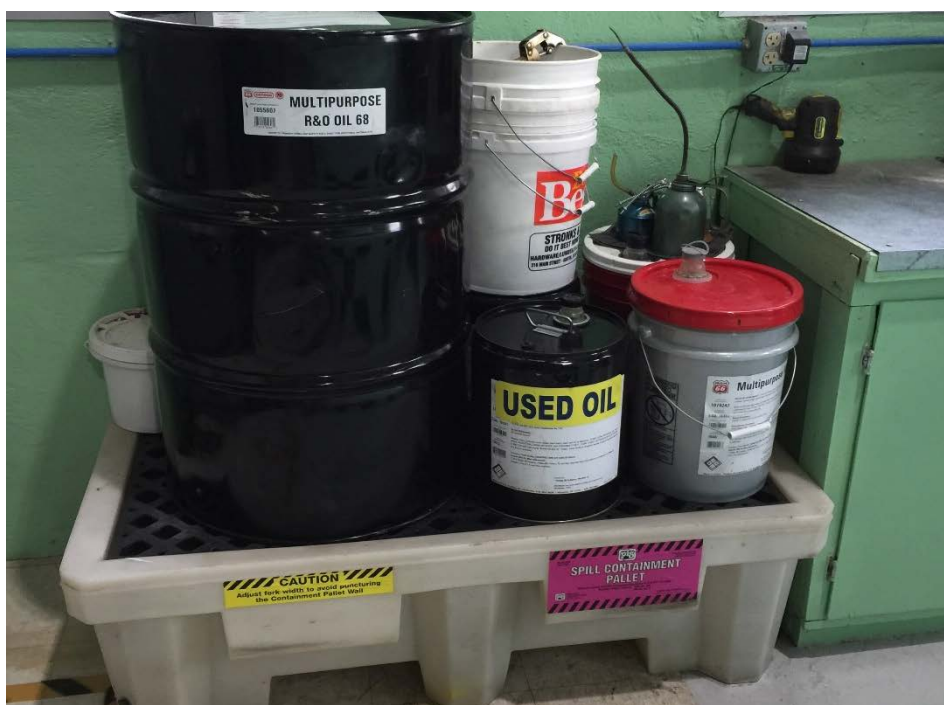
Photo 4. Hazardous materials with secondary containment system in Ashton Powerhouse.

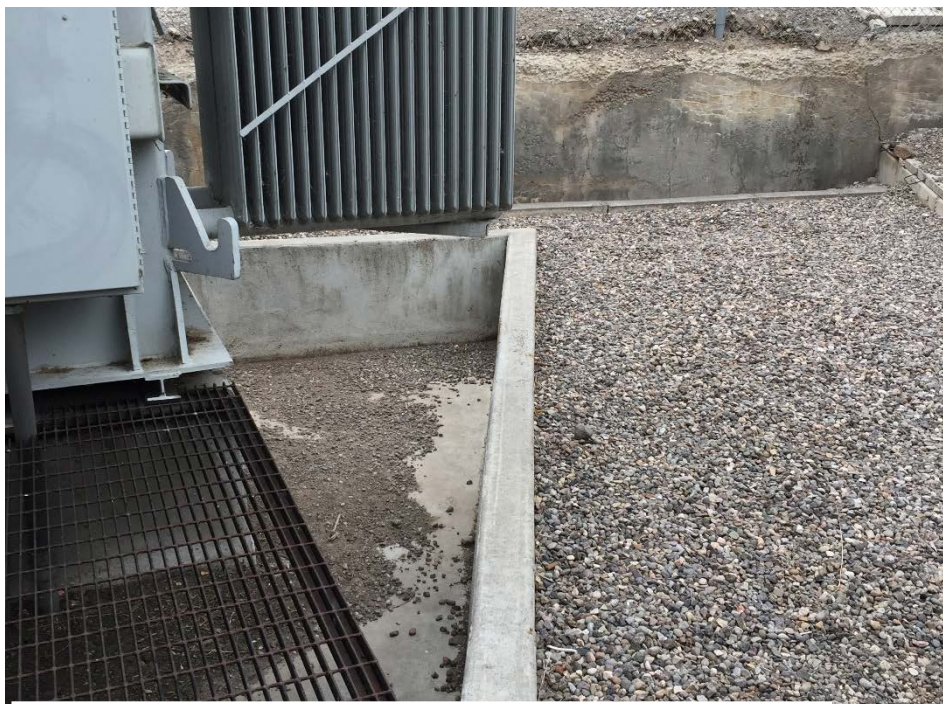
Photo 5. Outdoor transformer with secondary containment barrier at Ashton switchyard.

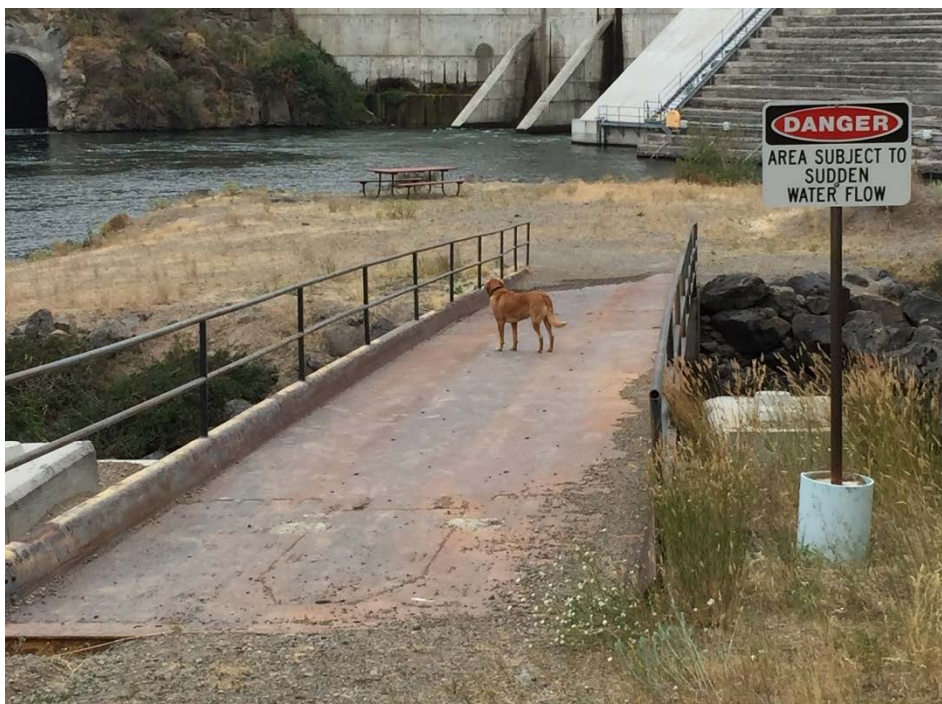
The Ashton Project has one recreation fishing site below the dam and one multi-use recreation site on Henry's Fork near Highway 20. Both recreation sites were well maintained the day of the inspection (Photos 6-9).

Photo 6. Fishing recreation site below Ashton Dam.

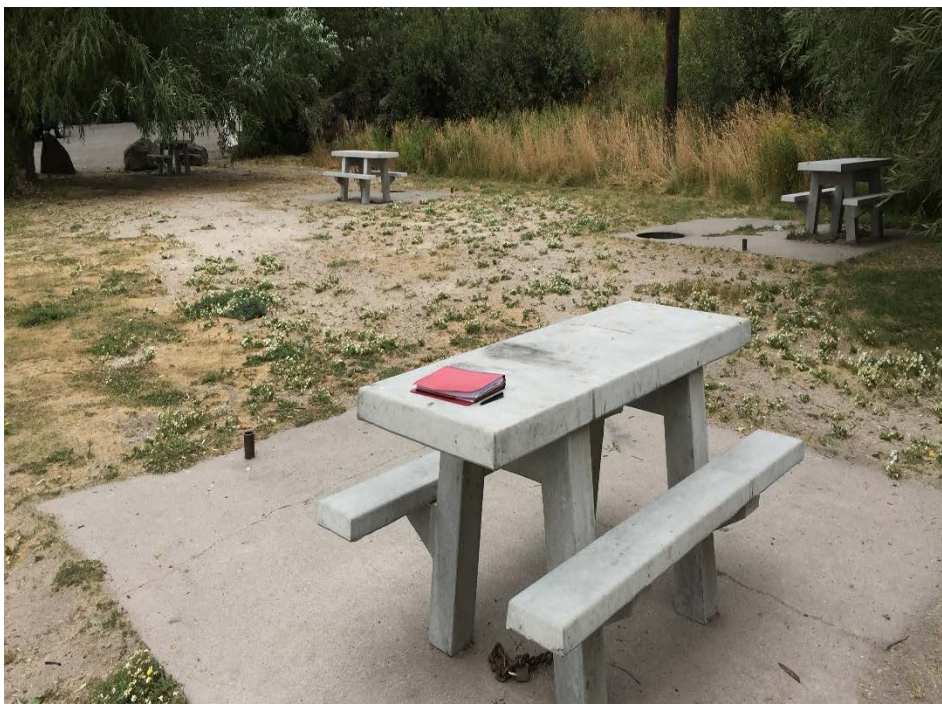
Photo 7. Picnic area at recreation site on Henry's Fork.

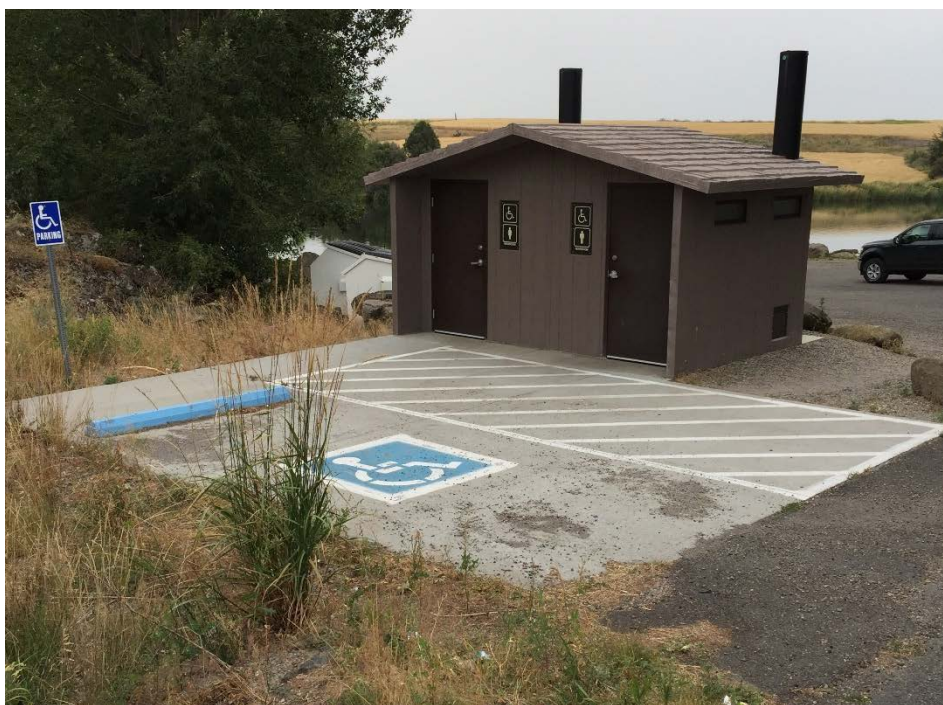
Photo 8. Sanitation facilities at recreation site on Henry's Fork.

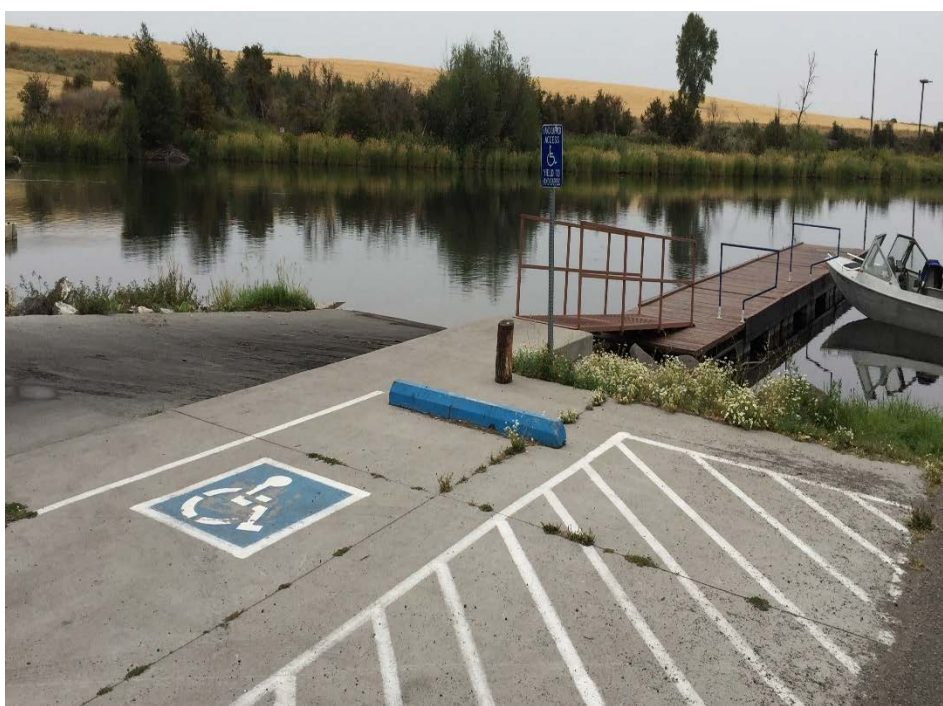
Photo 9. Parking, fishing dock, and boat ramp at recreation site on Henry's Fork.

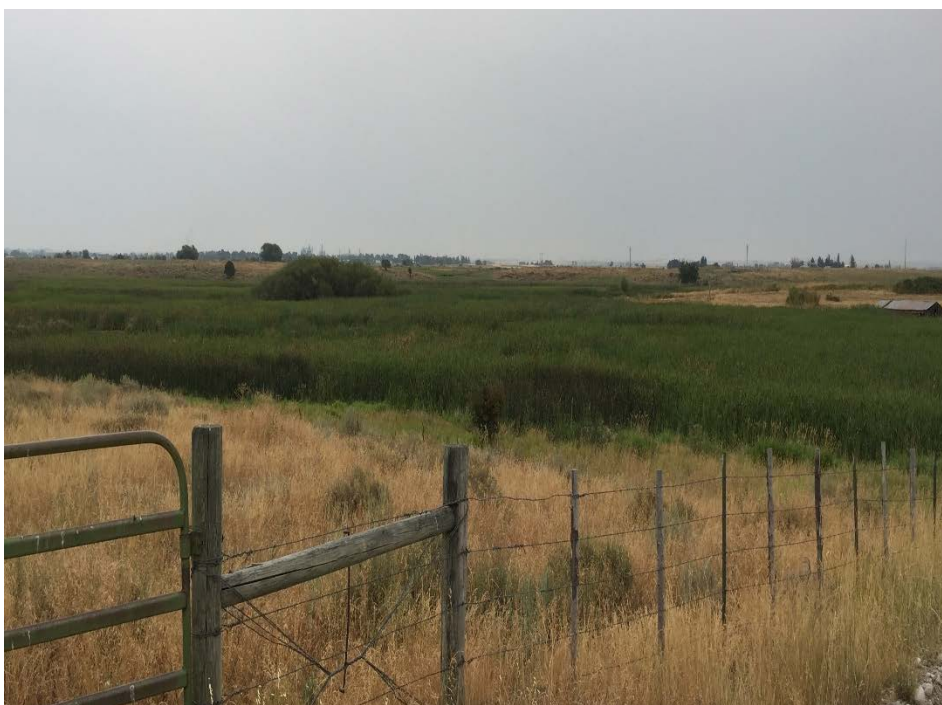
The Ashton Project has multiple wildlife enhancement and wetland protection measures required by the approved Wildlife Enhancement Plan (Photos 10-12).

Photo 10. Wetland complex with cattle exclusion fencing at the Ashton Project.

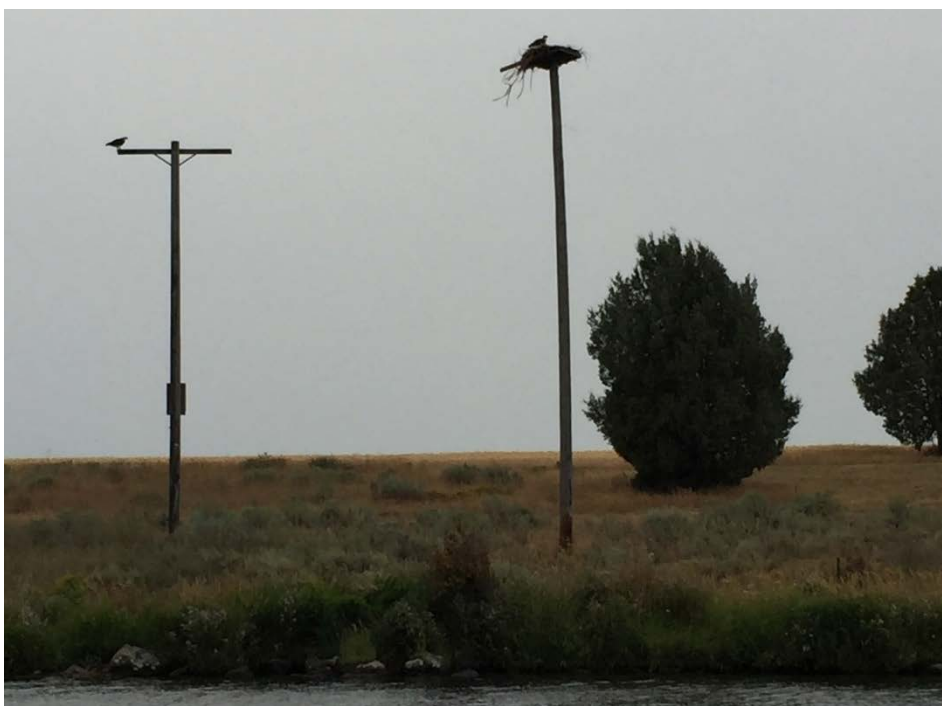
Photo 11. Perching post and nest platform on Ashton Reservoir.

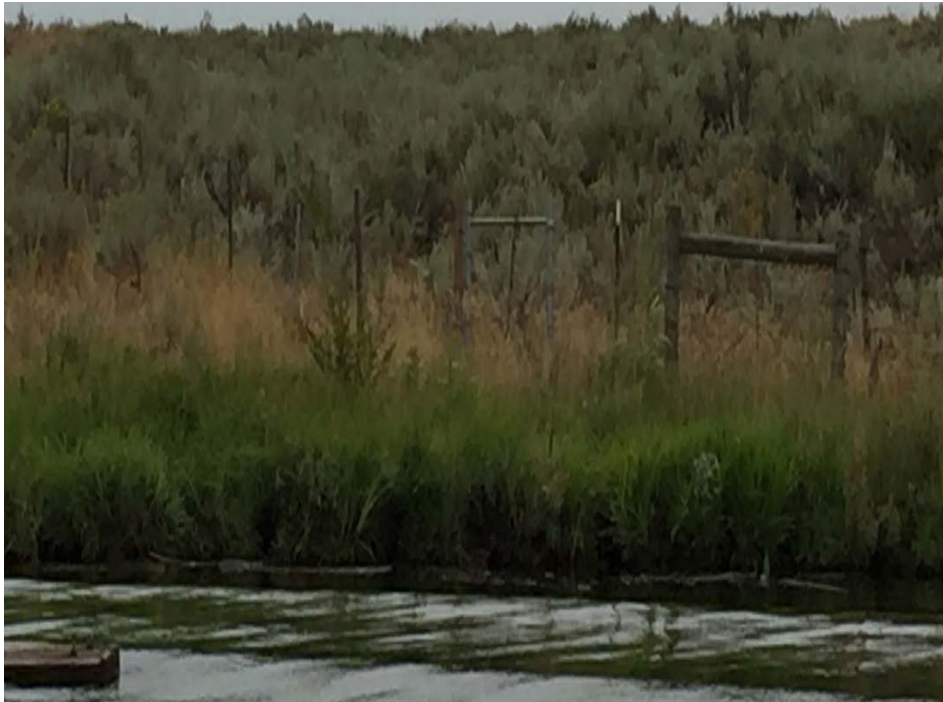
Photo 12. Cattle exclusion fencing on Ashton Reservoir.

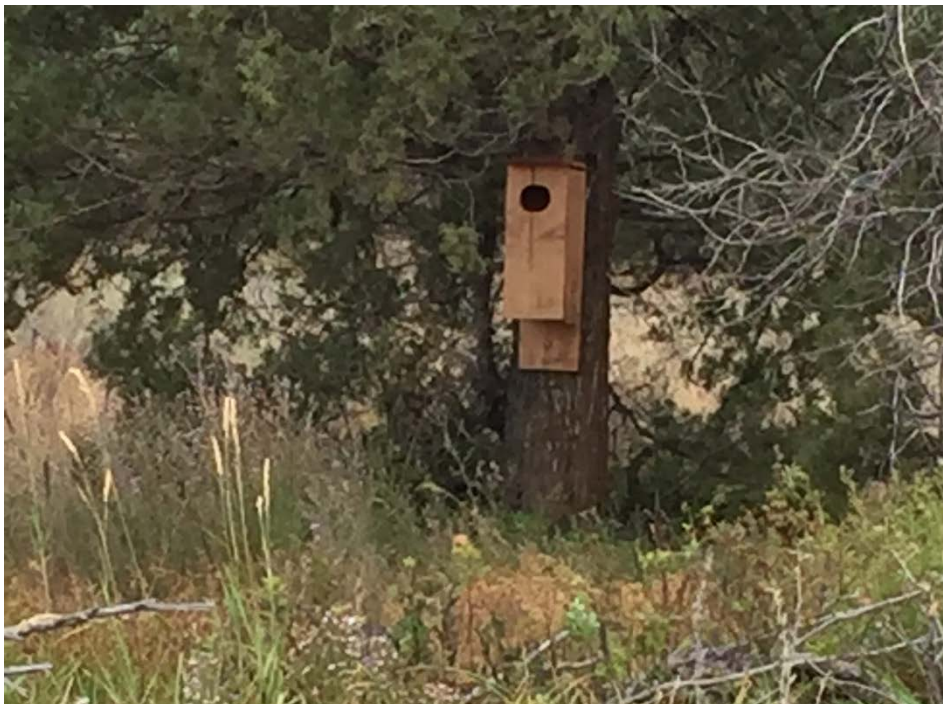
The Wildlife Enhancement Plan (WEP) for the project was updated in 2016 and approved by the Commission in 2017. The updated WEP requires the licensee to install waterfowl nesting boxes in consultation with Idaho Department of Fish and Game (Idaho DFG) and the U.S. Fish and Wildlife Service (FWS). Approximately five nesting boxes were observed on the day of the inspection (Photo 13). The nesting boxes were observed without predator guards and some nesting boxes were side by side. Research has indicated that predator guards and widely spaced nesting boxes increase the rate of successful nesting attempts. The post-inspection letter requested Pacificorp consult with the Idaho DFG and FWS on installing predator guards and insuring boxes are adequately spaced and submit a plan and schedule for implementation.

Photo 13. Waterfowl nesting box on Ashton Reservoir.

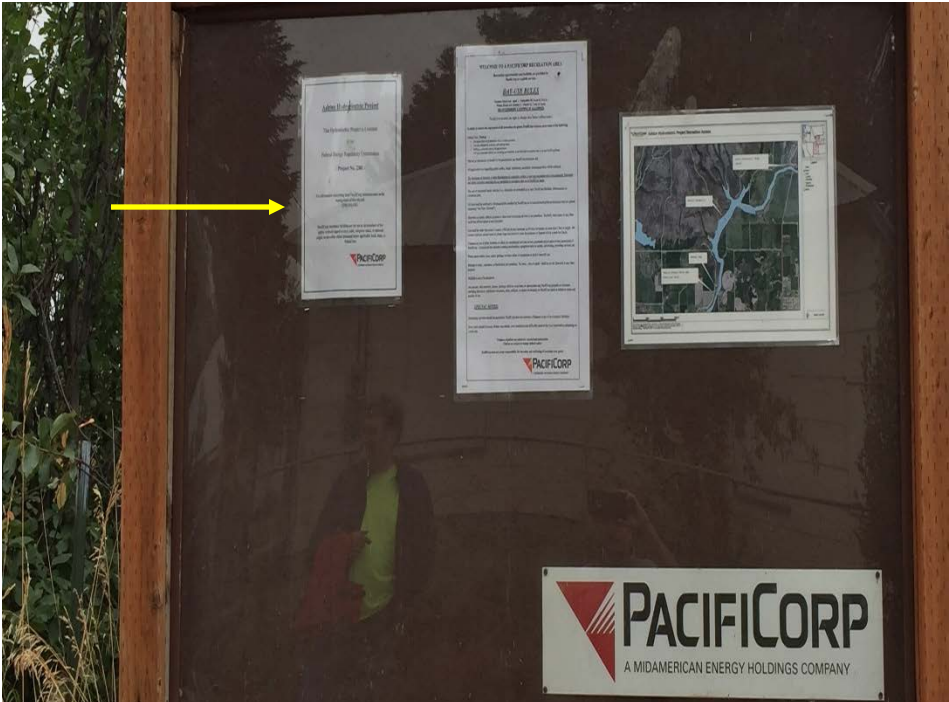
18 CFR § 8.2 (a) requires the licensee to post a “conspicuous” sign detailing recreation and project information at all points of public access and other points designated by the Commission. There were 3 part 8 signs observed during the inspection. The part 8 signs were 8”x11” laminated pages posted to bulletin boards at public access points (Photos 14-15). The part 8 signs should be larger with a larger font size so they are more easily spotted and read by public recreationists. The post-inspection letter requested Pacificorp increase the page size and font of the part 8 signs and submit a photo verification once reposted.

Photo 14. Part 8 sign at dam fishing access trailhead.

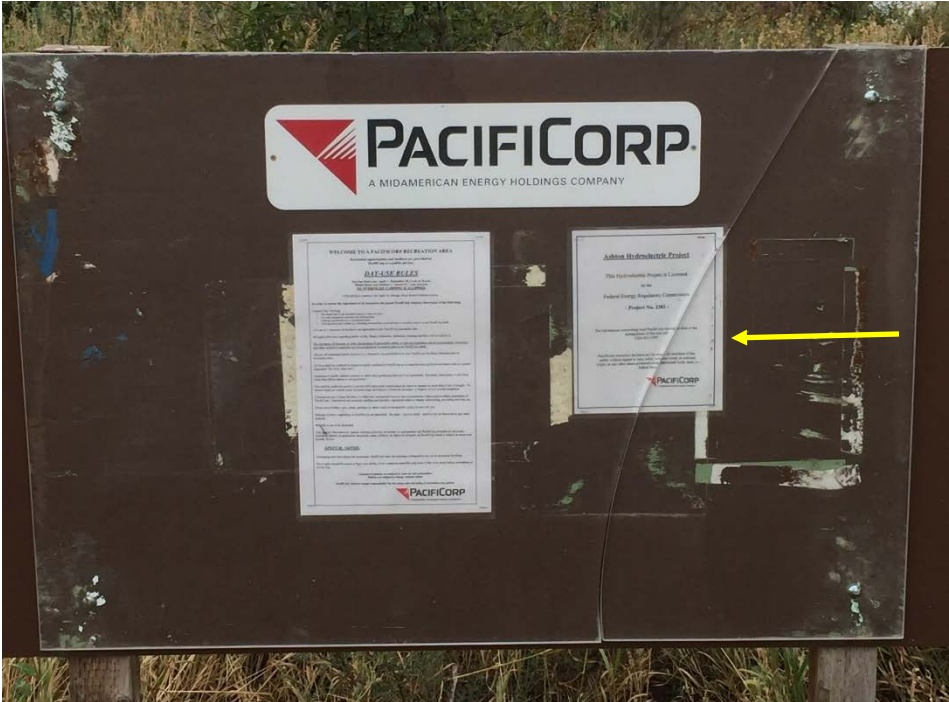
Photo 15. Part 8 sign at Henry's Fork recreation site access.

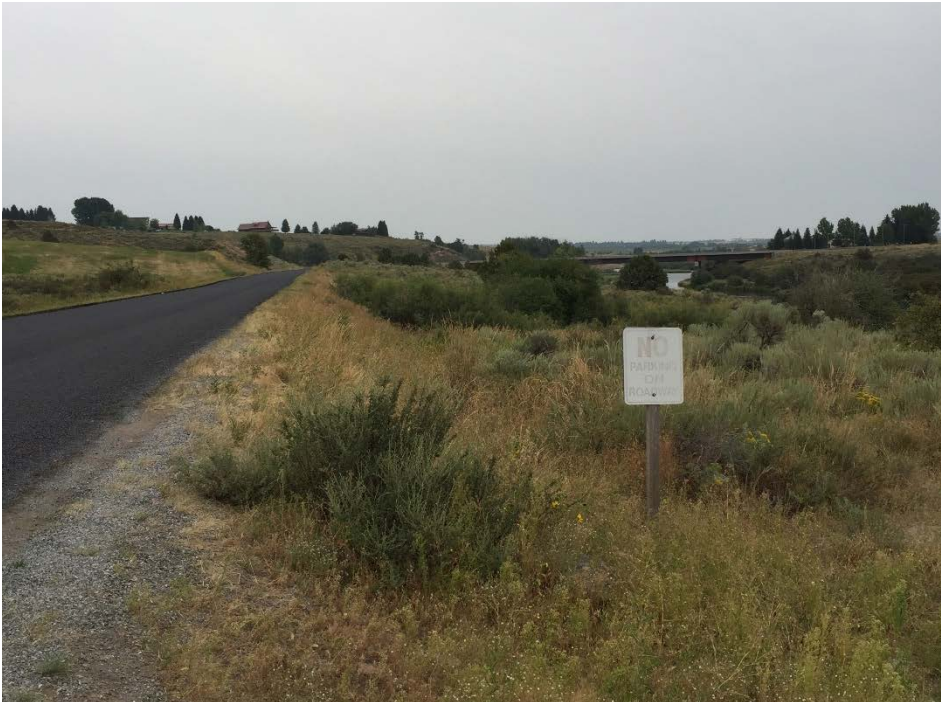
Sign No. S22 warning “No Parking on Roadway” in the recreation site public safety plan was very faded and needs replacing (Photo 16). The post-inspection letter requested Pacificorp replace the faded sign and submit a photo verification.

Photo 16. Faded "No Parking" sign at Henry's Fork recreation site.
