UTAH POWER AND LIGHT COMPANY
GRACE DAM RECONSTRUCTION 1949-1950
CONSTRUCTION PHOTOGRAPHS

UTAH POWER & LIGHT COMPANY
GRACE HYDRO-ELECTRIC STATION
1950 ROCK FILLED CRIB DAM

CROSSOVER CONNECTION

FLOWLINES THREE TO ONE.

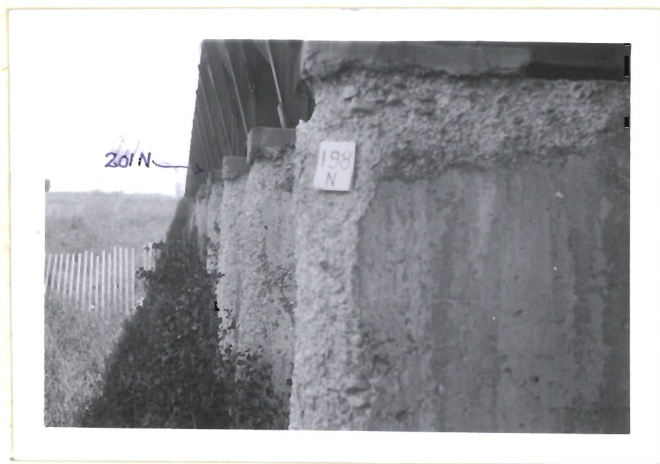
6

Condition of old saddle bases in sections rebuilt with steel saddles in 1937 and 1939.

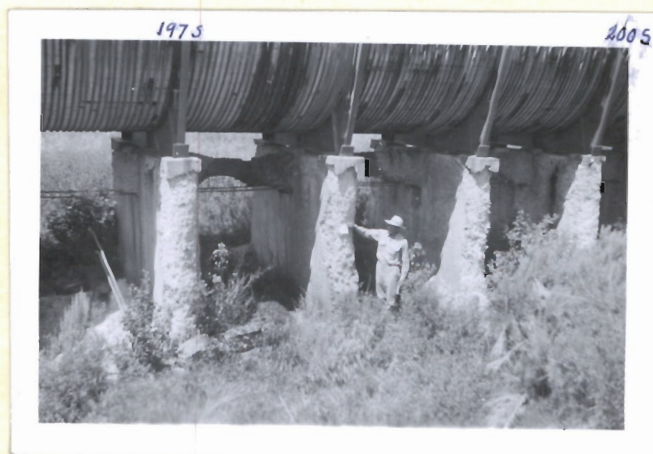
1

Condition of old saddle bases in sections rebuilt with steel saddles in 1937 and 1939. Bases 196 south to 208 south.

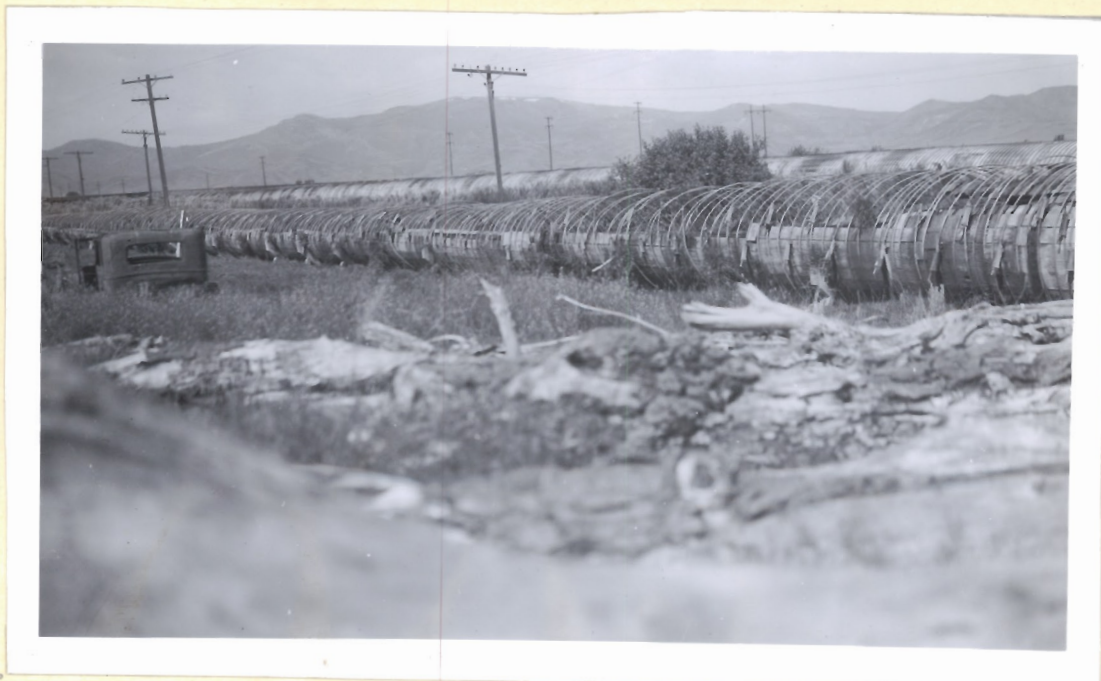
9

Collapsed old wood stave section of flowline 1 a short distance downstream from original valve position. Collapsed condition observed at 9:00 A.M.

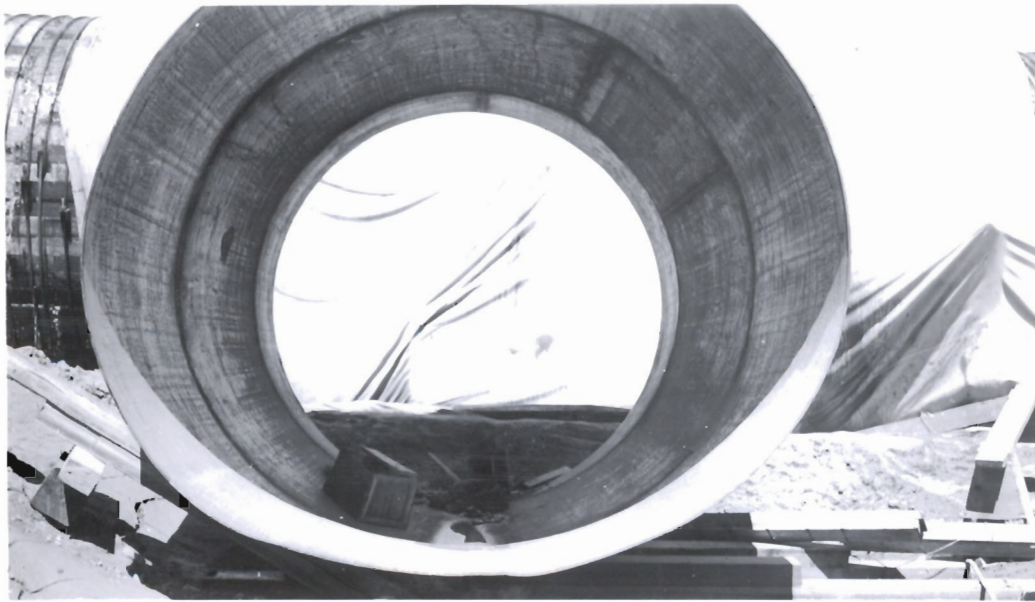
27

Transition section - showing flat side as received from Olson Manufacturing Company. Later rounded out.

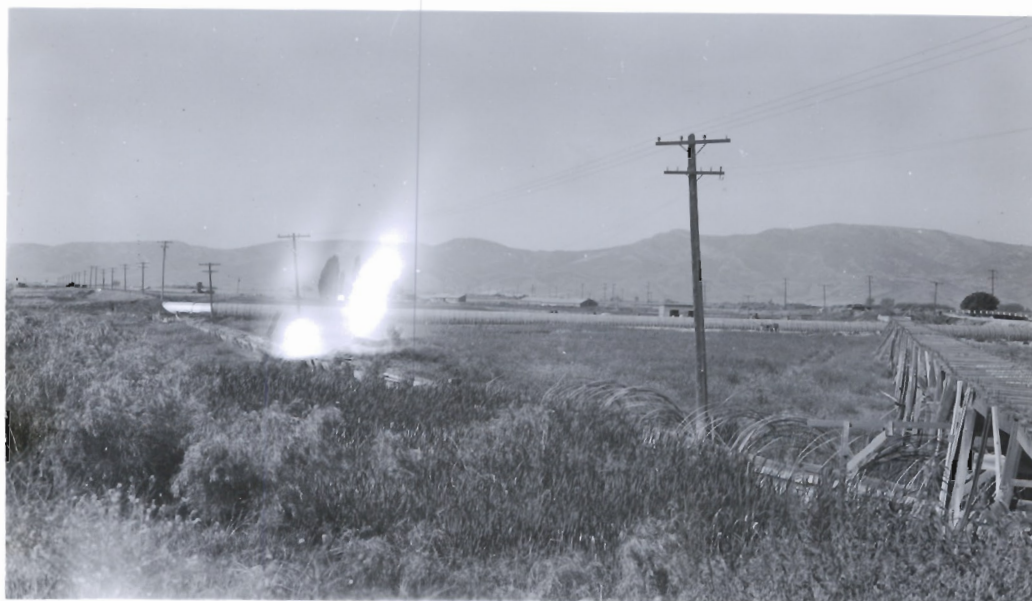
30

View from railroad track east of crossover. Steel bend connection to old steel section of Flowline 1 at left. Collapsed wood section of Flowline 1, replaced by crossover, in foreground.

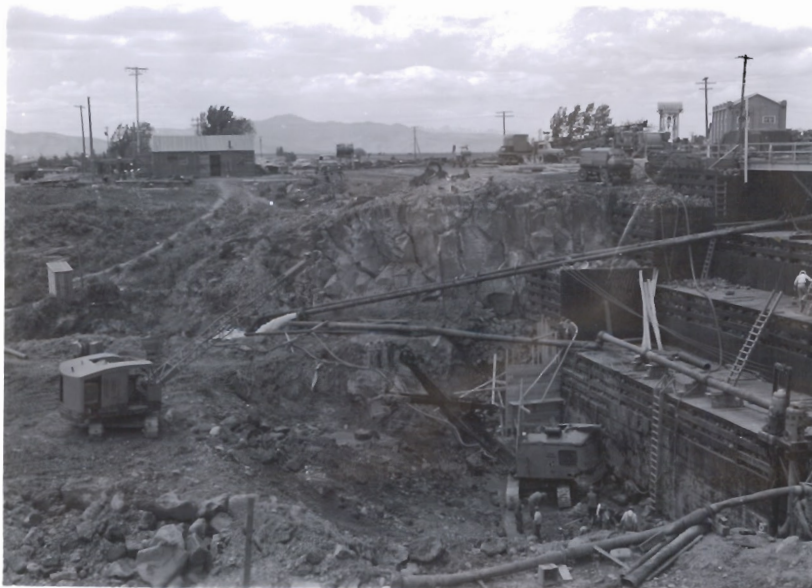
#94

Power shovel again cleaning out excavation after it was found that formation could not be developed into a solid rock key for the concrete thrust block.

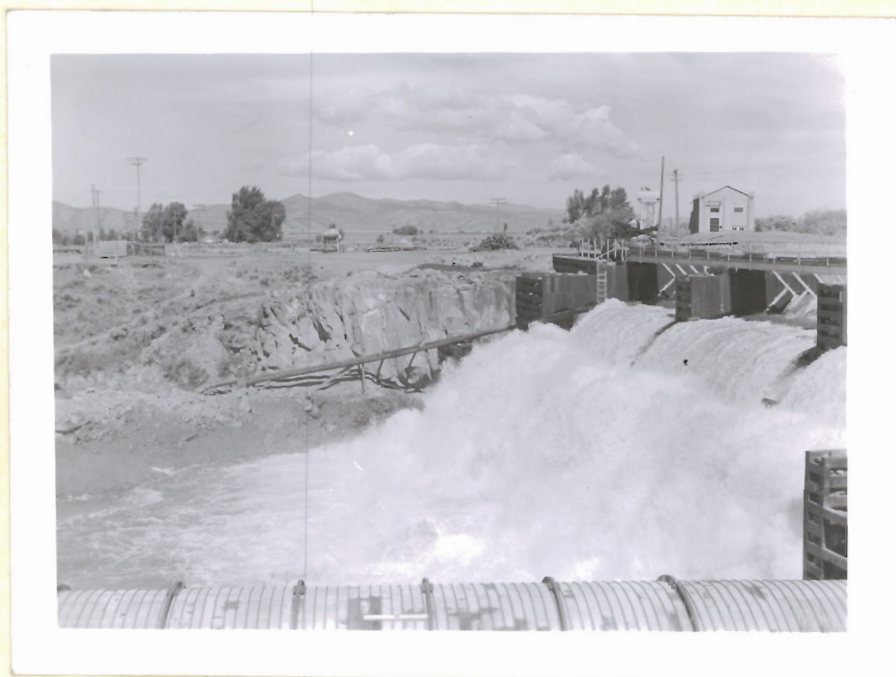
#123

Shows action of baffleboards with spill of approximately 950 cfs. Velocity of water was such as to bypass the first two tiers of baffles.
