UTAH POWER & LIGHT COMPANY

GRACE NO. 2 WOOD STAVE PIPELINE - 1950 CONSTRUCTION

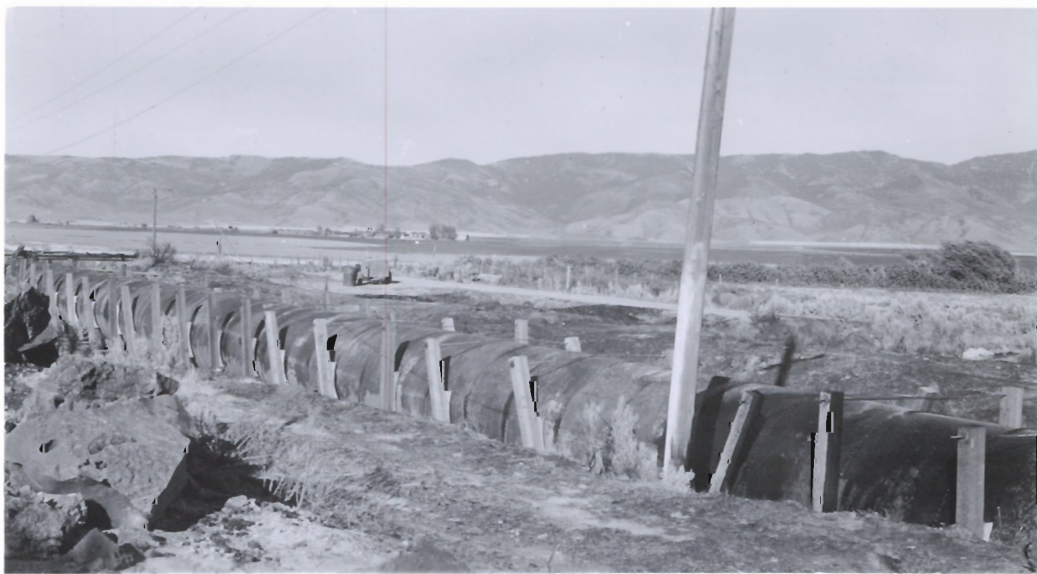
Steel section of Flowline 1 crossing over Flowline 2 after filling. With 16 to 18 ft. static head steel rounded up, releasing pressure against side braces, and allowing them to tip over. Top tension rod prevented loosened sets from falling completely away from pipe. 7-27-48

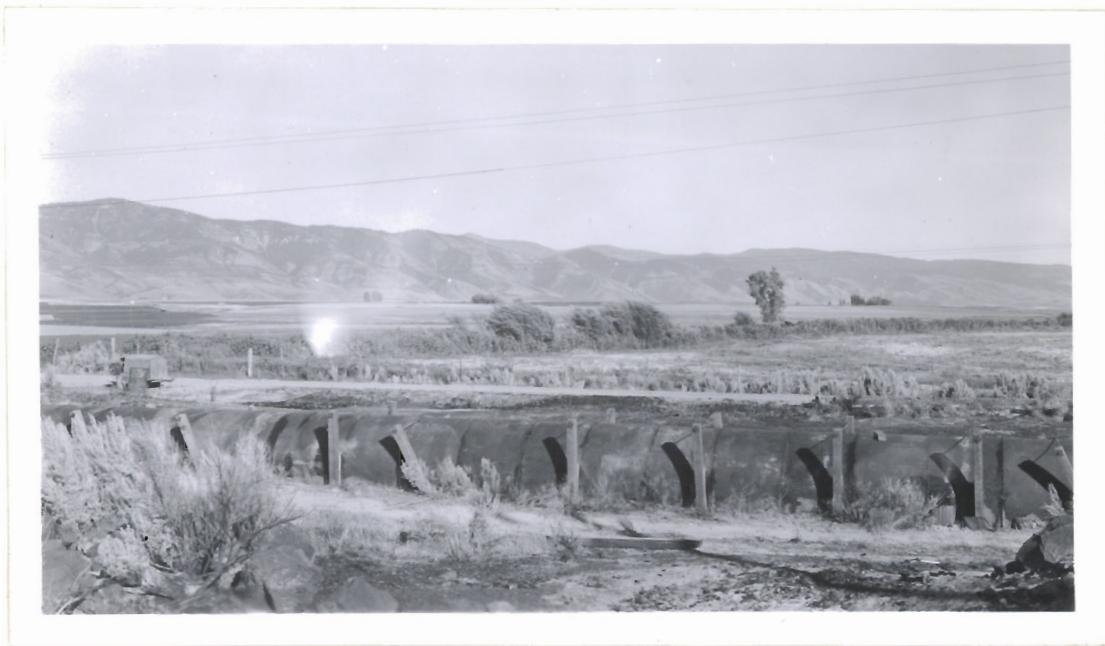
Steel section of Flowline 1 crossing over Flowline 2 after filling. With 16 to 18 ft. static head steel rounded up, releasing pressure against side braces and allowing them to tip over and hang on top tension rod. 7-27-48

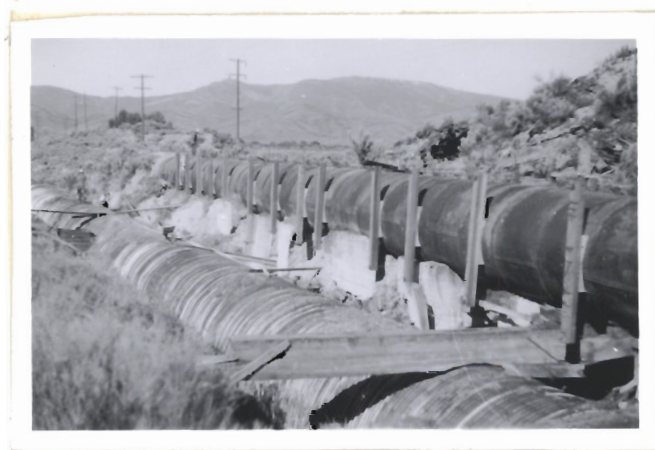
Portion of section collapsed 7-14-48 after restoration and filling and after replacing and tightening braces loosened in filling. Note rounded out appearance of top arc of pipe. It was this rounding out that pulled the egg shaped sides back to place and loosened the braces during last stages of filling. 7-28-48

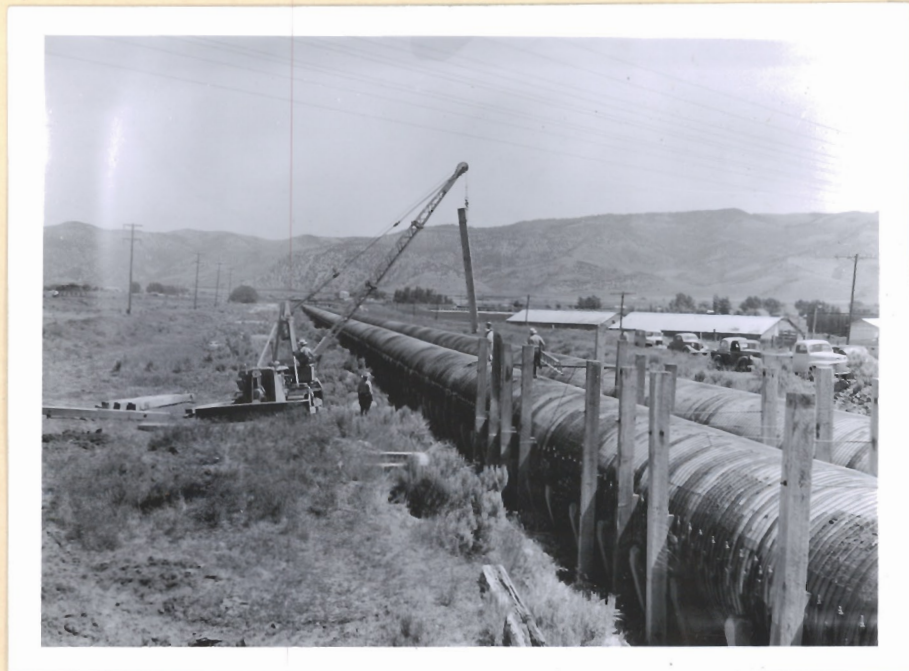
7-20-50 39019 #F-1  
Erecting timber reinforcement on upper section of No. 2  
Flowline. Timbers removed from section to be rebuilt in  
1950. ER 48-1230.

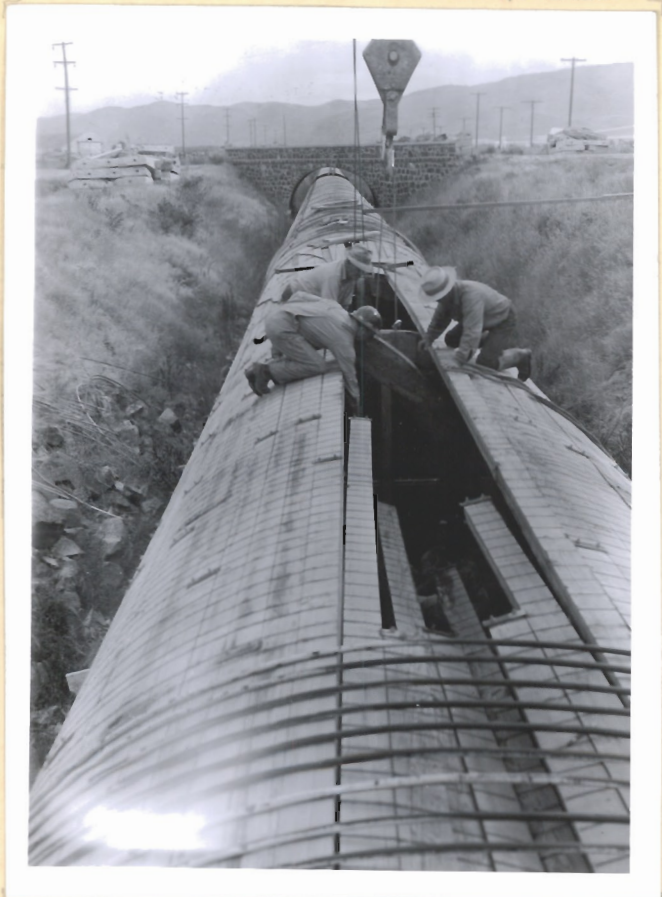
Shows workmen repairing section of pipe below highway bridge (1947 pipe construction) which collapsed due to vacuum created when pipe was drained to remove lower bulkhead of steel Wye (150 construction).

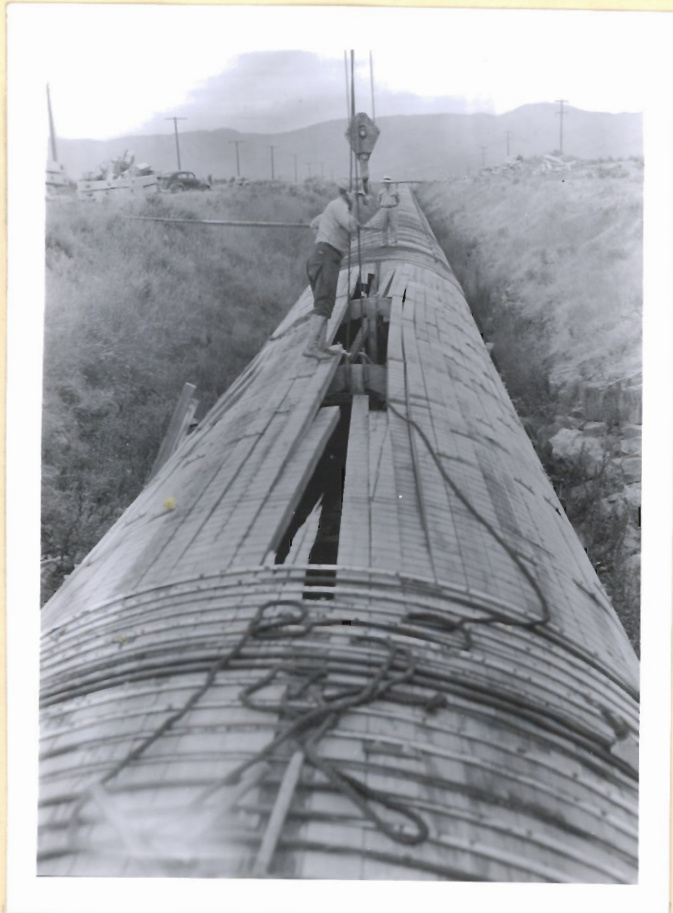
Foreman Leo Adams directing placing of templates in repair of collapsed pipe.

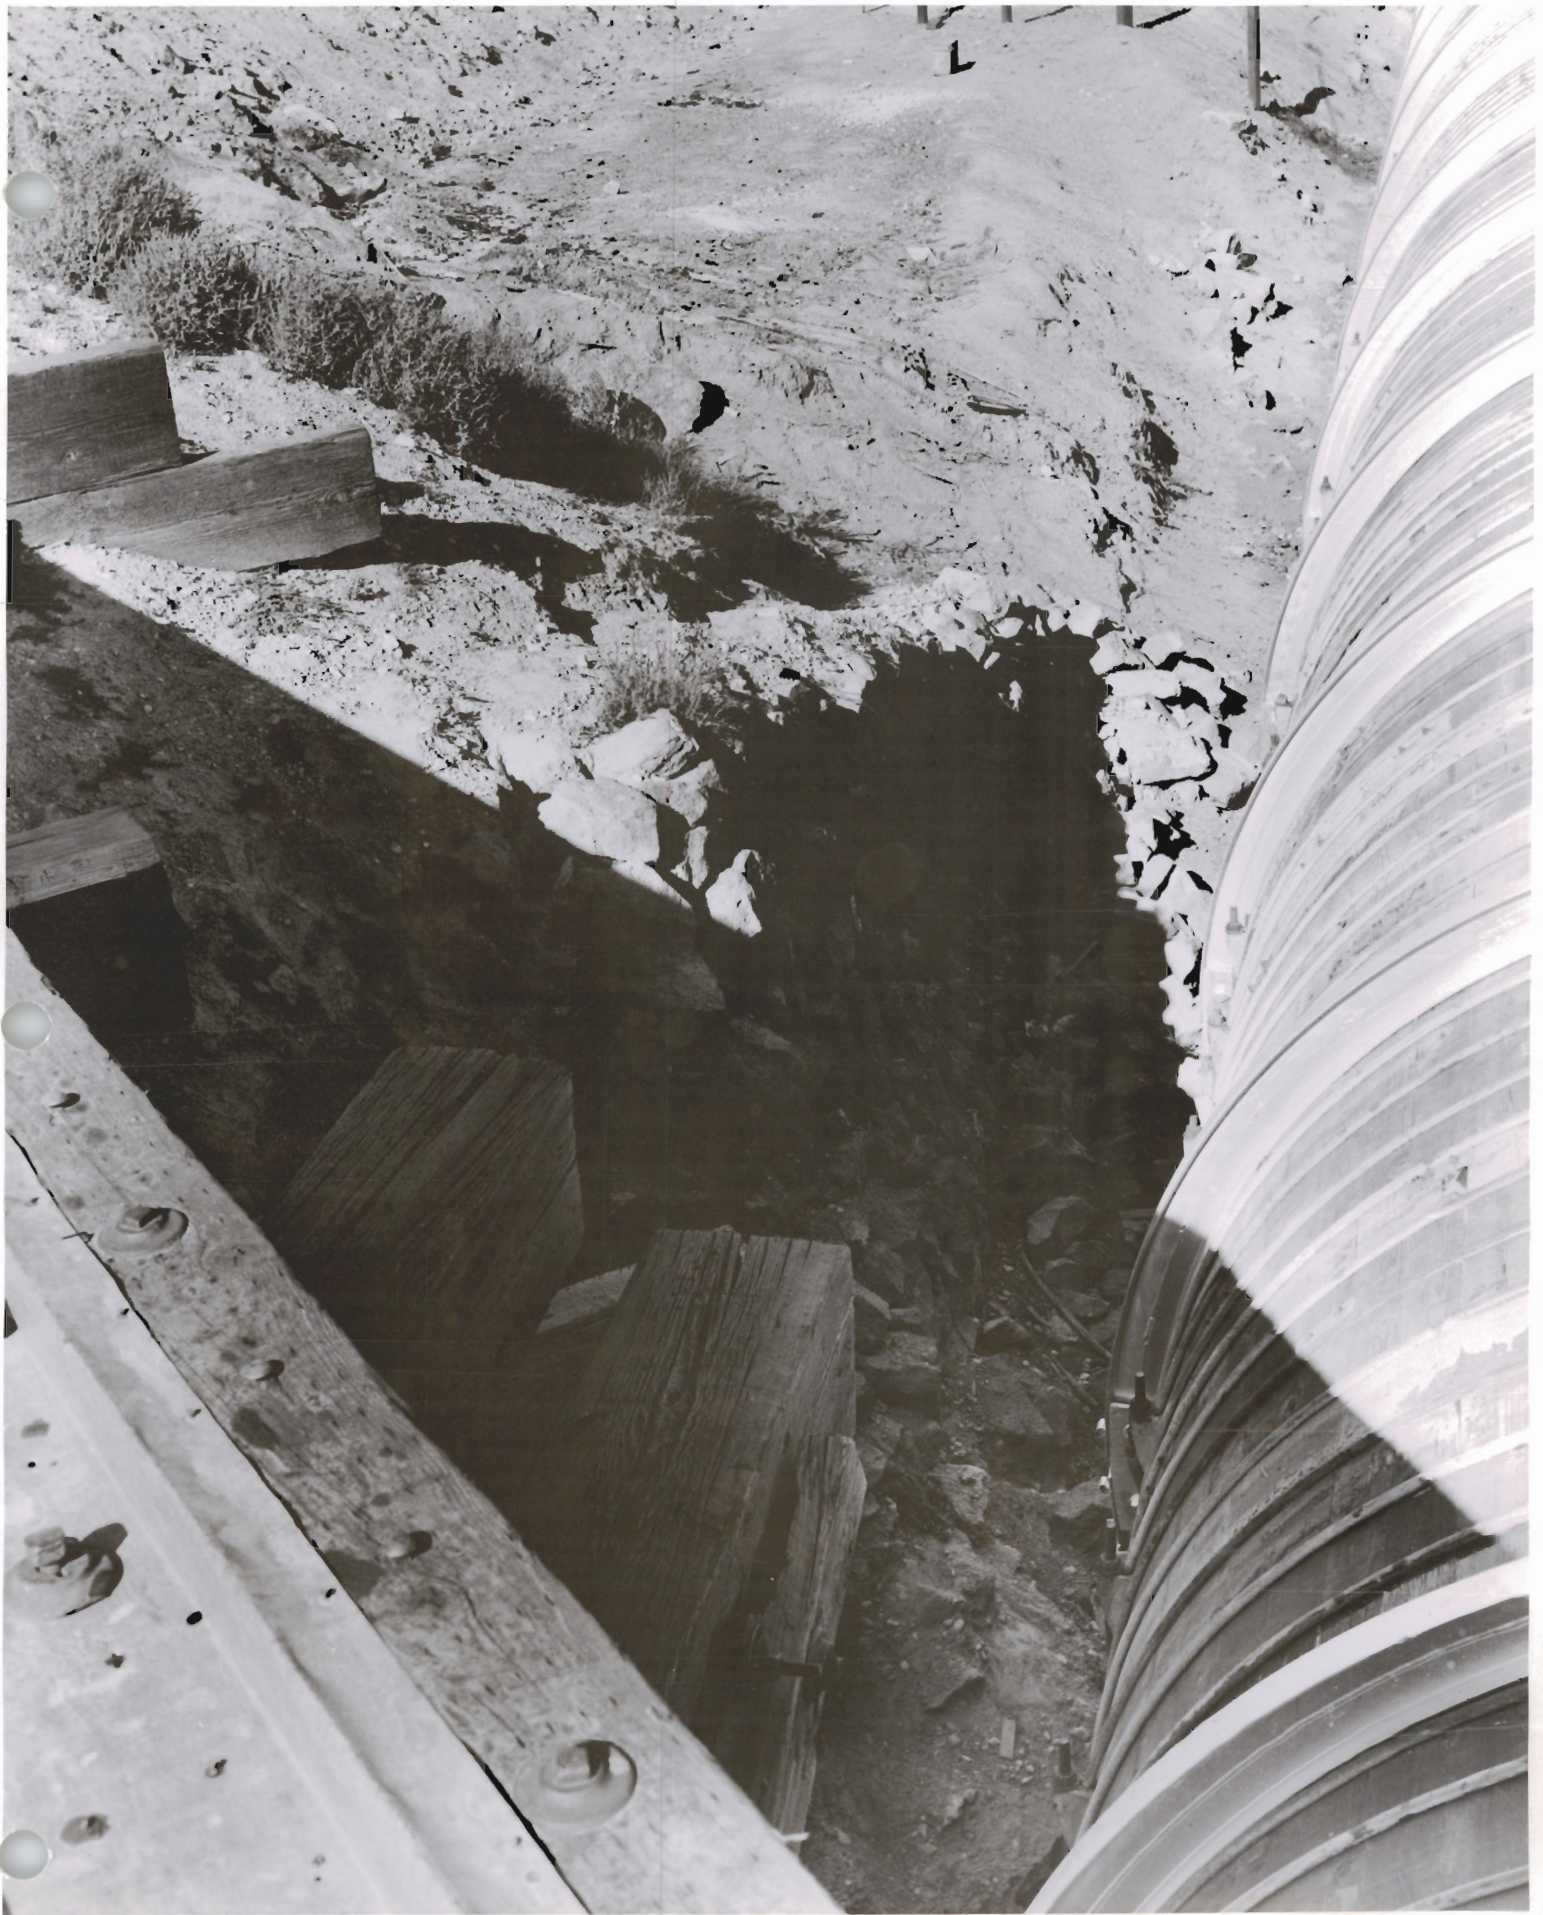
U.P.R.R. CO. Bridge over Grace Flowline, showing dry masonry  
No. side and pipe looking upstream

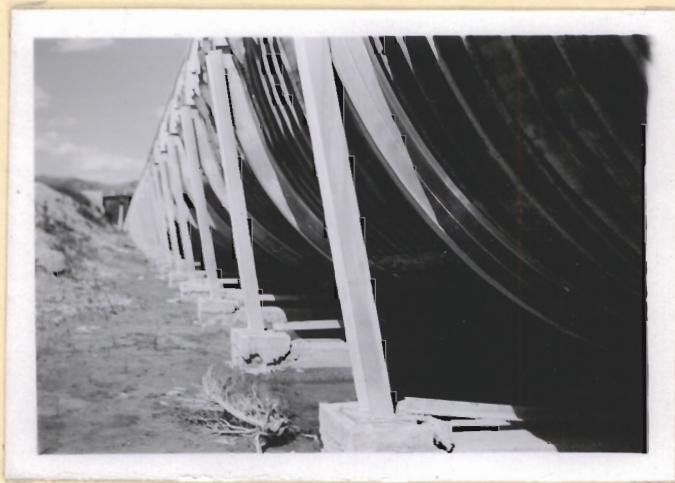
Looking Upstream. Showing bent lower member  
of saddle and fractured pad. 6--22-53

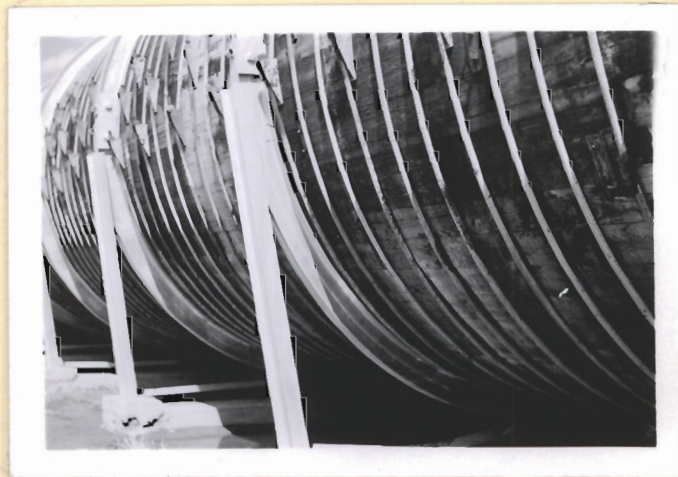
Showing bent lower member of saddle and fractured  
pad. 6-22-53

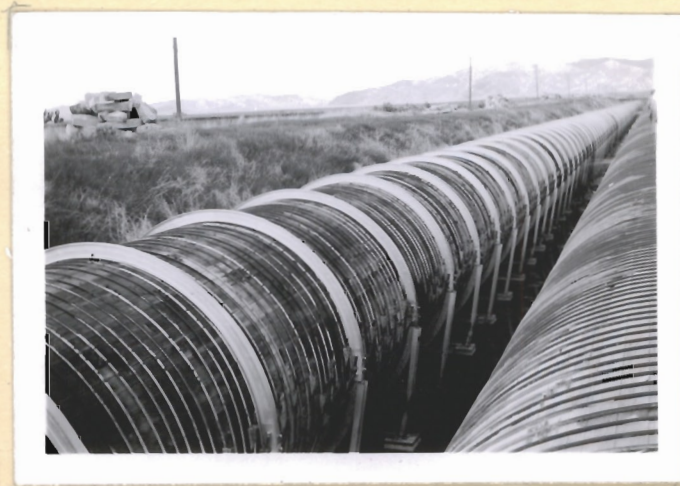
Showing bent saddle legs. 6-22-53

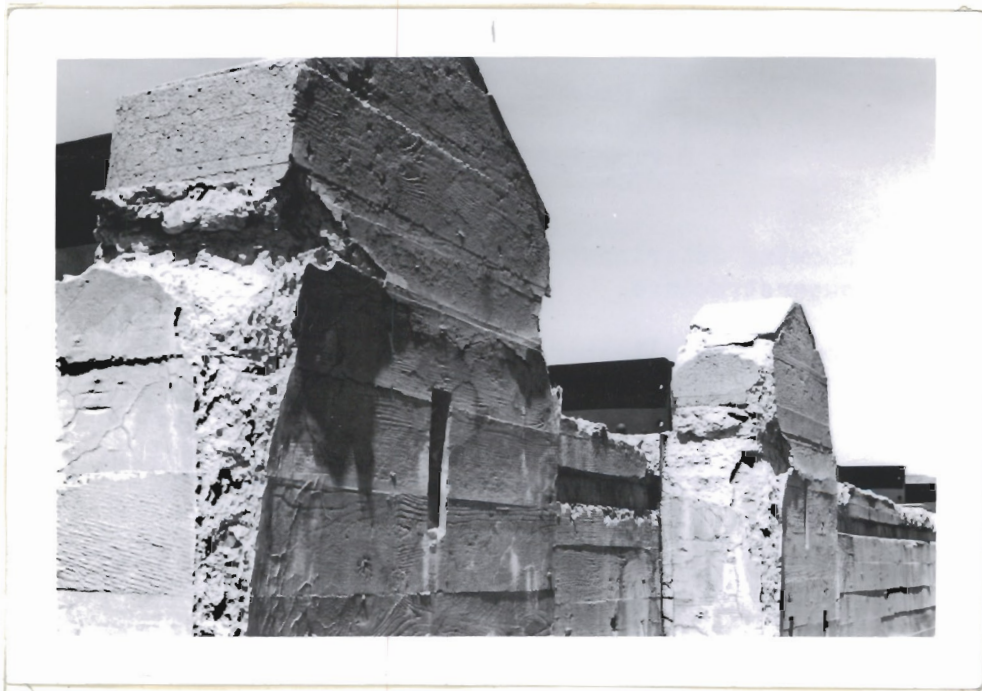
UTAH POWER & LIGHT COMPANY  
GRACE HYDRO-ELECTRIC STATION  
No. 2 FLOWLINE BRIDGE OVER BEAR RIVER

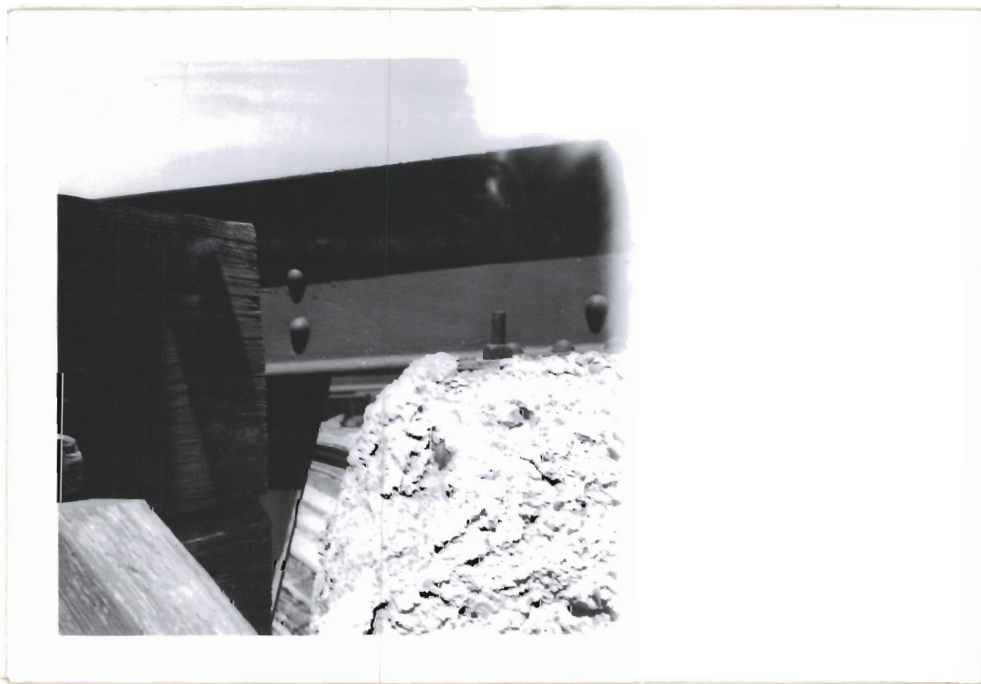
2. Showing deteriorated condition of concrete superstructure. 5-22-51

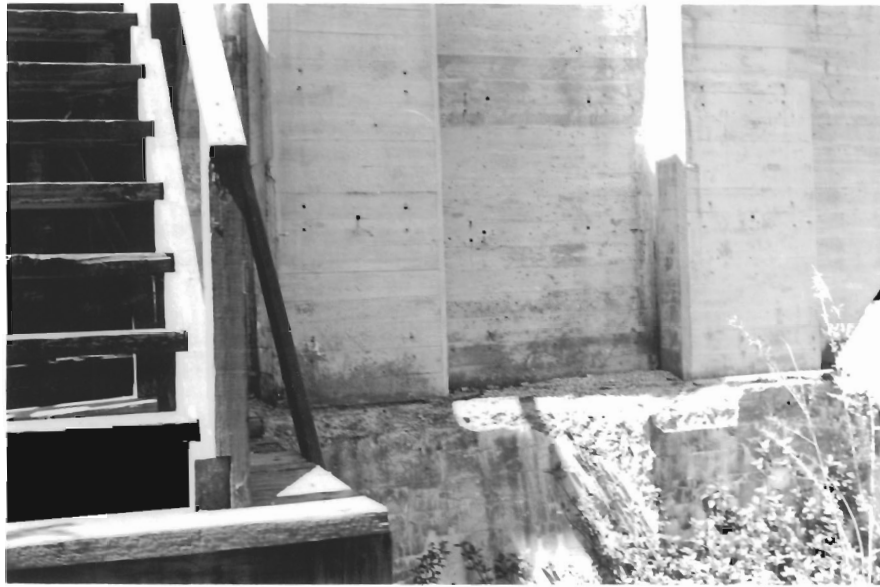
3. Showing deteriorated condition of concrete superstructure. 5-22-51

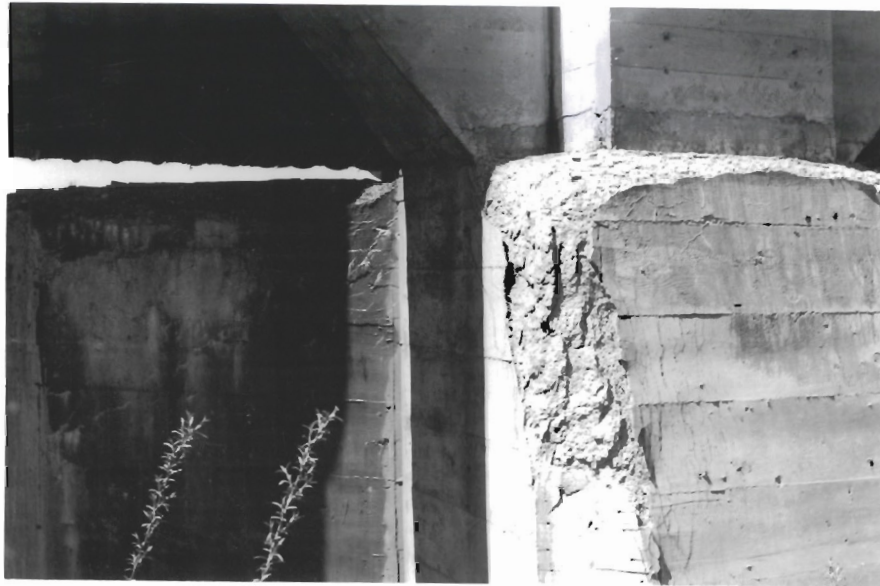
4. Showing deteriorated condition of concrete superstructure. 5-22-51

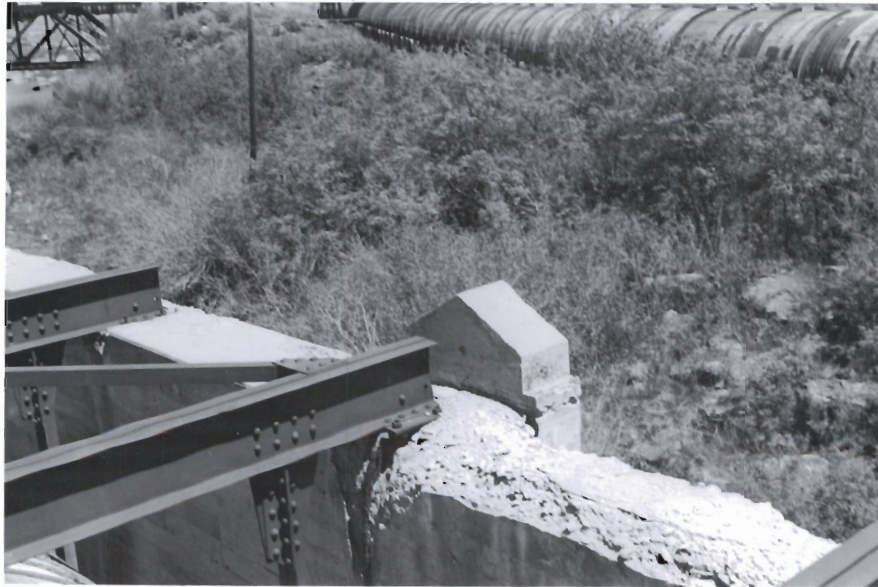
5. Showing deteriorated condition of concrete superstructure. 5-22-51

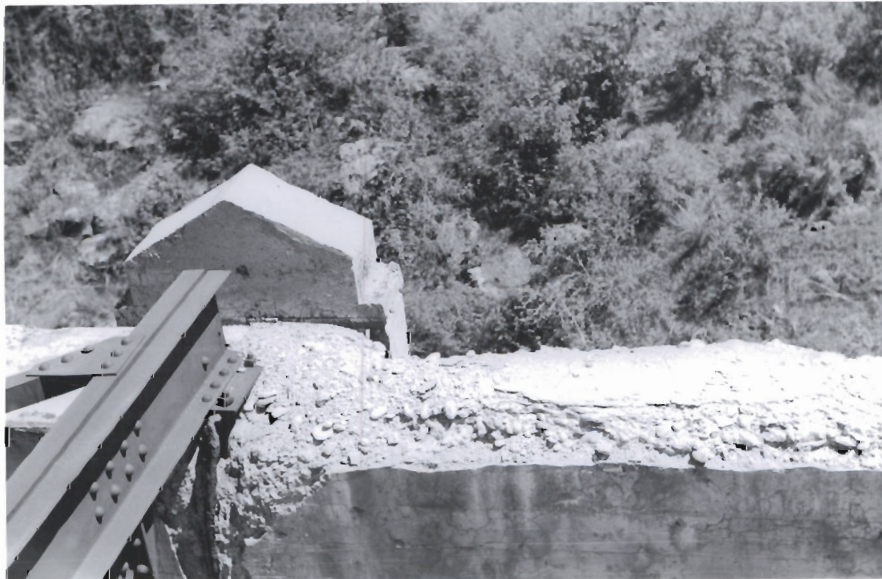
6. Showing deteriorated condition of concrete superstructure. 5-22-51

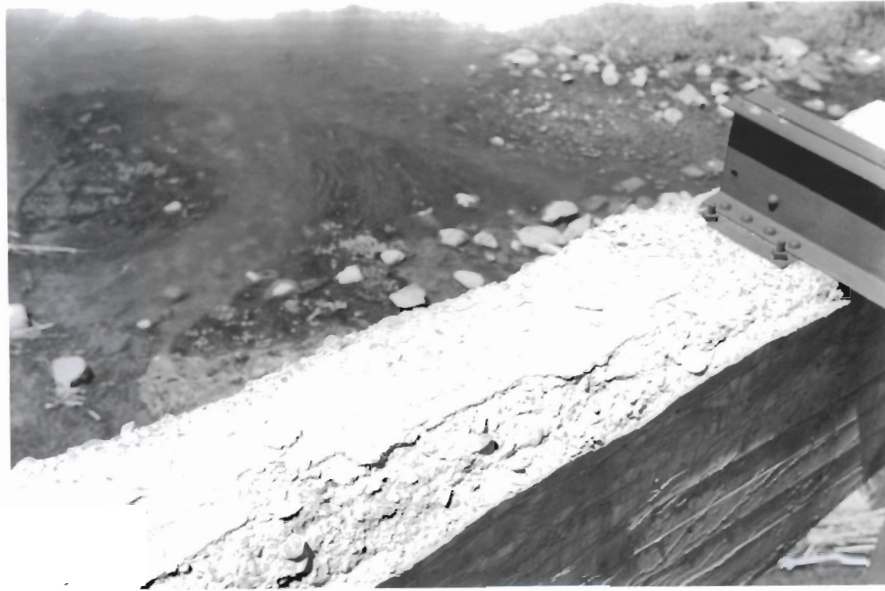
7. Showing deteriorated condition of concrete superstructure. 5-22-51

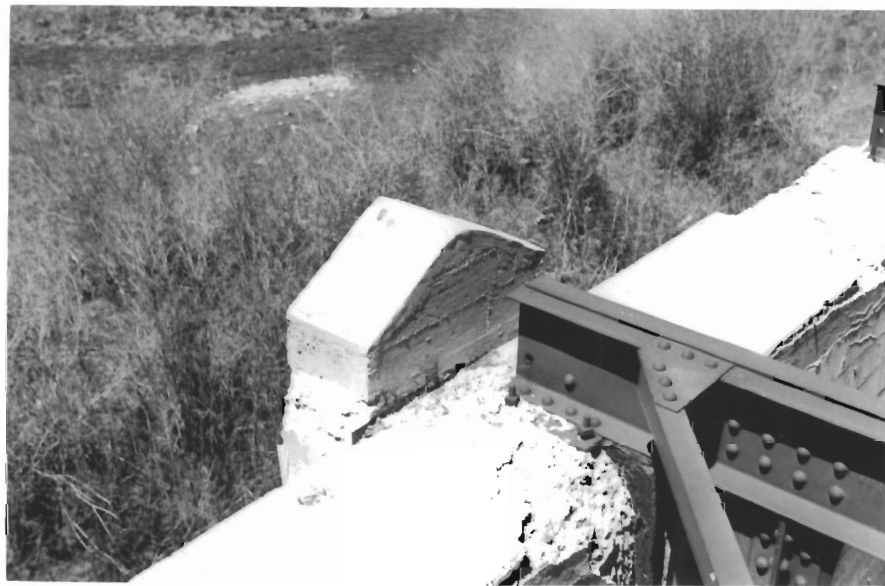
8. Showing deteriorated condition of concrete superstructure. 5-22-51

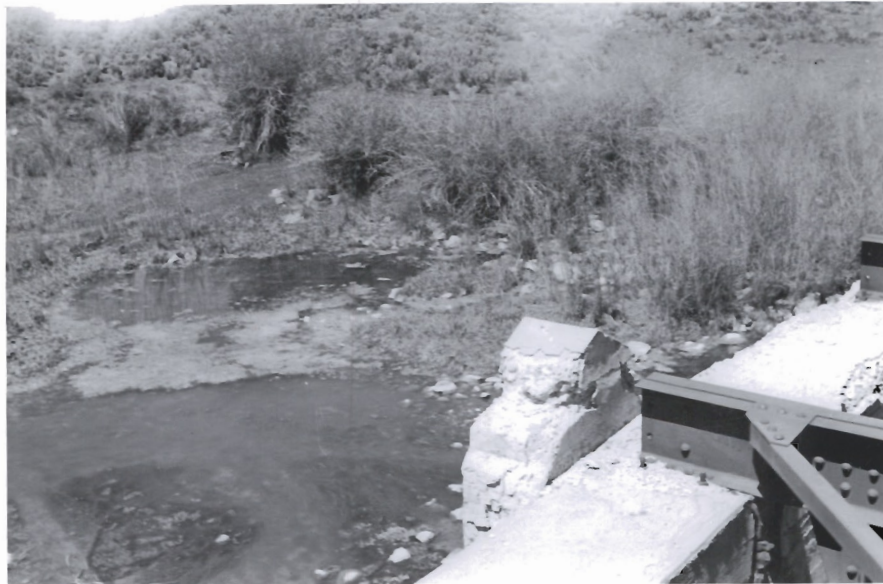
9. Showing deteriorated condition of concrete superstructure. 5-22-51  
8th pilaster upstream on north side.

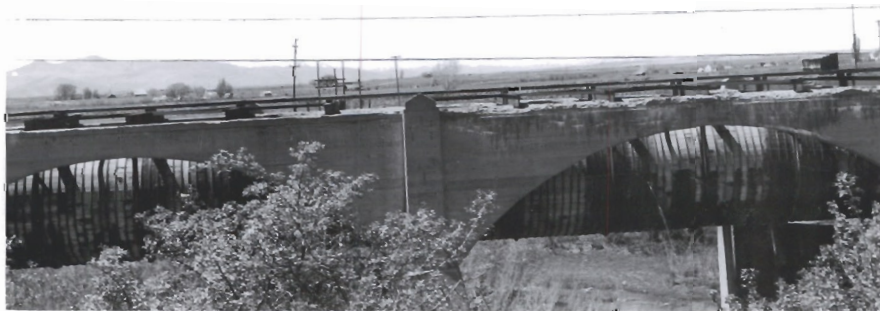
10. Showing deteriorated condition of concrete superstructure. 5-22-51

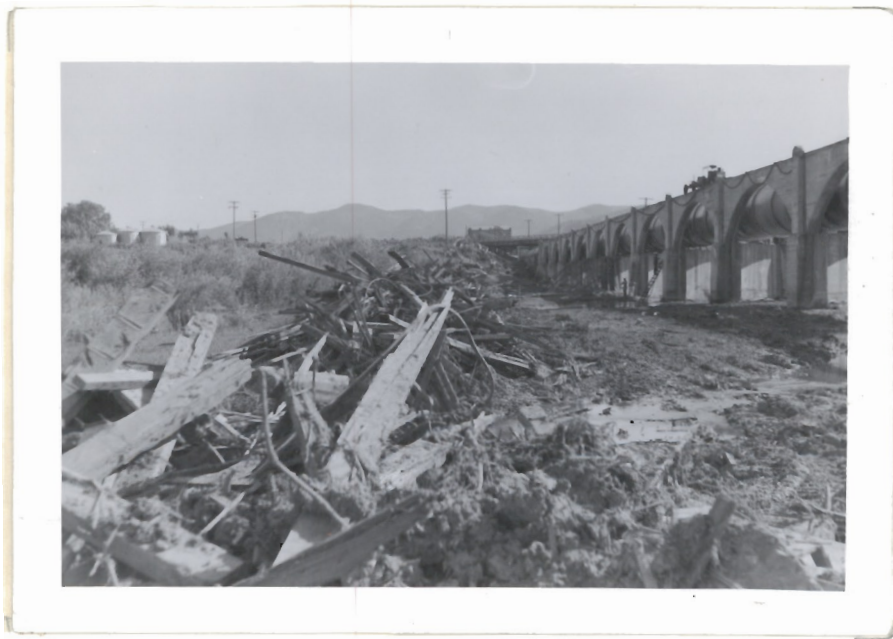
View of debris in river bottom downstream from pipe crossing. Looking NW 8-7-52

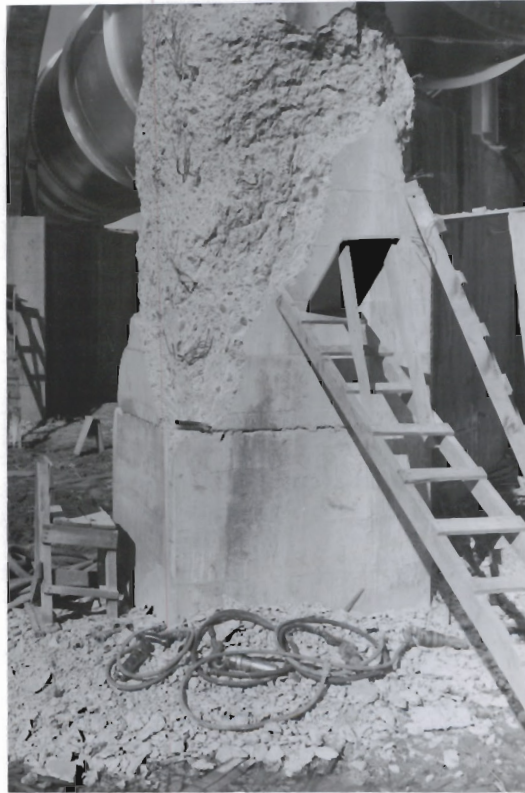
Pier #12 right tangent - Deteriorated concrete partially  
chipped away. 8-15-52

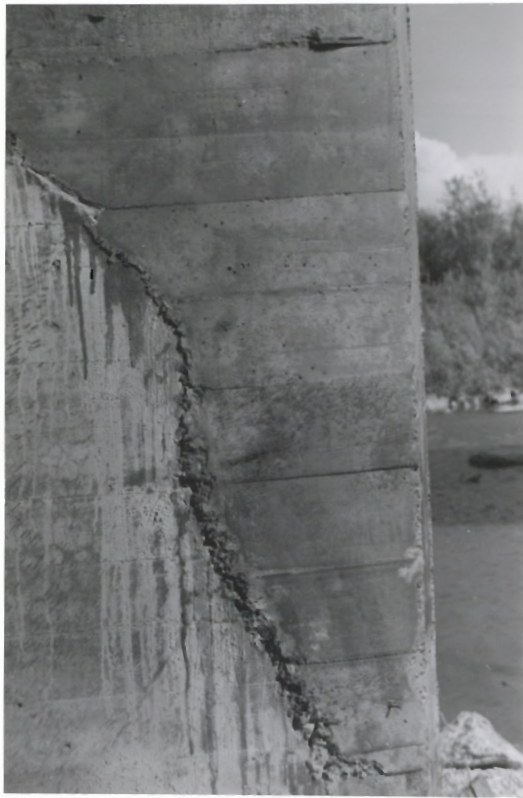
Pier #6 right tangent. Repairs complete. Note poor appearance due to faulty placement of forms. 8-14-52

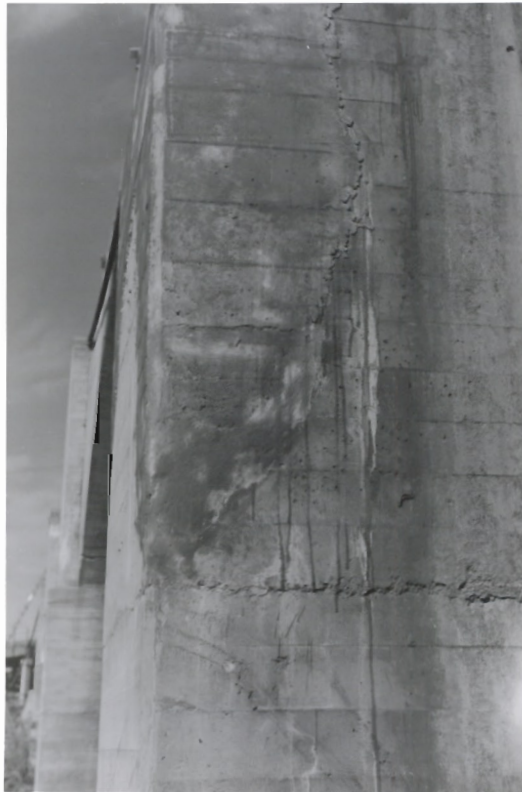
GRACE H E PLANT  
#2 FLOWLINE

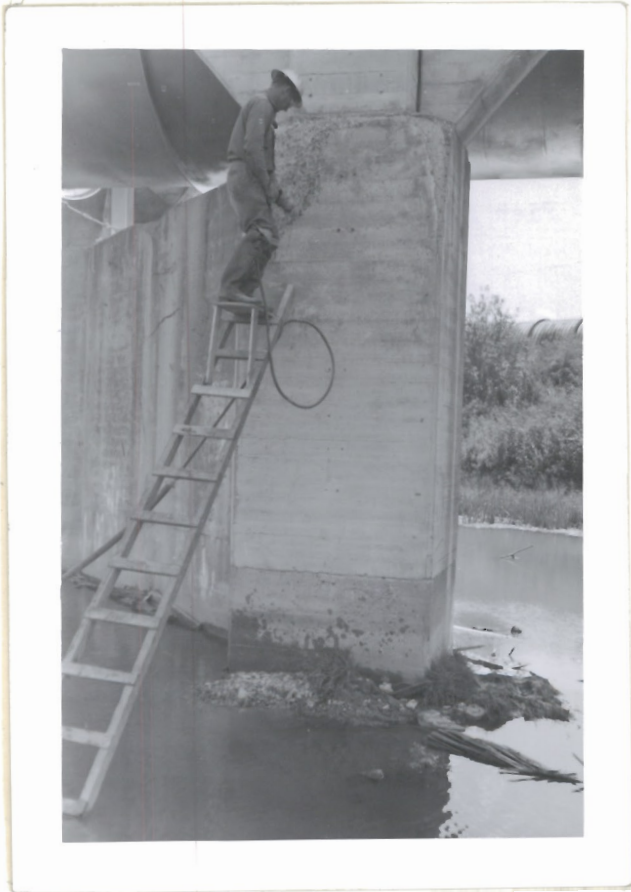
Pier #5 right tangent. Chipping away deteriorated concrete. 8-8-52

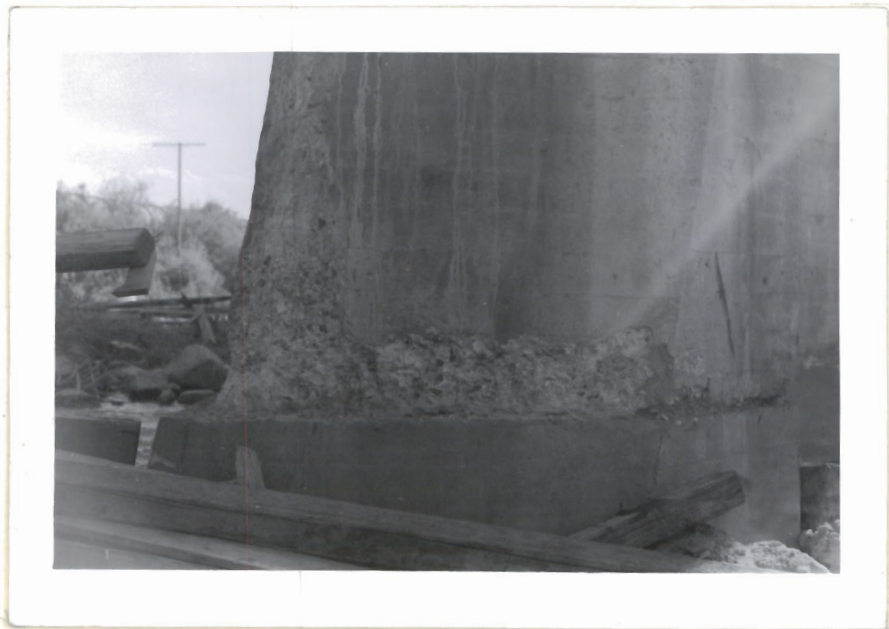
Pier #5 left tangent. Base deteriorated concrete chipped away, ready for forming. 8-10-52

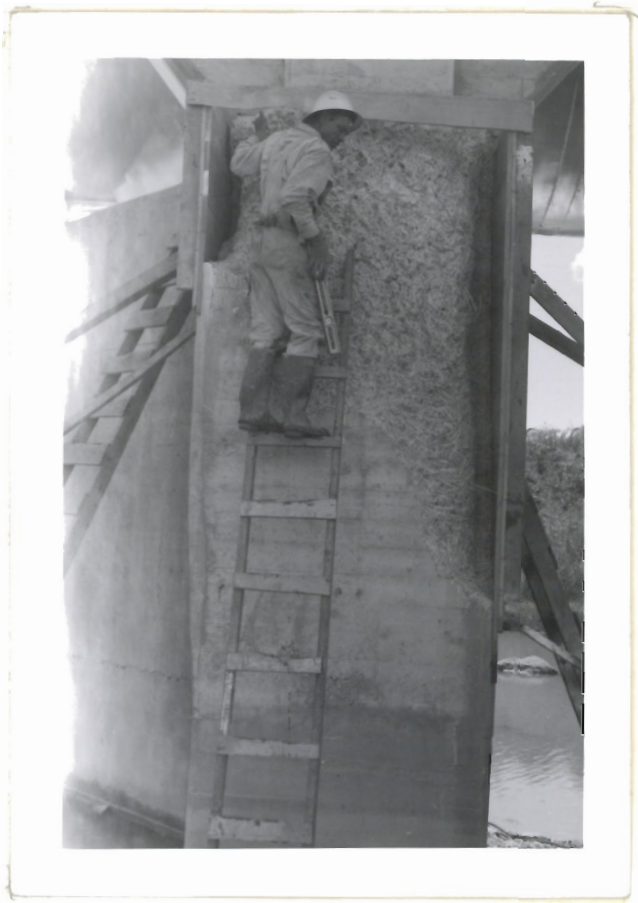
Pier #5 right tangent. Chipped & ready for forms.  
8-9-52

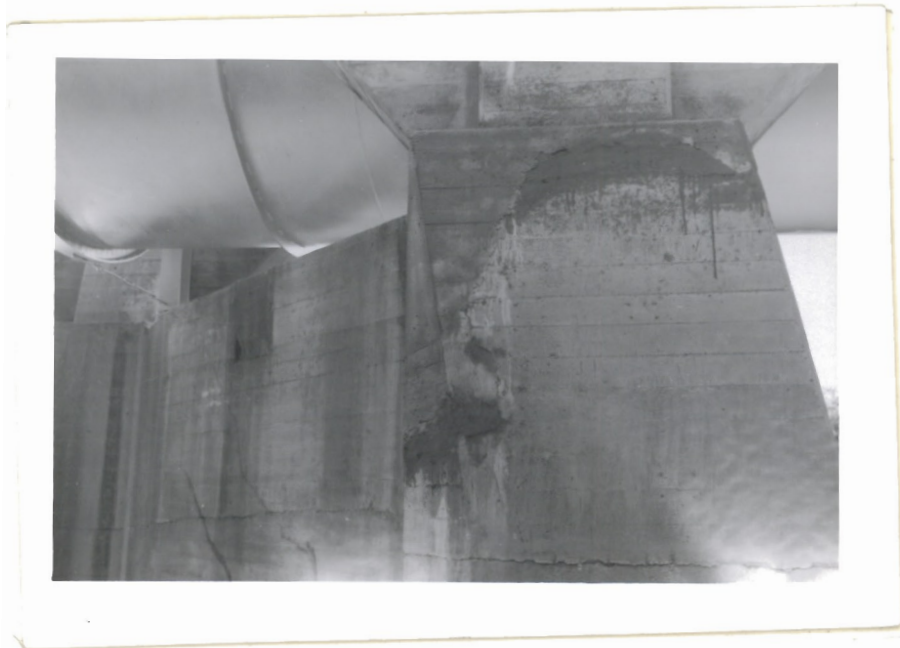
Pier #4 right tangent. Repairs complete. 8-14-52

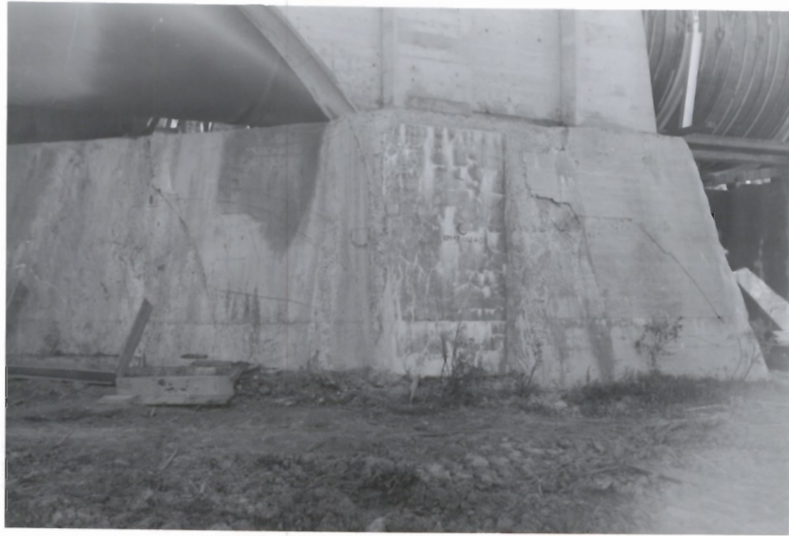
Downstream abutment right tangent. Shows spalled concrete  
before chipping. 8-15-52

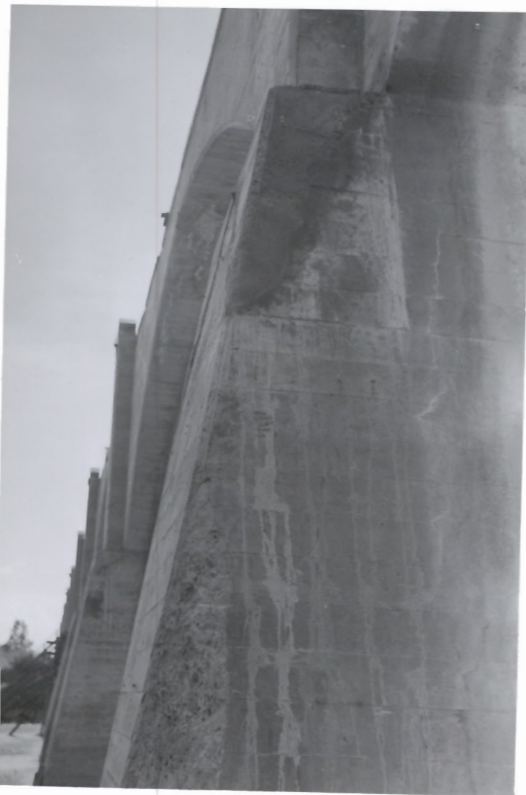
Pier #5 left tangent. Top repairs completed. 8-14-52

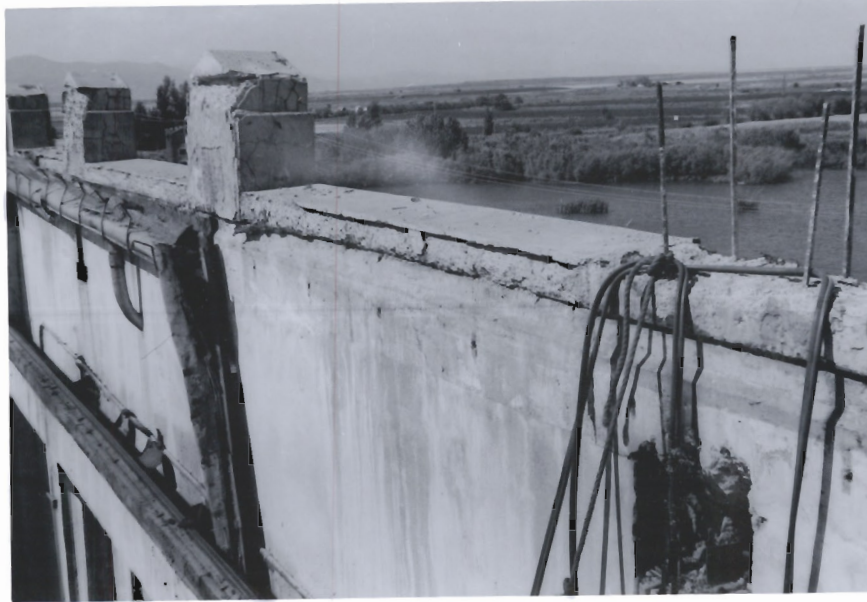
Top of North wall inside, Shows deteriorated concrete in coping and pillaster tops 9-26-57

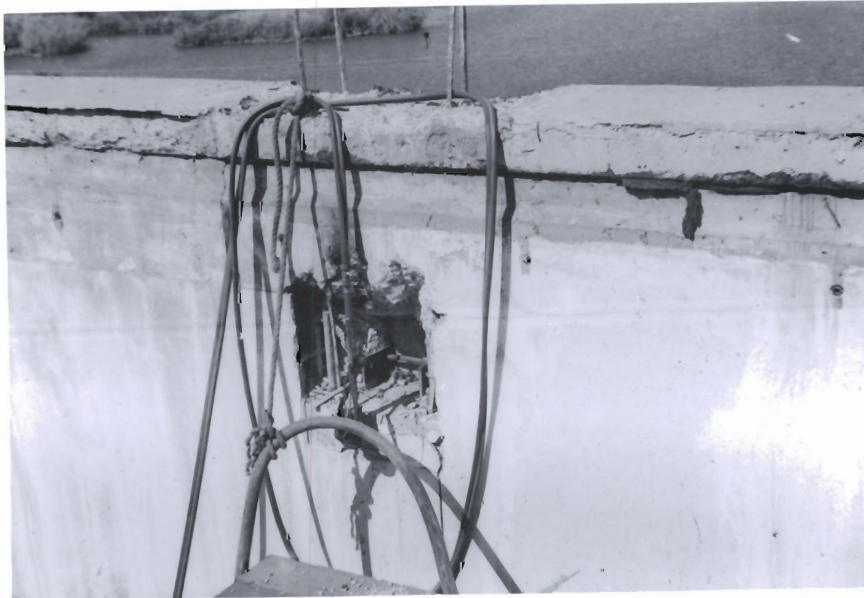
Top of pillaster removed - View northerly 9-26-57

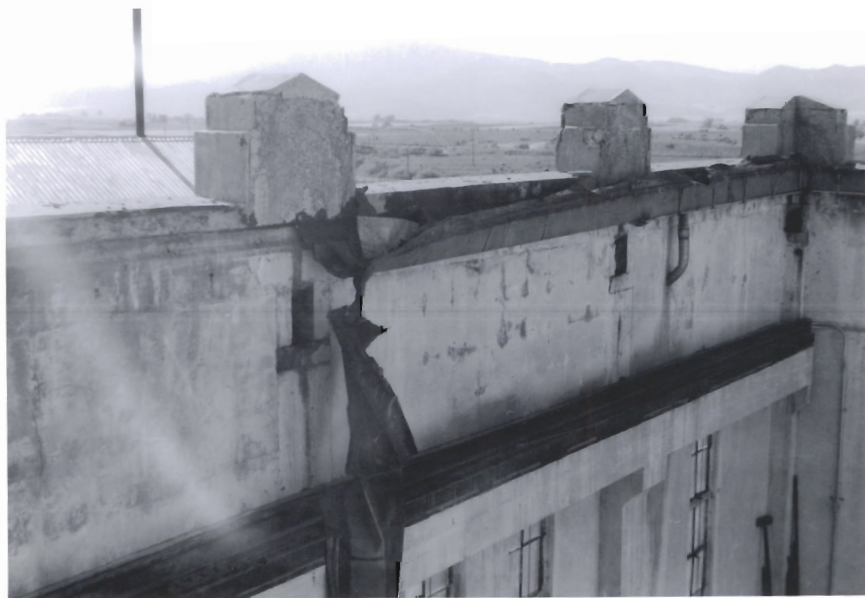
South wall inside after roof removal. Note deteriorated concrete. 9-26-57
