APPENDIX A – ASSESSMENT DATA BY SITE

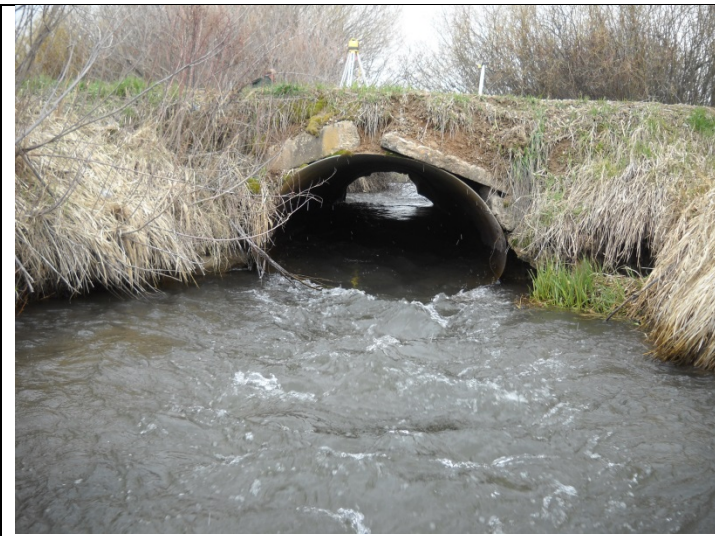
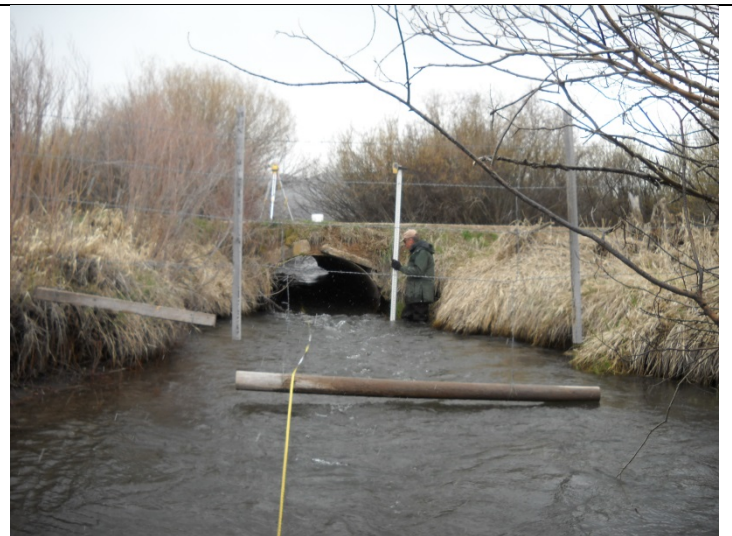
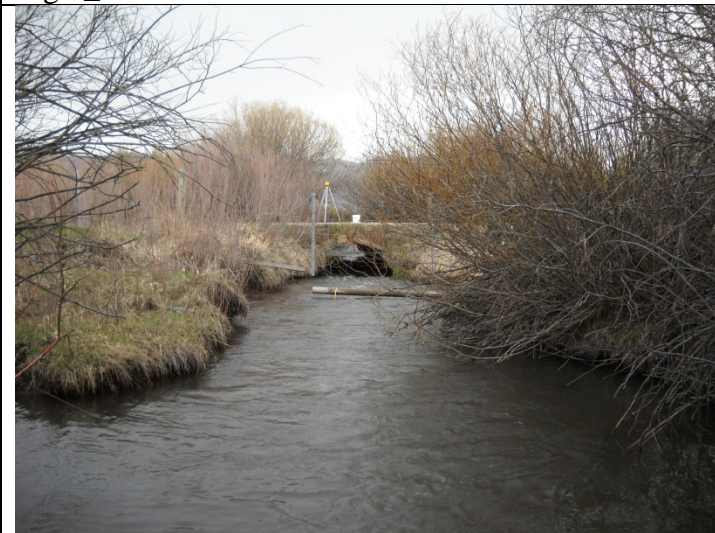
National Inventory and Assessment Procedure (NIAP)	FishXing		Does the structure constrict bankfull flows?
Juvenile Fish Passage Rating: RED Why: bankfull ratio	Low Passage Design Flow High Passage Design Flow Passable Flow Range Depth Barrier	6.50 cfs 389.00 cfs 6.50 to 56.69 cfs None	Yes
Adult Fish Passage Rating: RED Why: bankfull ratio	Leap Barriers Velocity Barrier Pool Depth Barrier	None 56.69 cfs and Above None

Eight_2.42 Culvert Outlet

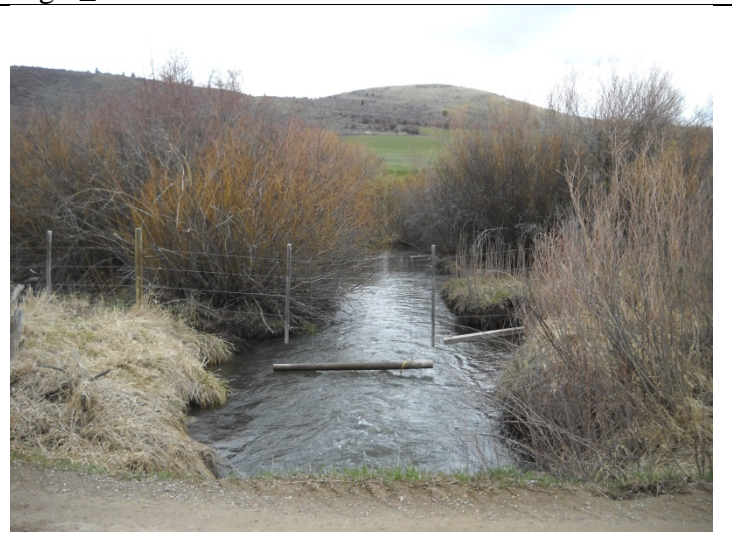
Eight_2.42 Looking Downstream from road

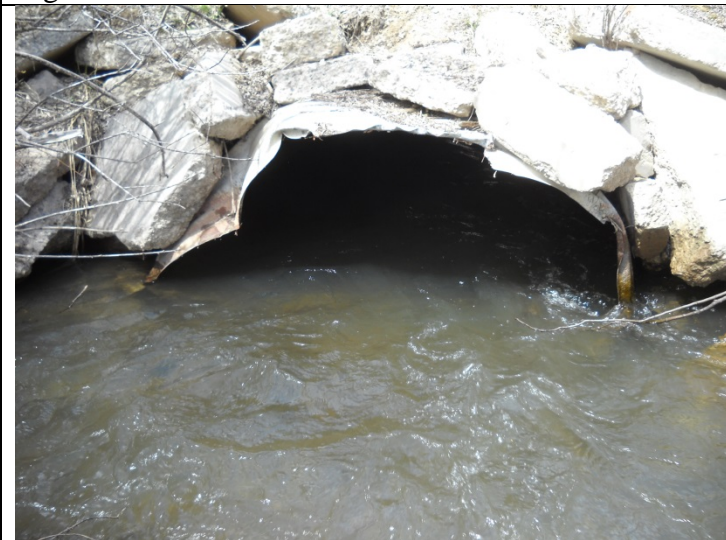
Eight_2.42 Culvert Inlet (bent inlet, armor present)

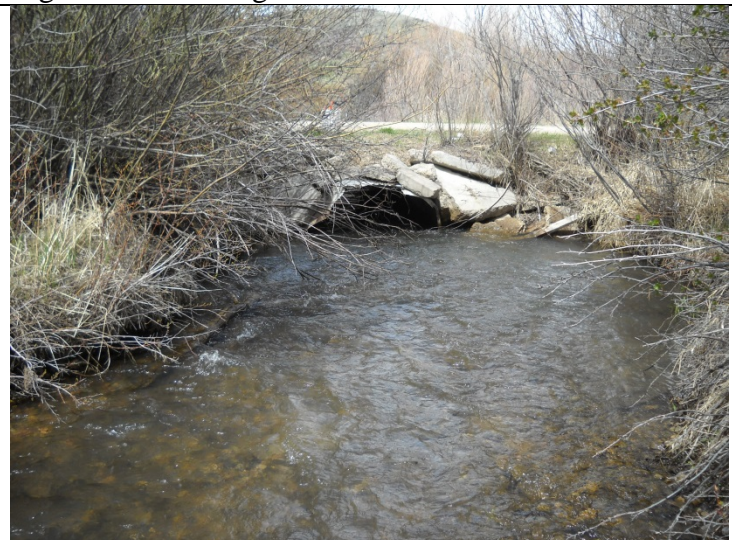
Eight_2.42 Culvert Inlet

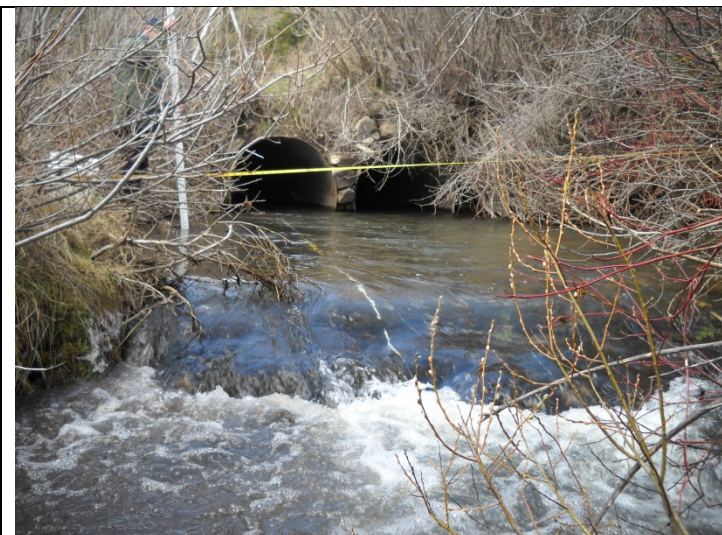
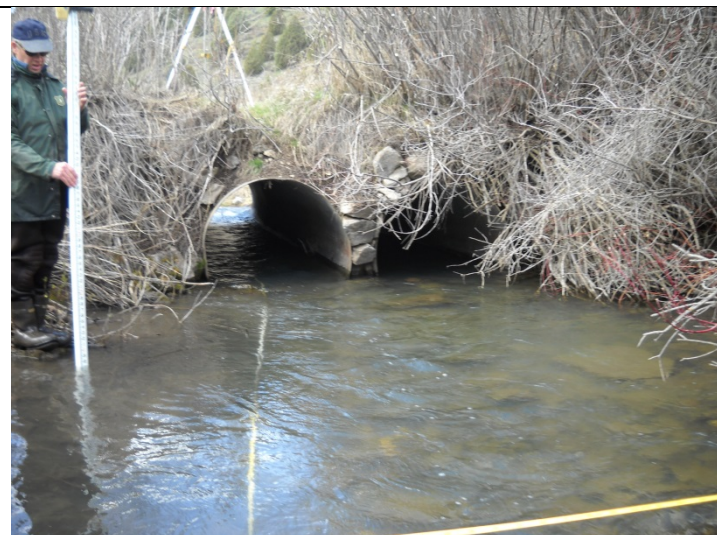
National Inventory and Assessment Procedure (NIAP)	FishXing			Does the structure constrict bankfull flows?
Juvenile Fish Passage Rating: RED	Low Passage Design Flow High Passage Design Flow Passable Flow Range Depth Barrier Leap Barriers Velocity Barrier Pool Depth Barrier	CULVERT 1	CULVERT 2	Yes
Why: culvert slope		5.00 cfs 256 cfs 5 - 64.33 cfs, 100 – 156.28 cfs	5.00 cfs 256 cfs 5 -92.92 cfs	
Adult Fish Passage Rating: RED		None	None	
Why: culvert slope		None	None	
		64.33 – 100 cfs, 156.28 cfs and above	92.92 cfs and above	
		None	None

Eight_5.81 Culvert outlet and rip-rap Tailwater control

Eight_5.81 Culvert Outlet

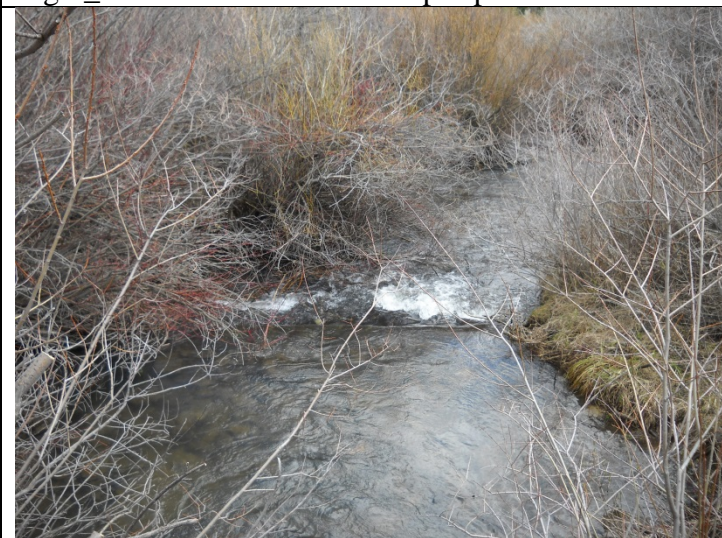
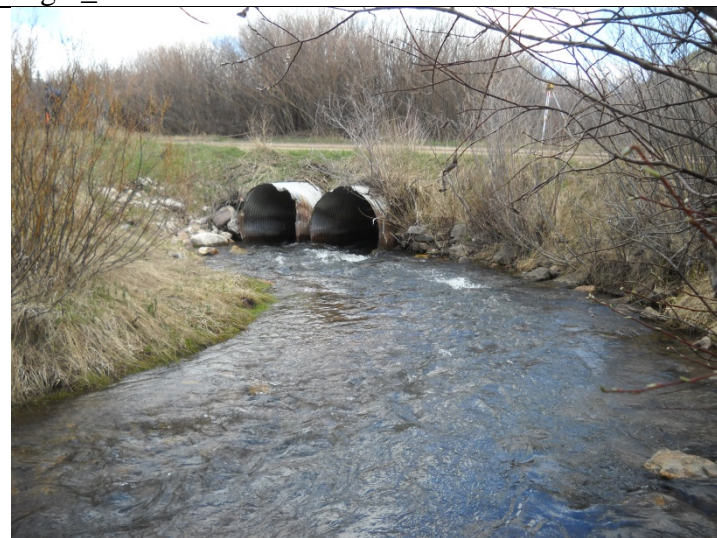
Eight_5.81 Rip-rap tailwater control

Eight_5.81 Culvert inlet, poor alignment with stream

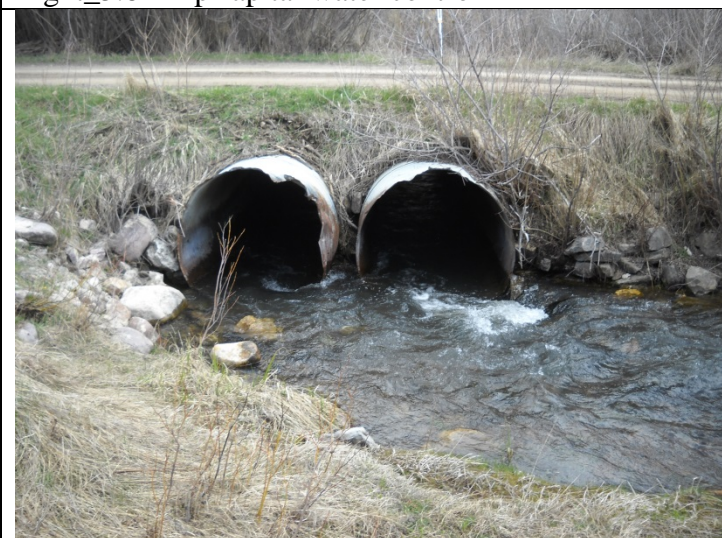
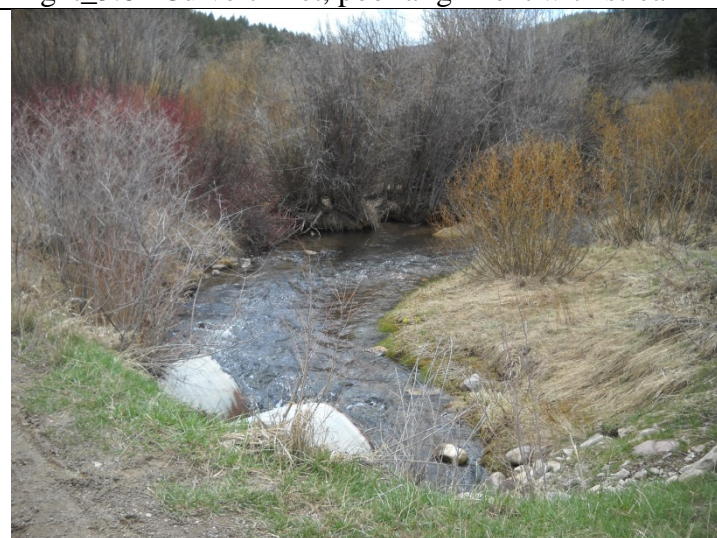
Eight_5.81 Culvert Inlet, poor alignment with stream

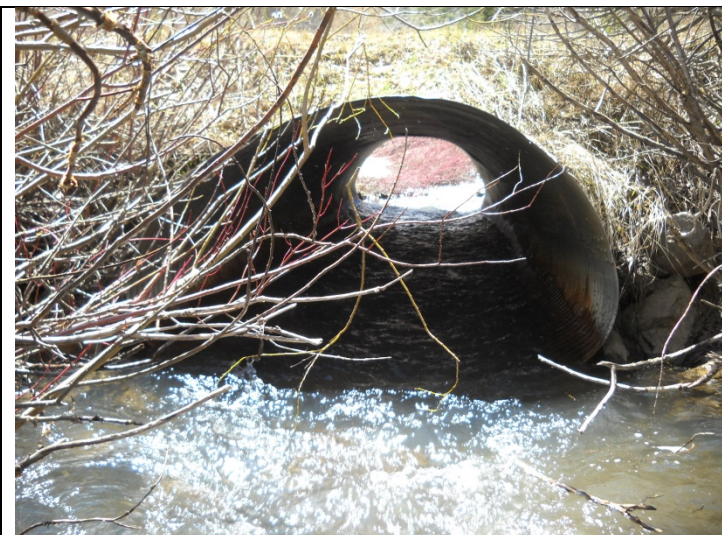
National Inventory and Assessment Procedure (NIAP)	FishXing		Does the structure constrict bankfull flows?
Juvenile Fish Passage Rating: RED	Low Passage Design Flow	2.87 cfs	Yes If both structure widths were added, bankfull flows would still be constricted. Ratio of inlet to bankfull would be 0.87.
Why: culvert slope, outlet drop, bankfull ratio	High Passage Design Flow	186 cfs	
Adult Fish Passage Rating: RED	Passable Flow Range	6.25 to 27.43 cfs	
Why: culvert slope, bankfull ratio	Depth Barrier	0 to 6.25cfs	
	Leap Barriers	None	
	Velocity Barrier	27.43 cfs and Above	
	Pool Depth Barrier	None

Eight_7.69 Culvert outlet

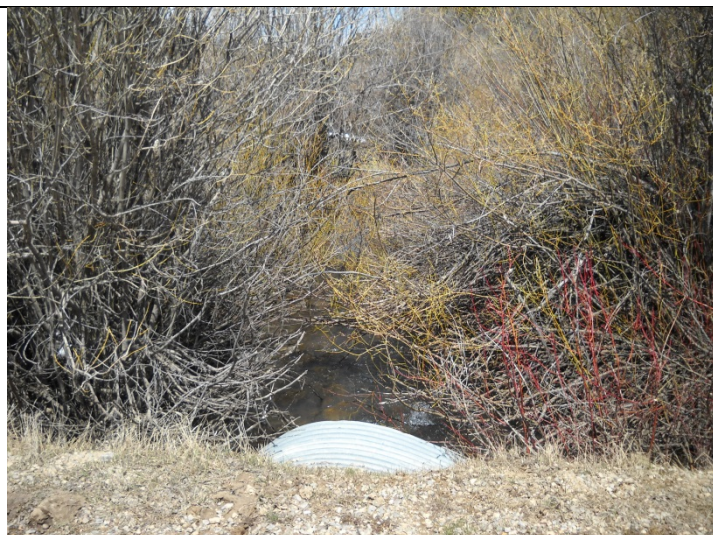
Eight_7.69 Culvert Outlet, looking downstream

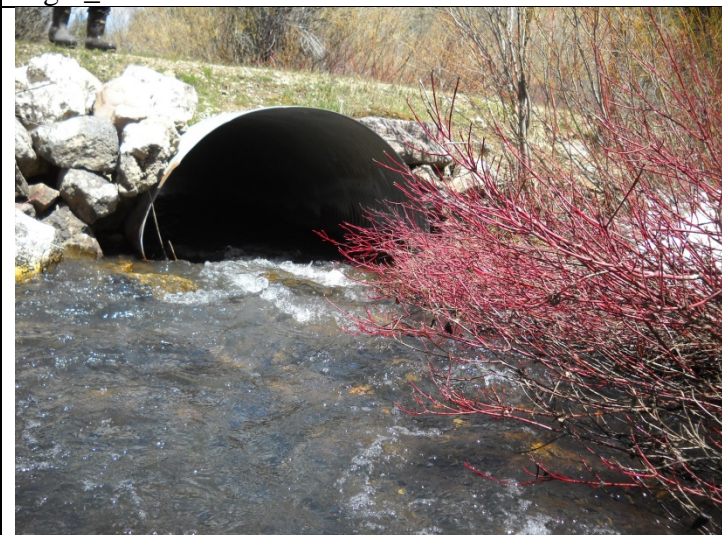
Eight_7.69 Culvert Inlet and Rip-rap

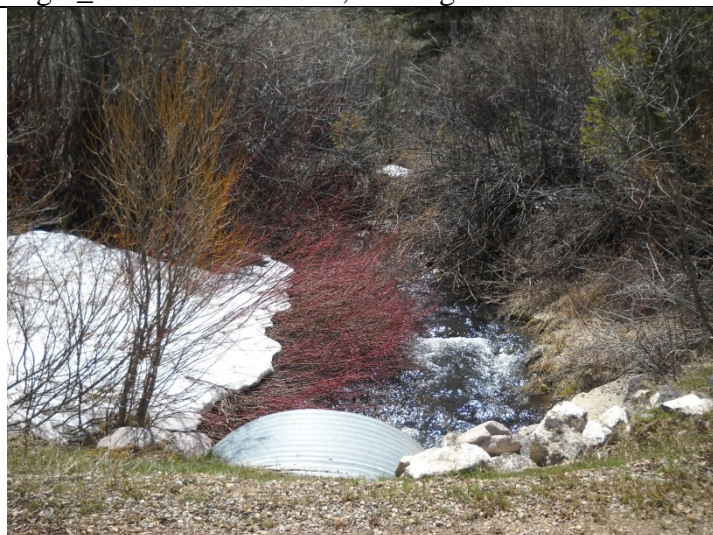
Eight_7.69 Culvert inlet, looking upstream

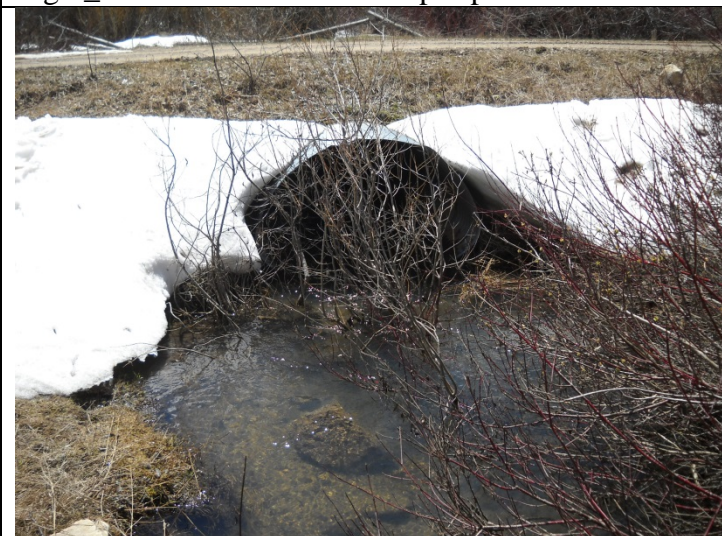
Culvert 1			Culvert 2
Culvert Slope	3.19	%	This additional crossing was not surveyed in 2005 because the channel was dry. During the field visit of 2014 this channel was active but had minimal flows. The structure did have a rust mark at 0.6 ft, indicating that this culvert is active during high flow periods. This additional culvert could impact passage and needs to be further assessed before rating this site for passage.
Channel Gradient (upstream)	3.2	%	
Channel Gradient (downstream)	1.14	%	
Outlet Drop	0.54	ft.	
Inlet Gradient	3.9	%	
Residual Inlet Depth	0	ft.	
Residual Pool Depth	0.55	ft.	
Ratio of Inlet to Bankfull Width	0.48

Eight_7.69B Culvert Outlet

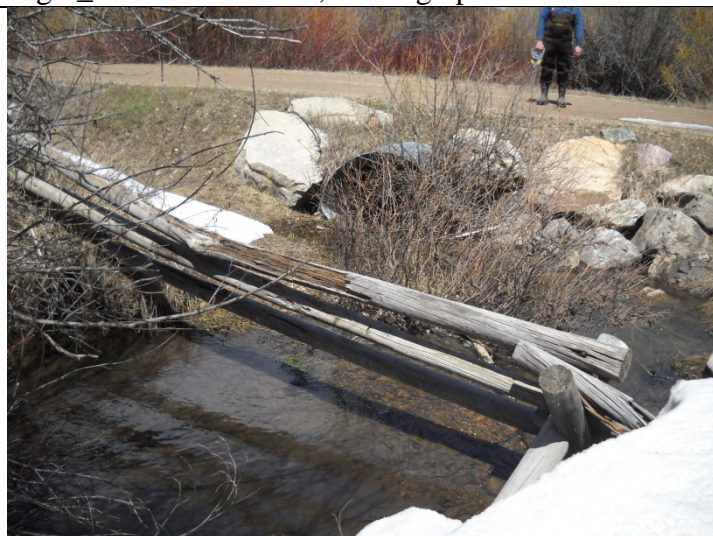
Eight_7.69B Culvert Inlet, poor alignment with stream

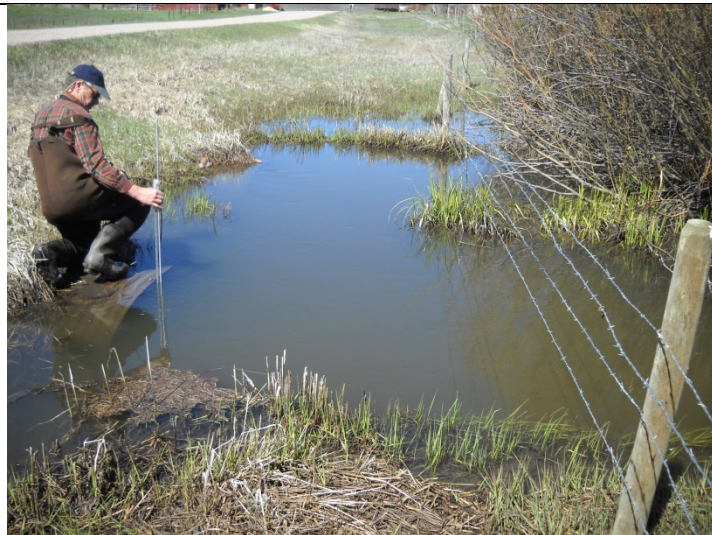
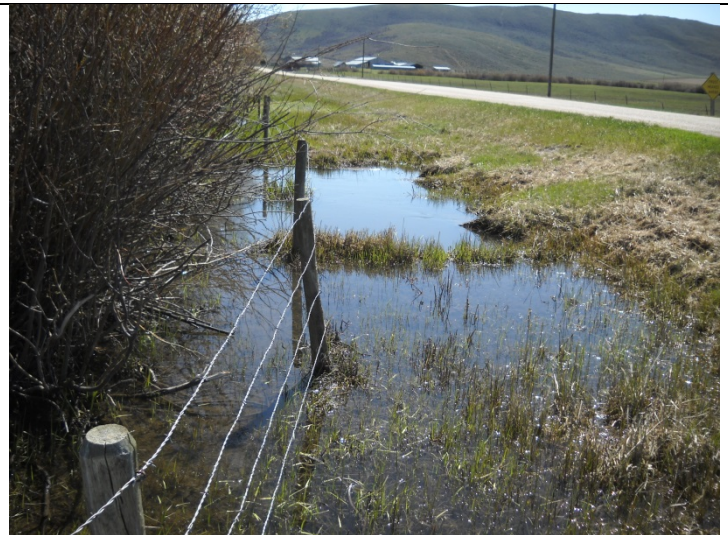
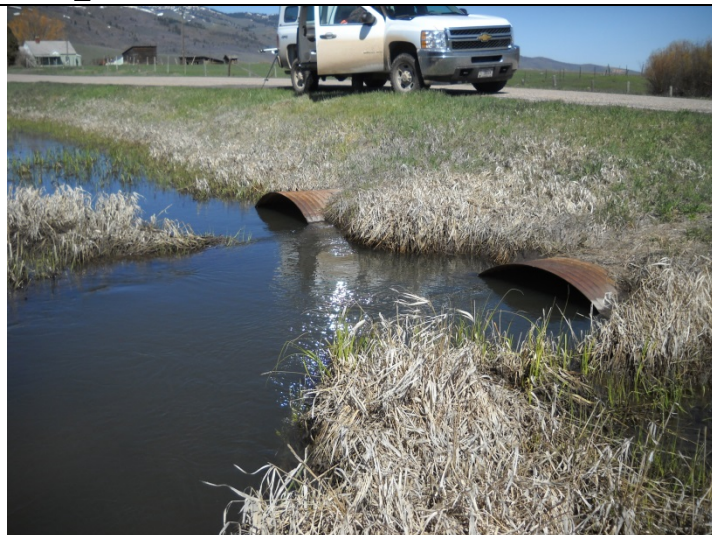
This stream crossing is located under the Nounan road on Stauffer Creek. The crossing consists of two 4 x 6 ft squashed culverts that are routinely submerged due to the systems low gradient. Both pipes have sediment throughout the structures (depths 1 -1.5 ft) and have low velocities (1.08 ft/sec measured on 4/30/2014). It is assumed that these crossings do not impede fish passage. No fish passage surveys were conducted at this site.

Stauf_2.70 Culvert outlet

Stauf_2.70 Culvert inlet, looking down the pipe

Stauf_2.70 Culvert inlets

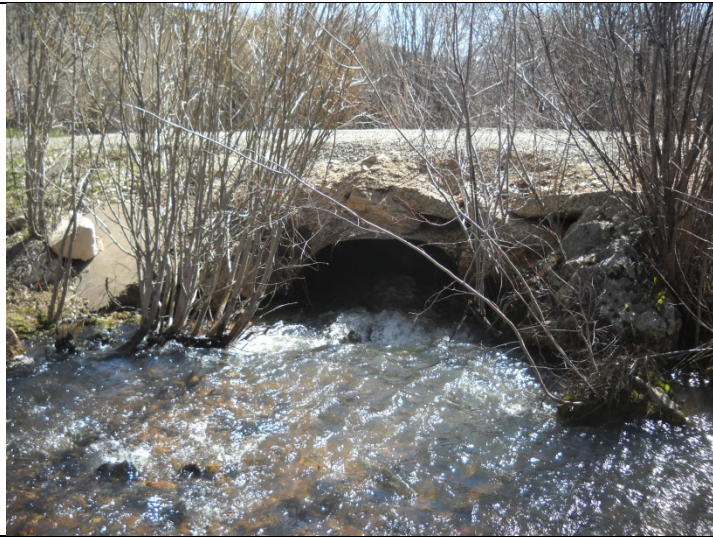
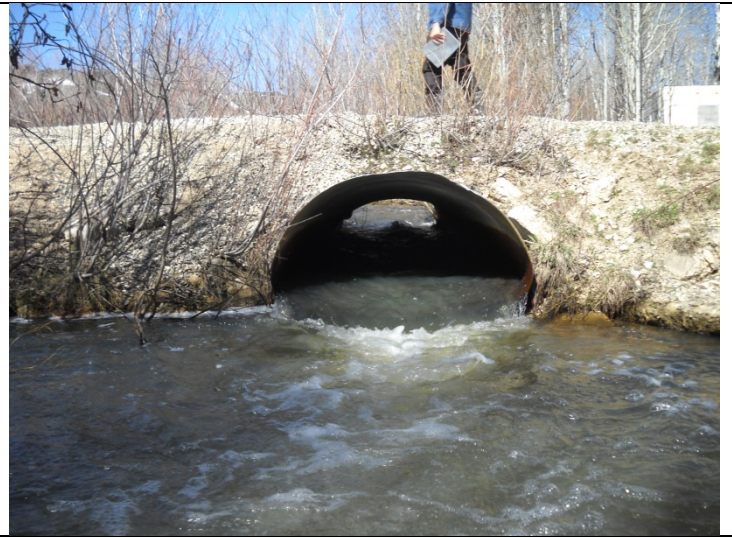
National Inventory and Assessment Procedure (NIAP)	FishXing		Does the structure constrict bankfull flows?
Juvenile Fish Passage Rating: RED Why: bankfull ratio, culvert slope	Low Passage Design Flow High Passage Design Flow Passable Flow Range Depth Barrier	2.77 cfs 148 cfs 5.79 – 49.05 cfs 0 to 5.79 cfs	Yes
Adult Fish Passage Rating: RED Why: bankfull ratio	Leap Barriers Velocity Barrier Pool Depth Barrier	None 49.05 cfs and Above None

Stauf_7.5 Culvert Inlet with rip-rap

Stauf_7.5 Culvert outlet

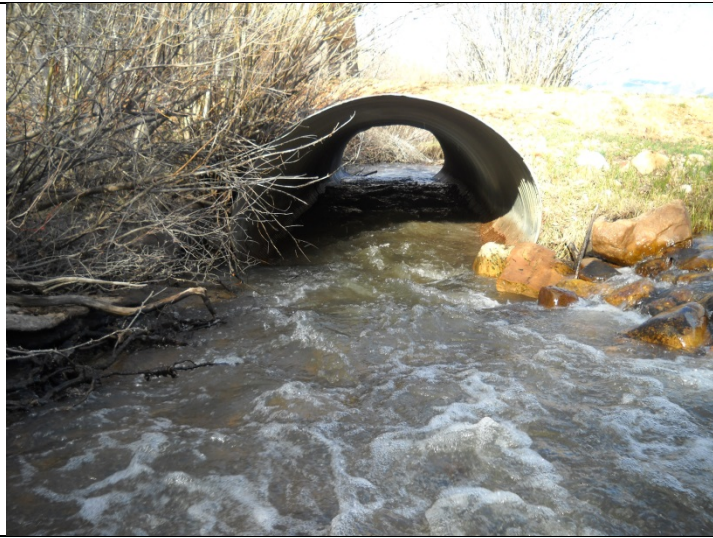
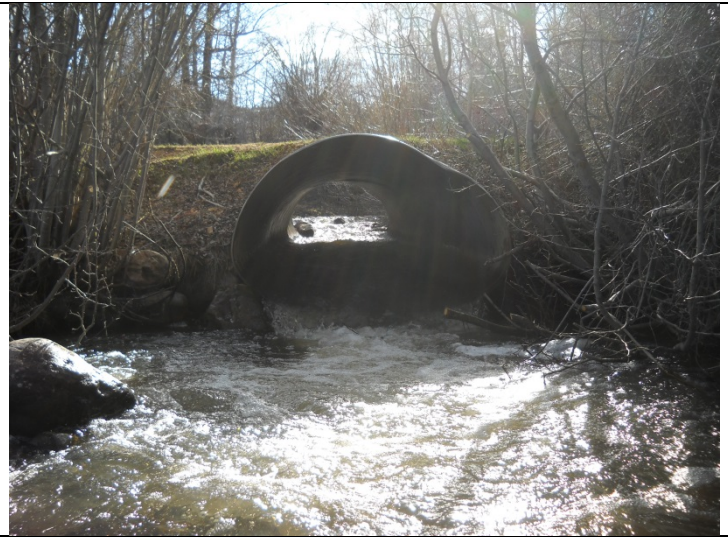
National Inventory and Assessment Procedure (NIAP)	FishXing		Does the structure constrict bankfull flows?
Juvenile Fish Passage Rating: RED Why: bankfull ratio, culvert slope, outlet drop	Low Passage Design Flow High Passage Design Flow Passable Flow Range Depth Barrier	1.79 cfs 98 cfs 5.83 – 26.84 cfs 0 to 5.83 cfs	Yes
Adult Fish Passage Rating: RED Why: bankfull ratio, culvert slope	Leap Barriers Velocity Barrier Pool Depth Barrier	None 26.84 cfs and Above None

Stauf_7.71 Culvert Inlet with rip-rap

Stauf_7.71 Culvert outlet

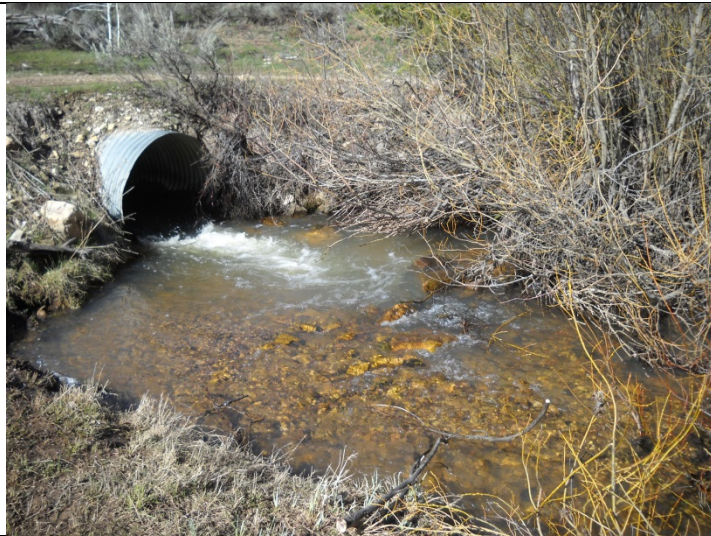
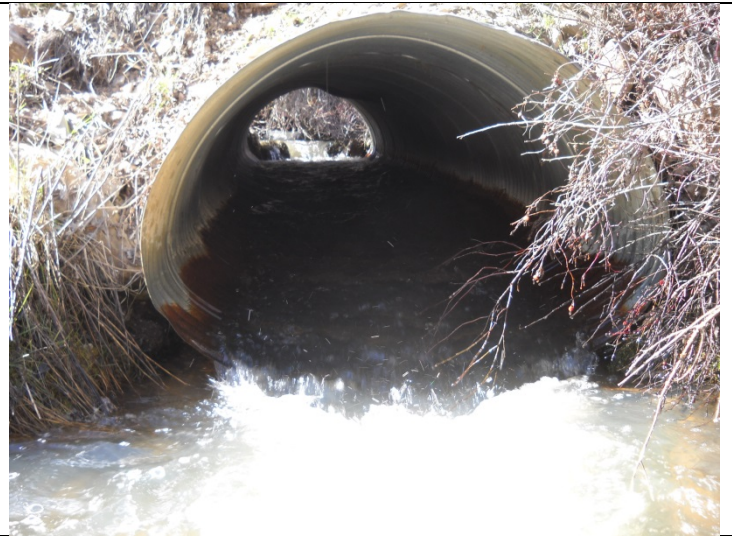
National Inventory and Assessment Procedure (NIAP)	FishXing		Does the structure constrict bankfull flows?
Juvenile Fish Passage Rating: RED Why: bankfull ratio, culvert slope, outlet drop	Low Passage Design Flow High Passage Design Flow Passable Flow Range Depth Barrier	0 cfs 42.6 cfs 6.39 to 17.43 cfs 0 to 6.39 cfs	Yes
Adult Fish Passage Rating: RED Why: bankfull ratio, culvert slope	Leap Barriers Velocity Barrier Pool Depth Barrier	None 17.43 cfs and Above None

Stauf_8.66 Culvert outlet and tailwater control

Stauf_8.66 Culvert outlet

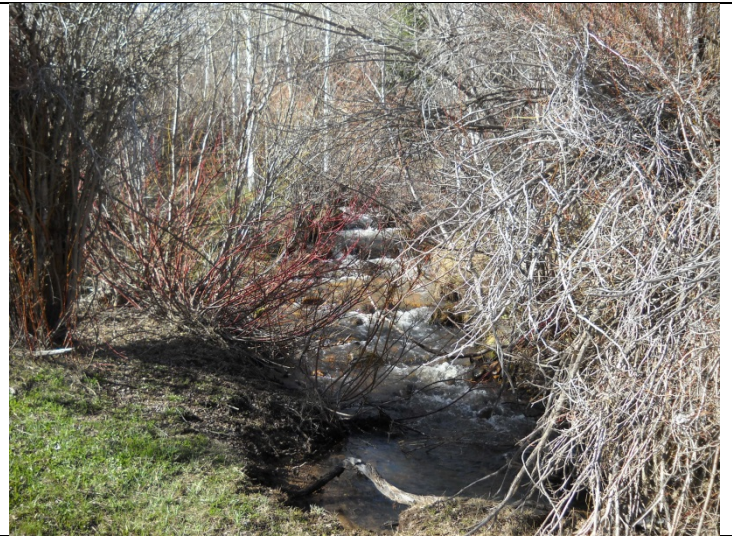
Stauf_8.66 stream gradient upstream of crossing

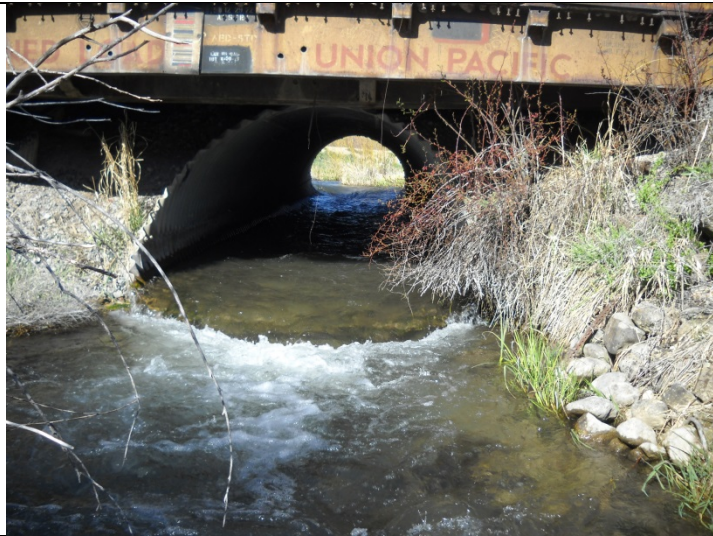
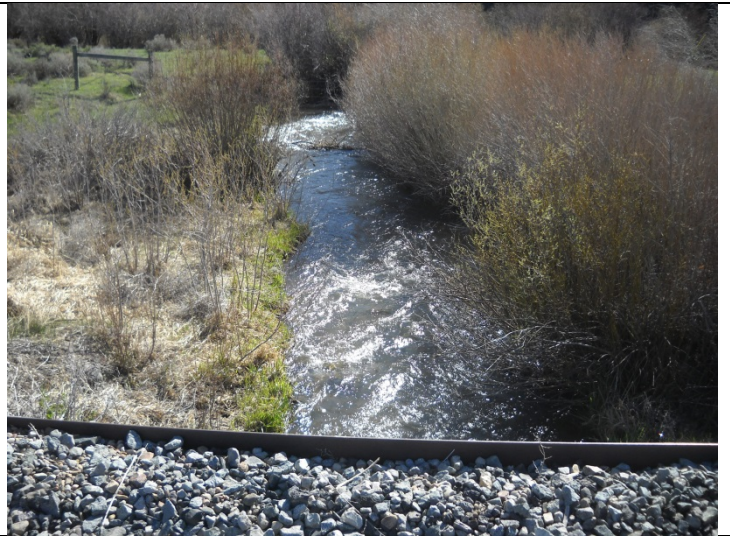
National Inventory and Assessment Procedure (NIAP)	FishXing		Does the structure constrict bankfull flows?
Juvenile Fish Passage Rating: RED Why: culvert slope, outlet drop	Low Passage Design Flow High Passage Design Flow Passable Flow Range Depth Barrier	6.6 cfs 227 cfs 6.6 to 8.30 cfs None	Yes
Adult Fish Passage Rating: RED Why: culvert slope	Leap Barriers Velocity Barrier Pool Depth Barrier	None 8.31 cfs and Above None

Gtown_0.04 Culvert outlet

Gtown_0.04 Culvert outlet, looking downstream

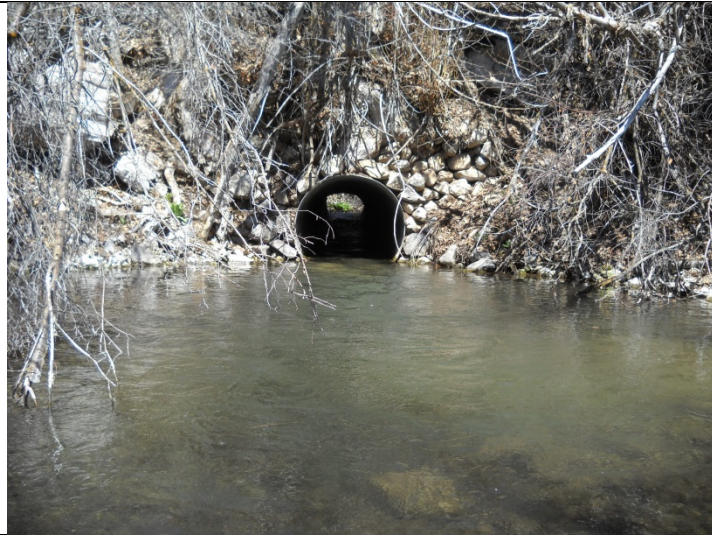
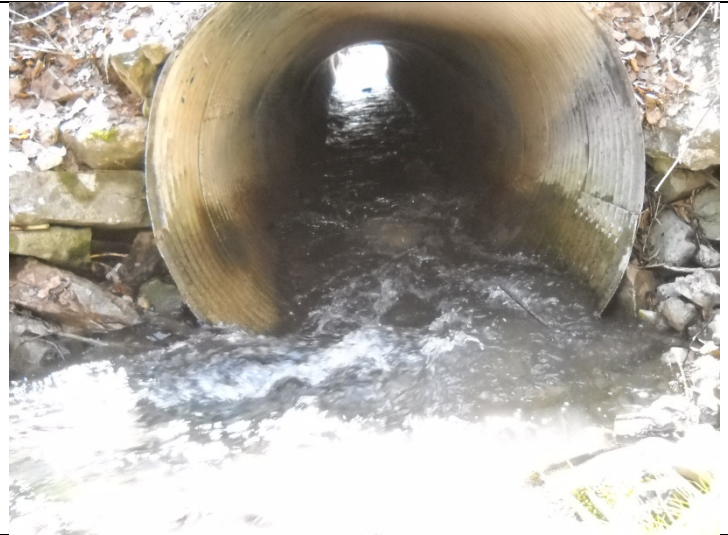
This stream crossing is located under the Left Hand Fork road. The valley bottom of Georgetown Creek has been extensively filled to elevate the road way. Fill depths of 35' at the site made survey efforts tedious. To date fish passage surveys have not been completed at this site. However the condition of the culvert warrants replacement. The culvert has a drastic break in slope near the inlet and the culvert bottom is rusting out with holes visible. Site information: Round 4 ft culvert that is 55 ft long.

Gtown_3.91 Culvert outlet

Gtown_3.91 Culvert inlet, looking down the pipe

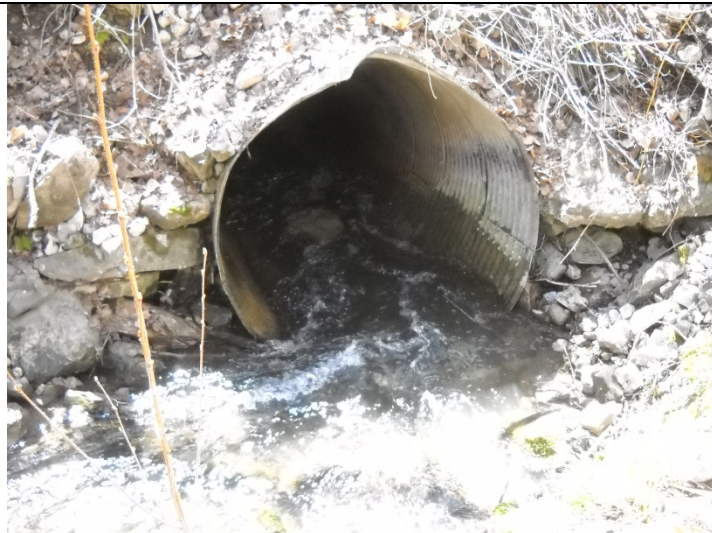
Gtown_3.91 Culvert inlet, poor alignment

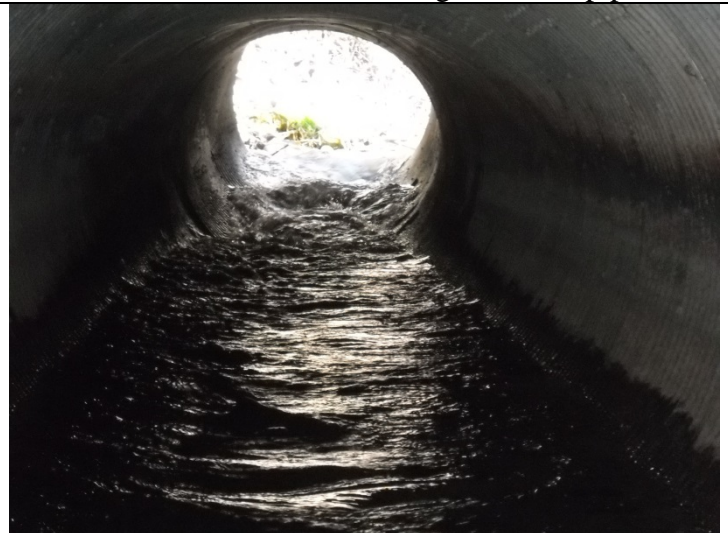
Gtown_3.91 Culvert inlet, grade break in culvert

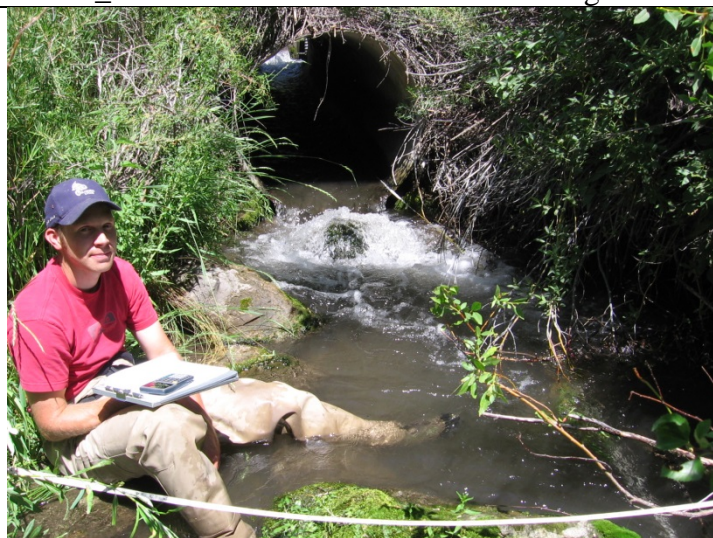
National Inventory and Assessment Procedure (NIAP)	FishXing		Does the structure constrict bankfull flows?
Juvenile Fish Passage Rating: RED Why: bankfull ratio, culvert slope, outlet drop	Low Passage Design Flow High Passage Design Flow Passable Flow Range	4.21 cfs 150 cfs 4.21 – 9.30 cfs, 76 - 81.88 cfs	Yes
Adult Fish Passage Rating: RED Why: bankfull ratio, culvert slope, outlet drop	Depth Barrier Leap Barriers Velocity Barrier Pool Depth Barrier	None None 9.30 – 76 cfs and 81.88 cfs and Above None

Gtown_4.85 Culvert outlet and Tailwater control
