Condit Hydroelectric Project Decommissioning

FERC Project No. 2342

POST-RESERVOIR-DEWATERING ASSESSMENT REPORT

February 22, 2012

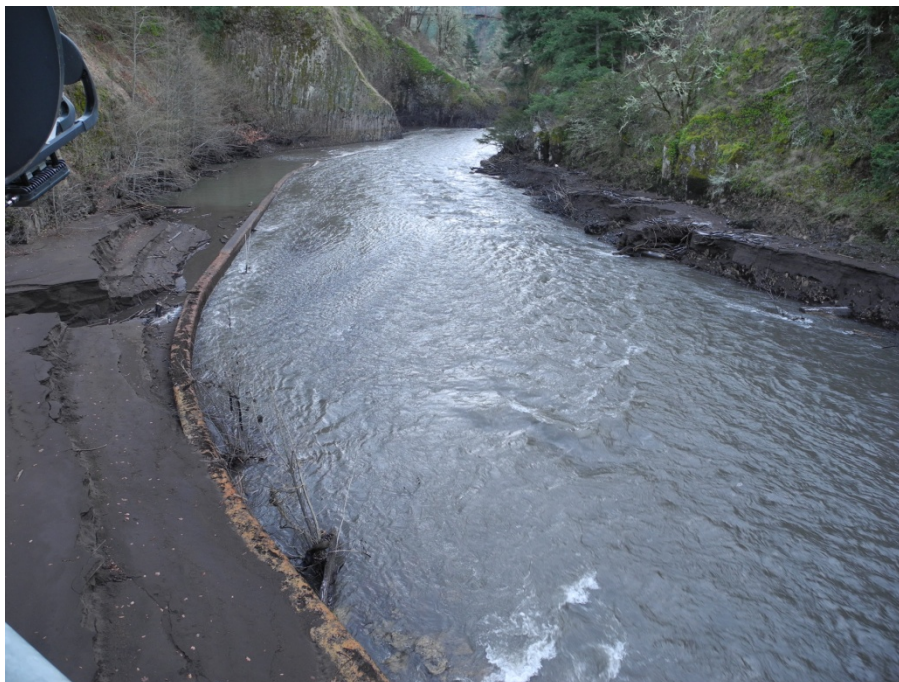
As the water levels dropped at the powerhouse, the level of temporary sediment filling of the channel bed could be seen. Photo 1 shows what is left of the temporary channel bed fill, with the sediment drape line on river right (view is looking downstream).

Photo 1. Downstream view of the White Salmon River at the powerhouse. Temporary bed sediment levels can be inferred from the deposition on river right. On river left the powerhouse tailrace is filled with sediment. Photo date December 7, 2011.

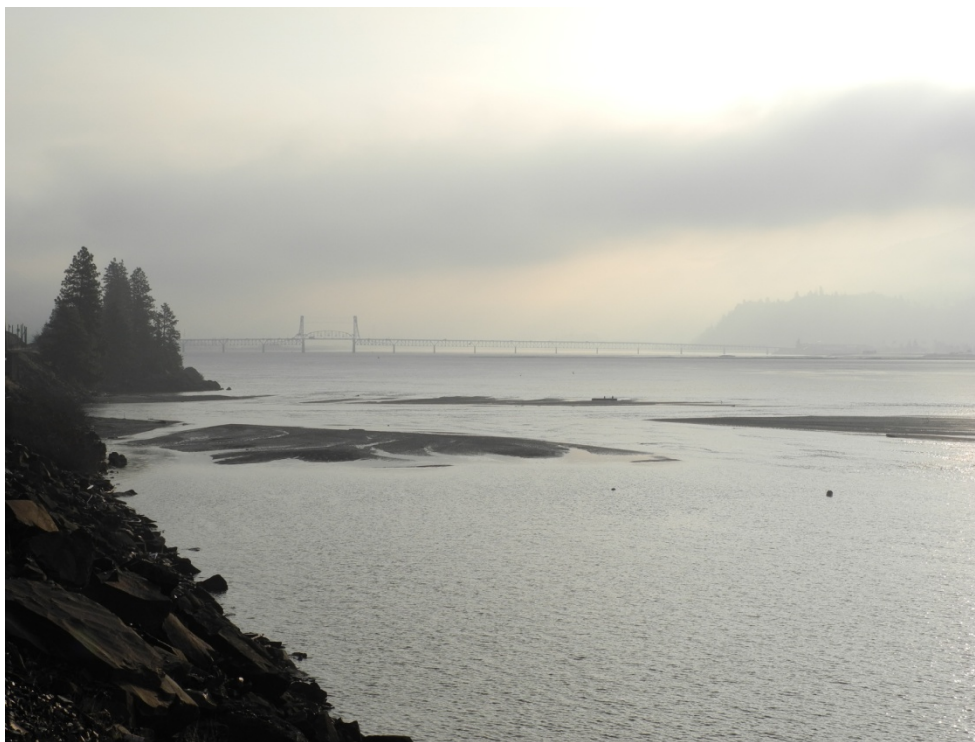
Sand-size sediment accumulated at the "Underwood In-Lieu site" on the White Salmon River, just upstream of the Columbia River confluence. At this location the width of the White Salmon River doubles from the typical channel width upstream, and the gradient of the river is quickly reduced because of backwater effects from the Bonneville Pool. It took only a few days for the Underwood In-Lieu site to fill almost completely with sand, creating a wide and shallow flow of water and sediment across the new bed surface. Conversely, it took almost four weeks after the breach before sand deposits were visible on the surface of the Columbia River at the mouth of the White Salmon River (Photo 2). After three months time, the White Salmon has cut a new

channel through the sediments at the Underwood In-Lieu site, but enough sediment still remains to make the former boat ramp unusable until some dredging work is completed.

Photo 2. Columbia River at the mouth of the White Salmon River on December 8, 2011. Sand bars visible.

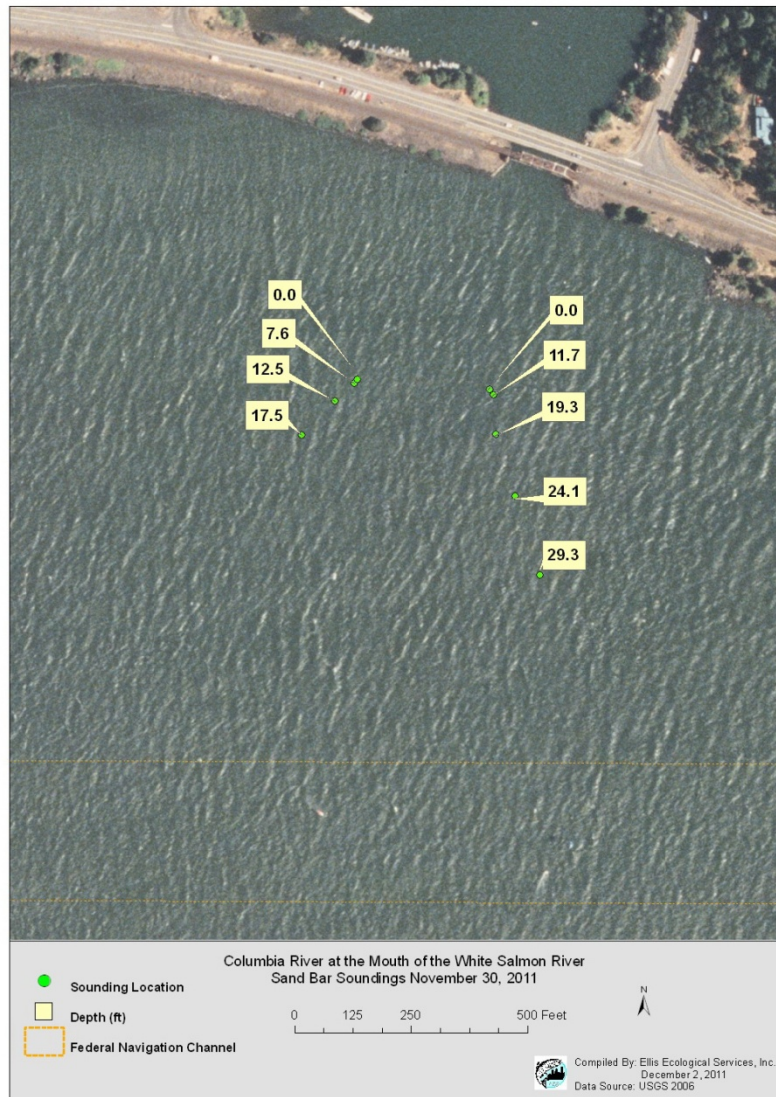
Bathymetric surveys conducted in the Columbia River at the mouth of the White Salmon River in the first week post breach revealed approximately 433,000 cubic yards deposited. It is apparent that the bulk of the bedload sediment volume had taken weeks rather than days to reach the Columbia River. A limited number of sediment depth data points were collected on November 30, 2011. These data points and depth are shown on Photo 3, as is the commercial navigation channel (faint yellow line). The Coast Guard placed a lighted warning buoy at the outer extent off the sediment deposition area to warn mariners of the sandbar.

Photo 3. Depth to sediment surface measurements taken on November 30, 2011. Columbia River at the mouth of the White Salmon River. Note: photography is from an earlier date.
