Condit Hydroelectric Project Decommissioning

FERC Project No. 2342

ANNUAL SEDIMENT ASSESSMENT REPORT - 2012

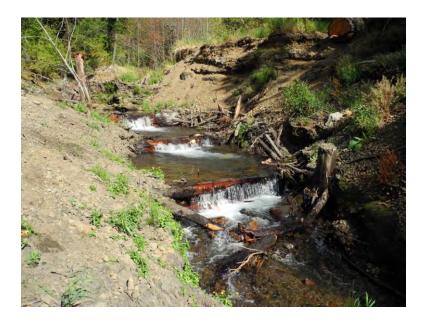
Log check dams installed on Mill Creek.

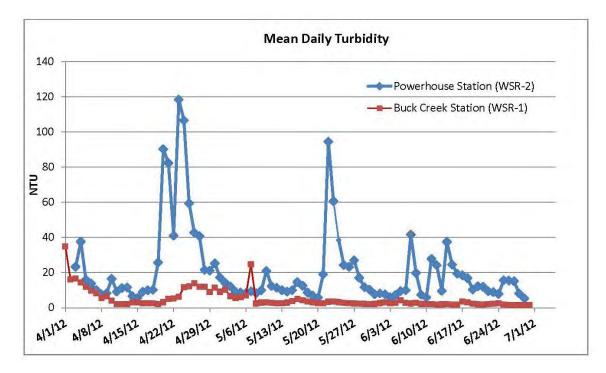
being conducted, and times when a rainfall/runoff event occurred. The graph of turbidity in the White Salmon River shown below indicates that after the beginning of May, background turbidity levels in the river measured at the Buck Creek site (upstream of the former reservoir) remained at a consistently low level. Turbidity levels measured at the powerhouse site (downstream of the former reservoir) show the influence of sediment management activities, but also indicate the overall trend towards stability in the project site, when downstream turbidity measurements approach the upstream levels.

Measured turbidity for the period April through June, 2012 in the White Salmon River upstream and downstream of the project site.

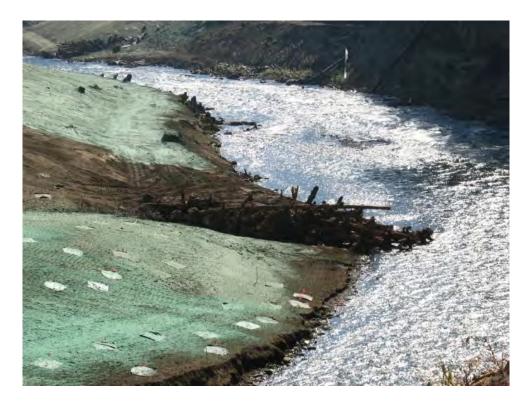
Engineered Log Jam structures: Location 4 in the foreground, Location 3 in the background (downstream). Purpose is to reduce soil erosion on the riverbanks in areas where a riparian bench has been constructed. Note: partial coverage of hydroseed and mulch is visible on the left, along with weed barriers for upcoming tree plantings.

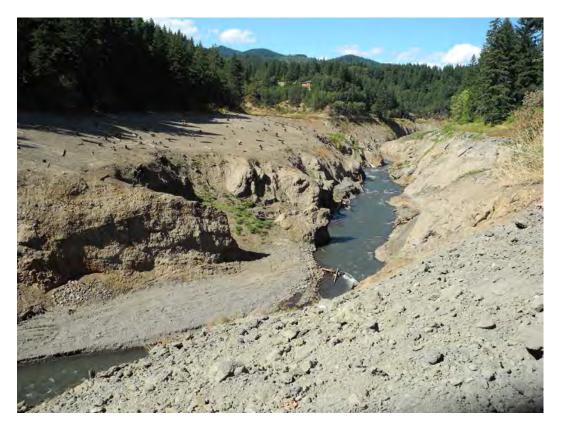
Photo Point #6 Looking Upstream 8.28.12 Note: photo vantage point slightly different since the dam no longer exists.
