Condit Hydroelectric Project Decommissioning

FERC Project No. 2342

ANNUAL SEDIMENT ASSESSMENT REPORT - 2014

September 26, 2014

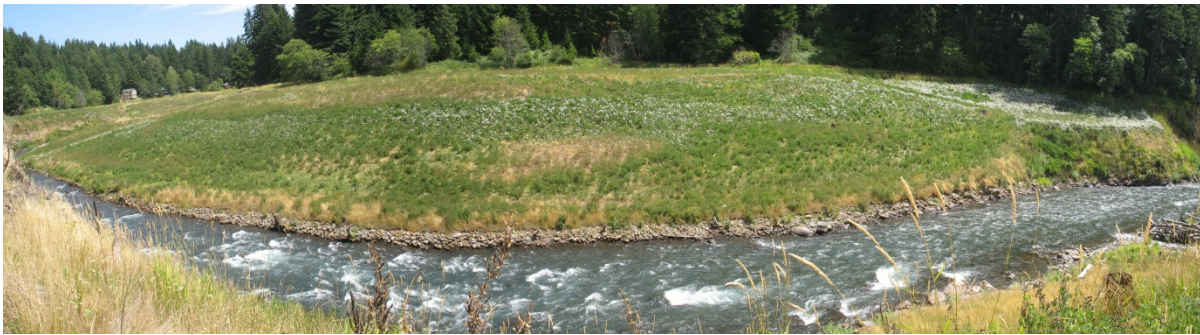
Location 4 – July 11, 2014

The seven Engineered Log Jams (ELJ) that were placed to facilitate the development of riparian floodplains adjacent to the river remain intact and stable. An ELJ at Location 4 was directly across the river from, and affected by, the rockfall that occurred in January 2014. Inspection of the site indicated that the rockfall caused a wave that ran up the opposite riverbank at least 20 feet above the ELJ. After the initial wave, the rock debris at the base of the vertical wall

temporarily diverted the thalweg so the force of the river's flow was aimed directly at the ELJ. These conditions eroded some of the sediment that was covering the ELJ on the upland side and possibly caused some scour under the ELJ. With the shift in the thalweg, the ELJ was also evaluated as a hazard to boating and plans were initiated to shorten some logs overhanging the main channel. However, the ten-year event in March 2014 mobilized the talus from the rockfall and the thalweg shifted back to the previous alignment. Modification to the ELJ was subsequently determined not to be necessary and monitoring of conditions will continue.

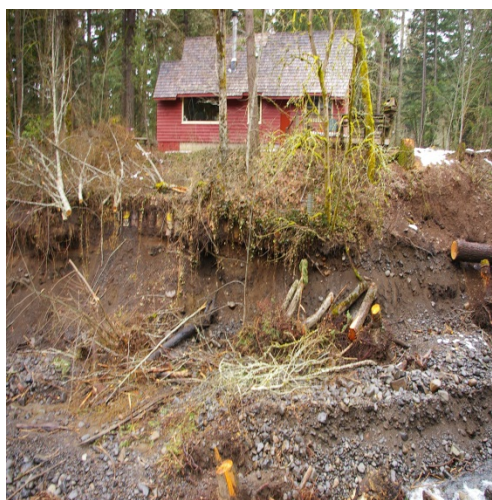
In February 2012, two cabins built on sites leased from PacifiCorp Energy located on each side of Buck Creek at its confluence with the White Salmon River were identified as safety hazards due to the potential for riverbank erosion to undermine the cabins. Under the terms of the leases, these cabin sites were closed to further recreational use. One cabin was removed in 2012 and the second cabin is anticipated to be removed during fall 2014. The slope below this cabin exceeds the angle of repose and is subject to erosion. The site will be graded to a stable slope in conjunction with demolition.

Cabin at mouth of Buck Creek - to be removed

The criterion for stable slopes has been met in most of the reservoir area, but additional grading at the mouth of Buck Creek is needed in conjunction with cabin demolition. Repair of the bank

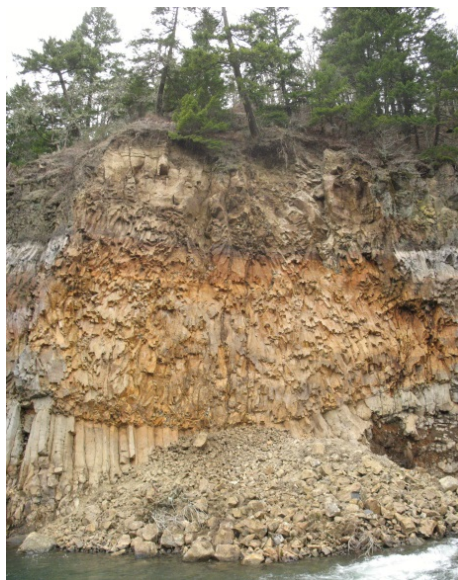
contributing to the geotechnical stability of slopes in the former reservoir area can be attributed to the ongoing effectiveness of factors including low slope angles, good herbaceous cover, and the collection of water from the hillsides into natural or graded channels. There have been no observed mass failures of reservoir sediments. Herbaceous cover has continued to develop and has been effective in limiting surface erosion. A rockfall occurred in January 2014 on an existing vertical rock face along the White Salmon River opposite Location 4. Freeze-thaw effects on the rock slope are believed to have caused the rockfall.

Rockfall opposite Location 4—January 21, 2014
