Condit Hydroelectric Project Decommissioning

FERC Project No. 2342

ANNUAL SEDIMENT ASSESSMENT REPORT - 2016

September 28, 2016

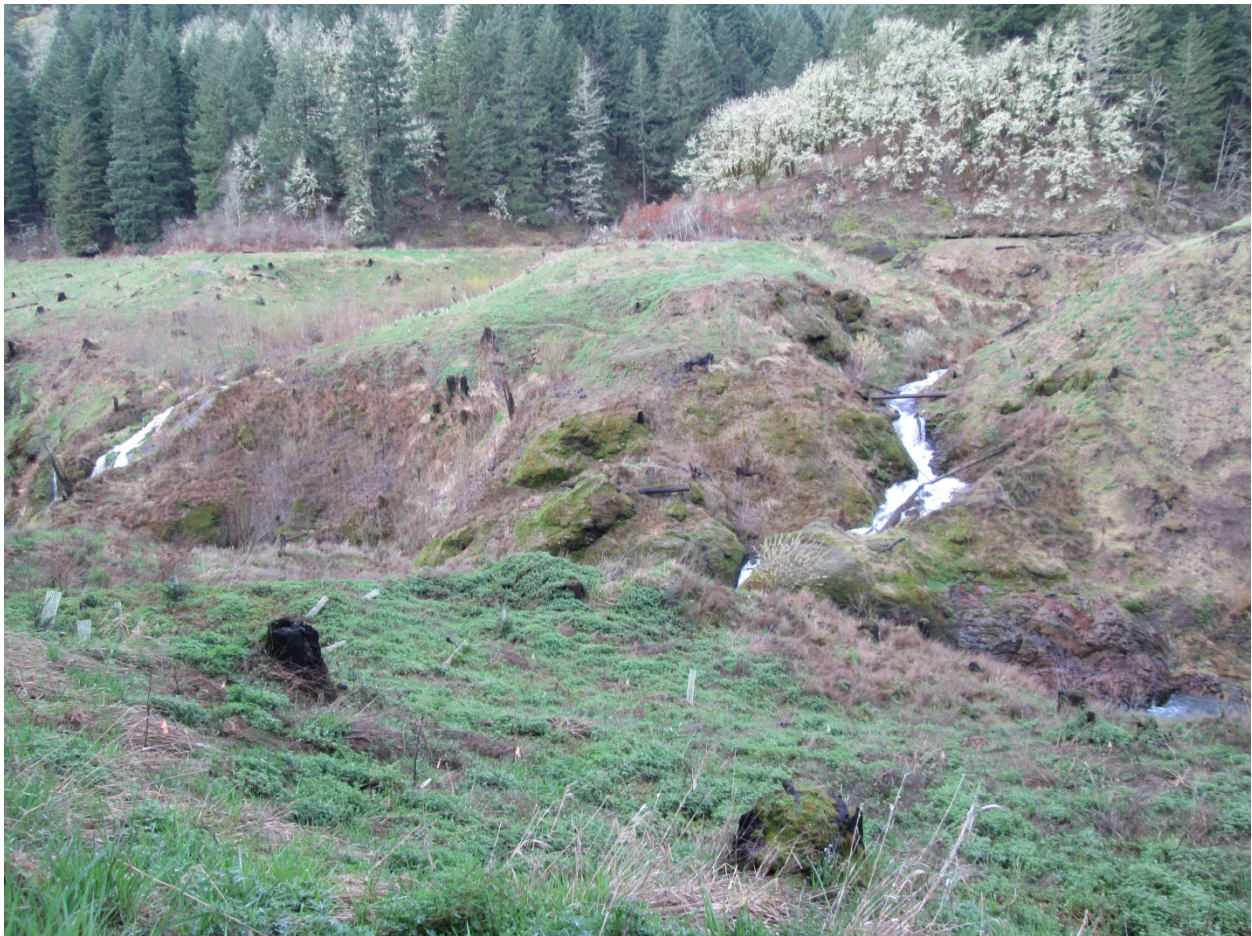
Tributary streams Spring Creek and Little Buck Creek on the right bank approximately 1,000feet upstream of the dam site.

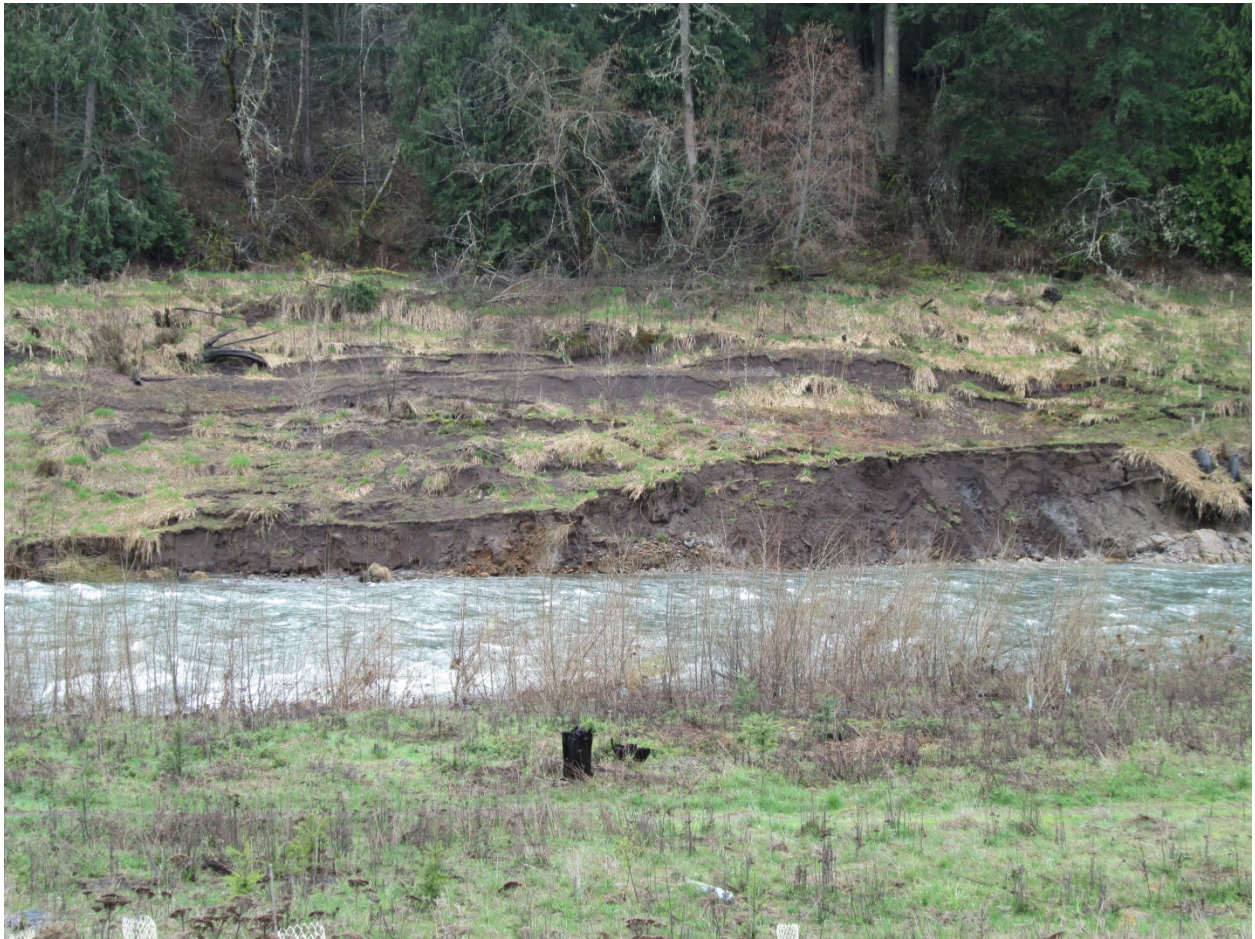
Erosion and sloughing occurred along the left riverbank from approximately 2,800 feet to 3,500 feet downstream of Northwestern Lake Bridge. The upstream end of this area is a transition zone from a steep, rocky bank with little or no remaining sediment to a graded bank overlain with reservoir sediment. At the base of the slope, erosion of pre-reservoir alluvial deposits occurred. In the transition zone that has not been previously graded or planted, ground movement is

ongoing with offset cracks and stair-stepping scarps up to six feet in height. The base of the slope is steeper than the angle of repose and is susceptible to erosion. Downstream of this transition zone, eroded areas below the graded and planted area have the potential for continued sloughing as the bank evolves to an angle of repose. Observations have not indicated releases of sediment to the river under most flow conditions. While the area may continue to naturally erode over time, sediment releases are generally only expected during high-flow channel-forming events. Regarding public safety, there are neither established nor informal trails to the area and hazard conditions are similar to other steep areas along the riverbank. No corrective actions are proposed.

View of the left bank approximately 3,000 feet downstream of Northwestern Lake Bridge. Ground movement is ongoing since the area was eroded during the December 2015 high-flow event.

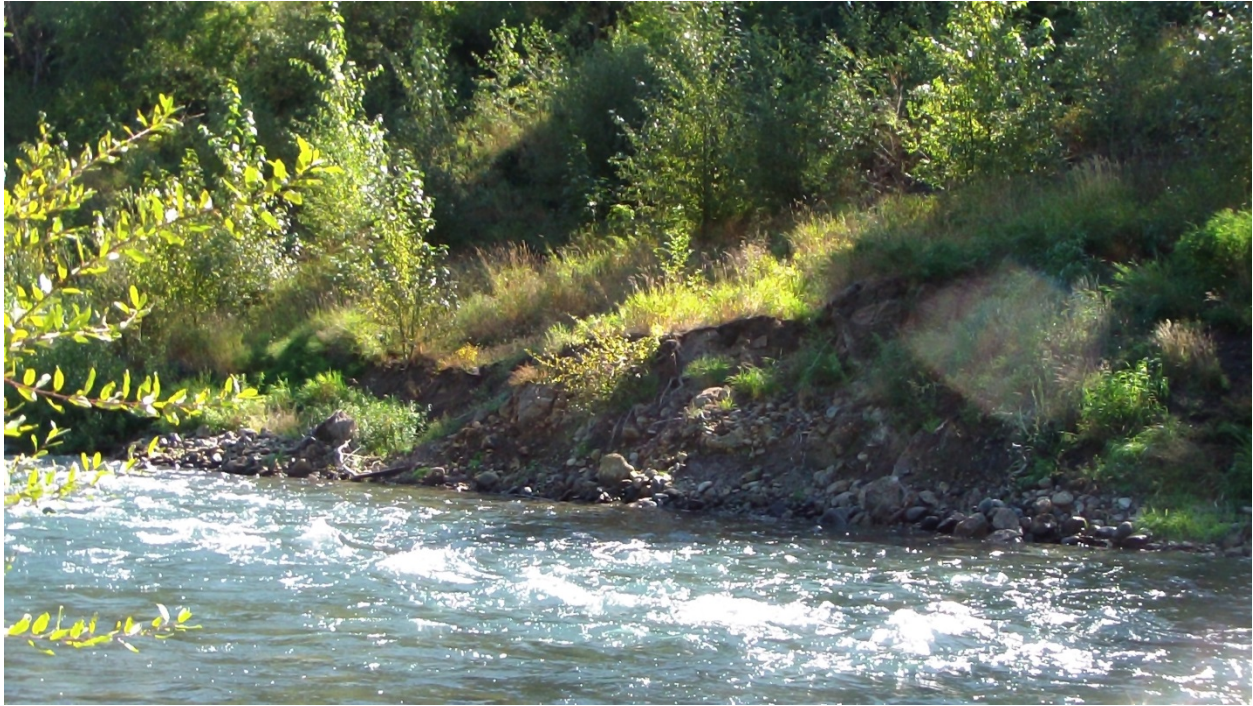
View of the left bank approximately 3,000 feet downstream of Northwestern Lake Bridge.
September 21, 2016

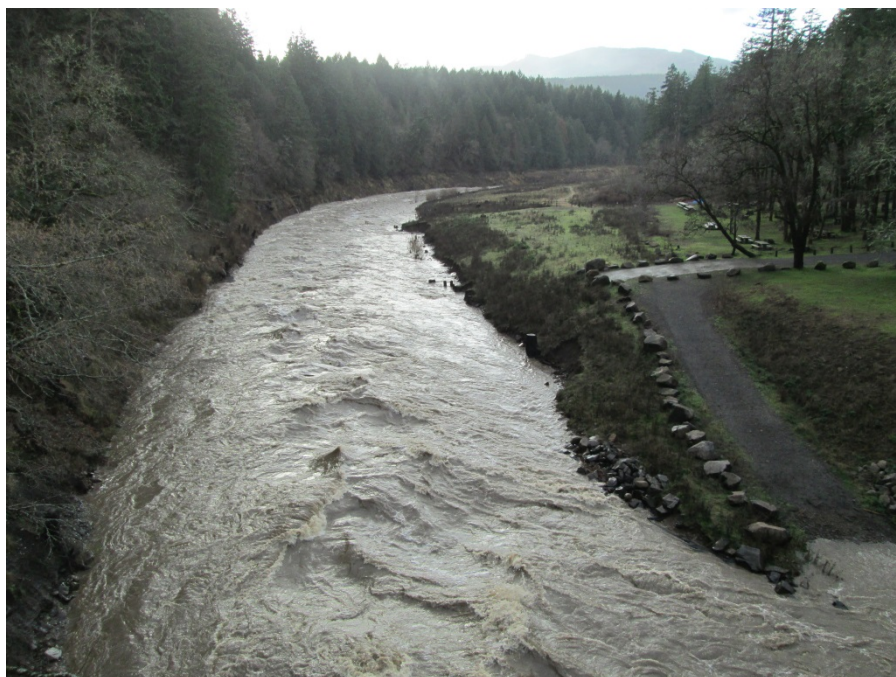
View downstream from Northwestern Lake Bridge during 50-year recurrence flow event
December 9, 2015

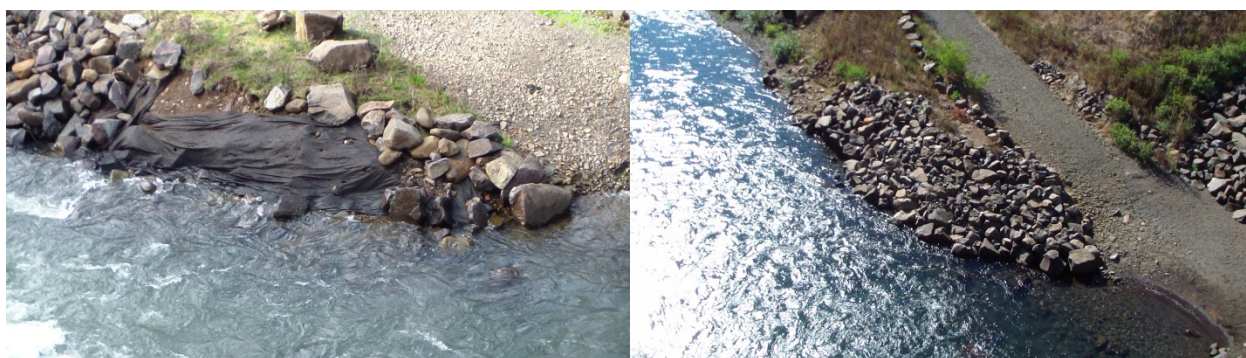
At Northwestern Park, the December 2015 high-flow event dislodged riprap slope protection at the boater take-out ramp. On August 8, 2016, concurrent with the slope grading work upstream of the bridge, additional riprap was placed to restore this slope protection.

Views of the Northwestern Park boater take-out before and after repairs to the riprap slope protection.
March 3, 2016 and September 21, 2016

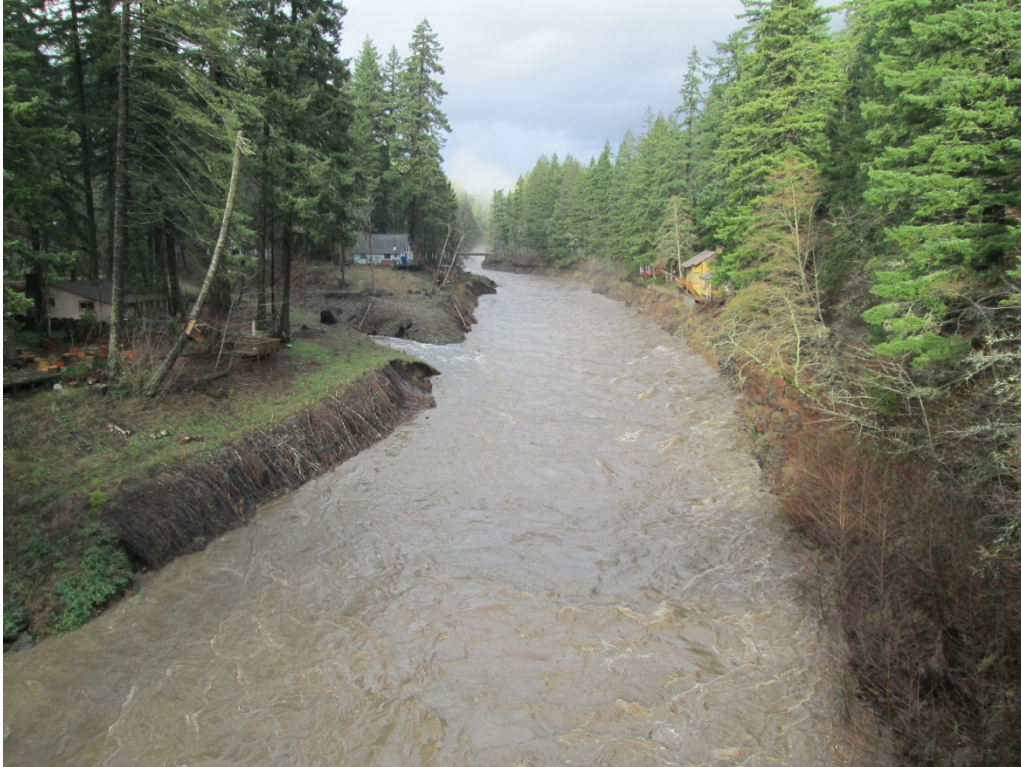
In the area along the right bank between Northwestern Lake Bridge and Buck Creek where measures had been implemented to correct bank erosion that had occurred during previous high-flow events, the December 2015 event caused additional erosion. The bank had been stabilized in the fall of 2014 with the placement of a brush mattress, willow stake plantings and live fascine bundles. The high flow scoured soil beneath the brush mattress and swept away most of the fascine bundles. Following consultation with the Washington Department of Ecology and the U.S. Army Corps of Engineers, during August 2016 the remnants of the brush mattress were removed and the bank was graded to a slope of approximately 2H:1V. To achieve this slope, the location of the top of the bank was moved back from the river and significant sediment deposits were hauled off site. This contrasts with previous efforts on this slope that had been based on maintaining the location of the top of the bank to avoid removing decks associated with cabins and to preserve trees. This constraint had resulted in over-steepened slopes approximating the angle of repose of the remaining sediments. The current finished slope better approximates slope angles that have proven stable in the project area. The bank will be seeded and hydromulch will be applied during October 2016.

View upstream from Northwestern Lake Bridge during 50-year recurrence flow event. Bank repair measures on the right bank were undermined. - December 9, 2015

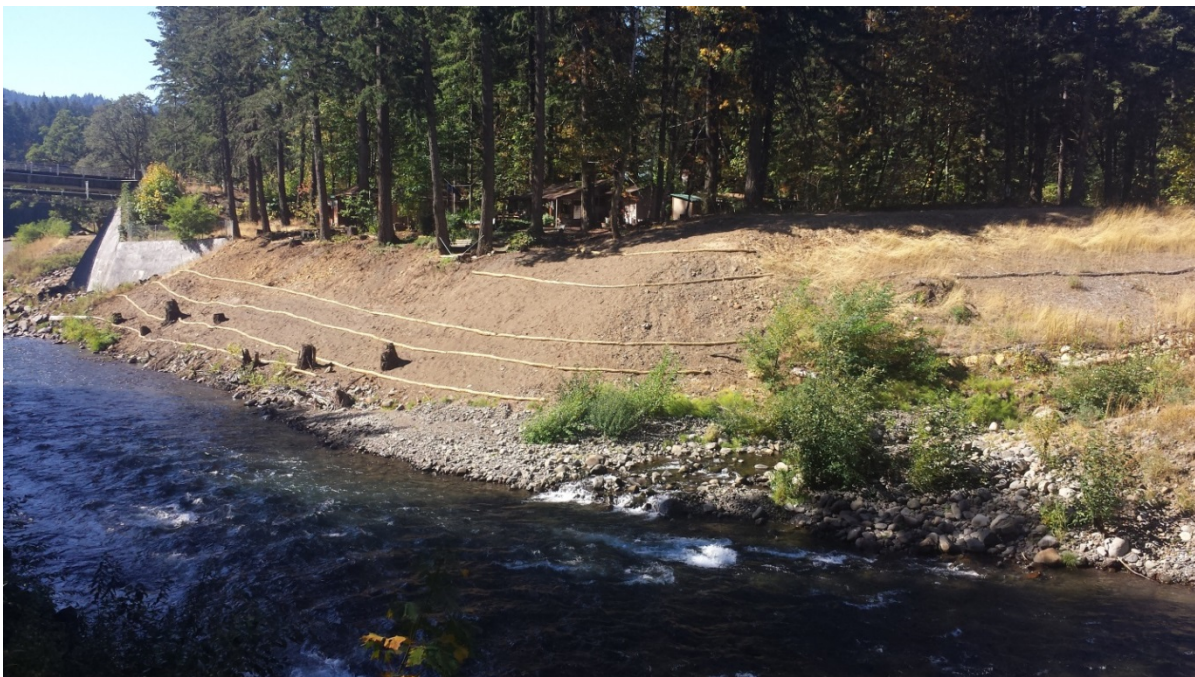
Right bank from Buck Creek to Northwestern Lake Bridge after grading the bank during August 2016.
September 21, 2016
