### Subject: Merwin Trap Upgrades

### **Merwin Trap Operating Condition Improvements**

# **MERWIN HYDROELECTRIC PROJECT**

# **FISH TRAP UPGRADES**

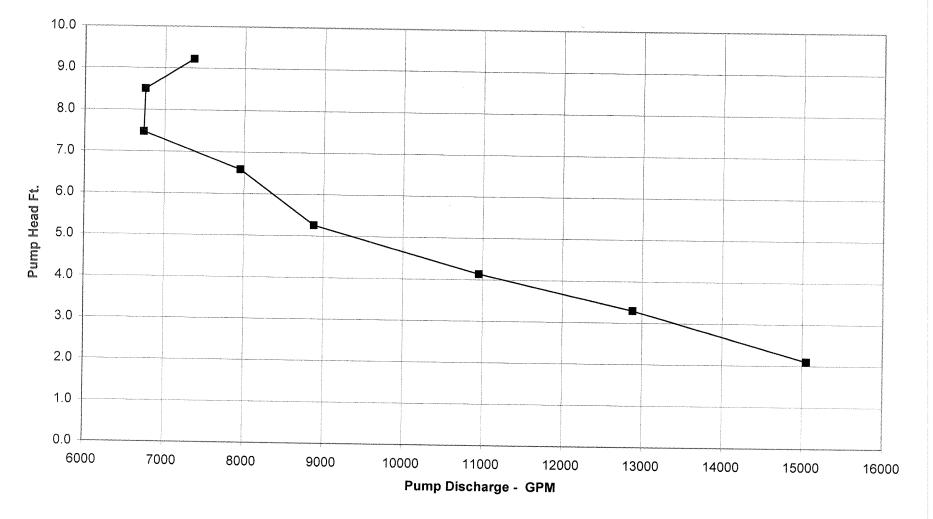
Figure 2

The data recorded during the pump trip tests is provided in Table 1 and is plotted on Figure 2. During the tests, flow meter measurements of the flow through the fish bypass piping were attempted but the readings are inconsistent and are not reliable; which may be caused by unstable flow conditions. The water level in the fishway was measured by both the staff gage in the fishway and the reading from the powerhouse control system. However, based on the calibration performed prior to the test, the staff gage readings in the fishway are considered the most accurate and have been used in this analysis.

As shown on Figure 2, the time for the water level to rise from elevation 48.75 ft (level when the fish are sorted) to the tailwater elevation of 49.8 Ft. during tests was determined to be:

The water level in the fishway near the end of Tests 1 & 2 continued to rise above the tailwater level, but at a slower rate, because of the return flow from the hatchery.
