**Subject: Yale Hydroelectric Project, FERC No. P-2071
SA 11.2.2.2 and License Article 406, Yale/International Paper (IP) Road Phase One**

On June 26, 2008, the Federal Energy Regulatory Commission issued a new operating license for PacifiCorp Energy's Yale Hydroelectric Project (P-2071). Article 406, *Yale/International Paper (IP) Road Trail Plan*, of this license directs PacifiCorp to complete a trail technical assessment for approximately ten miles of former logging road on the eastern shore of Yale Lake, by the fourth anniversary of issuance of the new license (December 26, 2012). Furthermore, on June 28, 2012 PacifiCorp received an order granting an extension of time to submit for Commission approval by March 1, 2013. Much of this road has been closed since 2008 due to illicit activities and unsafe road conditions caused by erosion, landslides, and rock fall hazards.

The Yale Lake IP Road project is associated with the relicensing agreements for the Merwin, Swift, and Yale hydroelectric projects on the Lewis River. As part of the Yale Lake relicensing, PacifiCorp has been directed to complete a trail feasibility analysis for approximately ten miles of former logging road on

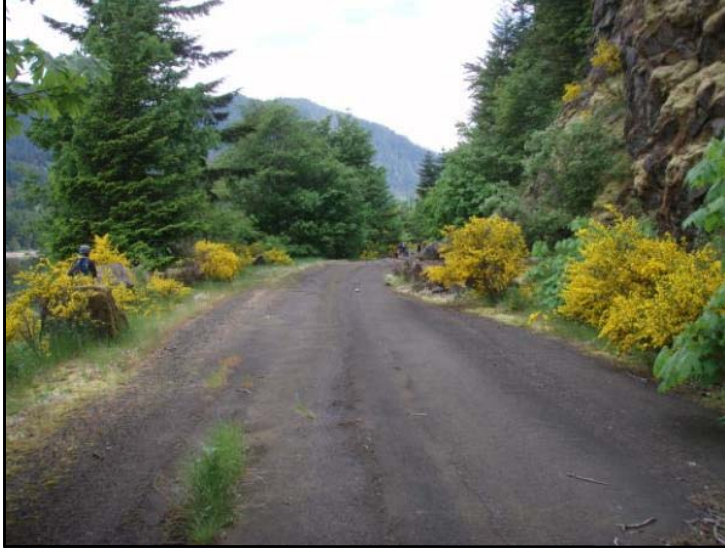
Figure 1: Slumped and Rutted Pavement Areas in Segment 2

Road slumps were observed in several areas of the alignment adjacent to the lake shore in areas with relatively steep hillside cut/fill slopes. The road slumps are typically identified by ground cracks on the downhill side of the road. An approximate 200-foot-long set of ground cracks is located just north of the landslide blocking access to the remainder of the southern portion of the road at Station 45+00.

The least expensive and most feasible remediation alternative to increase the stability of these slumps will likely be to remove or replace plugged or damaged culverts, improve the uphill drainage, and re-grade the areas of slope movement to reduce the potential for future ground movement. If a culvert is removed a creek crossing may be required.

This project will close and re-grade the ground cracks with mechanical effort to improve culvert function and uphill drainage where surface water is observed to pond.

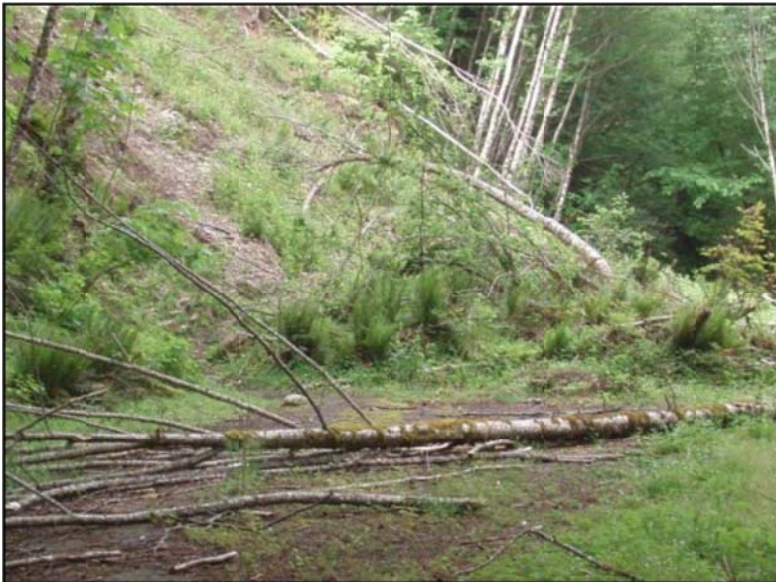
Figure 2: North Landslide

This landslide located at approximate Station 48+00 represents the first location blocking vehicular access past the gate at the north end of the trail. The landslide blocks about 100 to 150 feet of the trail, extends about 60 to 80 feet up from the road, and about 30 to 50 feet down to the lake. The estimated volume of landslide material is 500 cubic yards. Preliminary field observations indicate the landslide removed significant portions of the soil overburden down to the underlying rock surface. Access to the landslide is currently limited to a narrow (several feet wide) trail through the landslide debris.

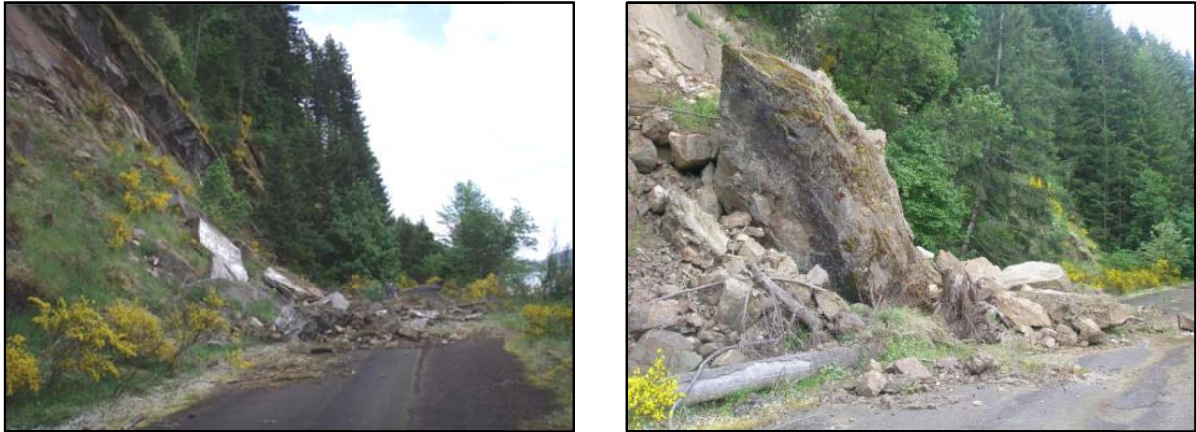
Figure 3: Examples of Larger Rockfalls (2 views)

originating from the rock slope on the uphill (east side) of the road alignment. Larger rockfall with pieces in excess of 10 cubic yards are present in at least two locations along the segments. In some areas, outcrops that are several hundred feet high are the source of the rockfall. The estimated amount of rockfall debris on the trail or within the catchment areas is on the order of 500 cubic yards. One small landslide with on the order of 50 cubic yards of debris is also present.

This project will clear accumulated rockfall and loose landslide debris from ditch areas and re-establish catchment areas. Scaling and installation of rockfall nets or rock bolts may be appropriate for certain areas with higher risk.

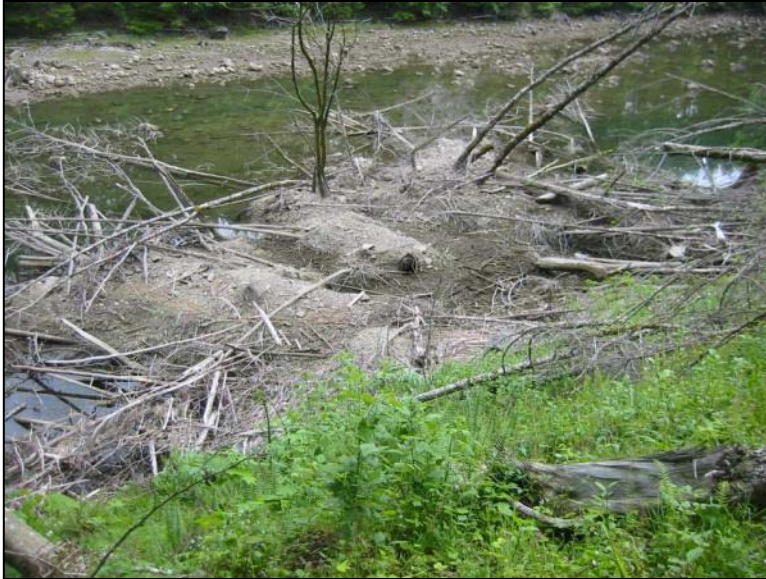
Figure 1: Toe Erosion in Segment 1

A major slide and toe erosion exists near station 30+00 in Segment 1. This area has less than one mile fetch, and wave erosion is not likely the cause of damage. River currents have possibly scoured away some slide material; however, the extent of woody debris indicates that limited scour has occurred since the slide.

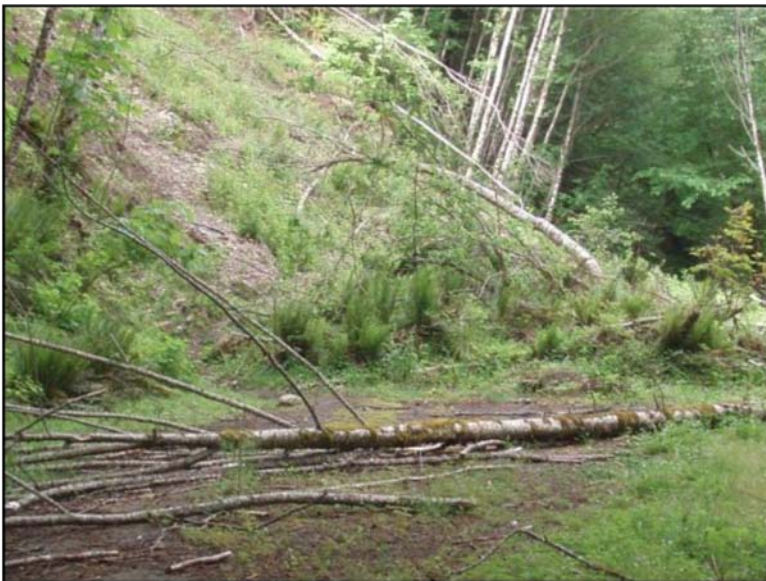
Figure 2: Slide Area in Segment 1

This area of the roadway will require reconstruction to make it viable for bike and pedestrian traffic. In addition to the slide, there are also several portions of the road that show signs of pavement failure. These areas commonly referred to as slumps, will require regrading and repaving for safe use as a paved trail.

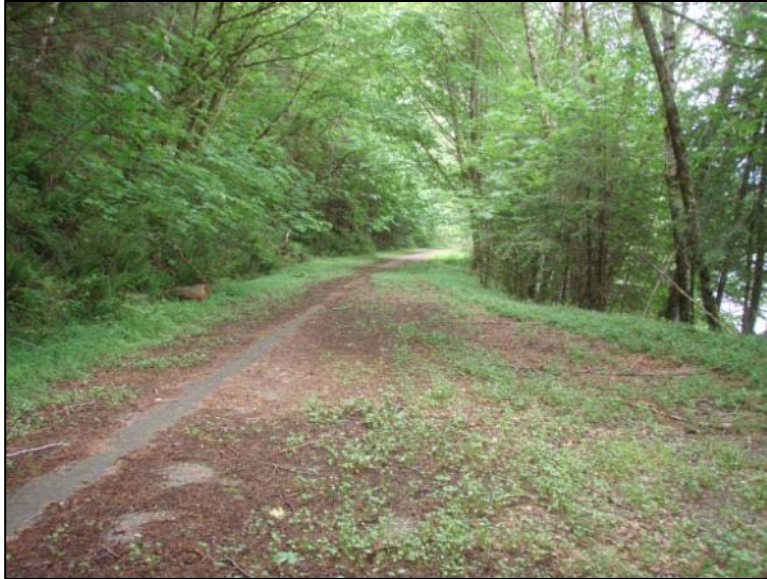
Figure 3: Adequate Condition Area in Segment 1

In the areas considered to be in adequate condition, there are vegetation growth and other debris on the roadway, which is to be expected on a roadway that has been unused for several years. Cleanup and minor maintenance is needed, but no major issues were noted that would require reconstruction. In areas considered to be in good condition, the roadway would require minor cleanup and reconditioning.

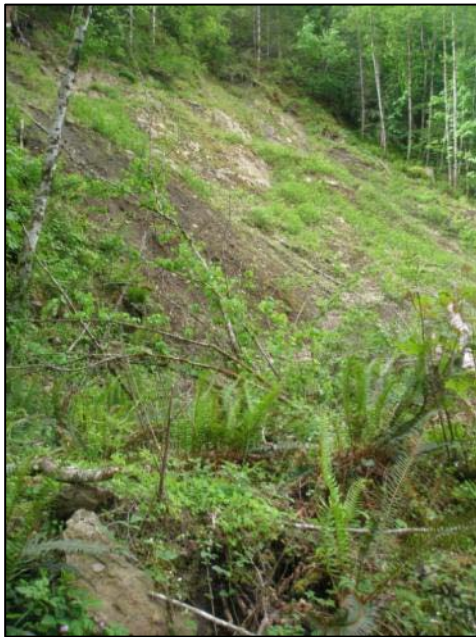
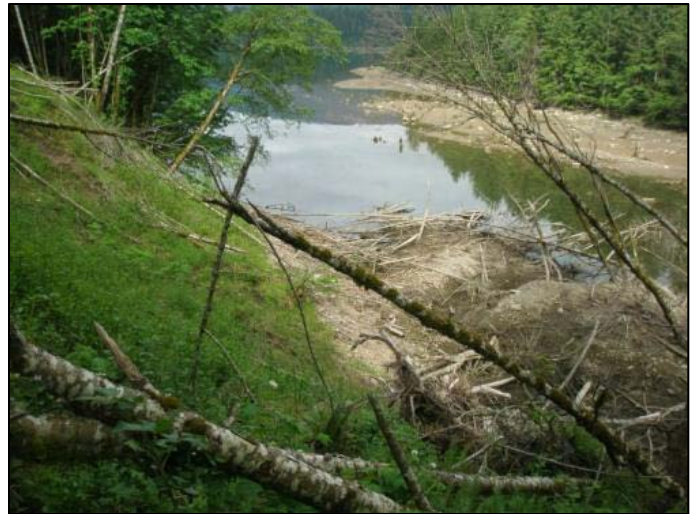
North Landslide. This landslide represents the first location blocking vehicular access past the gate at the north end of the trail. The photographs below (Figures 6 and 7) show the slope uphill of the landslide and the landslide debris that was carried into the lake. Preliminary field observations indicate that the landslide removed significant portions of the soil overburden down to the underlying rock surface. Access across the landslide is currently limited to a narrow (several feet wide) trail through the landslide debris. Remediation of the landslide to create a full-width trail would require significant earthwork that would likely include a new downslope rock buttress fill or other structural modification. A narrower trail could be established with significantly less downslope earthwork and upslope grading. Some selective regrading, scaling, and rockfill mitigation will also likely be required for the upslope portion of the landslide to improve safety through the landslide area. Additional

Figure 6: Slope Uphill of Landslide

Figure 7: Landslide Debris in Lake

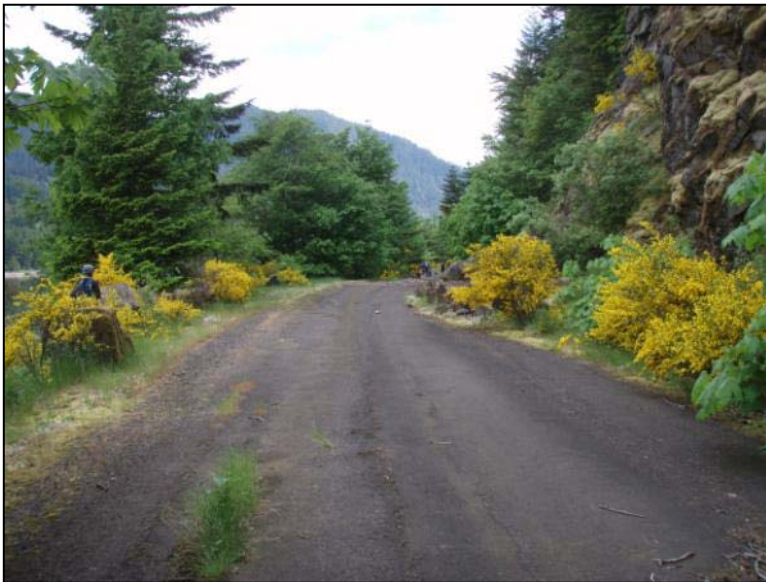
Figure 8: Slumped and Retted Pavement Area in Segment 2

There are approximately ten portions of the road in Segment 2 that show significant pavement failure that will require repaving, reconstruction, and possibly realignment to provide continued through access on the trail.

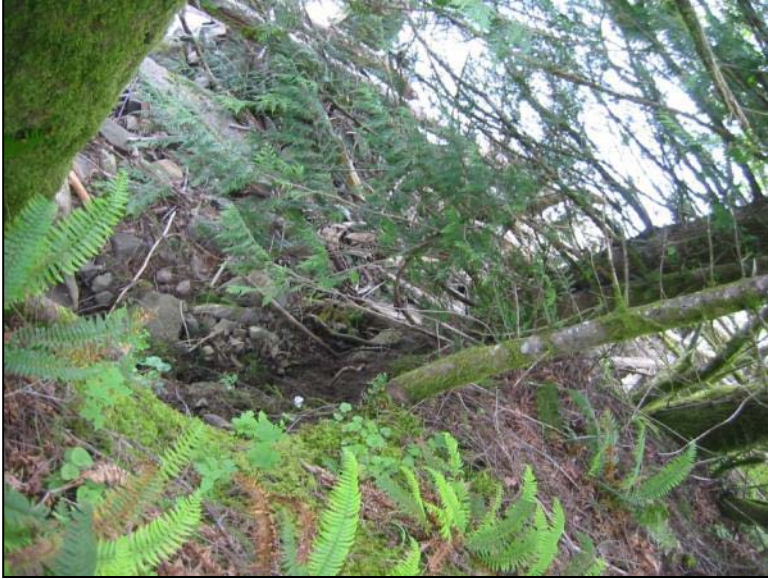
Figure 9: Slope Failure Area in Segment 2

Limited areas of slope failure caused by wave erosion are present along this segment. These areas are losing material over time, but given the size of the existing trees, the rate appears slow.

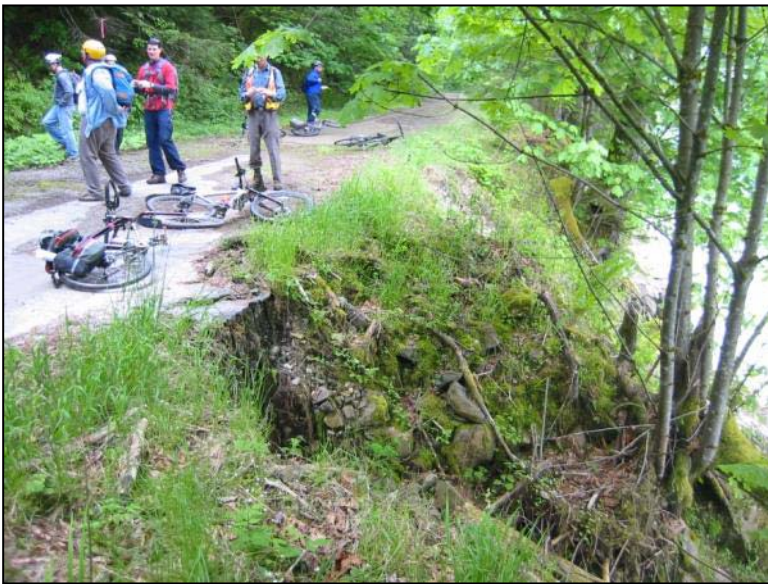
Figure 10: Bank Erosion Area in Segment 2

Some minor bank erosion is also located at several culverts that have been plugged, causing flow over the roadway. The water cascading down the bank has created areas of limited failure.

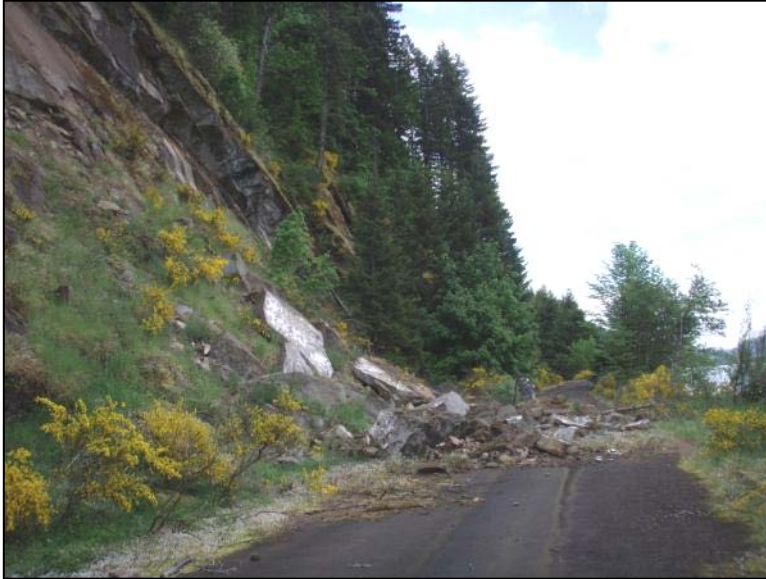
Figure 11: Rock Fall and Other Debris Area in Segment 2

In areas of adequate condition there is rock fall debris, mud, vegetation growth, and other obstacles that will need to be removed. Cleanup and minor maintenance is needed, but no major issues were visible that would require reconstruction or significant repairs. In areas of good condition the roadway would require minor cleanup and reconditioning.

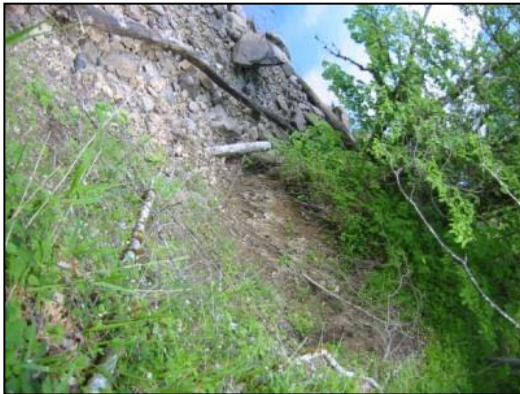
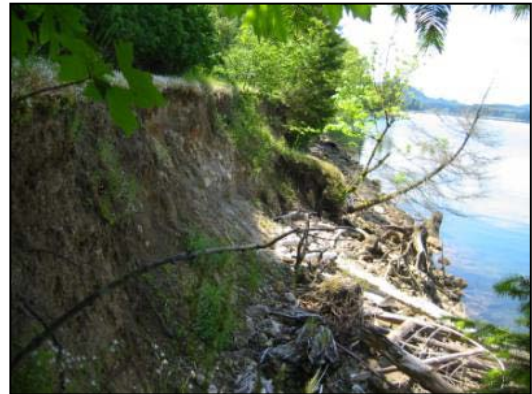
Figure 15: Slope Failure at Approximate Station 205+00 (2 views)

A moderate-sized slope failure has occurred over time near station 205+00. Limited rock exists along the toe, and bank material is fine gravel. With a combination of high pool and waves from the optimal direction, additional erosion is likely. Erosion along the toe will likely cause additional slope failure.

These areas of erosion damage will require major repairs and possible realignment away from the erosion area. The existing width of pavement will allow for a narrower portion of trail for through access.

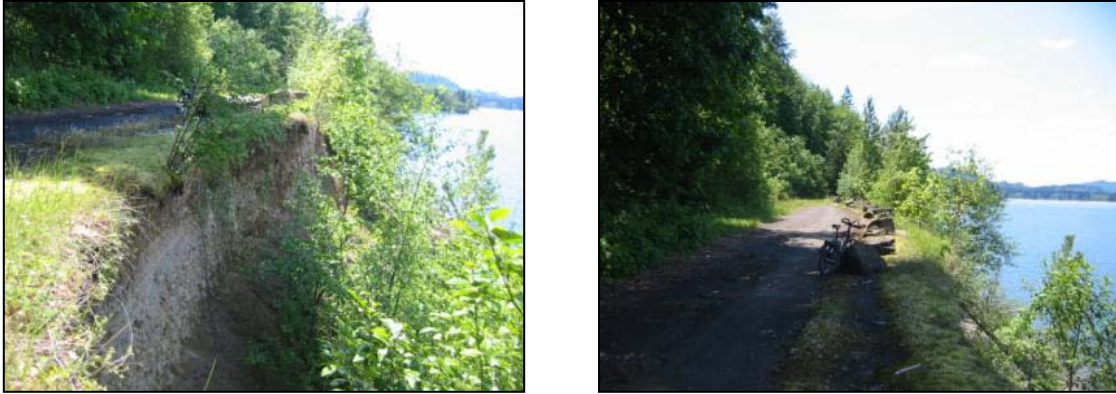
Figure 16: Slope Failure at Approximate Station 215+00 (2 views)

A much larger slope failure exists at approximate station 215+00. This section of bank is much higher, the exposed face is steeper, and the bench at the pool elevation is steep and has limited armor. Erosion has occurred over a very long period of time, and a majority of the trees have fallen and washed away. Limited vegetation exists to control surface water erosion.

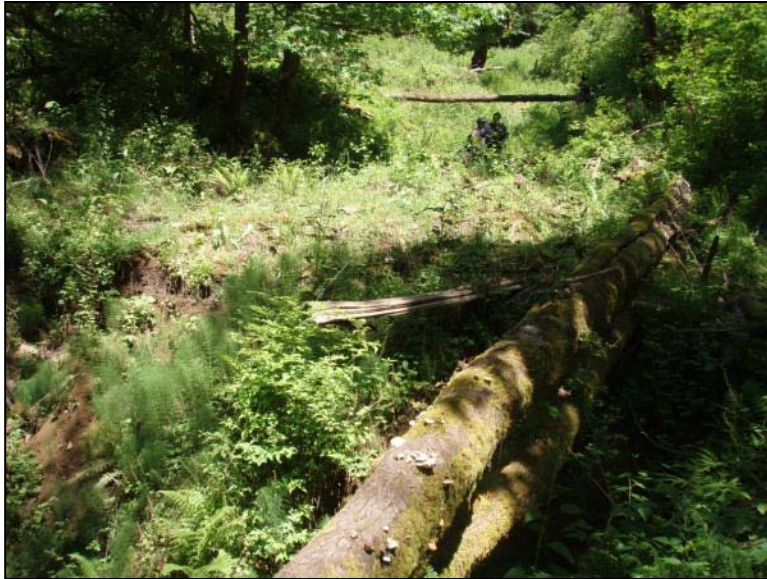
Figure 18: Slide Area in Segment 3

A portion of the road at approximate station 300+00 is under a hillside landslide that will likely require reconstruction and rehabilitation to make it usable for bike and pedestrian traffic.

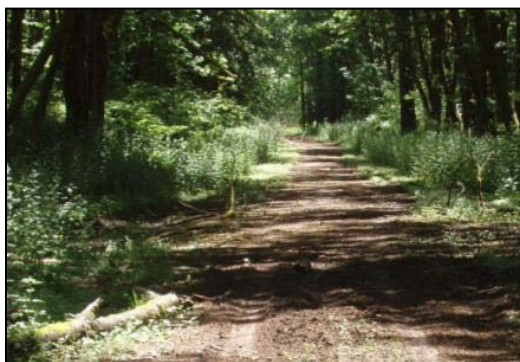
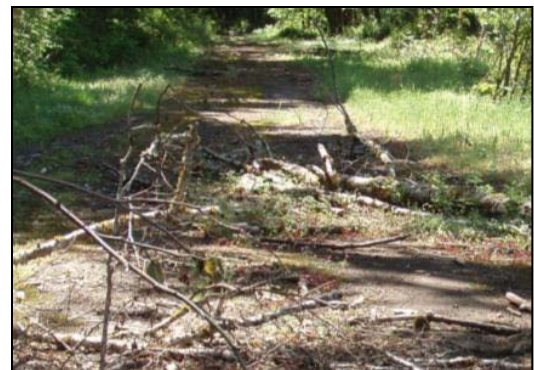
Figure 19: Mud and Debris Area in Segment 3 (2 views)

In areas considered to be in adequate condition there is mud, vegetation growth, and other debris that will need to be removed. Cleanup and minor maintenance is needed, but no major issues were visible that would require reconstruction or significant repairs. In areas considered to be in good condition the roadway would require minor cleanup and reconditioning.

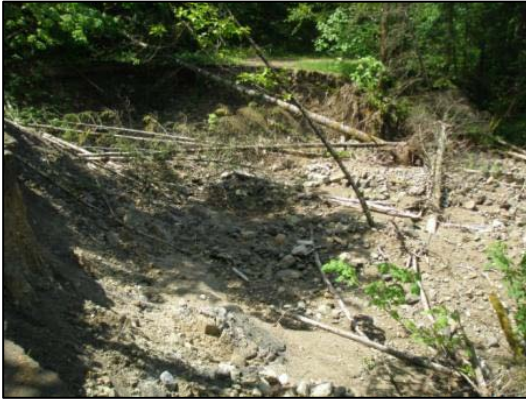
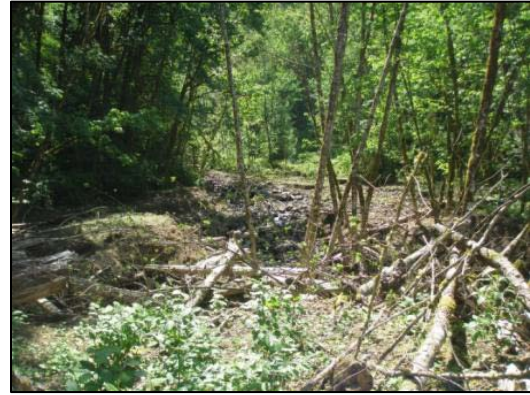
Figure 20: Washout Looking Along Trail Alignment *Figure 21: Upstream Debris Flow Deposits*

Although it is a relatively low-cost option, a dip crossing will be subject to inundation from streamflow and accumulation of debris on the crossing. The most cost-effective option for repairing the washout will likely be replacing the culvert and road fill. Geotechnical earthwork considerations for this alternative are relatively straightforward. However, it should be acknowledged that this repair will not significantly reduce the risk of a similar, future debris flow during a significant storm event.

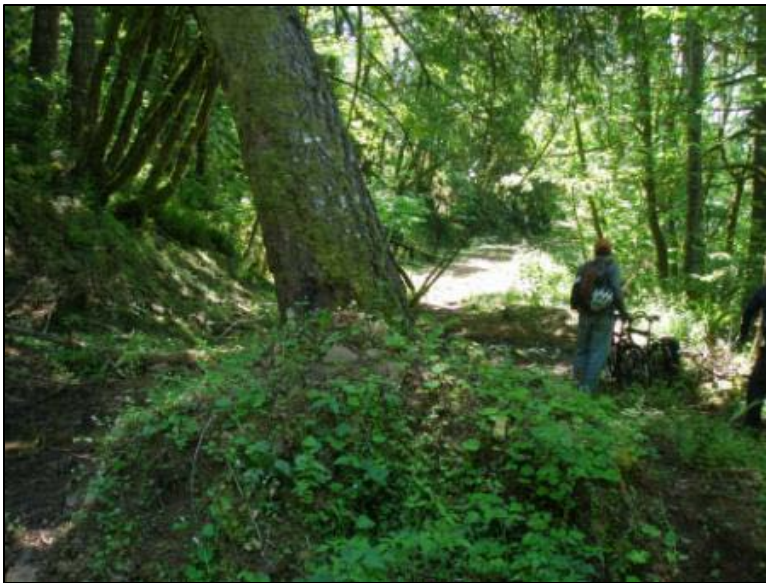
Figure 22: Tree and Landslide Debris in Middle of Road

Older Landslide. Based on discussions with PacifiCorp, we understand the landslide shown in the first photograph below (Figure 22) occurred prior to the January 2009 storm event. The landslide has deposited significant amounts of debris into the middle of the road alignment as shown in the first photograph (Figure 22). The second photograph below (Figure 23) shows the location of the headscarp and additional landslide debris above the alignment. Some regrading, drainage improvements, and repair of this upslope debris will likely be necessary to reduce the risk of future trail closures at this location.

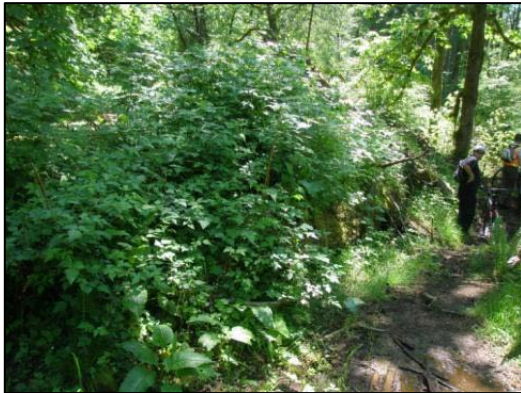
Figure 24: Debris in Trail Looking South

Debris Flow. A moderate-sized debris flow is currently blocking the alignment south of the older landslide described above, as shown in the first photograph below (Figure 24). Remediation efforts at this location will likely involve removal of the accumulated debris and repair/replacement of the culvert. A lesser amount of downslope fill and regrading will also likely be necessary to repair the surface erosion features shown in the second photograph below (Figure 25).

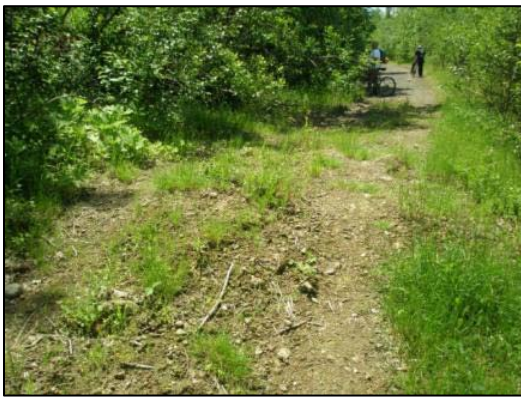
Figure 26: Small Landslide Debris

Other Debris. Other areas of rock and soil debris are present over the road at several locations along Segment 3. Common sources for this debris include surficial upslope landslides or small debris flows caused by plugged culverts. Examples of this type of debris are shown in the photographs below (Figures 26 and 27).

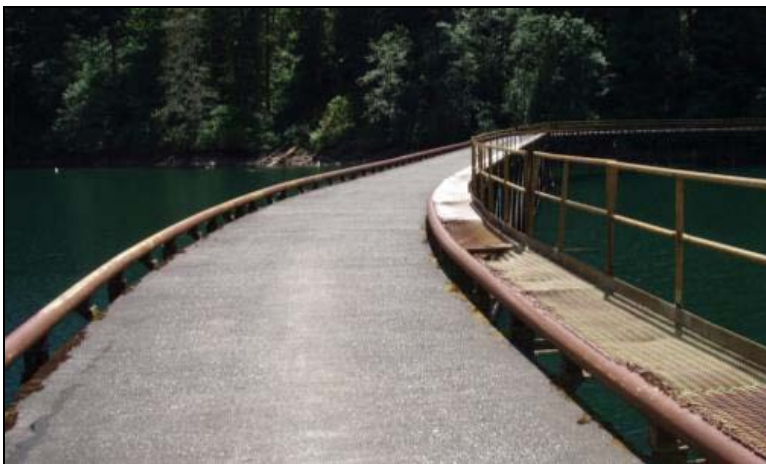
Figure 28: Siouxon Bridge at the Beginning of Segment 4

Overall the path surface in Segment 4 is in good condition for use as a trail. The beginning of the segment is at the Siouxon Bridge, which is in good condition but which will require guardrail and handrails for bicycle and pedestrian safety. However, this segment of the trail contains a large portion of unpaved road. In addition to the condition of the trail, there are several gates that limit access to the entire segment.

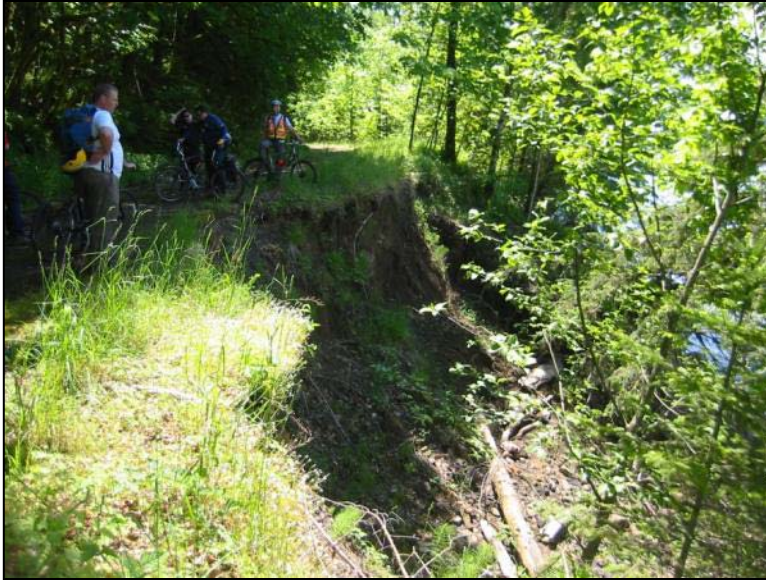
Figure 29: Eroded Cut Bank in Segment 4

IP Road leaves the shoreline and is located landward in this segment. One limited area of eroded cut bank was identified that would require major repair. Upslope water may be contributing to the issue because the soil appeared to be well saturated.

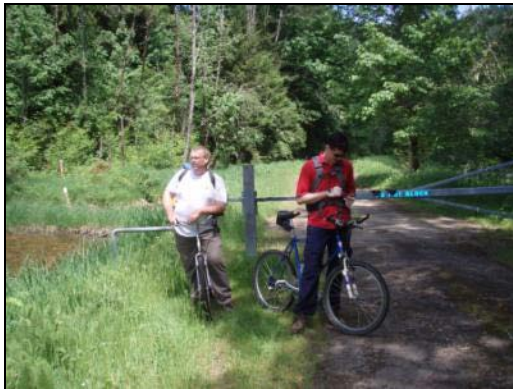
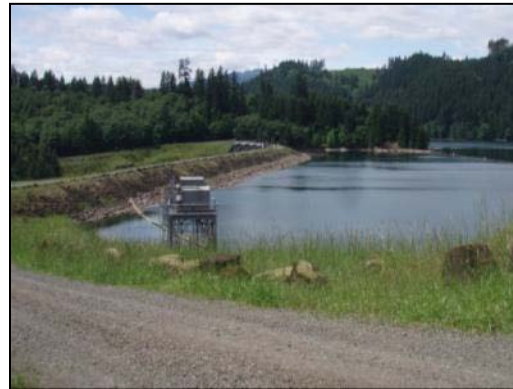
Figure 30: Gates and Unpaved Areas on Segment 4 (2 views)

The paved portion of the trail that is in good condition would require minor cleanup and repair, if any. There are several gates in this part of the trail that make it inaccessible to the general public. If this area is to remain closed, an alternative terminus will need to be determined.

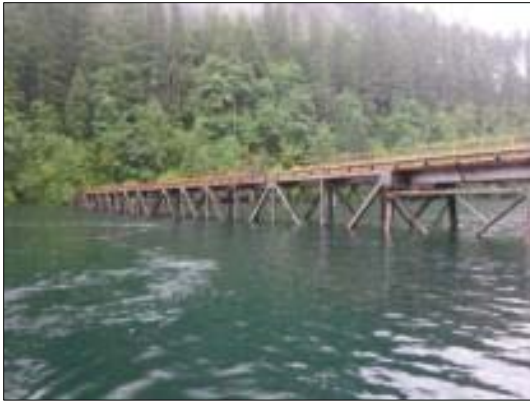
Figure 31: Siouxon Creek Bridge

Built in 1951, this steel girder and steel truss bridge is roughly 645 feet long. The two longest spans are trusses (about 140 feet and 110 feet). The bridge is straight at the north end and follows a well-defined curve at the south end. The trusses' lower chord was about five feet below water during this inspection and could not be properly inspected. The bridge deck is concrete. The deck width is 12 feet. There is a 2.5-foot wide sidewalk supported on brackets on the west (lake) side of the bridge.

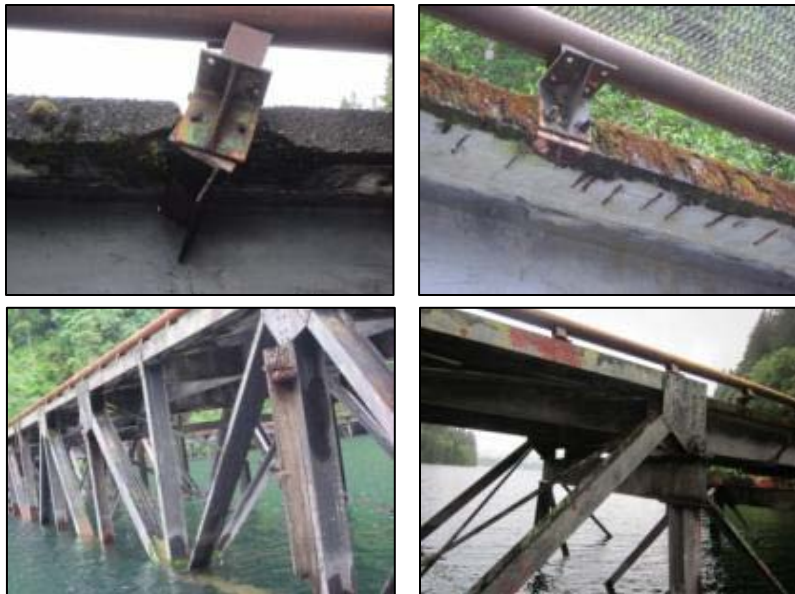
Figure 32: Siouxon Creek Bridge Defects (4 views)

The bridge's general structural condition can be summarized as satisfactory. This means that structurally the bridge's principal components, such as the deck, girders, beams, truss elements, and gusset plates, are sound but contain some minor defects. These defects do not have a measurable effect on the bridge's principal load-carrying capacity.

The defects are summarized as follows:
