Yale Lake IP Road Trail

Implementation Plan

PacifiCorp

December, 2012

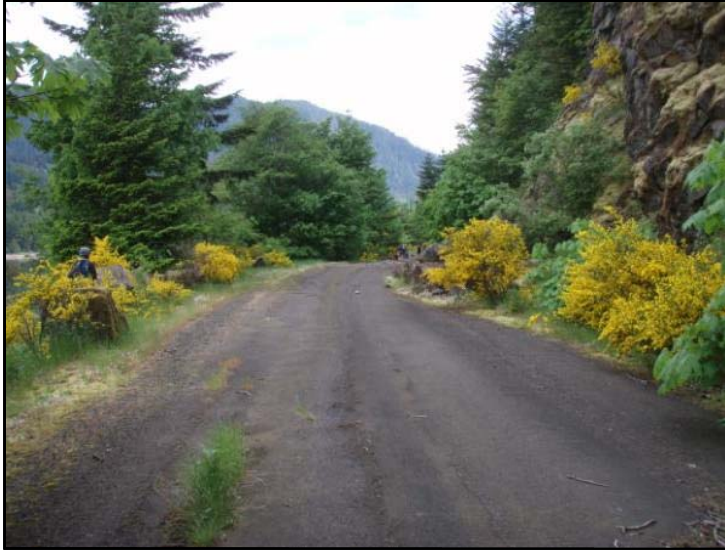
Figure 1: Slumped and Rutted Pavement Areas in Segment 2

Road slumps were observed in several areas of the alignment adjacent to the lake shore in areas with relatively steep hillside cut/fill slopes. The road slumps are typically identified by ground cracks on the downhill side of the road. An approximate 200-foot-long set of ground cracks is located just north of the landslide blocking access to the remainder of the southern portion of the road at Station 45+00.

The least expensive and most feasible remediation alternative to increase the stability of these slumps will likely be to remove or replace plugged or damaged culverts, improve the uphill drainage, and re-grade the areas of slope movement to reduce the potential for future ground movement. If a culvert is removed a creek crossing may be required.

This project will close and re-grade the ground cracks with mechanical effort to improve culvert function and uphill drainage where surface water is observed to pond.

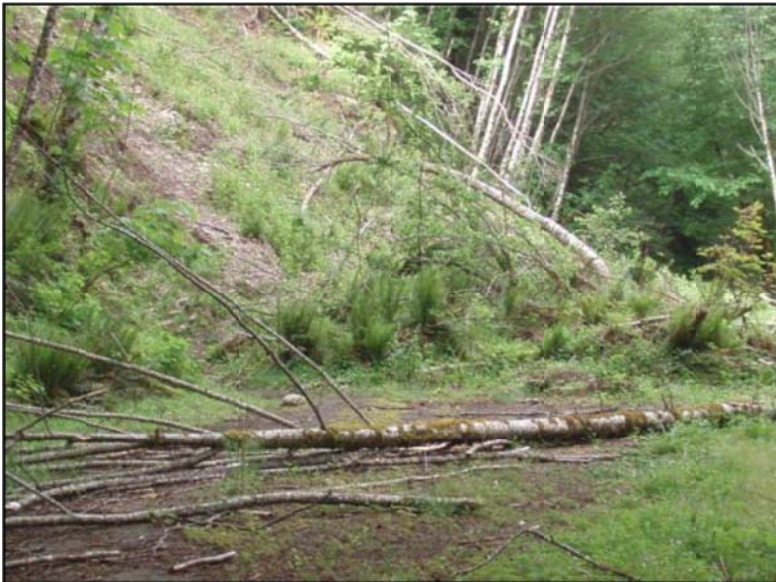
Figure 2: North Landslide

This landslide located at approximate Station 48+00 represents the first location blocking vehicular access past the gate at the north end of the trail. The landslide blocks about 100 to 150 feet of the trail, extends about 60 to 80 feet up from the road, and about 30 to 50 feet down to the lake. The estimated volume of landslide material is 500 cubic yards. Preliminary field observations indicate the landslide removed significant portions of the soil overburden down to the underlying rock surface. Access to the landslide is currently limited to a narrow (several feet wide) trail through the landslide debris.

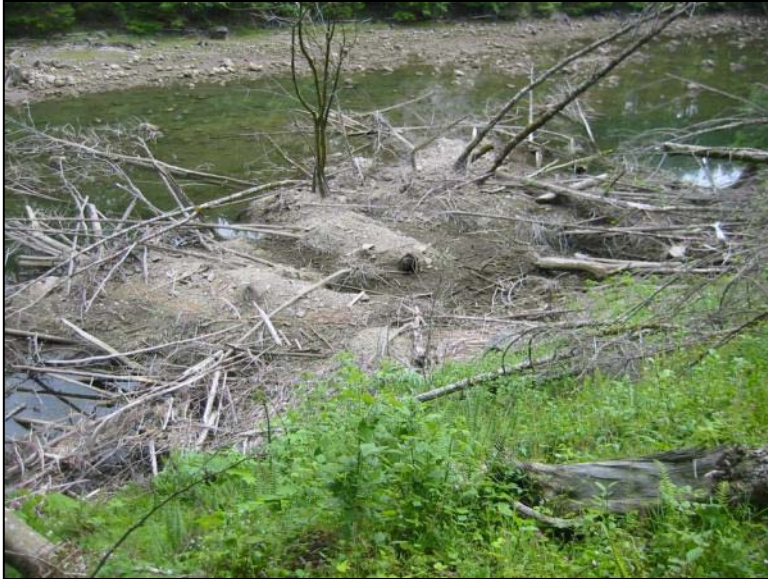
Figure 1: Toe Erosion in Segment 1

A major slide and toe erosion exists near station 30+00 in Segment 1. This area has less than one mile fetch, and wave erosion is not likely the cause of damage. River currents have possibly scoured away some slide material; however, the extent of woody debris indicates that limited scour has occurred since the slide.

This area of the roadway will require reconstruction to make it viable for bike and pedestrian traffic. In addition to the slide, there are also several portions of the road that show signs of pavement failure. These areas commonly referred to as slumps, will require regrading and repaving for safe use as a paved trail.

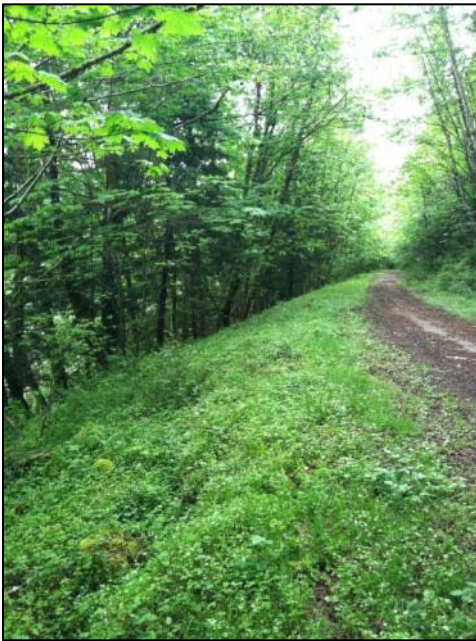
Figure 4: Slump of Downhill Fill Slope

Road Slumps. Road slumps were observed throughout the majority of the alignment adjacent to the lake shore in areas with relatively steep hillside cut/fill slopes. The majority of the slumps are visible as circular-shaped surface offsets encroaching into the downhill fill slope or road prism section. The first photograph shown below (Figure 4) was taken just north of the landslide that blocks access to the remainder of the southern portion of the road. At this location, the slope movements have occurred in the vegetated shoulder below the road. In other areas, the slope movements have offset the paved asphaltic concrete (AC) surface several inches.

Slump-type slope movements are very common in relatively steep hillside road cut/fill situations, and continued movements should be anticipated in the current, unmitigated condition. A significant portion of the slump movements along the alignment correlates to areas of poor drainage on the uphill/cut side of the road. An example of standing water in a ditch due to a plugged culvert is shown in the second photograph below (Figure 5). Water infiltration increases the hydrostatic pressure within the slope and tends to decrease the overall factor of safety of the road fill prism.

1. improve the uphill drainage,
2. regrade with granular fill,
3. regrade and repave,
4. overexcavate and replace, or
5. make a structural repair, such as a retaining wall.

The least expensive remediation alternative to increase the stability of these slumps will likely be to repair plugged or damaged culverts, improve the uphill drainage, and regrade the areas of slope movement. Even with improved drainage, some maintenance and additional movement of these slumps and other fill slope movements should be anticipated. In this regard, a paved trail surface will likely be more expensive to maintain than an unpaved trail surface. Structural repairs could include options such as soil-nail or soldier pile walls. The options for structural repairs or overexcavation and replacement will result in significantly less future maintenance, but we anticipate these alternatives will likely be cost-prohibitive for the majority of the slump locations.

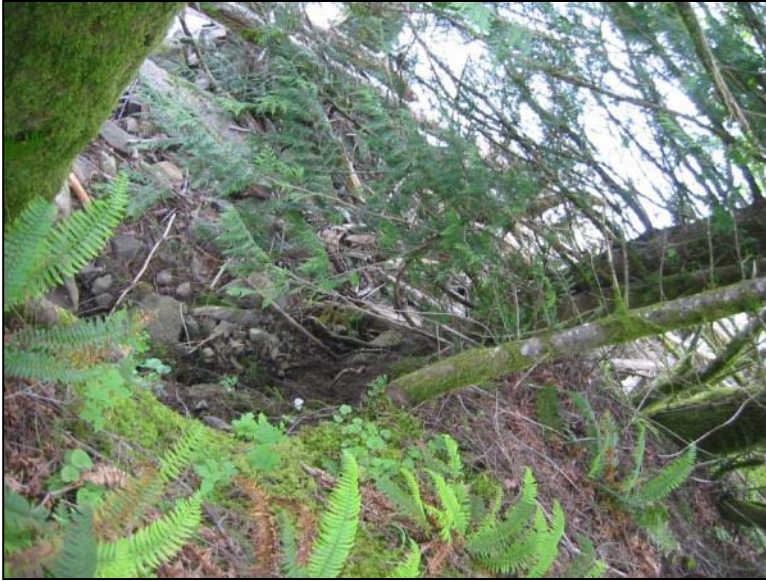
Figure 9: Slope Failure Area in Segment 2

Limited areas of slope failure caused by wave erosion are present along this segment. These areas are losing material over time, but given the size of the existing trees, the rate appears slow.

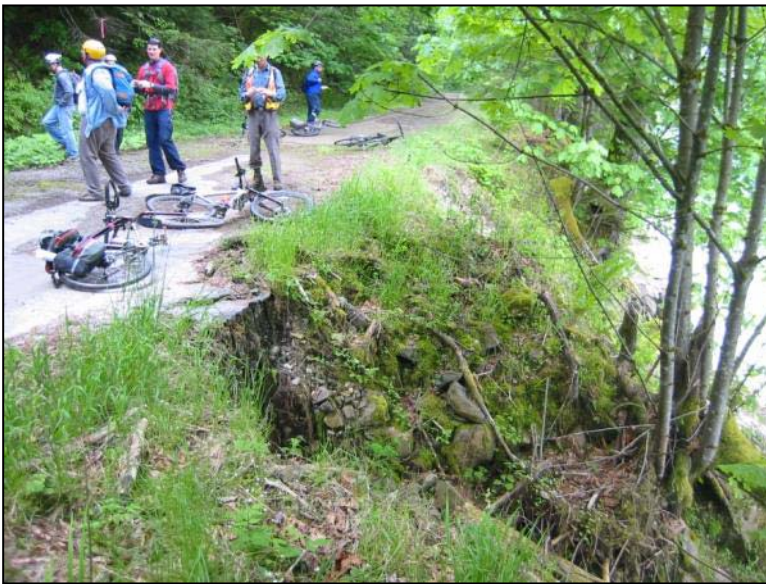
Figure 10: Bank Erosion Area in Segment 2

Some minor bank erosion is also located at several culverts that have been plugged, causing flow over the roadway. The water cascading down the bank has created areas of limited failure.

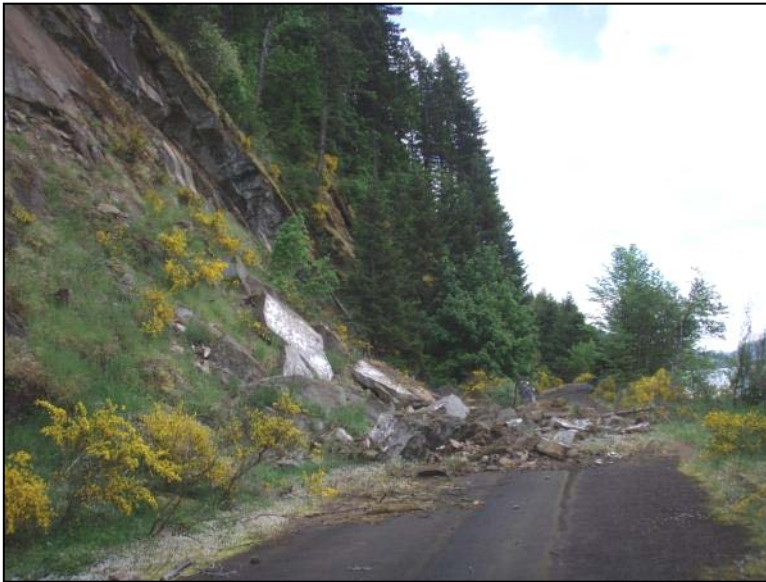
Figure 11: Rock Fall and Other Debris Area in Segment 2

In areas of adequate condition there is rock fall debris, mud, vegetation growth, and other obstacles that will need to be removed. Cleanup and minor maintenance is needed, but no major issues were visible that would require reconstruction or significant repairs. In areas of good condition the roadway would require minor cleanup and reconditioning.

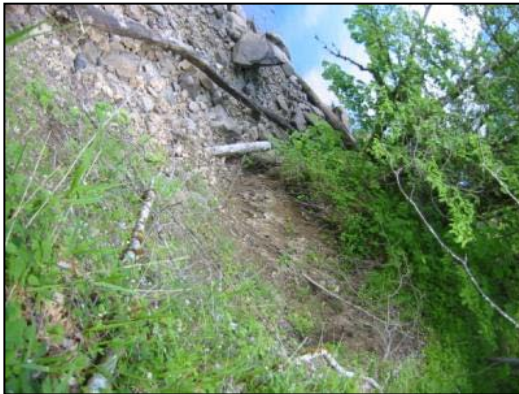
Figure 15: Slope Failure at Approximate Station 205+00 (2 views)

A moderate-sized slope failure has occurred over time near station 205+00. Limited rock exists along the toe, and bank material is fine gravel. With a combination of high pool and waves from the optimal direction, additional erosion is likely. Erosion along the toe will likely cause additional slope failure.

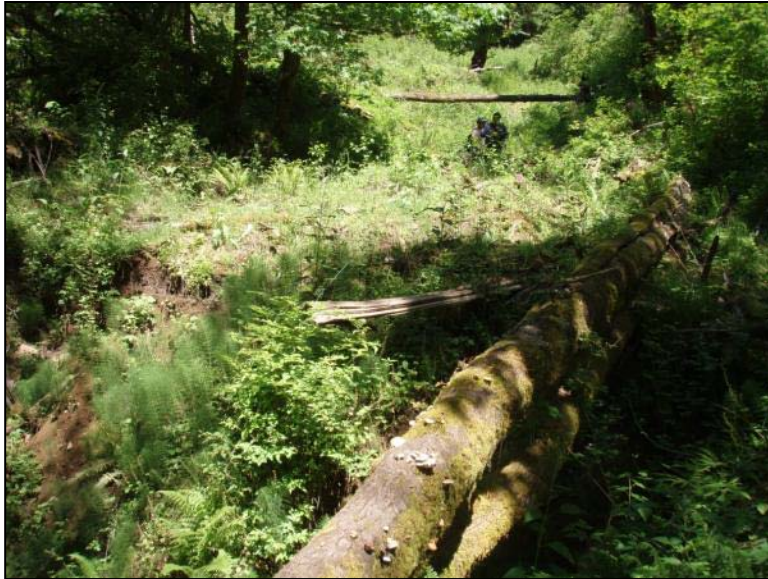
Figure 18: Slide Area in Segment 3

A portion of the road at approximate station 300+00 is under a hillside landslide that will likely require reconstruction and rehabilitation to make it usable for bike and pedestrian traffic.

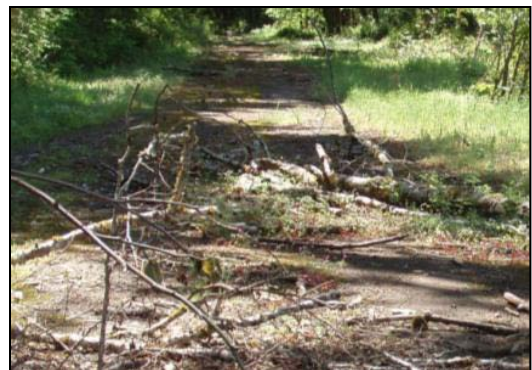
Figure 19: Mud and Debris Area in Segment 3 (2 views)

In areas considered to be in adequate condition there is mud, vegetation growth, and other debris that will need to be removed. Cleanup and minor maintenance is needed, but no major issues were visible that would require reconstruction or significant repairs. In areas considered to be in good condition the roadway would require minor cleanup and reconditioning.

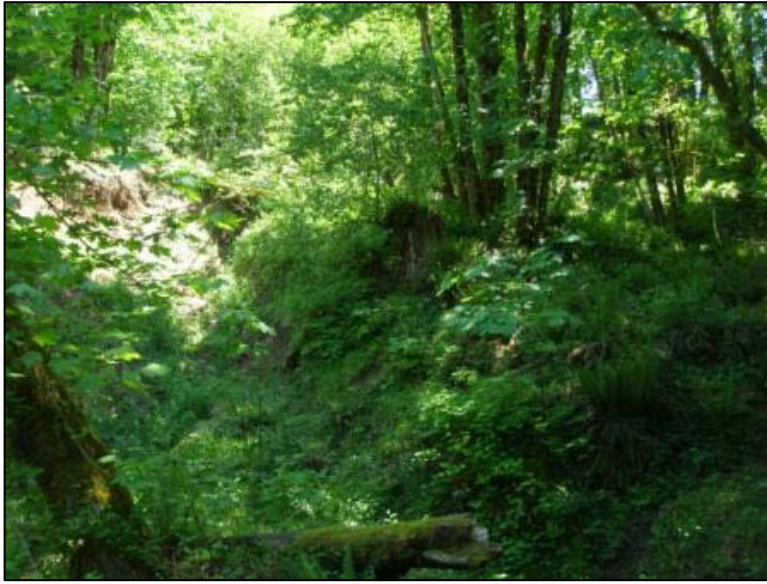
Older Landslide. Based on discussions with PacifiCorp, we understand the landslide shown in the first photograph below (Figure 22) occurred prior to the January 2009 storm event. The landslide has deposited significant amounts of debris into the middle of the road alignment as shown in the first photograph (Figure 22). The second photograph below (Figure 23) shows the location of the headscarp and additional landslide debris above the alignment. Some regrading, drainage improvements, and repair of this upslope debris will likely be necessary to reduce the risk of future trail closures at this location.

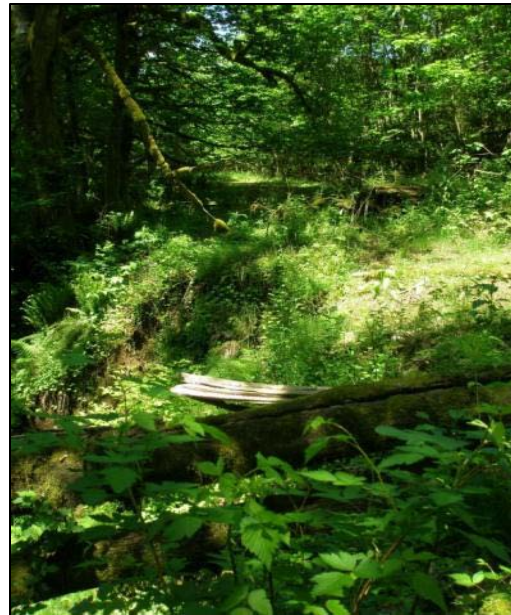
Debris Flow. A moderate-sized debris flow is currently blocking the alignment south of the older landslide described above, as shown in the first photograph below (Figure 24). Remediation efforts at this location will likely involve removal of the accumulated debris and repair/replacement of the culvert. A lesser amount of downslope fill and regrading will also likely be necessary to repair the surface erosion features shown in the second photograph below (Figure 25).
