Lewis River Dispersed Campsites Program

Dispersed Site Monitoring Report

**Prepared by
Mason, Bruce & Girard, Inc.
Portland, Oregon**

January 2010

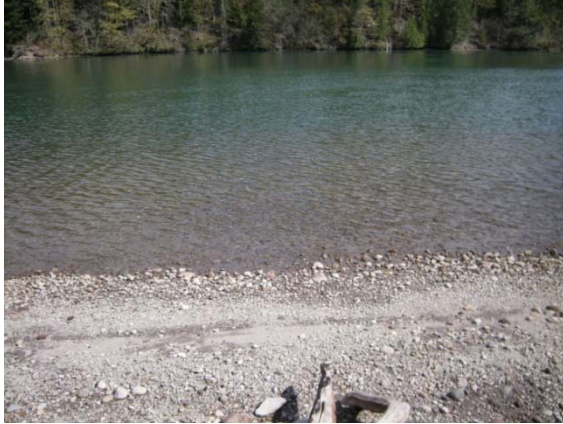
Photo Direction:
North

Description/Notes: View towards Merwin Reservoir from M1 S. Campsite center is near edge of water, in sandy beach area.

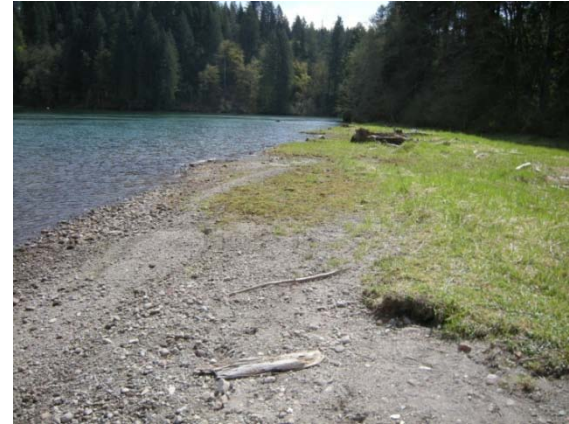
Photo Direction: East

Description/Notes: Eastern edge of campsite M1 S. Island is dominated by reed canarygrass (*Phalaris arundinacea*)

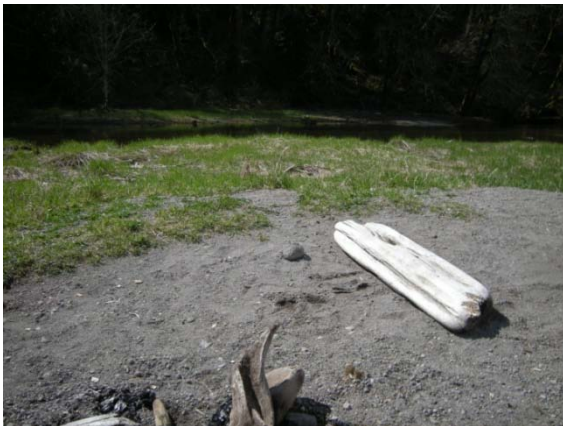
Photo Direction:
South

Description/Notes: Southern edge of M1 S. Note adjacent wetland in photo background.

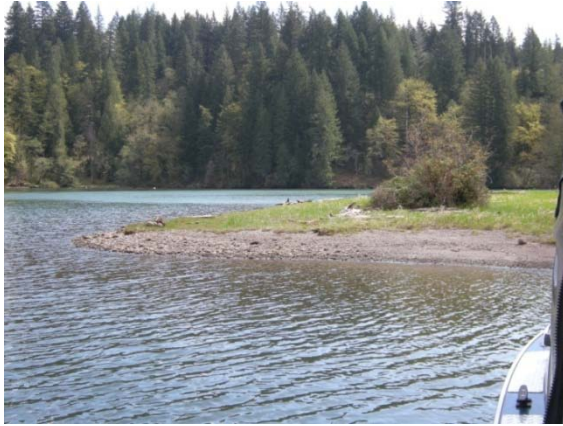
Photo Direction: East

Description/Notes: View of campsite M1 S, as seen from the reservoir, looking east. West end of island provides suitable boat access point.

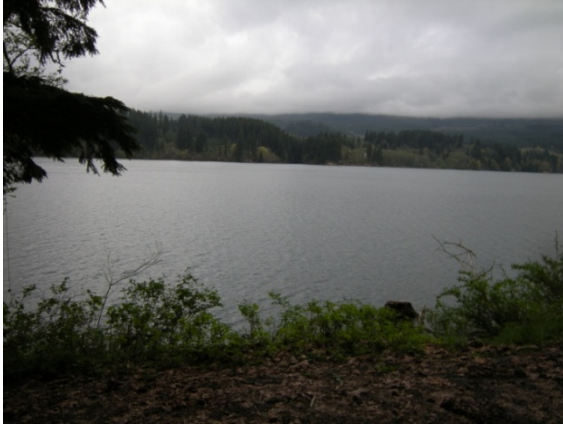
Photo Direction:
North

Description/Notes: View towards Merwin Reservoir from M2 S. Campsite center is near edge of slope.

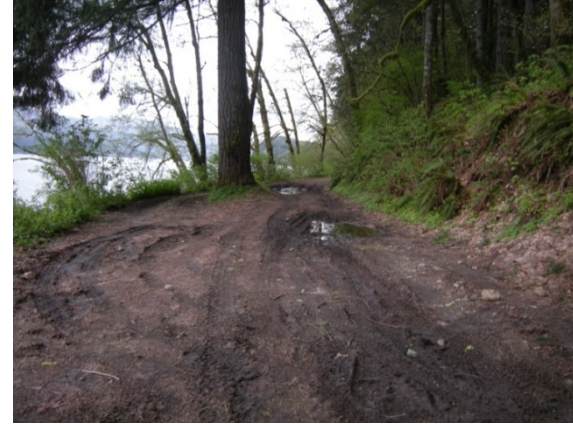
Photo Direction: East

Description/Notes: Eastern edge of campsite M2 S, which is located in dirt road.

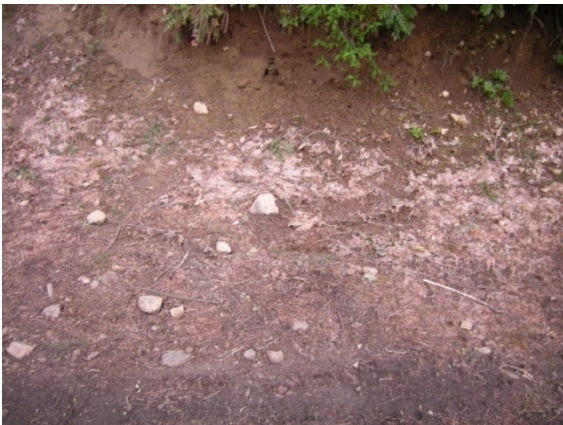
Photo Direction:
South

Description/Notes: Southern edge of M2 S. Note steep slope in photo background.

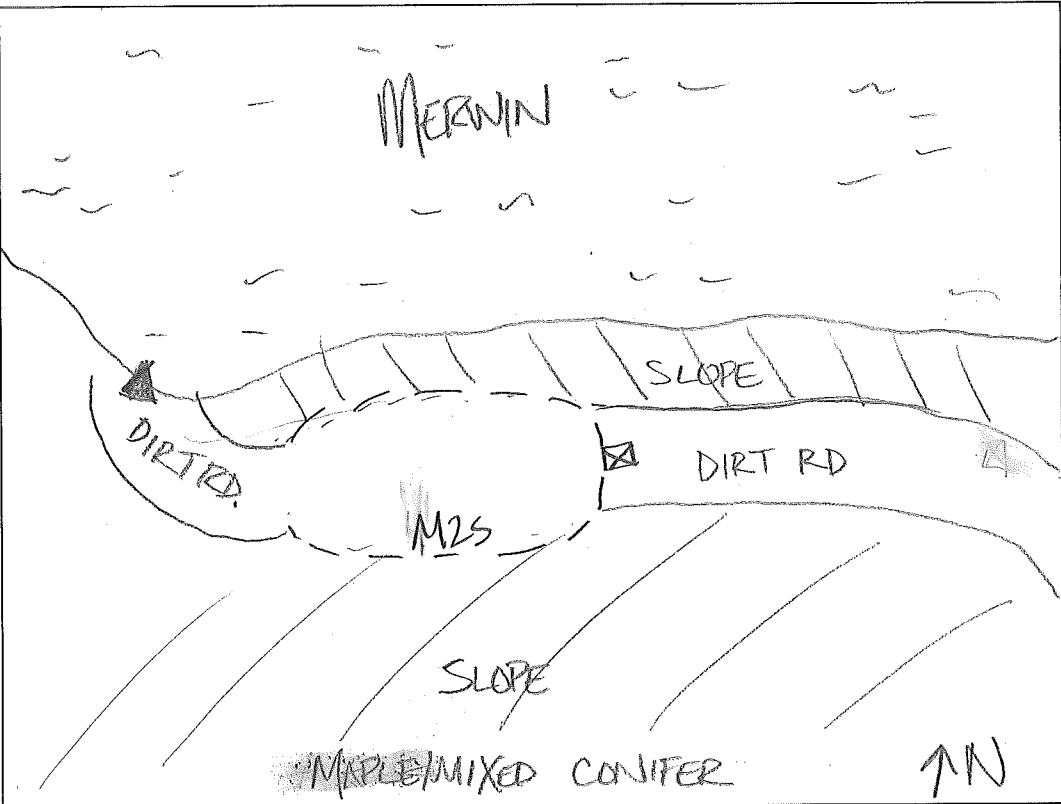
Comments: Site along / within old dirt rd adjacent to Merwin reservoir. No fire ring present. Easy access from water

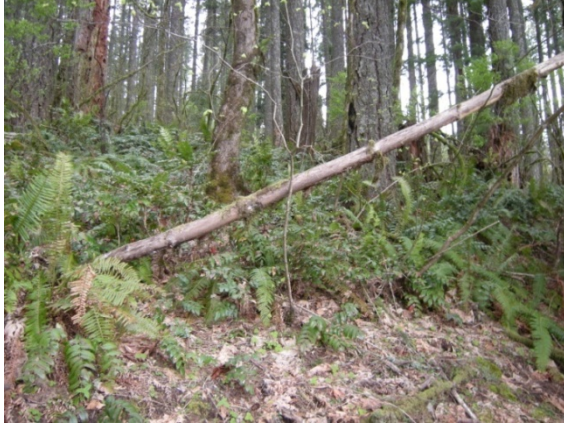
Photo Direction:
North

Description/Notes: Mapped location of campsite M3 N. Note steep slope and thick vegetation.

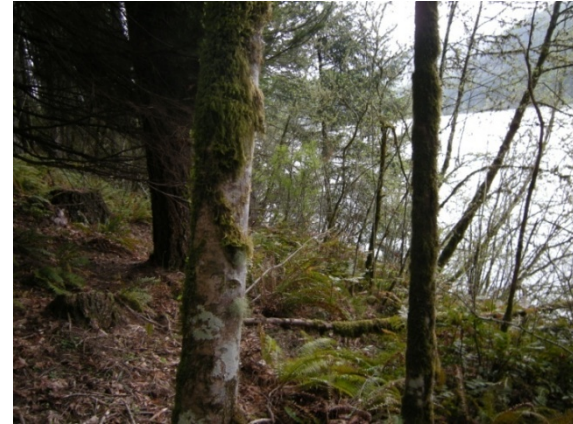
Photo Direction: East

Description/Notes: Mapped location of campsite M3 N. No evidence of site or use was observed.

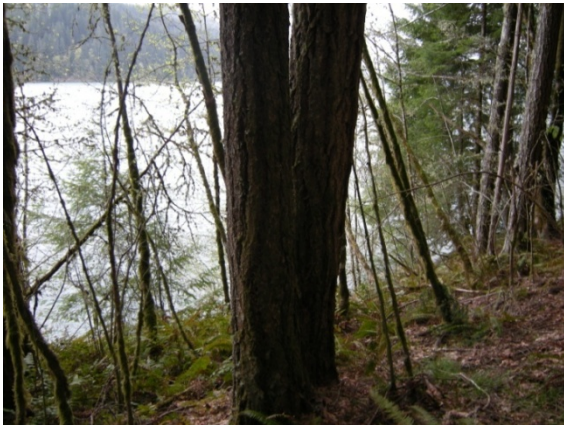
Photo Direction:
South

Description/Notes: View towards Merwin Reservoir from mapped location of campsite M3 N.

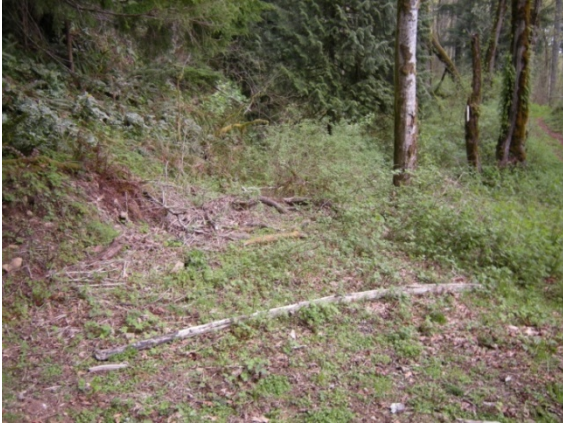
Photo Direction:
North

Description/Notes: Northern edge of campsite M4 N. Stinging nettle (*Urtica dioica*) at campsite edge.

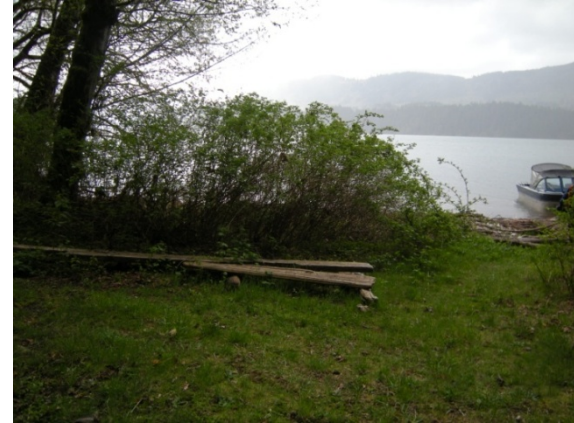
Photo Direction: East

Description/Notes: View towards Merwin Reservoir. Path leads from campsite to waters edge.

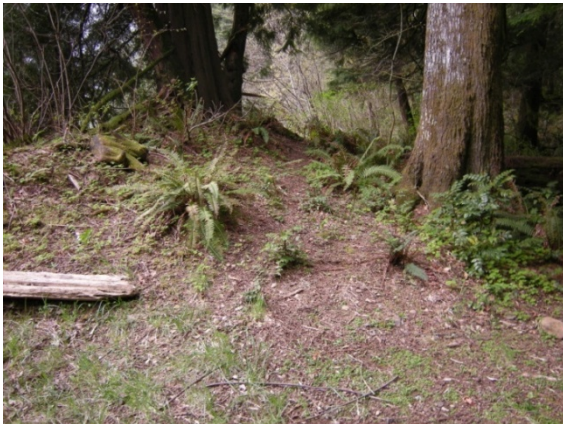
Photo Direction:
South

Description/Notes: Southern edge of campsite M4 N. Note driftwood "bench" at photo left.

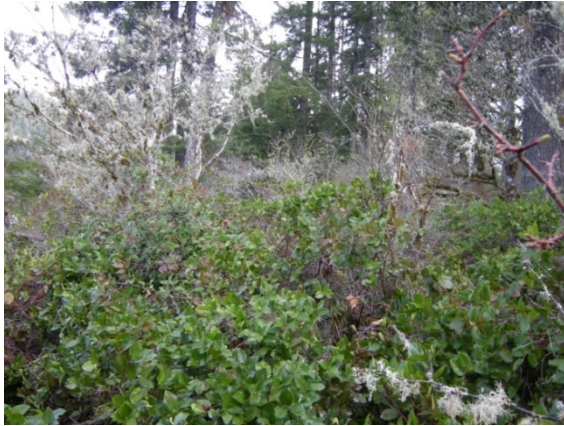
Photo Direction:
North

Description/Notes: Mapped location of campsite M5 N. Note dense undergrowth throughout area.

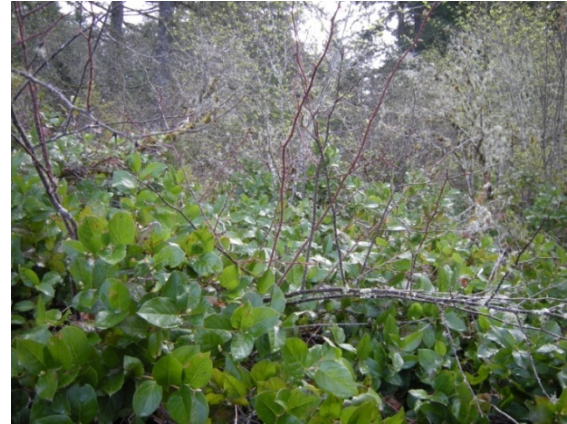
Photo Direction: East

Description/Notes: Mapped location of campsite M5 N. No evidence of site or use was observed.

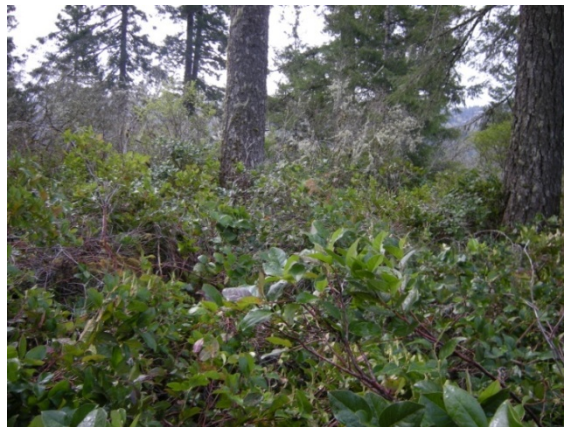
Photo Direction:
South

Description/Notes: Mapped location of campsite M5 N. Note dense undergrowth throughout area.

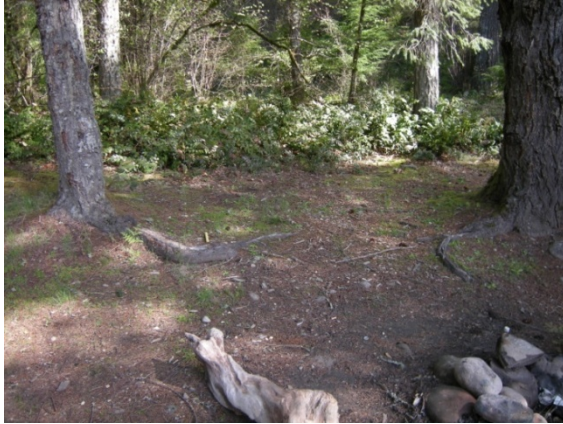
Photo Direction:
North

Description/Notes: Northern edge of campsite M6 N. Note exposed tree roots resulting from site use.

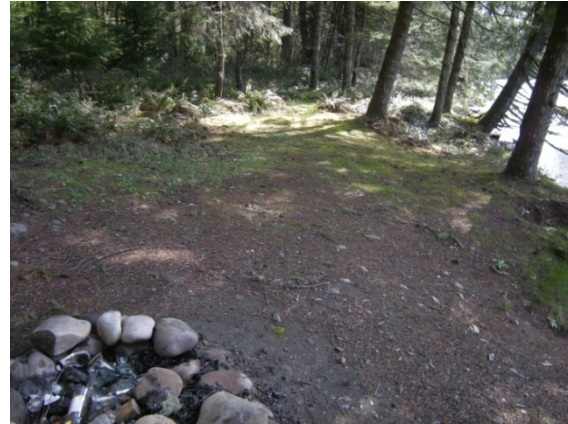
Photo Direction: East

Description/Notes: Eastern edge of campsite M6 N. Note fire ring in photo foreground.

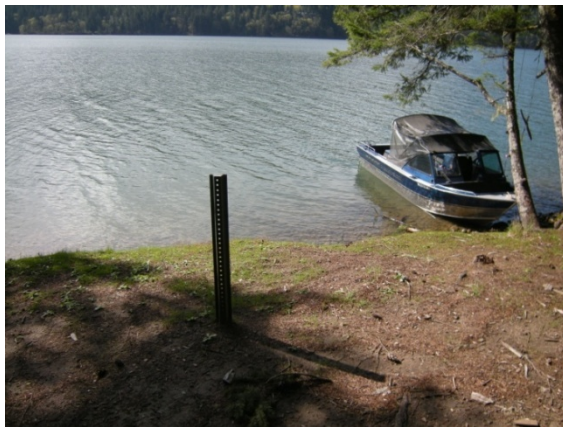
Photo Direction:
South

Description/Notes: View to Merwin Reservoir. Sign has been removed from post in foreground.

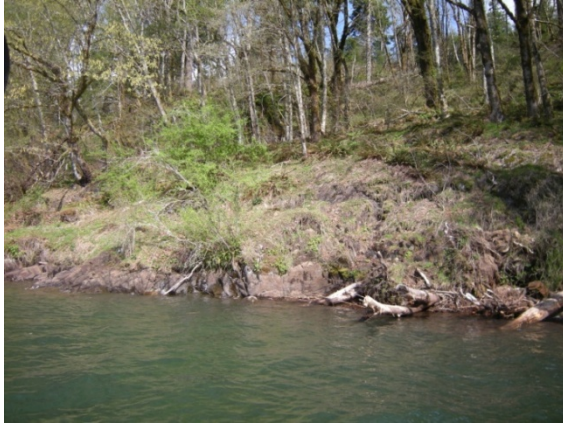
Photo Direction:
North

Description/Notes: Mapped location of M7 N. No evidence of campsite was observed.

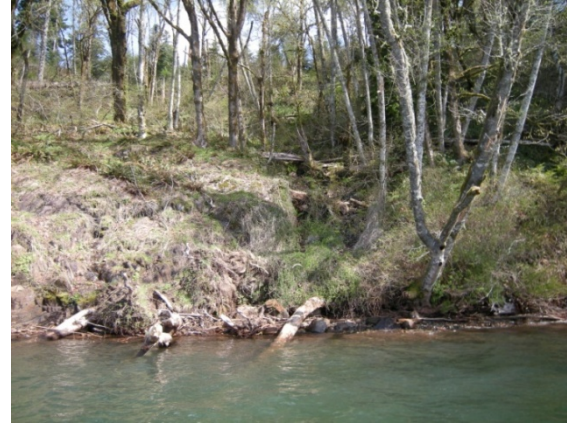
Photo Direction:
North

Description/Notes: Mapped location of M7 N. Note small creek entering reservoir, photo center.

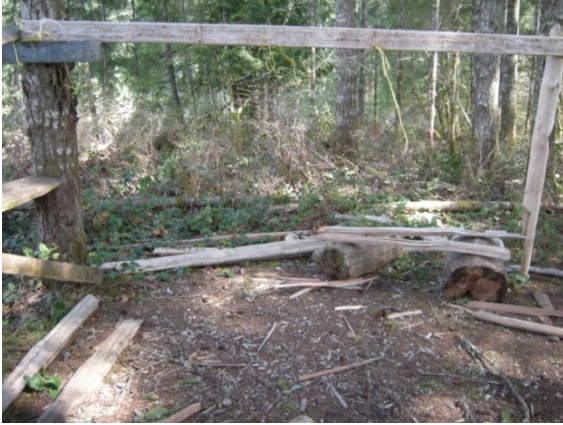
Photo Direction:
North

Description/Notes: Northern edge of campsite M8 N. Note user-created wooden structure.

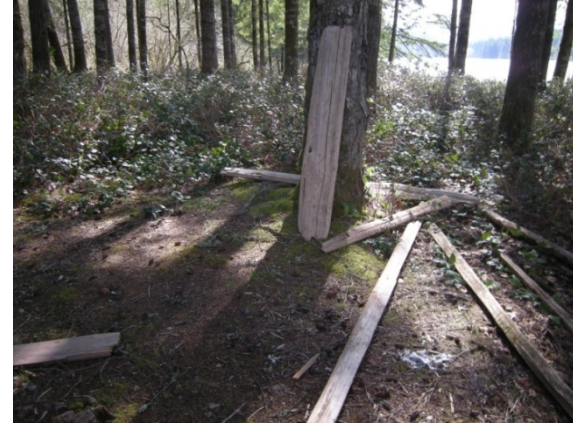
Photo Direction: East

Description/Notes: Eastern edge of campsite M8 N. Multiple pieces of driftwood observed in campsite.

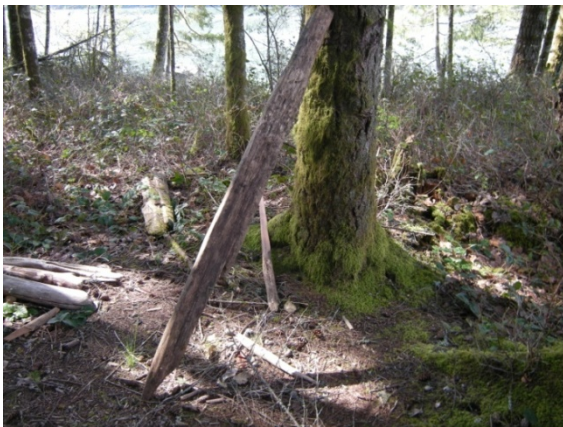
Photo Direction:
South

Description/Notes: Southern edge of campsite M8 N. Merwin Reservoir can be seen in background.

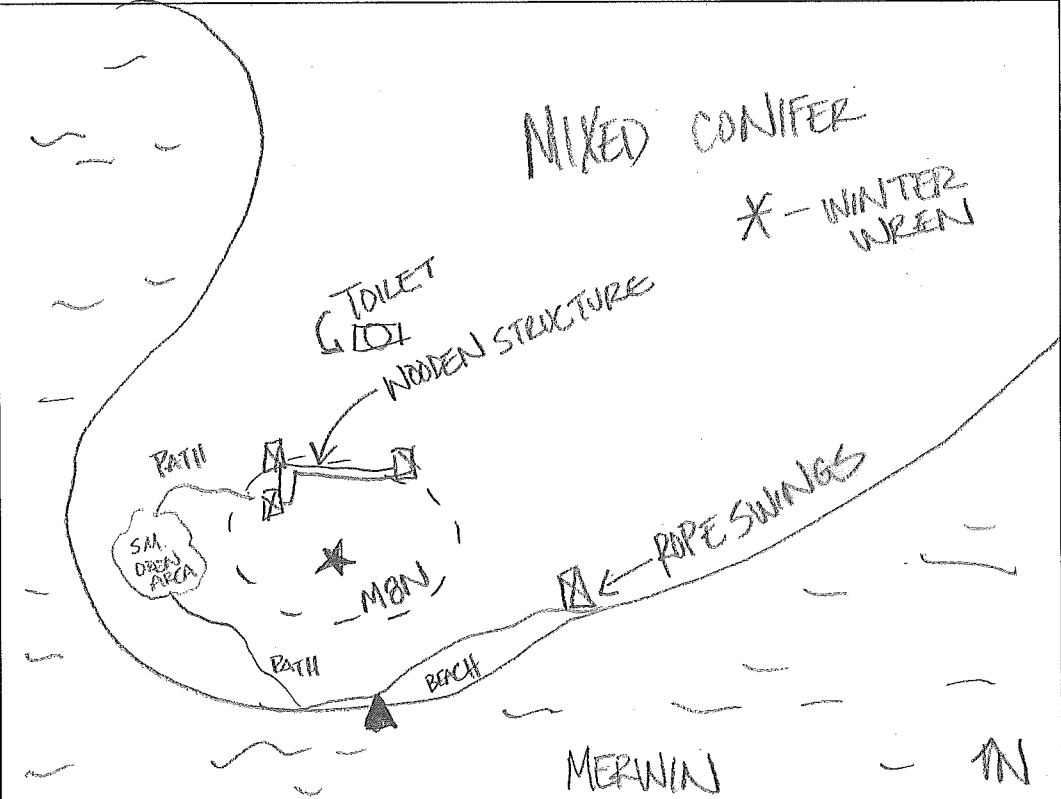
Comments: SM SITE LOCATED ON POINT. WOODEN STRUCTURE BUILT BETWEEN SEVERAL TREES. (PHOTO 2985). NUMEROUS PIECES OF LONG/STRAIGHT DRIFTWOOD IN SITE. TOILET CONSTRUCTED OUTSIDE MAIN AREA OF IMPACT.

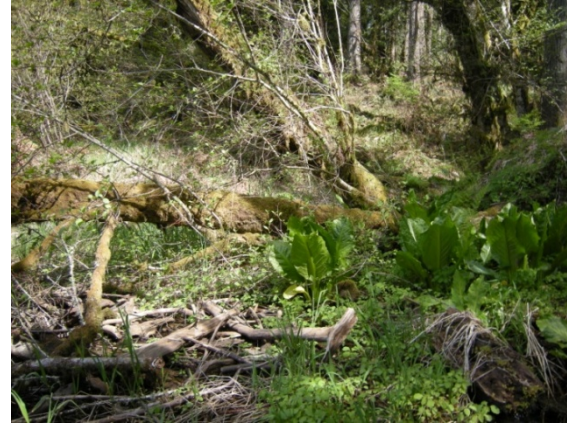
Photo Direction: East

Description/Notes: Mapped location of campsite M9 N. No evidence of site or use was observed.

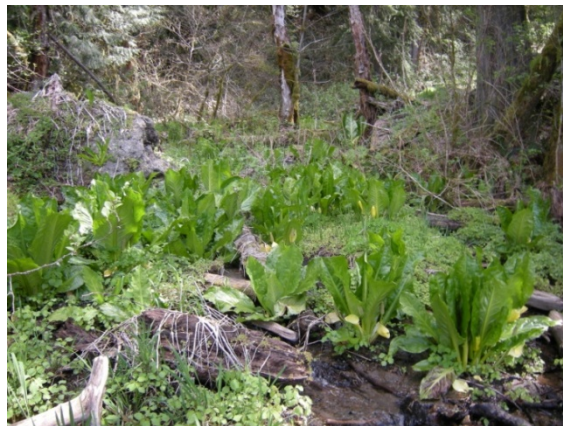
Photo Direction:
South

Description/Notes: Mapped location of M9 N is unsuitable for campsite due to stream/wetland.

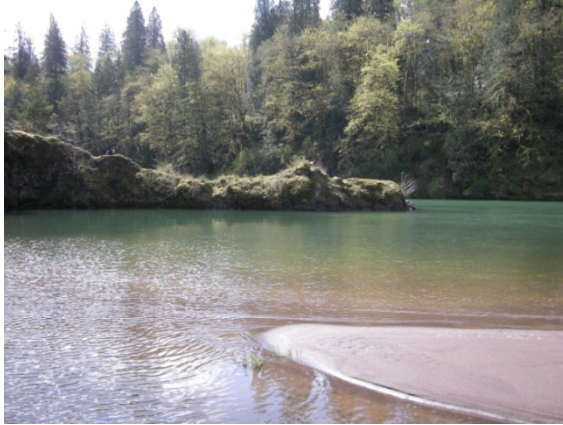
Photo Direction:
Southeast

Description/Notes: Mapped location of M10 N. This area is a steep, narrow peninsula.
