## 5.7 TRIBUTARY STREAM STUDY (TER 7)

**Lewis River  
Hydroelectric Projects**

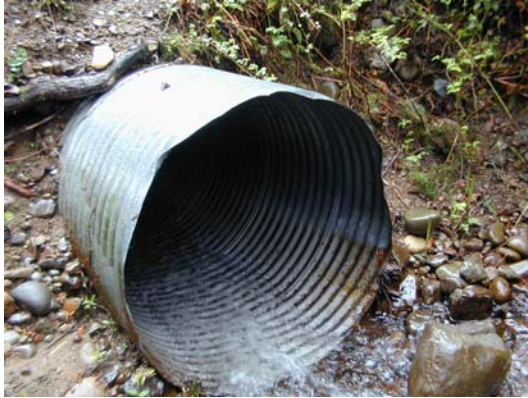
Photo of culvert m170c4 inlet

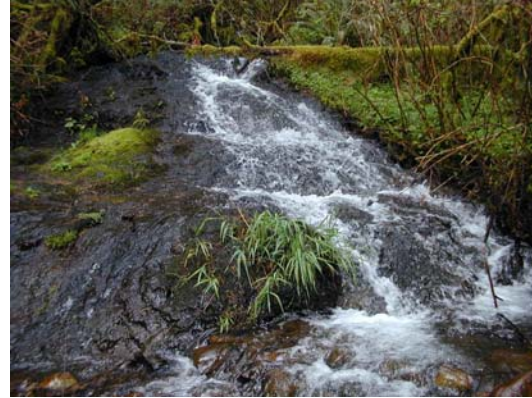
Photo looking upstream of culvert m170c4

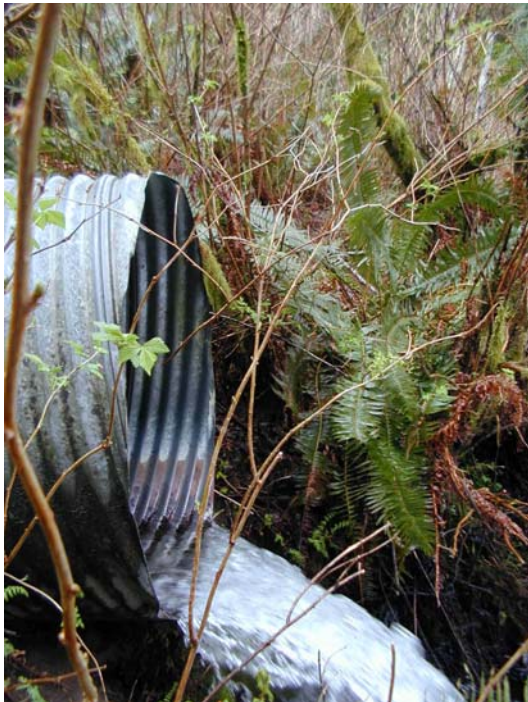
Photo of culvert m170c4 outlet

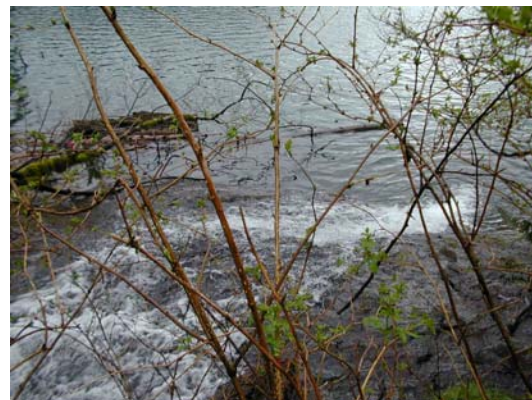
Photo looking downstream of culvert m170c4

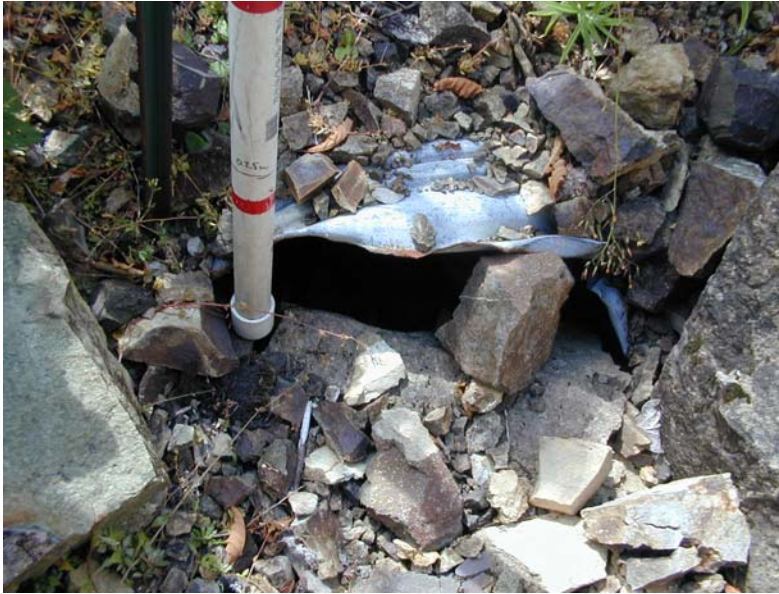
Overall, 78 percent of stream culvert inlets and 62 percent of the outlets show signs of rusting, crushing, and/or plugging (Figures 5.7-4 and 5.7-5). An example of a culvert with some rust, crushing, and plugging is shown in Figure 5.7-6.

Plugged and crushed culverts are a more significant concern than rusted culverts because they can result in flooding and erosion. Over 62 percent of culvert inlets were at least partially crushed or plugged, as were 20 percent of the outlets. Three culverts had either inlets or outlets that were crushed more than 50 percent. Plugging is a more extensive problem; 27 stream culvert inlets and 8 outlets were more than 50 percent plugged. Crushed and plugged culverts are also problematic for the passage of small mammals and amphibians.

**Figure 5.7-6. Culvert with a rusted, crushed, and plugged outlet.**

- Replace damaged and nonfunctioning traditional metal culverts with bridges or bottomless arch culverts where feasible. Replace other nonfunctioning culverts with larger culverts. New culverts should be placed in a way that minimizes changes to streamflows and gradient. Culverts placed with the bottom buried into the streambed are preferred to those placed on top of the streambed.

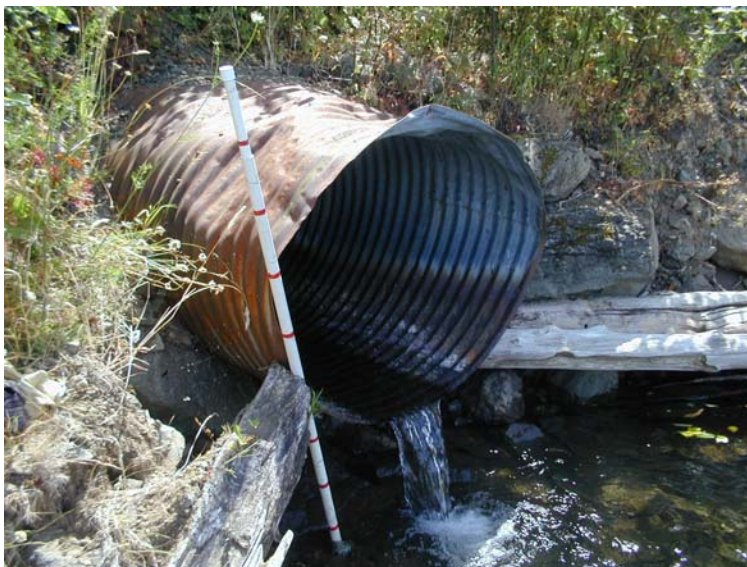
Over 70 percent of the stream culverts surveyed had a drop from the outlet to the ground (Table 5.7-3 and Figure 5.7-7). An outlet drop example is shown in Figure 5.7-8.

**Figure 5.7-8. Photo of outlet drop.**

Excessive drop presents a migration barrier for fish and can restrict the movement of some aquatic and riparian dependent wildlife species, especially upstream. Outlet drops averaged 1.4 feet (0.44 m) and ranged up to 11.8 feet (3.6 m). Fifty-nine percent of outlets had drops greater than 6 inches (15.2 cm), and 26 percent had drops more than 2 feet (0.6 m). None of the 3 log culverts have drops.
