**EROSION CONTROL PLAN  
5-YEAR ROLLING ACTION PLAN  
CALENDAR YEAR 2023**

North Umpqua Hydroelectric Project  
FERC Project No. 1927

## **2022 ANNUAL EROSION CONTROL PLAN SUMMARY REPORT AND 5-YEAR ROLLING ACTION PLAN**

### **North Umpqua Hydroelectric Project (FERC Project No. 1927)**

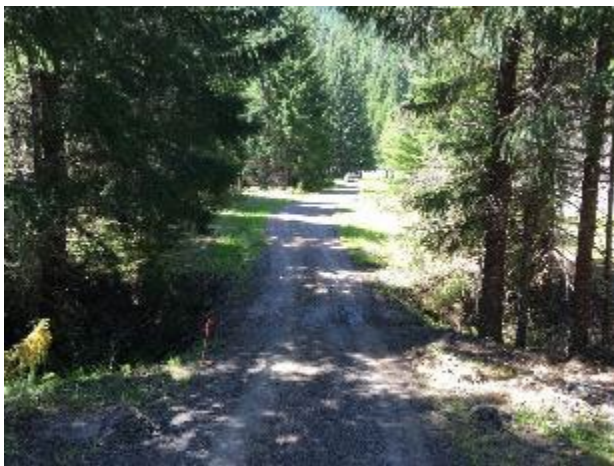
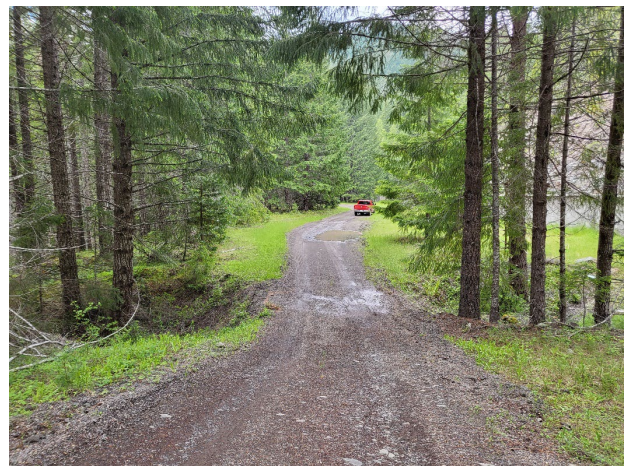
Lemolo 2 – Site LM2-2 (May 2016)

Backfill and reclamation was performed at LM2-2 along the Lemolo 2 Waterway between the 2016 and 2017 inspections. Photographs below depict the site in May 2016 compared to the June 2022 inspection.

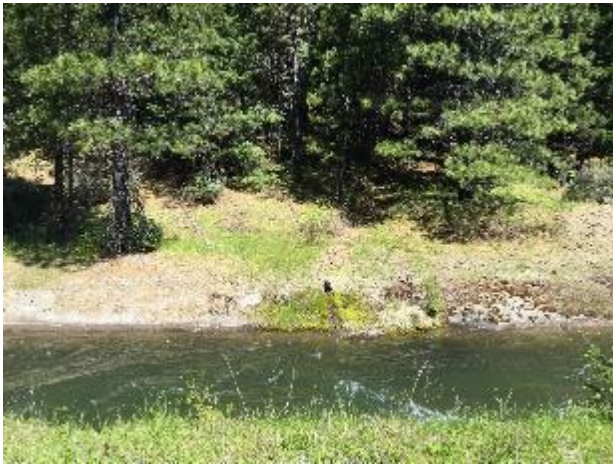
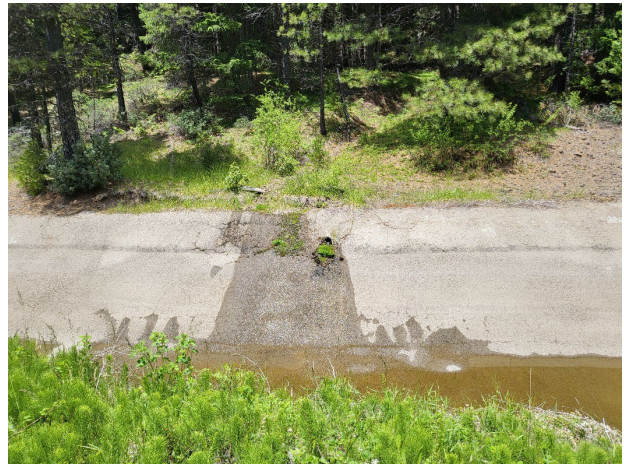
Lemolo 2 – Site LM2-6 (May 2016)

New shotcrete was placed and vegetation was removed at LM2-6 along the Lemolo 2 Waterway between the 2016 and 2017 inspections. Photographs below depict the site in May 2016 compared to the June 2022 inspection. LM2-6 has exhibited no visible change in the canal bulge and no indications of erosion. This site appears to be stable, and the risk level was lowered from MEDIUM to LOW in 2012. The site will be monitored in future inspections.

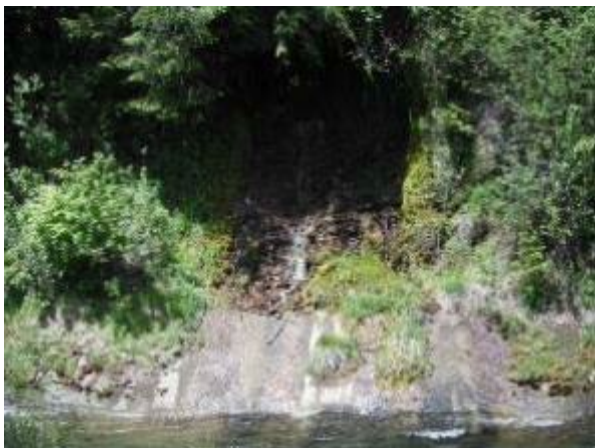
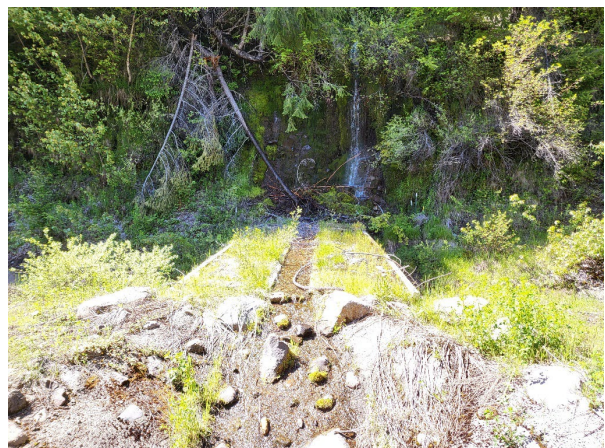
Lemolo 2 – Site LM2-25 (June 2015)

LM2-25 was remediated along the Lemolo 2 Waterway between the 2015 and 2016 inspections. Photographs below depict the site in June 2015 compared to the June 2022 inspection.

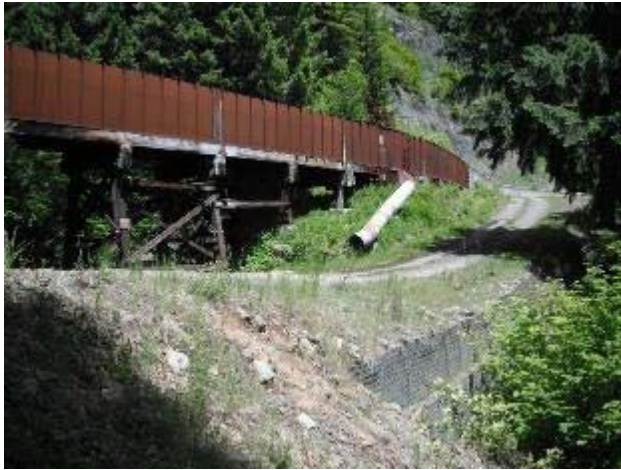
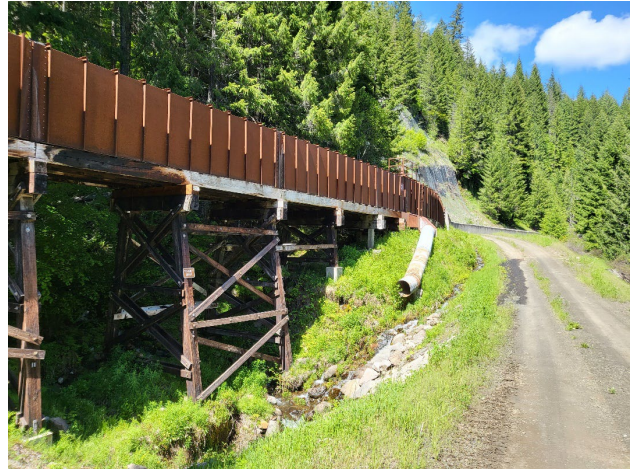
Lemolo 2 – Site LM2-26 (June 2015)

LM2-26 was remediated along the Lemolo 2 Waterway between the 2015 and 2016 inspections. Photographs below depict the site in June 2015 compared to the June 2022 inspection.

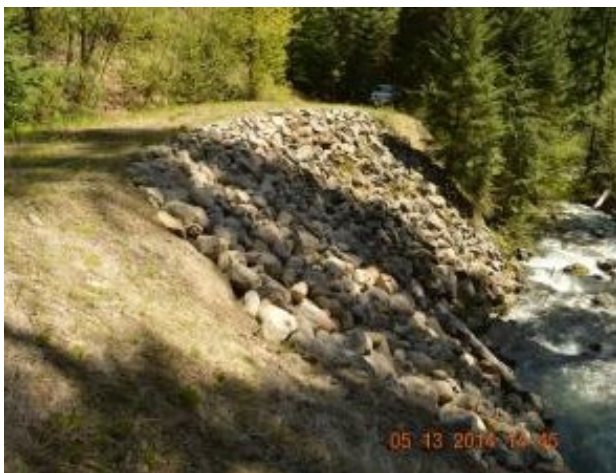
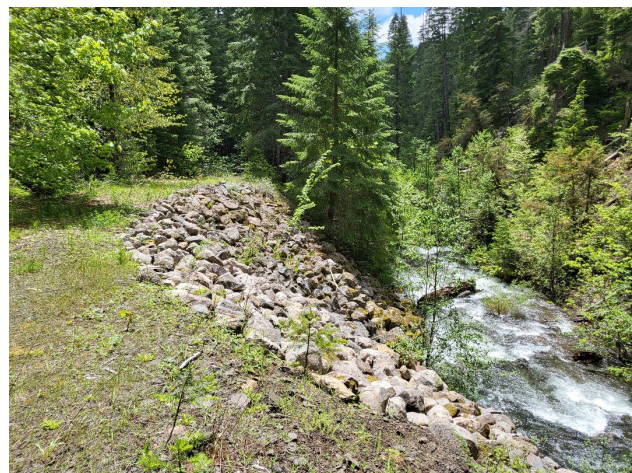
Lemolo 2 – Site LM2-4 (May 2014)

The 2 photographs below depict site LM2-4, where a slump failure released a portion of FR 090 between the 2007 and 2008 inspections. Remedial efforts in 2009/2010 appear to be effective, and vegetation density continues to improve. Monitoring at this site will continue to evaluate the effectiveness of the remediation effort.

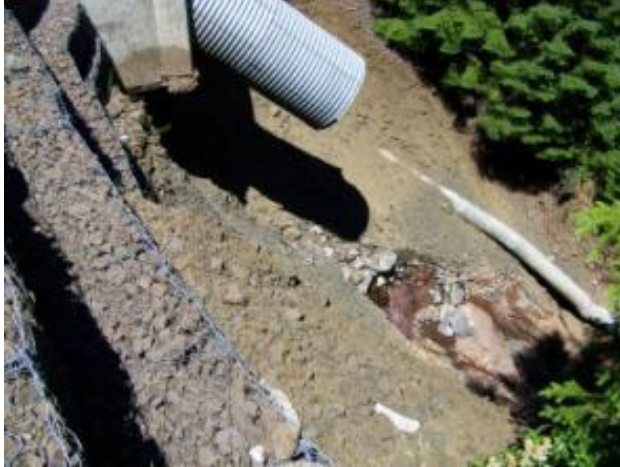
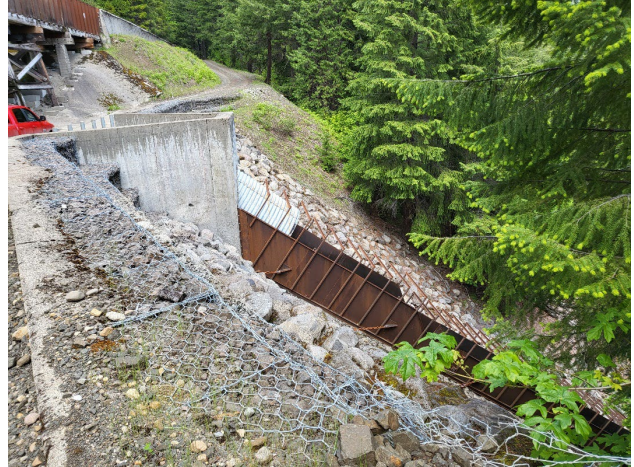
Lemolo 2 – Site LM2-15 (July 2011)

The corrugated metal discharge pipe at site LM2-15 failed in July 2011. PacifiCorp re-armored the slope below the road and constructed a flume to channel overflow from the nearby Flume 15. Photos from July 2011 and June 2022 show the difference between before and after the site was remediated. The remediation appears to be effective.

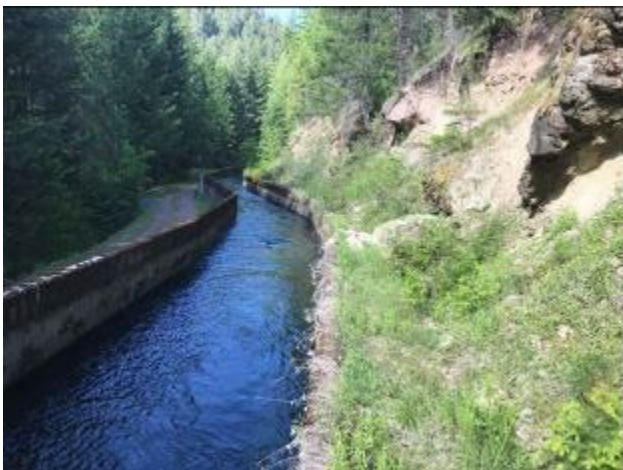
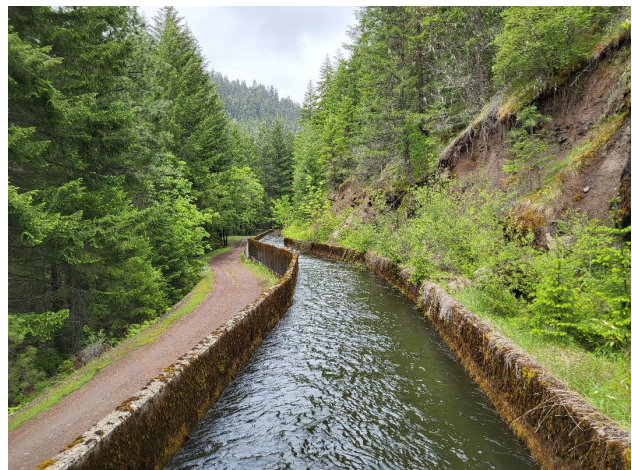
Clearwater 2 – Site CW2-5 (May 2018)

At site CW2-5, additional rock fall was noted from the slopes above the canal between the 2018 and 2019 inspections. Vegetation coverage has improved, and the pumice padding is in excellent condition (see photographs below).

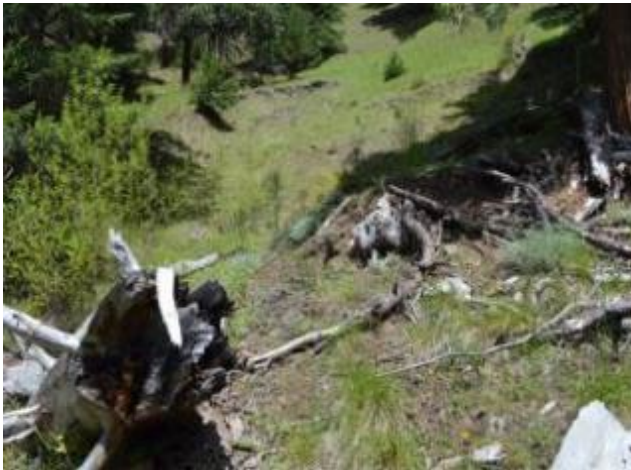
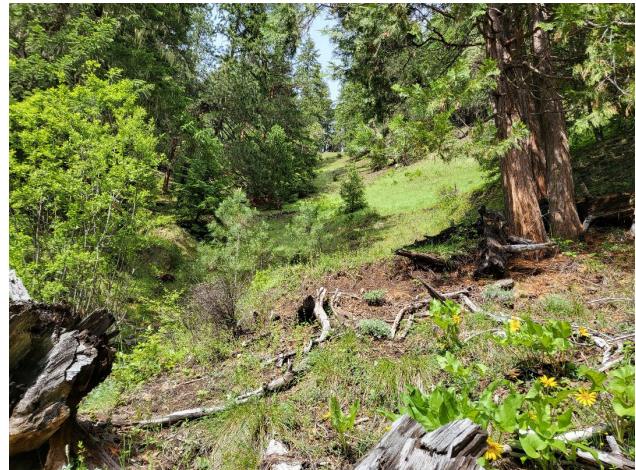
Clearwater 2 – Site CW2-6 (May 2014)

No obvious changes were observed to the scarp at site CW2-6 since the 2014 inspection. The scarp is shown in the upper left corner of the following pictures.

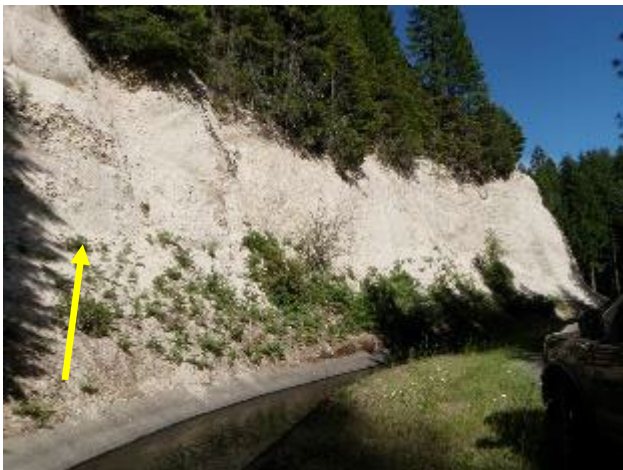
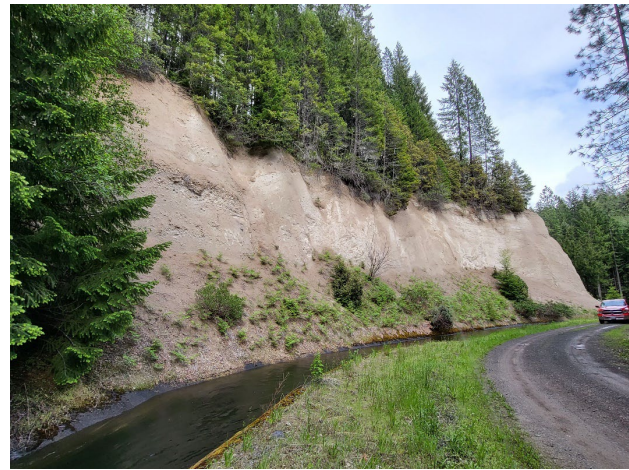
Clearwater 2 – Site CW2-12 (June 2019)

At site CW2-12, a small horizontal crack on the west side of the pumice wall was observed as indicated by the arrow in the 2019 photograph below. No significant changes were noted between the 2019 and 2022 inspections. This site has not been remediated and will be monitored annually.

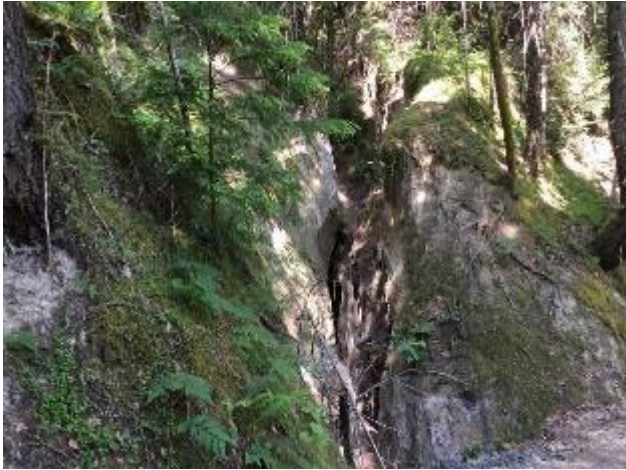
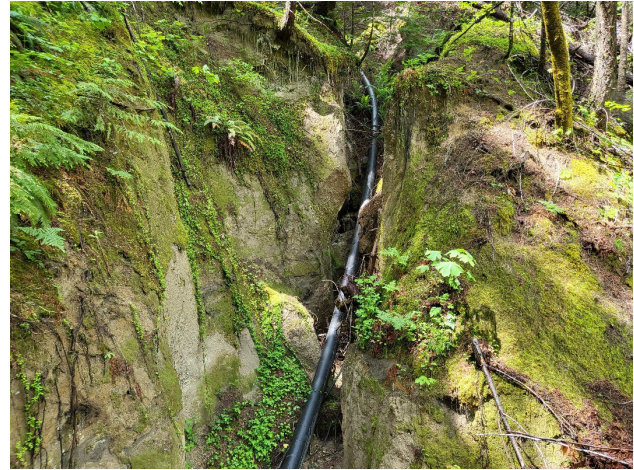
Fish Creek – Site FC-13 (June 2018)

The Fish Creek Canal Shut-off and Drainage System became operational in the spring of 2009. Several high priority sites that have been remediated are shown below to monitor the effectiveness of the remedial efforts. Remedial activities were conducted at FC-13 between the 2012 and 2013 inspections. This effort was the result of erosion from a culvert under OR 138 at milepost 58, above the site. Remediation included rehabilitation of service road 4700570, installation of a culvert and armoring downslope from the service road at the area of erosion. Additional erosion was noted along the roadway, which appeared to cut away the insloped relief ditch (June 2022 photo below). However, the ditch has been piped and

directed across the road towards the downslope armored culvert and appears to be stable. The following photos show the condition of FC-13 between the 2018 and 2022 inspections.

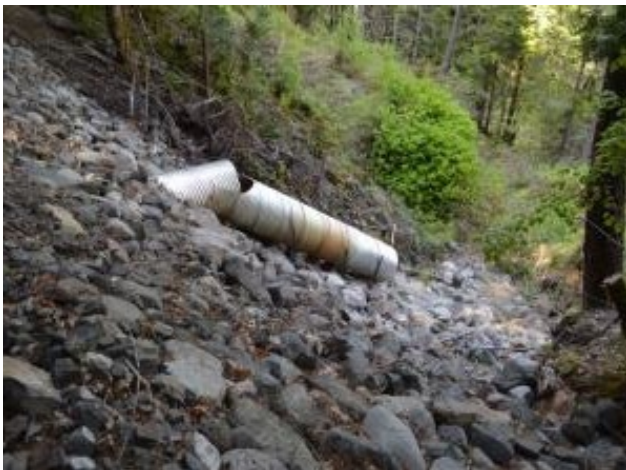
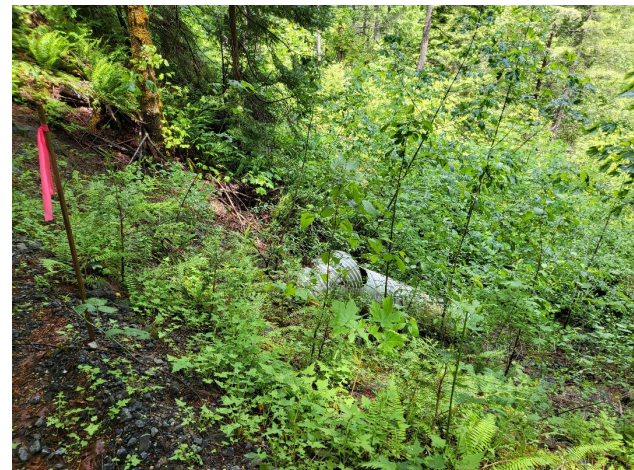
Fish Creek – Site FC-13 (May 2014)

The culvert and armoring are shown in the following photographs:

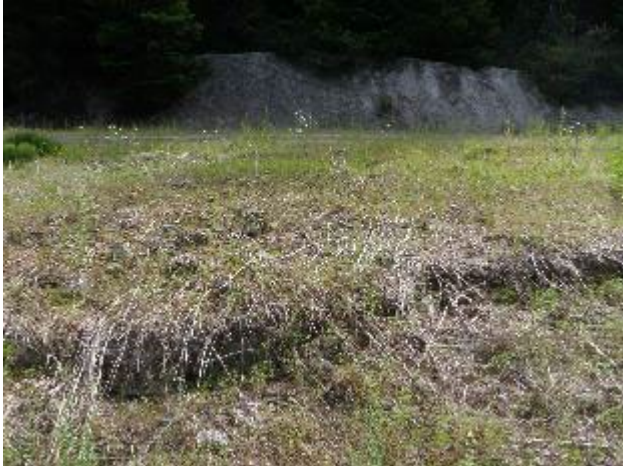
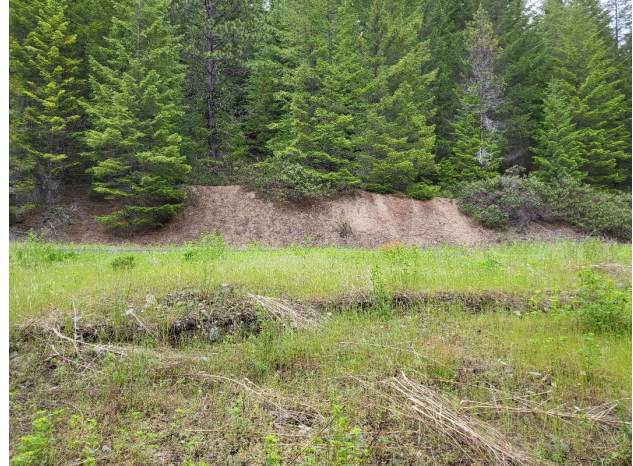
Fish Creek – Site FC-2 (June 2019)

Site FC-2 was remediated in 2002 and partially remediated in 2015. In 2015, the road was regraded and silt fencing was installed on the creek side of the inspection area. The silt fencing had been knocked down in several locations during the 2016 inspection. More vegetation was observed during the 2017 inspection. However, the silt fencing was still partially buried and a new crack in the ground formed due to slumping between the 2018 and 2019 inspections. The crack appeared to be unchanged between the 2019 and 2022 photos, as shown below.

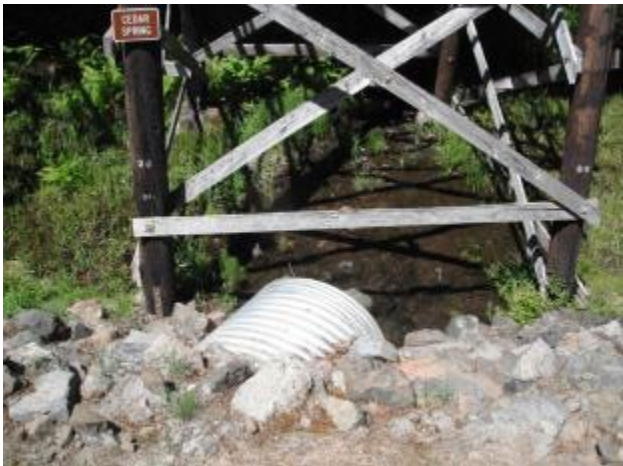
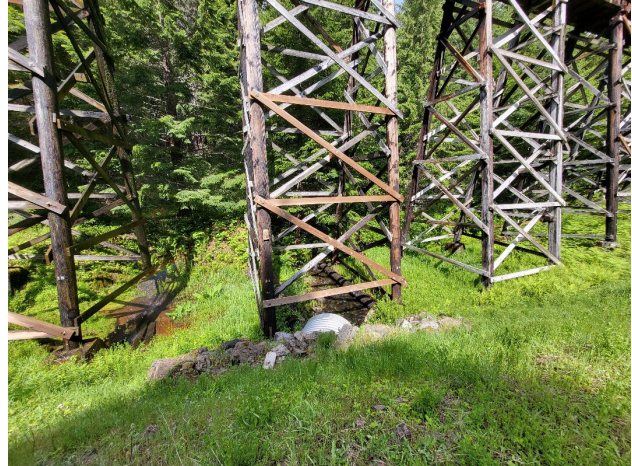
Fish Creek – Site FC-14 (June 2016)

The remedial effort at site FC-14, Cedar Springs was performed between the 2015 and 2016 inspections. It consisted of armoring of the footings of bents #29 and #30 of Flume #7. The remediation appears to be effective.

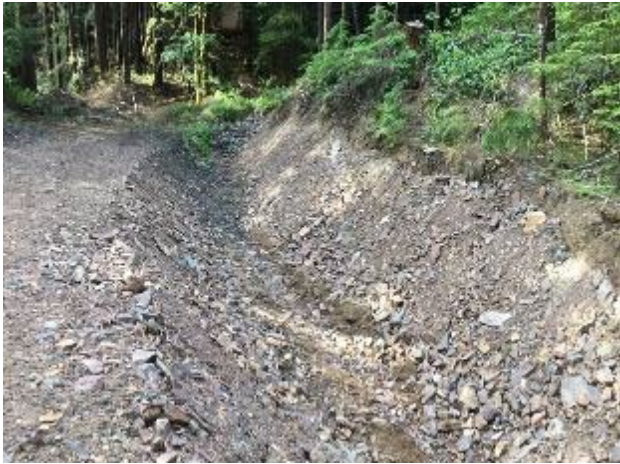
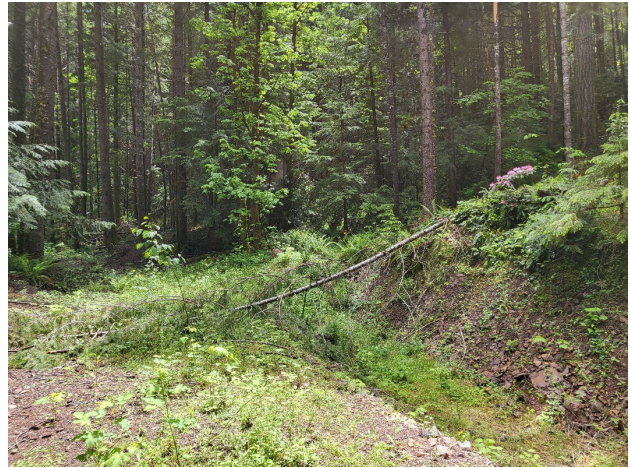
Fish Creek – Site FC-15 (June 2018)

Site FC-15, added between 2017 and 2018, is situated upslope from the westernmost residence at 7229 Toketee School Road in Toketee Village. An armored run-on ditch was developed between the 2017 and 2018 inspections to divert drainage from Boyden Spring away from the residence. This site was assigned a MEDIUM priority in 2018, and subsequent inspections showed that vegetation was establishing in the drainage channel. The ditch will continue to be monitored annually.

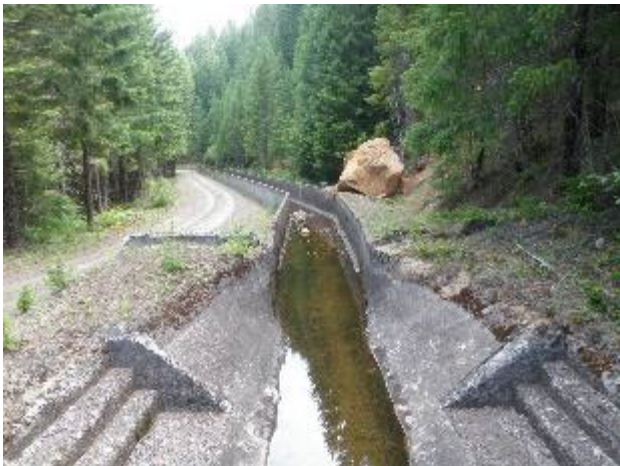
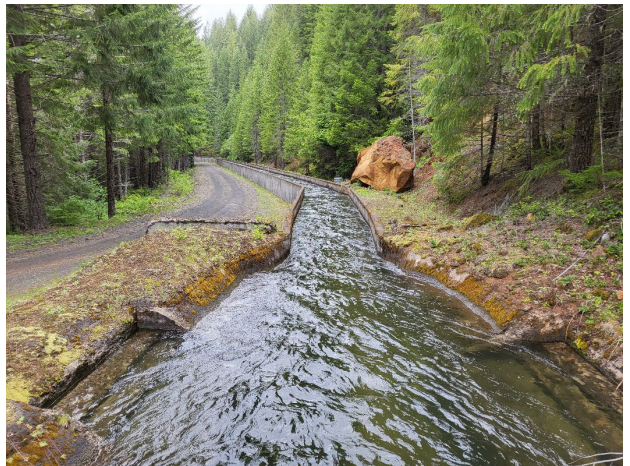
Fish Creek – Site FC-7 (June 2019)

A large boulder was observed downstream of site FC-7 during the 2019 inspection and appears unchanged in the 2022 inspection, as shown in the photographs below. Site FC-7 was remediated in 2002. Additional rock fall is not anticipated, but cannot be ruled out in this area.

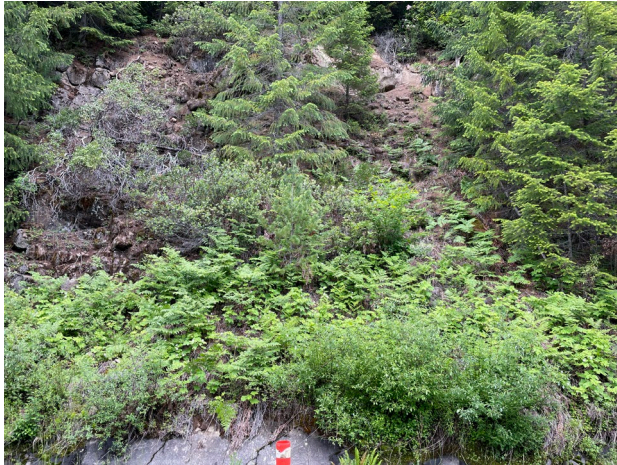
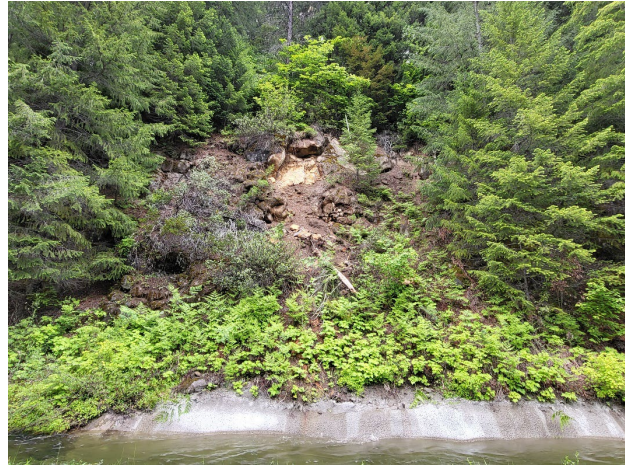
Fish Creek – Site FC-3 (June 2021)

Remediation measures have been completed at 12 of the 17 sites. Remediation is necessary at FC-3 and FC-4. New tree fall was observed at FC-3 during the 2022 inspections. Because no changes had been observed prior to 2021, FC-3 was reduced from a Medium priority to Low priority site. Site FC-3 has been assigned Medium priority in 2022 due to the changes observed. Partial remediation was conducted at FC-2 and FC-13. Monitoring is presently recommended at FC-3, FC-4, FC-8, FC-9(1), FC-9(2), FC-13, and FC-15.

A tree had fallen at site FC-3 between the 2021 and 2022 inspections. The debris from the tree fall had been removed and new gunite was placed along the canal below the slope. This site was downgraded to a low priority rating in 2021, but has been assigned a medium rating in 2022.

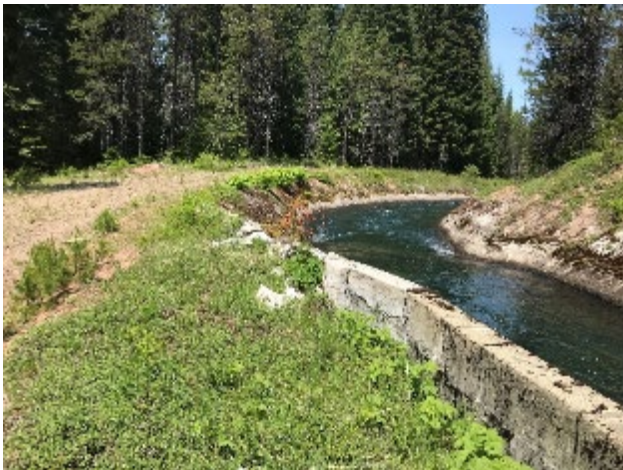
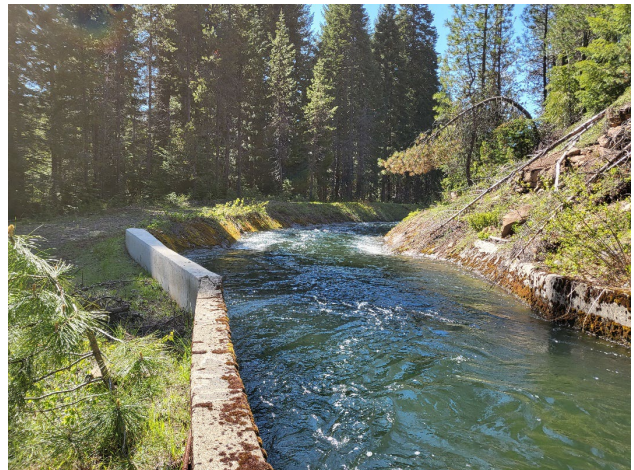
Lemolo 1 – Site LM1-1 (June 2018)

The connectivity of White Mule Creek was restored at site LM1-1 in fall 2006, with revegetation completed in summer 2007. Additionally, the site was remediated in summer 2007 by placement of pumice padding on the upslope canal wall. The sidecast between the access road and the North Umpqua River has been left in-place. Large trees growing on the sidecast appear to have stabilized the slope. Replanting the slope for stability was selected over pulling back the steep slope. Hazards continue to exist for rockfall in the canal. Minor remediation occurred which consisted of repair to the concrete flume wall and regrading the adjacent road surface since the 2018 inspection. Monitoring will continue, and reshaping or removal of the sidecast may be required, as determined by monitoring activities.

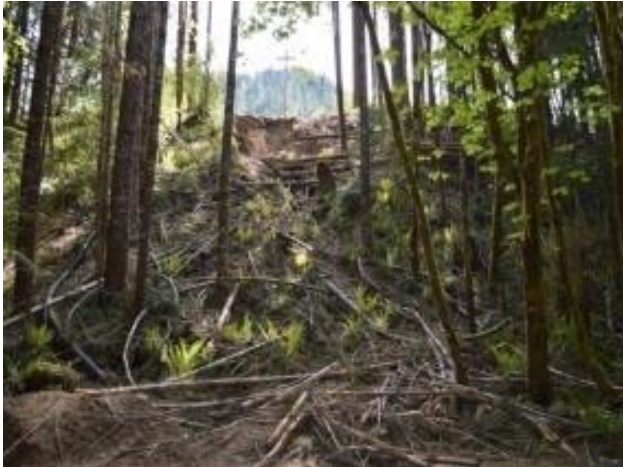
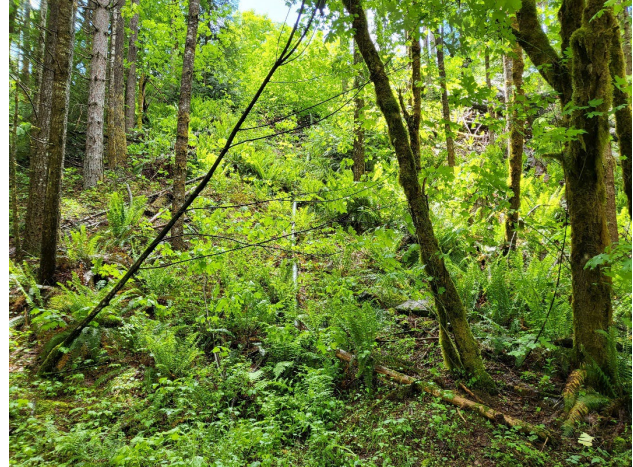
Slide Creek – Site SC-2 (May 2014)

Site SC-2 was added in 2014 at the slide below the Toketee Control Center. Erosion at this site occurred below the outfall of a parking lot drain line. The Site was assigned a MEDIUM priority and was remediated in 2014, as shown below. The remediation appears to be effective.

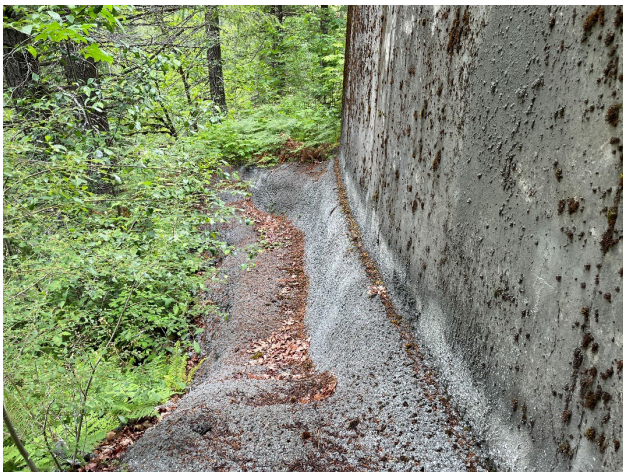
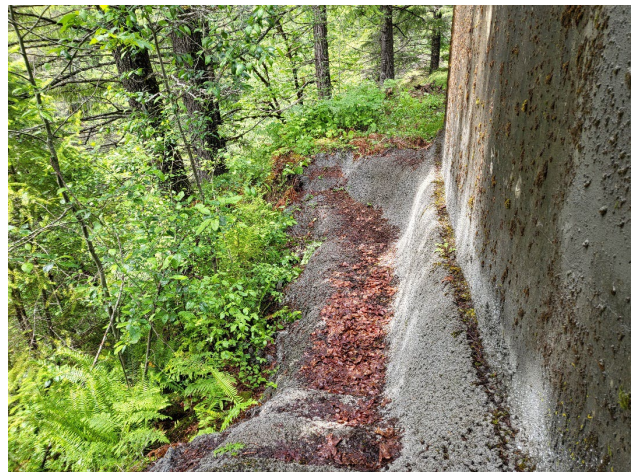
Slide Creek – Site SC-3 (June 2021)

Sites SC-3 and SC-4 were added in 2019 below the Slide Creek waterway east of the Slide Creek power plant. These sites were added because of eroded areas downslope of the double walled concrete flume. Guniting reinforcement was added to the slope to protect the ground surface from slumping and eroding. Both sites were assigned a LOW priority rating and ongoing monitoring is recommended. Minor cracks in the guniting near the base of the canal were noted at the SC-3 site in subsequent inspections, and the site will be monitored annually.

Sites SC-3 and SC-4 were added in 2019 below the Slide Creek waterway east of the Slide Creek power plant. Erosion at these sites occurred downslope of the double walled concrete flume. Guniting reinforcement was added to the slope to protect the ground surface from slumping and erosion. Both sites were assigned a LOW priority rating and ongoing monitoring is currently recommended. In 2020, a small crack was noted at SC-3 where the guniting meets the bottom of the concrete flume.
