Erosion Control Plan

North Umpqua Hydroelectric Project (FERC Project No. 1927)

Volume 2 - Appendix A HIGH and MEDIUM Priority Sites Remediation Data

April 26, 2004

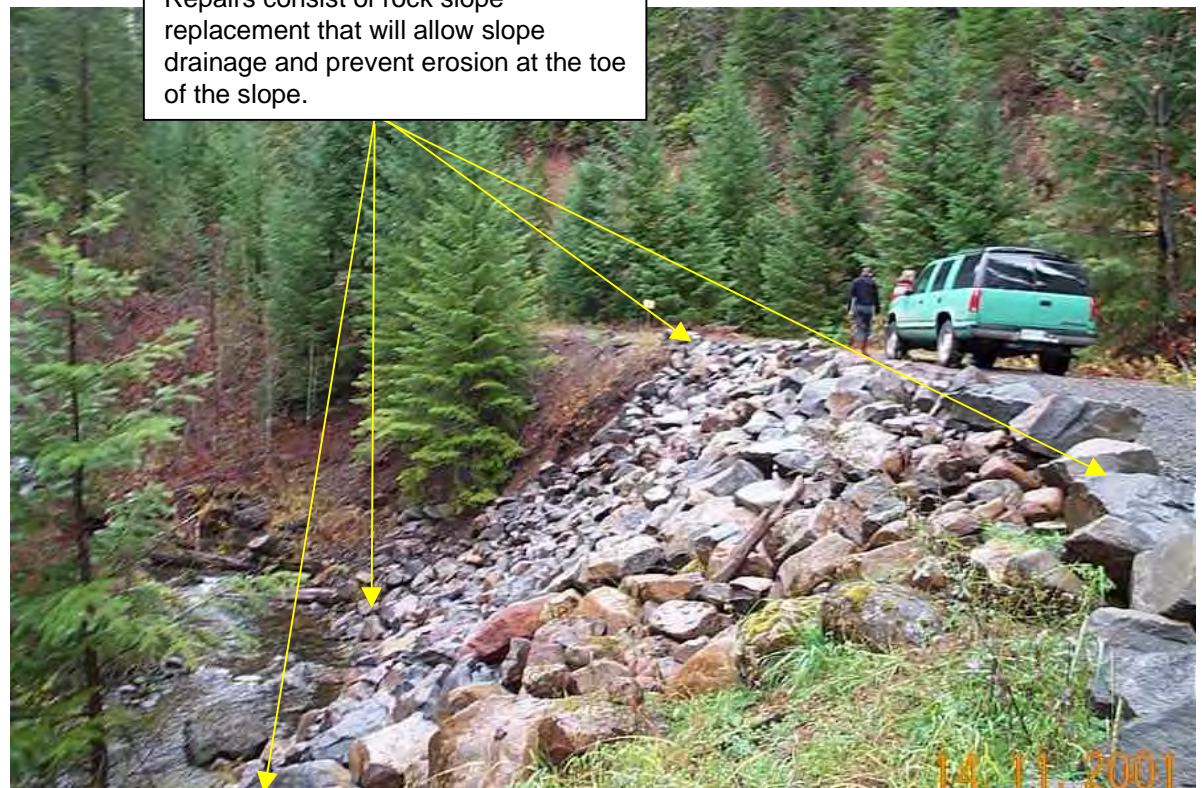
LM2-4 Site Photo Deer Creek Access Road

Deer Creek site had a slope failure in 1997. This area was repaired in 2000. No further erosion control measures recommended at this site.

Extent of year 2000 repairs.
Repairs consist of rock slope replacement that will allow slope drainage and prevent erosion at the toe of the slope.

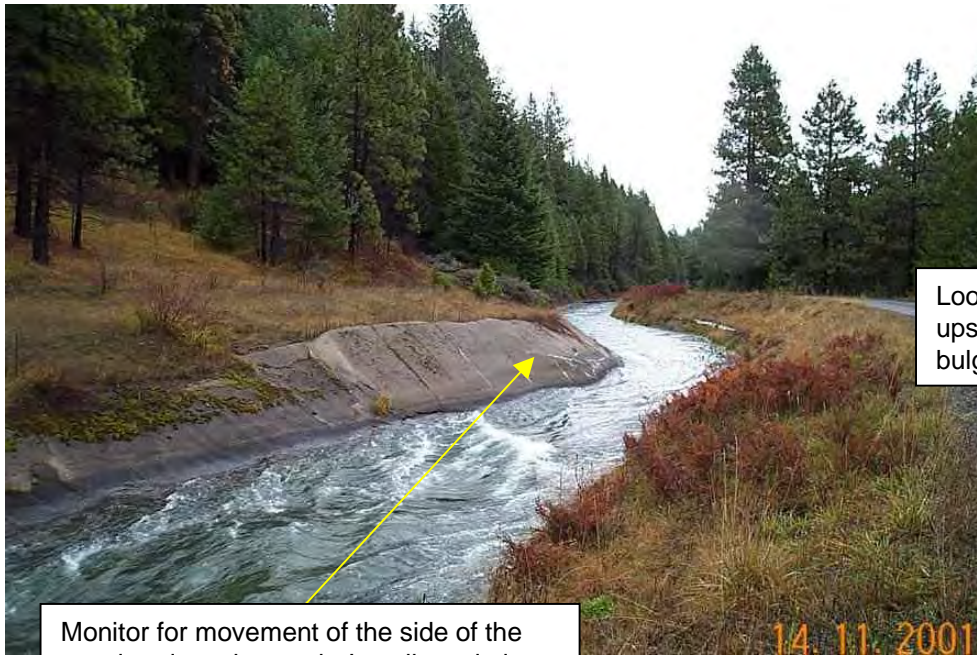
LM2-6 Site Photos

Looking
upstream at
bulge area.

Monitor for movement of the side of the canal and crack growth. Install steel pins to allow monitoring of crack growth.

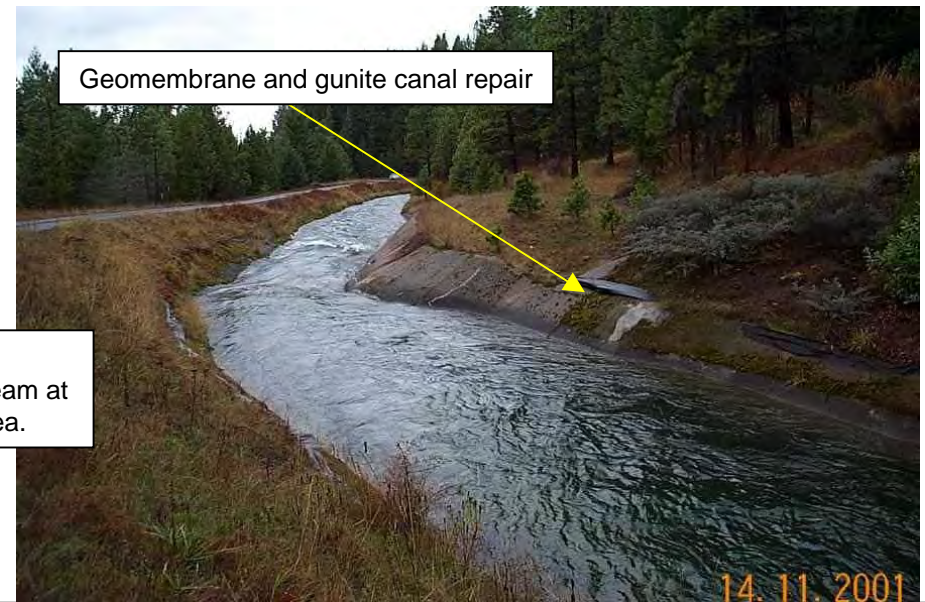
Geomembrane and gunite canal repair

Looking
downstream at
bulge area.

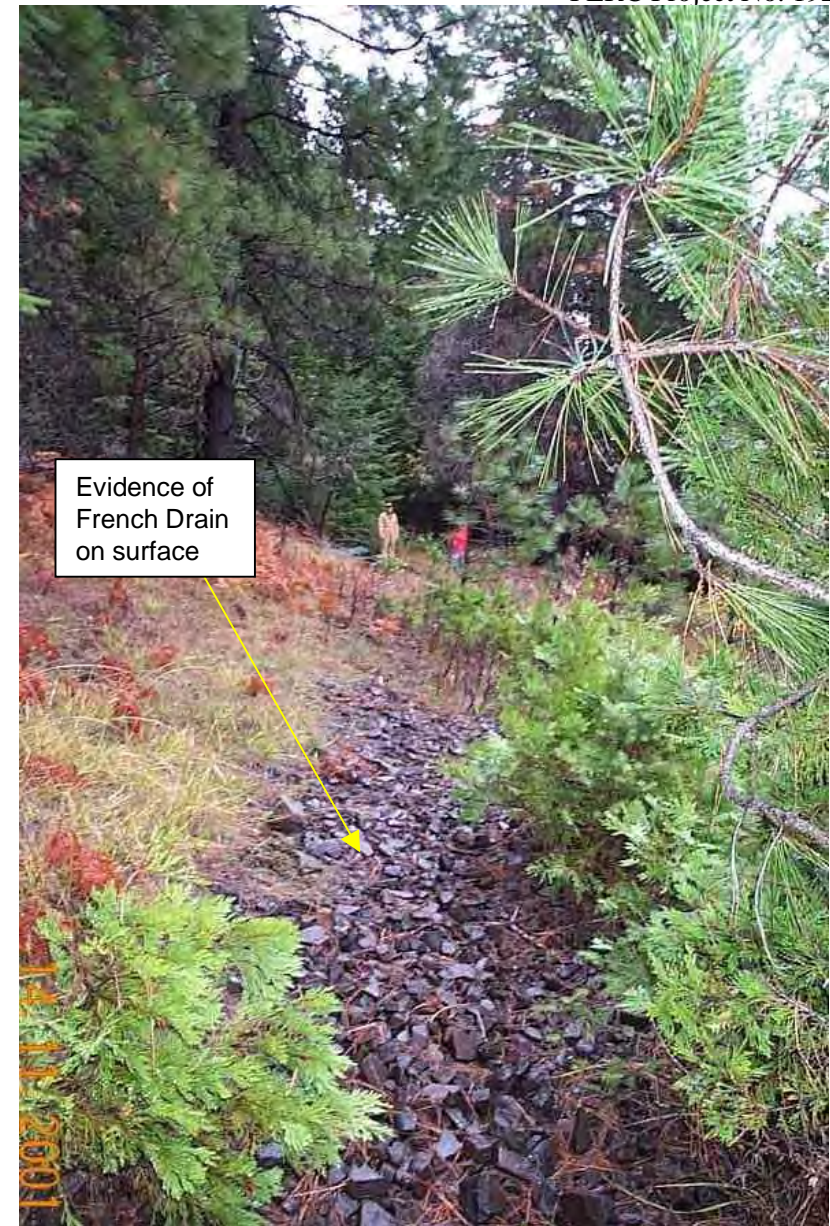
Squier Associates studied this site prior to installation of geomembrane and gunite canal repair in the fall of 1997. Reports were issued by Squier Associates in Aug and Nov of 1997 in which possible mitigation options were examined. The chosen options was to clean out the surface drainage system.

The picture shows surface evidence of French Drain that was reported in the Squiers Report to have been installed in the 1960s.

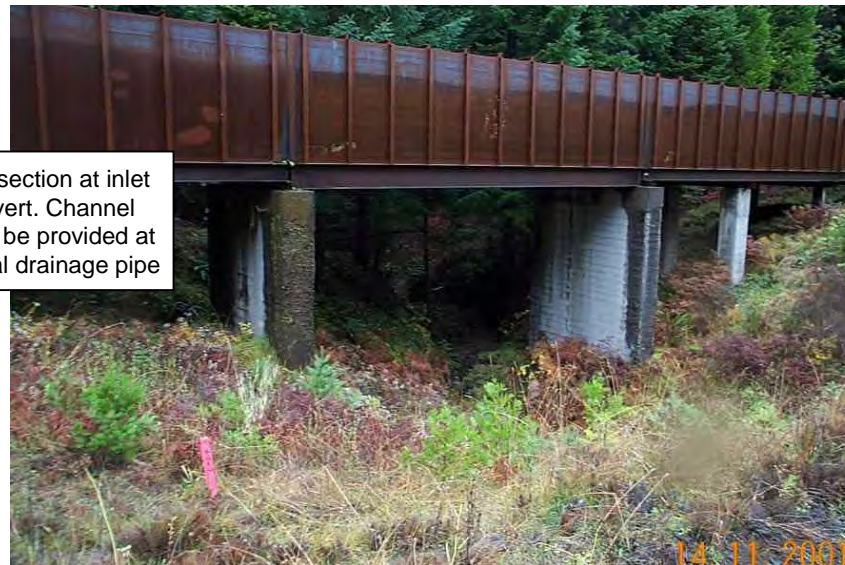
Steel flume section at inlet
side of culvert. Channel
protection to be provided at
outlet to canal drainage pipe

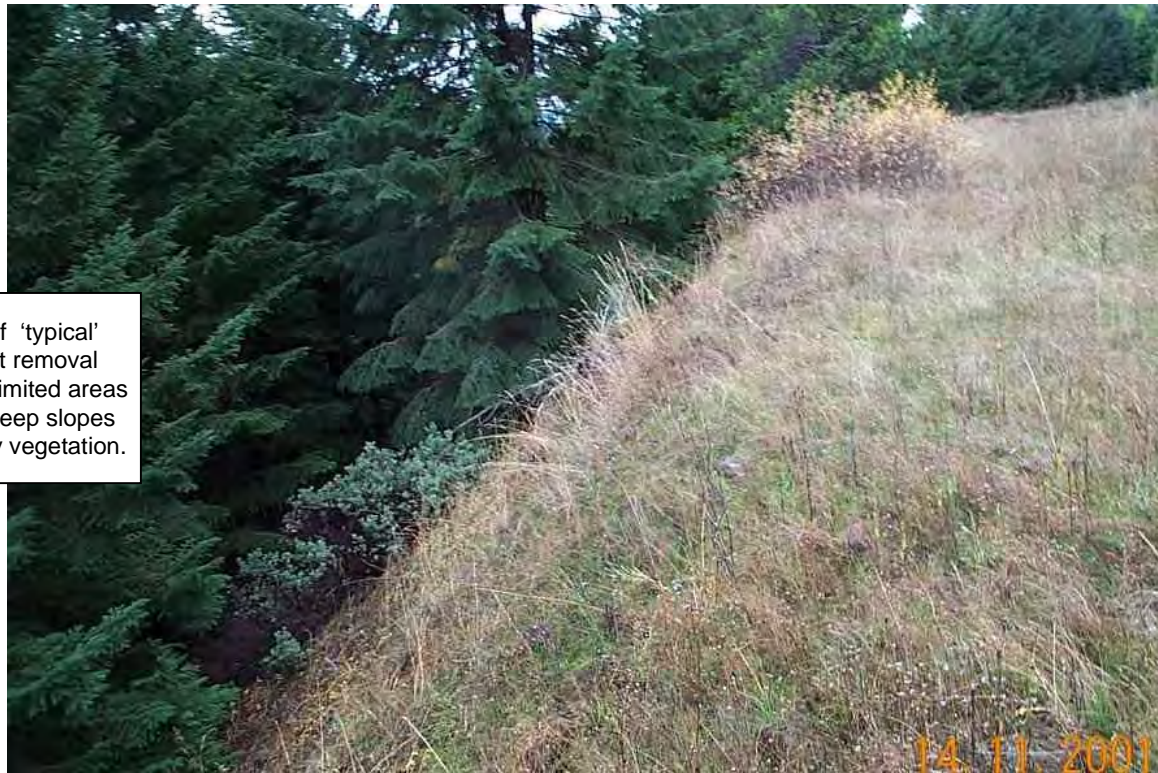
Photo of 'typical'
sidecast removal
section. Limited areas
of over steep slopes
with heavy vegetation.

Areas where ground is disturbed by construction will be protected with jute mats or other comparable erosion control measures until vegetation planting or other ground cover is provided in accordance with the VMP. Slope above canal has potential for some boulders to roll towards canal, however this is considered a low hazard. Mitigation to be provided through installation of 30-minute waterway drainage system.			
Sidecast Removal									
Excavation		2,500	CY						
Use as padding material (or stockpile)		2,250	CY						
Waste disposal		250	SF						
Gabion Wall 6'x110'									
Excavate for tie backs		200	CY						
Spread compact backfill		150	CY						
Use as padding material (or stockpile)		50	CY						
Place wire mesh tie-backs		990	SF						
Place gabion baskets 6' high		110	LF						
Stone fill in baskets		70	CY						
Slope Revegetation									
Jute Matting		21,000	SF						
Revegetation		21,000	SF

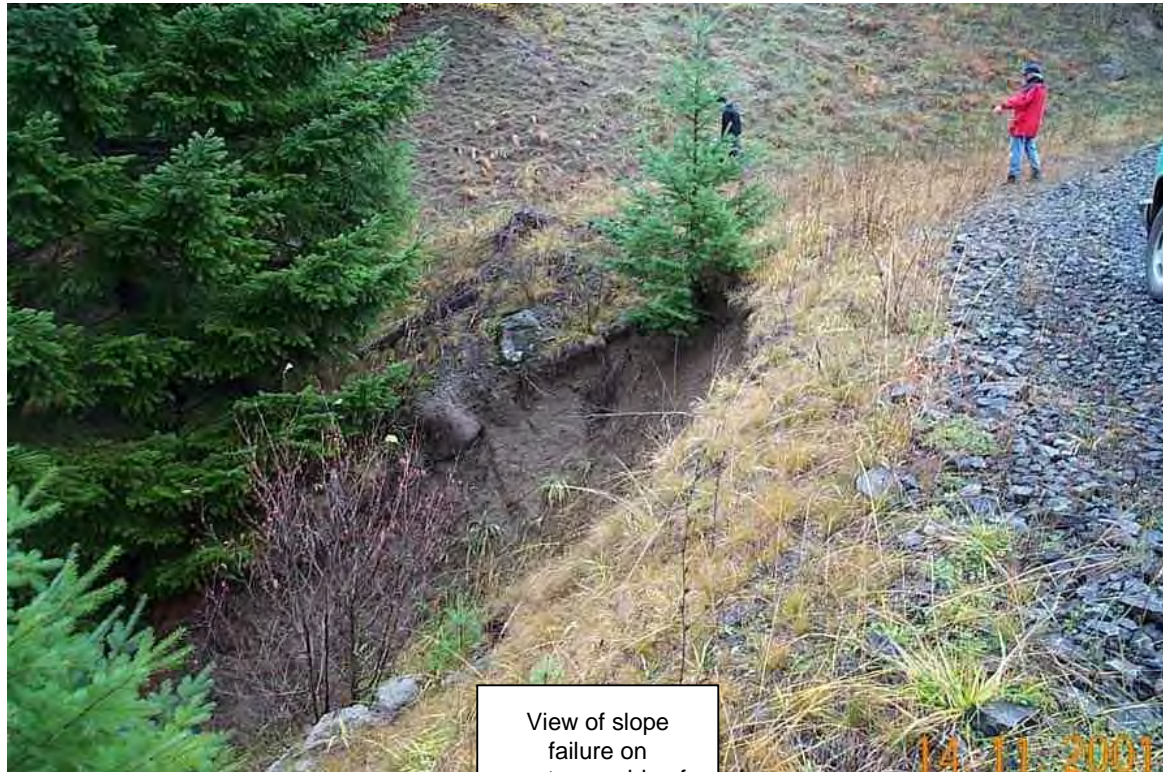
View of slope
failure on
upstream side of
culvert
embankment.

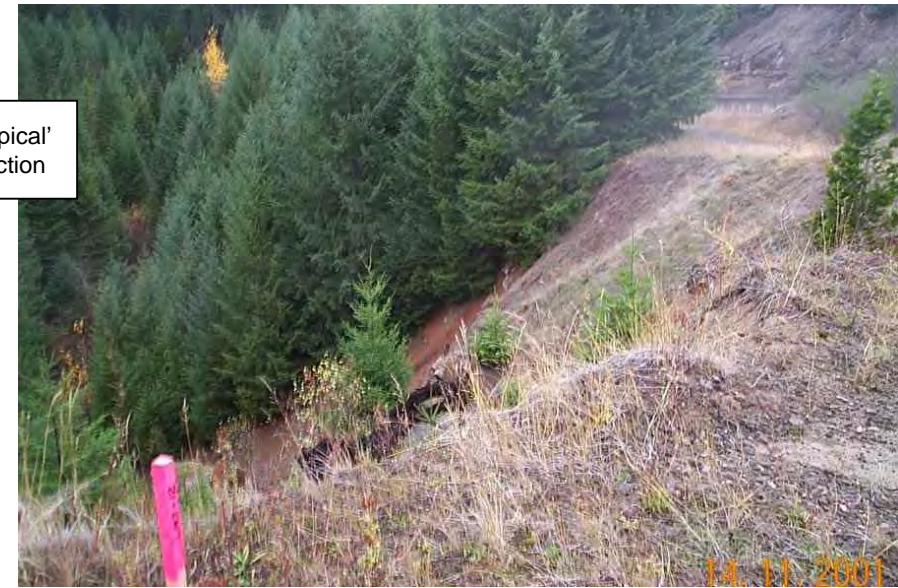
Views of 'typical'
sidecast section

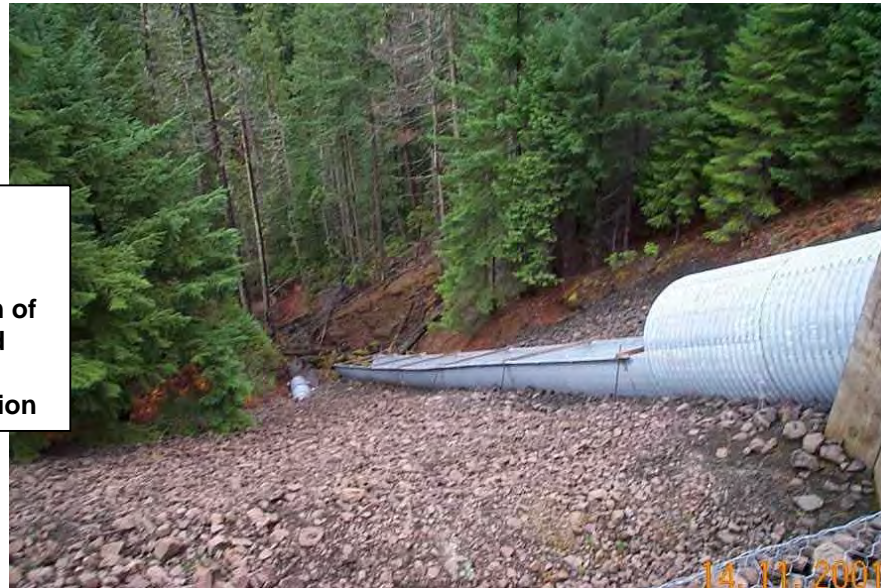
No remediation planned -
developing access to bottom of
spillway drainage pipe would
cause significantly more
damage than existing condition

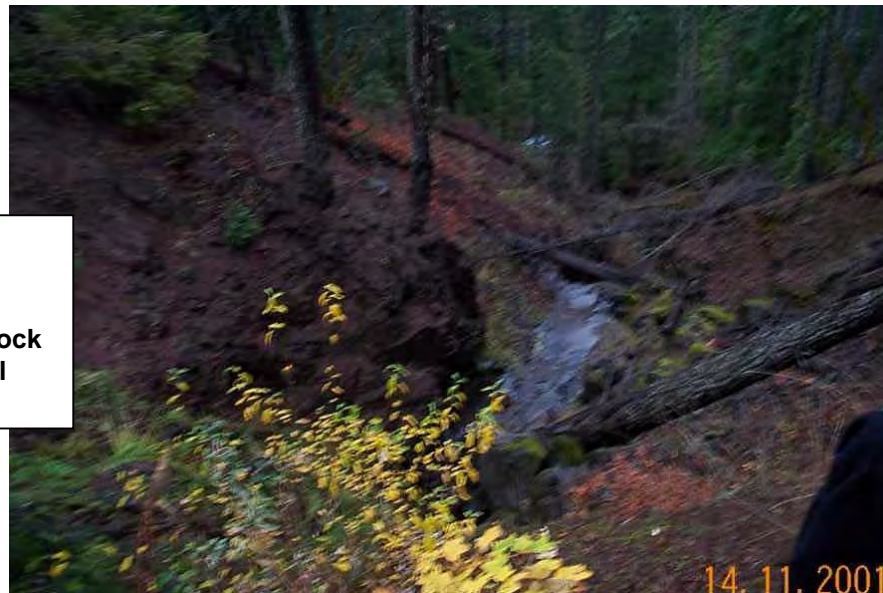
**View of Sag Pipe Spillway
discharge.**

The pipe discharge is into a rock
channel below – no additional
erosion likely.

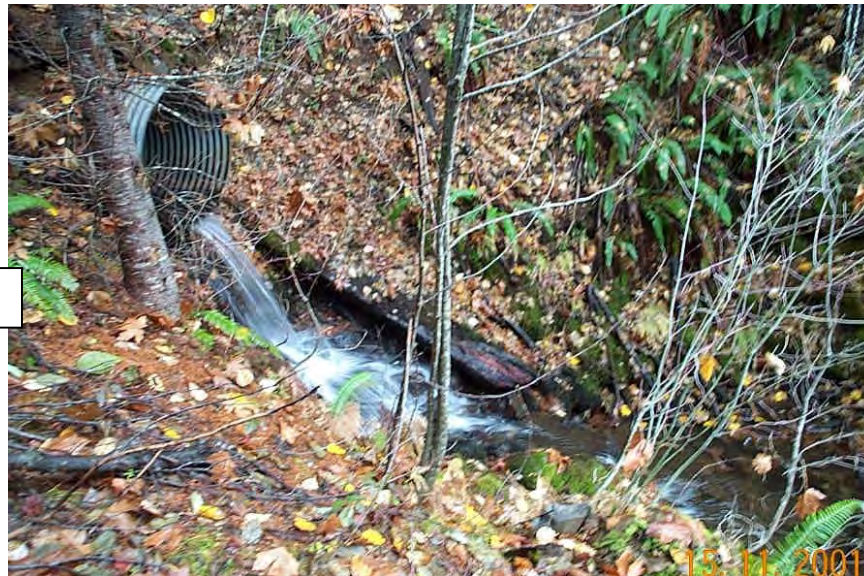
View of
Culvert Outlet

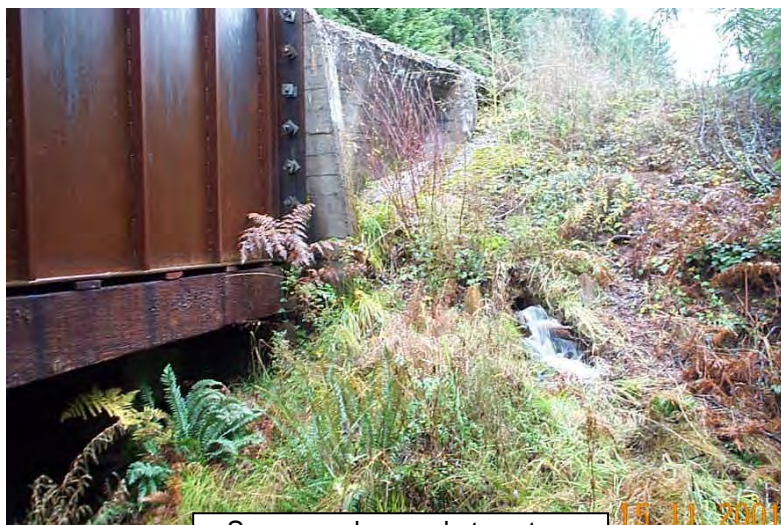
Seepage observed at eastern
(upstream) transition from steel
flume to concrete canal. Water to
be captured in a pipe and brought
down to the creek bed

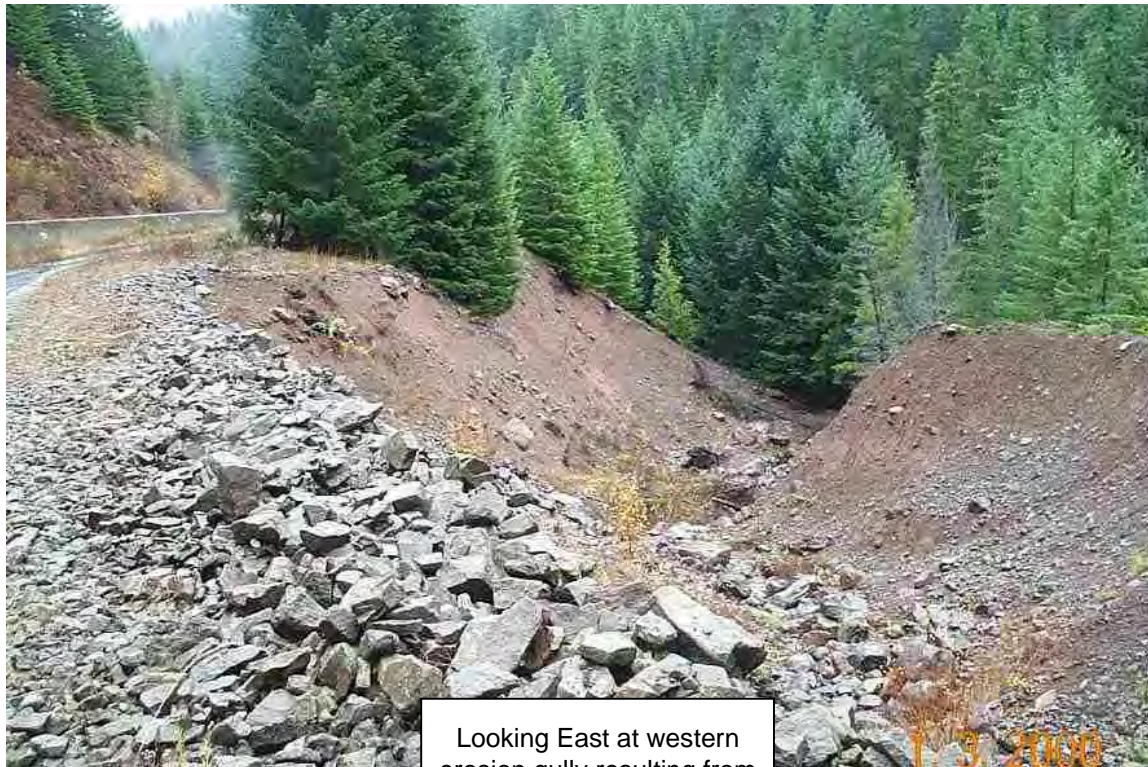
Looking East at western
erosion gully resulting from
failure of Flume 2.

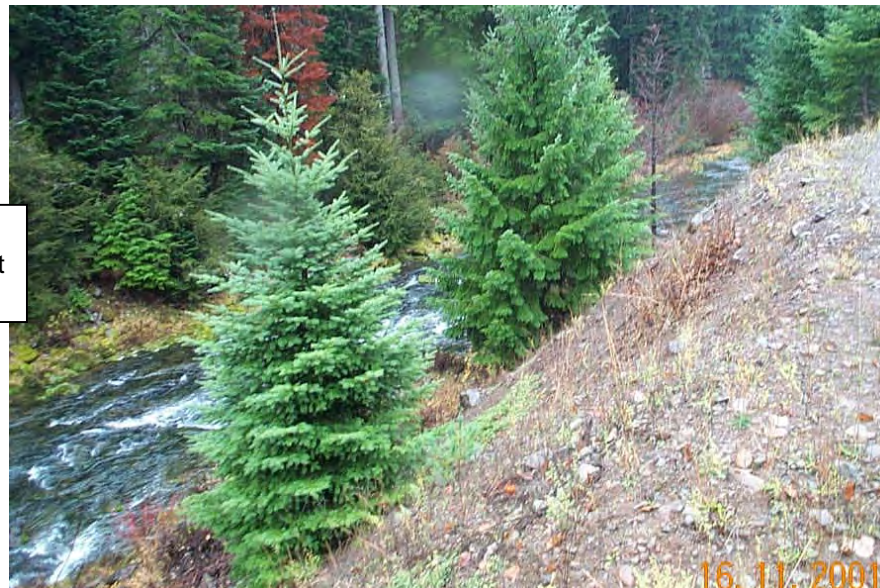
View of over
steep sidecast
below road

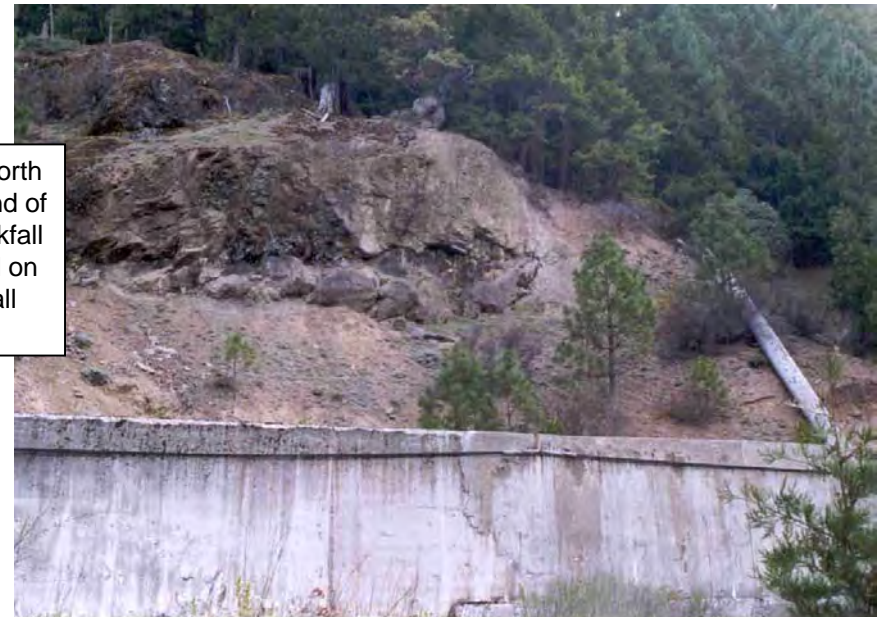
Representative view north across canal at east end of site, in area where rockfall padding will be placed on upslope side of 2-wall concrete flume.

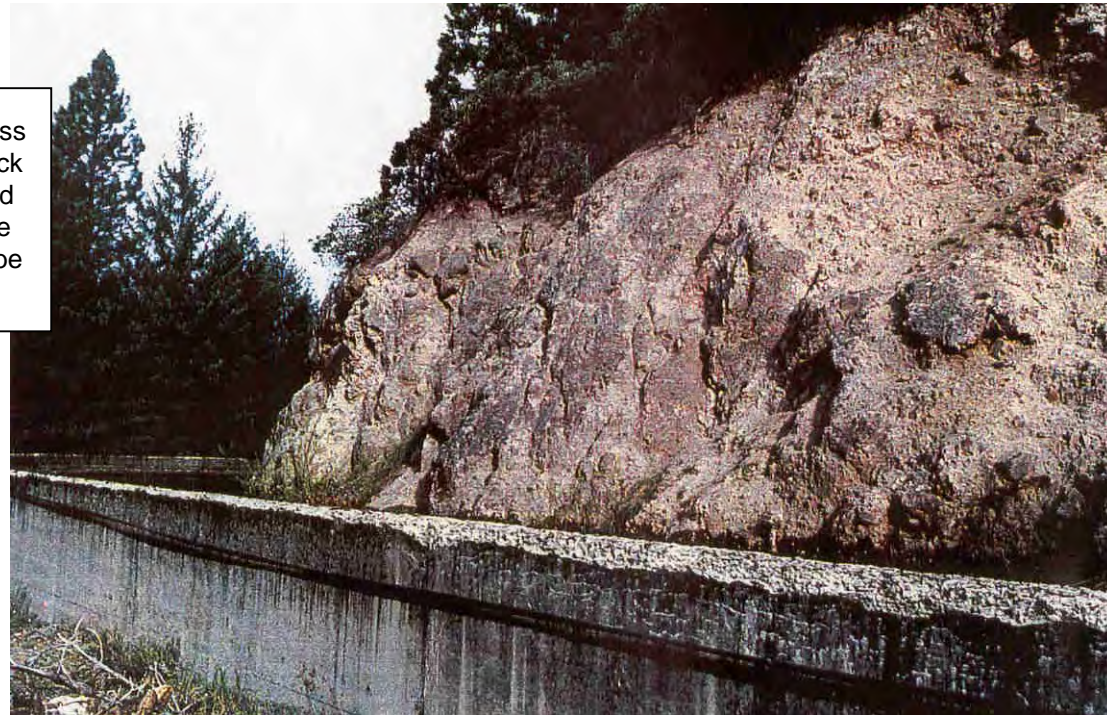
Representative view north across canal showing concrete and rock flume. Mitigation to be provided through installation of drainage system that will allow canal to be drained within 30 minutes.

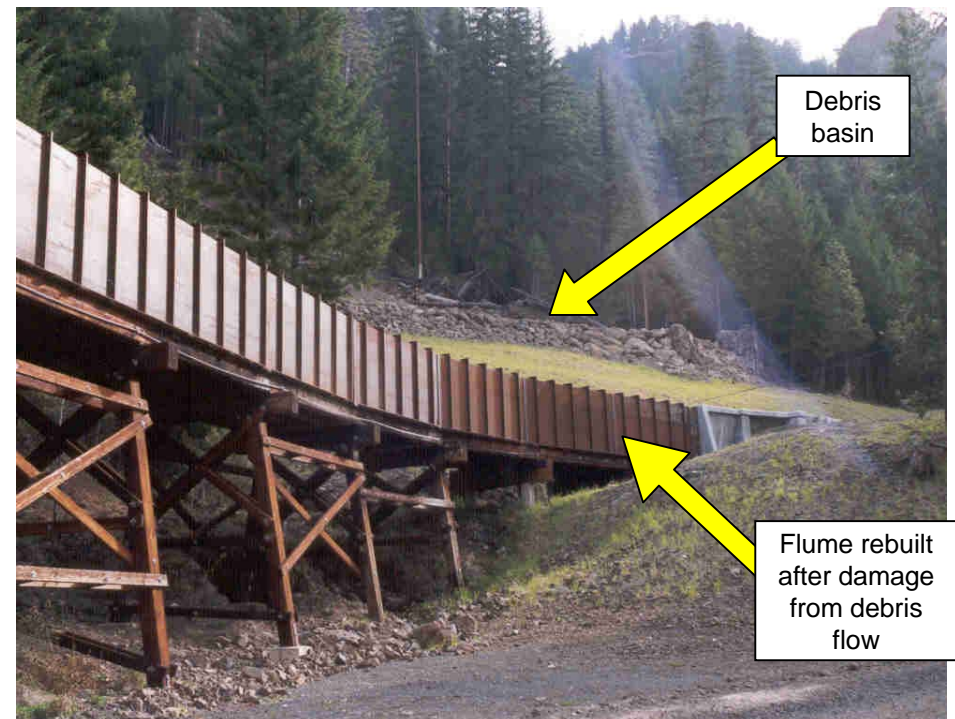
Debris catch basin at base of slope.

Flume rebuilt after damage from debris flow

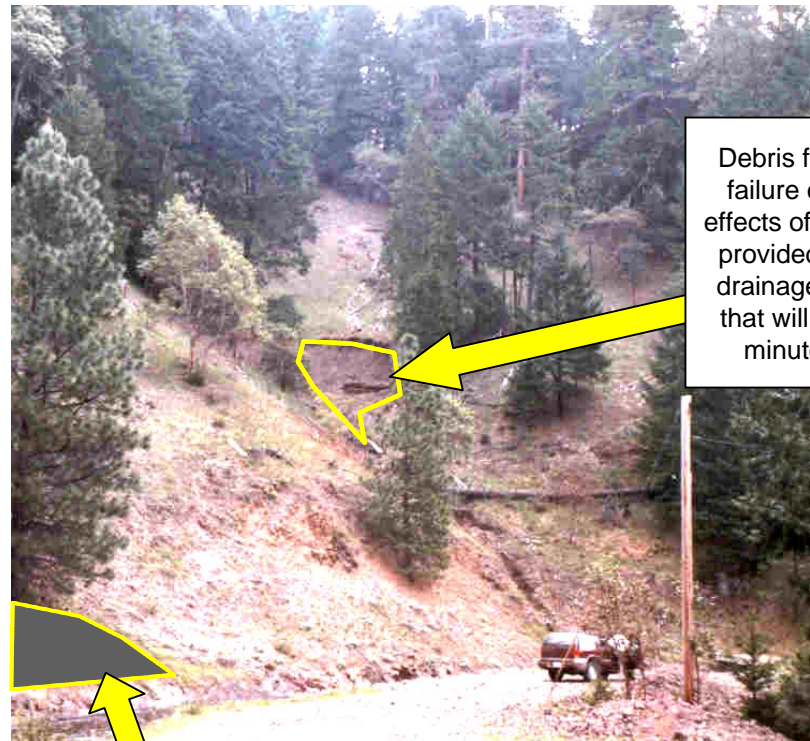
Debris flow source area and channel above canal.

Debris flow source area for 1997 failure event. Mitigation against effects of future slope failures to be provided through installation of a drainage system along waterway that will allow drainage within 30 minutes of any flume failure.

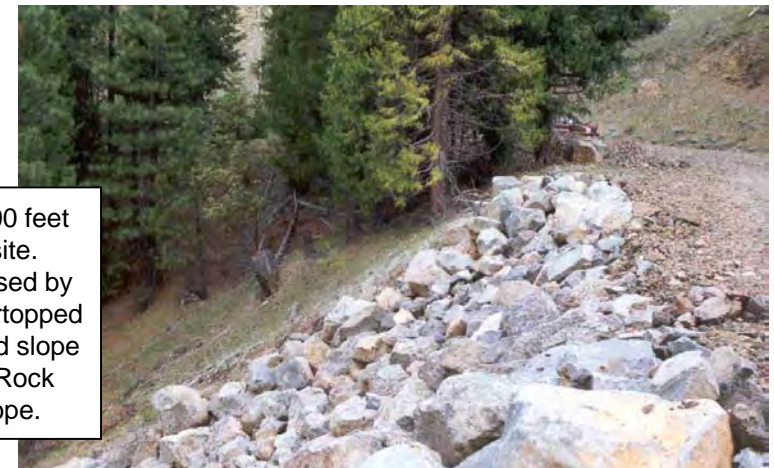
Area approximately 100 feet east of debris flow site. Waterway backup caused by debris flow deposit overtopped canal banks and eroded slope below access road. Rock placed to restore slope.

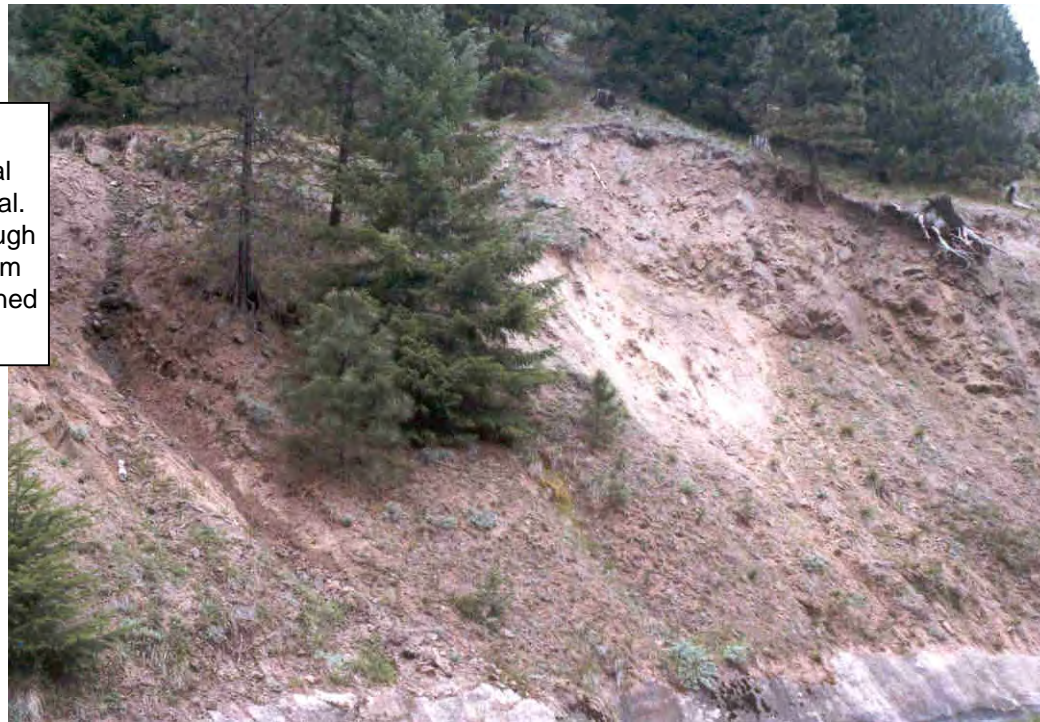
Representative view north
across canal showing typical
slope above gunite-lined canal.
Mitigation to be provided through
installation of drainage system
that will allow canal to be drained
within 30 minutes.

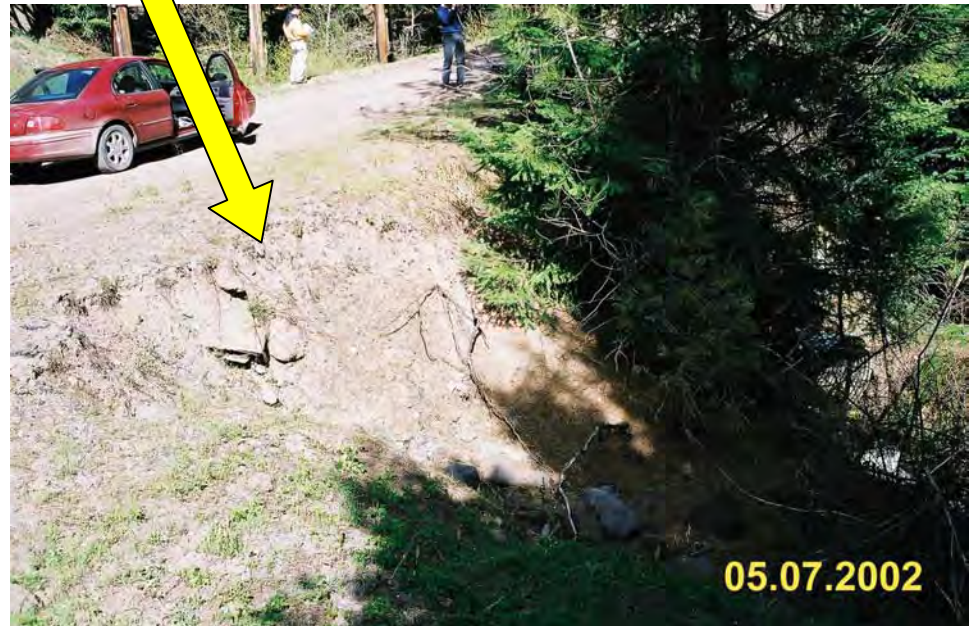
Slope failure on downslope side of access road embankment caused by drainage across road surface from upslope ditch. Embankment and culvert to be replaced.

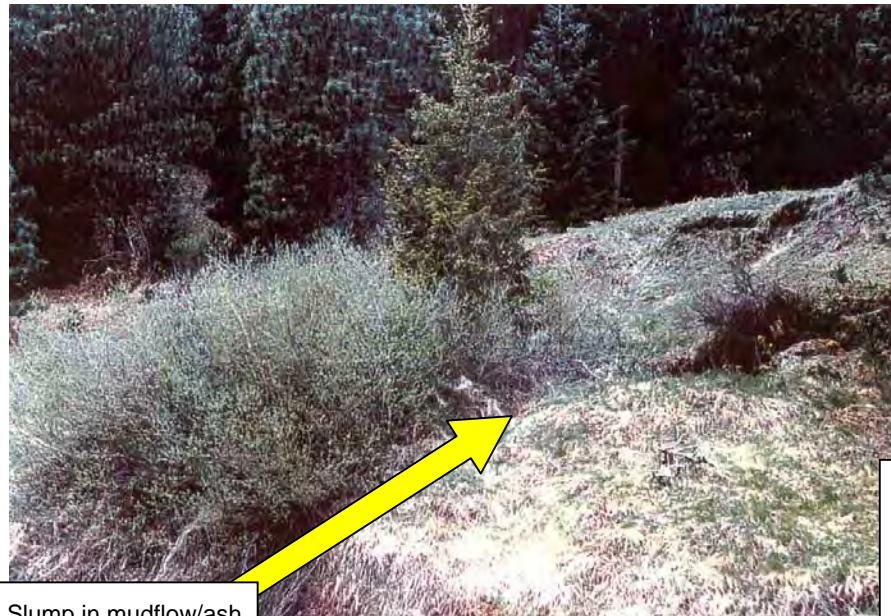
Slump in mudflow/ash
deposit on slope
above canal

Install horizontal drains to stabilize slope in area showing signs of creep deformation. Provide additional mitigation against effects of any future slope failures through installation of drainage system along waterway which will allow canal drainage within 30 minutes of any flume failure. Nearest drainage pipe will be approximately 100 ft upstream of site where horizontal drains to be installed.

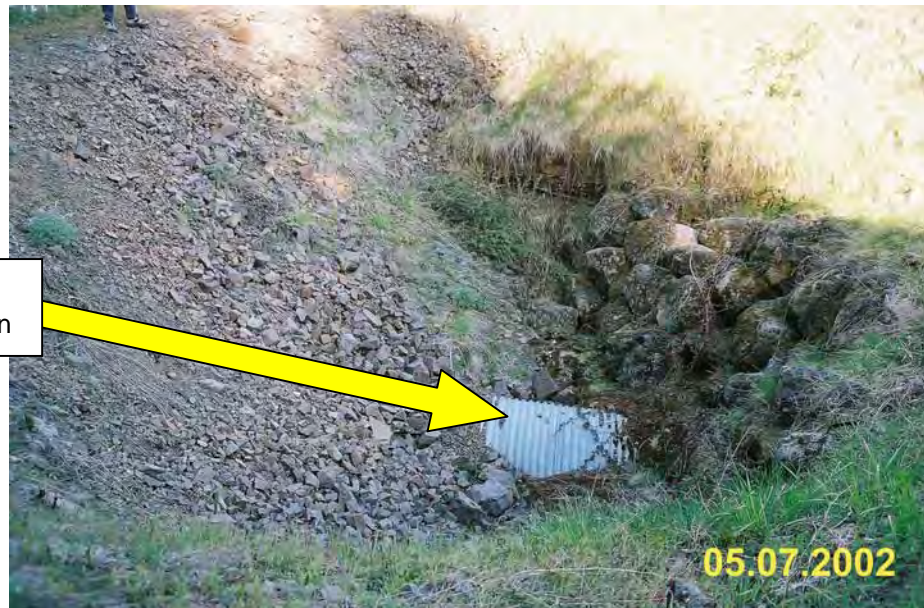
Exposed Culvert at
bottom of depression

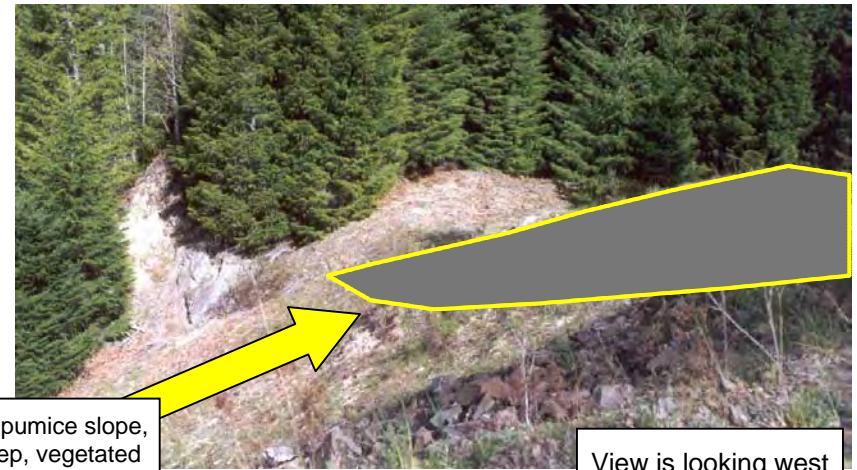
View is looking south
at southern side of
failure area

Failed area in pumice slope,
up to 30 ft deep, vegetated
along sides, recontour sides
of failure area, place rock to
buttress slope

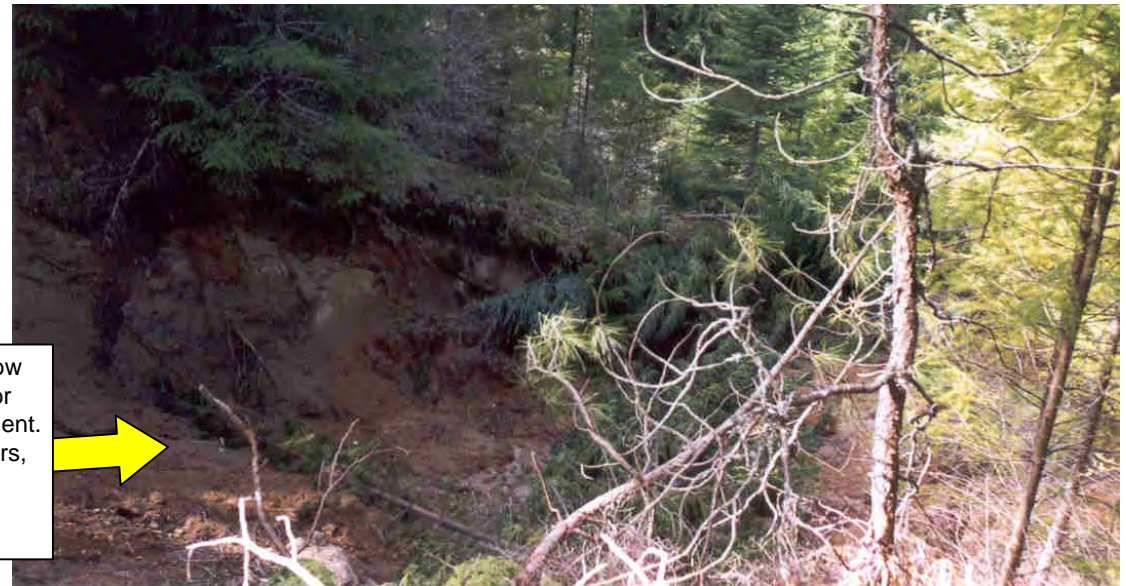
View looking west
across area underlain
by earthflow

Failed area in slope below
access road. Monitor for
signs of additional movement.
If movement/failure occurs,
develop access and
implement remedial
measures.

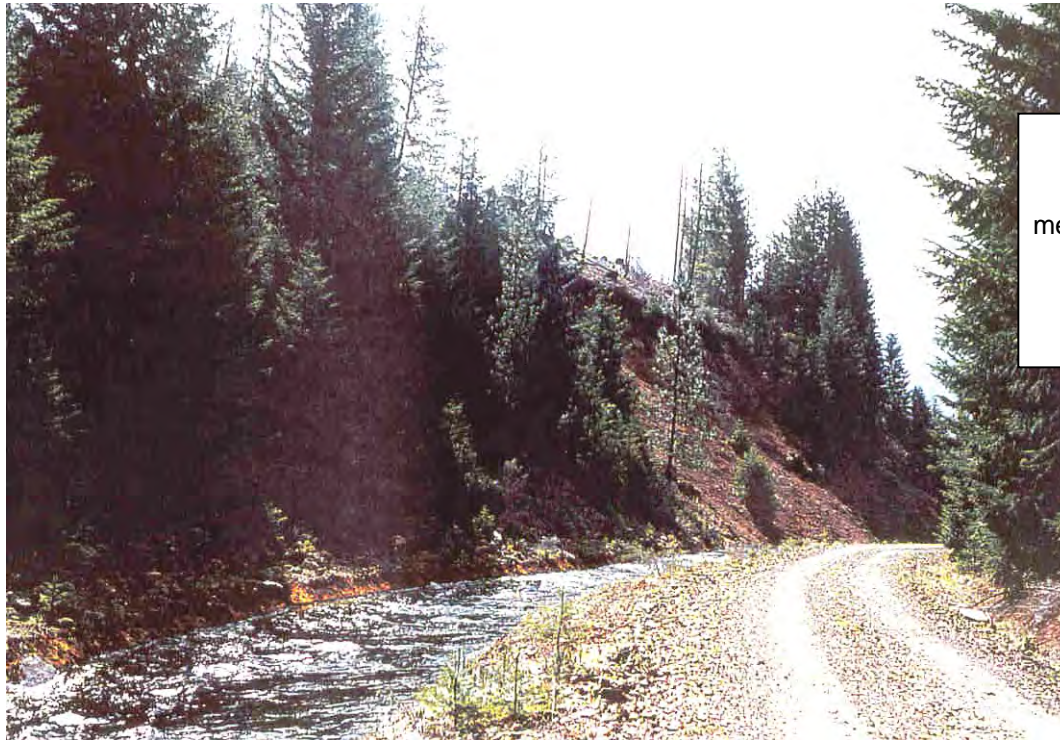
Photo looking east along typical gunite-lined canal. Mitigation measures to be installed on upslope side of canal to protect against rockfall hazard in two reaches totaling approximately 250 feet.

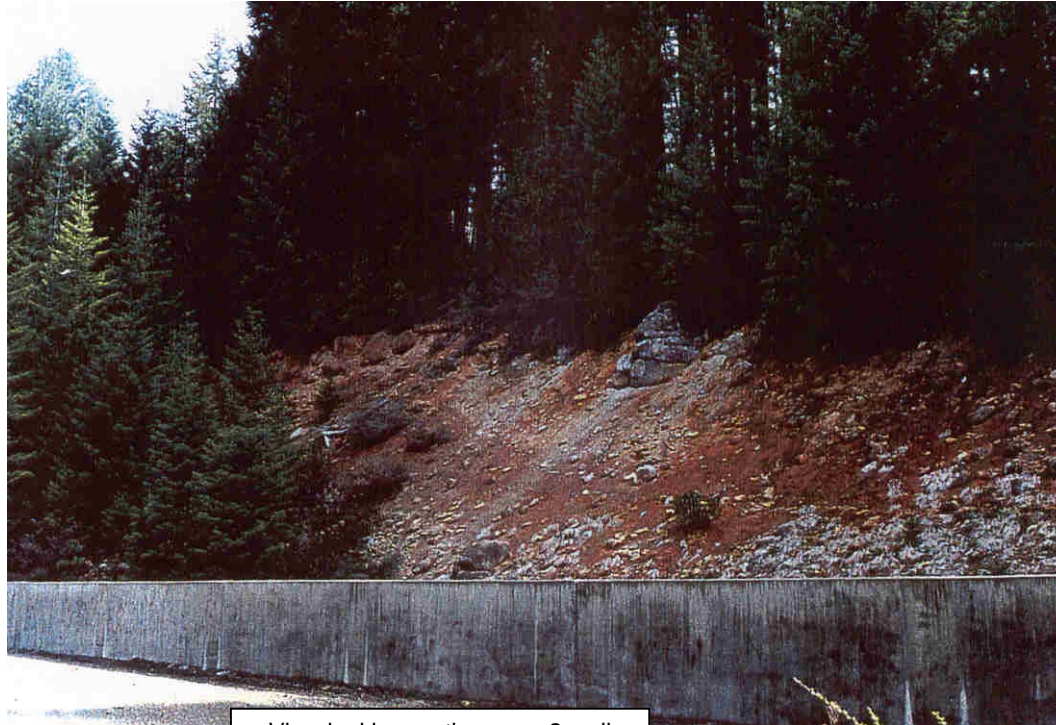
View looking north across 2-wall concrete flume showing typical upslope conditions. Place padding material on upslope side of concrete flume to provide rockfall protection, add slotted risers to existing drainage culverts to maintain drainage from behind flume
