Subject: Wallowa Falls Hydroelectric Project, FERC No. P-308 Forebay Flushing Report, September 2017

## Attachment 2: Wallowa Falls 2017 Forebay Flushing Photos

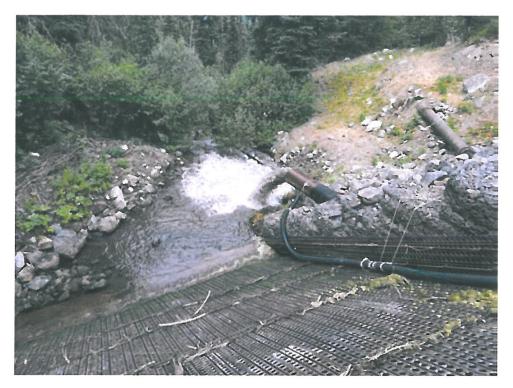
Photo 1- Dredge hose installed over spillway

July 24, 2017 – Upon delivery of equipment to the forebay, the work crew assembled a six inch dredge hose by connecting 100 foot long sections into a continuous 200 foot long hose that was installed over the dam spillway crest. The assembled dredge hose was secured in multiple places using rope. Approximately 40 feet of the hose was installed upstream of the spillway and the remaining 160 feet was installed over the spillway and continued down the spillway into the bypassed reach of the East Fork Wallowa River (Attachment 2 – Photos 1 and 2).

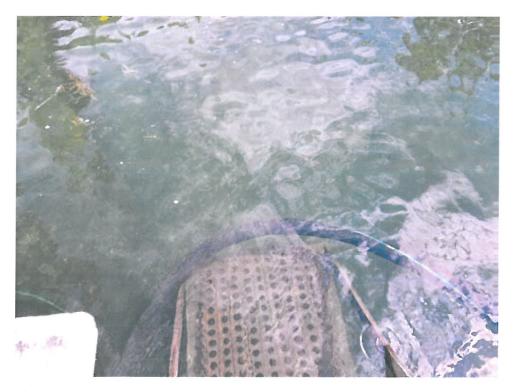
Photo 2 – Dredge hose upstream of penstock intake

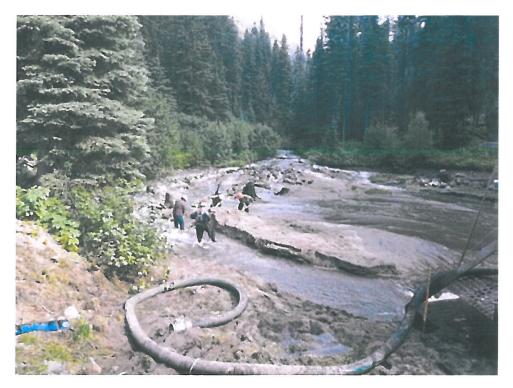
Photo 3-Crew working to direct stream flow for sediment transport

July 25, 2017 – Dive crew made a short dive and performed more suction dredging. Diving and dredging work was temporarily suspended and the low level sluice gate was hoisted and opened to the full open position. Material was flushed out through the low level sluice outlet for the remainder of the eight hour shift. The crew worked continuously to move and reconfigure large rocks within the forebay to direct stream flow into different areas of the forebay to facilitate sediment cutting and transport through the low level sluice outlet (Attachment 2 – Photos 3 and 4).

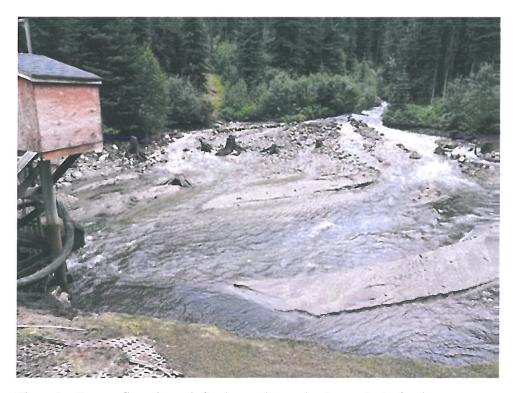
Photo 4 – Stream flow through forebay redirected using rocks in forebay

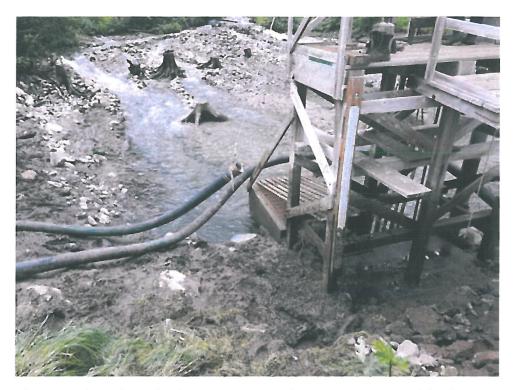
Photo 5 – Channels dredged out to increase sediment transport out of forebay

July 26, 2017 – Although some material was exiting the forebay through gravity flushing, heavy granitic sand continued to be deposited and build up immediately upstream of the low level sluice gate. The low level sluice gate was again closed and a dive crew again suction dredged the area upstream of the penstock intake and low level outlet. The dive crew also used the suction dredge to dredge out several small channels, approximately three feet wide by 10 feet long, upstream of the larger dredged area (Attachment 2 – Photo 5). Dive work was suspended and the low level sluice gate was again hoisted to the full-open position. The combination of the dredged channels through the forebay and the crew continuing to move the current in the forebay using hand placement of large rocks to channel flows, made this period of flushing much more effective.

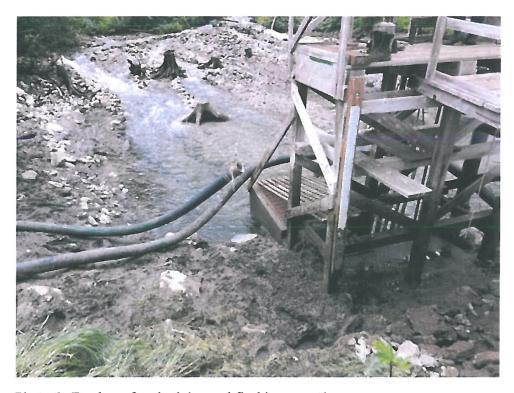
Photo 6 –Forebay after dredging and flushing operation

July 27, 2017 – July 28, 2017 - Continued same procedure of dive crew suction dredging out areas upstream of the intakes, and then opening the low level sluice gate periodically to concentrate material movement down towards that gate. This procedure proved to be the most effective way of moving the heavy granitic material downstream through the forebay and out the low level sluice outlet (Attachment 2 - Photos 6 and 7). All dredging work was completed July 28, 2017.

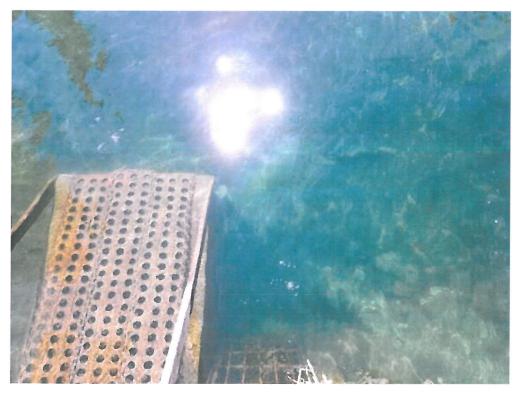
Photo 7 – Penstock intake and low level outlet trash rack after dredging and flushing operation
