# Lewis River Aquatic Fund Projects (SA 7.5.3.2)

## Project Closeout Report

**Project Title:** Lewis River Hydroelectric Project  
Muddy River 8322700 Tributary Road Decommission

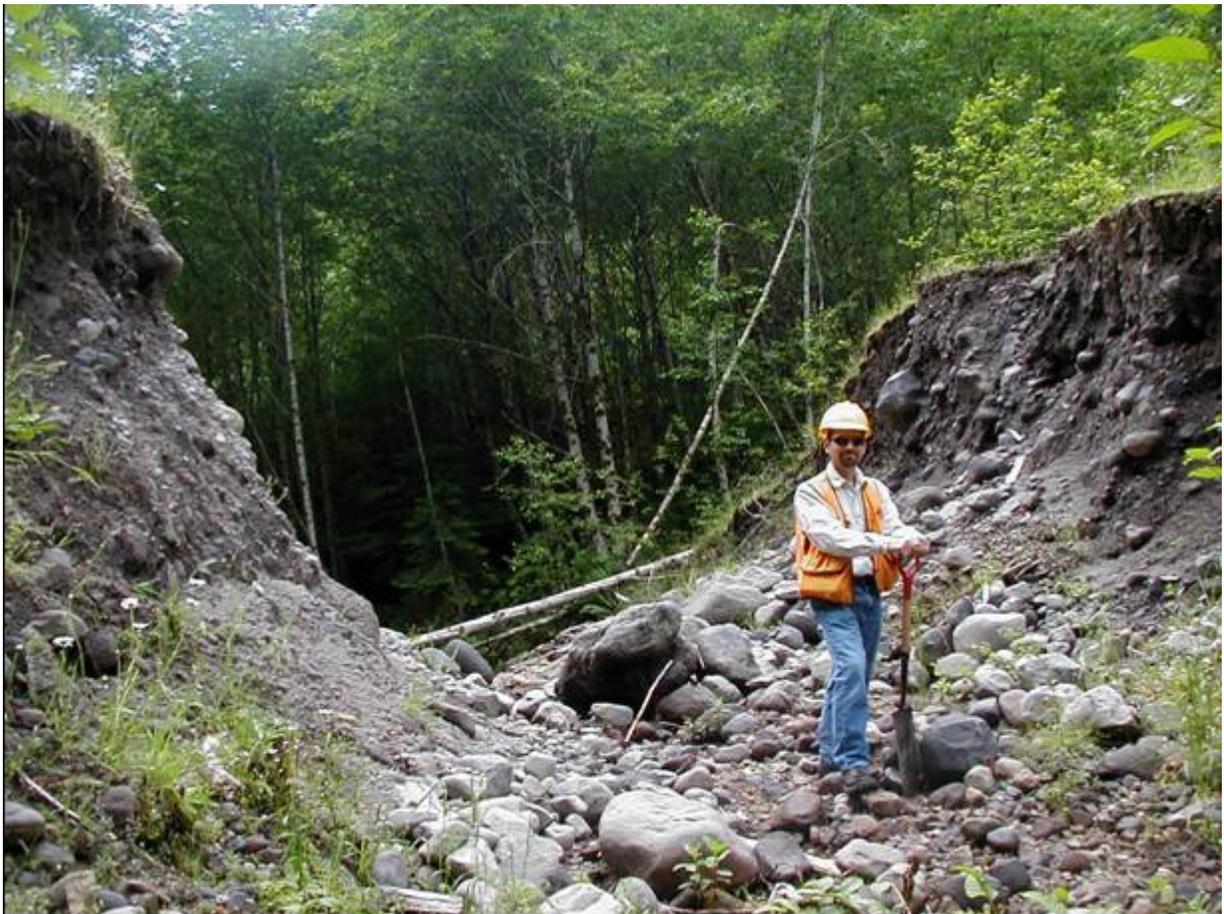
Pre project culvert failure photo.

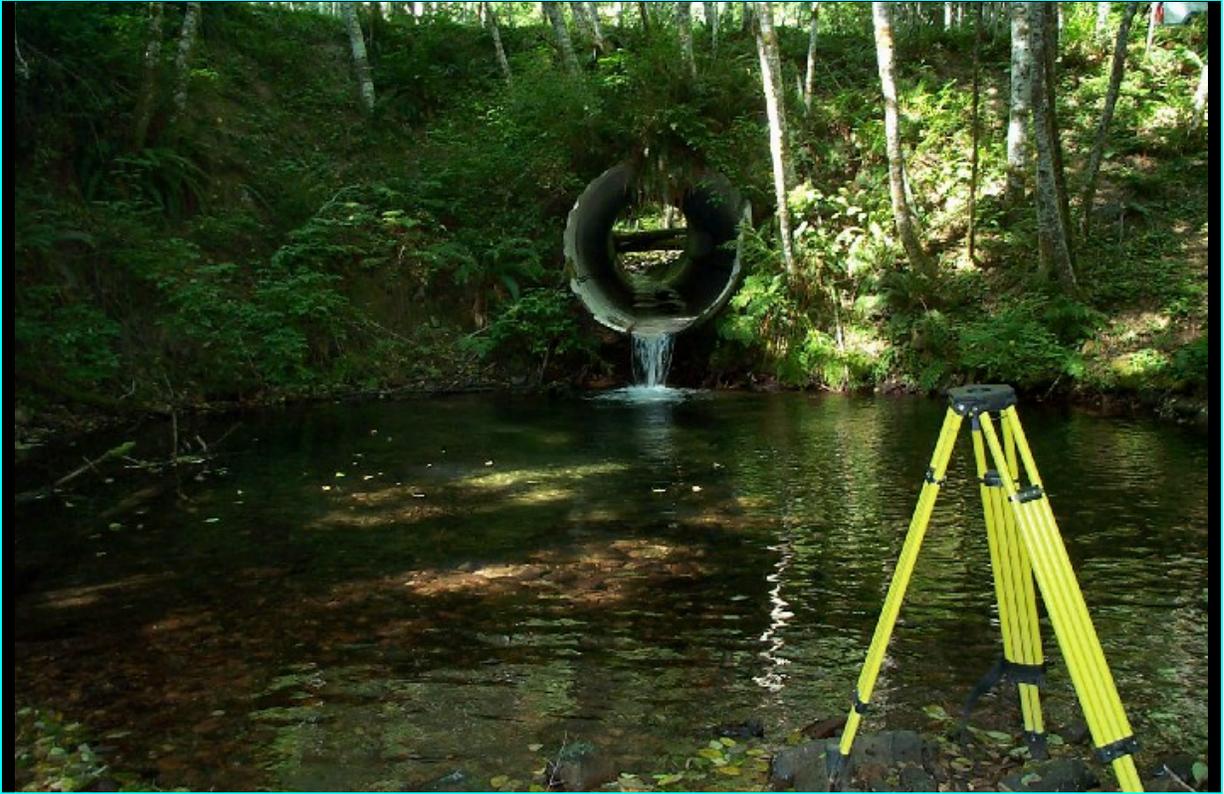
Figure 2. Outlet of Fish Bearing Culvert with 0.1 miles anadromous habitat above culvert.

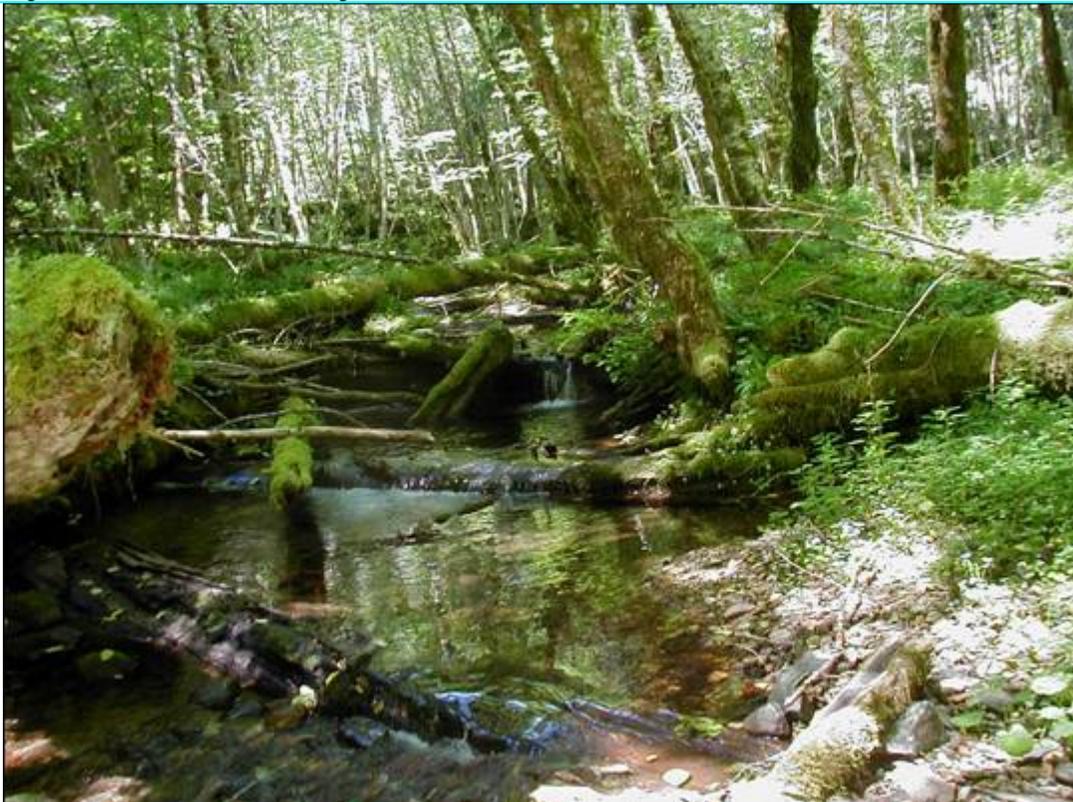
Figure 3. Anadromous and resident habitat downstream of fish bearing culvert at risk of sediment delivery if culvert fails.

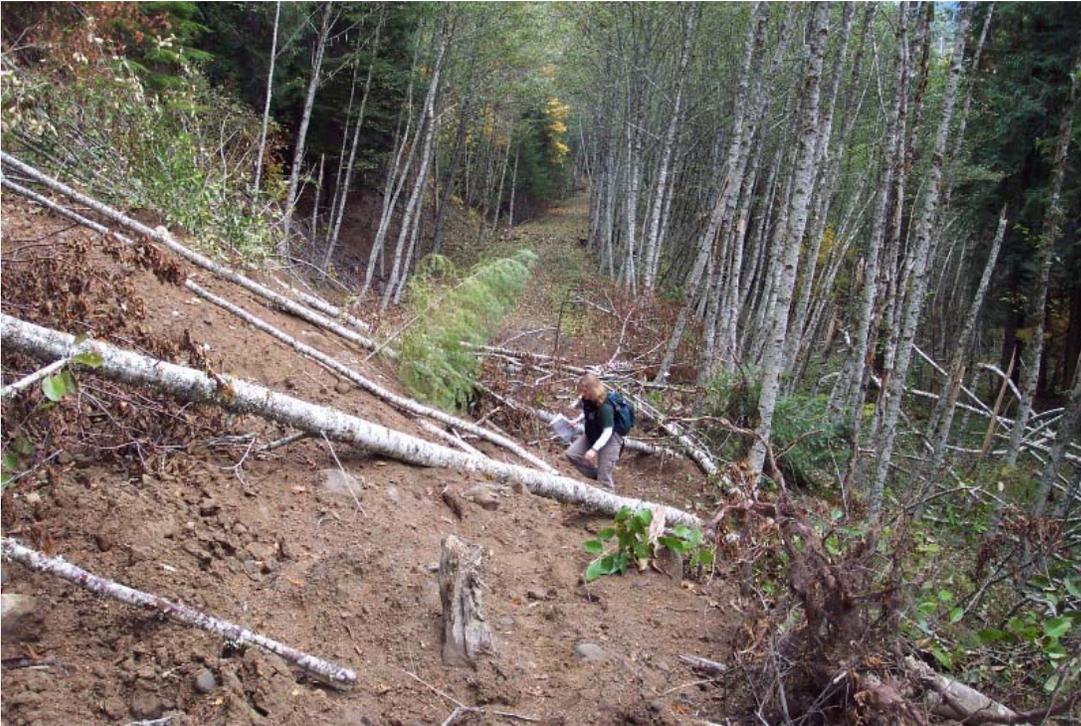
Figure 4. Spoil pile of dirt after project
