<b>Project Title</b>	Muddy River Side Channel Restoration
<b>Agency</b>	US Forest Service Gifford Pinchot National Forest Mount St. Helens Ranger District
<b>Project Manager</b>	Adam Haspiel (360) 449-7833 <a href="mailto:ahaspiel@fs.fed.us">ahaspiel@fs.fed.us</a>
<b>Project Approved By</b>	Aquatic Coordination Committee
<b>Project Funding</b>	ACC Funding      \$39,000 USFS Funding      \$32,000 Partner Funding    \$ 2,000 <b>Project Total      \$73,000</b>
<b>Project Description (work completed)</b>	<p>In 2012 the Gifford Pinchot National Forest used funds from PacifiCorp and Cowlitz PUD to furnish equipment, operators, and labor for construction of a habitat restoration project on two side channels associated with tributaries on the Muddy River. Restoration work occurred wholly on US Forest Service lands. Work included placing approximately 200 logs, most with rootwads attached, to create 34 complex structures to restore fish habitat. The structures were designed to alter stream flows and modify stream morphology, including pool depth, overhanging banks, and by slowing water to drop and capture mobile sediment.</p> <p>The project objectives were to:</p> <ul style="list-style-type

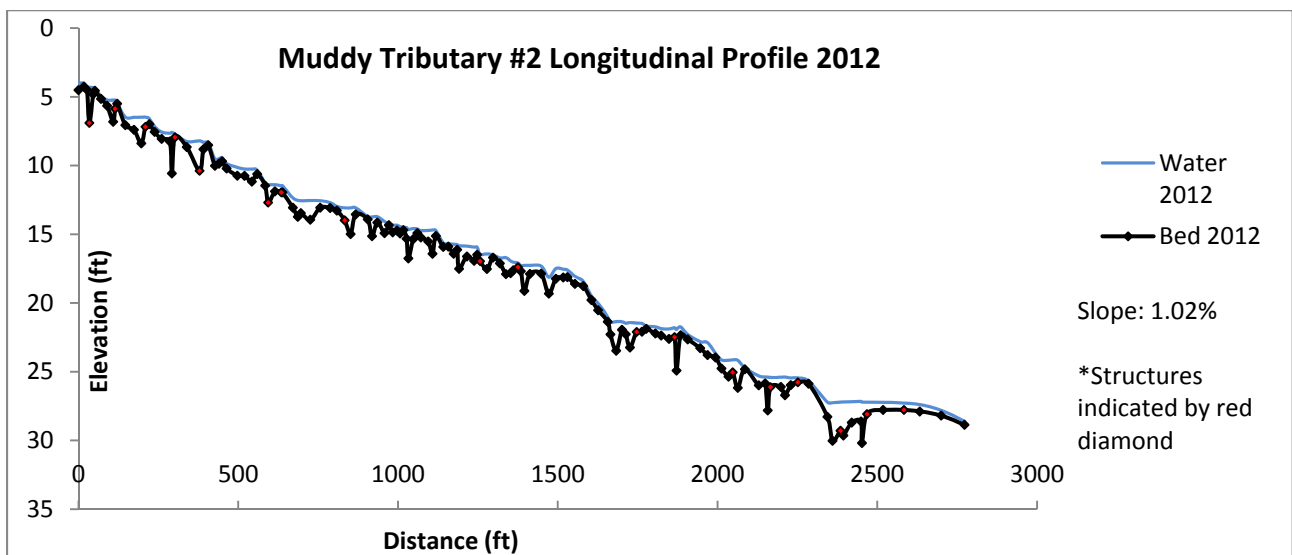
Figure 2: 2012 Muddy Tributary #2 Longitudinal Profile. 15 pools are associated with installed structures. Slow and fast water count ratio is 1:1 (or 28:28 units) and slow and fast water length is 1189.5 ft. to 1583.5 ft.

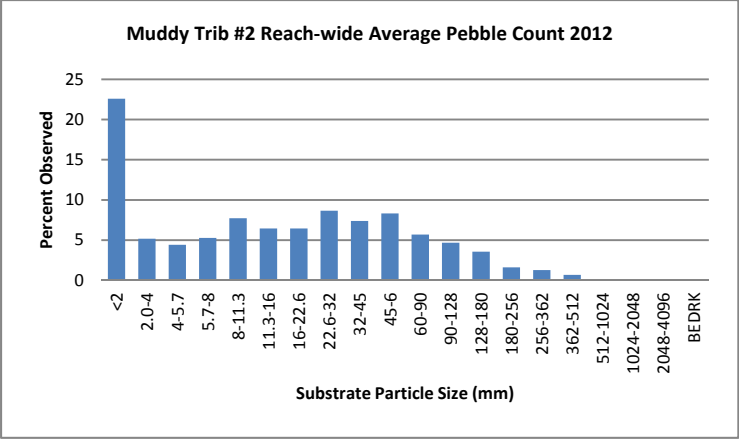
Figure 3: Reach-wide Pebble Count Averaged; note the high % of fines (<2mm); these may be a result of earth moving required in structure installation.

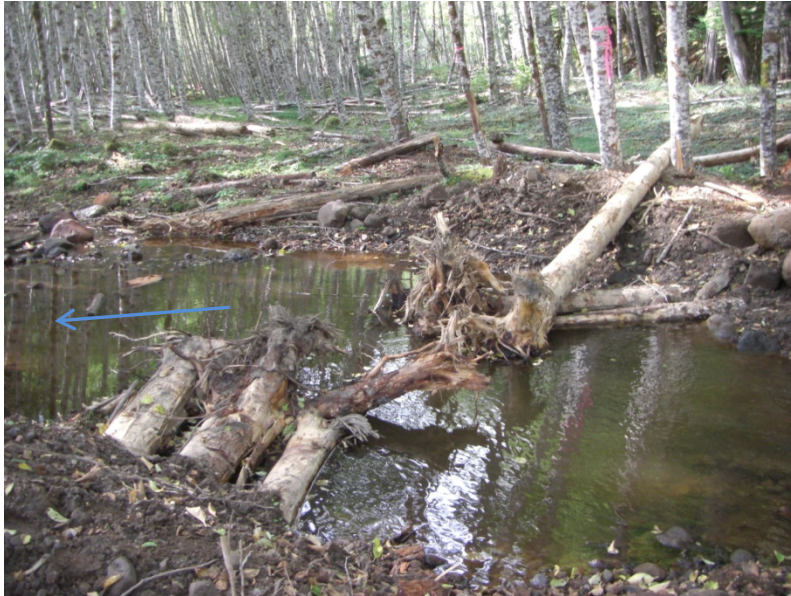
STRUCTURE 1

Figure 4: ST 1, standing on LB, note cross section is upstream from structure

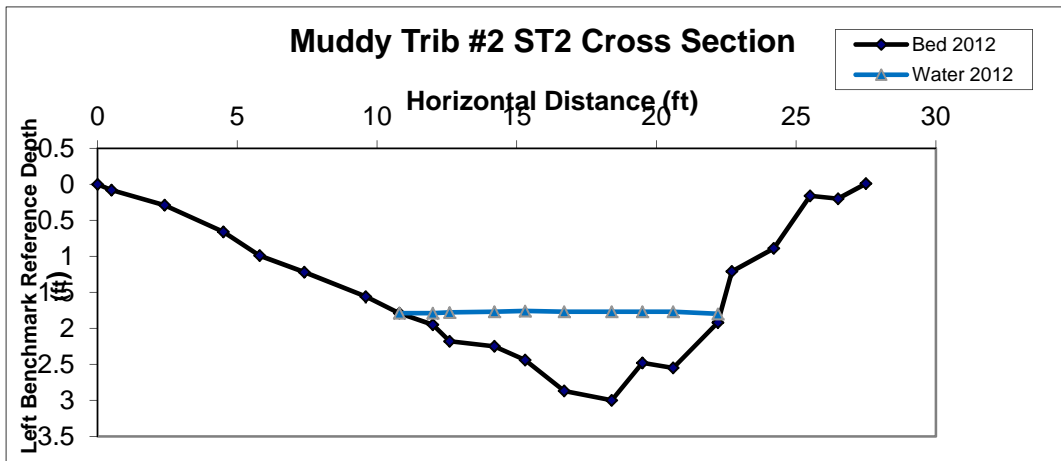
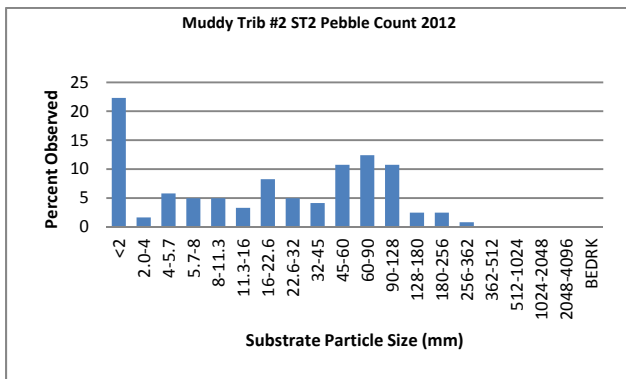
Figure 7: Structure 2 X-section. Note the high number of fines in the pebble count graph below.

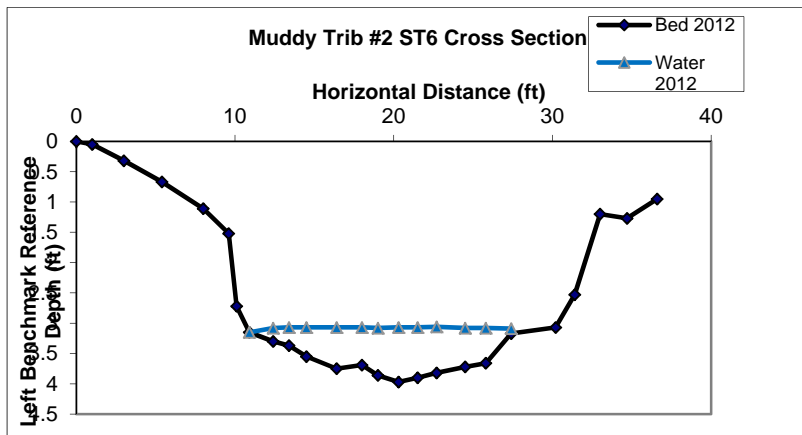
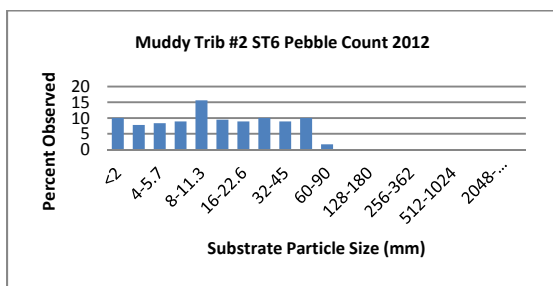
Figure 15: ST 6, cross-section upstream from structure

Note: equal fines, gravels and small cobbles

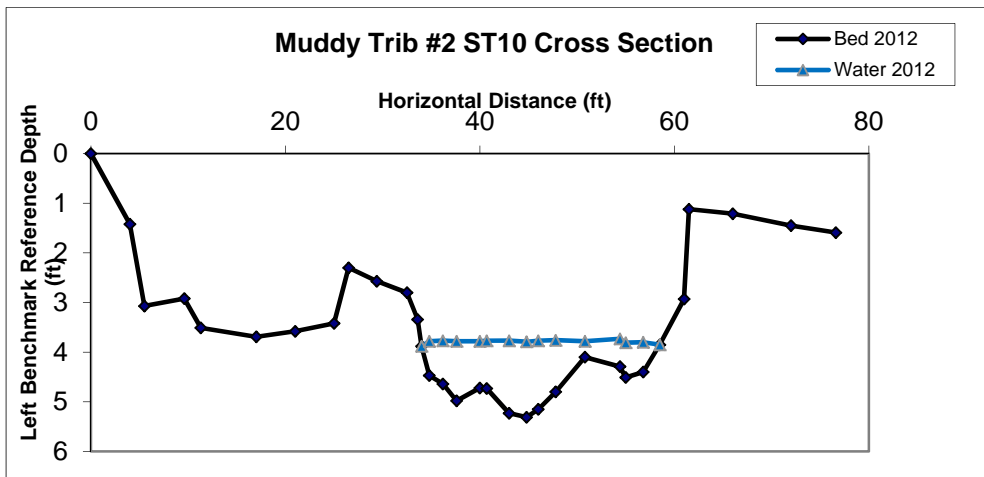
Figure 21: ST 10, the depression between 10 and 30 ft. corresponds to the fill in the center right of the photo above

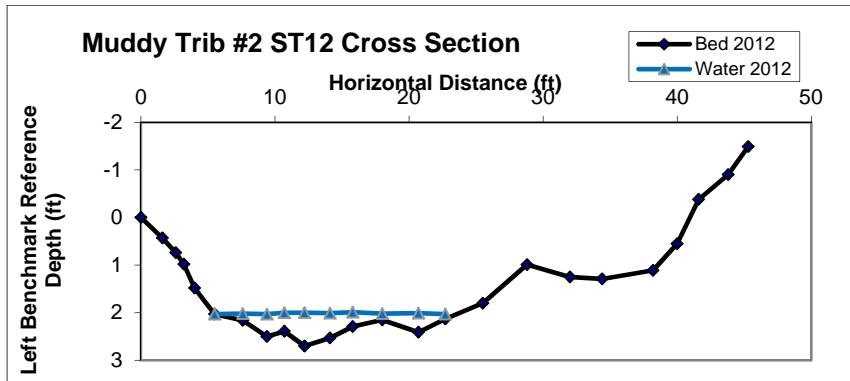
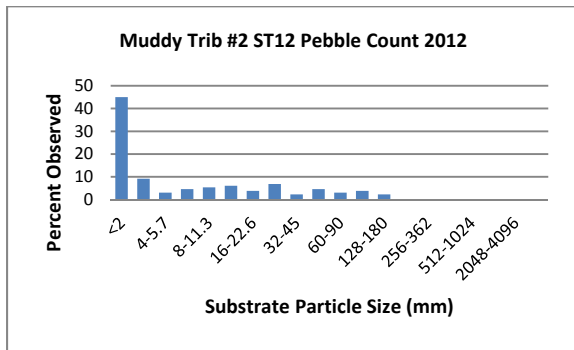
Figure 25: ST 12 Cross section from LB to RB

Note: high percentage of fines

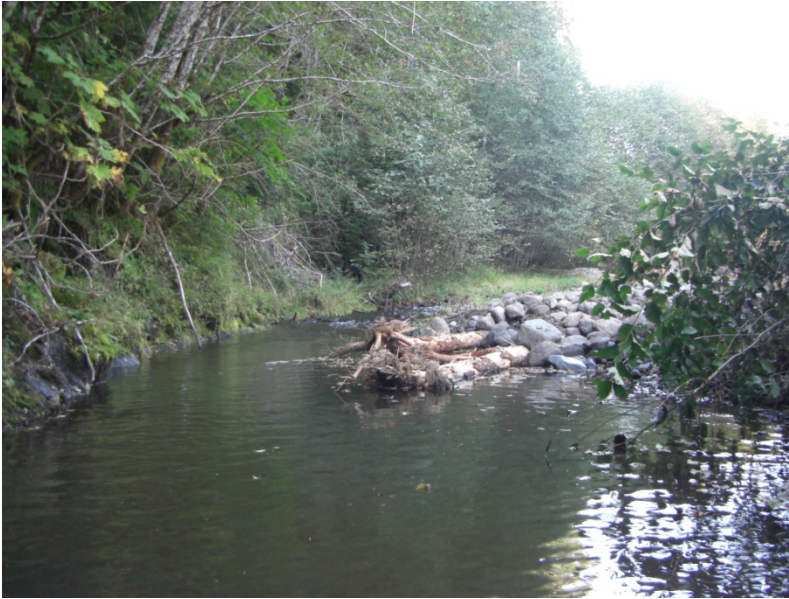
\*No cross-section or pebble count due to RB cliff, LB instability and pool depth

Figure 33: ST 17 below ST looking upstream

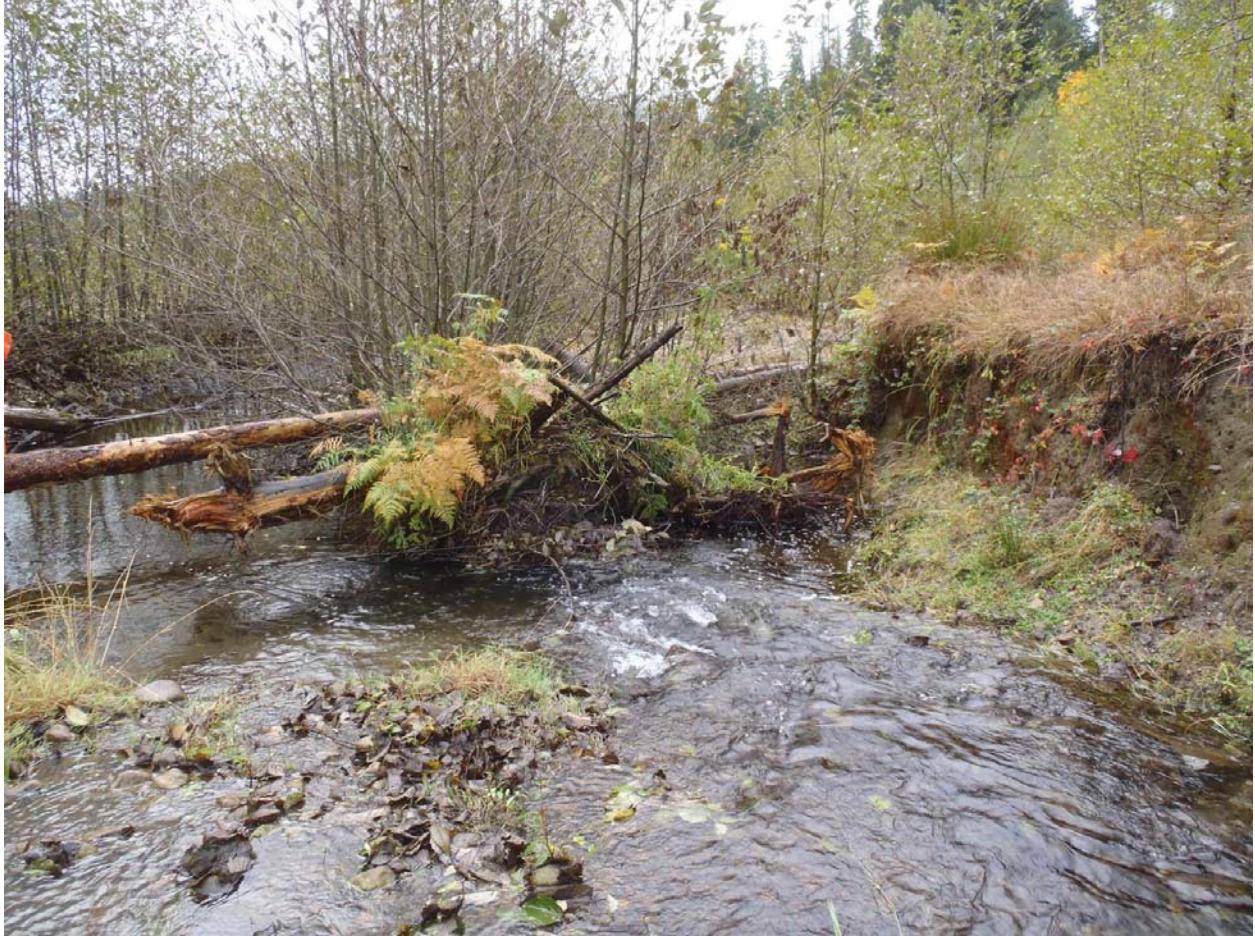
Structure 1A

Maximum Pool Depth 1.9 Feet

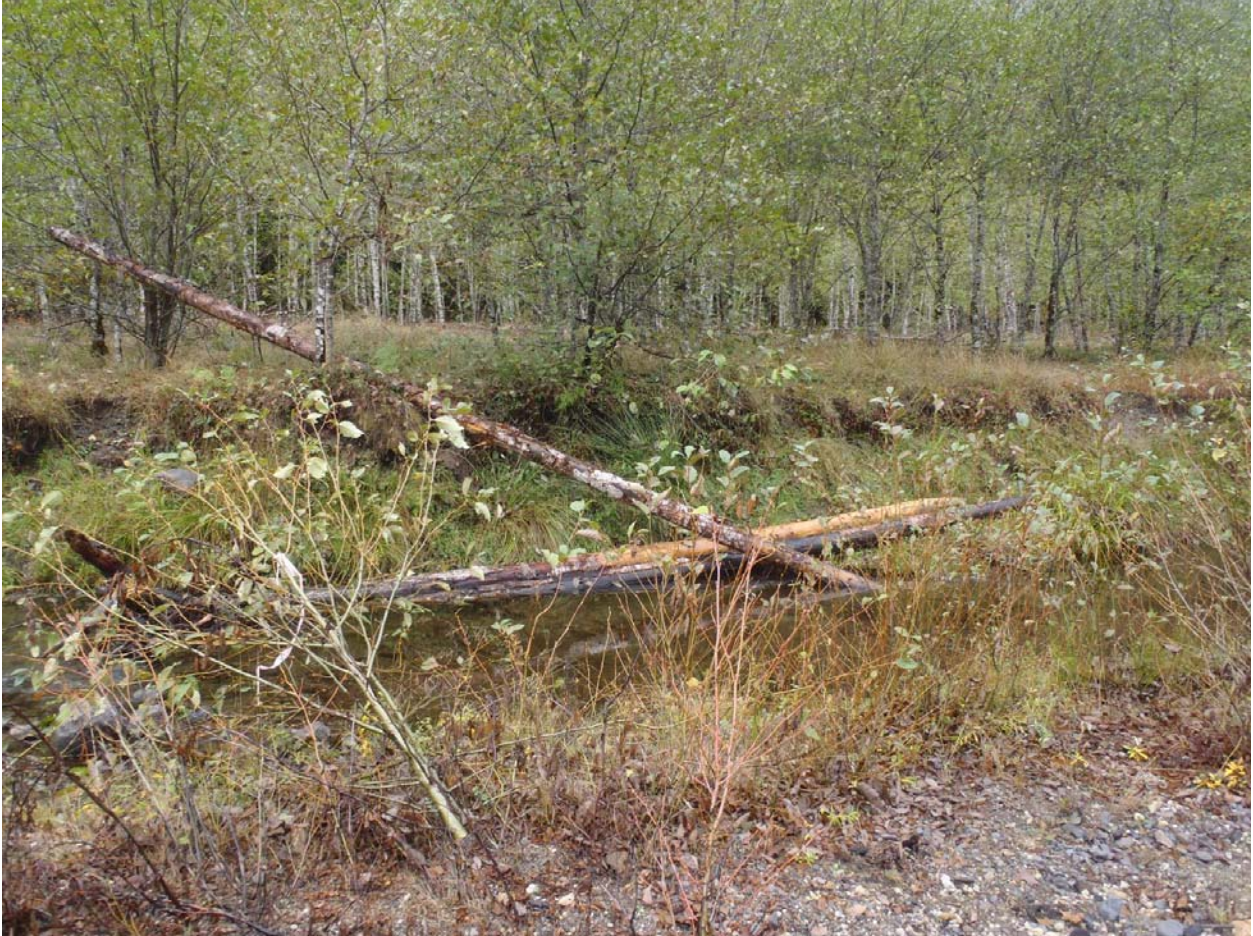
Structure 1

Maximum Pool Depth 2.0 Feet

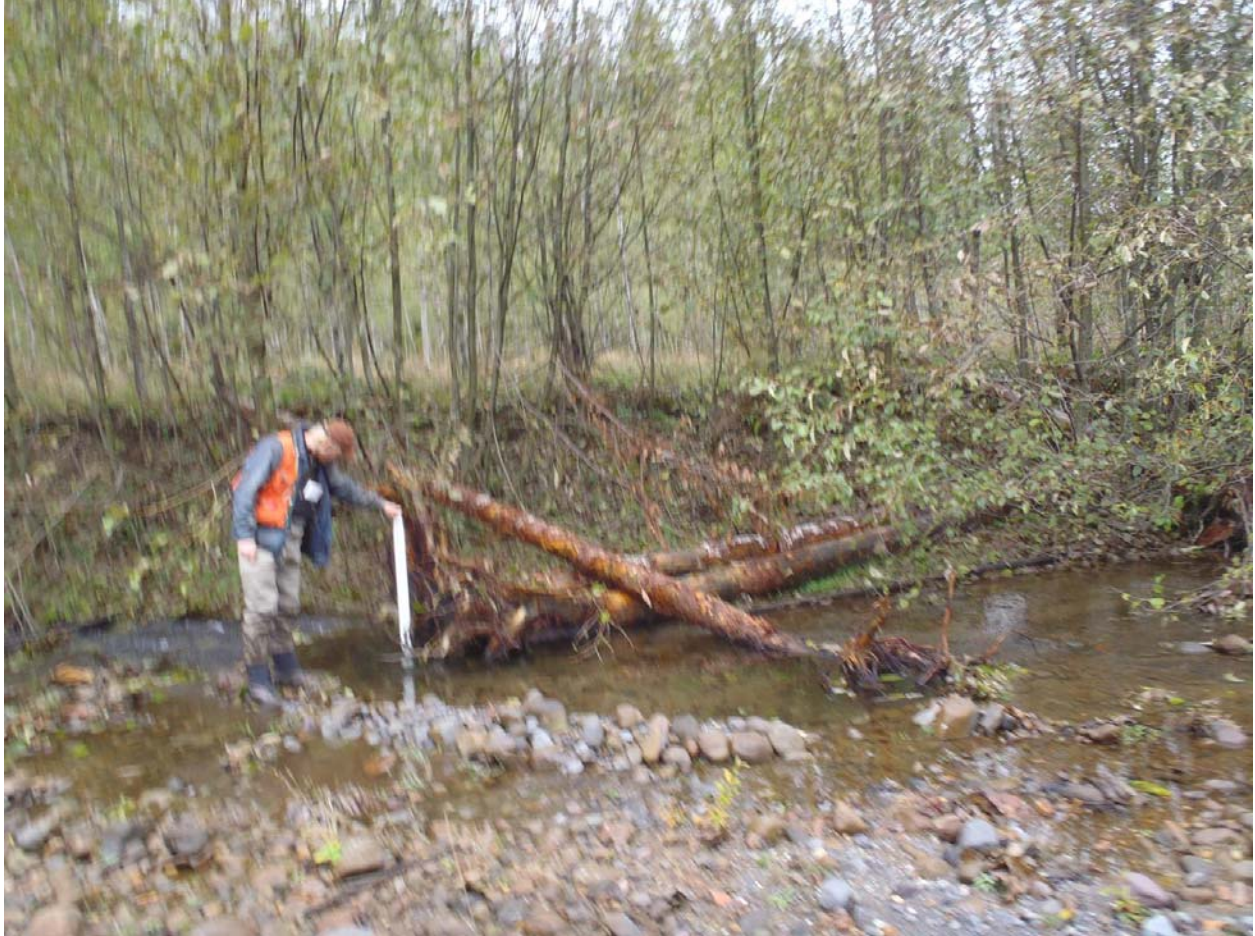
**Structure 39**

Maximum Pool Depth 2.7 Feet

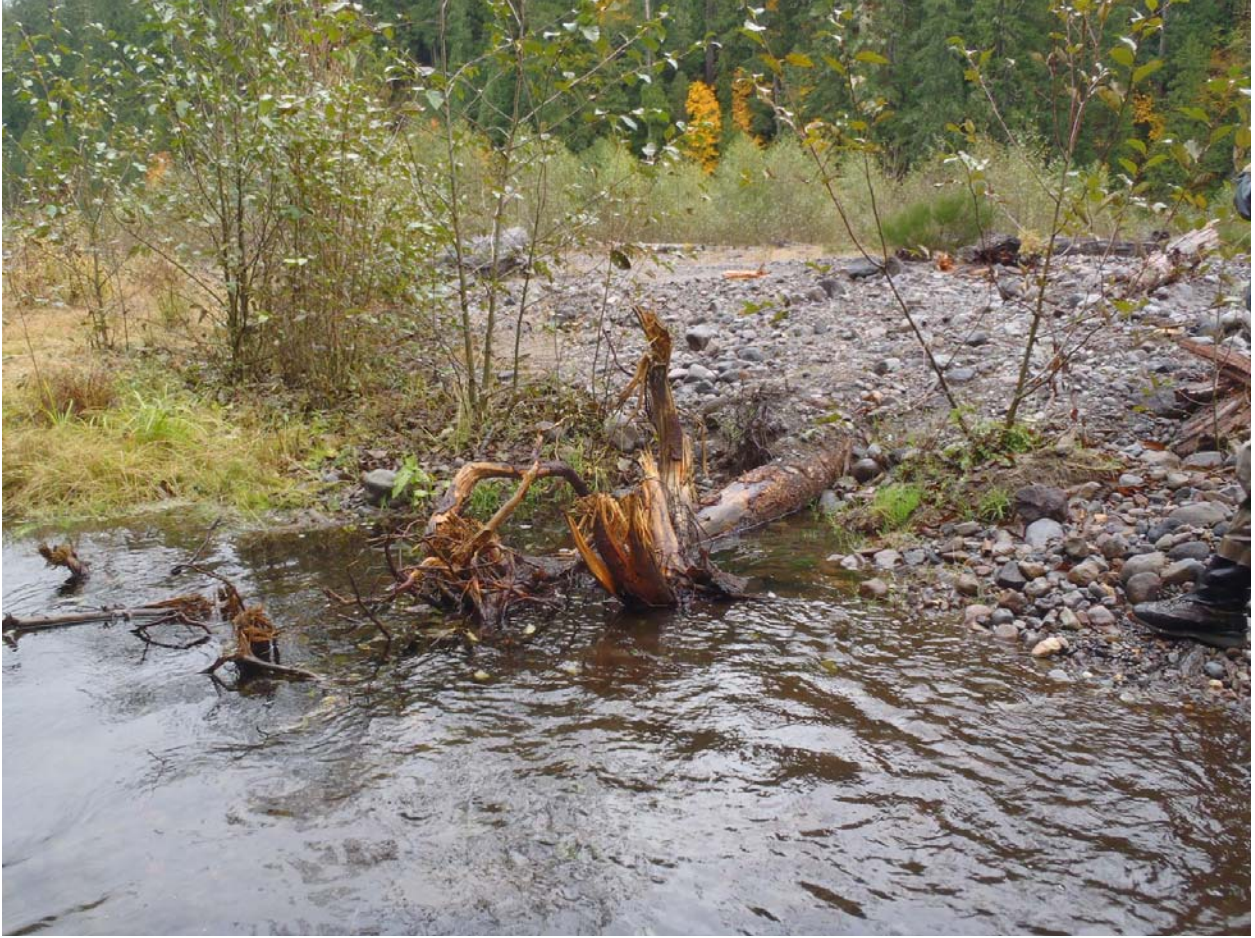
Structure 40

Max Depth 2.8 Feet

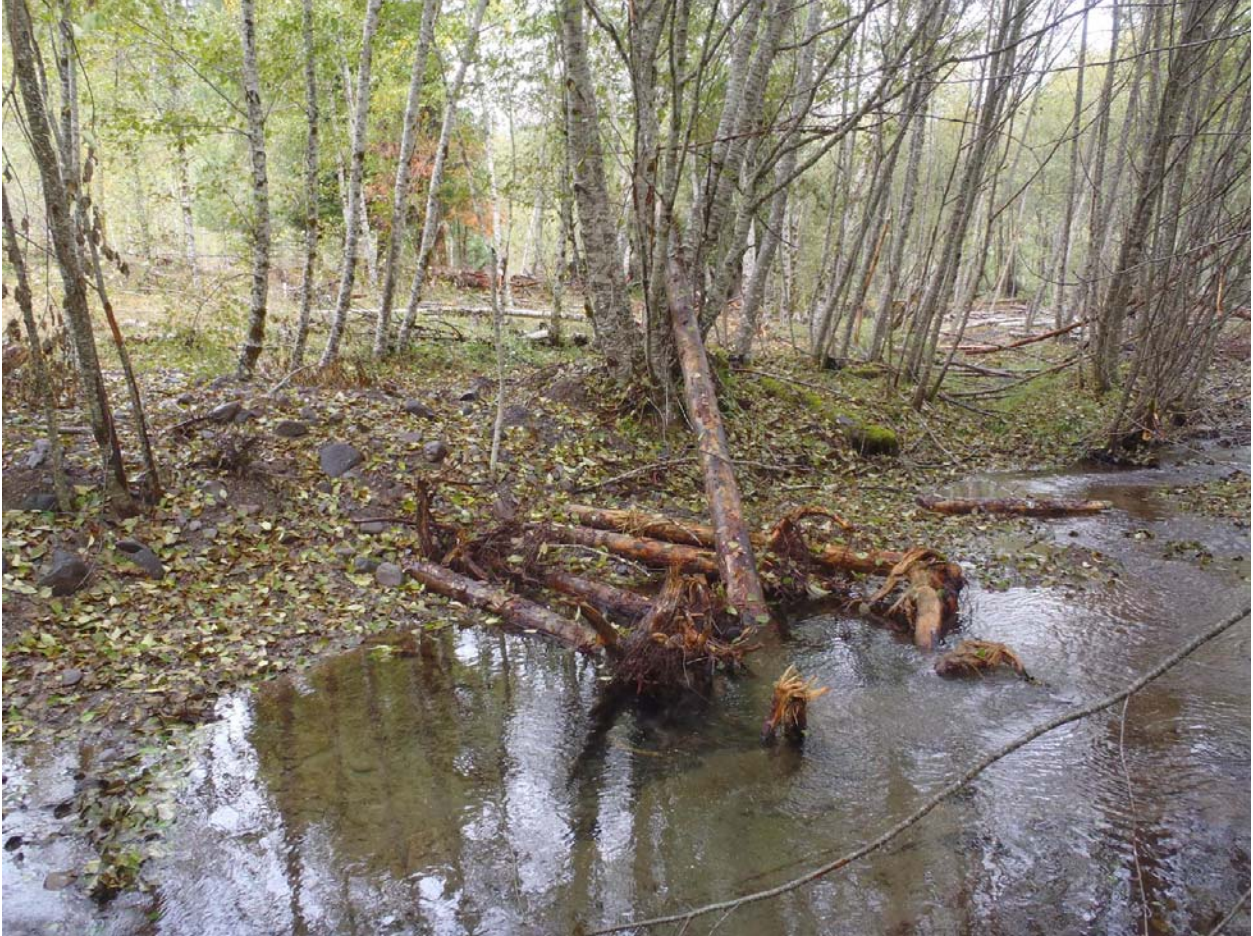
Structure 41

Max Depth 3.2 Feet

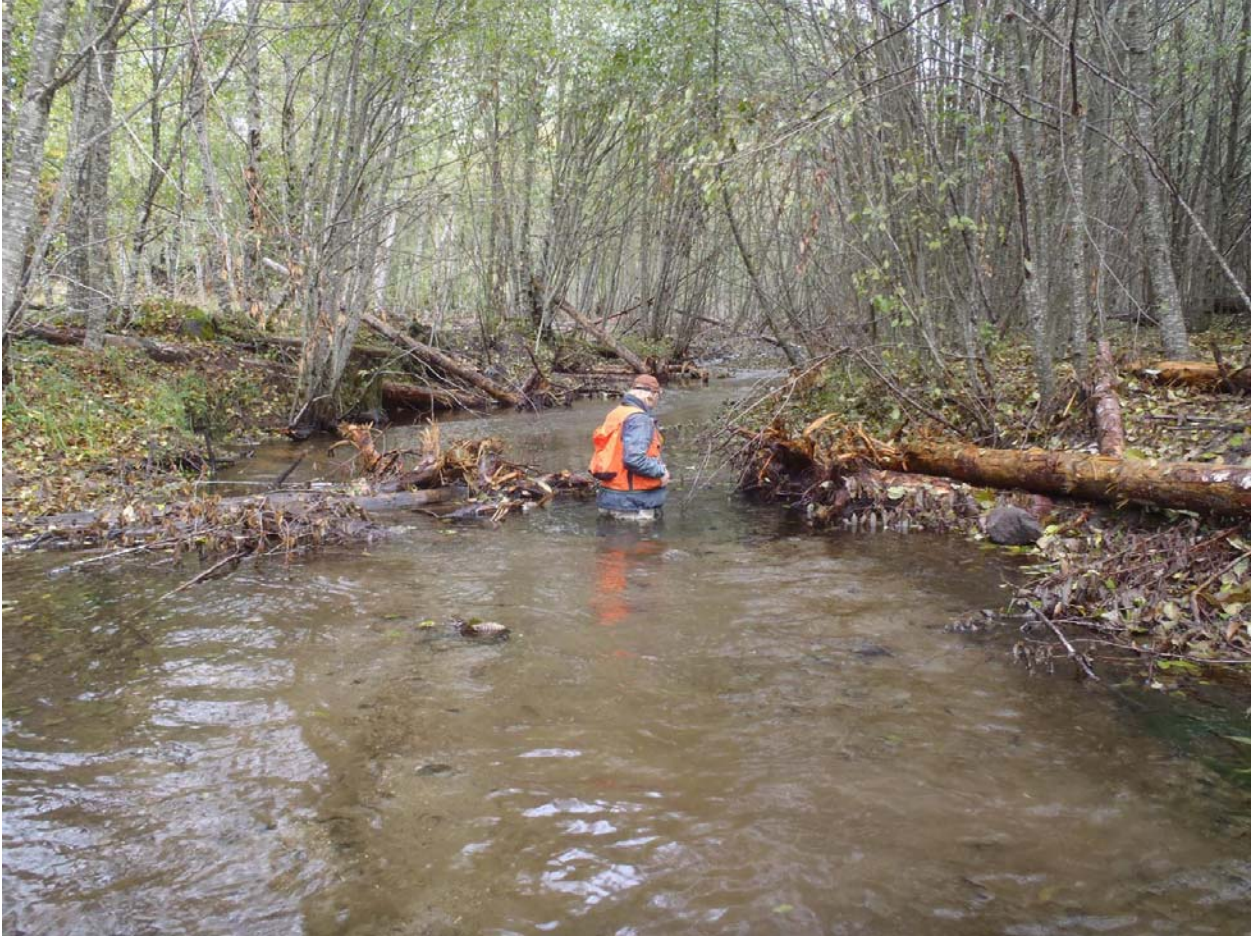
**Structure 42**

Maximum Pool Depth 3.0 Feet

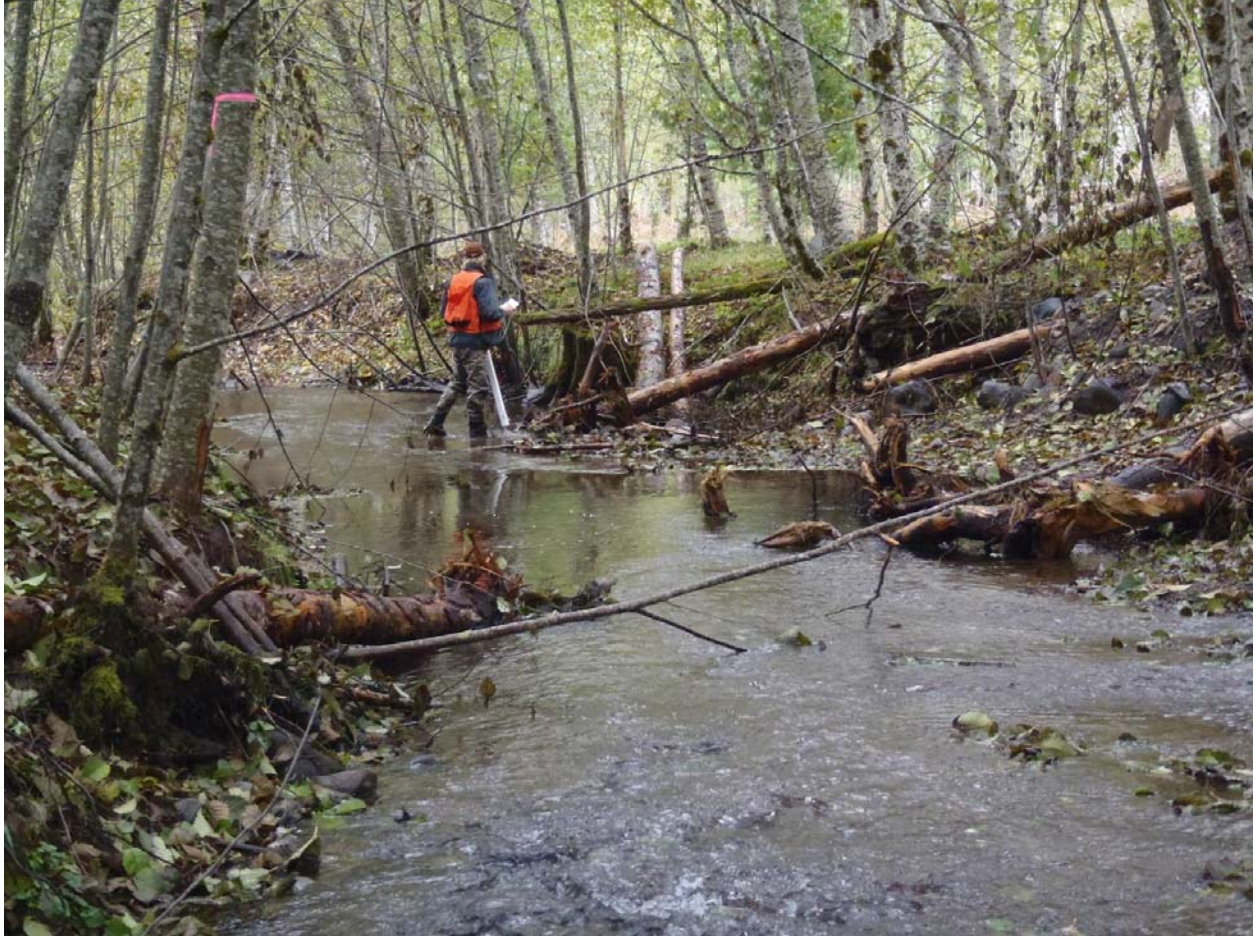
Structure 43

Maximum Pool Depth 3.6 Feet

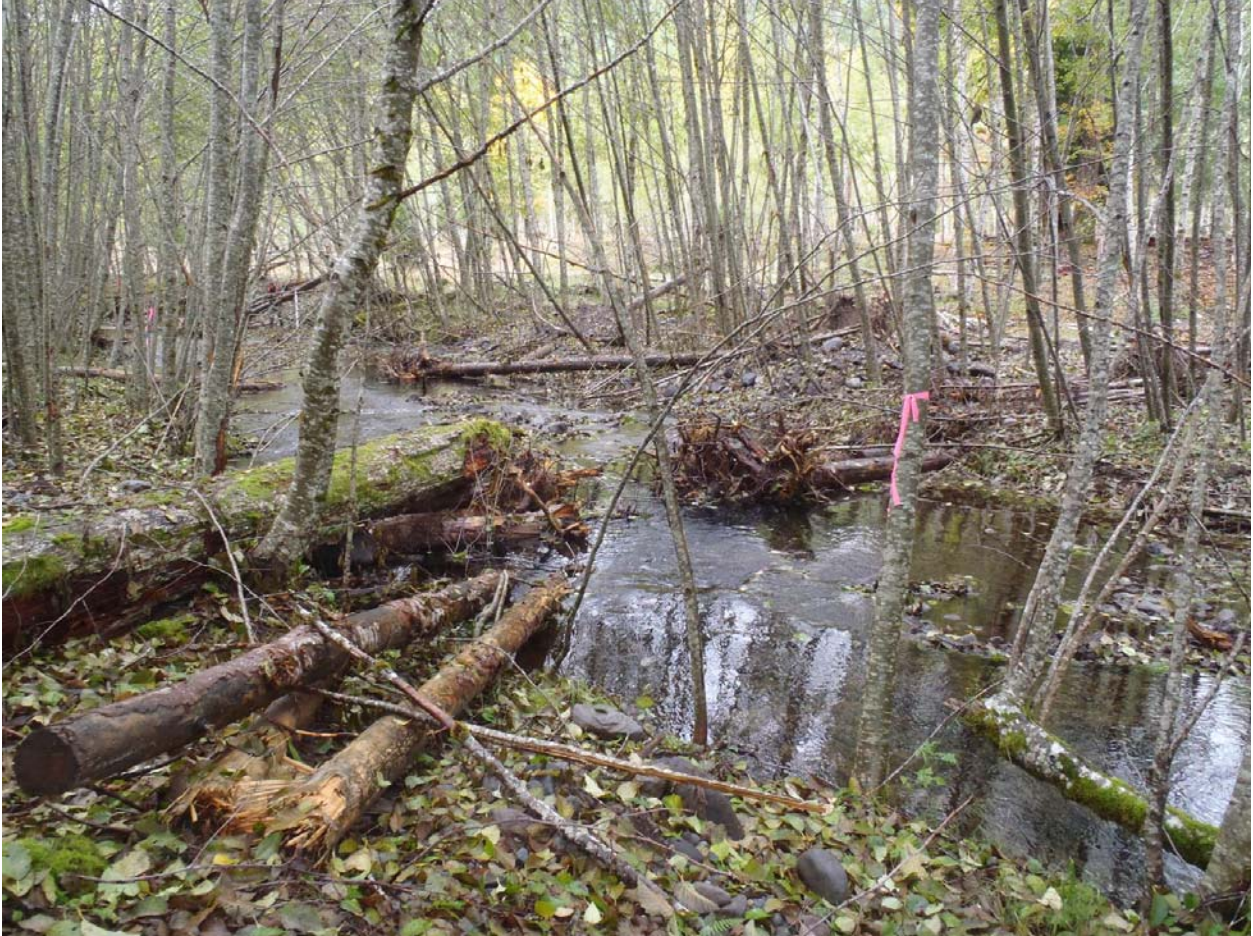
Structure 44

Maximum Pool Depth 3.5 Feet

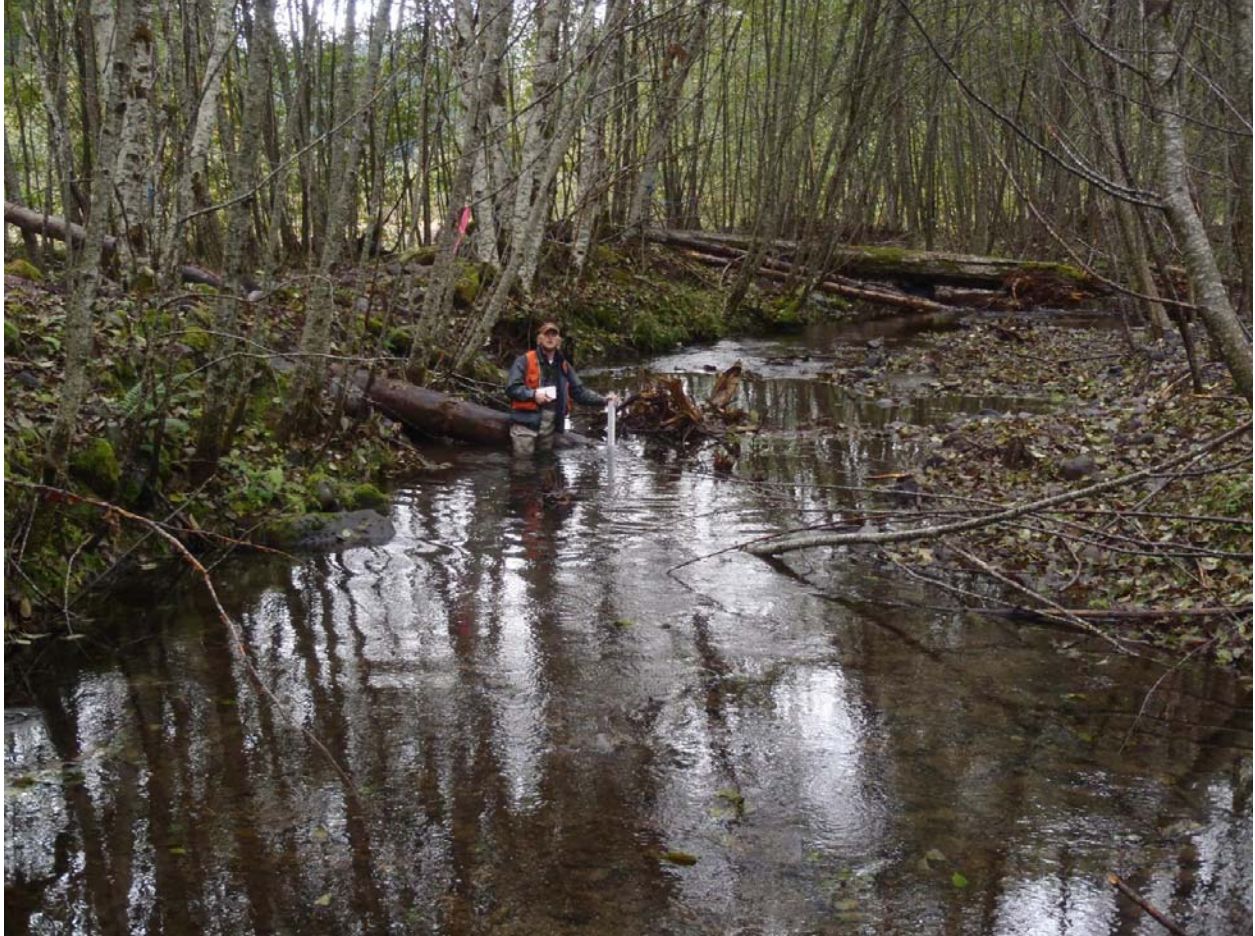
Structure 45

Maximum Pool Depth 3.9 Feet

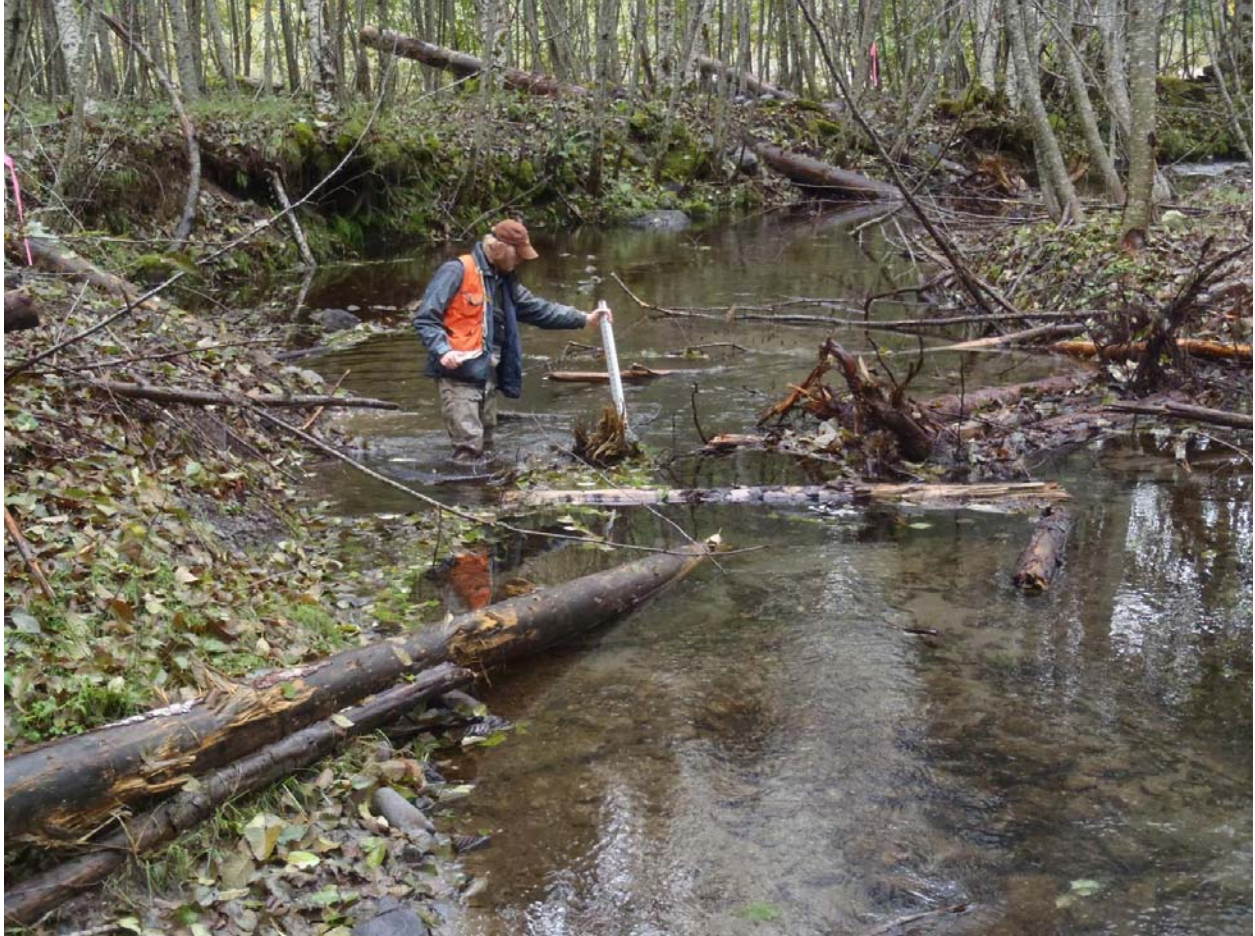
Structure 46

Maximum Pool Depth 3.0 Feet

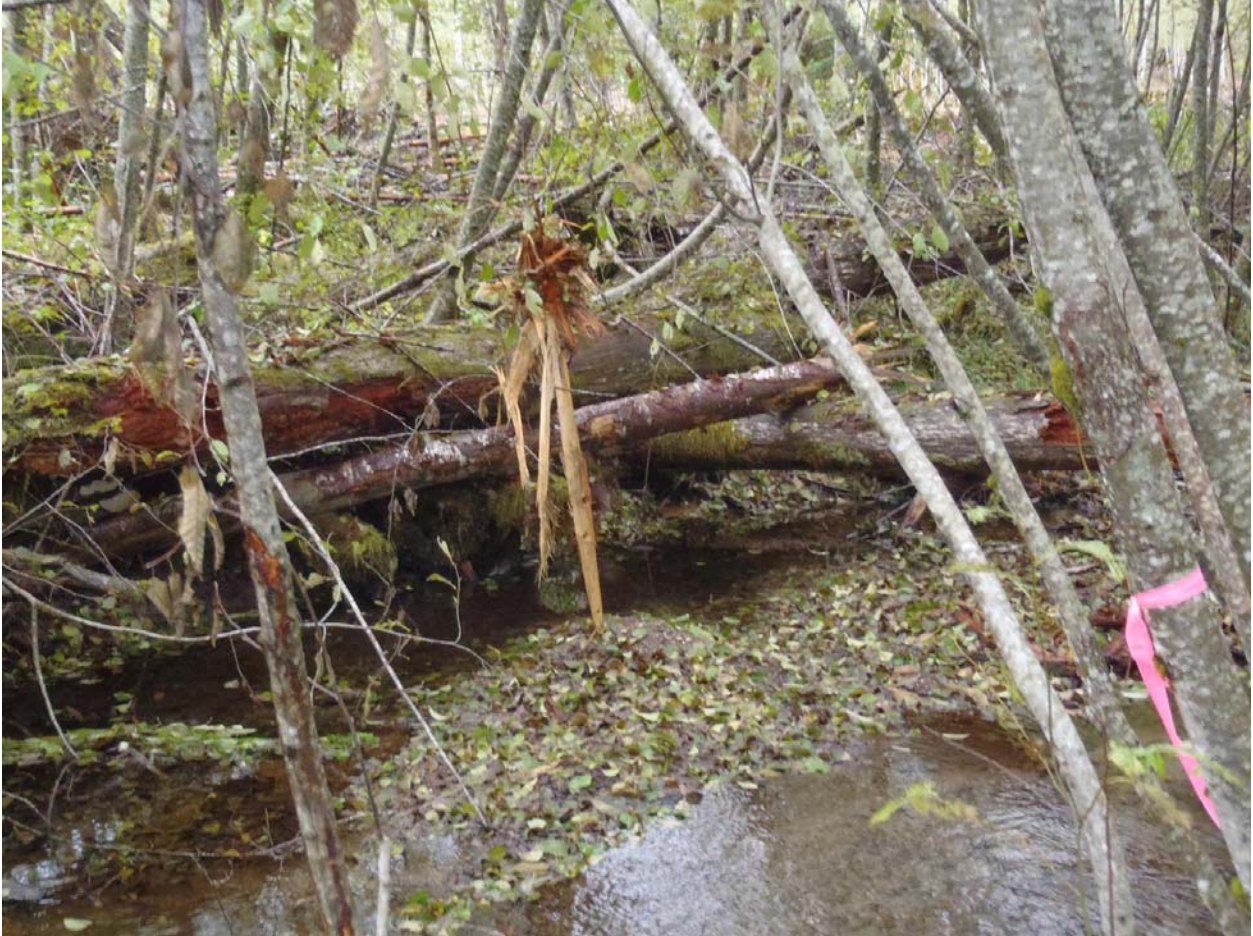
**Structure 47**

Maximum Pool Depth 2.8 Feet

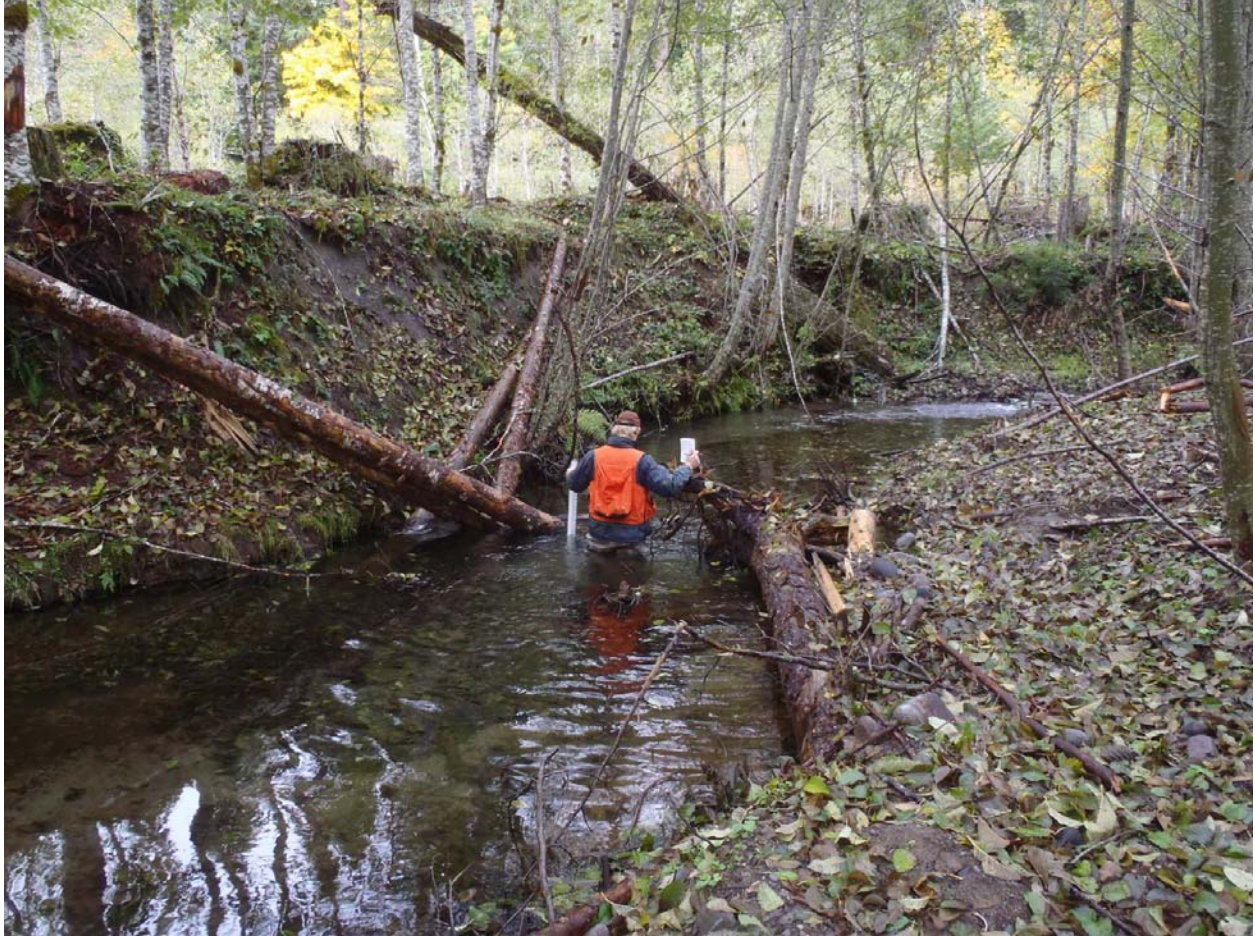
Structure 49

Maximum Pool Depth 3.8 Feet

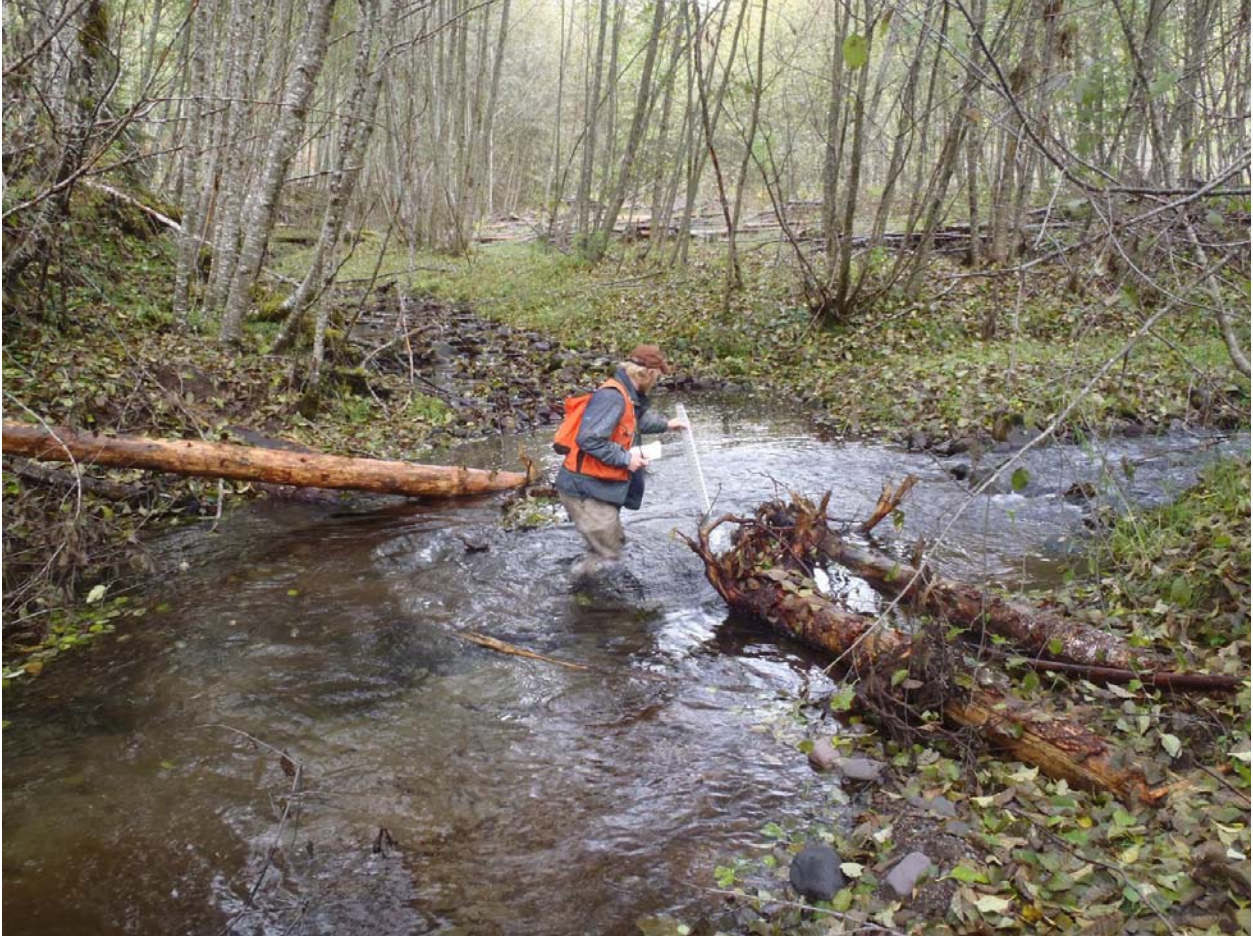
**Structure 50**

Maximum Pool Depth 2.8 Feet
