Condit Hydroelectric Project Decommissioning

FERC Project No. 2342

ANNUAL SEDIMENT ASSESSMENT REPORT - 2013

September 27, 2013

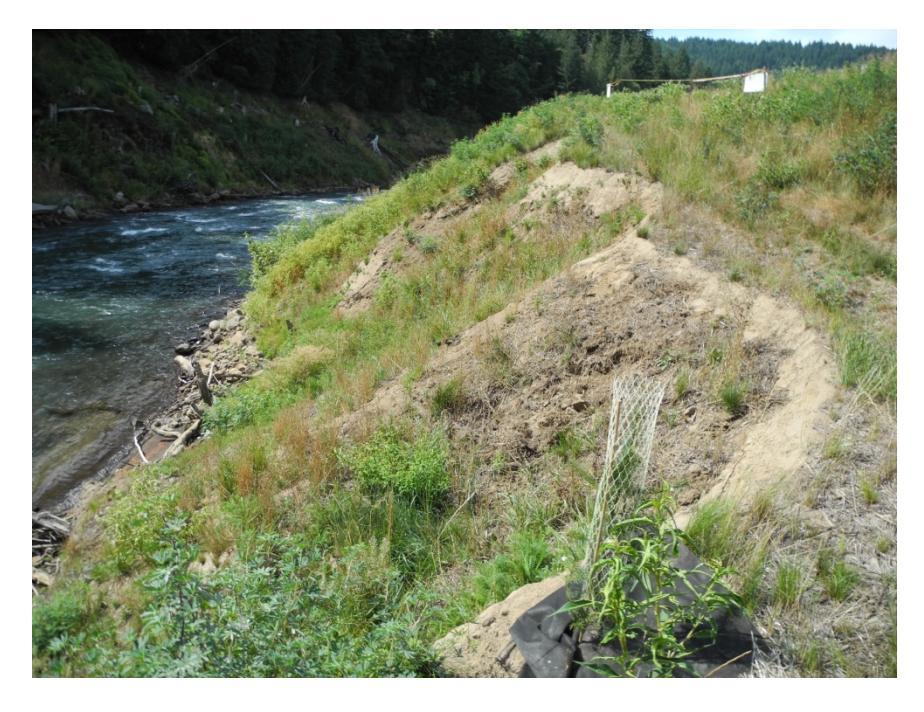
Area of maximum slope instability in Location No. 3. Herbaceous cover is beginning to stabilize the remaining soils.

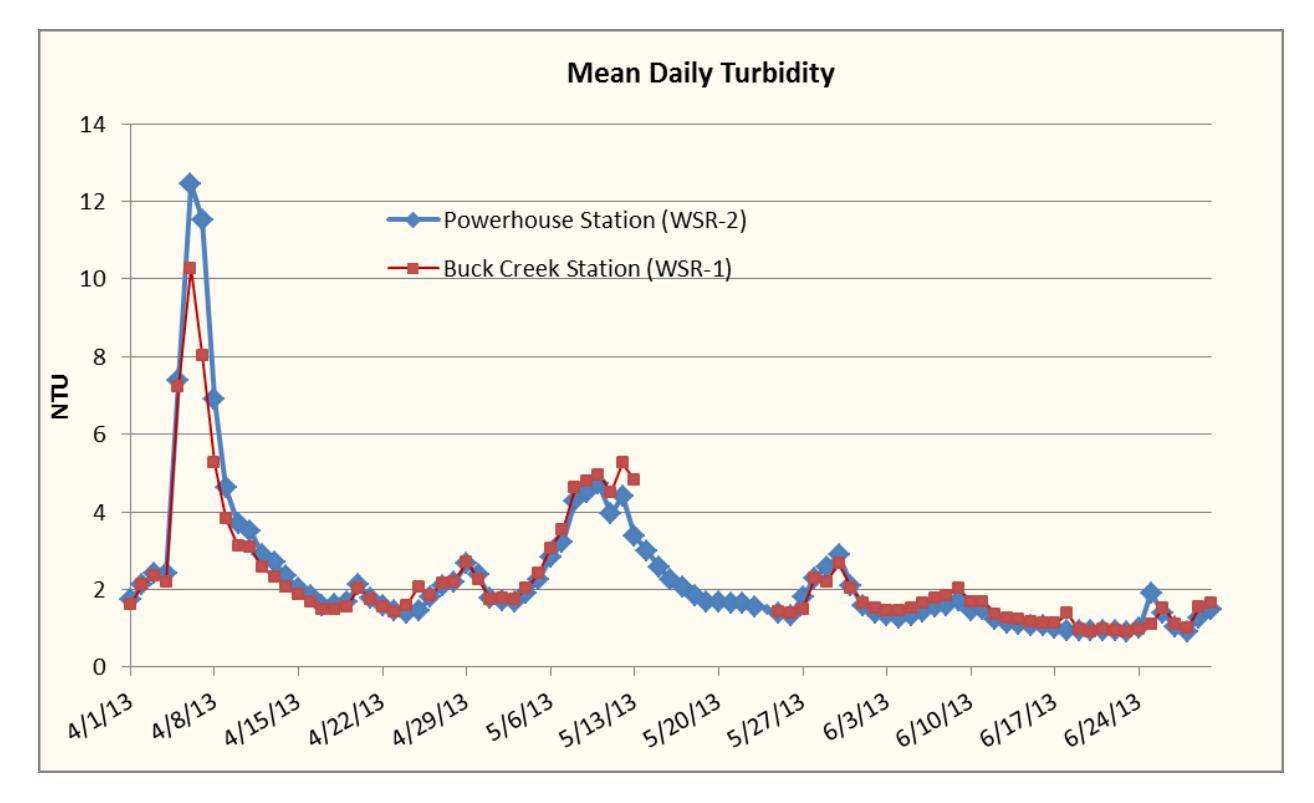
Sediment concentrations in the White Salmon River measured as turbidity have steadily improved since 2012. The graph of turbidity in the White Salmon River shown below indicates that for the period of April to July 2013 turbidity levels below the project site at the powerhouse station were very similar to the turbidity measured at the Buck Creek site upstream of the former

reservoir. Water discharge in the White Salmon River for this same time period ranged from about 2,200 cfs to 1,000 cfs. Measured turbidity at the Buck Creek site ranged from 10 NTUs to 1 NTU for this three month period, compared with turbidity measurements ranging from 10 to 40 NTUs for the same time period in 2012. Stream flow in 2012 ranged from approximately 2,400 cfs to 1,300 cfs. While the downward trend in overall turbidity may be attributable to lower flows in the river, the difference between turbidity levels above the reservoir and below the reservoir has decreased in the past year. This suggests that the supply of sediment within the former reservoir that can be eroded by the river in normal flow conditions has been reduced to very low levels.

Measured turbidity for the period April through June 2013 in the White Salmon River upstream and downstream of the project site.

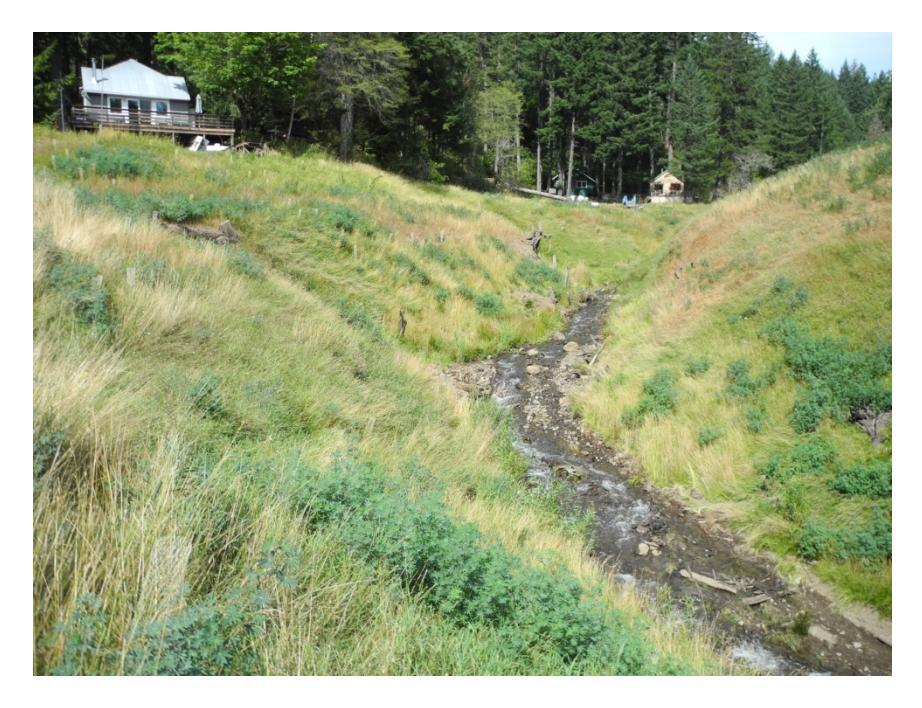
Mill Creek. August 2013, shortly after removal of the log check dams.

The largest tributary stream channel where log check dams were installed is Mill Creek. This is a perennial watercourse, and one that is thought to provide potential spawning habitat. Following the installation of log check dams in the fall of 2012, concerns had been raised by the Yakama Nation and state and federal agencies regarding whether or not the check dams constituted a barrier to upstream fish movements. At the recommendation of the White Salmon Working Group (PacifiCorp Energy, tribal and agency representatives), PacifiCorp Energy followed the consensus and agreed to remove these check dams in August of 2013. Conditions in Mill Creek will continue to be monitored.

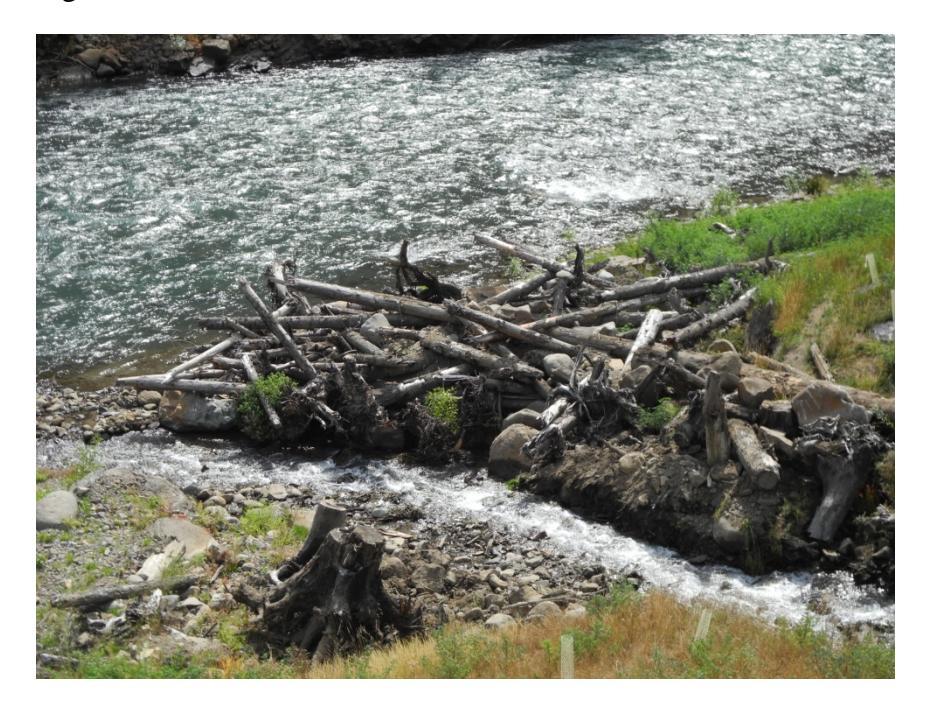
Engineered Log Jam structure at the mouth of Mill Creek.

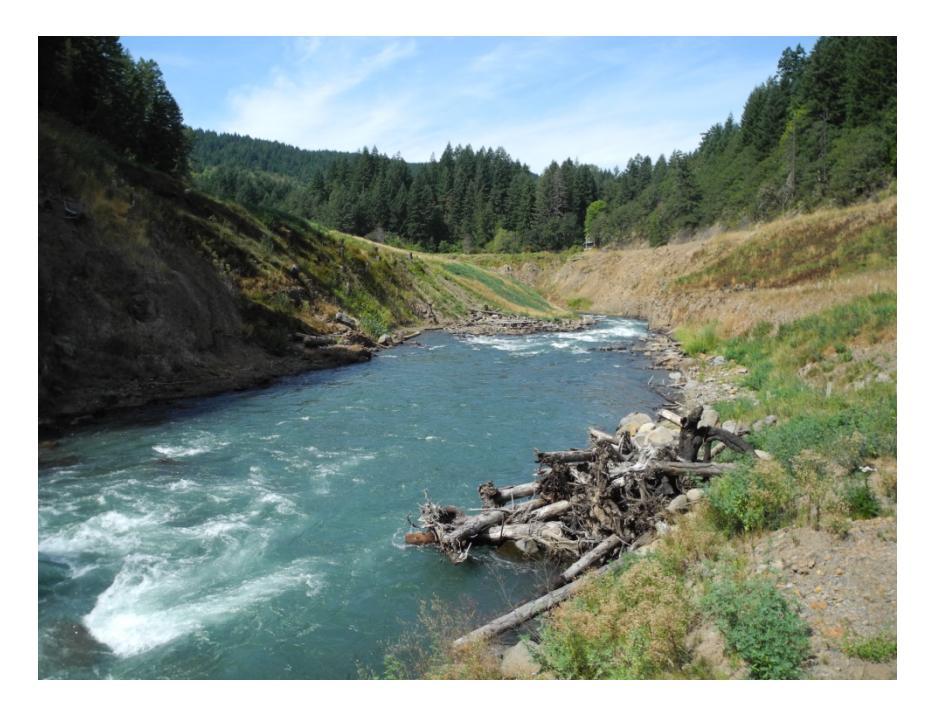
Engineered Log Jam structure at the lower end of Location No. 3. This structure has deeper water underneath because of the pool form in the river, and may provide some fish habitat. A second ELJ on river left downstream is just visible at the upstream end of the graded side bar.

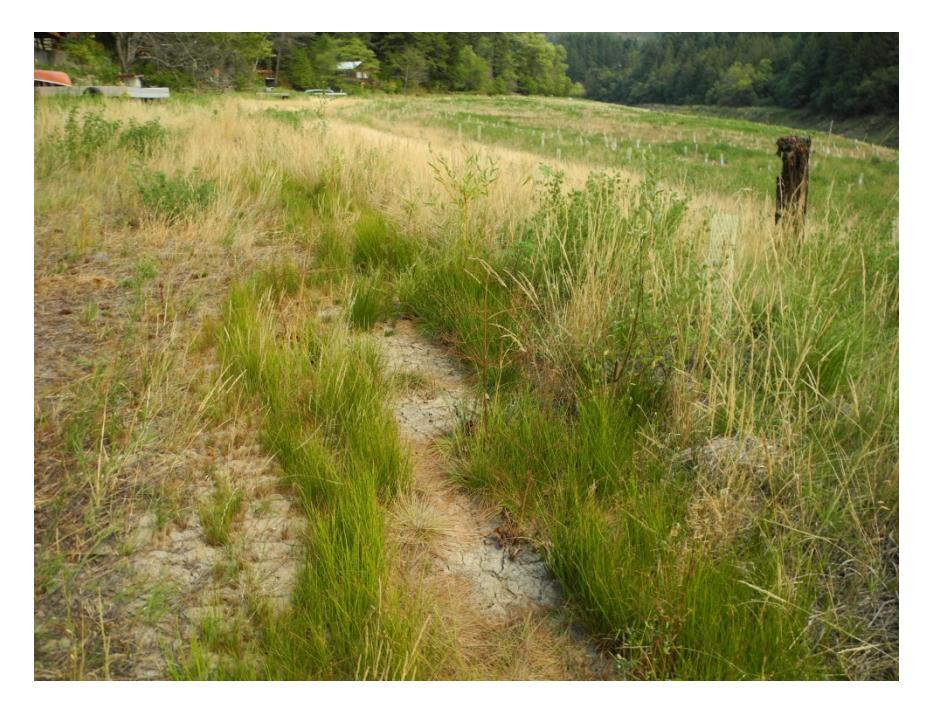
Swale at north side of Location No. 5. Juncus species are thriving, despite ephemeral hydrology. Willow transplants are healthy and Agrostis has proliferated.

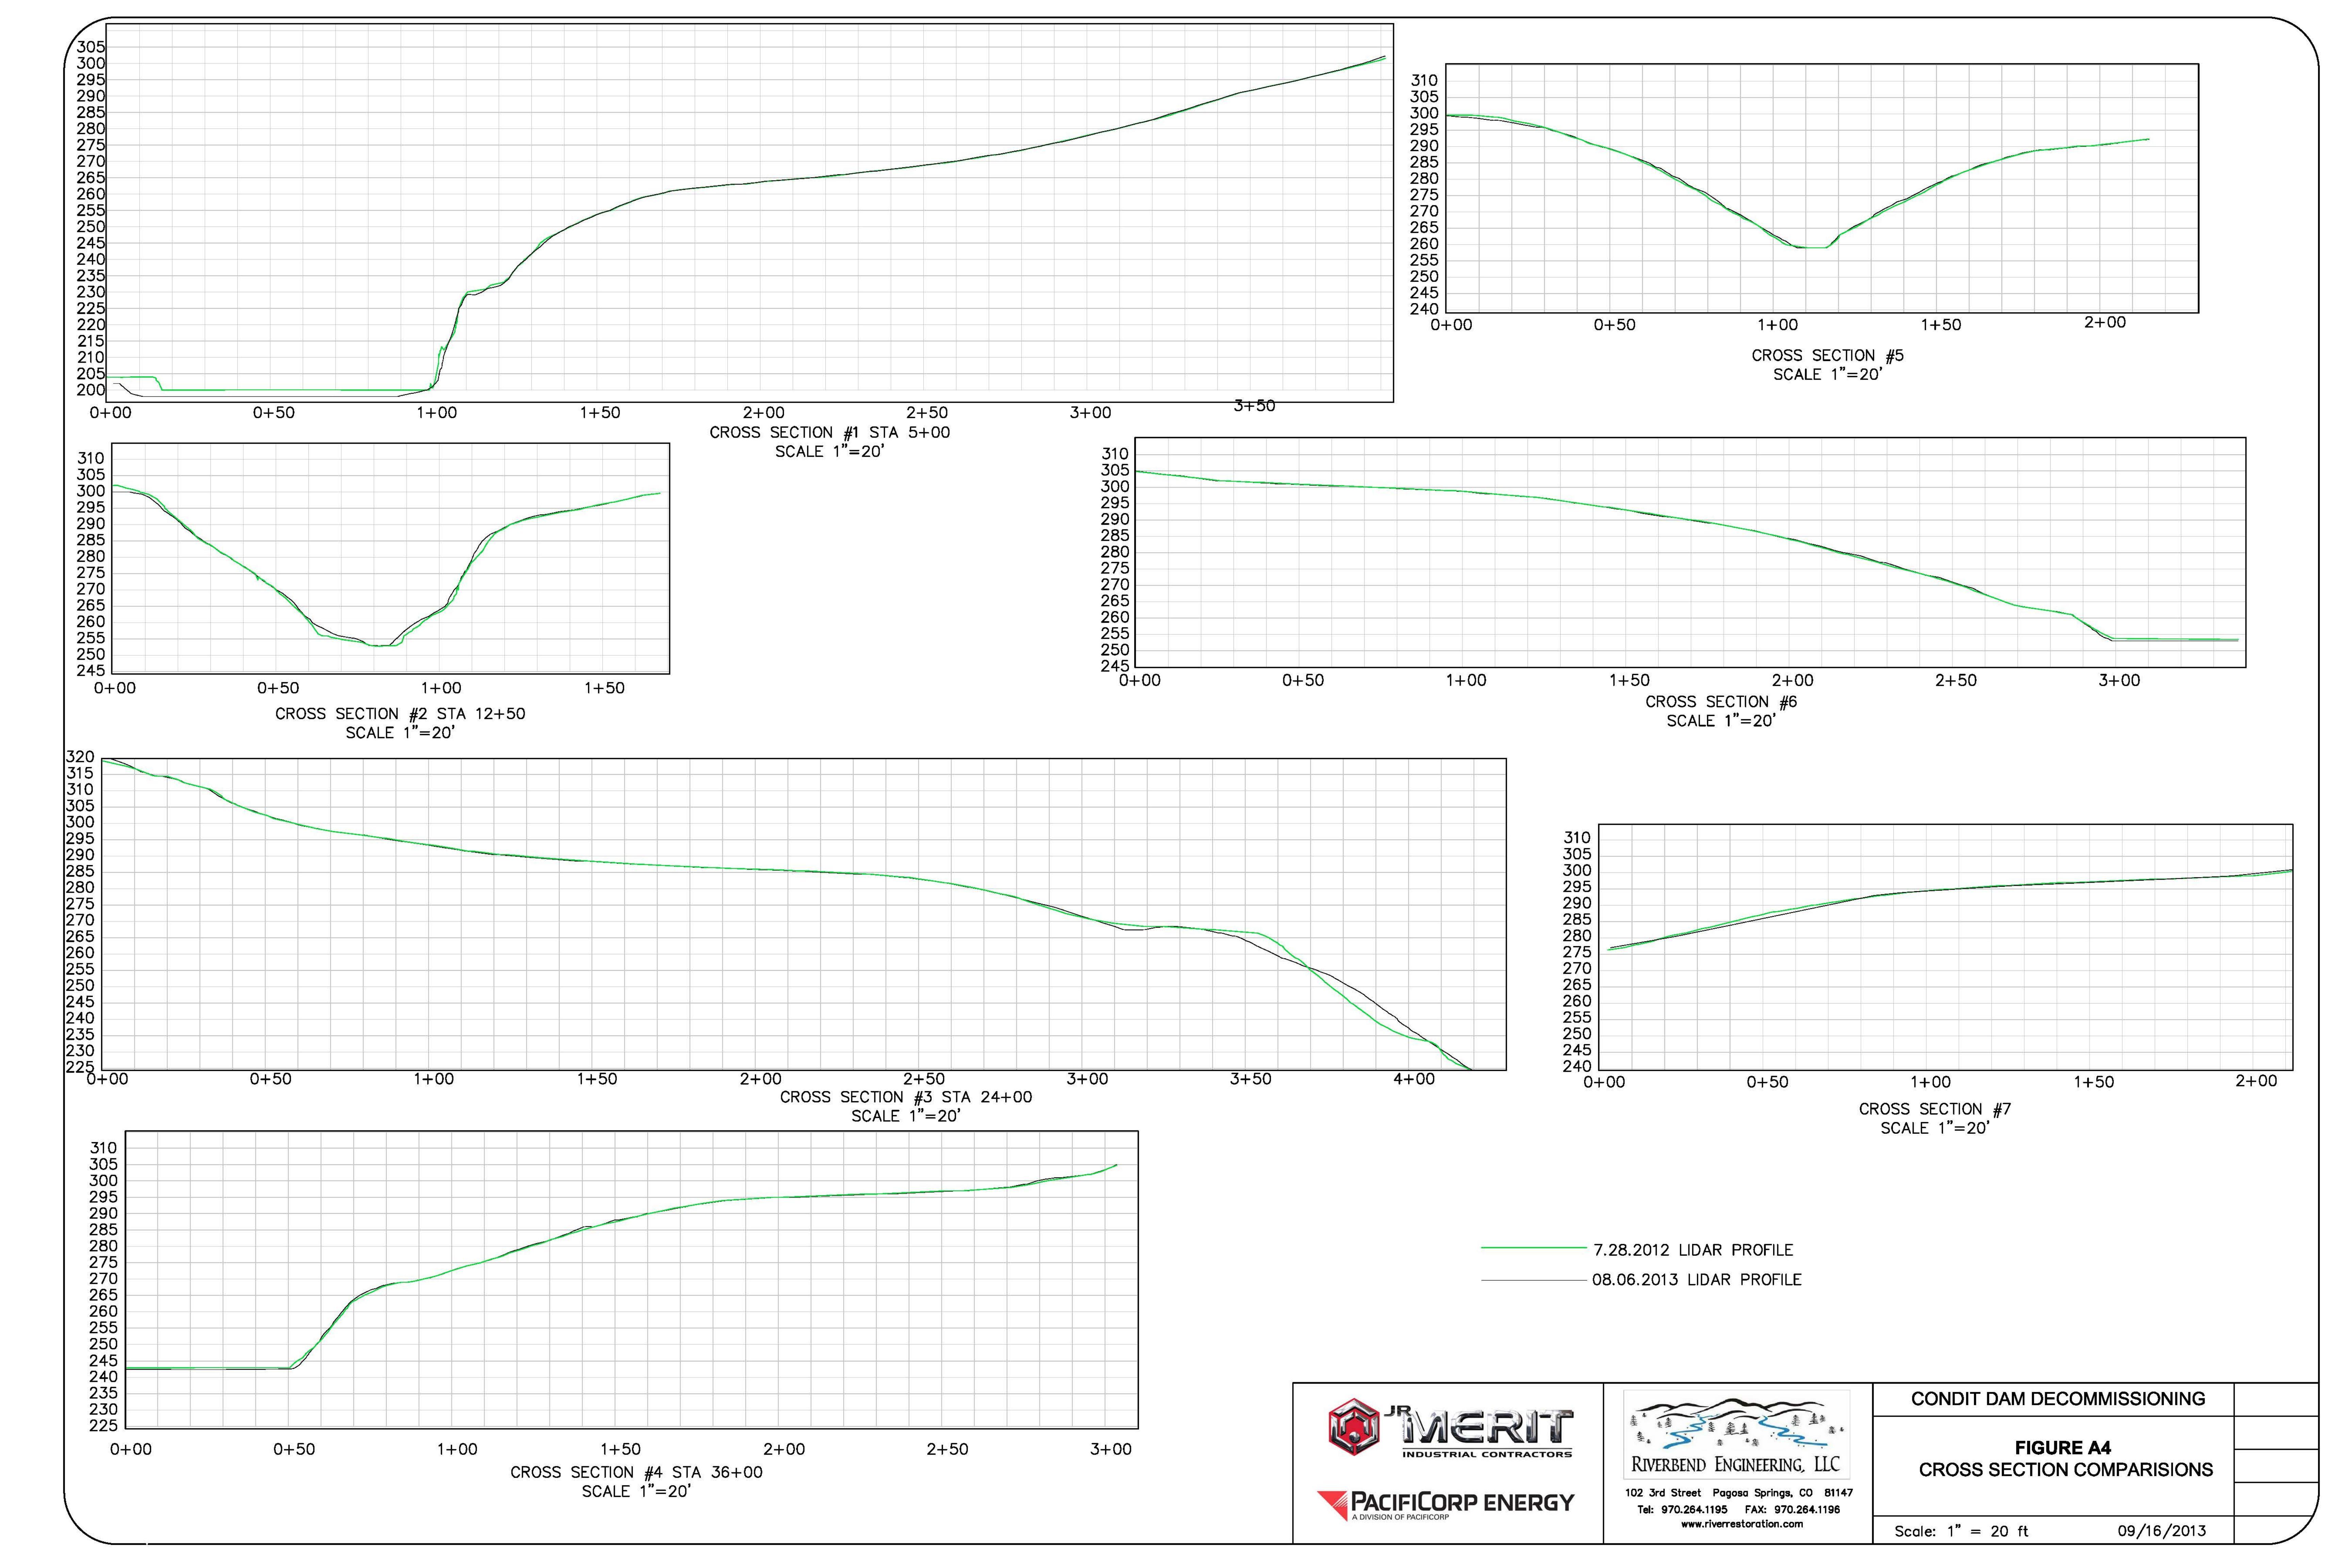
Cross section comparisons between 2012 and 2013 topographic mapping are shown on Sheet A-4. Sections 1, 2, 4, 5 and 6 show little if any change to the sediment surface. Sections 3 and 7 show a distinct change in the past year. In both of these locations the change observed is directly attributable to grading work that was accomplished after the 2012 topographic map data was collected.
