State of California — The Resources Agency
DEPARTMENT OF PARKS AND RECREATION
PRIMARY RECORD

*Resource Name or #: Klamath River Hydroelectric Project District – COPCO #2

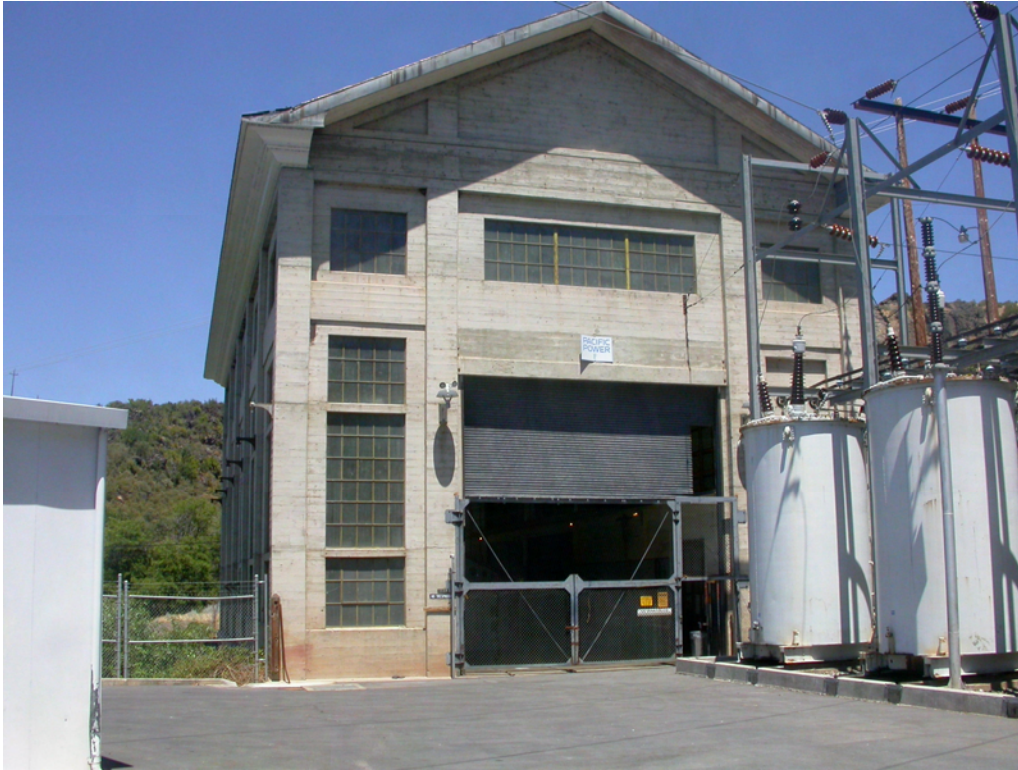
The **COPCO #2 powerhouse** is located at the bottom of the penstock run, on a small flat shelf next to the river. It is a reinforced, poured concrete structure that houses two turbine-generators. It is a full story with a mezzanine level, over a basement. The structure has a rectangular footprint and a front gable roof with a monitor top along the ridge. It is three bays wide and five bays long. Each bay is delineated by an engaged pilaster. Set into panels within the bays, the windows are multi-light industrial steel sash, with operable hopper sections. In each bay, the top row of windows is separated from the rest of the bay by a wide, flat band, except in the front façade, center bay. On the front (south) and rear (north) facades, the center bay is dominated by a metal roll-up door. On the front (south) facade, the roll-up door is behind metal-framed, chain link gates – one pedestrian gate and one large double-leaf gate. A concrete header defines the top of the opening, which is somewhat shorter than the flanking window openings. Above this door opening in the center bay is a row of three 15-light windows. On the rear (north) facade, the center bay contains the roll-up door and a row of windows on either side of it. On each side of the doorway, there are three windows – the top and bottom windows are 6-lights each, while the center window is 18-lights. The door opening is even shorter relative to the window openings than the one on the front façade, and it lacks the separate header. A large, recessed square panel above the doorway aligns with the top of the flanking windows. Also on this rear facade, the column of windows on the east side consists of only the top, 15-light window. Below that is a recessed panel that contains two small metal vents.

The powerhouse is remarkably well designed for an industrial building in an isolated setting. Each pilaster on the front, rear and west side facades is adorned with a stylized metal light fixture bracket. Unfortunately, none of them retain their original shade or globe. The four on the front and rear facades cast light up instead of down and have been altered by the addition of non-original shades and/or lighting elements. The gable ends of the building are articulated by three recessed panels above a wide, flat band that appears to originally have had a cornice across it. The walls terminate in a substantial, projecting molded metal cornice that returns around the corners. Marks on the concrete bands that span the gable ends appear to indicate that the cornice or a similar construction detail originally ran all the way across the gable ends. The deep overhang on the gable ends is faced with a tongue and groove soffit.

View: COPCO #2 Powerhouse – front (south) façade – July 2003

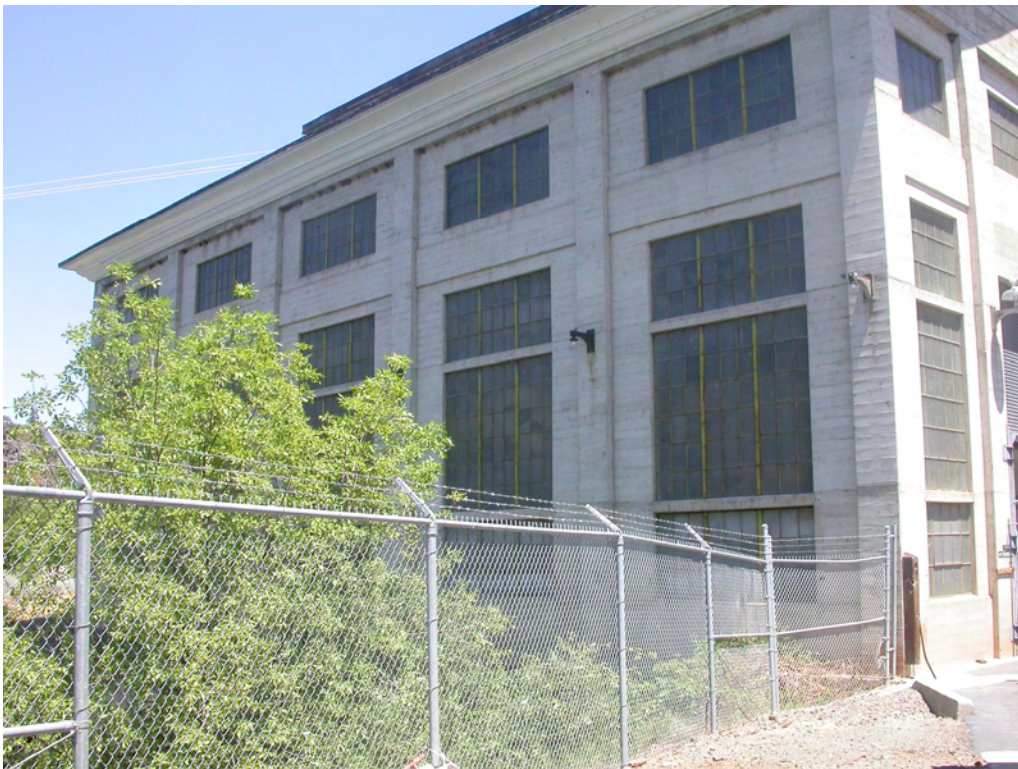
View: COPCO #2 Powerhouse – west side façade – July 2003

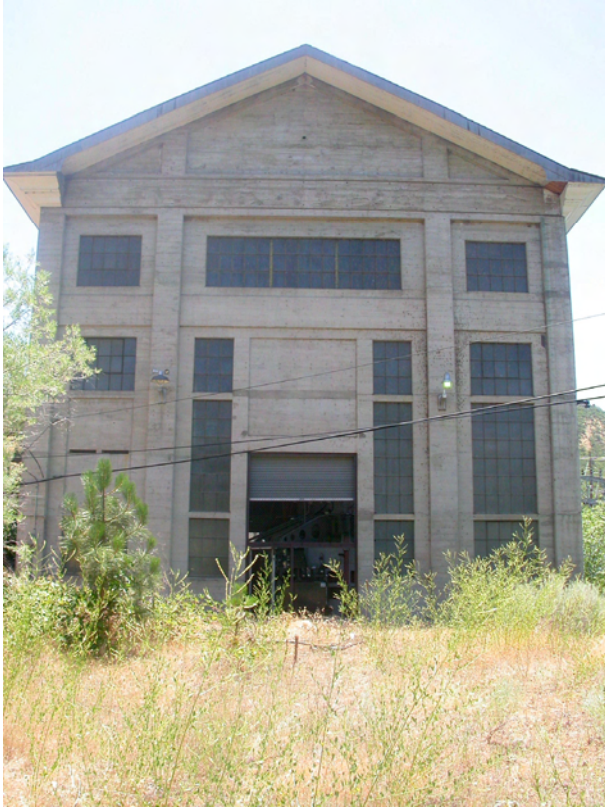
View: COPCO #2 Powerhouse – rear (north) façade – July 2003

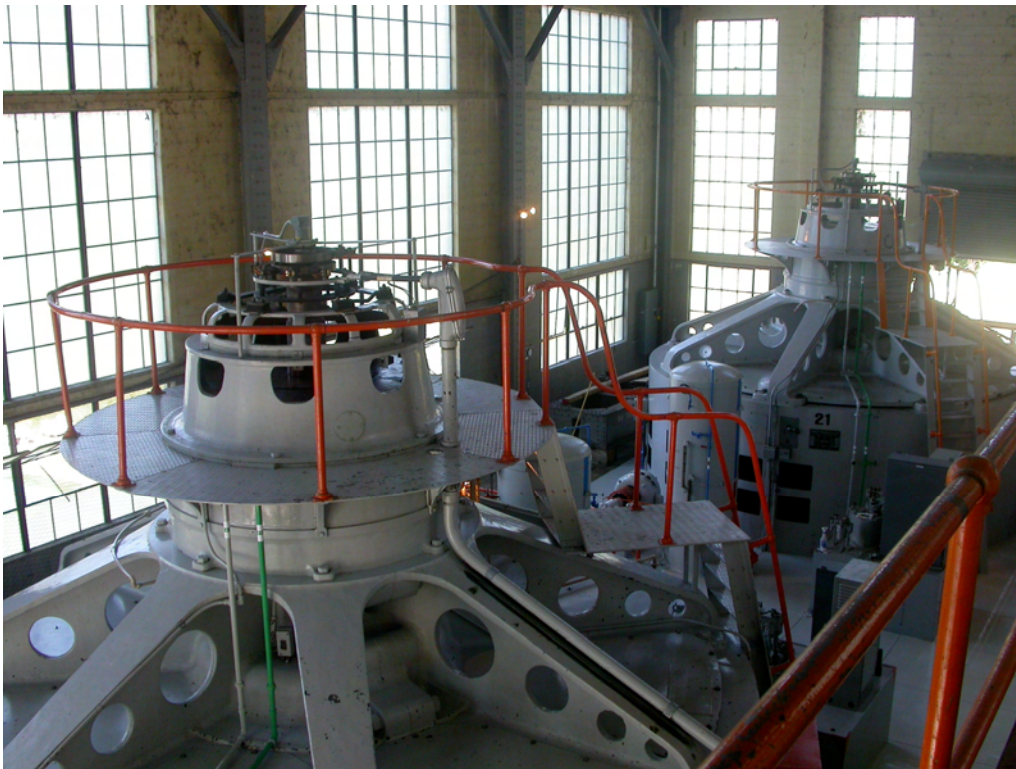
The powerhouse contains two turbine-generators. The generators are on the main level, while the turbines are housed below. There is also an upper mezzanine level that runs along the east wall. The turbine-generators are vertical-shaft, Francis-type hydraulic turbine and synchronous generator sets. The turbine for Unit #1 was overhauled and the runner replaced in 2000. Originally an Allis-Chalmers unit, it is now an American Hydro unit. Unit #2 still retains its original Allis-Chalmers turbine. The generators were manufactured by General Electric. In the basement, where the turbines are located, are screened, metal louvered openings that look out to the concrete tailrace apron. The building is in good condition and has good integrity.

View: COPCO #2 Powerhouse Interior – both generators – view from mezzanine level – July 2003

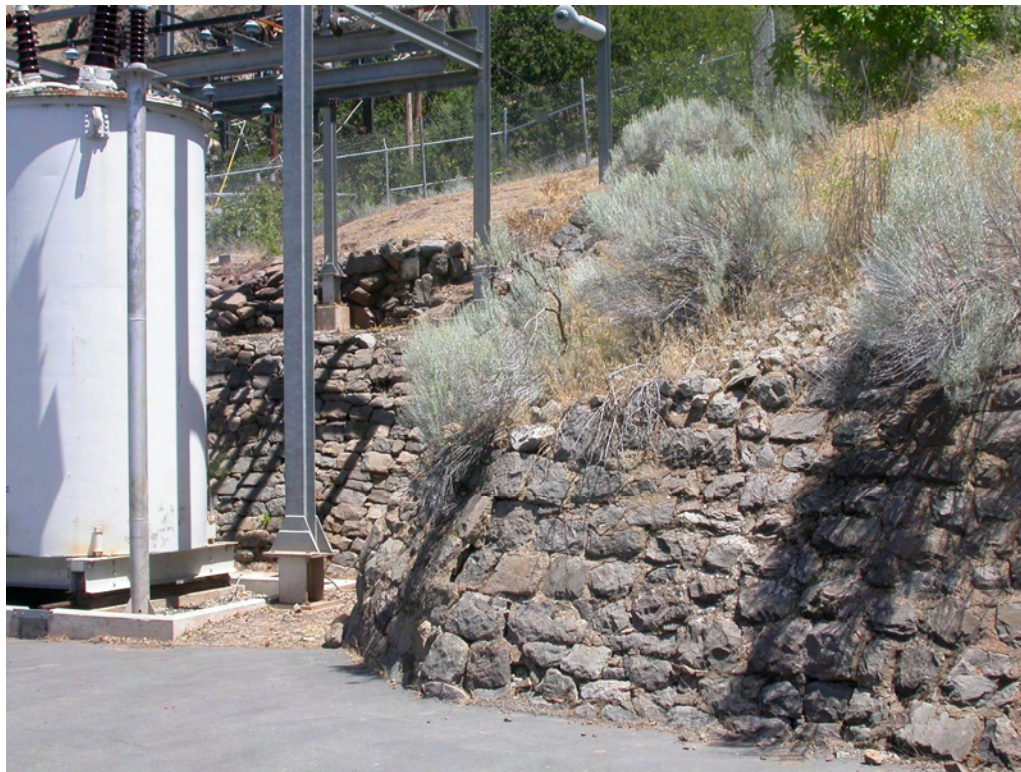
The powerhouse site also includes an elaborate mortared and coursed stone retaining wall south of the powerhouse, at the step-up transformers. This wall was extended in 1996.

View: COPCO #2 Stone Retaining Wall south of Powerhouse – July 2003

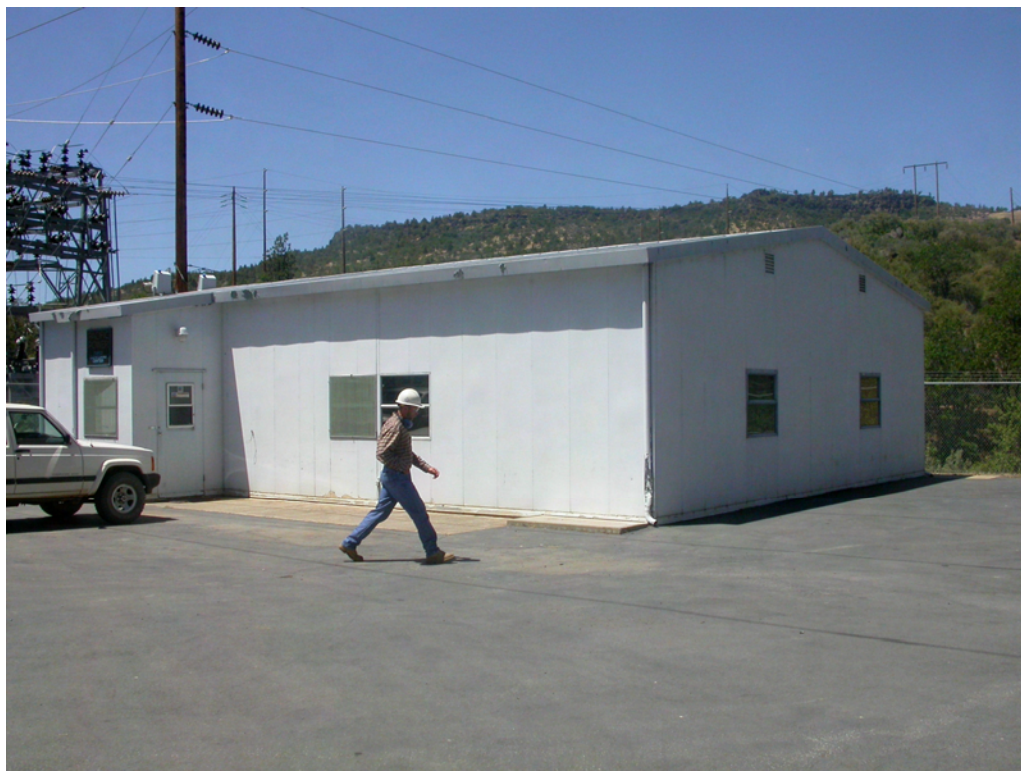
Southwest of the powerhouse is the **control center building (5.6)**. This is a non-historic building that appears to be a modular/pre-fabricated structure, basically rectangular in plan with a very shallow side gable roof. The protruding entry has a shed roof. The building is constructed on a concrete foundation and is clad in metal panel siding. It has 1/1 fixed aluminum windows and metal doors. The building is in good condition but is not a contributing element.

View: COPCO #2 Control Center Building – July 2003

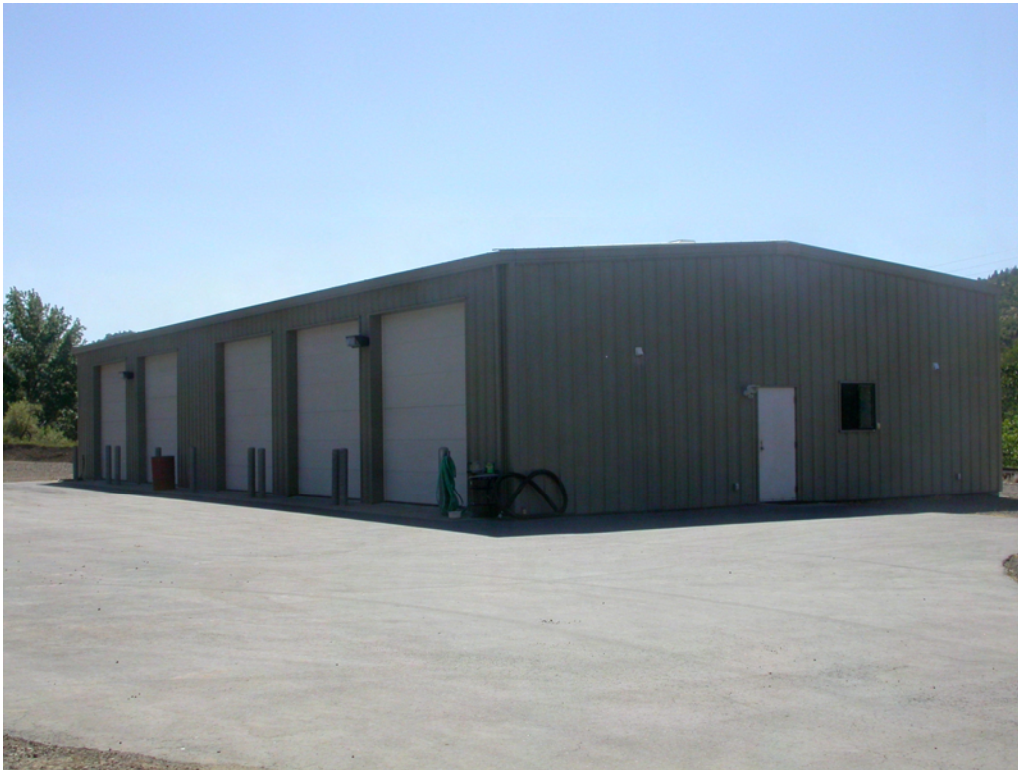
West of the control center building is a large substation. All of this site is contained within a chain link fence topped with barbed wire. On the west side of the substation is a service area, with the maintenance/shop building and the gas and oil storage shed. The **maintenance building (5.7)** is a modern, five bay warehouse clad in metal R-panels. It has a shallow side-gable roof. The front (south) facade is dominated by five large roll-up doors. The side (east) facade has one (cont.)

metal pedestrian door and one single-light window. Constructed in 1991, the building is in excellent condition but is non-contributing.

View: COPCO #2 Development – Maintenance/Shop Building (1991) – July 2003

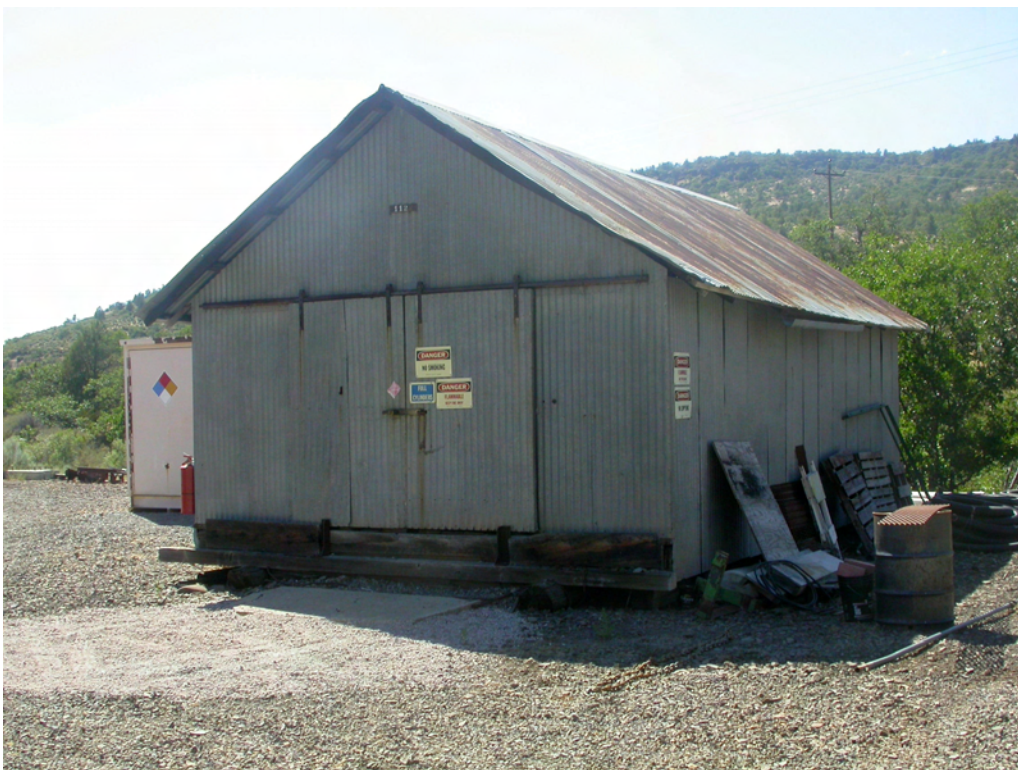
Northeast of the maintenance building is a small metal building that appears to be an **oil and gas storage house**. It is wood-framed with corrugated metal walls and roof. It sits on a log or timber foundation. The eaves reveal exposed purlins and rafter tails. The front (south) façade contains a pair of metal-clad sliding doors on an overhead rail. There appears to be no further fenestration on the building. Although the construction date is unknown, it may date from the construction period of COPCO #2. It is in fair condition with good integrity.

View: COPCO #2 Oil and Gas Storage Shed – July 2003

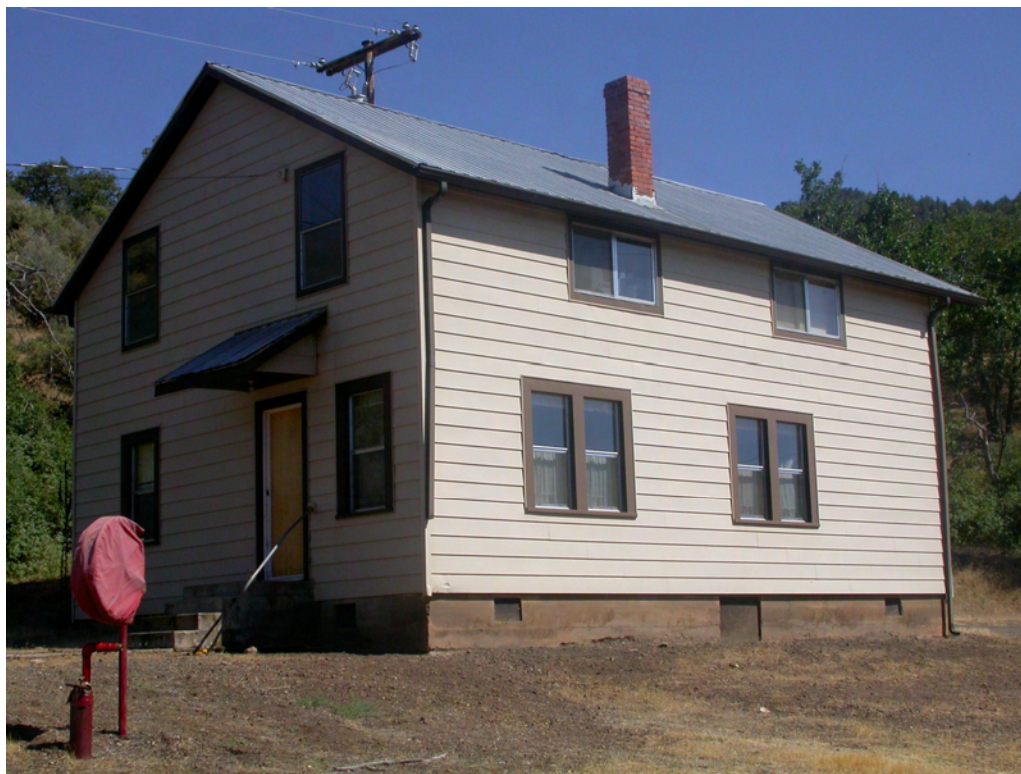
The former **cookhouse/bunkhouse** is a two story, wood frame building that faces north. It is two bays wide with a rectangular plan. Built on a concrete foundation, it is now clad in vinyl siding with aluminum replacement sash in the windows. Many of the replacement sash mimic the 1/1 configuration of the original wood sash, as evidenced by a 1942 photograph. The front gable roof is standing seam metal, and it retains its interior chimney on the western slope of the roof. A shed roof protects the front door, which is accessed by concrete steps with a metal handrail. The open eaves have been covered with vinyl soffits. Originally, the building had exposed rafter tails, elbow braces at the corners of the eaves, and decorative gable bracing, but that has all been removed. The building is in good condition, with fair integrity.

View: COPCO #2 Village – former Cook and Bunkhouse – July 2003

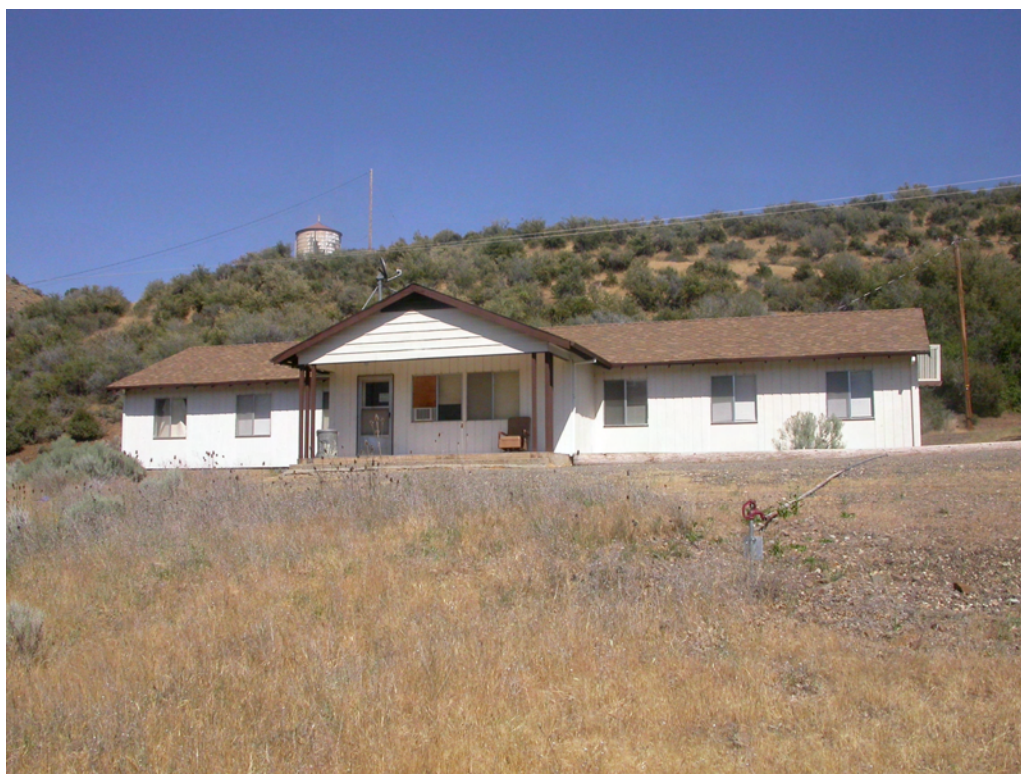
Just north of the former cookhouse/bunkhouse is a **modern bunkhouse** or rooming house. It faces west, with a large vacant lot or green space in front of it. It is a single story building on a concrete foundation. It features a projecting central entry section, with a three bay wing extending to both sides. The asphalt shingle roof is an intersecting gable with exposed rafter tails. The windows are sliding aluminum sash. The exterior is mainly wood paneling, but there is also masonite siding, and the gable ends feature rough-hewn wood siding. The building has a concrete front porch under the front gable, with triple wood posts at the outside corners. The building appears to date from the 1960s. It is in good condition but appears to be non-contributing.

View: COPCO #2 Village – Bunkhouse/Rooming House – July 2003

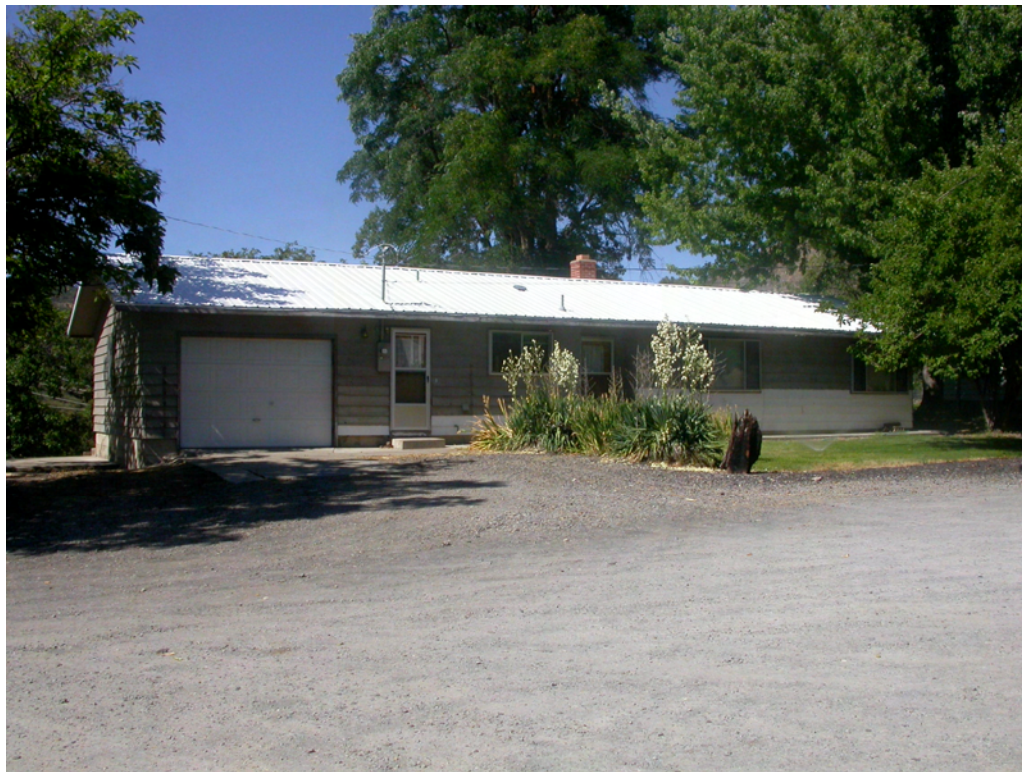
In COPCO #2 village, there are a number of **ranch-style houses**, probably dating from the early 1960s. They are all identical in appearance. They each have a rectangular footprint with a shallow side gable roof of R-panel metal and wide, boxed eaves. They are clad in 8-inch lapped wood siding on a concrete foundation. On one end is a 15-panel, aluminum overhead garage door. The windows are aluminum framed, either 1X1 sliding or sidelights flanking a picture window. The entry door is inset under the main roof, and there is an additional door near the garage. Both doors are covered by aluminum screen/storm doors. There is a large, brick, interior chimney set in the rear slope of the roof.

View: COPCO #2 Village – Worker Housing - typical ranch-style house – July 2003

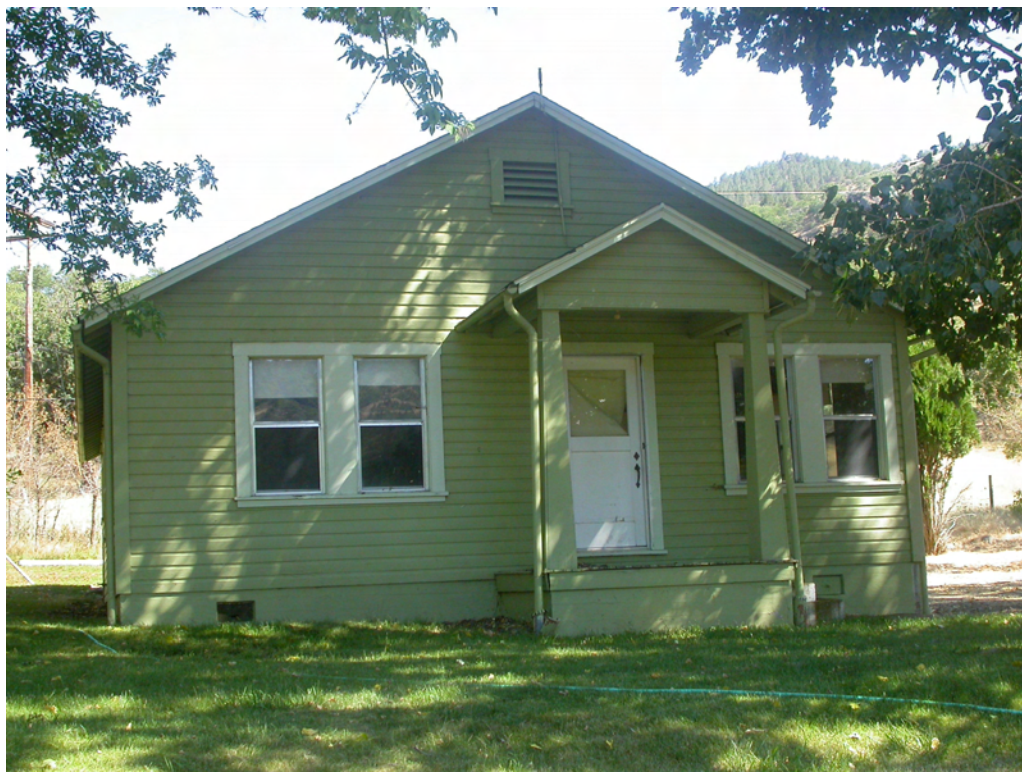
The village also contains a 1920s **bungalow** with garage, nearly identical to the bungalows found at COPCO #1. It is one story, three bays wide, with a front gable, asphalt shingle roof and concrete foundation. It is wood frame construction with drop wood siding and substantial surrounds on the doors and windows. The eaves have exposed rafter tails, and the front gable end is pierced by a wooden louvered vent. The front porch has a front gable roof supported on two battered wooden columns. It has wood decking and a tongue and groove ceiling. The original wood front door has a single panel below a single light window. On either side of the front porch is a set of paired windows. The sash have been replaced by 1/1 aluminum sash. On the rear facade, original windows have also been replaced by aluminum sliding sash. The rear door is the original 5-panel wood door, shielded by a shed roof overhang. The garage to the rear of the house has drop siding to match that of the house. Also on a concrete foundation, it has a front gable roof with a sliding, top rail, vehicular door that is also of drop siding. There is also a 5-panel door offset in this facade. This site has an expansive planted lawn with mature trees, including cottonwoods. A dry laid stone retaining wall encircles the property on the north and west sides.

View: COPCO #2 Village – Worker Housing – typical bungalow – July 2003

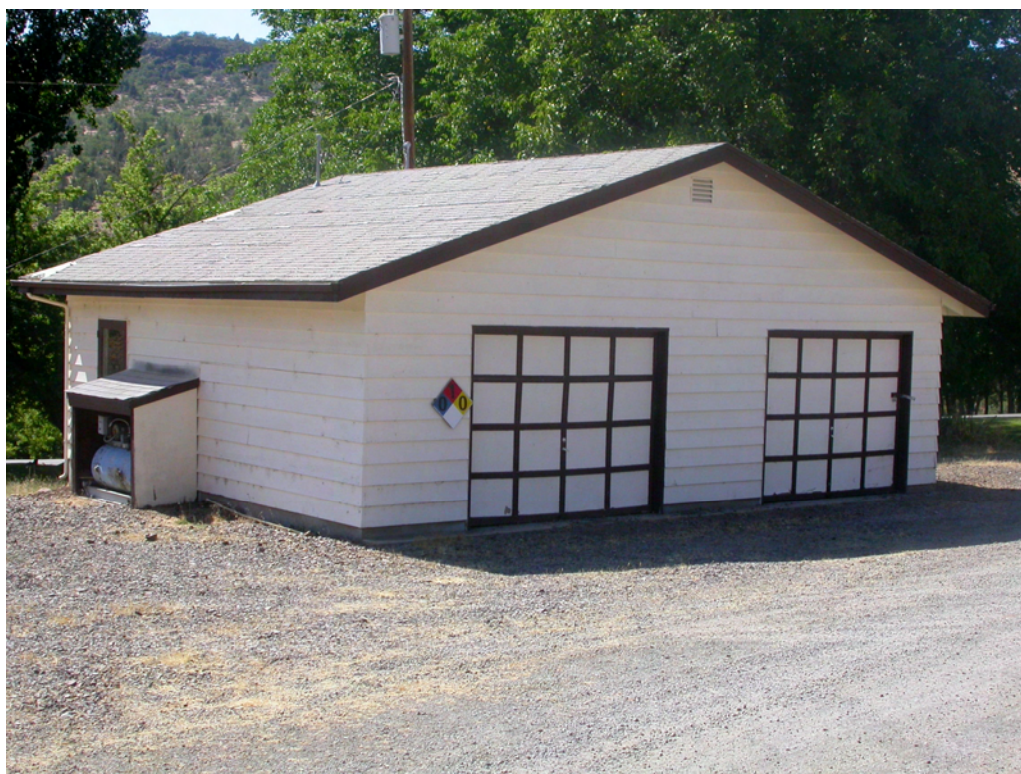
West of the former cookhouse/bunkhouse is a single story, two bay **garage/storage building**. It appears to be an accessory building with no primary building extant. Built on a concrete foundation, it has a shallow front gable roof of asphalt shingle with exposed rafter tails. It is clad in 8-inch lapped wood siding and has aluminum sash windows on the rear facade. The front facade features two paneled roll-up garage doors. There is a pedestrian door with a single-light window on each side facade. The front gable end is punctuated by a small louvered vent. An accessory shed is attached on the east side facade. The building is in good condition with good integrity.

View: COPCO #2 Village – Garage/Accessory Building – July 2003

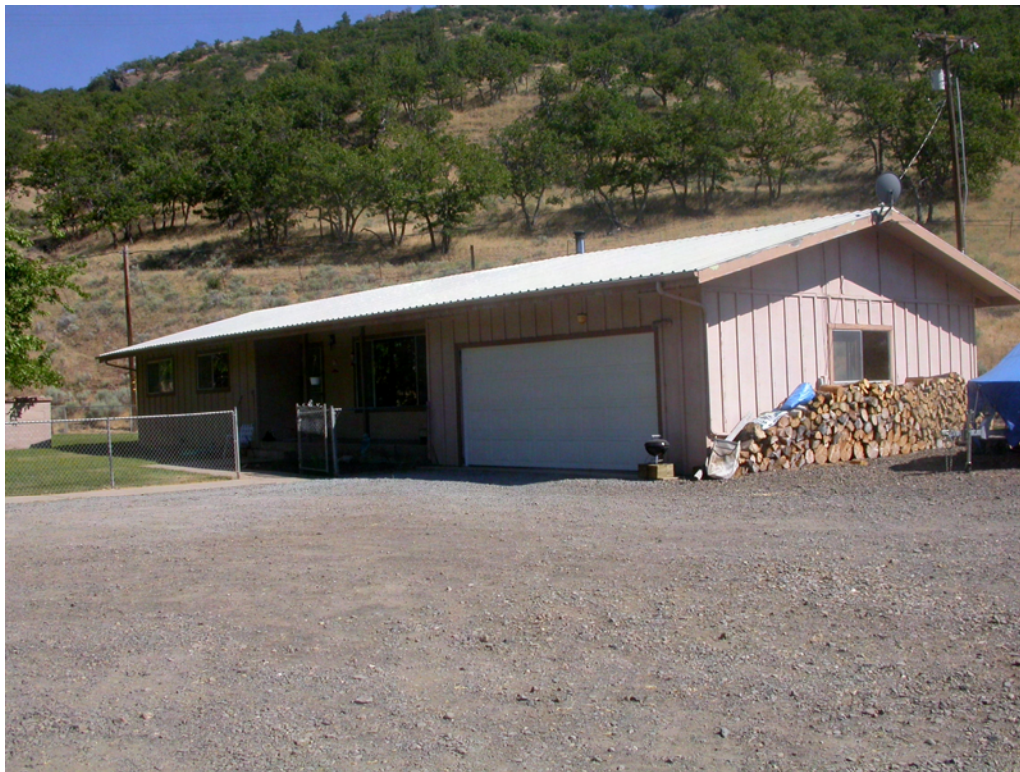
There are three modern, modular or **prefabricated houses** on the village site. A typical example is the one next to the 1965 school house. Single story and rectangular in plan, it is clad in board and batten siding and has a corrugated metal roof with a substantial eave overhang. The windows are aluminum framed. A deep inset in the center of the front façade protects the entry door and a picture window. Immediately adjacent to this is a paneled overhead garage door. At least two of these houses (cont.)

date from 1985, when they were constructed as operator's houses. They are all in good condition but are non-contributing.

View: COPCO #2 Village – Worker Housing – typical modular housing – July 2003

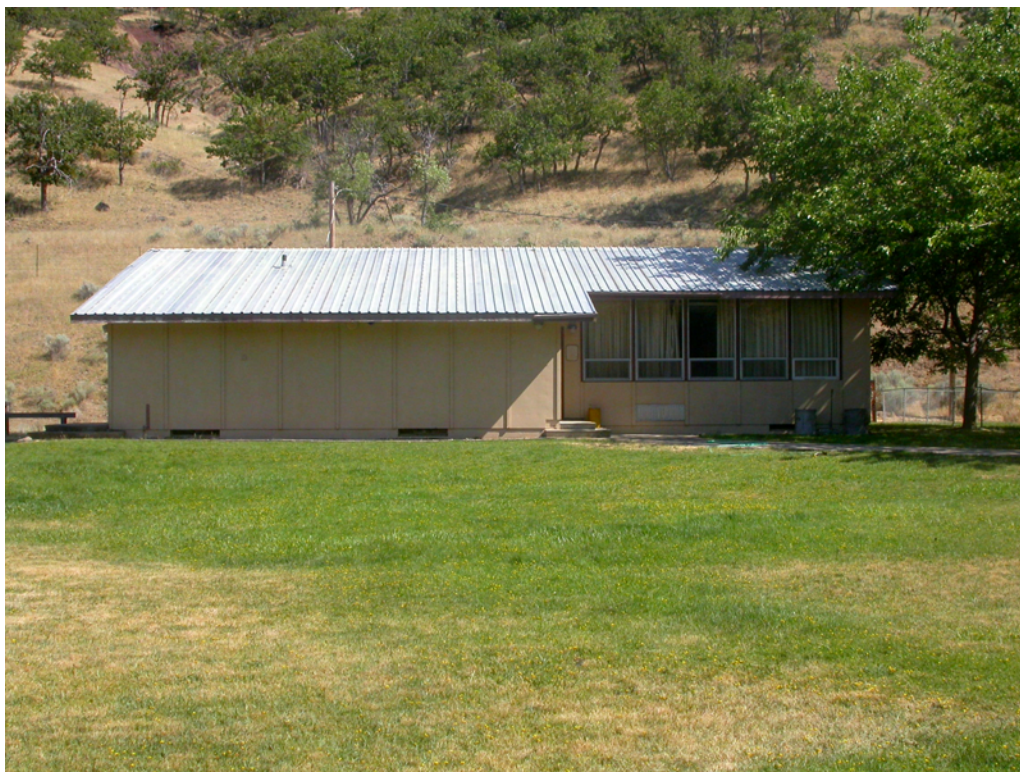
The 1965 **school house**, now used as a community center, replaced the 1922 school house at Fall Creek. It is a one story, wood framed building on a concrete foundation and is clad in masonite siding. It has a side gable roof of standing seam metal with deep eaves. Half of the front façade is dominated by large aluminum-framed windows. A relatively small building for a school, it is architecturally unassuming. It is in good condition and represents a continuation of the social development of the COPCO #2 village. While compatible with the project's history, it is considered a non-contributing resource due to its construction after the defined period of significance.

View: COPCO #2 Village – Former Schoolhouse (1965) – current Community Center – July 2003
