Lewis River Aquatic Fund Projects (SA 7.5.3.2)

Project Closeout Report

Project Title: Lewis River Hydroelectric Project
Eagle Island Site A Habitat Restoration

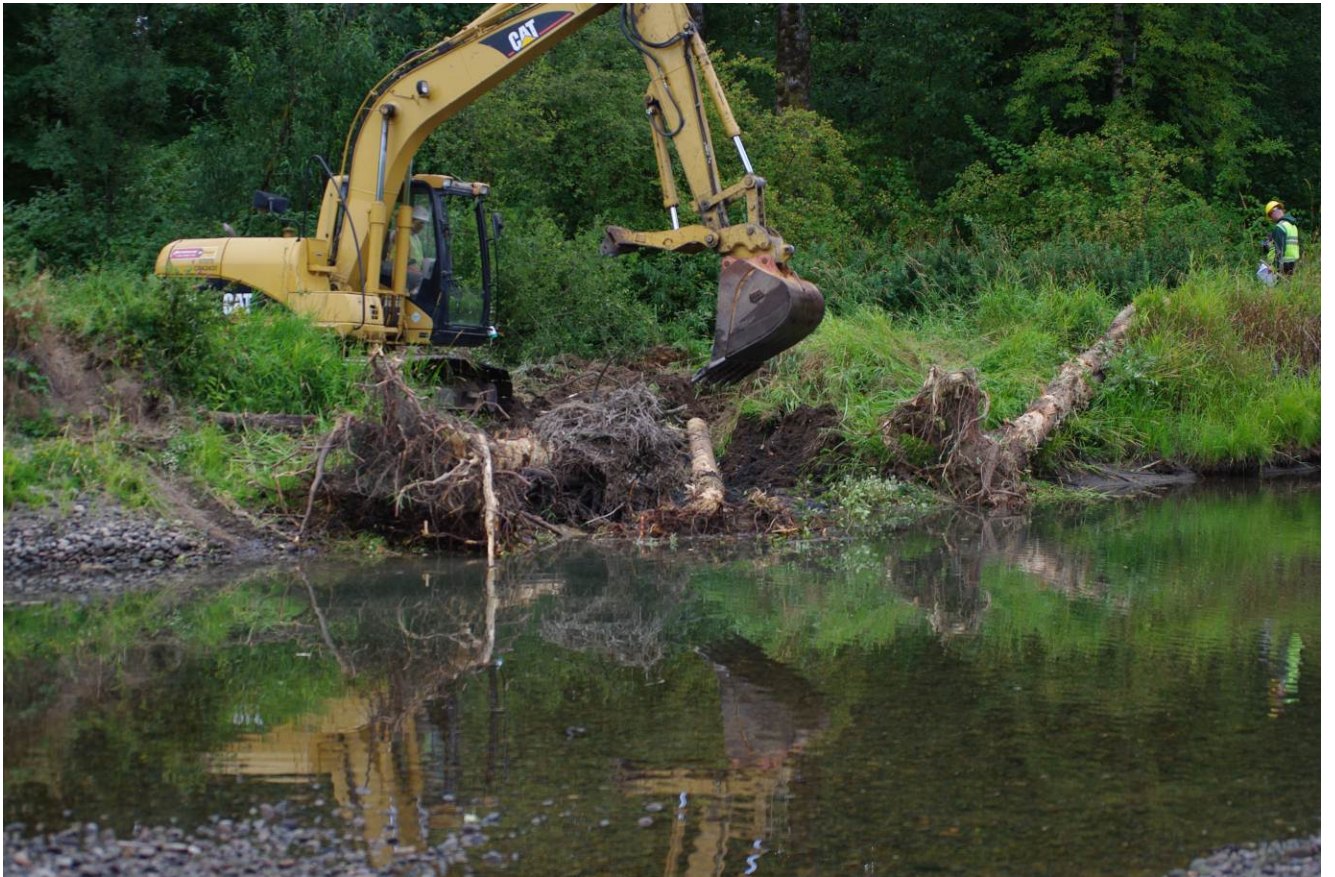
Installation of an upstream scour pool structure. This structure was buried and ballasted into the bank.

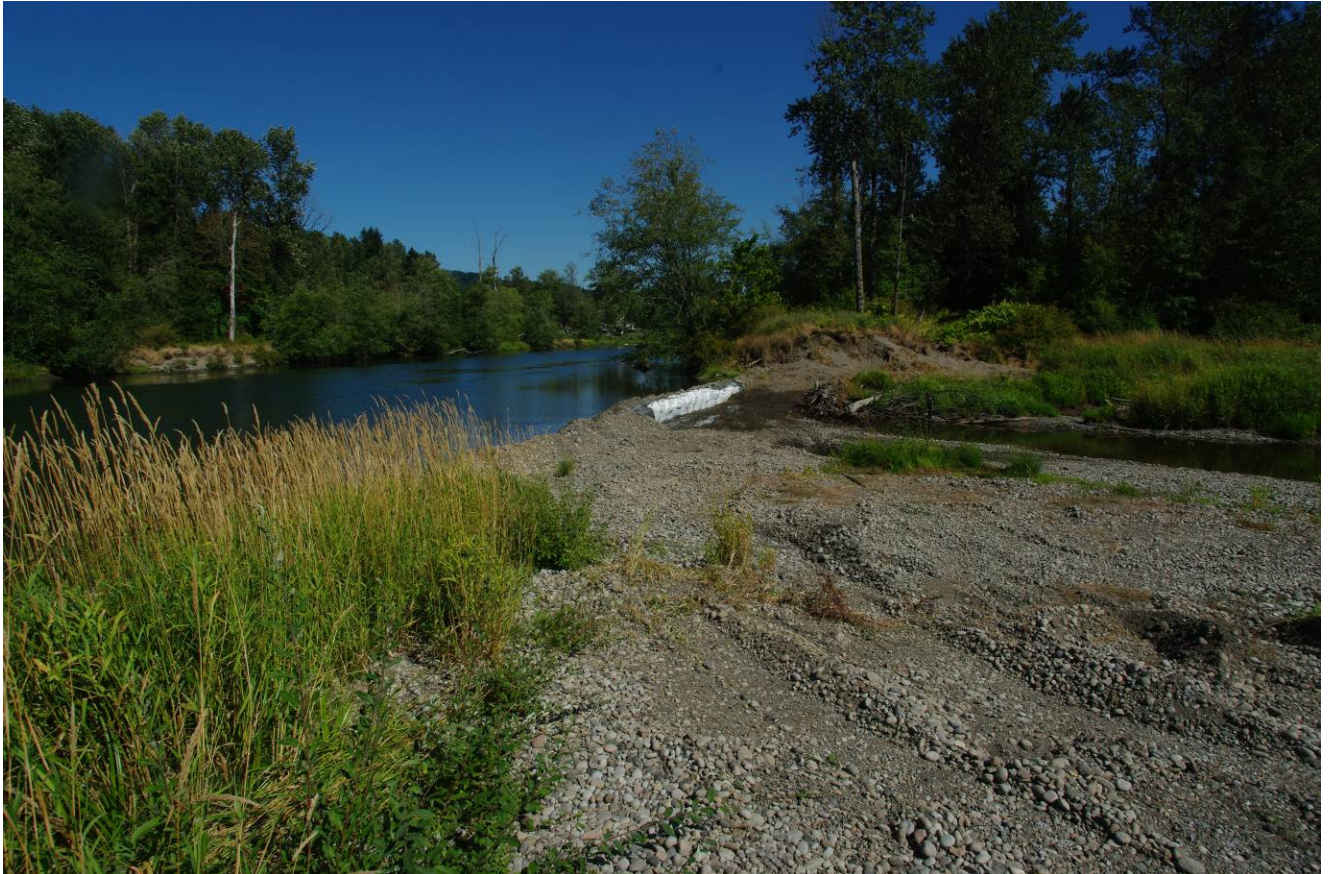
Upstream coffer dam. The entire project site was dewatered and kept from "live" water throughout the entirety of the construction phase.

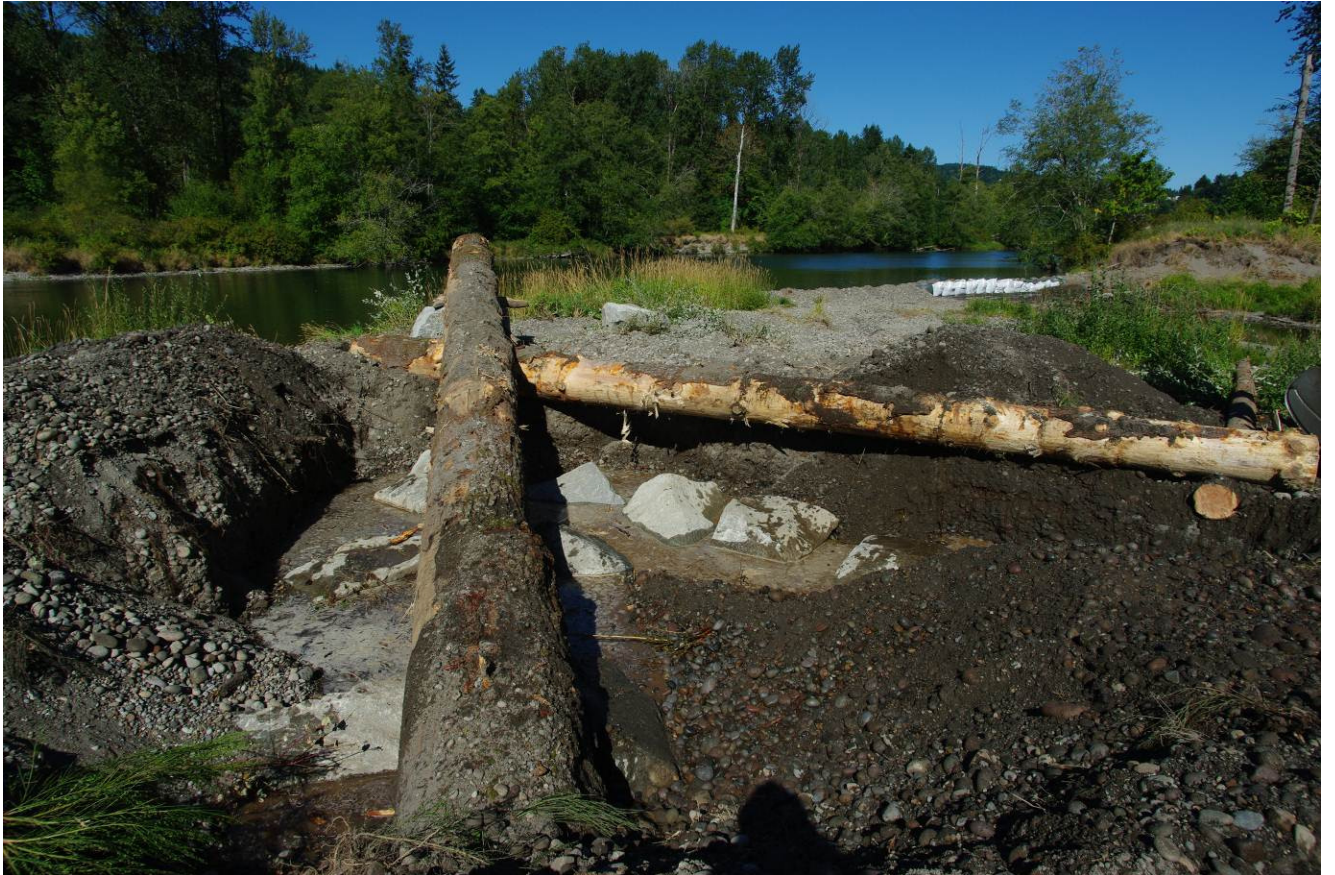
Key log structure of the apex bar jam at the head end of the project. Note the boulders loaded into the excavation in preparation of the next key elements.

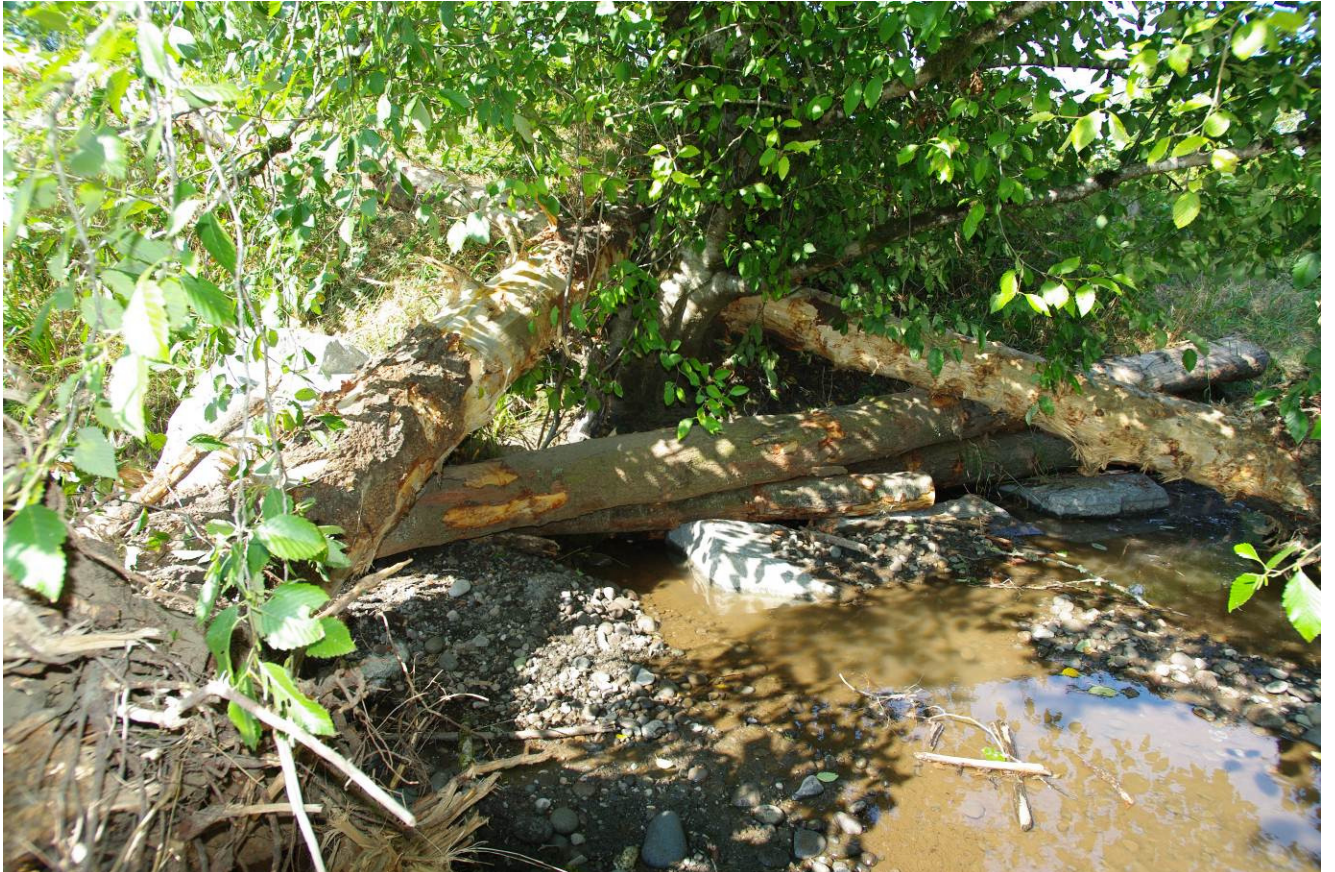
Incorporating an existing alder to make a habitat wood structure

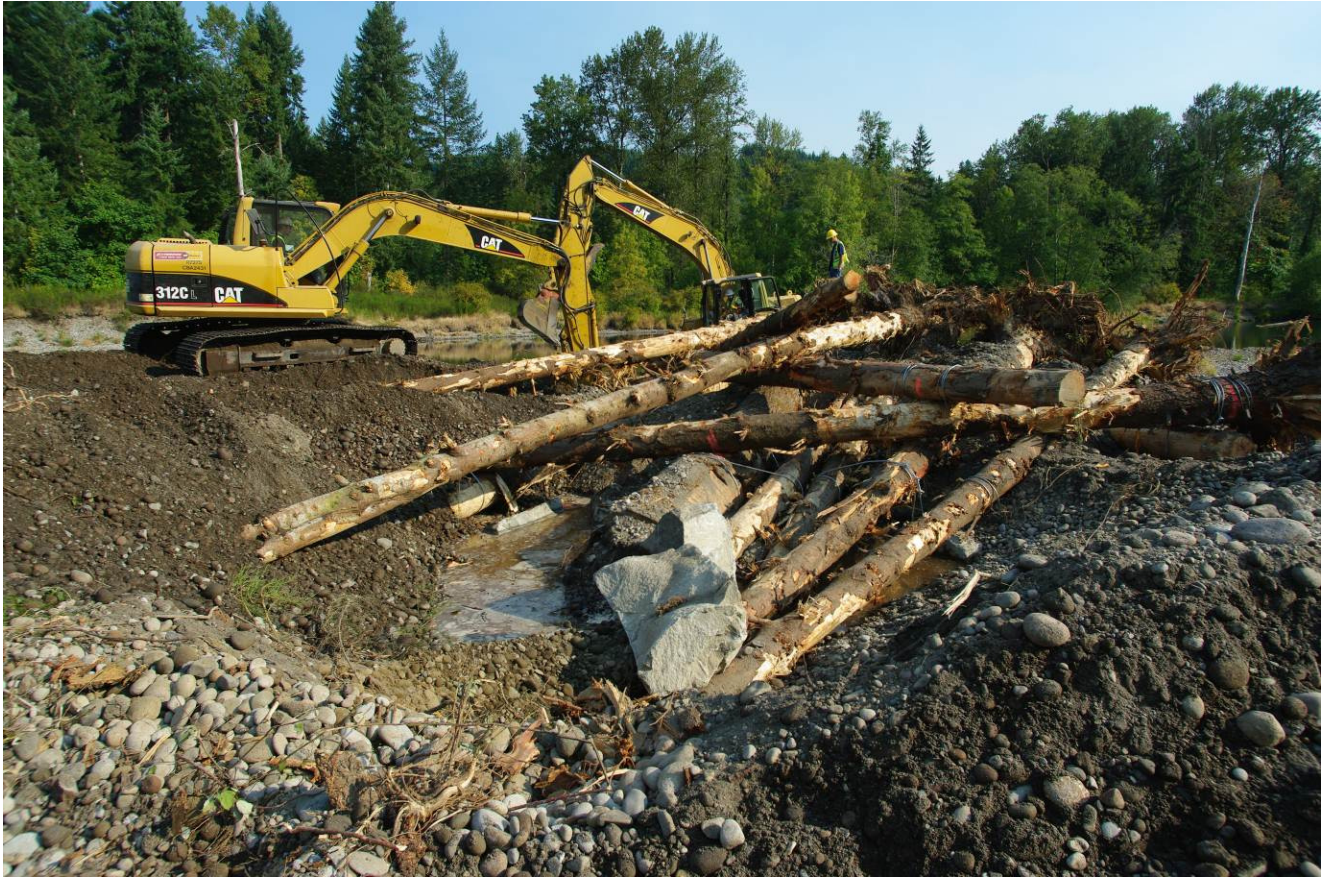
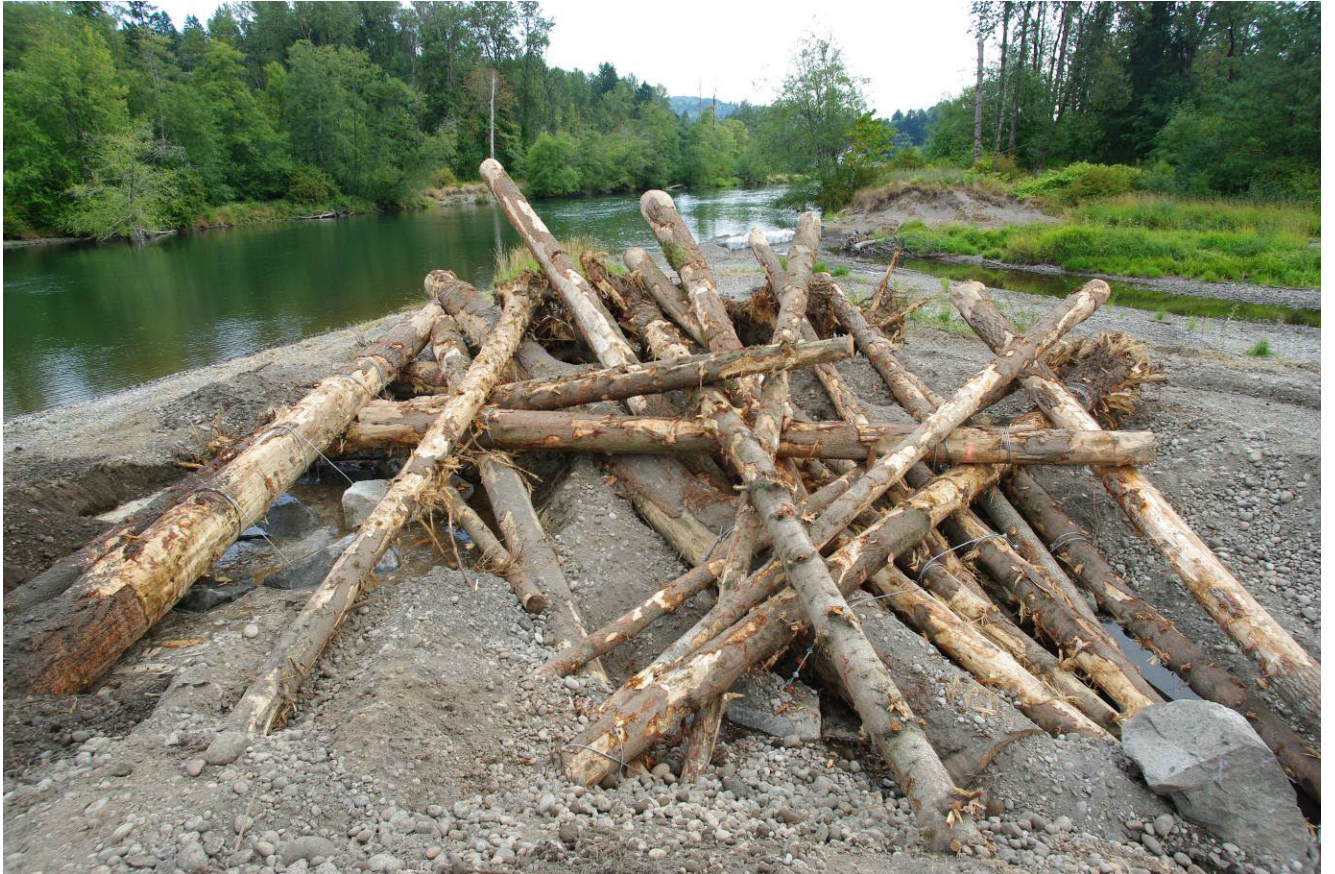
Adding wood pieces to the head end apex jam structure(above), below, looking down at the head end apex jam structure.

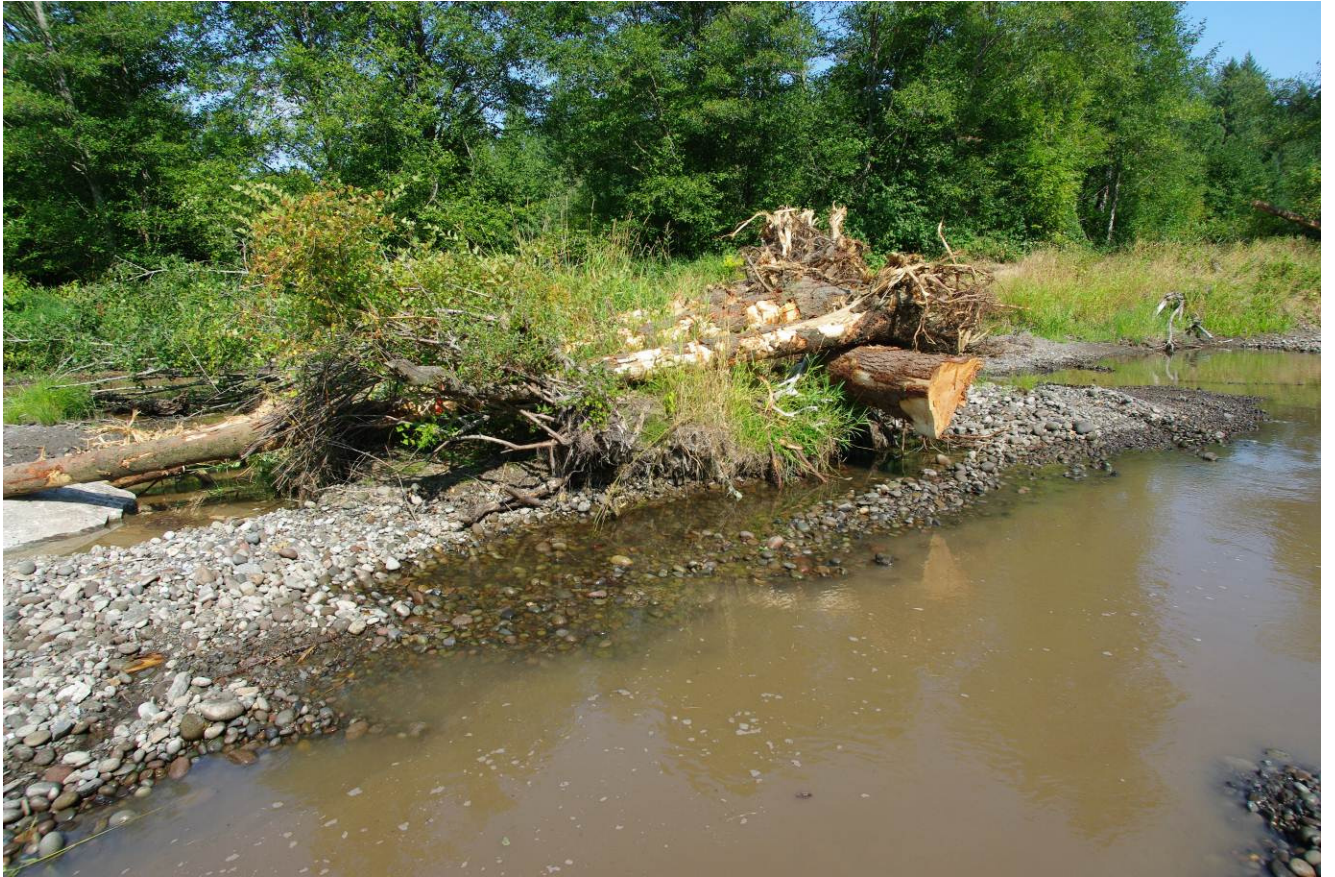
An apex bar jam structure built around an existing alder tree that had fallen

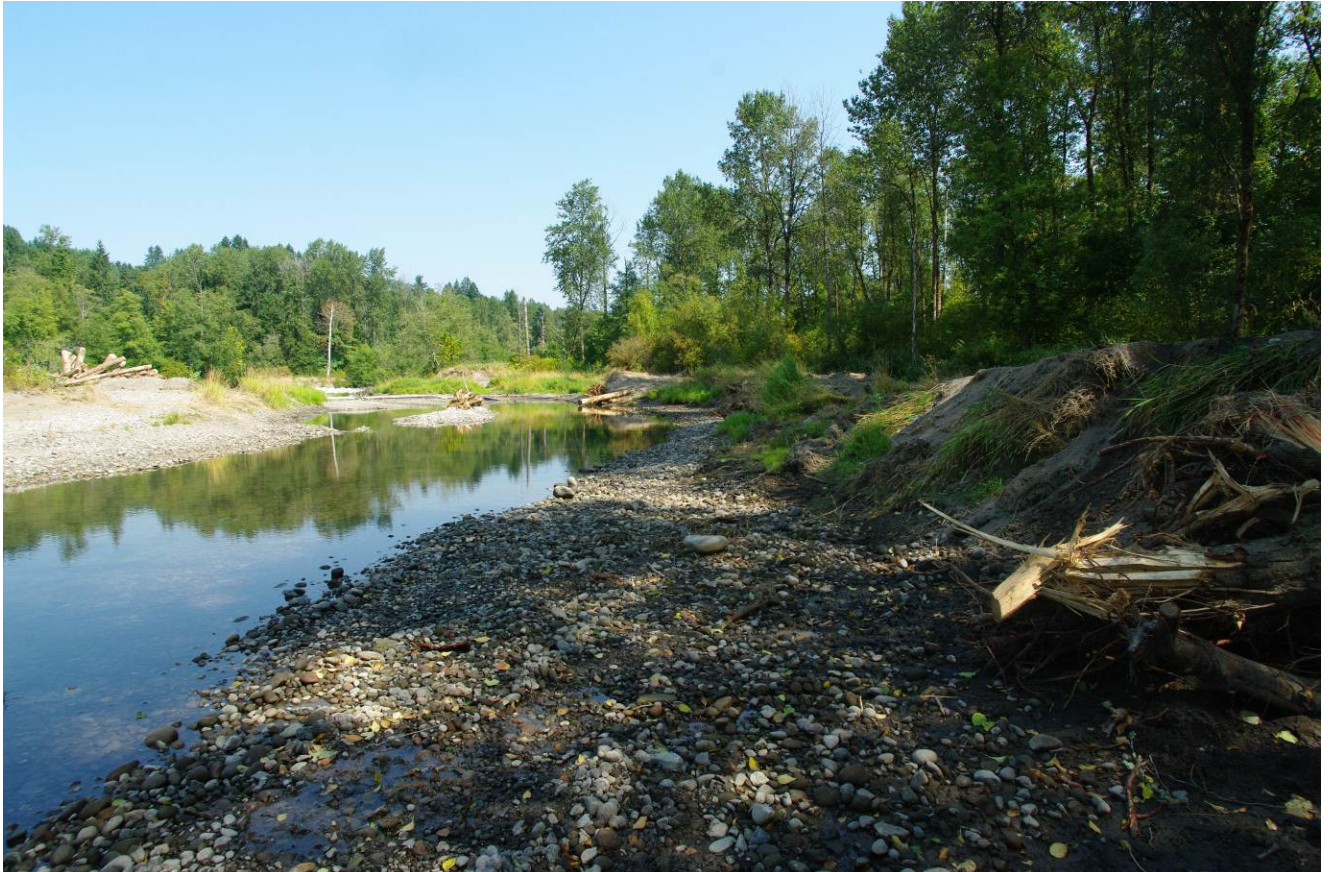
Looking upstream from the south bank of the side channel from the pre-construction photo. Visible on the right are three scour pool structures, in the center a log with rootwad anchored in place, and the head end apex bar jam on the left. Floodplain wood is not yet in place.

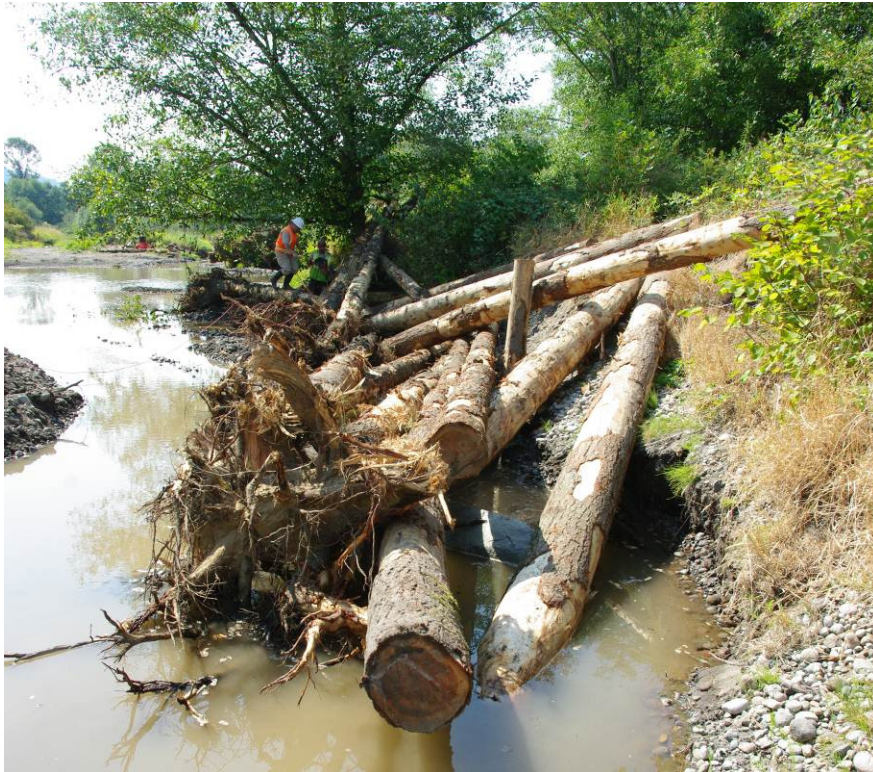
Habitat wood structure being cabled to boulder ballast (not visible in image)

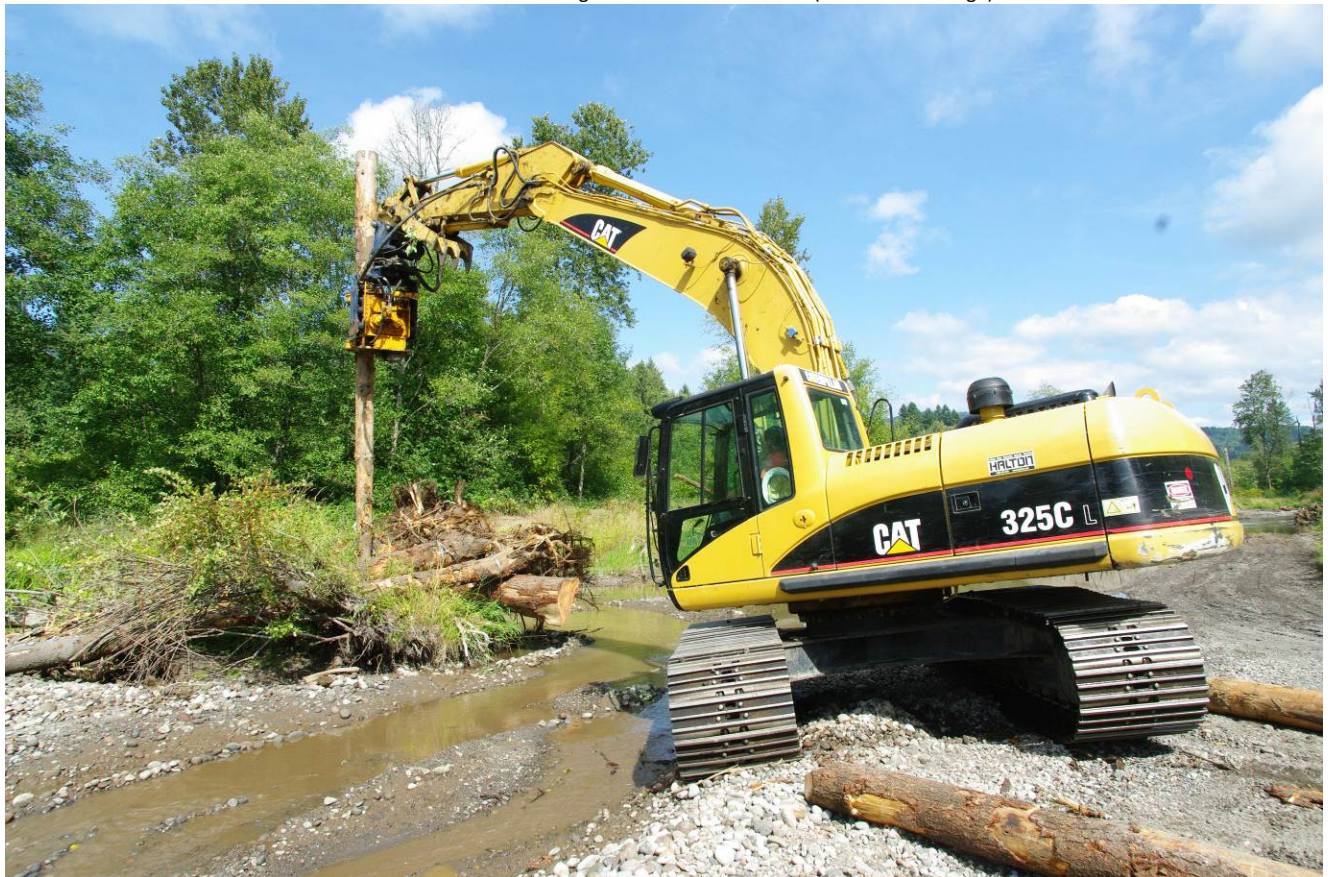
Pile being driven into apex bar jam number three. There were four apex bar jam structures built into the project.

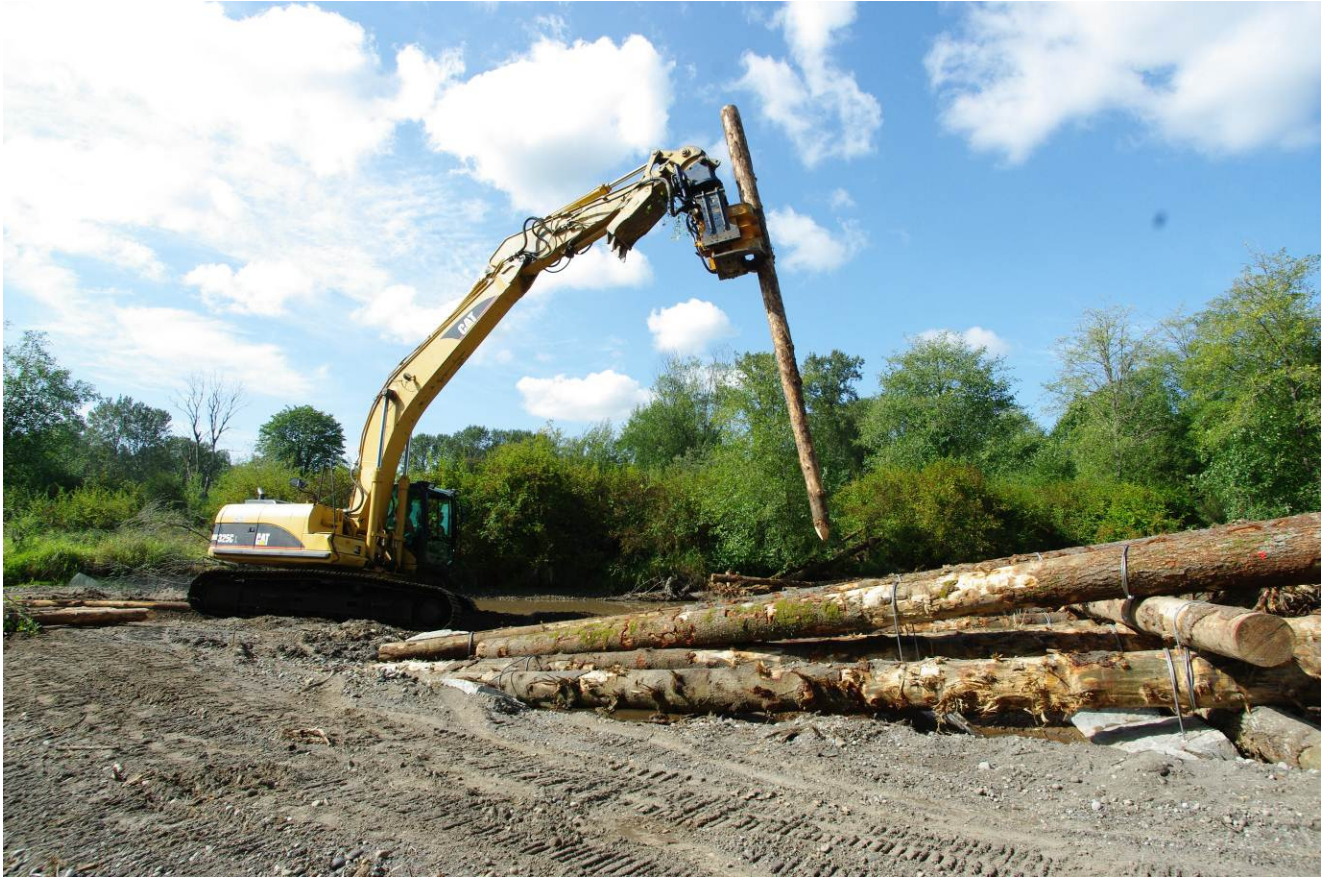
A pile being readied to be driven into apex bar jam #2. This was the typical length and diameter of the logs used as piles

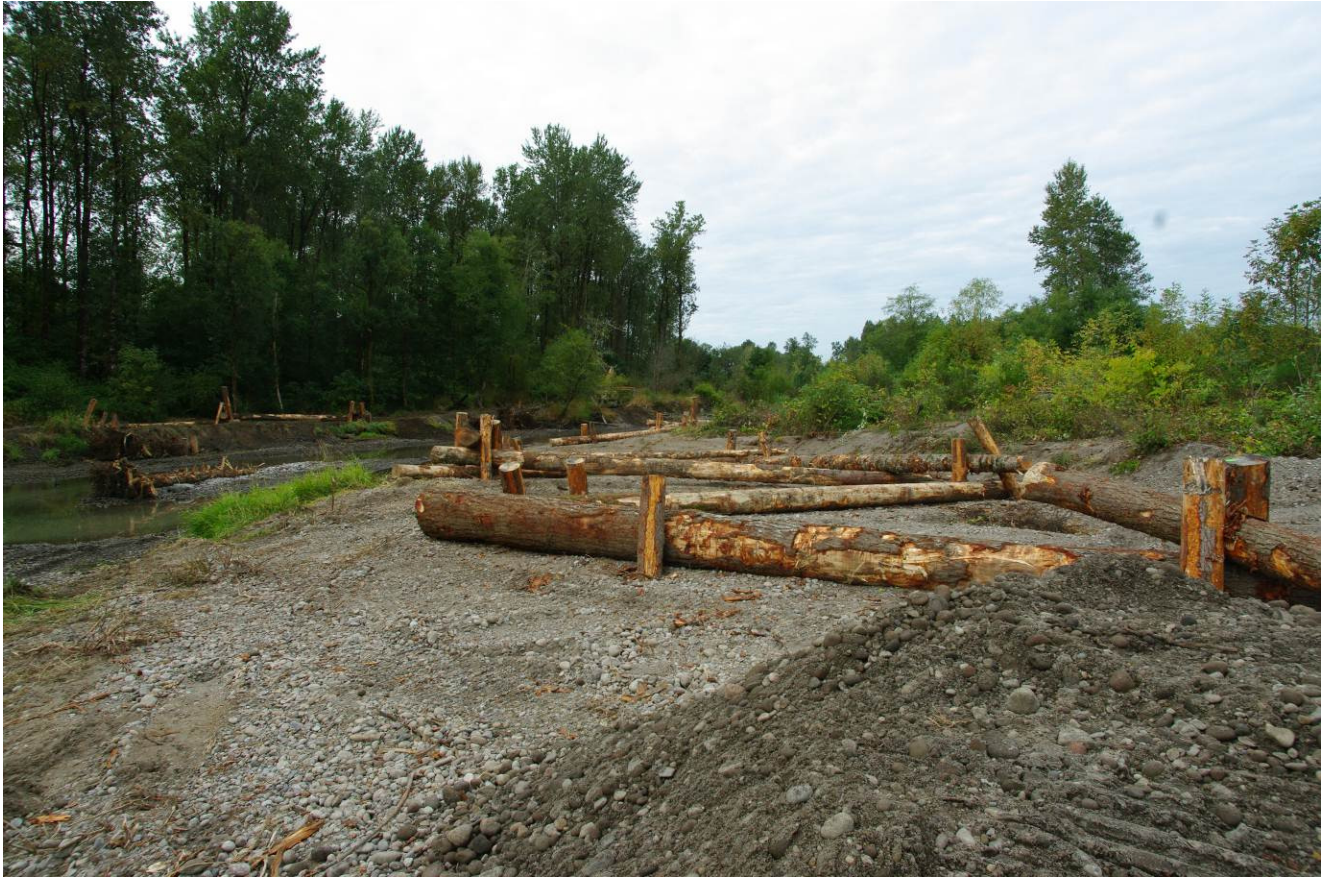
Floodplain wood structures. Consisting of approximately 90 logs, the two floodplain structures (part of the south bank structure is visible here) channel energy into the intended channel at high flows

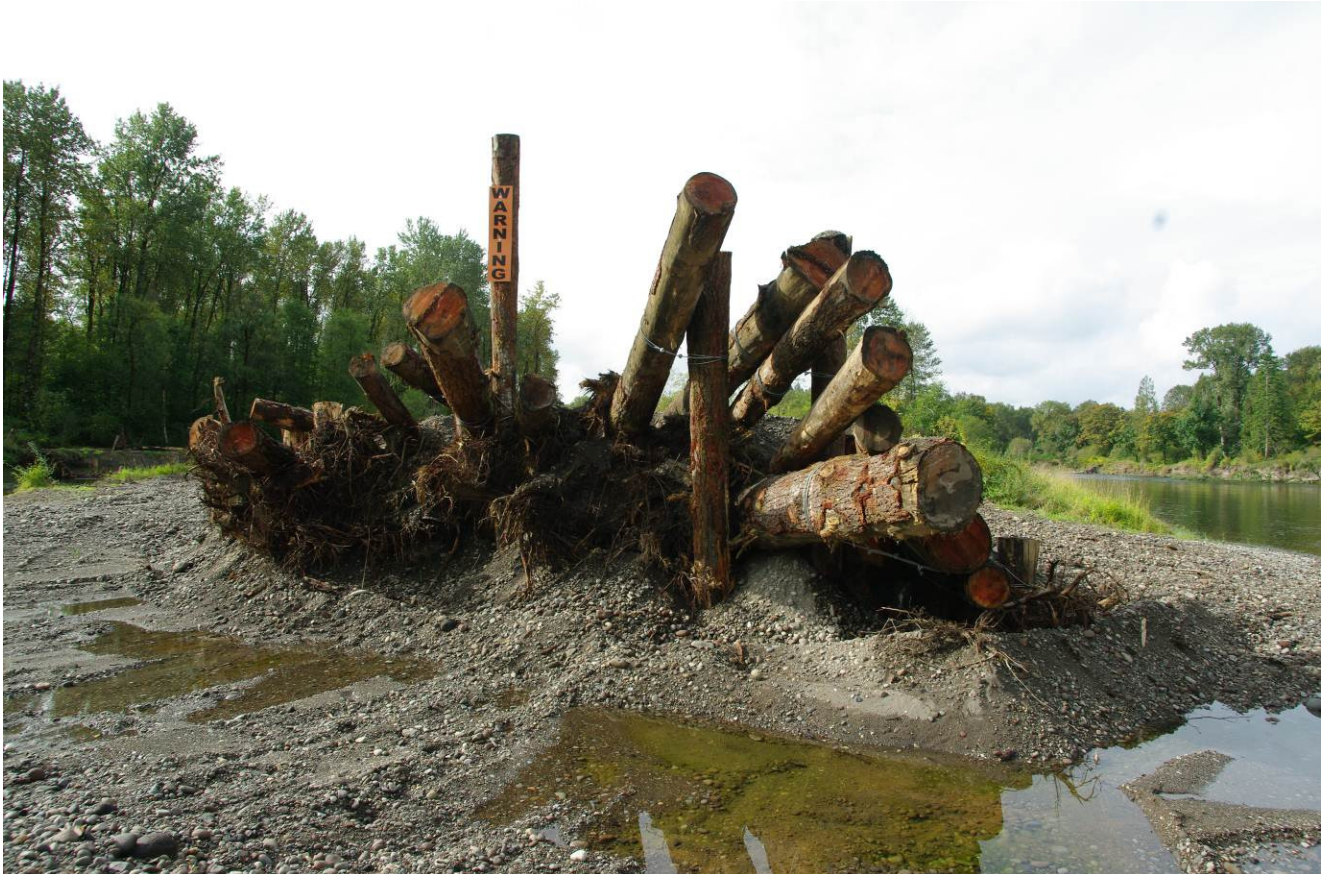
Apex bar jam structure at the head end of the project with warning sign visible. The sign uses 10inch letters and complements the detailed warning sign placed 50 feet out away from the structure.
