**CLEAR CREEK & CLEARWATER CREEK
GEOMORPHIC & HYDRAULIC
ASSESSMENT MEMO**

Gifford Pinchot National Forest
Mt Adams Ranger District
2455 Hwy 141
Trout Lake, WA 98650

DJ&A, P.C.
2000 Maple Street
Missoula, MT 59808

October 11, 2022

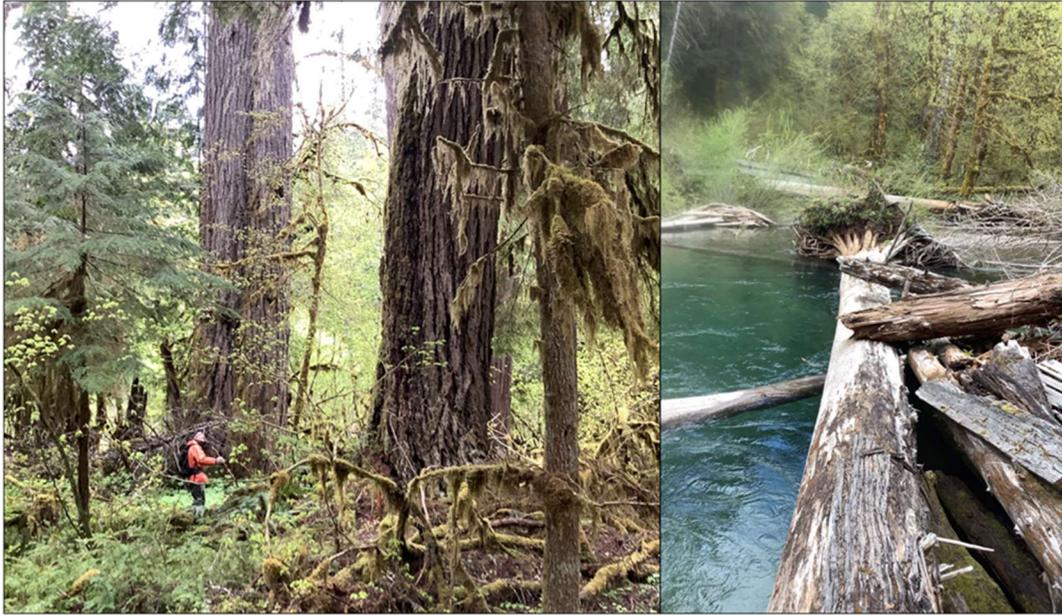
Photo 1. Old-growth-sized tree standing in the floodplain (left) and stabilizing a large wood accumulation in Clear Creek (right).

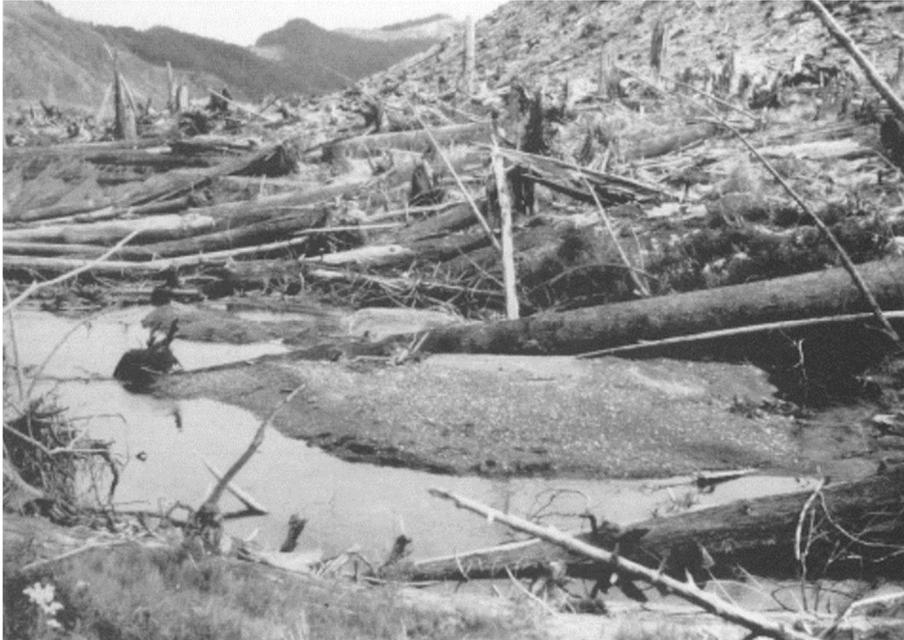
Lisle (1995) conducted monitoring in the upper reaches of Clearwater Creek (above the confluence with Bean Creek) and noted that a substantial amount of wood and sediment (ash, sand, pumice, and gravel) was washed into the channel in the first 1-2 years following the eruption and quickly transported to the lower reaches. Mass wasting on the hillslopes delivered coarse material to the stream. Figure 5 shows post-eruption channel conditions on Clearwater Creek, though specific information regarding the date and specific location were not included in the article.

Figure 5. Channel conditions in upper Clearwater Creek following the eruption of Mt St Helens (Lisle, 1995).

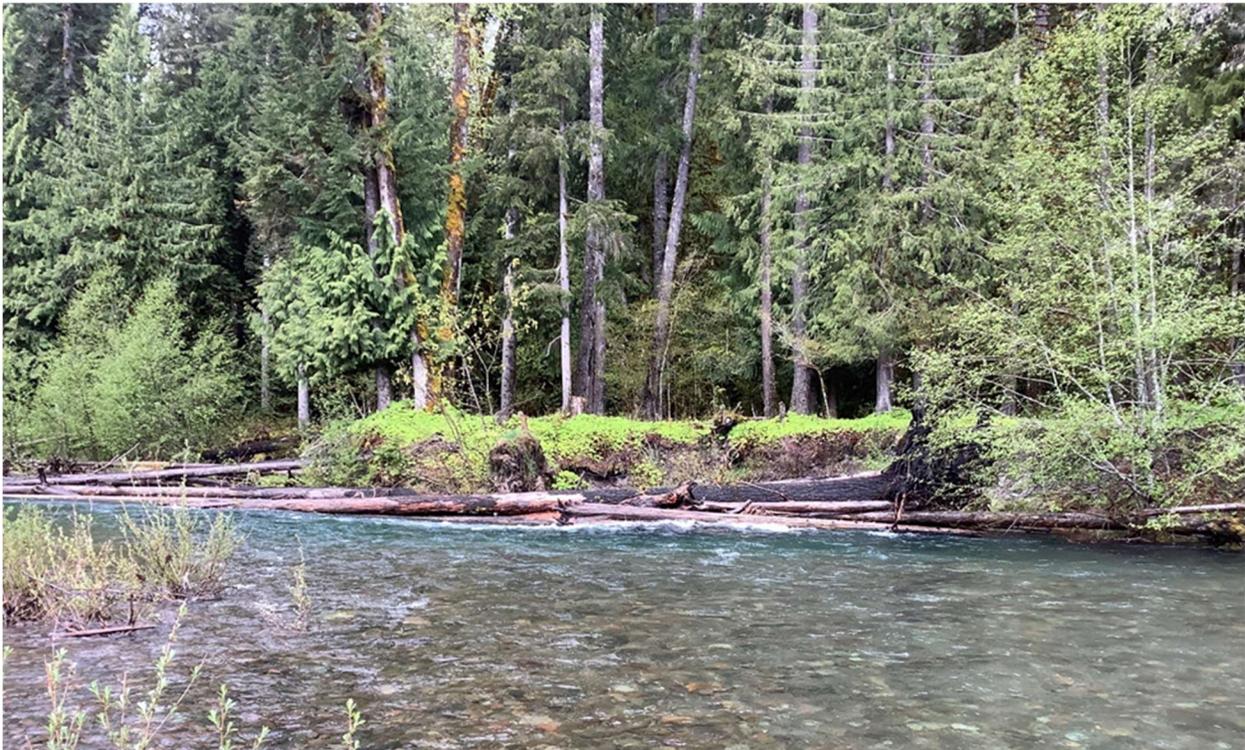
Photo 2. Large conifers, recruited from the terrace visible in the background, are forcing pool scour and the formation of bedforms in Clear Creek.

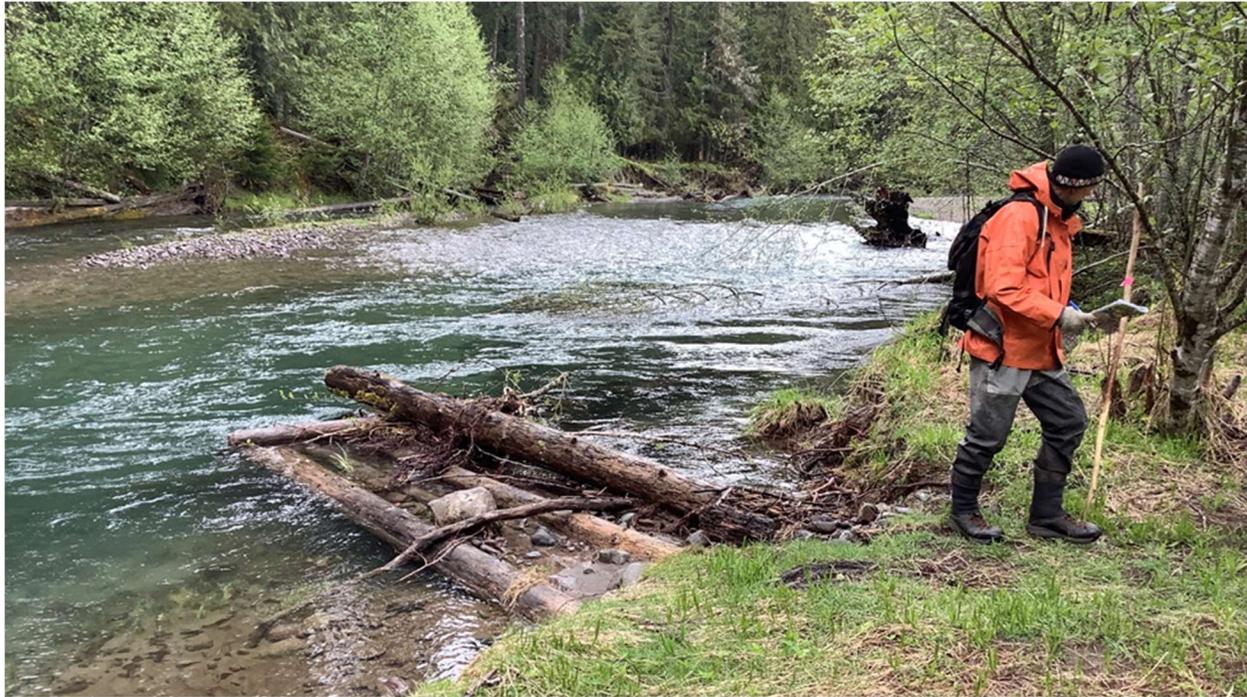
Photo 3. Remaining portion of a bank buried wood structure scouring a pool in Clear Creek.

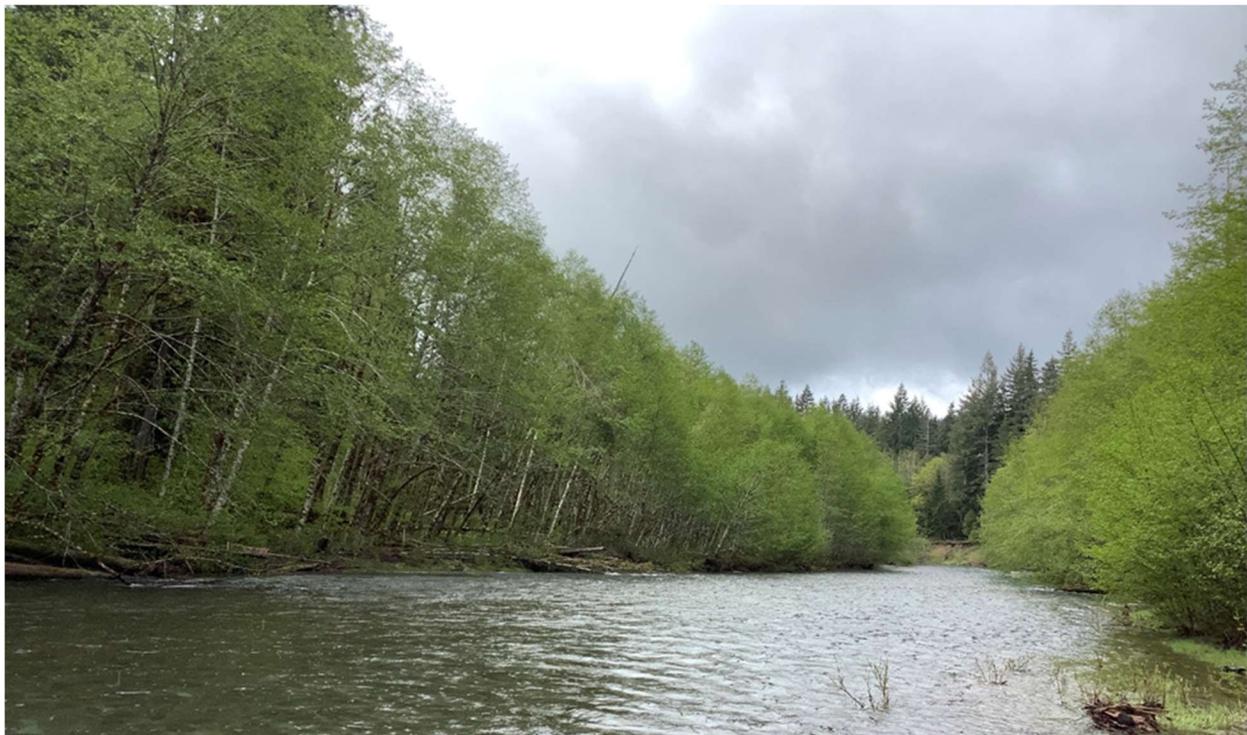
Reach 1 on Clear Creek extends downstream from the bridge on NF-93 to the confluence with the Muddy River. The reach is relatively unconfined, though bounded on the north side by an elevated river terrace (Photo 2). Channel slope is around half of a percent with an average bankfull width of approximately 260 feet. Unlike upstream reaches the channel is predominantly single thread, which may be related to the restoration project that was implemented at some point in the past (Photo 3). Much of the immediate overbank is covered by alder (likely deposited during the 1996 flood), which provides little erosion resistance to Clear Creek flows and thus is not large enough to influence channel geomorphology (Photo 4). The lack of large (key piece) trees has limited habitat development through Reach 1.

Photo 4. Alders, perhaps associated with the 1996 floods, line a portion of Clear Creek through Reach 1. The alders are not large enough to create roughness and influence the local geomorphology.

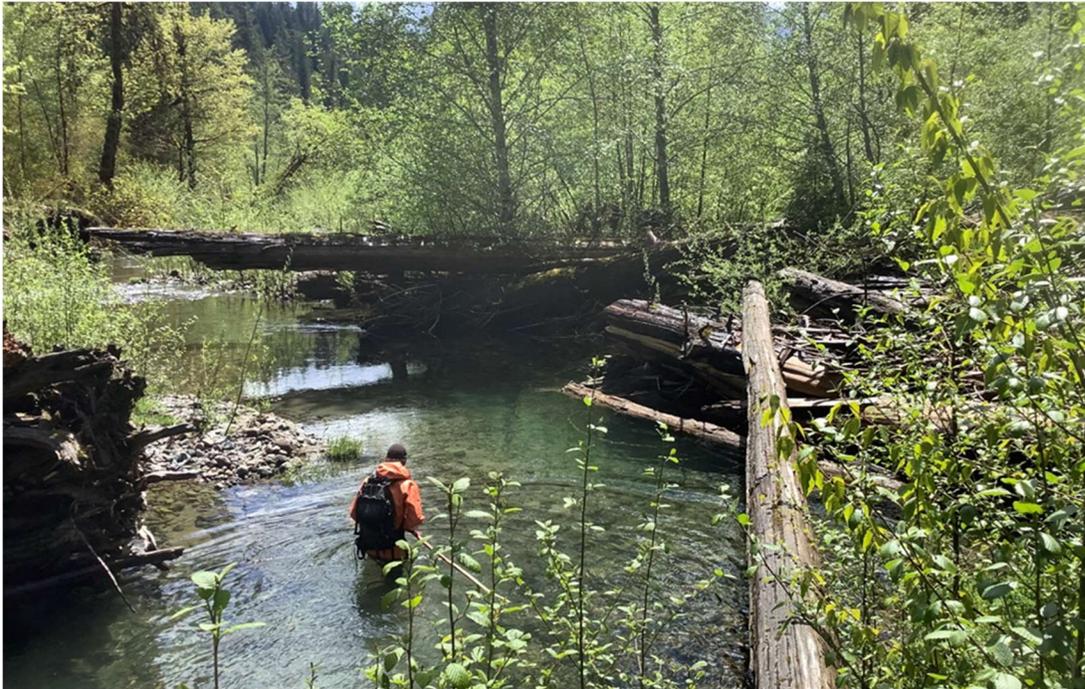
Photo 5. Clear Creek working through wood accumulations that have persisted through time. The wood accumulation has influenced the formation of deep pools and multiple channels across the valley bottom.

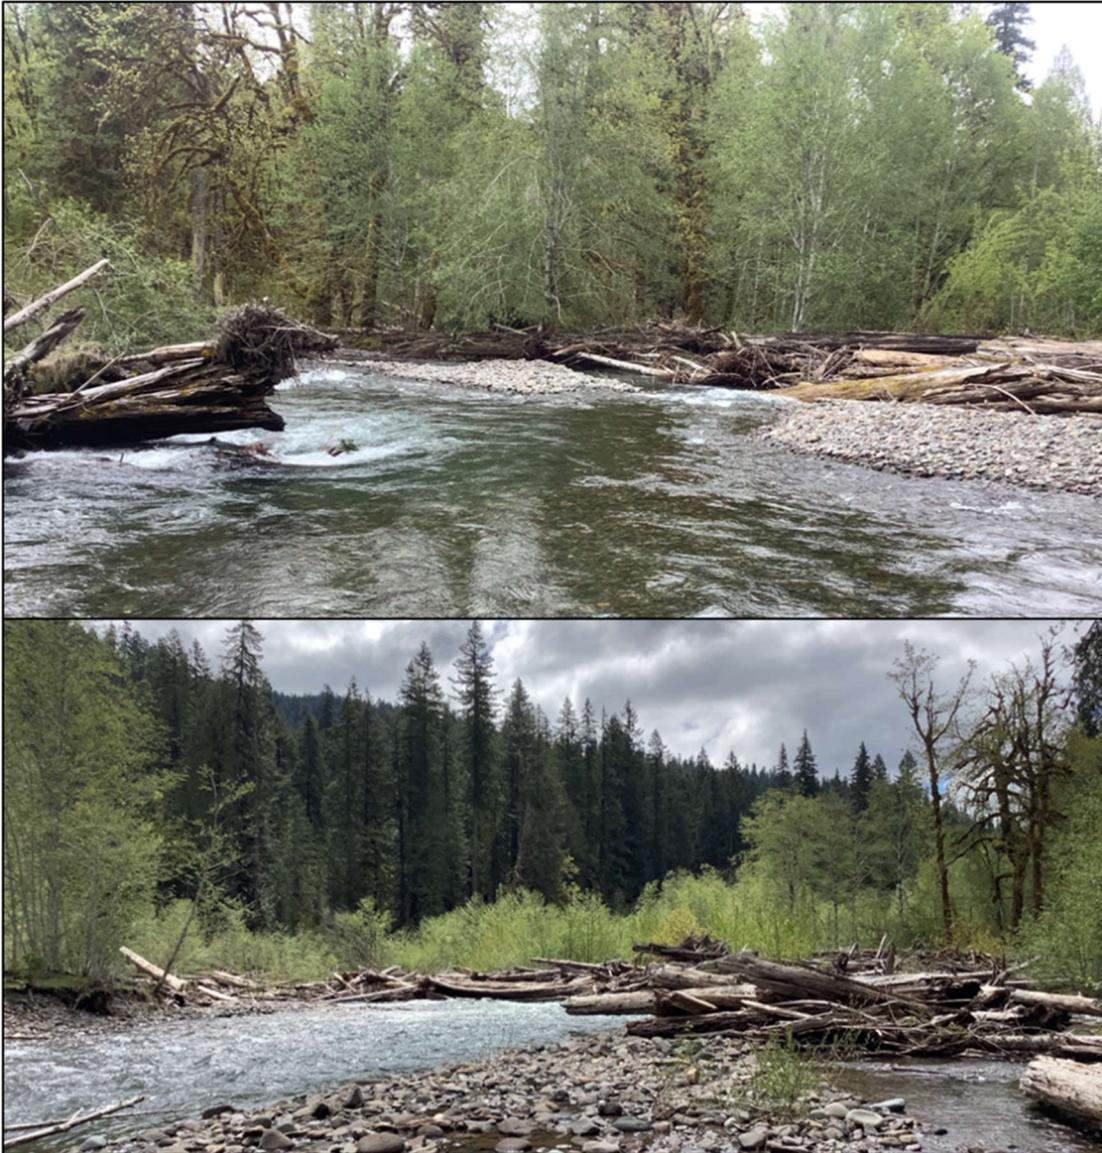
Photo 6. Valley-spanning wood accumulations with forest recolonization on the downstream side (hydraulic shadow) of the accumulations.

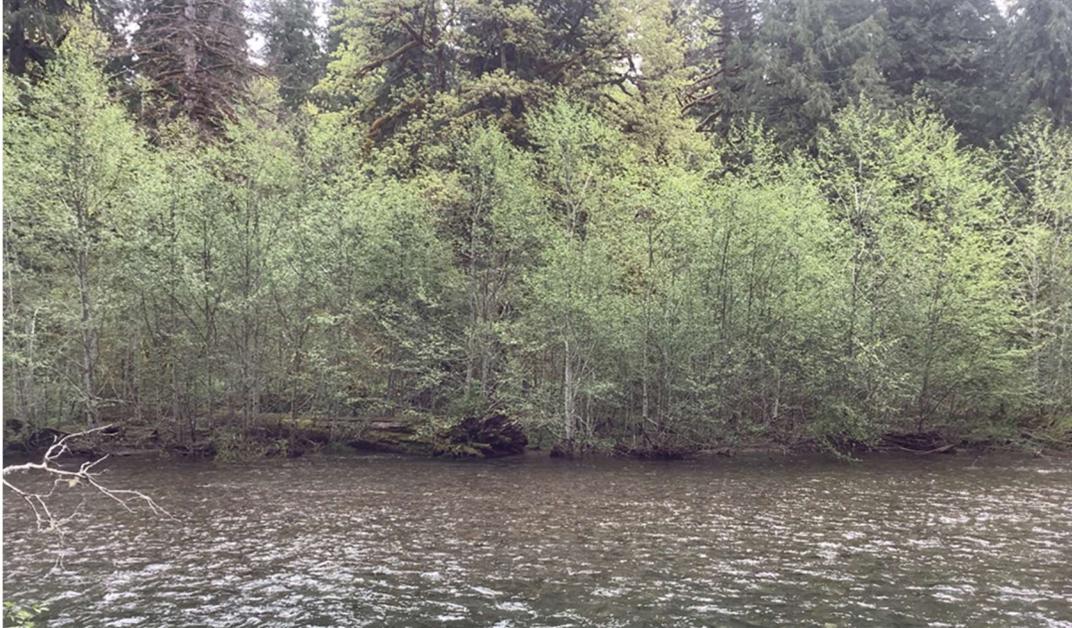
Photo 7. The channel upstream of a channel-spanning jam is aggraded (note the sediment buildup on the far side of the river in the inundated alder stems) and the available wood (young alder) is not sufficient size to influence the local geomorphology.

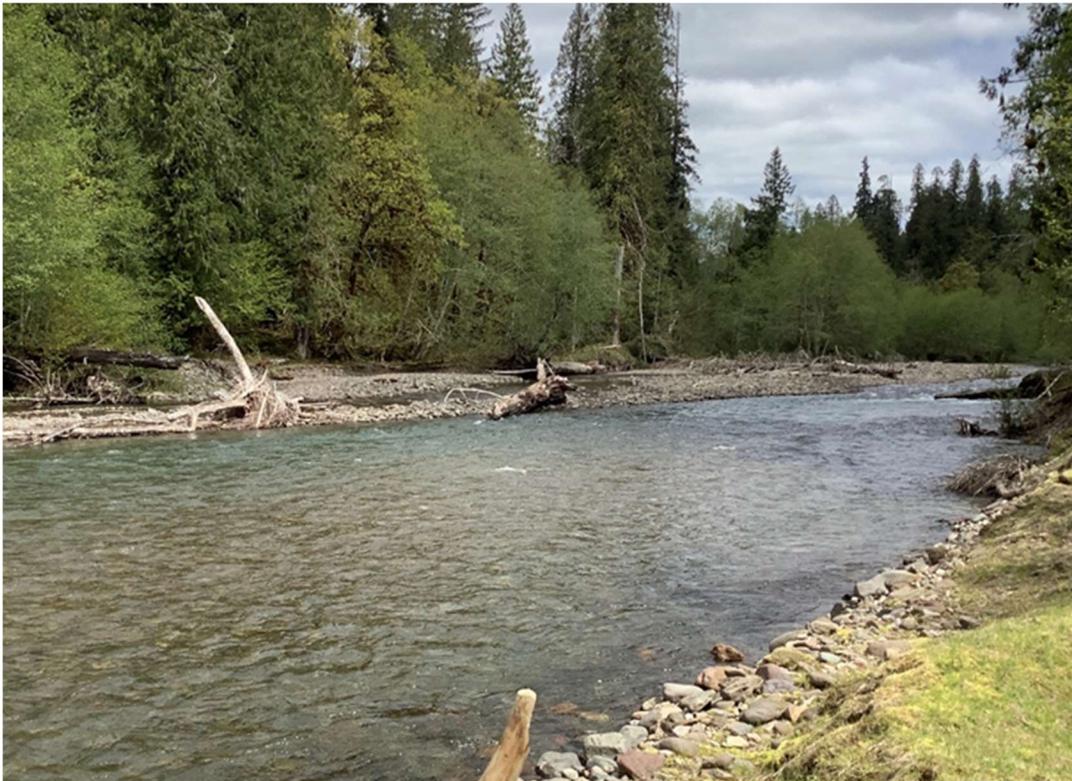
Photo 8. Wide and shallow section of channel lacking wood of sufficient size to self-stabilize in the channel.

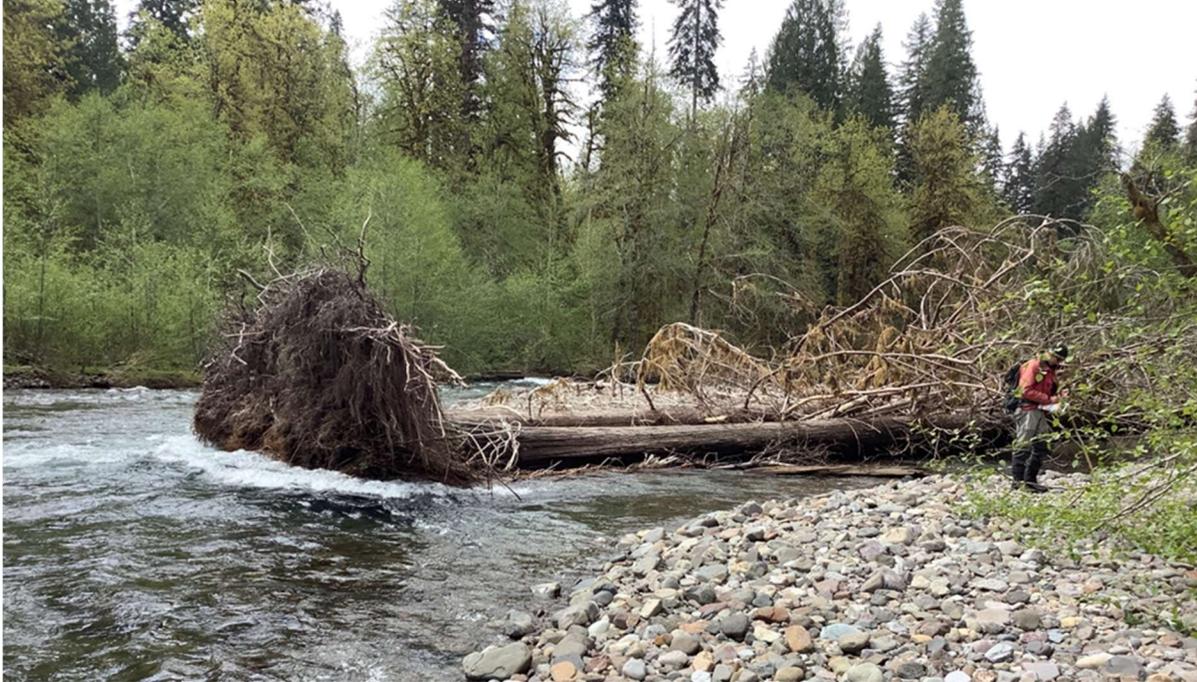
Photo 9. In situ key pieces provide opportunities onto which to rack additional material.

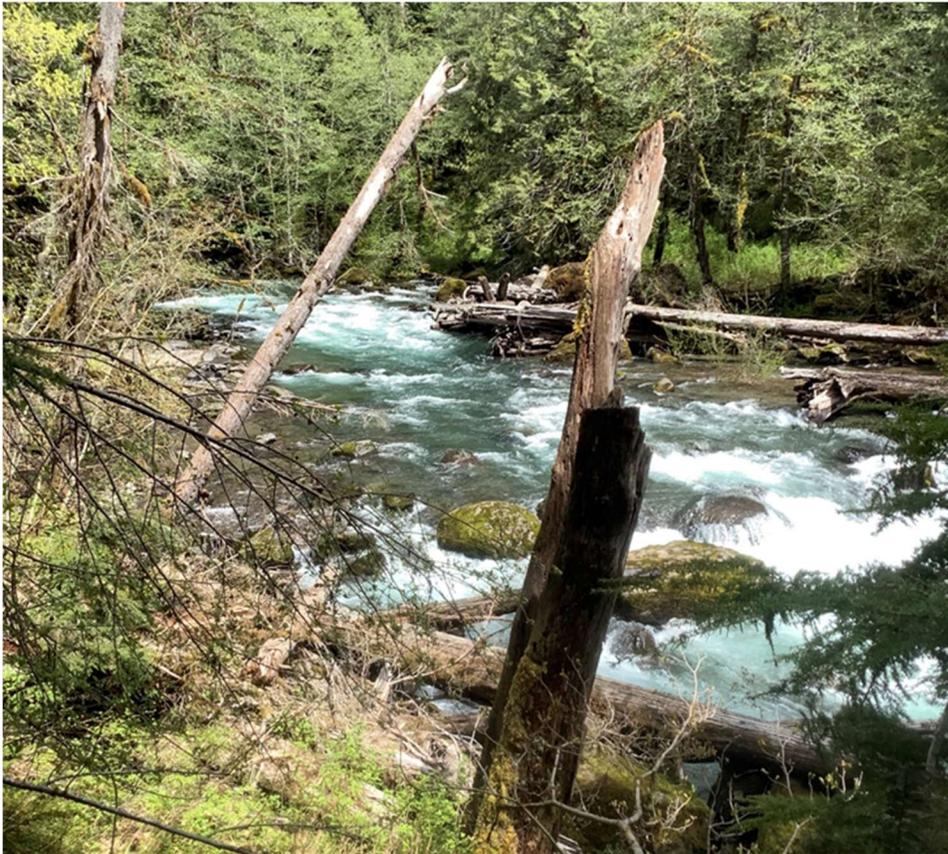
Reach 2 has an anastomosed channel pattern that periodically transitions to single thread in the locations most heavily constricted by tributary fans. The average channel gradient is 0.009 ft/ft (slightly steeper than Reach 1), and though relatively unconfined, the valley width is heavily encroached upon by tributary fans and debris flow. Old growth trees are present throughout the floodplain and act as key pieces in the channel, with valley jams (i.e., wood accumulations that span much of the valley bottom) driving anastomosis through avulsion around the hardpoints created by the wood accumulations (e.g., Photo 5, Photo 6). Key pieces vary in length but were estimated to be greater than 3 feet in diameter (i.e., diameter at breast height, DBH). Racked material contained pieces with stems in the 16-24 inch size class (with various lengths). Simplified sections of channel (e.g., Photo 7, Photo 8) coincide with tributary fans and flood deposits covered in alder. In these locations, the river has been unable to recruit large trees (e.g., Photo 9) into the channel. At the upstream end of the reach, a large landslide has pinched the valley, creating a steep cascade (Photo 10).

Photo 10. Rapids at the top of Reach 3 associated with a large debris fan.

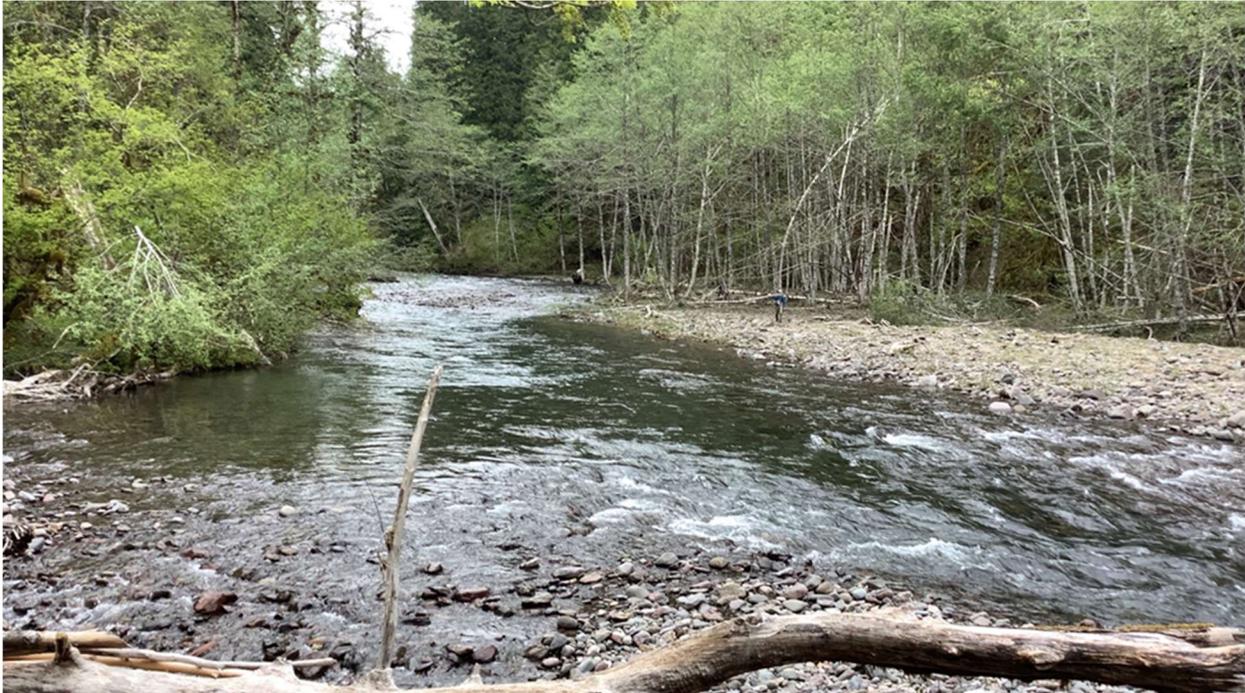
Photo 11. Looking upstream from the top end of Reach 3 at the transition from transport to response.

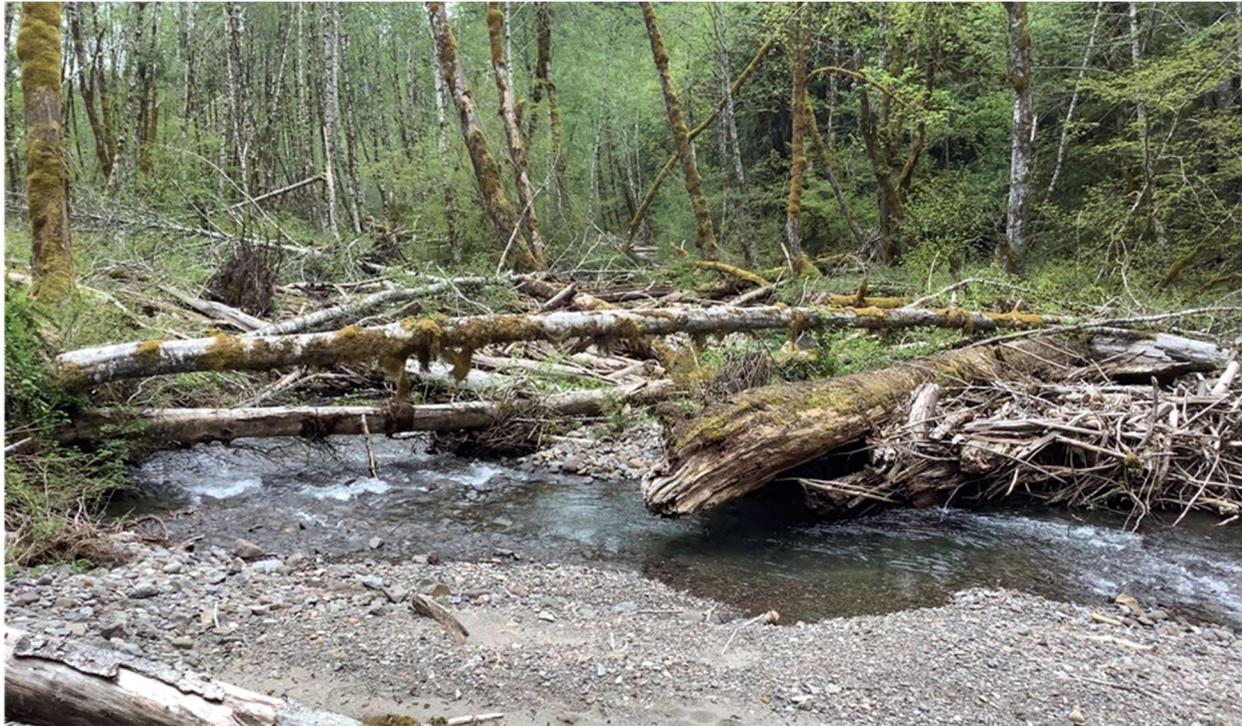
Photo 12. Racked wood forcing avulsion and side channel creation near the top of Reach 3.

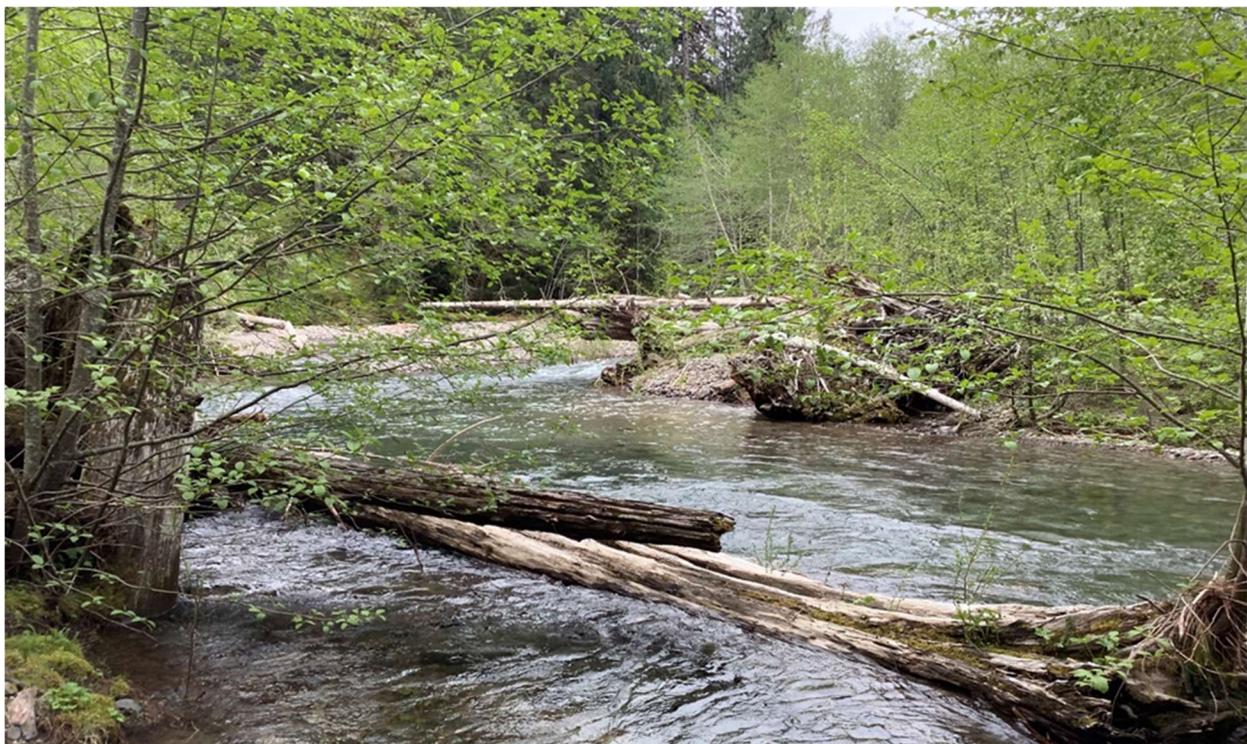
Photo 13. Two side channels converge (background) to form deep, covered rearing and holding pools (foreground).

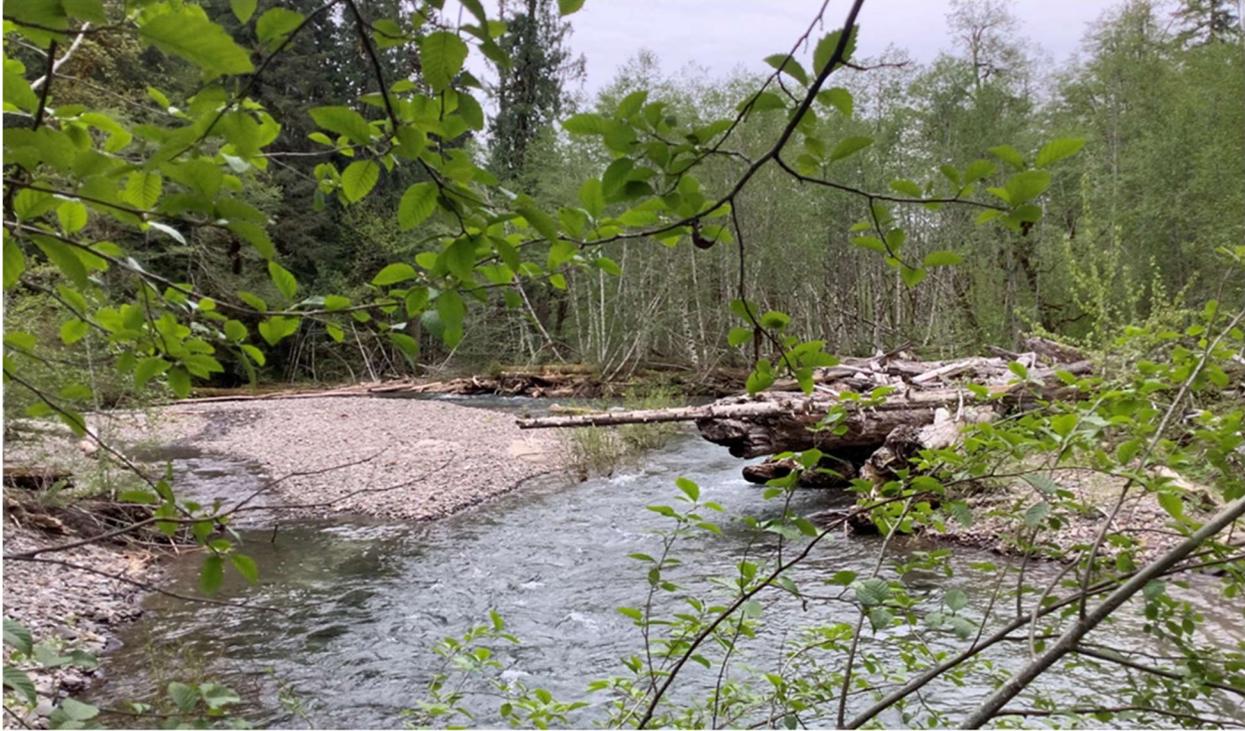
Reach 3 is similar to Reach 2, with a slightly narrower valley. Reach slope increases to 0.011 ft/ft and the channel pattern consists of a confined single-thread channel with pockets of multi-thread (i.e., response), largely driven by wood deposition. The upstream end of the reach is marked by a transition to a predominantly transport channel (Photo 11). Through Reach 3, channel pattern and complexity is driven by wood deposition, the recruitment of old growth trees, and the formation of valley jams. Considerable habitat complexity is created by avulsion around and through the valley jams (e.g., Photo 12, Photo 13). The vegetated islands seen in the aerial and in the REM are locations where the forest is recolonizing old wood accumulations (e.g., Photo 14).

Photo 14. Racked wood on the upstream face of a valley-wide jam supporting forest succession and an avulsion-induced anastomosing channel planform.

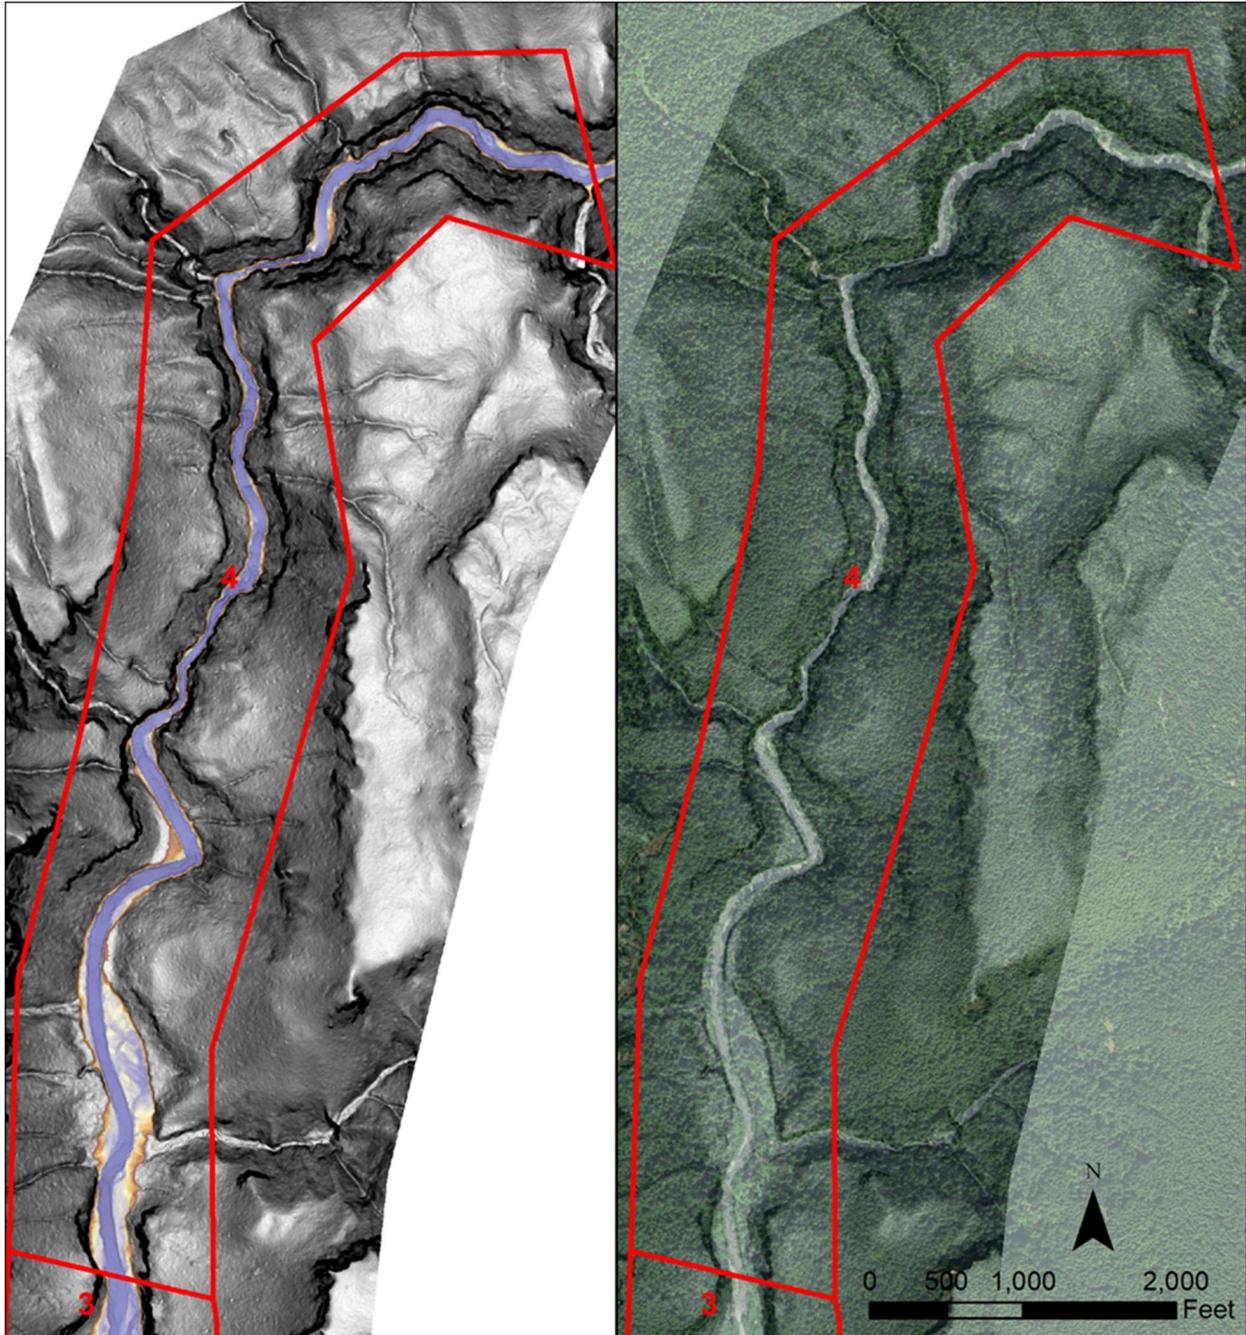
Reach 4 was not assessed in the field, but contains a highly confined, transport channel with little wood visible in the aerial photographs (Figure 8). Reach slope is estimated at 0.023 ft/ft and controlled by bedrock and boulders. The reach is predominantly transport with only small, lateral accumulations of alluvium visible.

Figure 8. REM and aerial imagery for Reach 4 of Clear Creek

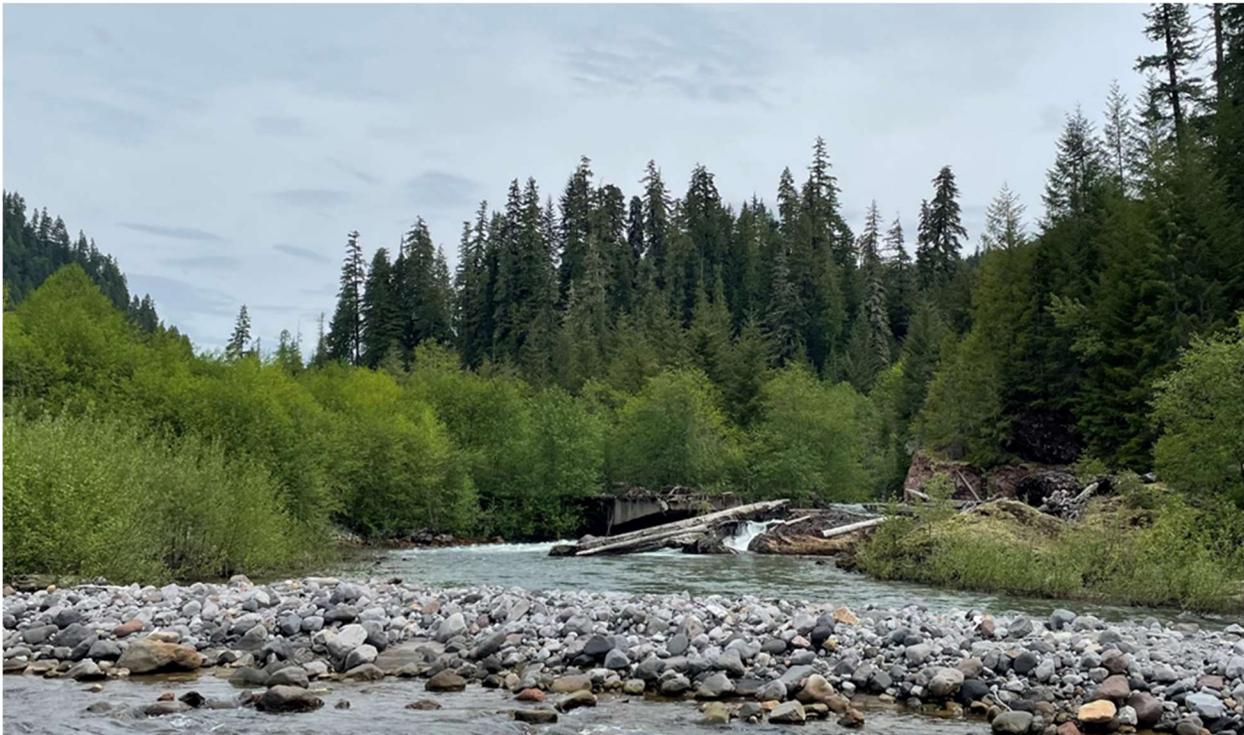
Photo 15. Confluence of Muddy River and Clearwater Creek with bridge and falls visible in the center of the photo.

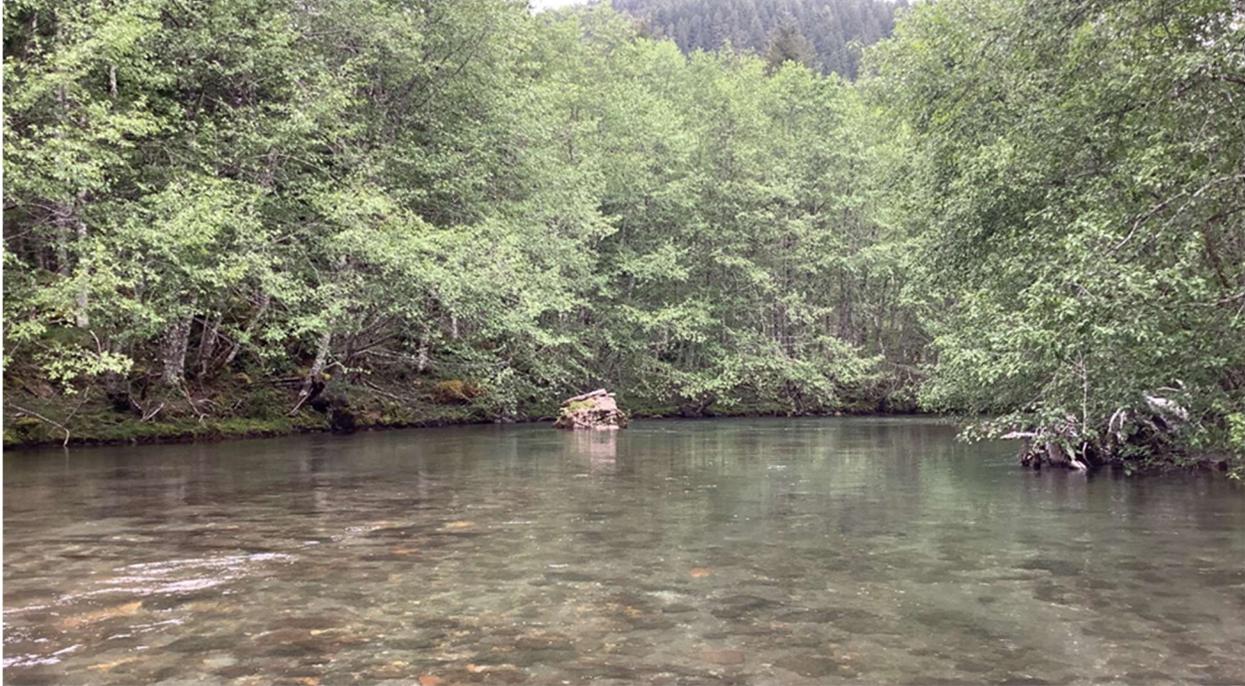
Photo 16. Riparian vegetation is dominated by single age class alder, perhaps associated with the 1996 floods. The channel bed through Reach 1 is highly embedded (foreground).

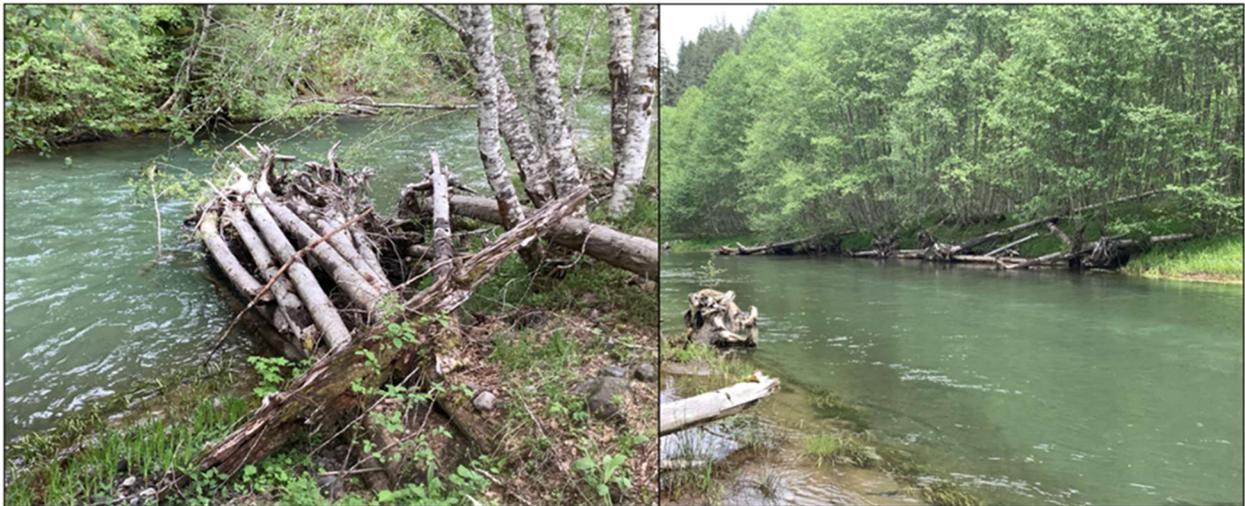
Photo 17. Wood structures and rootwads installed as part of the 2014 restoration project.

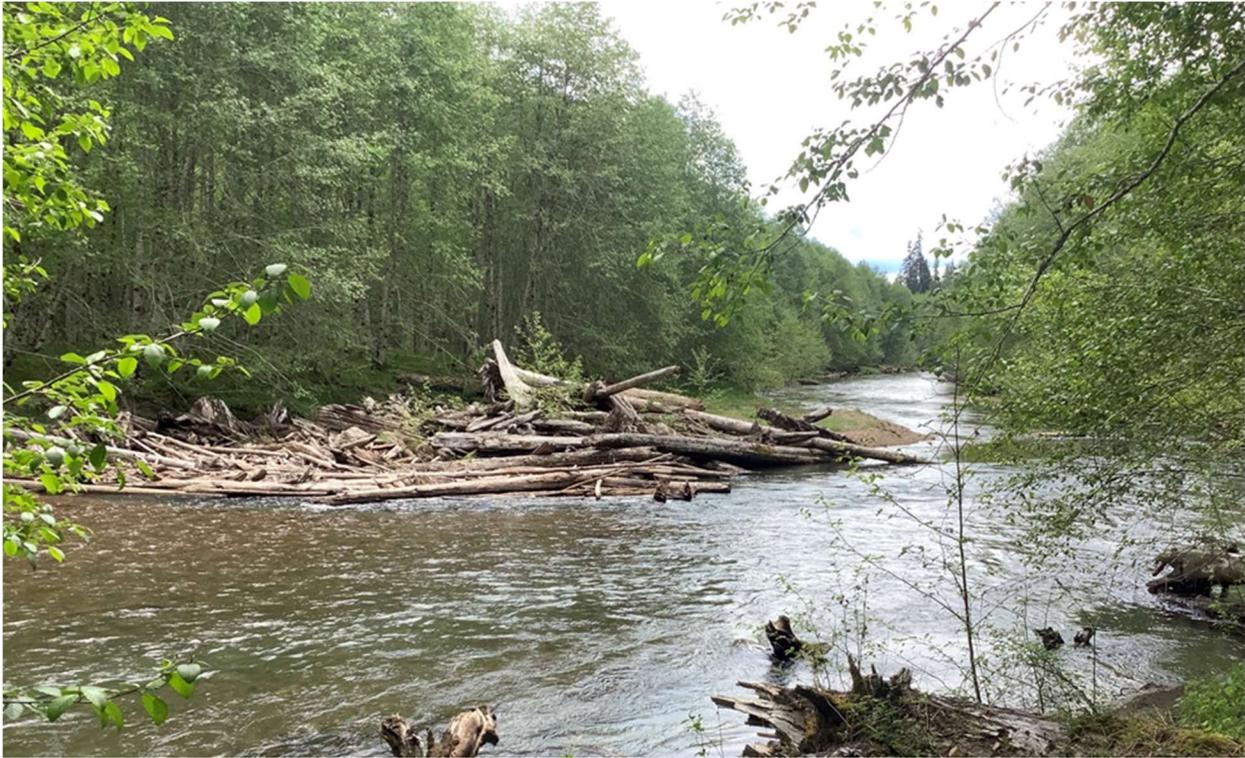
Photo 18. Apex log jam with substantial quantity of racked logs and debris.

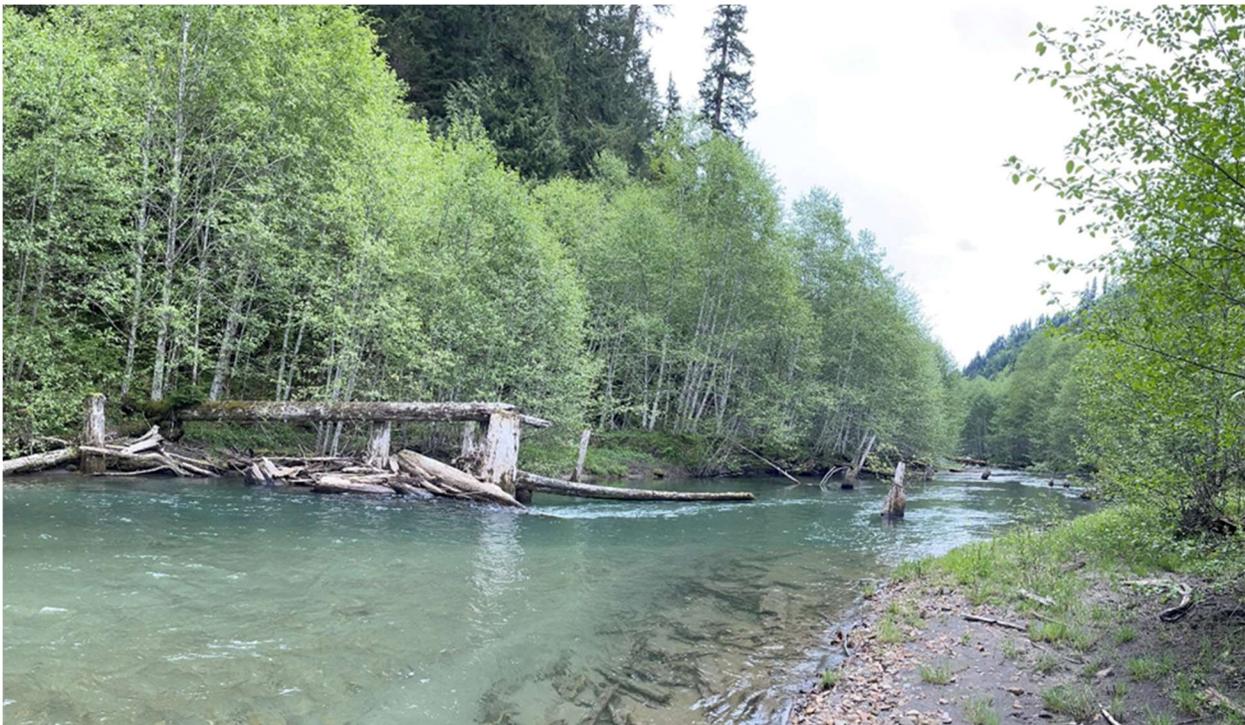
Reach 1 in Clearwater Creek has a relatively low gradient (0.0025 ft/ft) channel that is controlled by bedrock at the downstream end near the confluence with the Muddy River (Photo 15). The creek is single thread throughout the reach and appears to be working its way down through mudflow and flood deposits that have buried the past floodplain. The riparian vegetation is dominated by alder and the channel bed is heavily embedded in fine sediments (Photo 16). Ash and welded tuff were observed throughout. A 2014 restoration project lined the river right side with wood structures that were observed in various states of function (e.g., Photo 17). Complexity is limited to built structures that are still functioning, limited in situ jams (e.g., Photo 18), and sections where the active channel is working through standing dead trees that were buried by post-eruption sediments (e.g., Photo 19).

Photo 19. Clearwater Creek flowing through buried, former floodplain forest (note tree stumps sticking up in bed of channel).

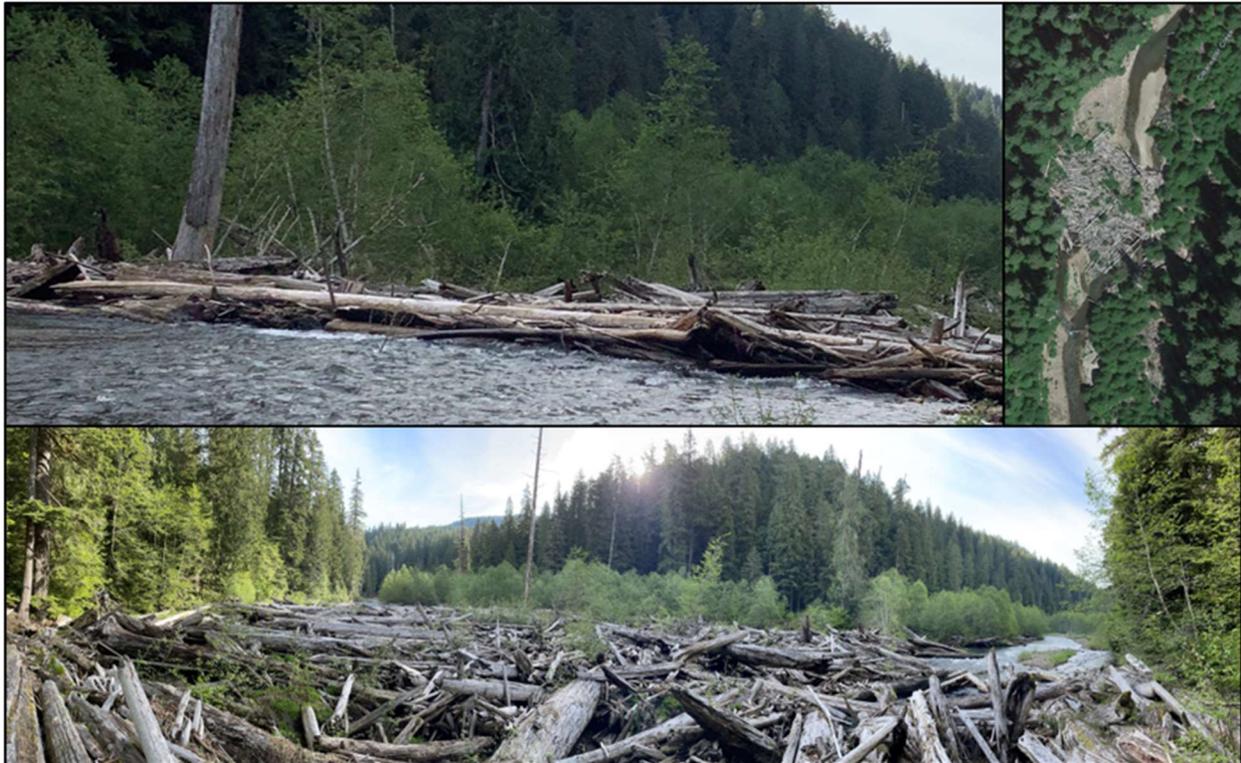
Reach 2 sees the channel transition back to anastomosis, driven by the presence of many large valley jams (e.g., Photo 20). Overall reach slope increases to 0.0085 ft/ft with the dominant control being the valley jams. Throughout much of the reach, active channels are working into buried, past floodplain and standing snags are prevalent. Habitats throughout the reach are complex and varied. Wood accumulations contain a mix of large pieces, a substantial amount of debris, and smaller racked material. Similar to observations from Clear Creek, key pieces vary in length and are at least 3 feet DBH; racking logs vary, and do contain larger pieces in the 16-24 inch size class (DBH).

Photo 20. Very large, valley-spanning log jam near the upper end of Reach 2 (top right). The jam contains a mixture of key pieces and substantial racked logs and debris (bottom). The channel is heavily aggraded on the upstream face of the jam (top).

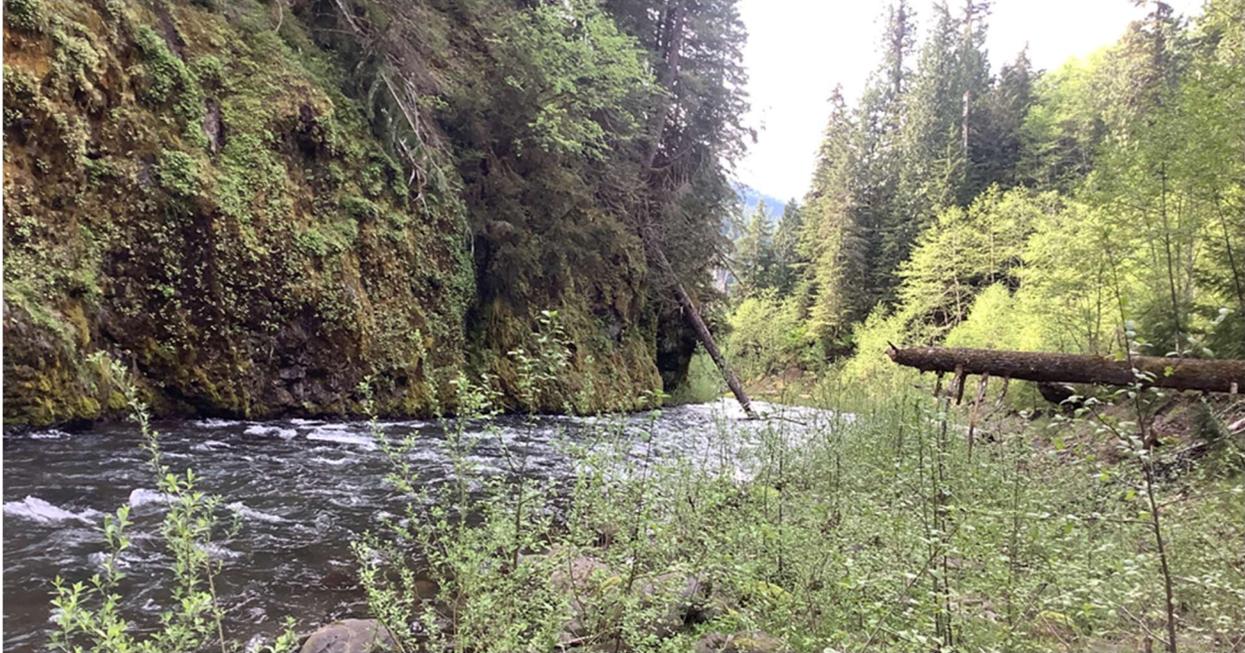
Reach 3 is a relatively short, bedrock-controlled and confined canyon reach (Photo 21). It is a high energy transport reach, with a slope of 0.015 ft/ft and very limited floodplain development.

Photo 21. Short, bedrock-controlled canyon reach of Clearwater Creek.
