**CLEAR CREEK & CLEARWATER CREEK
GEOMORPHIC & HYDRAULIC
ASSESSMENT MEMO**

Gifford Pinchot National Forest
Mt Adams Ranger District
2455 Hwy 141
Trout Lake, WA 98650

DJ&A, P.C.
2000 Maple Street
Missoula, MT 59808

October 11, 2022

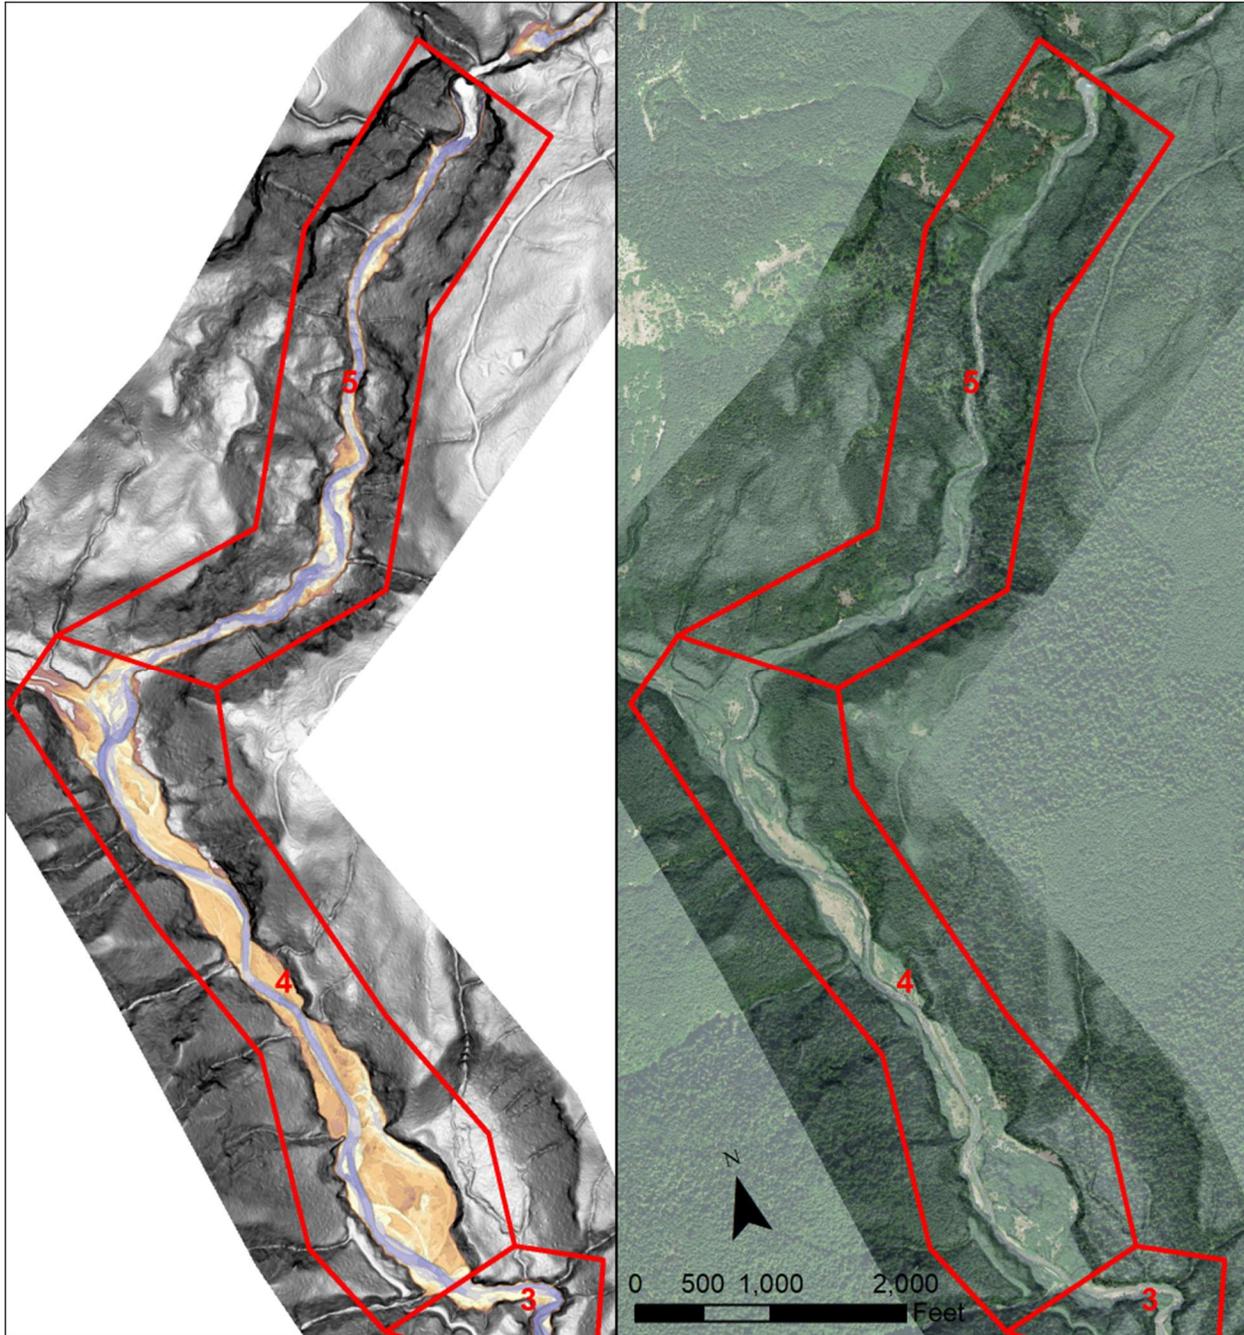
Reaches 4 and 5 were not assessed in the field, but a number of observations were made from other sources (Figure 10). Reach 4 is located in the blast zone, primarily single thread, and appears to be working through mudflow deposits from the Mt St Helens eruption and, likely, flood debris and deposits from flood events in 1996. Reach slope is 0.023 ft/ft with planform complexity limited to the Bean Creek fan. The portion of the reach affected by the blast remains unvegetated except for a riparian strip along the bank. These lateral deposits are likely high and hydrologically disconnected at all but the highest flows. Reach 5 is a highly confined transport reach, though some pockets of alluvium can be seen in the REM. Reach slope is relatively high (0.046 ft/ft), and the reach ends at Paradise Falls, a 125-foot tall waterfall and passage barrier to anadromous fish.

Figure 10. Reaches 4 and 5 of Clearwater Creek were directly impacted by the Mt St Helens eruption. Mudflow buried the valley through Reach 4. Reach 5 is heavily confined by bedrock.
