# Lewis River Aquatic Fund Projects (SA 7.5.3.2)

## Project Closeout Report

<b>Project Title:</b>	<b>Lewis River Hydroelectric Project Cedar Creek Reach 1A Restoration</b>
<b>Project Approved By:</b>	Aquatic Coordination Committee March 27, 2013
<b>Original Project Sponsor:</b>	Lower Columbia Fish Enhancement Group
<b>Project Funding</b>	Aquatic Coordination Committee - \$53,000 + \$12,931.00 (insurance expense) -
<b>Project Description (work completed):</b>	<ul style="list-style-type: none"><li>• Installed 150+ pieces of large wood in stream channel</li><li>• Installed 15+ logjams</li><li>• Installed 4 floodplain roughness logs</li><li>• Excavated a 100' long alcove rearing channel</li><li>• Re-directed perennial tributary to increase habitat function</li><li>• Removed/ controlled 2 acres of invasive non-native vegetation</li><li>• Installed 2,000 native trees and shrubs</li><li>• Installed boater safety sign upstream of project site</li></ul>
<b>Workforce:</b> <ul style="list-style-type: none"><li>○ <b>Personnel (by craft)</b></li><li>○ <b>Contractors:</b></li></ul>	<ul style="list-style-type: none"><li>• Bill Norris, P.E. Interfluve</li><li>• Peter Barber, LCFEG Project Manage

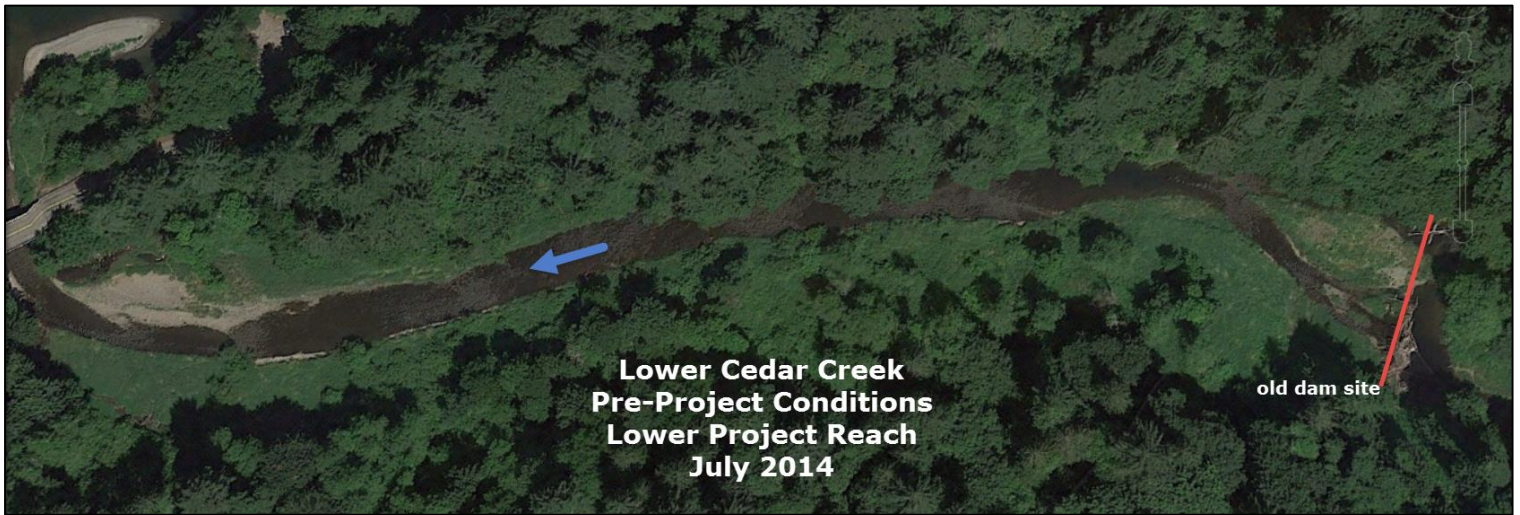
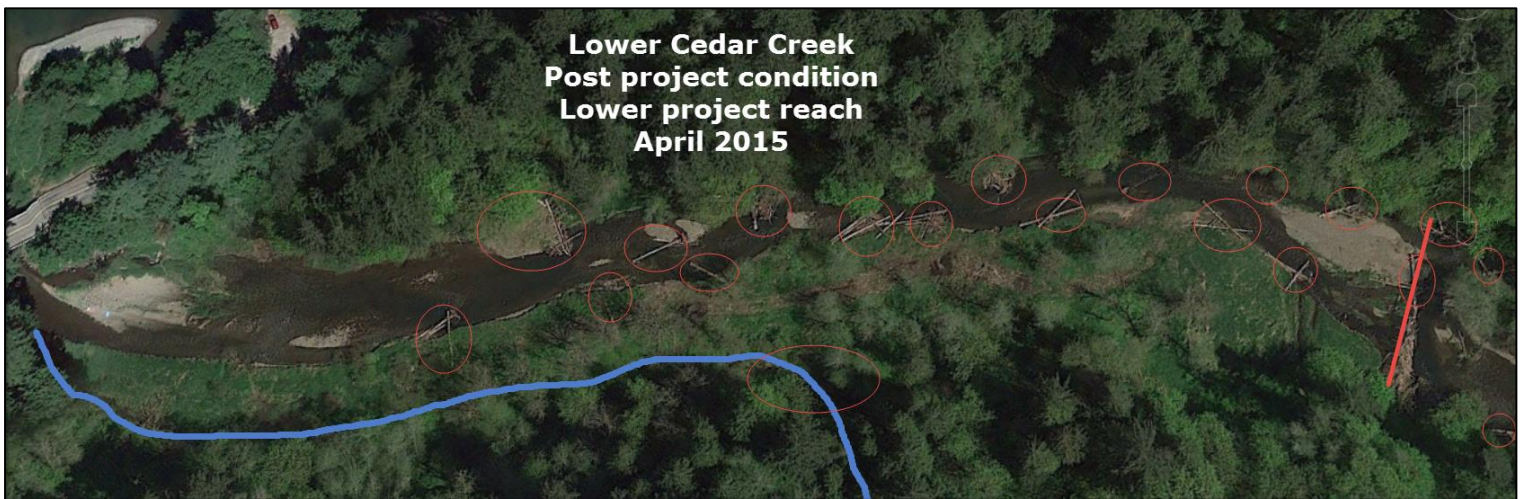
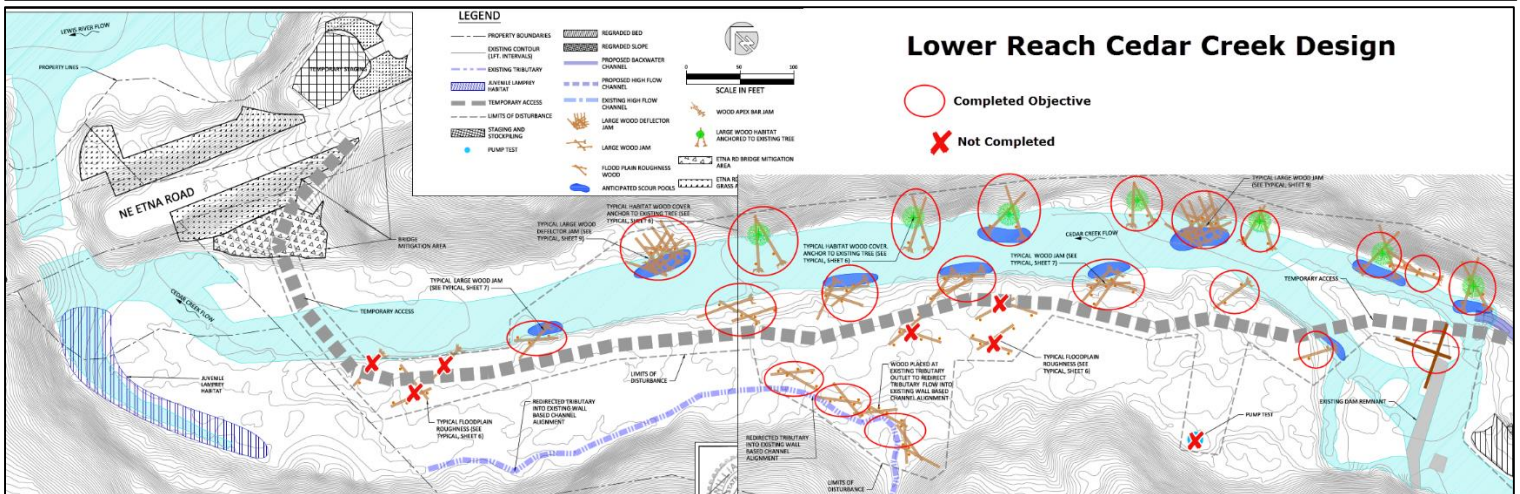
# AS-BUILT

- Deleted floodplain roughness wood due to cost
- Added 1 log on end of dam to direct flow, added 1 root-wad to increase scour
- Deleted lower left bank structures due to concern with lamprey habitat
- Did not complete pump test due to cost, vegetation impact and low likelihood of future need

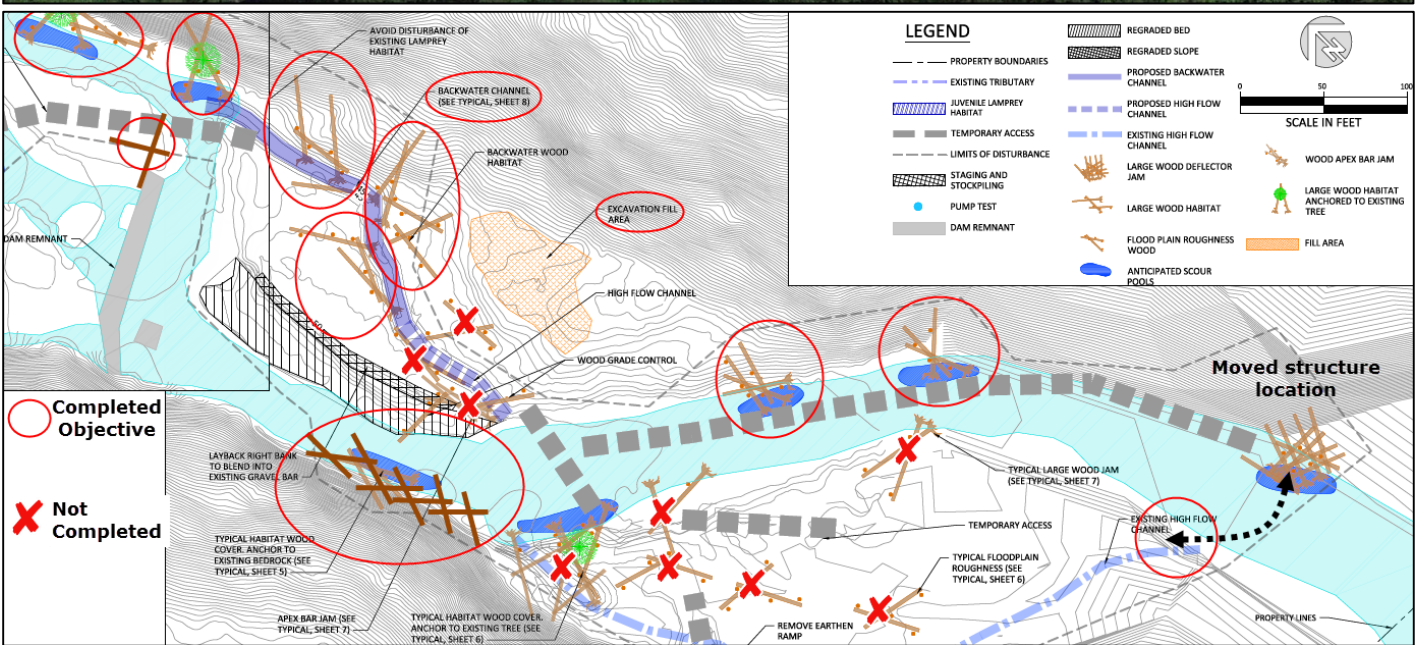
### Lower Reach- Cedar Creek Design

- Deleted floodplain roughness logs due to cost and level of disturbance to floodplain
- Deleted 3 left bank instream structures due to cost & boater safety concerns
- Added logs to lower left bank structure and dam
- Added boater beware sign upstream of project

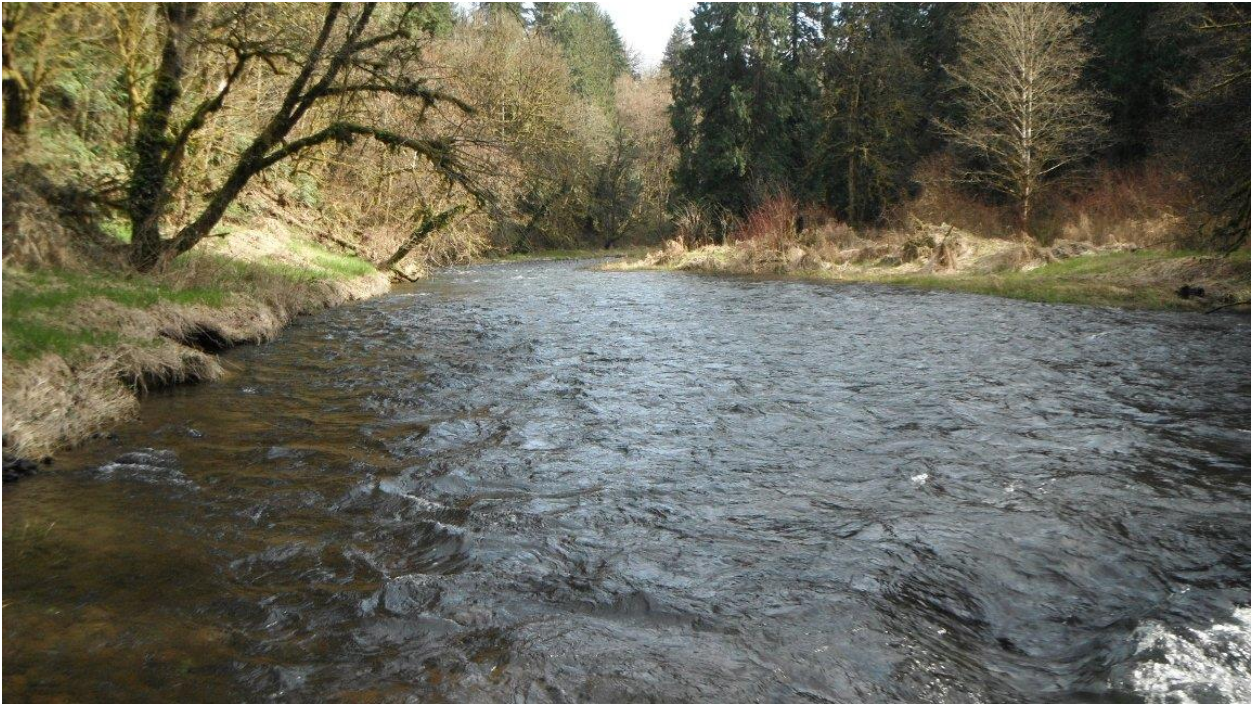
Upper project site at OHW view u/s

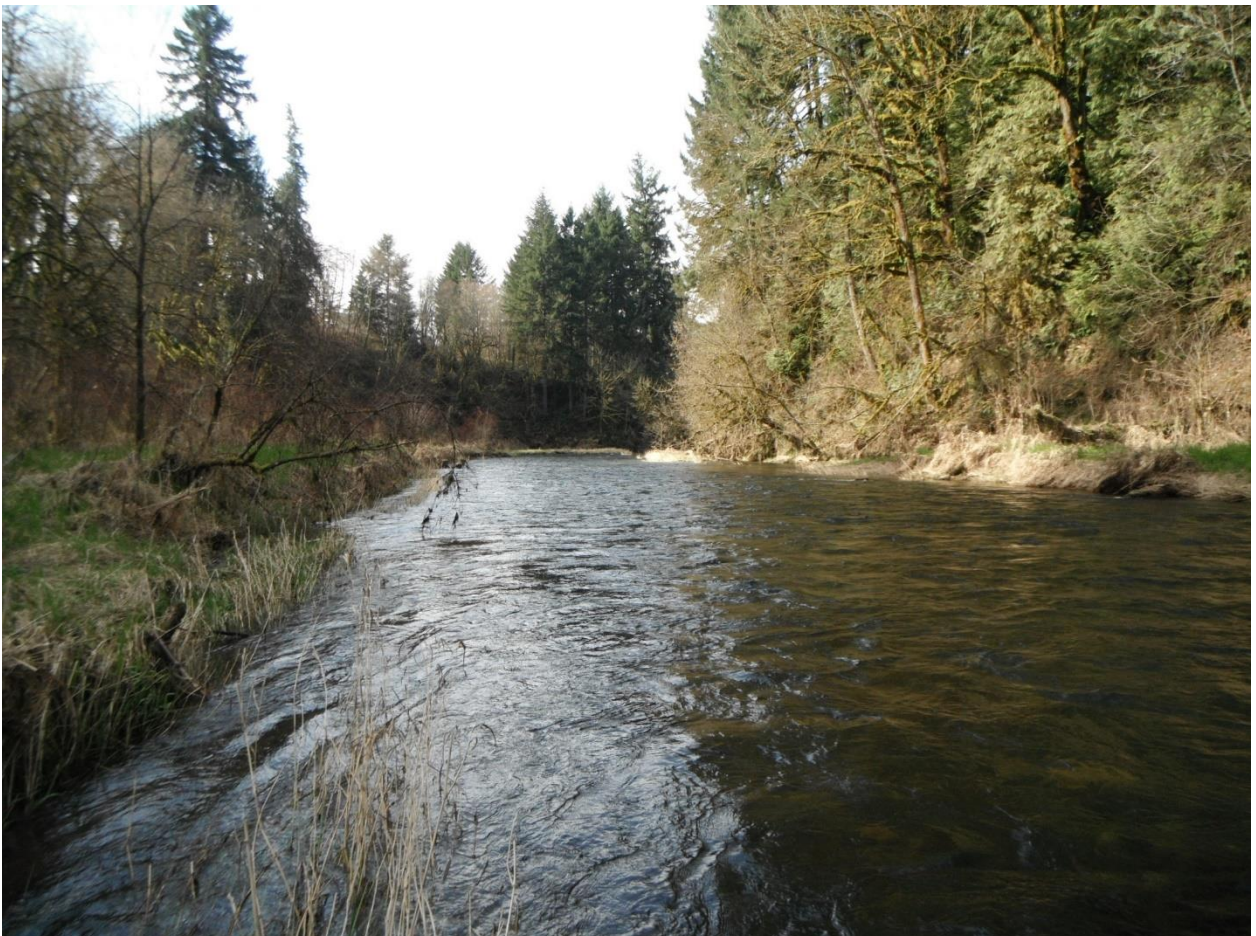
Lower project area at OHW, view d/s

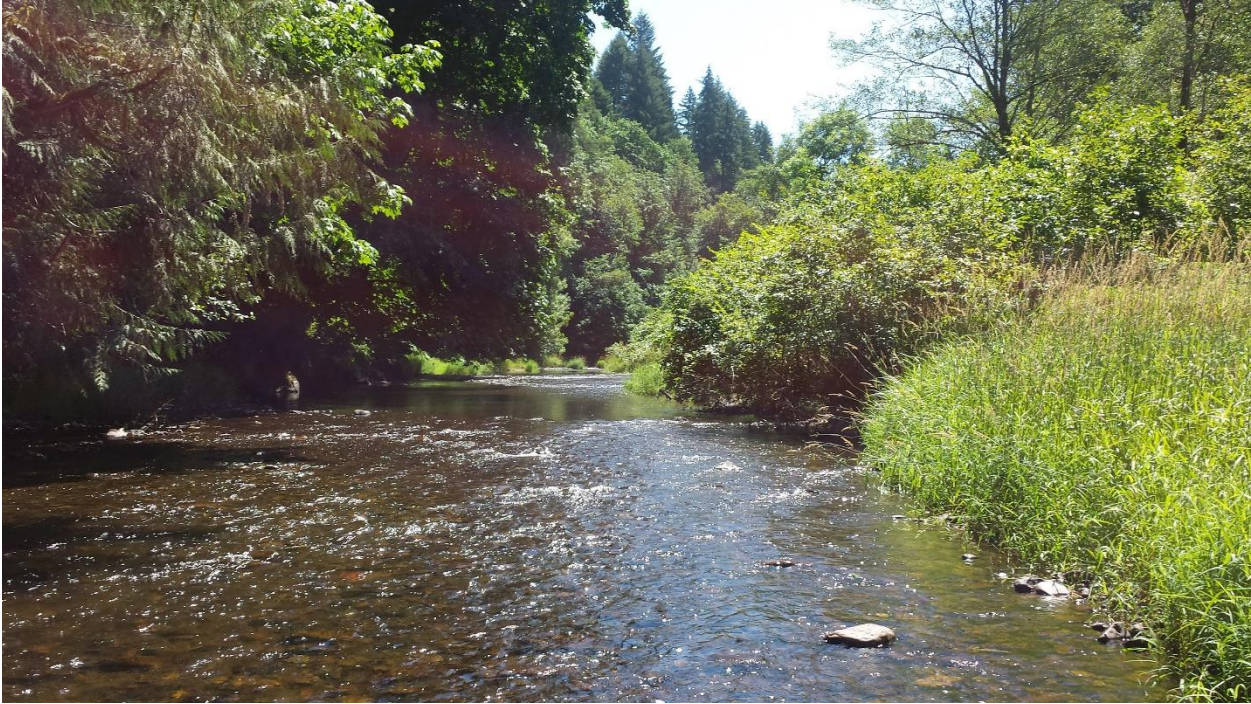
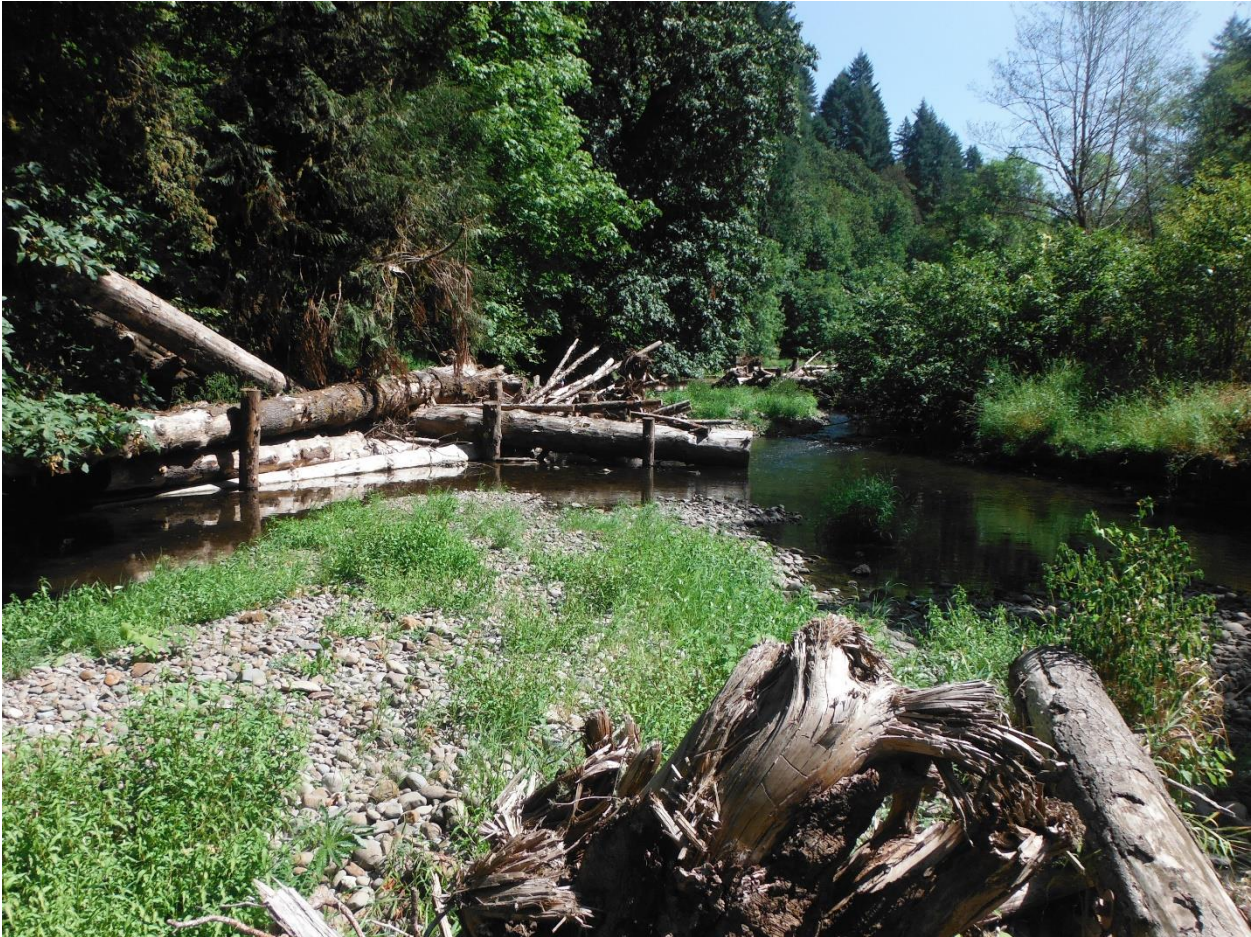
Note formation of new mid-channel bar

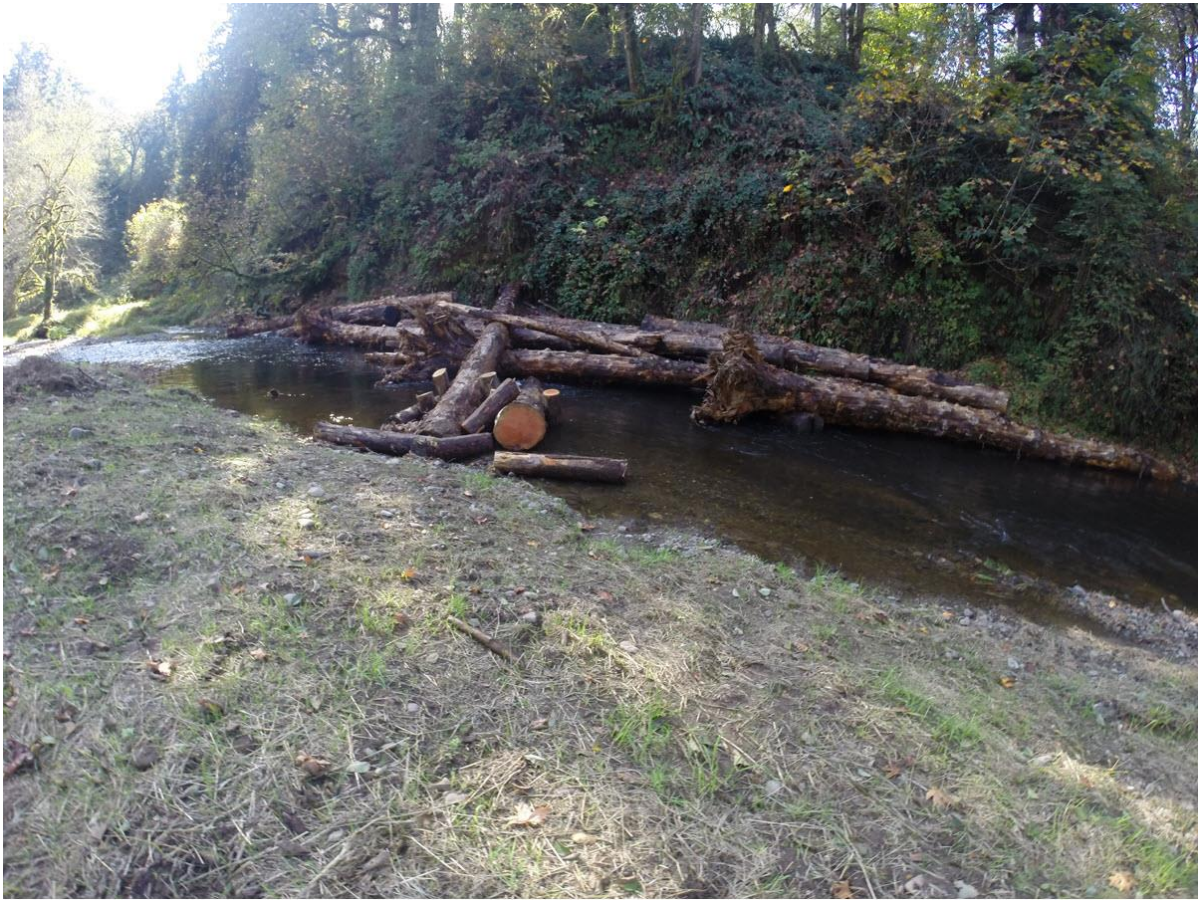
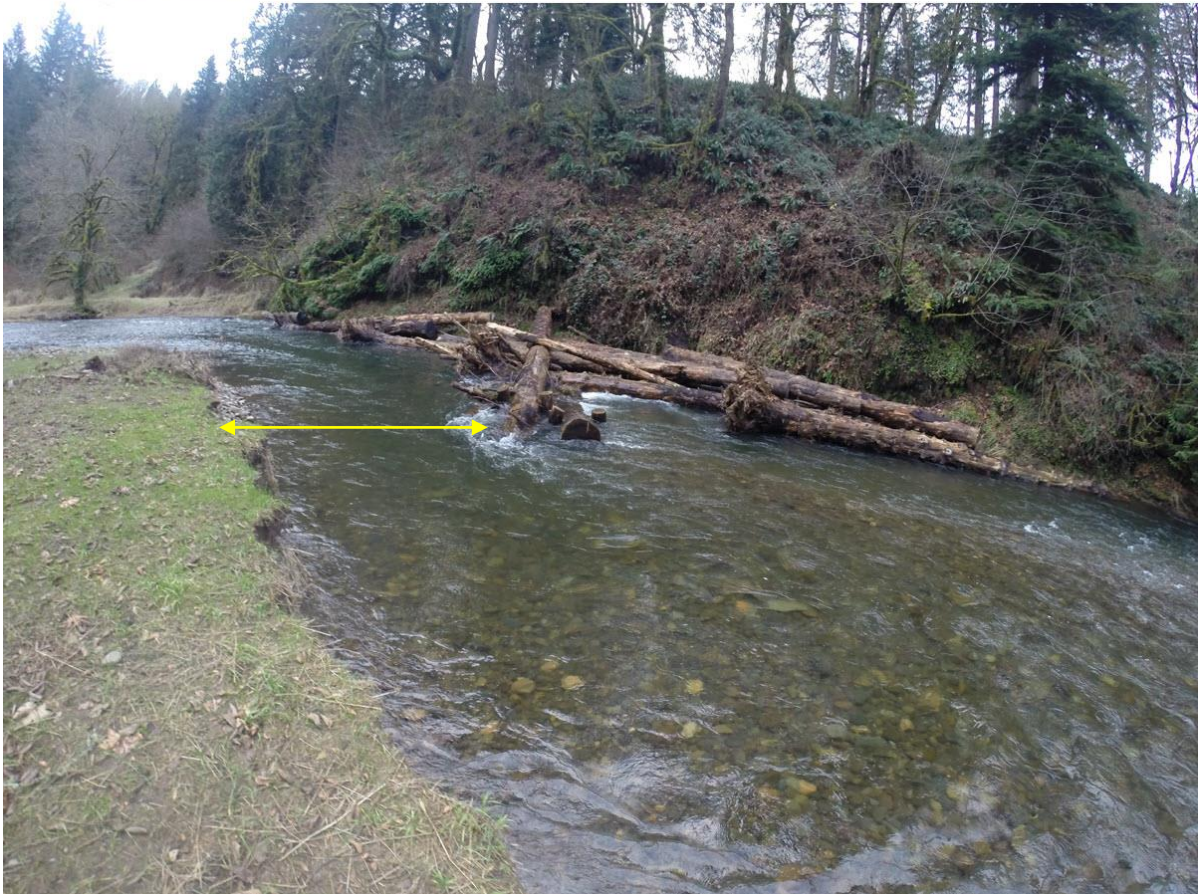
LWD significantly increased hydraulic complexity, note lateral channel expansion

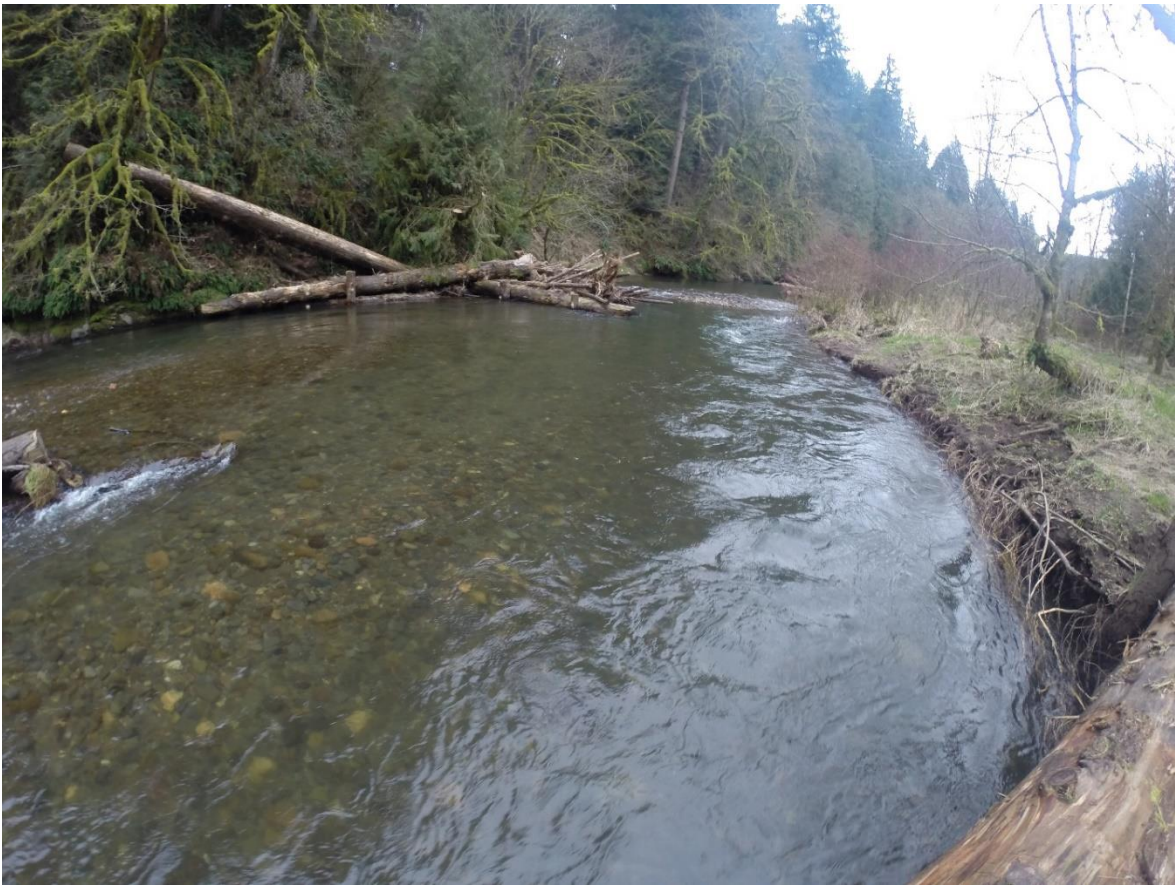
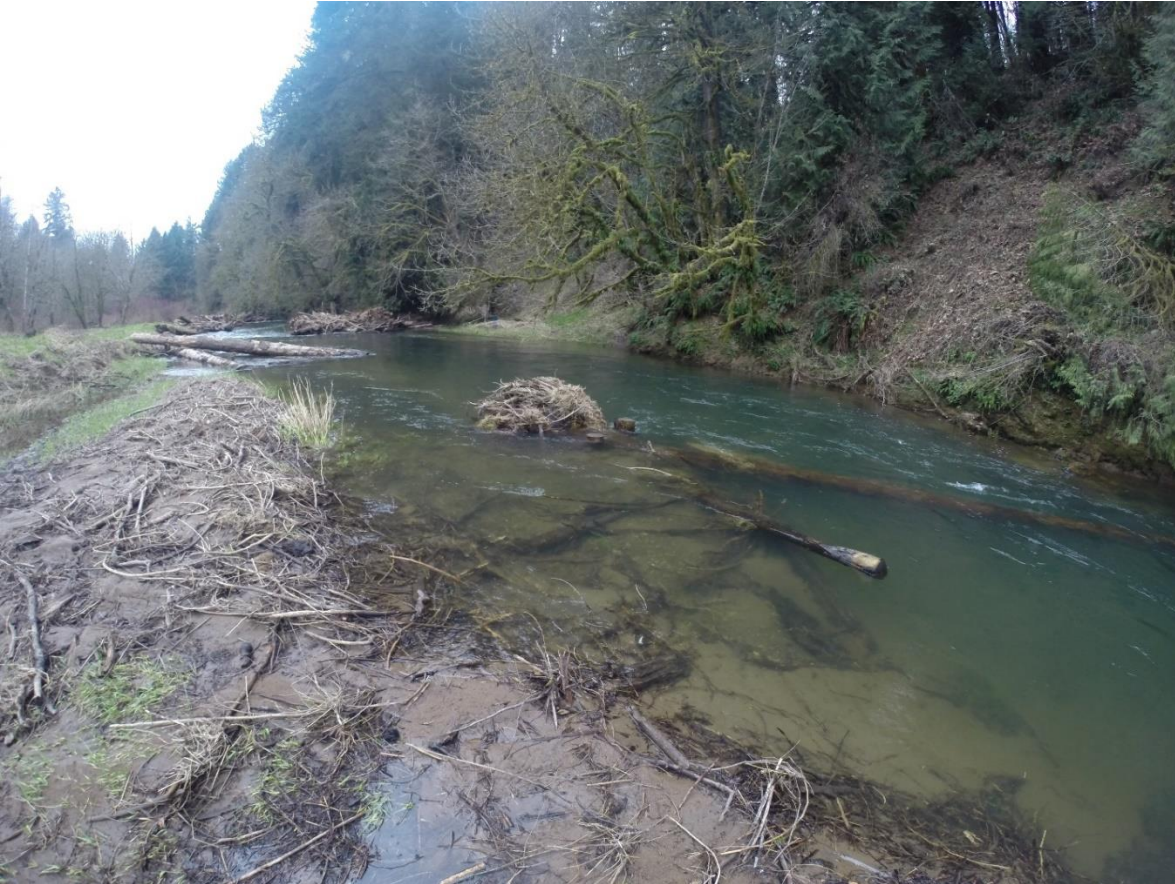
Excellent spawning and rearing habitat, diverse seasonal flow conditions

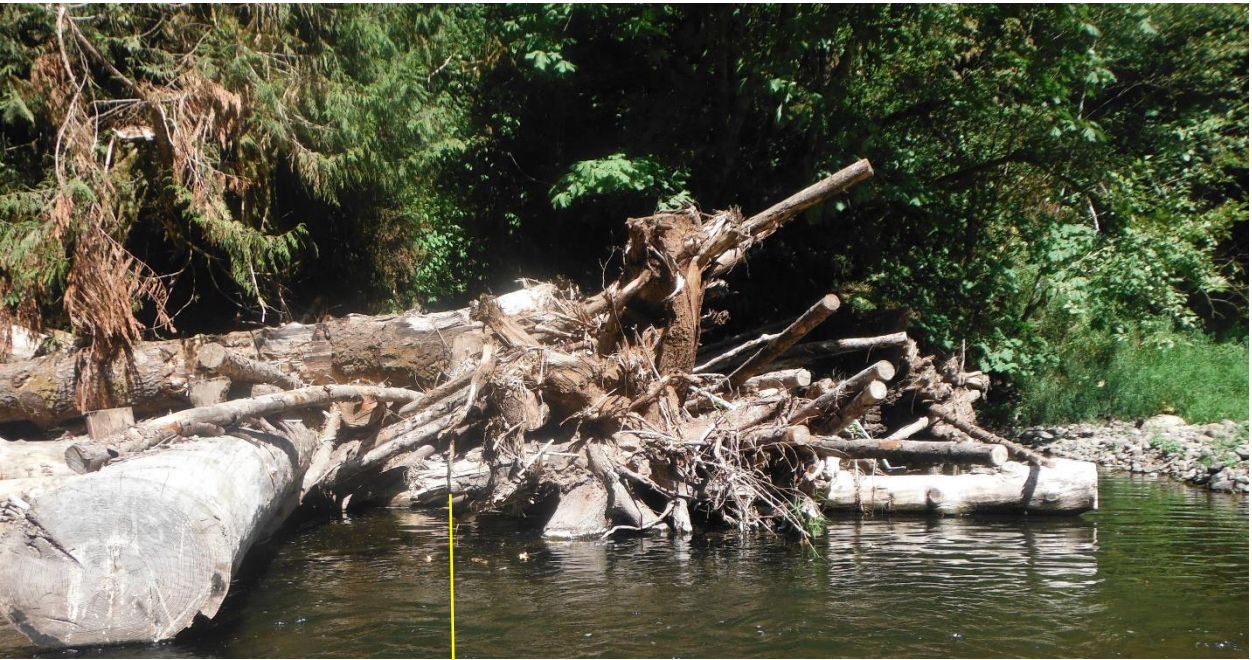
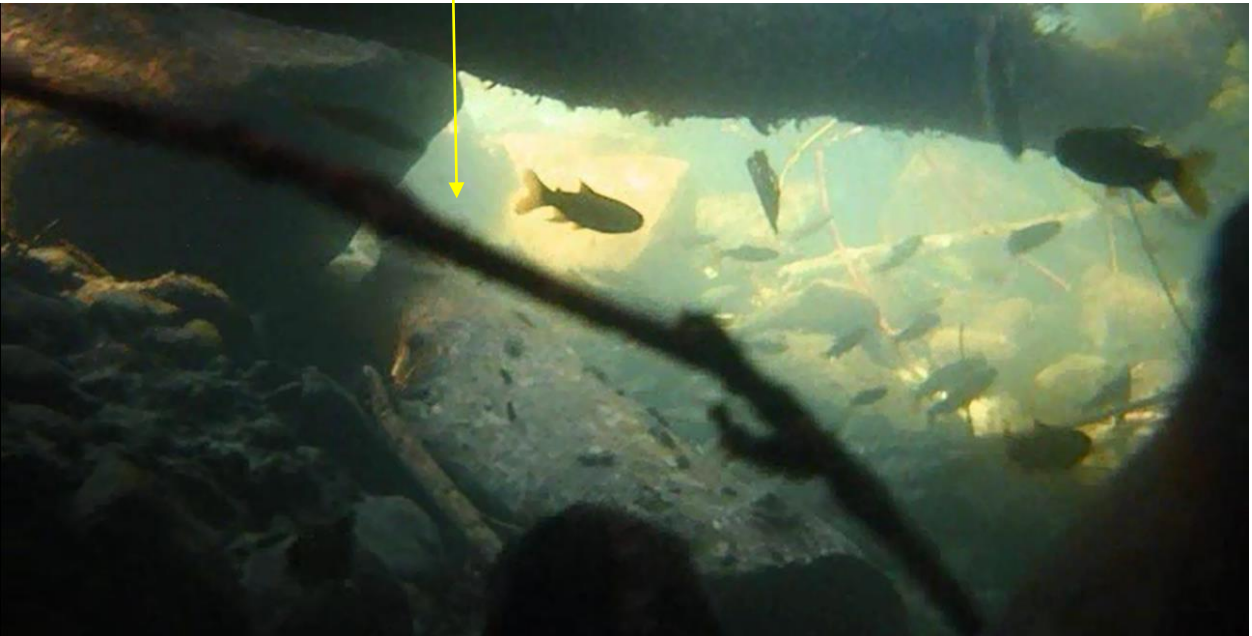
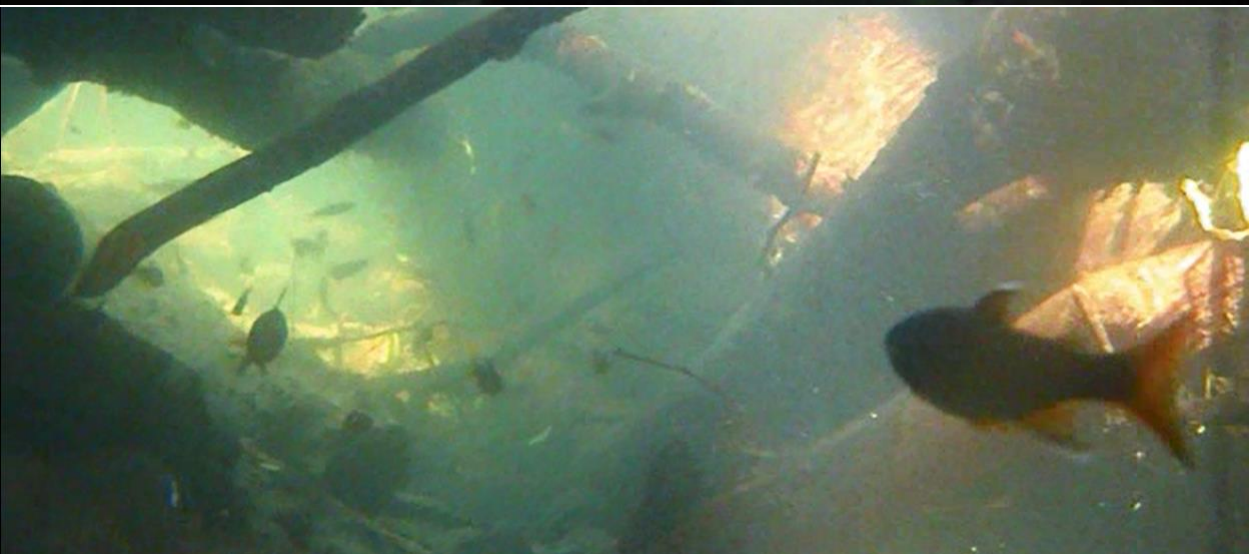
Even with extreme (75F) warm water conditions in lower Cedar creek in 2015 we found large numbers of juvenile salmonids in the pools under the log jams. Water temperatures are lower in the pools due to heavy shade and hyporeic/ ground water upwelling.

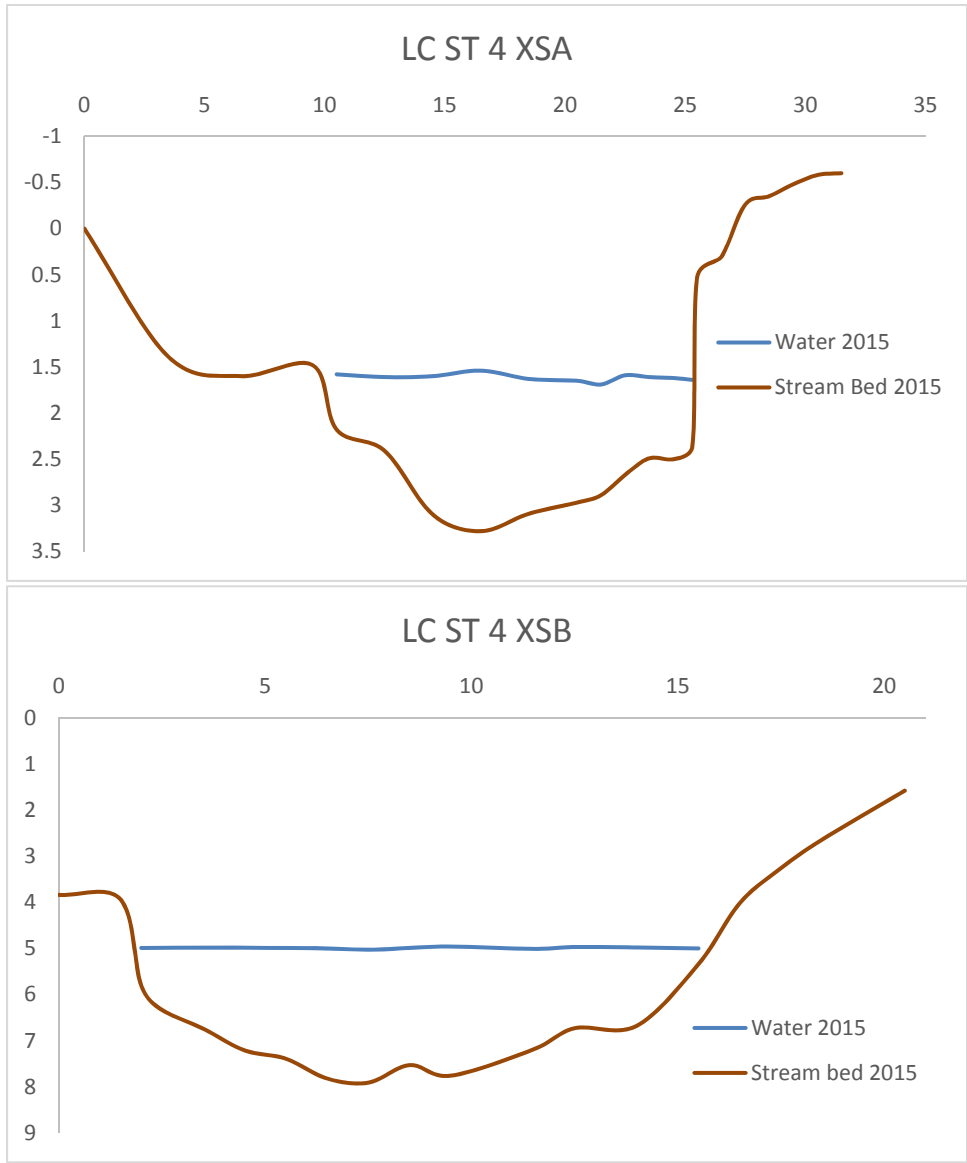
*Water is too deep/swift for accurate pebble count*
