**Fish Salvage & Temporary Tailrace Barrier Report for the
Wallowa Falls Hydroelectric Project Tailrace**

(FERC No. P-308)

December 27, 2019

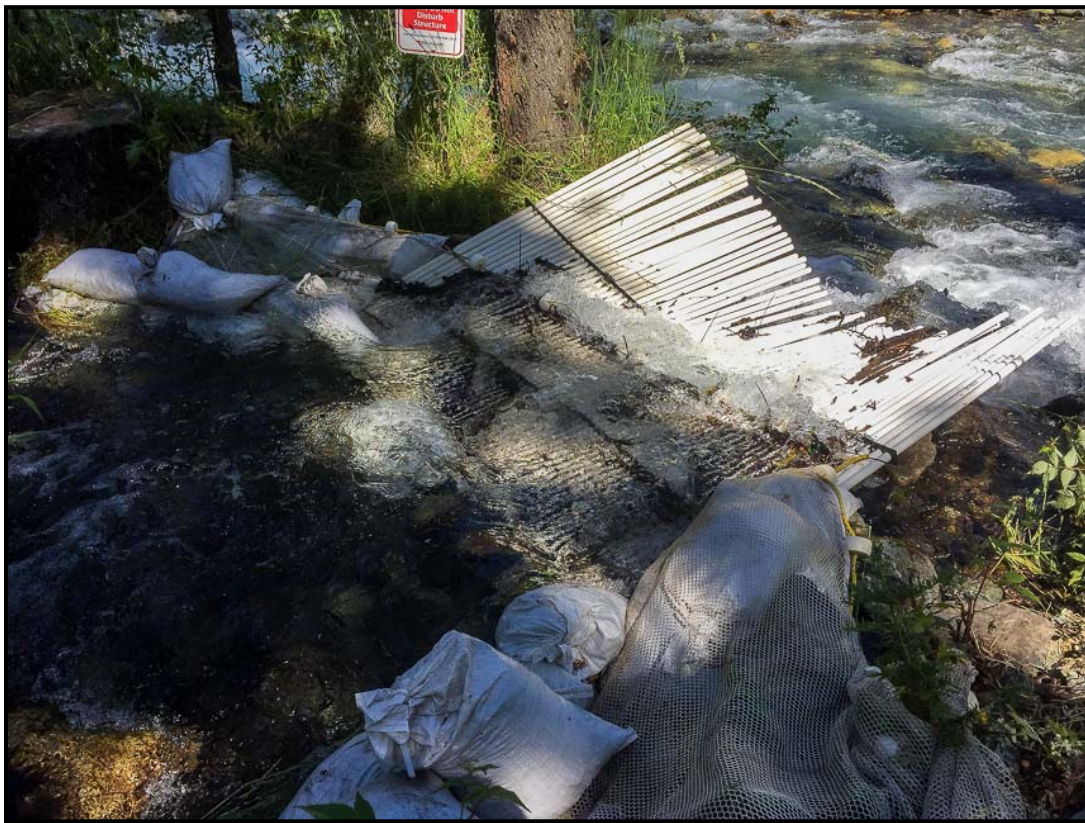
Also in 2019, a resistance type weir was constructed to serve as a temporary fish exclusionary device at the outlet of the tailrace channel and it’s confluence with the West Fork Wallowa River. The resistance weir utilized 25.4 millimeter (mm) diameter polyvinyl chloride (PVC) set to a length of 2.4 meters (m) and spaced apart 6.35 mm by mechanically constructed stringers, the weir was stream-spanning (Figure 2). As extra precaution, a barrier net was also laid across the entire bottom of the upstream side of the weir. The openings of this barrier net were also 6.35 mm and the net was held in place by large sandbags placed end to end along the stream bottom and spanning the entire stream-width.

Figure 2. Photo of Wallowa Falls tailrace barrier in operation. Photo taken on September 12, 2019.
