Geology and Soils Study Wallowa Falls Hydroelectric Project

Photo Exhibits

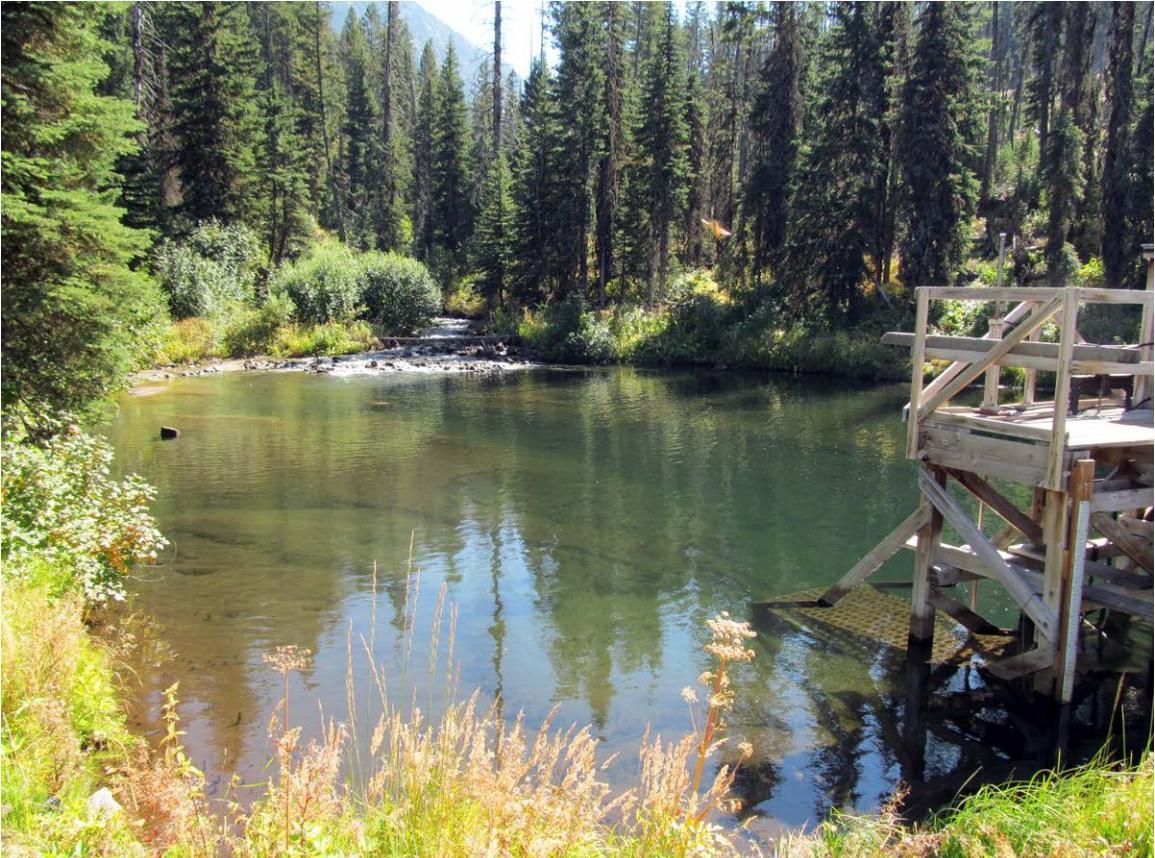
A. VIEW LOOKING SOUTH AT WALLOWA FALLS FOREBAY.

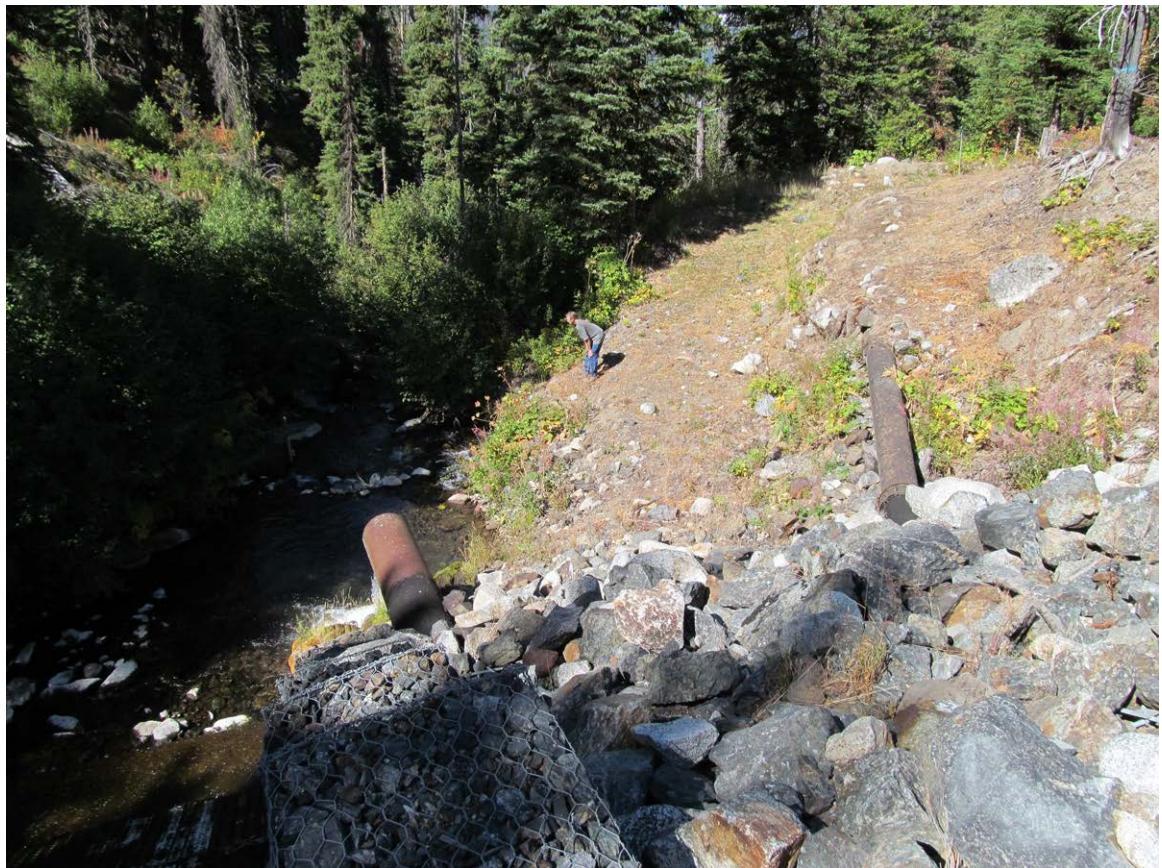
B. VIEW LOOKING NORTH (DOWNSTREAM) AT PENSTOCK (APPROXIMATE ACCESS ROAD STATION 0+00).

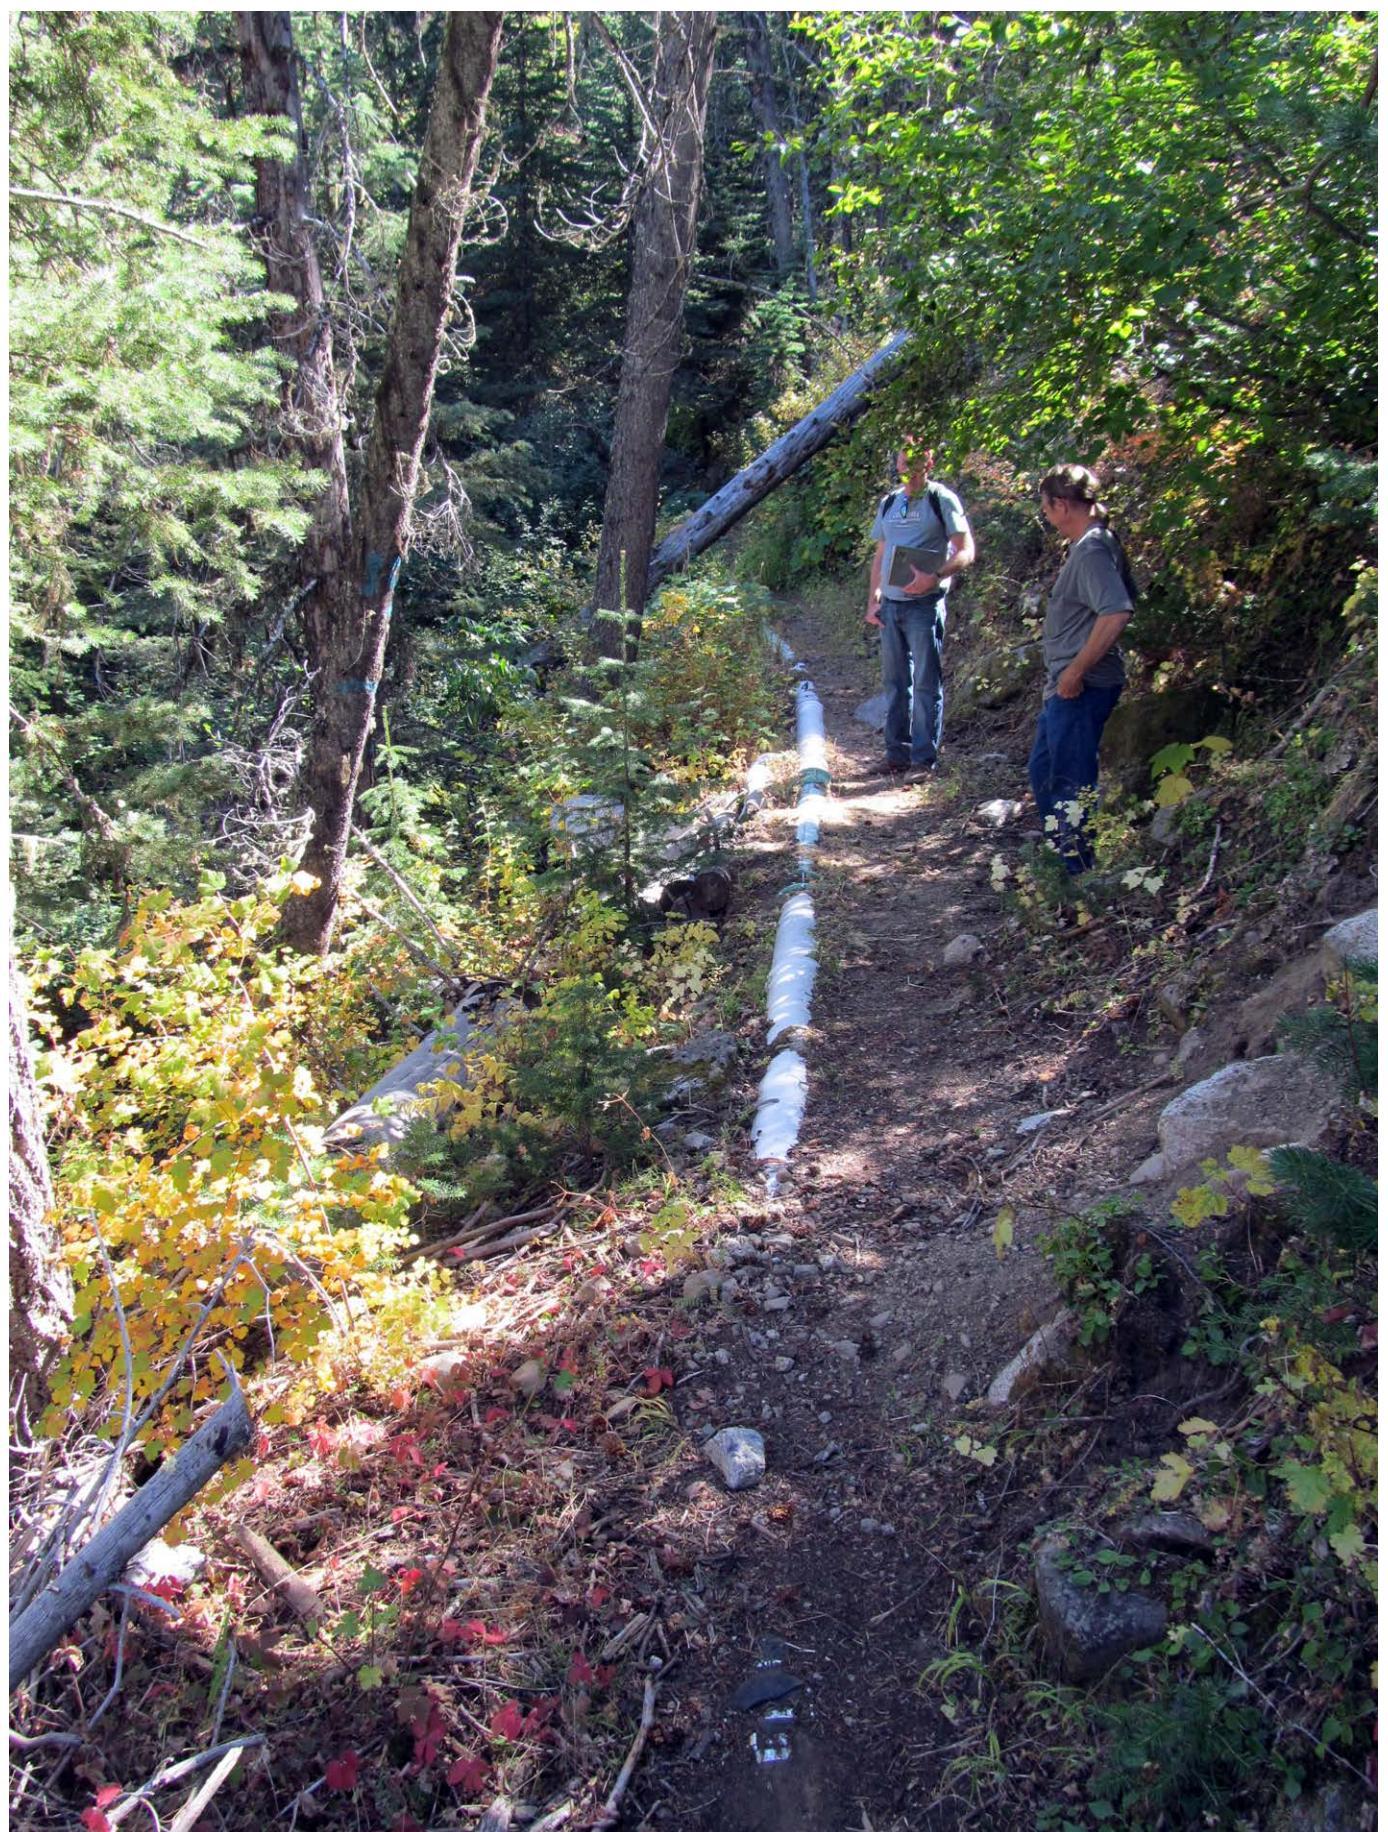
VIEW LOOKING SOUTHEAST AT 8-INCH PVC PIPELINE DIVERTING WATER FROM ROYAL PURPLE CREEK TO THE FOREBAY.

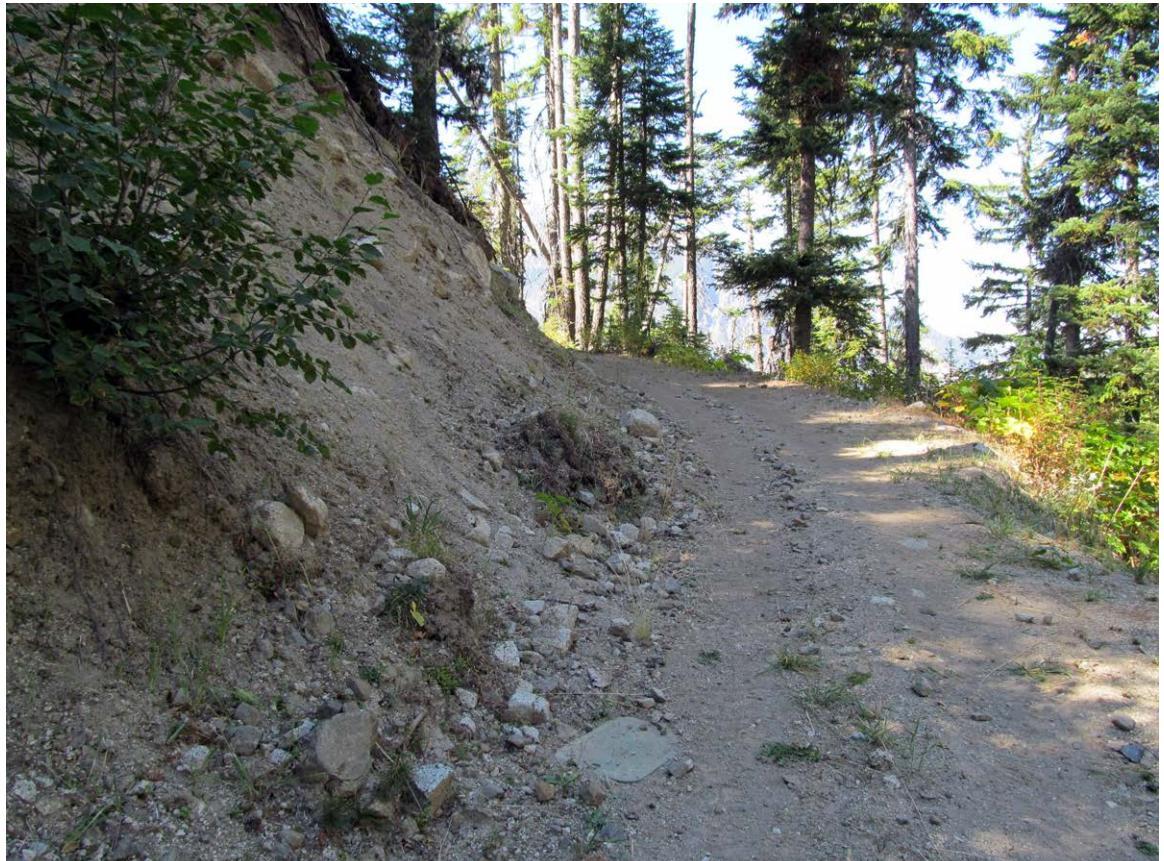
A. VIEW LOOKING WEST UP ACCESS ROAD TO THE DAM BETWEEN ROYAL PURPLE CREEK AND THE EAST FORK WALLOWA RIVER. NOTE SLOUGHING MATERIAL ON CUT SLOPE.

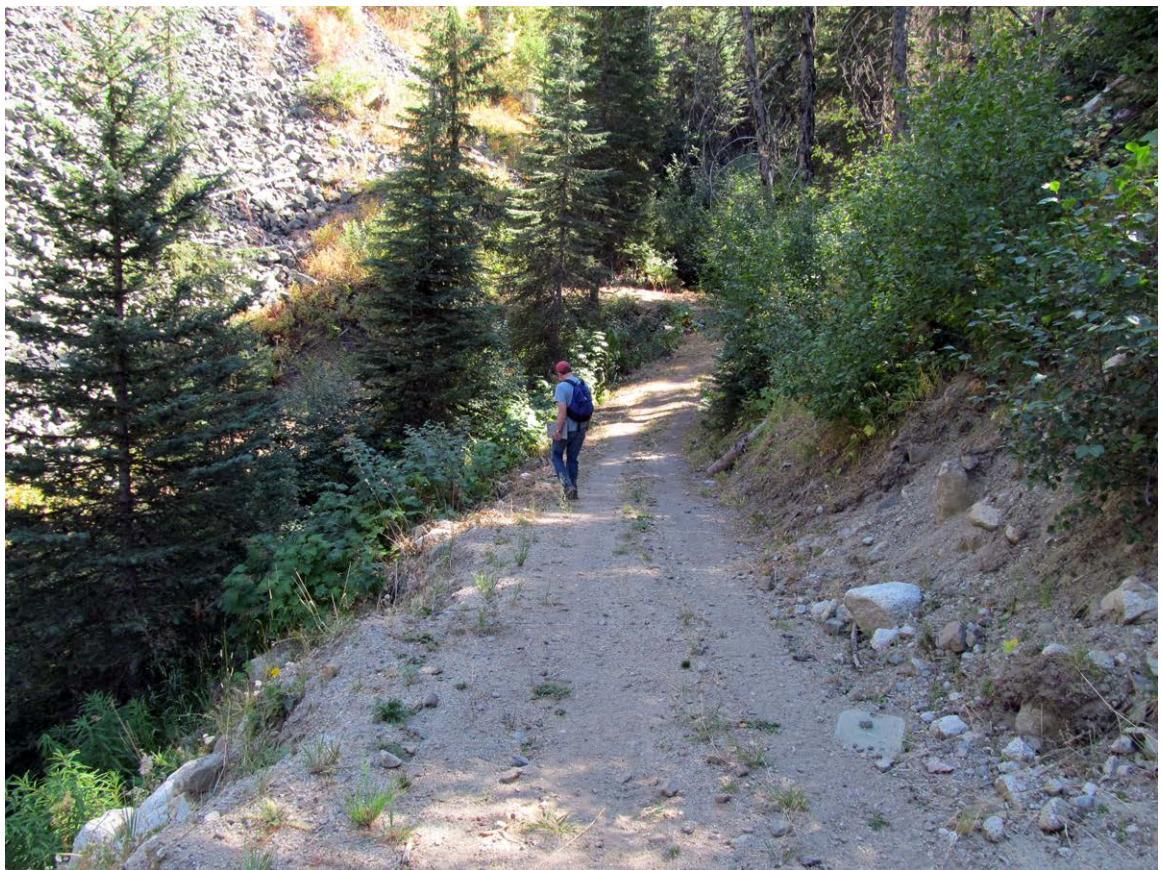
B. VIEW LOOKING SOUTHEAST DOWN ACCESS ROAD FROM THE DAM.

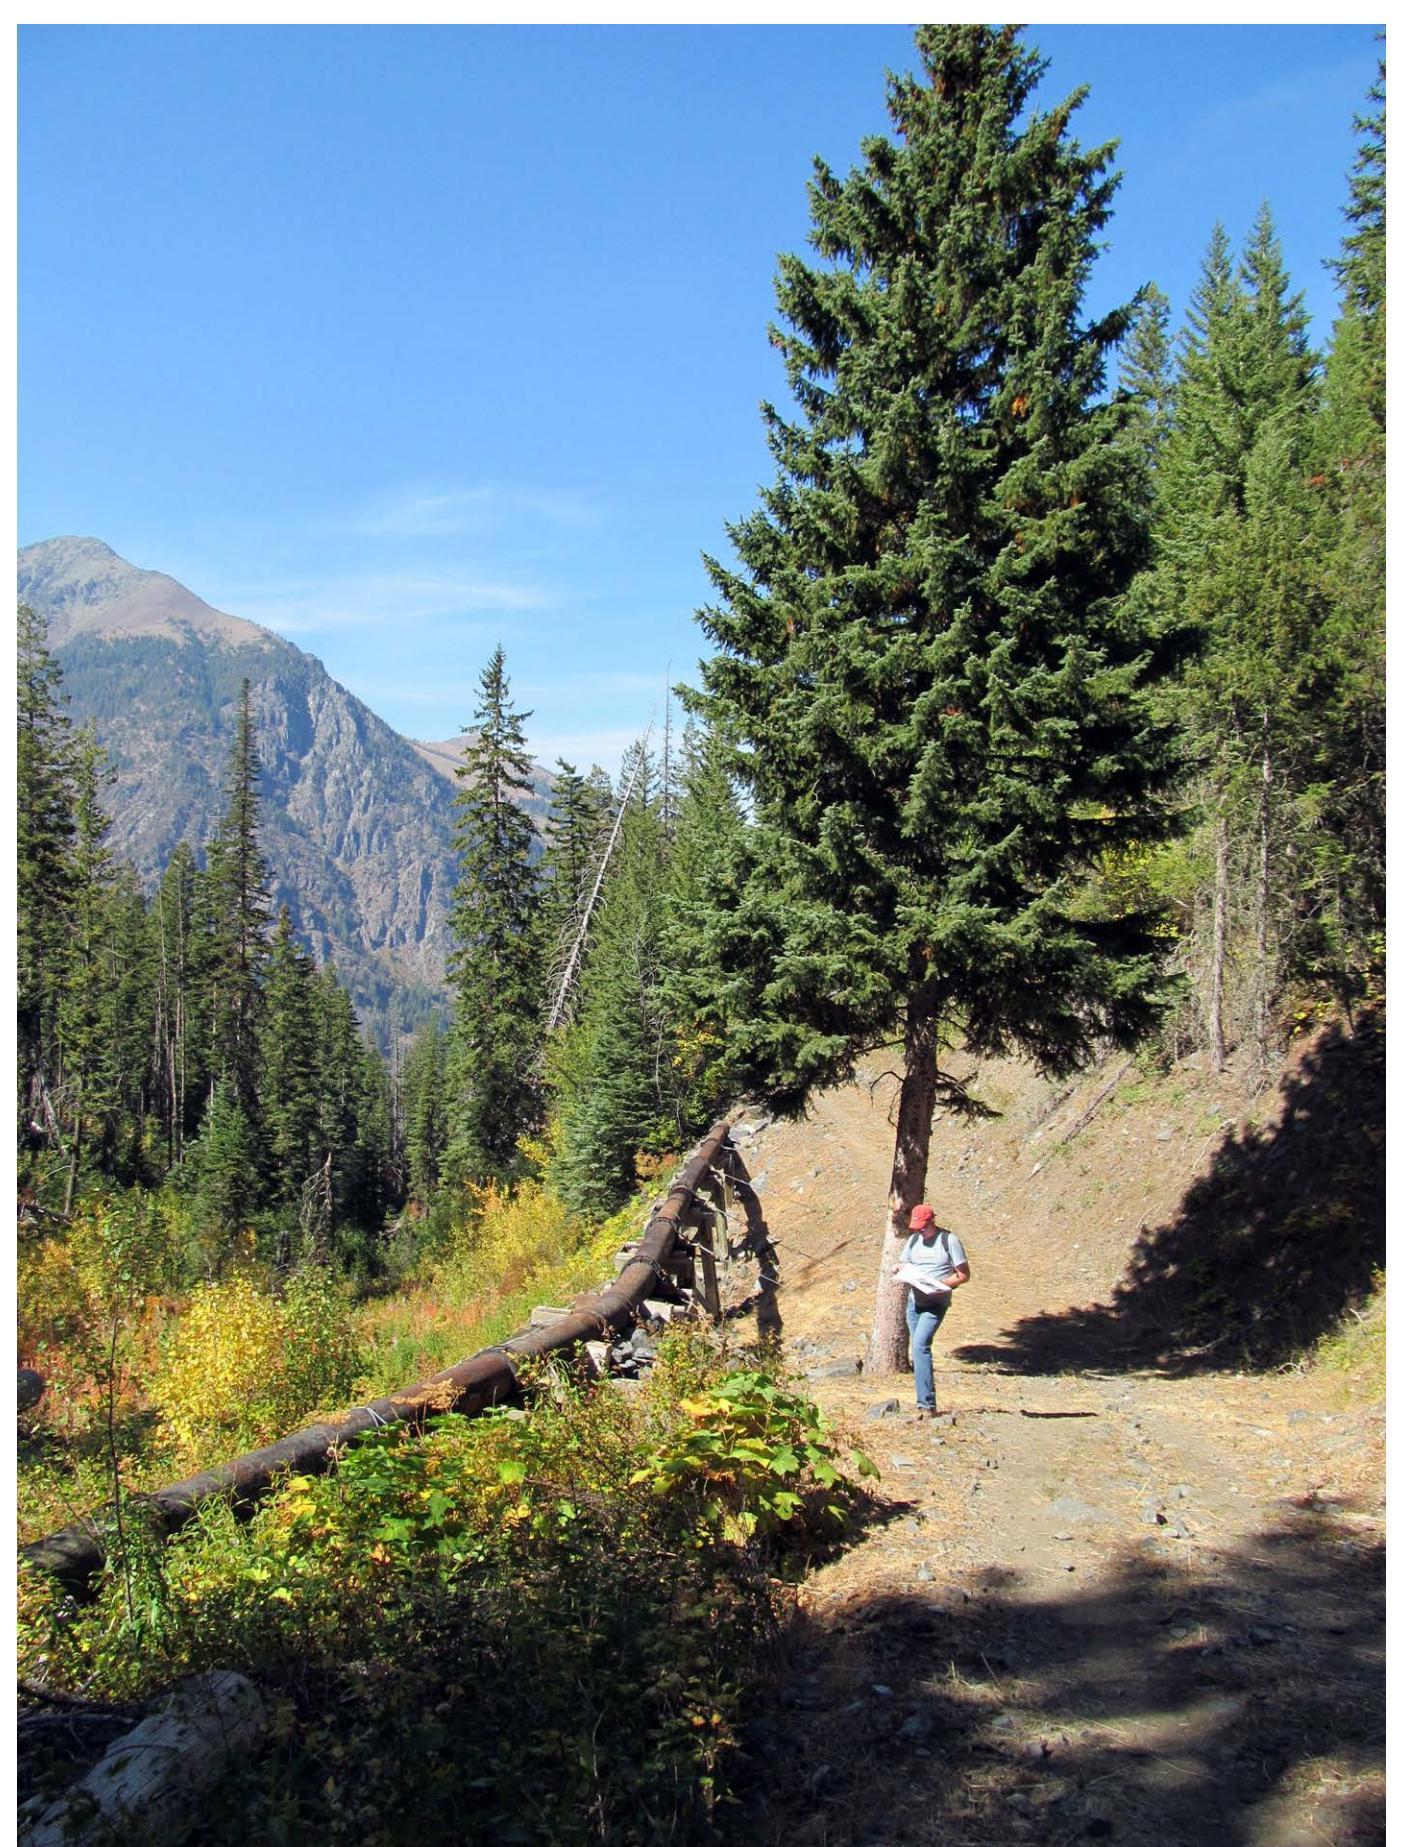
VIEW LOOKING NORTH-NORTHWEST AT THE UPPER PENSTOCK TRESTLE (APPROXIMATE ACCESS ROAD STATION 8+85).

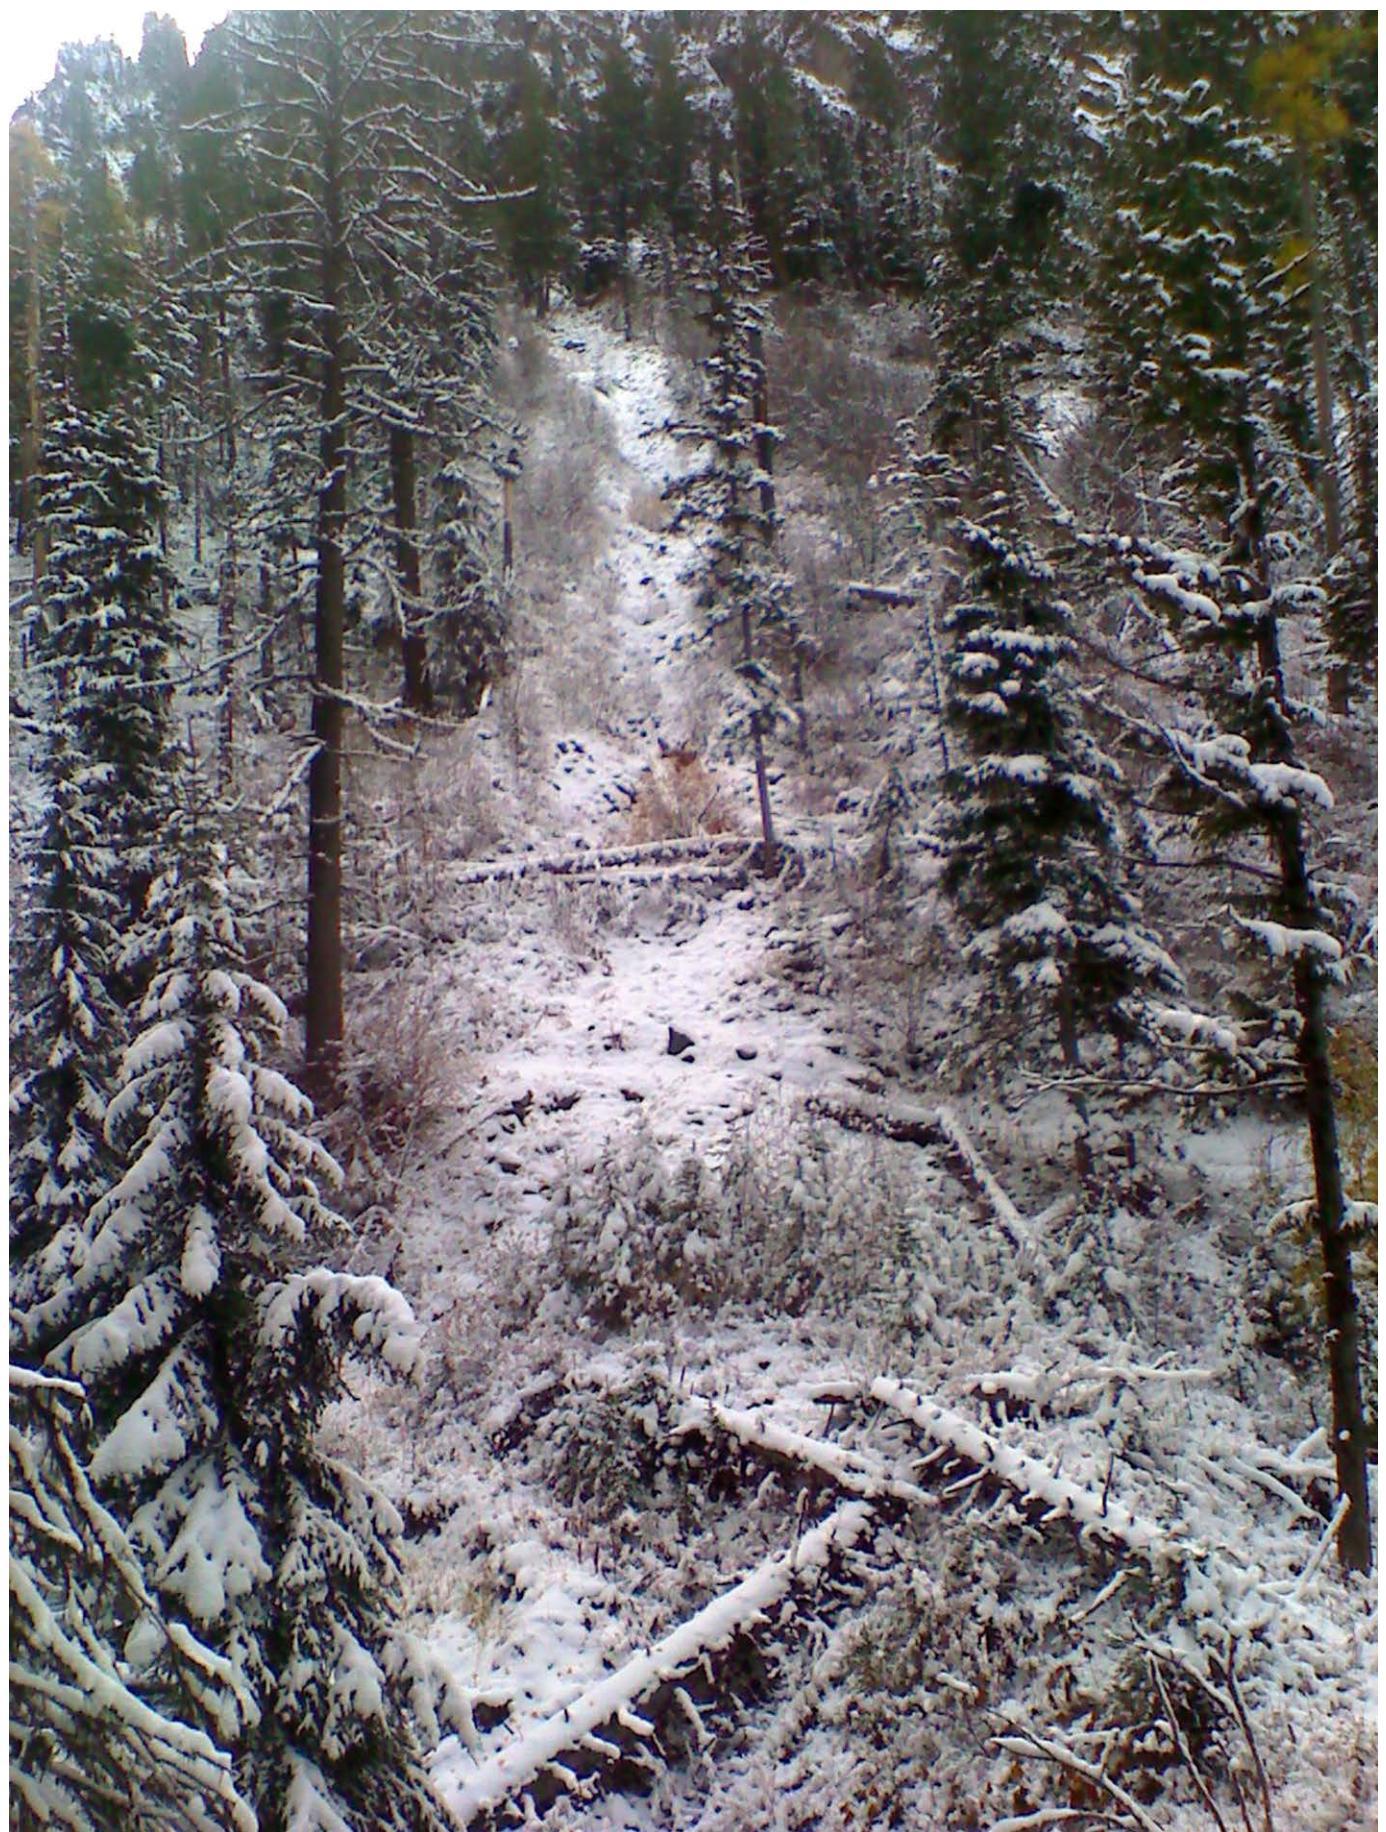
VIEW LOOKING SOUTHWEST AT DEBRIS FLOW CHANNEL ON SLOPE WEST OF THE EAST FORK WALLOWA RIVER. REPORTEDLY, THIS EVENT OCCURRED IN 2006 (PHOTO TAKEN BY OTHERS ON 10-24-2012).

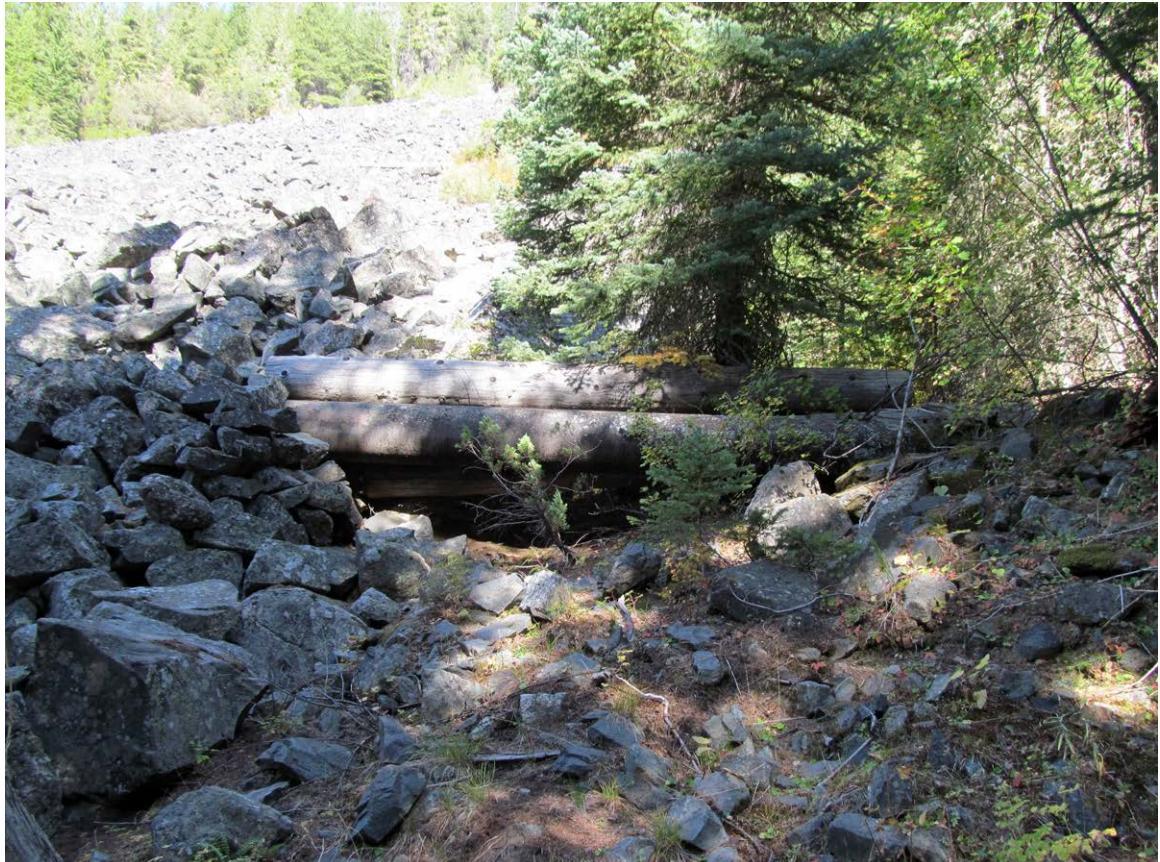
A. VIEW LOOKING EAST AT SECTION OF PENSTOCK LOCATED ABOVE GRADE (APPROXIMATE ACCESS ROAD STATION 20+30).

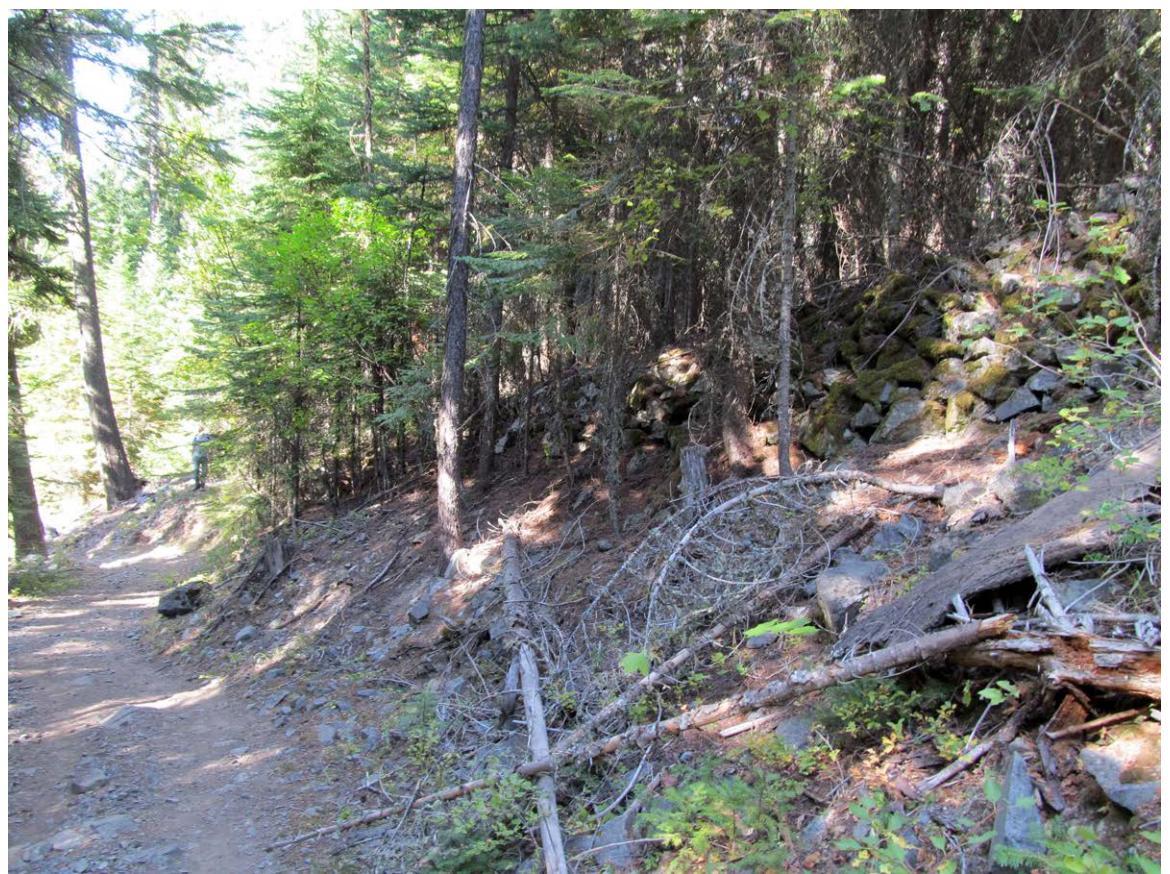
B. VIEW LOOKING NORTHEAST AT PENSTOCK ALONG TOE OF TALUS SLOPE (APPROXIMATE ACCESS ROAD STATION 21+45). PENSTOCK HAS BEEN ENCAPSULATED IN TALUS TO PROTECT FROM ROCKFALL.

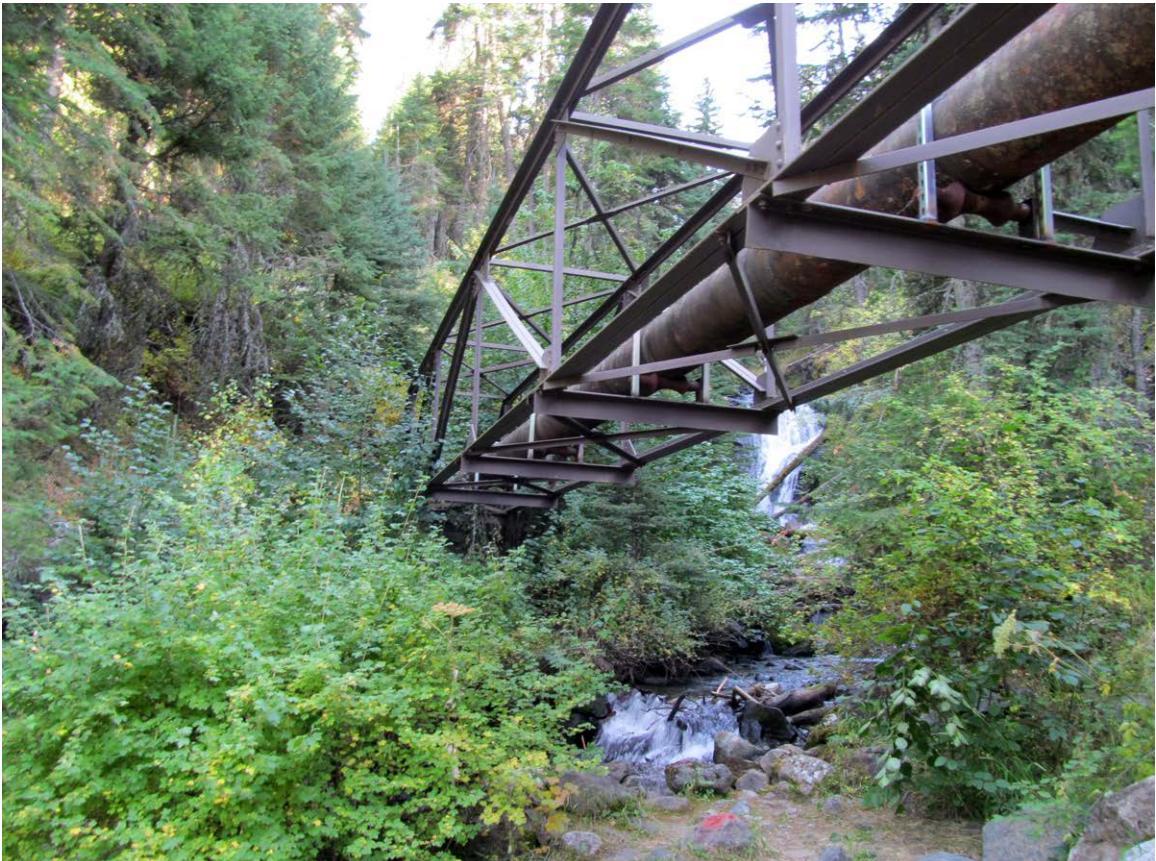
A. VIEW LOOKING SOUTHWEST AT LOWER PENSTOCK TRESTLE OVER THE EAST FORK WALLOWA RIVER (APPROXIMATE ACCESS ROAD STATION 57+00).

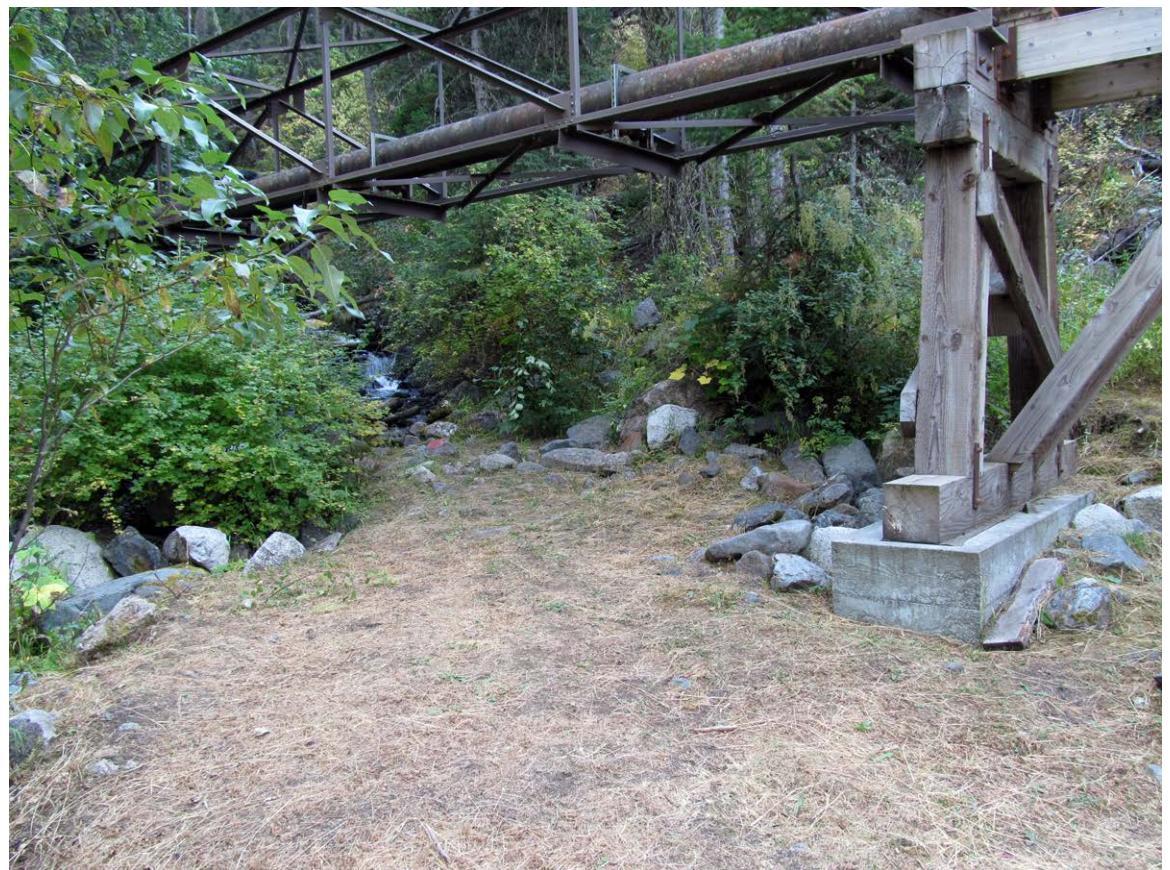
B. VIEW LOOKING SOUTHWEST AT LOWER PENSTOCK TRESTLE OVER THE EAST FORK WALLOWA RIVER.
