Wallowa Falls Hydroelectric Project FERC Project No. P-308 Updated Study Report (Final Technical Report)

Geology and Soils

Cornforth Consultants, Inc. 10250 SW Greenburg Road, Suite 111 Portland, OR 97223

December 2013

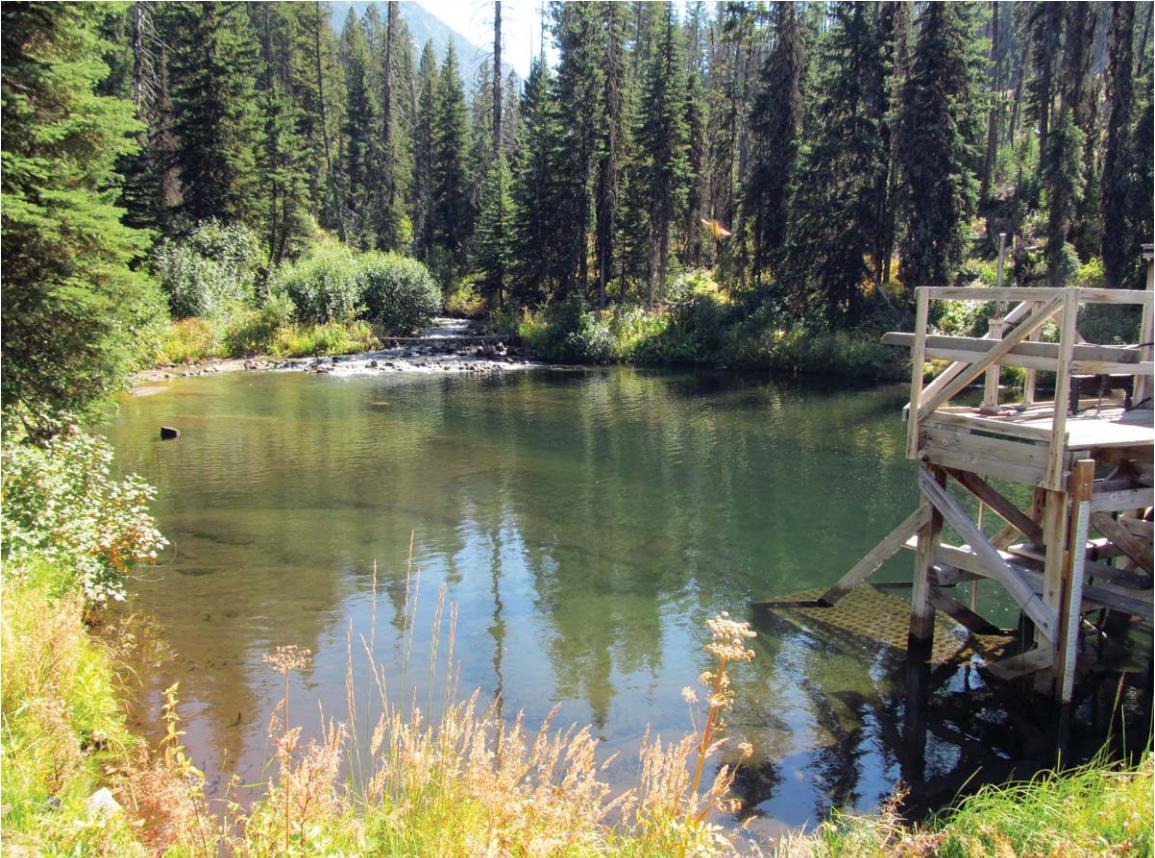
The slopes immediately around the dam's forebay are relatively flat and well vegetated (see Photo Exhibit 1A); however, they steepen considerably over a short distance to the east and west (i.e. outside of the river channel). No signs of landslide activity, slope instability, or erosion were observed around the forebay and the dam. Downstream of the dam, the penstock goes below grade and is covered by granular fill material (see Photo Exhibit 1B). The slopes in this area have been benched and graded relatively flat. The penstock is located northwest (downslope) of the access road in this area. No signs of landslide activity, slope instability, or excessive erosion were observed along this section of the penstock alignment.

A. VIEW LOOKING SOUTH AT WALLOWA FALLS FOREBAY.

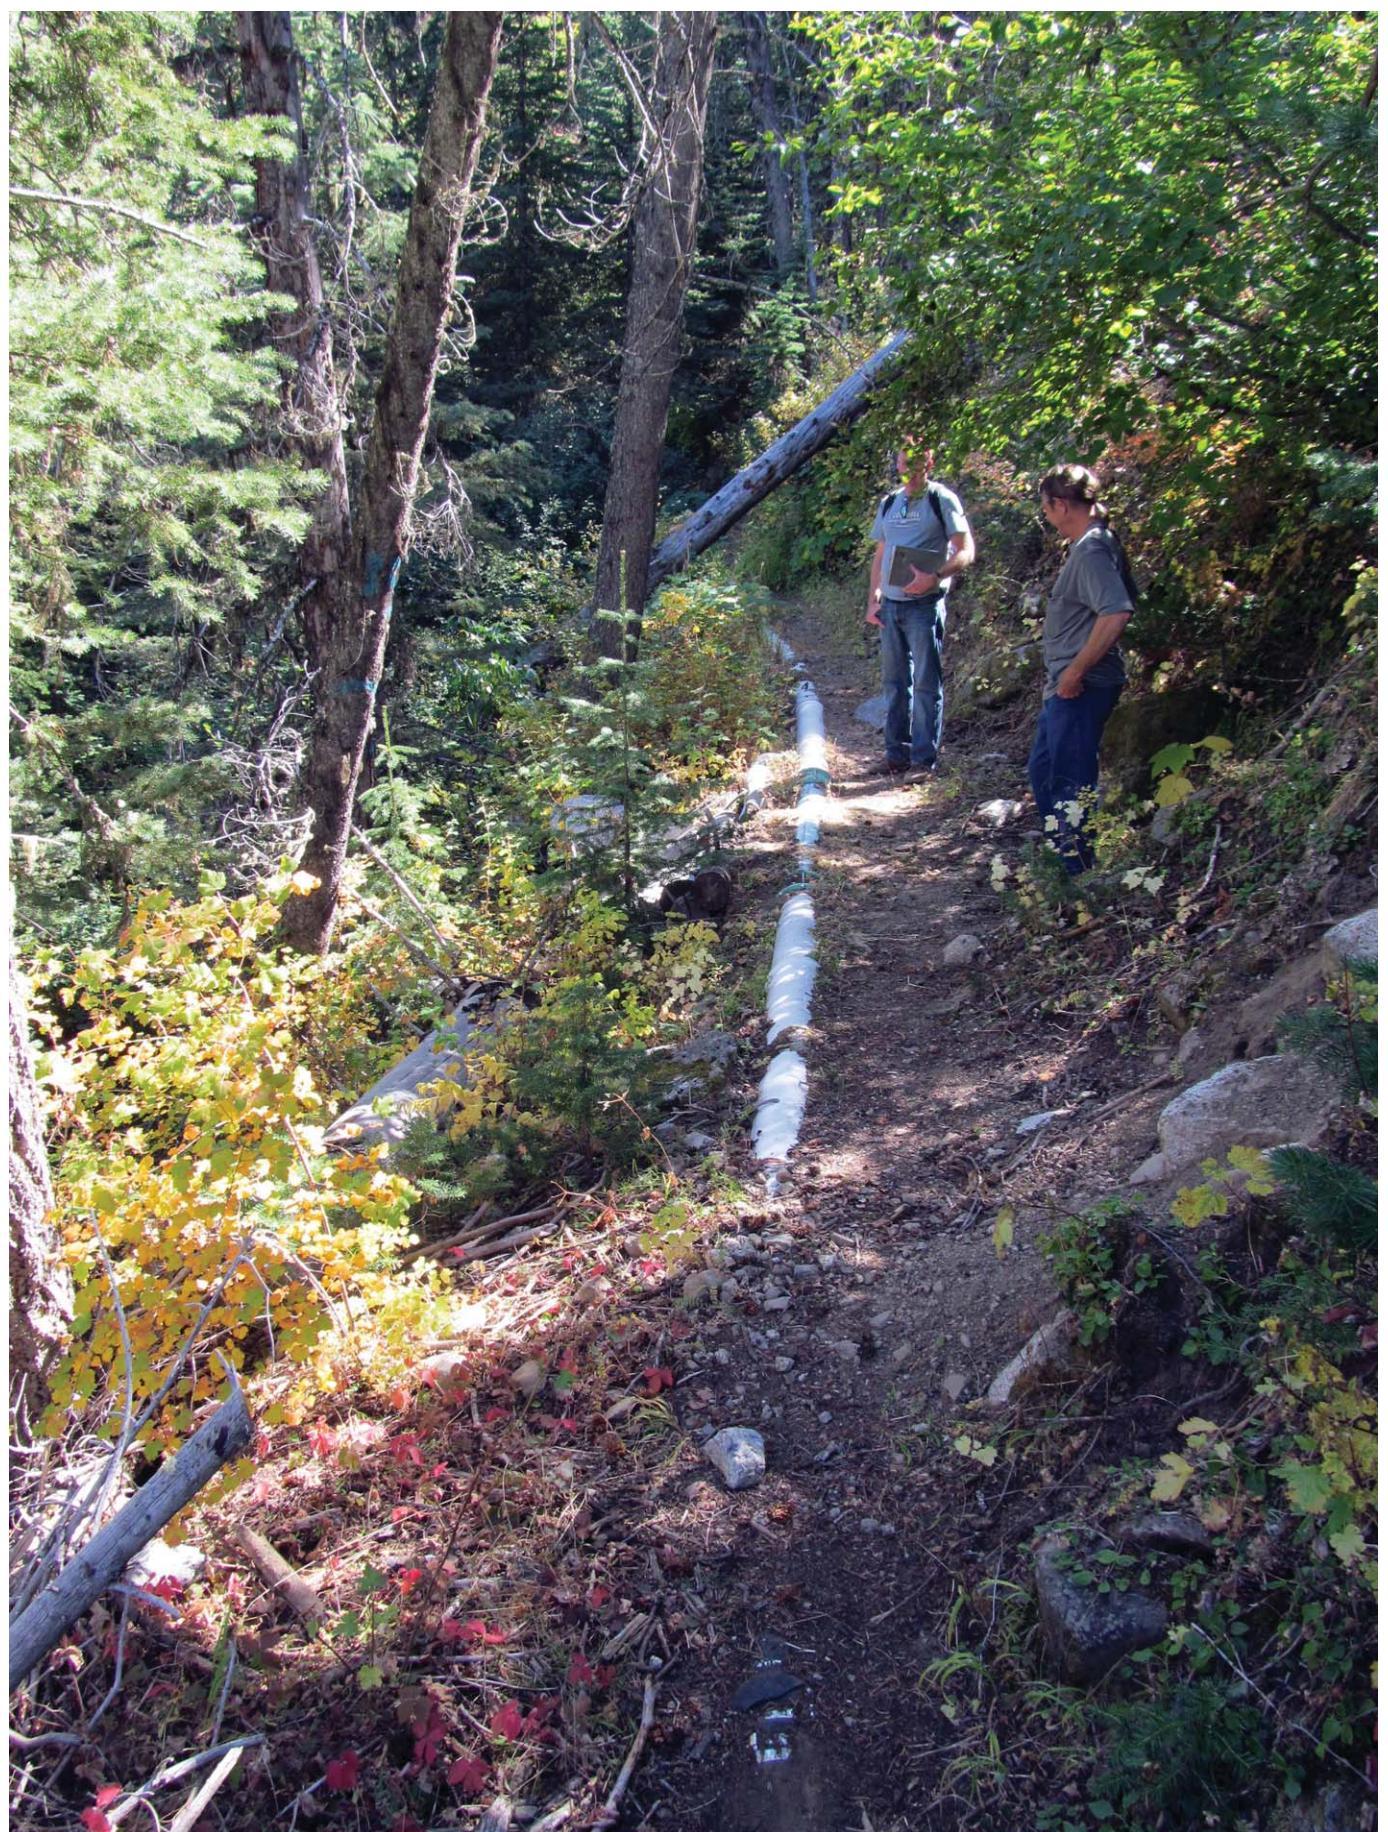
Approximately 200 feet upstream of the forebay, a diversion structure diverts water from Royal Purple Creek to the forebay through a 240-foot long, 8-inch diameter PVC pipe. This pipe is exposed above ground approximately half of its length (roughly 132 feet). Several hazard trees were observed along the flow-line (see Photo Exhibit 2). A localized shallow slough approximately 10 feet wide was observed on the outboard edge of the access trail to the diversion structure. No landslide activity or excessive erosion was observed in this area.

Wallowa Falls Hydroelectric Project FERC No. P-308 Updated Study Report - Geology and Soils December 2013 Page 8 Trees in the proximity of the Royal Purple Creek diversion flow line and the two trestle locations represent a significant hazard. As previously discussed, the only penstock failure and subsequent uncontrolled discharge of water due to natural hazards was the result of a tree fall event.

VIEW LOOKING SOUTHEAST AT 8-INCH PVC PIPELINE DIVERTING WATER FROM ROYAL PURPLE CREEK TO THE FOREBAY.

- Assess the tree conditions and remove any tree along the penstock alignment and the Royal Purple Creek diversion flow line that represents a hazard.
- Continue erosion control practices and vegetation management throughout the project area. If worsening conditions are observed, implement additional erosion control measures such as bioremediation techniques, water bars, rock inlays, natural or geo-synthetic mats, and cellular grids. In addition, culvert inlets and outlets should regularly be cleared of debris.

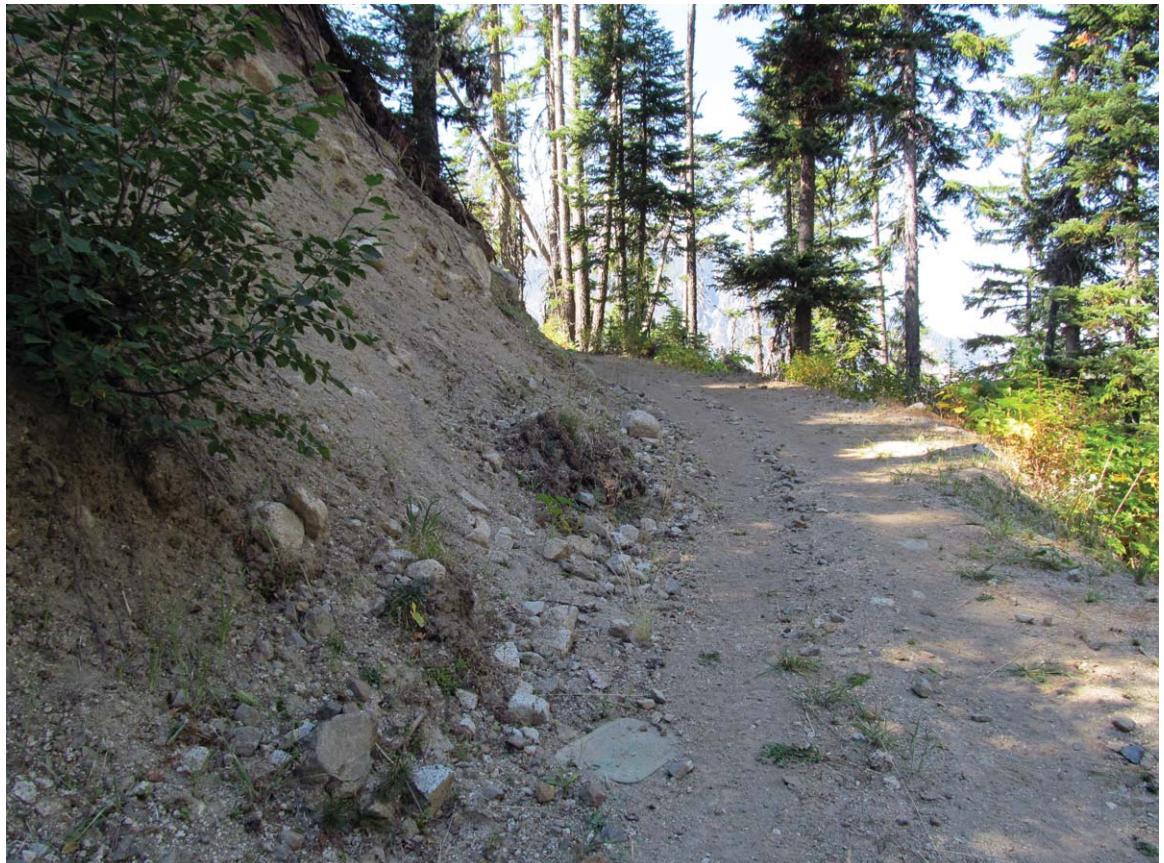
An approximately 600-foot section of the original access trail, located between the East Fork Wallowa River and Royal Purple Creek (northeast of the dam), was improved when the dam was rebuilt in 1994 (see Figure 1). The access road through this area (approximate Station 1+45) is approximately eight feet wide and was built using cut and cast construction techniques. Control cables that run from the generating unit to the intake gate controls at the dam are buried along the inboard edge of the road. An approximately 100-foot long portion of the cut slope on the inboard side of the road is over-steepened (greater than 50 degrees) and shows signs of sloughing and erosion (see Photo Exhibit 3). This area of localized surficial sloughing does not appear to pose a risk to the buried control cables, nor does it pose a risk to the penstock which is located 100 feet to the west of the access road. However, worsening conditions have the potential to cause localized instability concerns and increased road maintenance efforts. In addition, there is the potential for increased erosion activity.

A. VIEW LOOKING WEST UP ACCESS ROAD TO THE DAM BETWEEN ROYAL PURPLE CREEK AND THE EAST FORK WALLOWA RIVER. NOTE SLOUGHING MATERIAL ON CUT SLOPE.

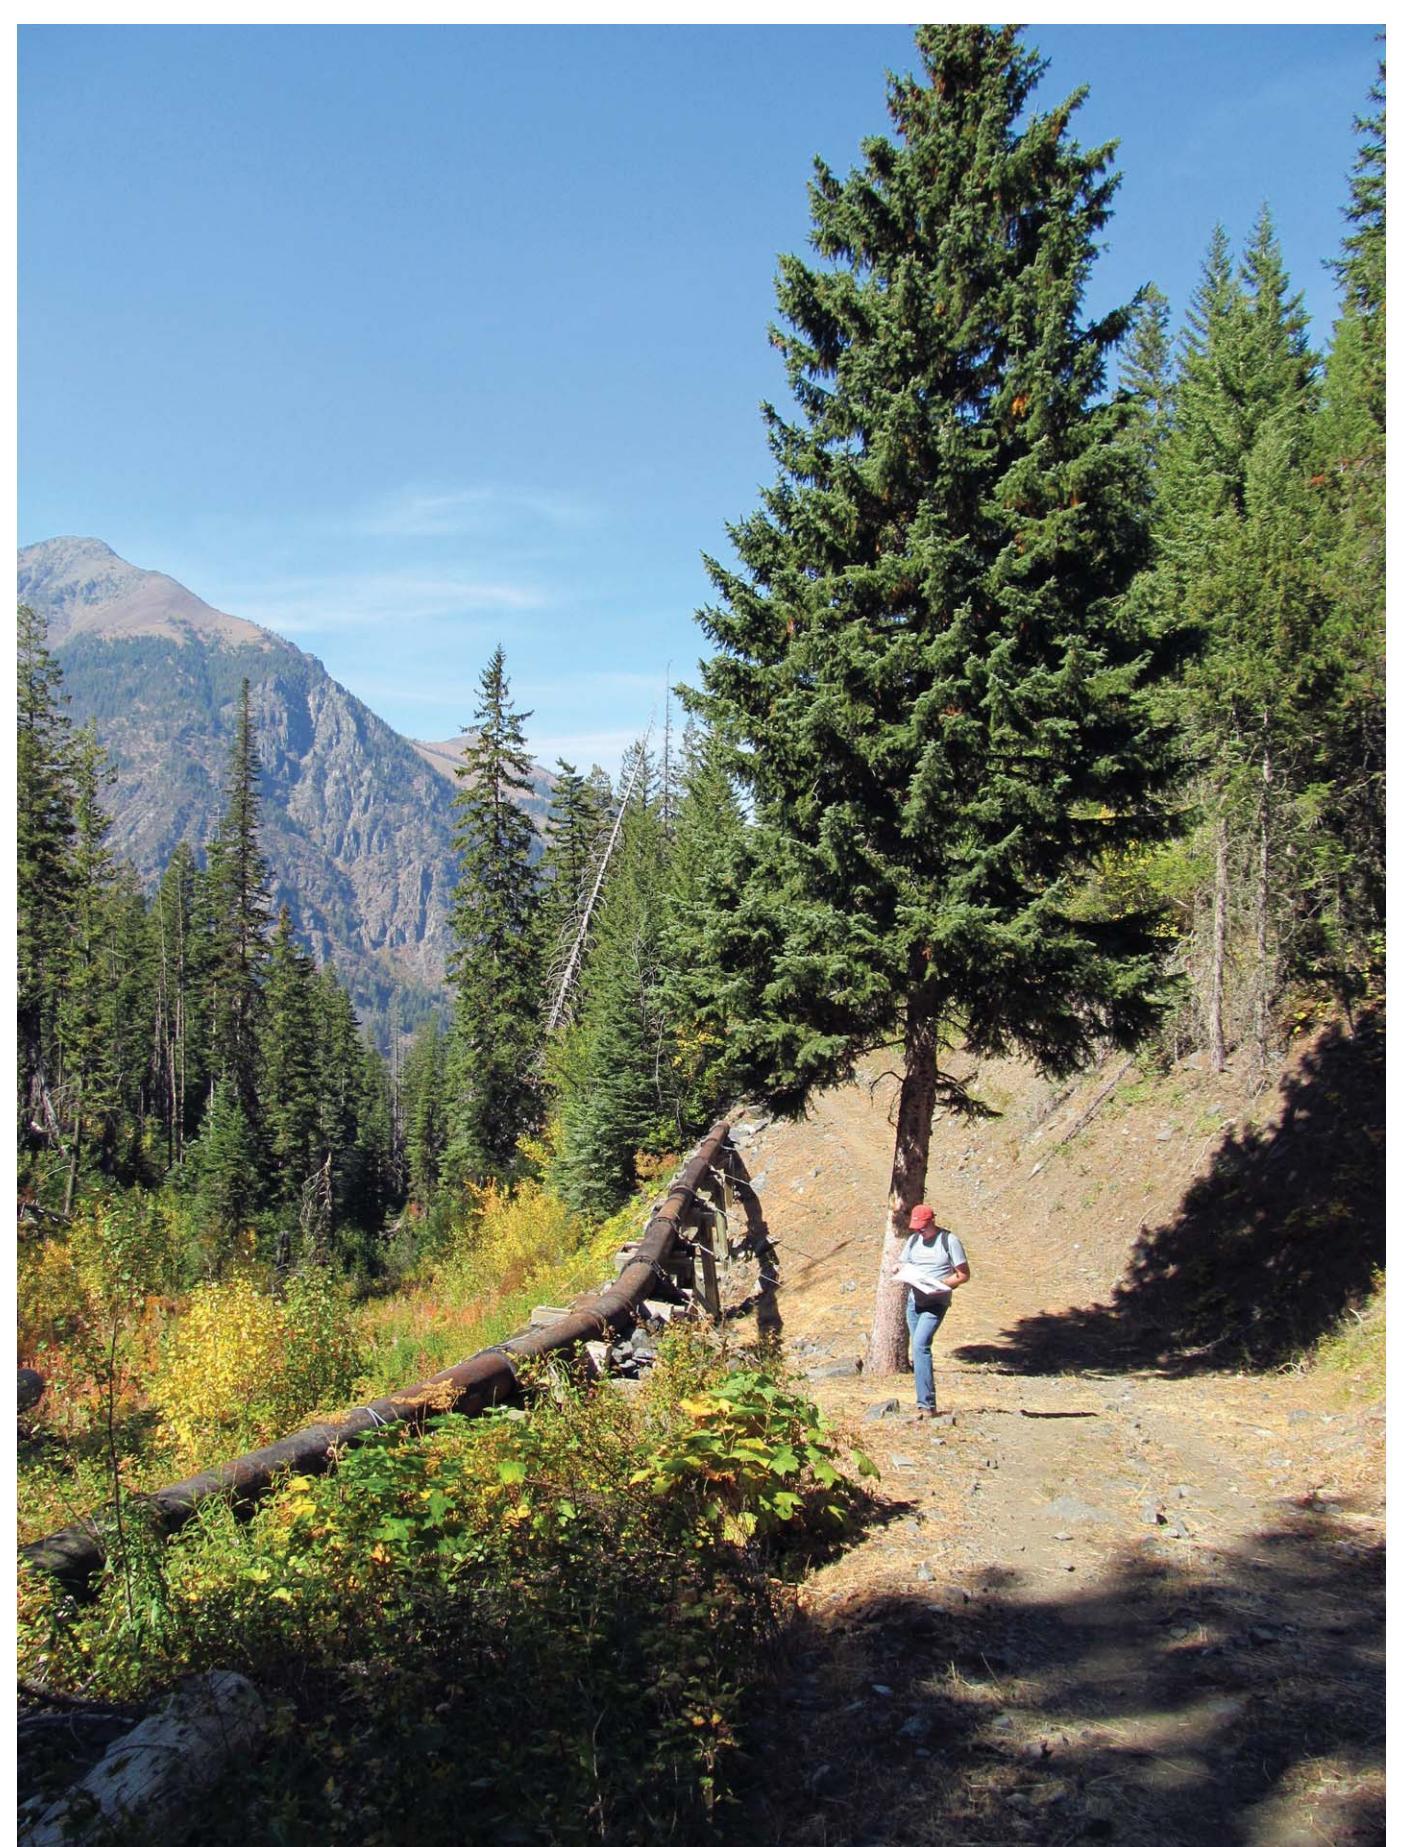
approximately 115 feet (see Photo Exhibit 4). PacifiCorp reports this trestle was rebuilt in 2000. No signs of landslide activity or slope instability were observed in the vicinity of the trestle footings, the penstock, or the access road. In addition, no signs of excessive erosion were observed. A potential hazard tree was observed on the south end of the trestle (see Photo Exhibit 4). Local sloughing of the outboard shoulder of the access road was observed at Station 11+50.

VIEW LOOKING NORTH-NORTHWEST AT THE UPPER PENSTOCK TRESTLE (APPROXIMATE ACCESS ROAD STATION 8+85).

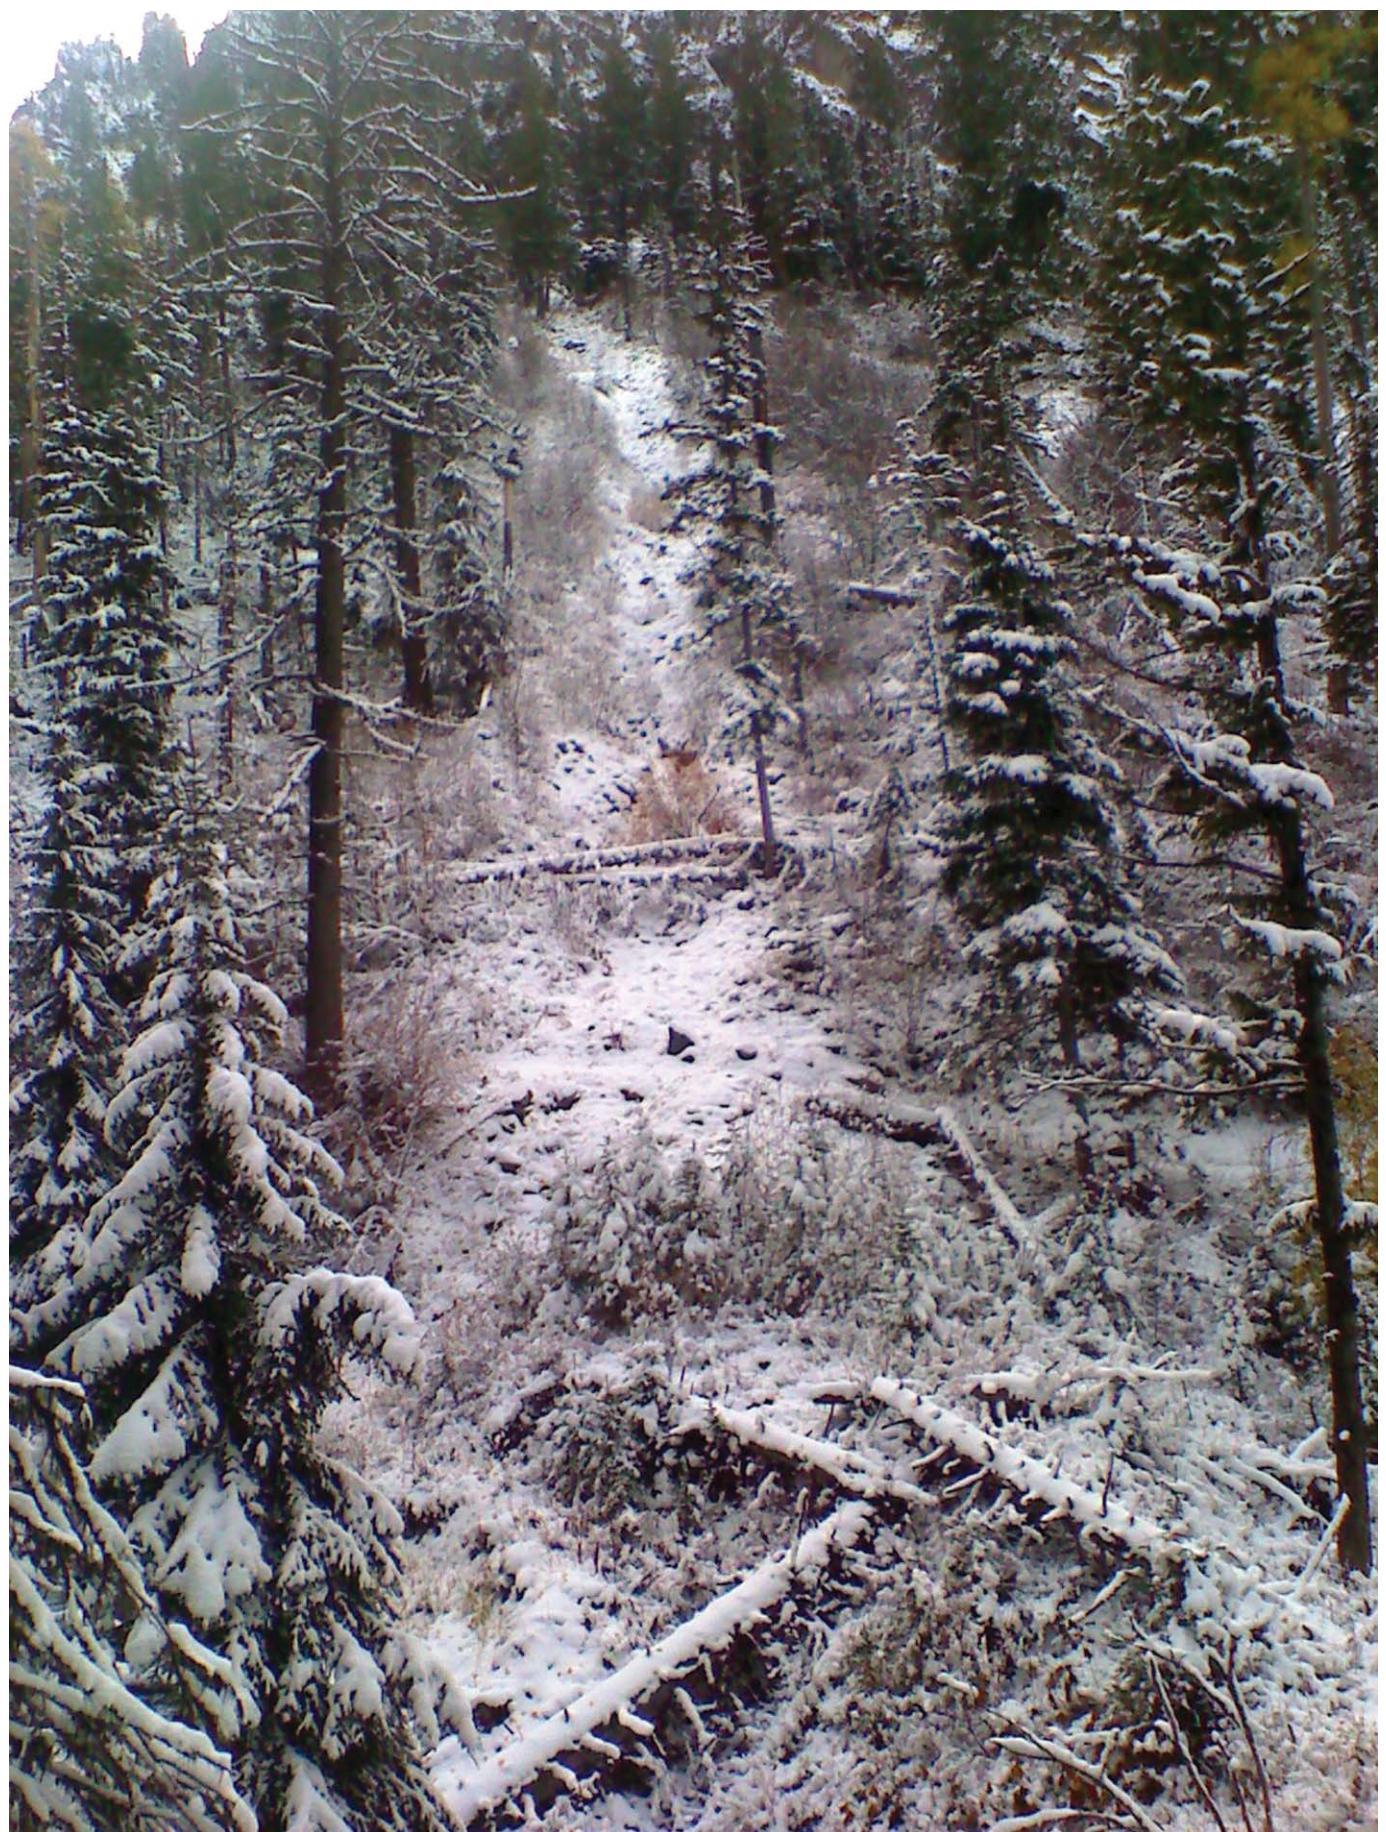
From the vantage point along the access road (approximate Station 11+50) a debris flow channel was observed on the west slope across the East Fork Wallowa River (see Photo Exhibit 5). Subsequent conversations with the Forest Service recreation maintenance supervisor indicated that the debris flow event occurred in 2006 and caused significant damage to the USFS 1804 trail located on the opposite side of the river from the penstock. Based on the size of the scour channel it left behind, the debris flow appears to have deposited a considerable amount of debris and sediment in the river, and may have temporarily dammed the river. This event, or associated high river flows, likely caused the river to scour the toe of the natural slope, resulting in a shallow failure within the outboard shoulder of the penstock access road (see Photo Exhibit 6). The main slide area is approximately 30 feet wide and 90 feet long (see Photo Exhibit 7A and 7B). Ground cracks were also observed running parallel to the access road extending roughly 25 feet to the northwest from the headscarp of the main slide area. The penstock is buried within the access road adjacent to the headscarp of the failure, which raises concern that the failing slope could retrogress further into the embankment and undermine the penstock.

As previously discussed, a debris flow slide occurred in 2006 on the west slope across the East Fork Wallowa River. The debris flow slide caused significant damage to the USFS 1804 trail located on the opposite side of the river from the penstock, and the event deposited a considerable amount of debris and sediment that temporarily dammed the river and undoubtedly caused major river sedimentation. It appears that this event, or associated high river flows, caused the river to scour the toe of the slope, resulting in a shallow failure within the outboard shoulder of the penstock access road. The penstock is buried within the access road adjacent to the head scarp of the failure, which raises concern that the failing slope could retrogress further into the embankment and undermine and\or rupture the penstock. PacifiCorp Energy retained Cornforth to further evaluate the failing slope section and develop mitigation measures. A 65foot long mechanically stabilized earth (MSE) wall has been designed to improve the stability of the access road and support the penstock along the failing slope section. The construction of this MSE wall is scheduled for the spring of 2014.

VIEW LOOKING SOUTHWEST AT DEBRIS FLOW CHANNEL ON SLOPE WEST OF THE EAST FORK WALLOWA RIVER. REPORTEDLY, THIS EVENT OCCURRED IN 2006 (PHOTO TAKEN BY OTHERS ON 10-24-2012).

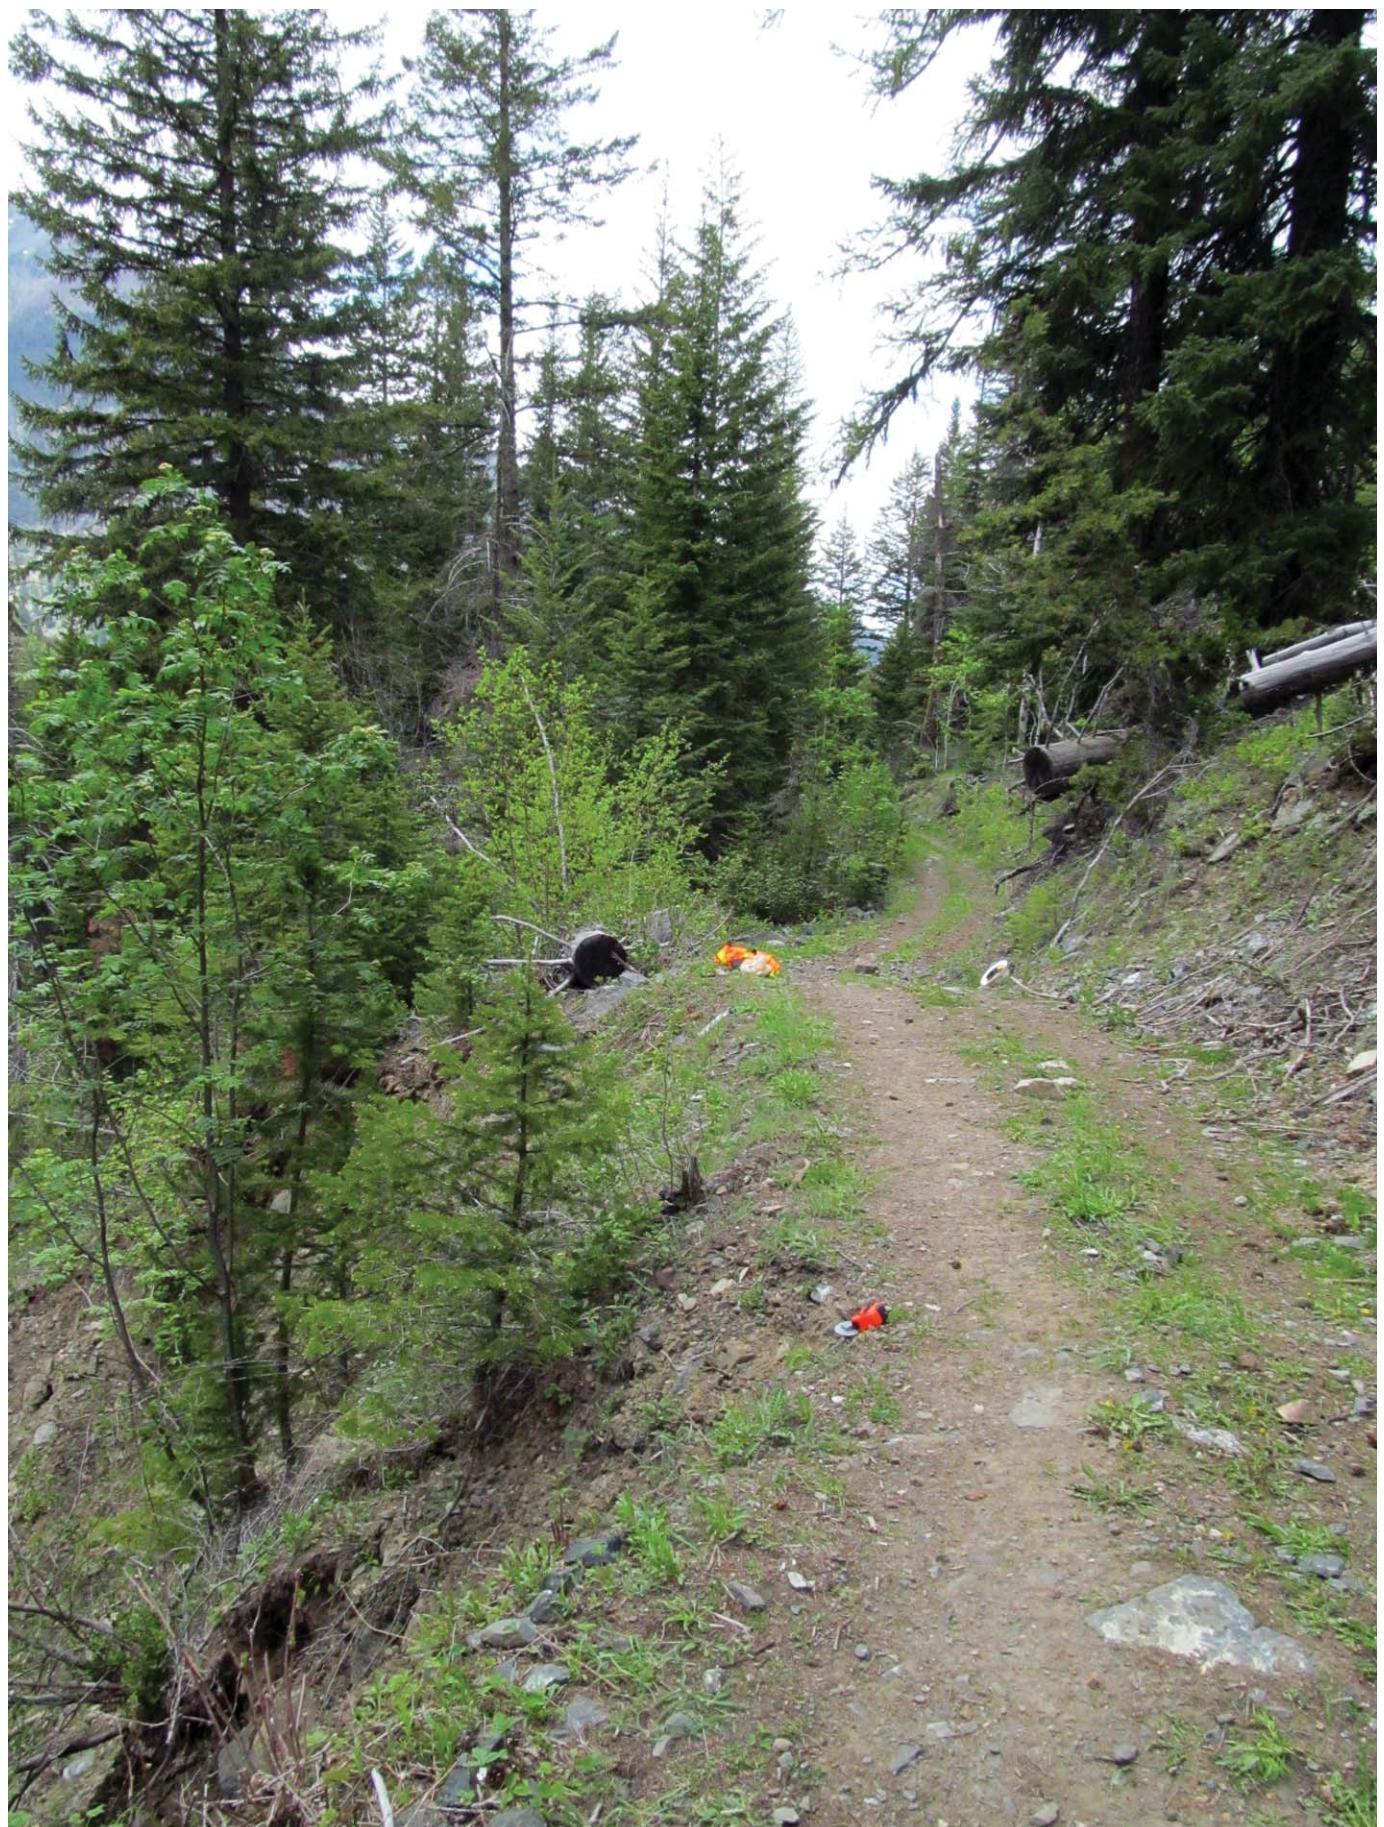
CORNFORTH CONSULTANTS, INC PHOTO EXHIBIT 6

Localized areas of minor sloughing associated with cut and side cast construction techniques along the access road were observed during the site reconnaissance. These areas do not pose an immediate risk to the penstock; however, worsening conditions have the potential to cause localized instability concerns such as the slide at Station 11+50. They will likely continue to be an access road maintenance issue. Localized areas of minor soil erosion associated with the access road were also observed during the site reconnaissance. The amount of sedimentation associated with these localized erosion areas is relatively small and likely on par with what the USFS trails experience throughout the area. However, worsening conditions could lead to increased erosion and sedimentation concerns in the future.

VIEW LOOKING NORTHWEST AT FAILING SLOPE SECTION ON THE OUTBOARD SHOULDER OF THE PENSTOCK ACCESS ROAD AT APPROXIMATE STATION 11+50. THE PENSTOCK IS BURIED WITHIN THE ROAD ADJACENT TO THE HEAD SCARP OF THE FAILURE.

- In the interim, monitor the failing (sloughing) slope section along the access road at Station 11+50 until mitigation measures can be implemented this spring. The objective of the monitoring program would be to provide forward notice to PacifiCorp of increased slope movement, which could undermine the buried penstock, leaving it unsupported within the road grade.

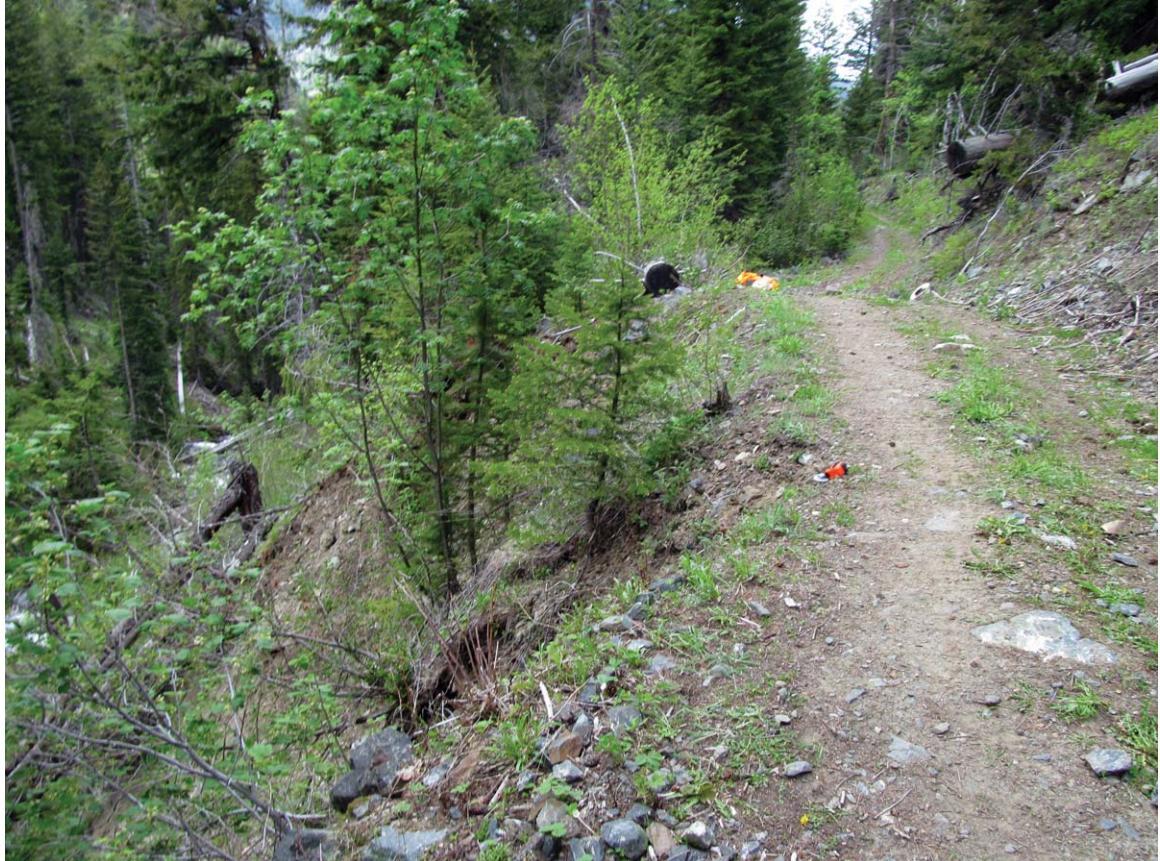
A. UPCLOSE VIEW OF THE FAILING SLOPE SECTION AT APPROXIMATE STATION 11+50.

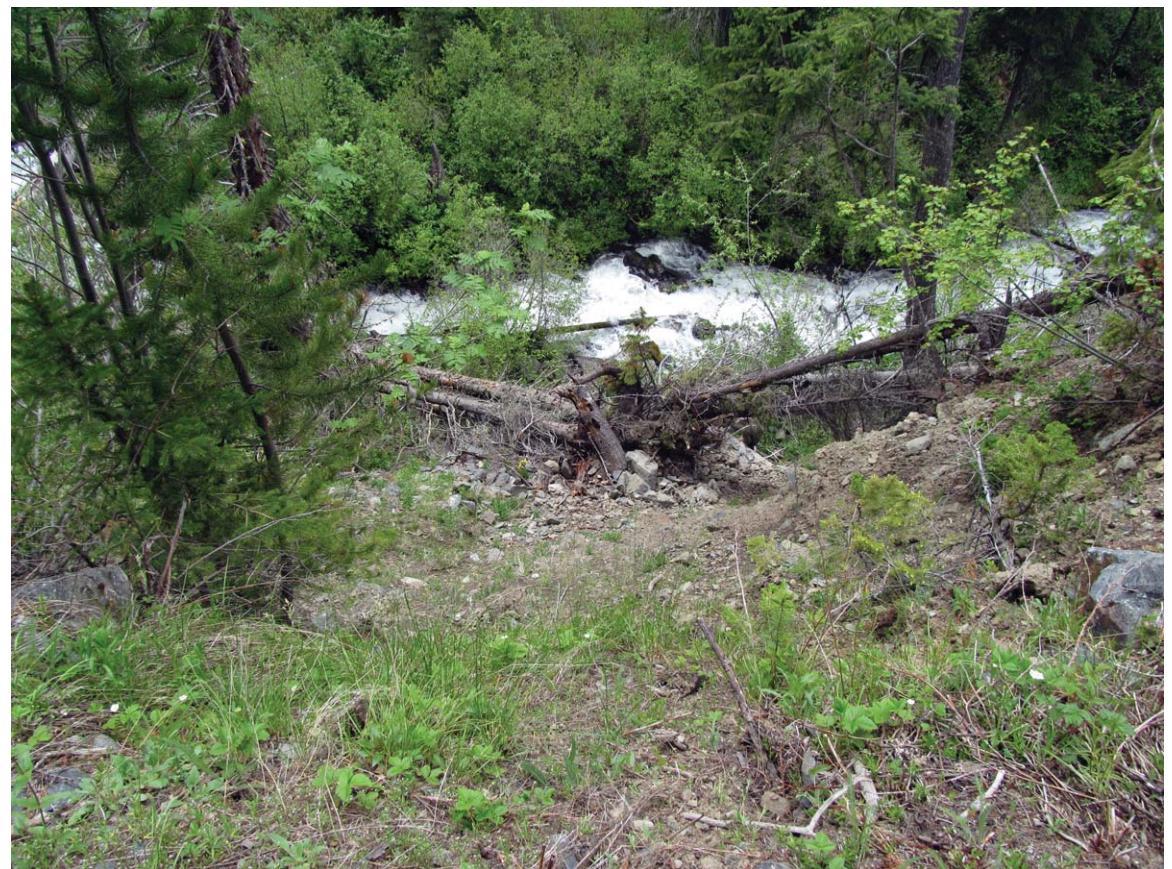
B. VIEW LOOKING SOUTHWEST AT SLIDE DEBRIS AT THE TOE OF THE FAILING SLOPE SECTION BELOW THE PENSTOCK AT APPROXIMATE STATION 11+50.

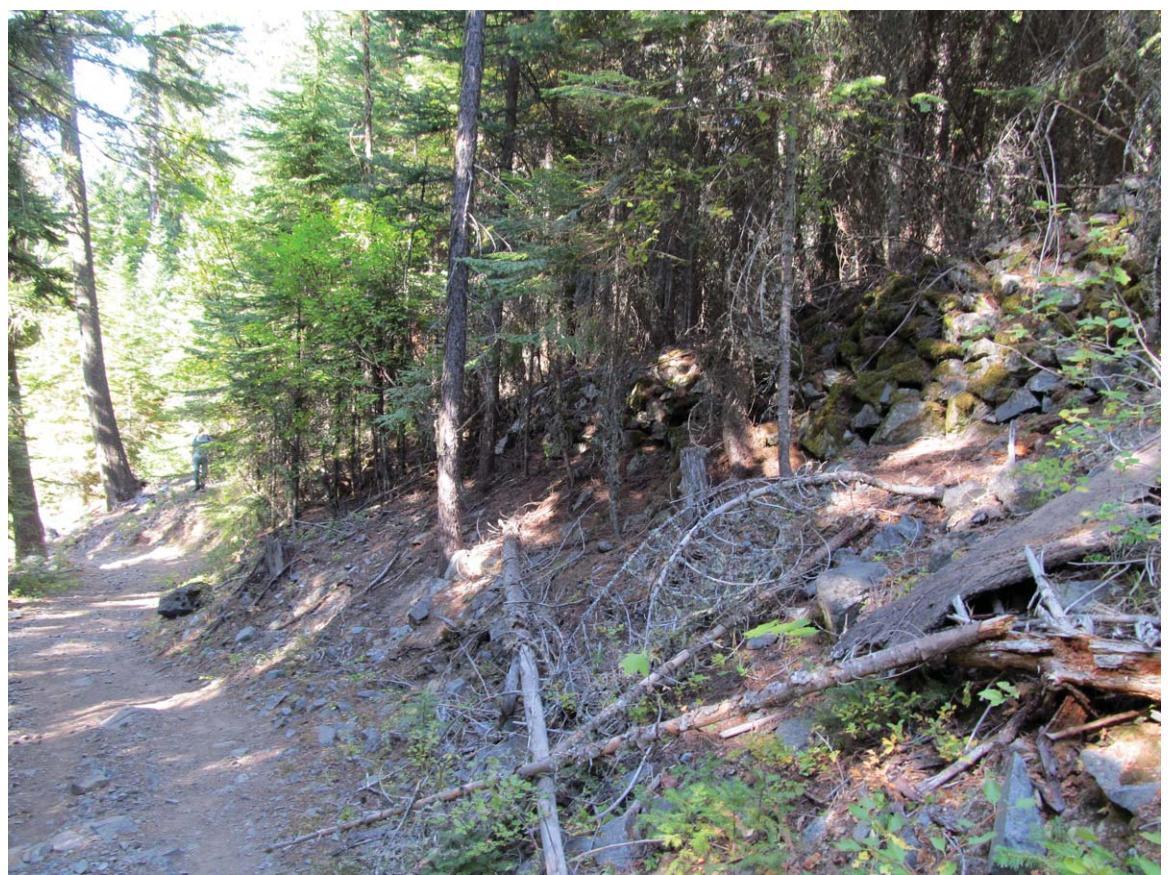
At approximate Station 17+50 (see Figure 2) the penstock crosses to the upslope (east) side of the access road. The penstock stays above the cut slope section of the access road until it crosses under the road again at approximate Station 34+66. No signs of landslide activity, slope instability, or excessive erosion were observed along this section of the penstock alignment. The penstock does cross the toe of a large talus field between Stations 20+30 and 21+45 (see Photo Exhibit 8). An approximately 17-foot segment of the penstock is exposed above grade on the southeast end of the talus pile. Several large logs have been stacked on the upslope side of the penstock to offer a level of protection from potential rockfall (see Photo Exhibit 8A). The remainder of the penstock through this segment has been encapsulated (covered) by hand-placed talus boulders to protect it (see Photo Exhibit 8B). The hazards associated with rockfall or instability of the talus pile along this segment is considered low.

B. VIEW LOOKING NORTHEAST AT PENSTOCK ALONG TOE OF TALUS SLOPE (APPROXIMATE ACCESS ROAD STATION 21+45). PENSTOCK HAS BEEN ENCAPSULATED IN TALUS TO PROTECT FROM ROCKFALL.

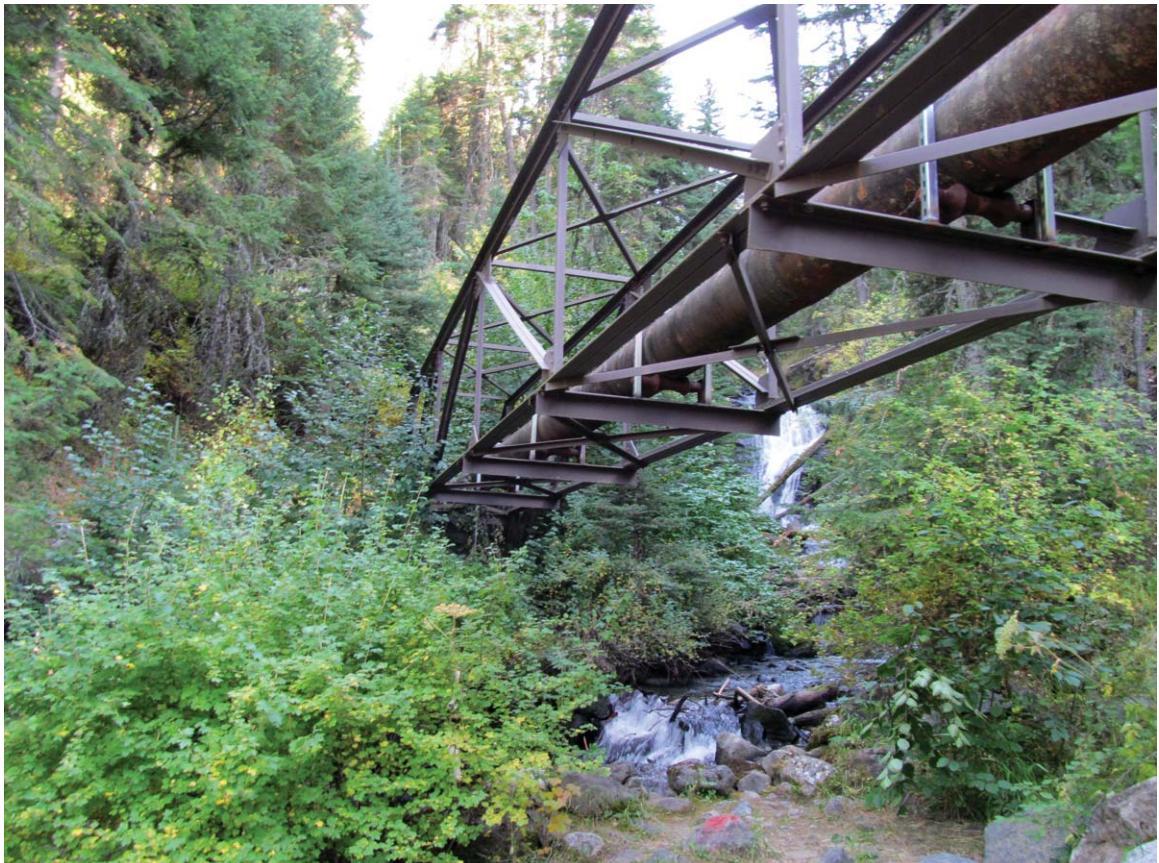
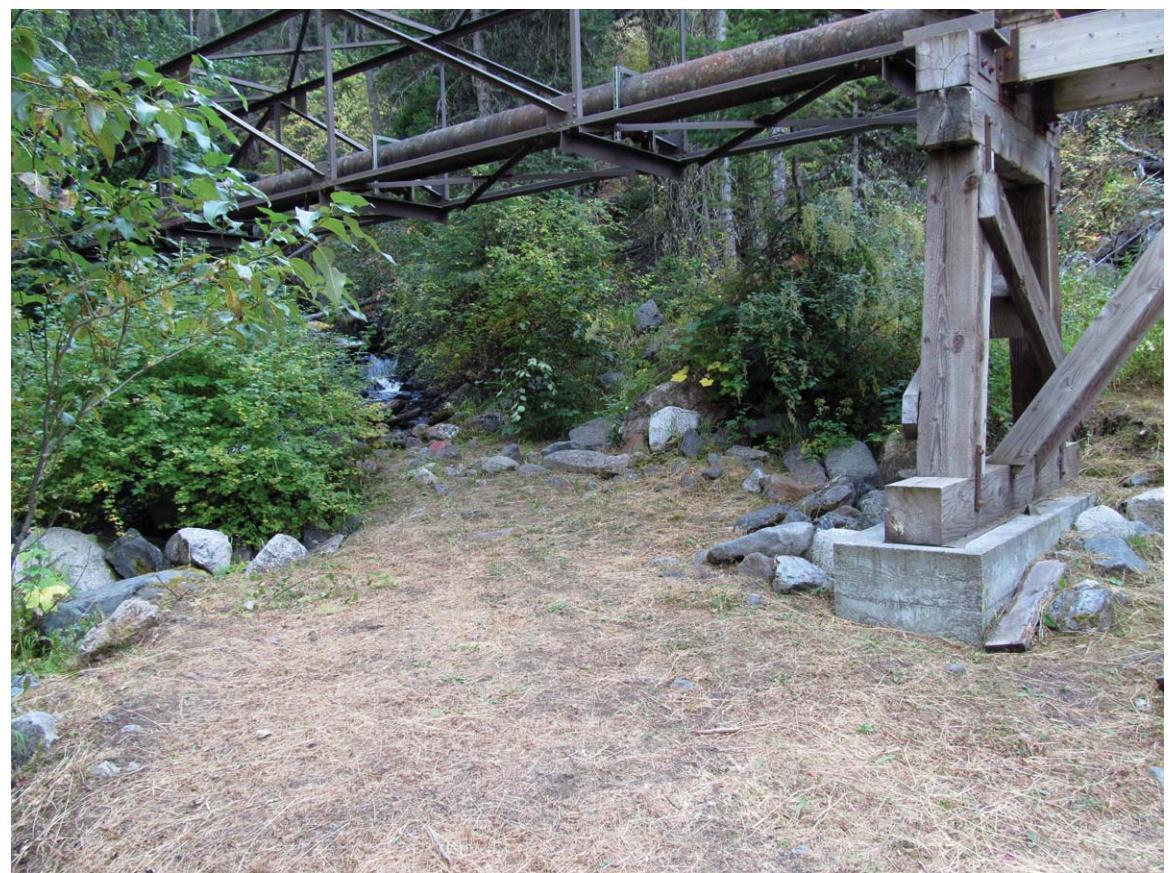
No signs of landslide activity, slope instability, or excessive erosion were observed along the penstock alignment or the access road from Station 34+66 to the powerhouse. The lower trestle is located approximately 1,000 feet above the powerhouse (see Photo Exhibit 7). No signs of landslide activity or slope instability were observed in the vicinity of the trestle footings. PacifiCorp reports that on September 26, 1999, a large tree fell on a penstock/trestle guy wire at the upper end of the lower trestle causing two sections of penstock pipe to separate. Remedial actions made in response to this incident included replacement of the penstock trestle and the inspection of the penstock alignment for hazard trees and the removal of ninety-one hazard trees in November 1999 and fifteen hazard trees in January 2000.

A. VIEW LOOKING SOUTHWEST AT LOWER PENSTOCK TRESTLE OVER THE EAST FORK WALLOWA RIVER (APPROXIMATE ACCESS ROAD STATION 57+00).
