# Lewis River Aquatic Fund Projects (SA 7.5.3.2)

## Project Closeout Report

**Project Title:** Lewis River Hydroelectric Project  
*Eagle Island Site A Habitat Restoration*

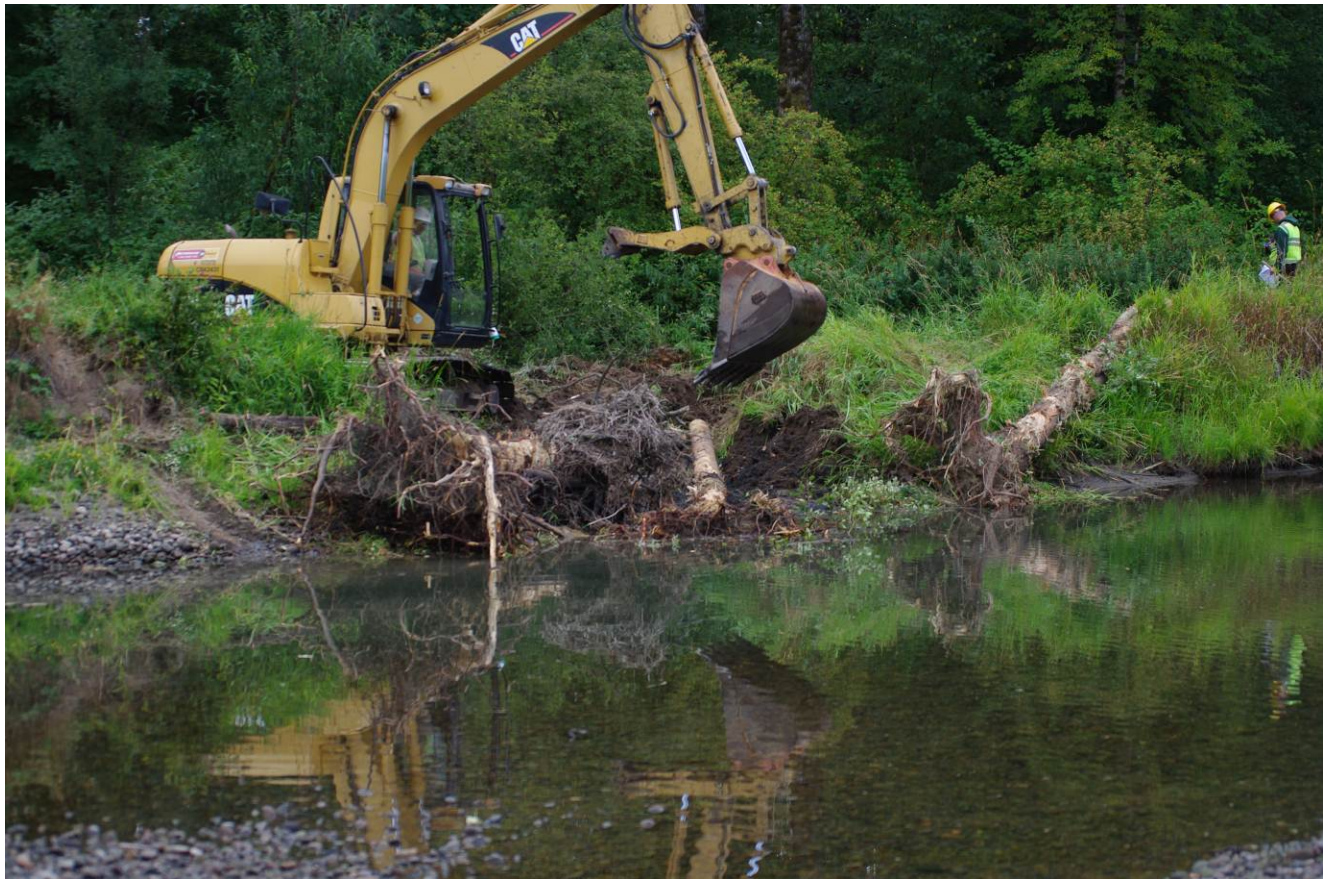
Installation of an upstream scour pool structure. This structure was buried and ballasted into the bank.

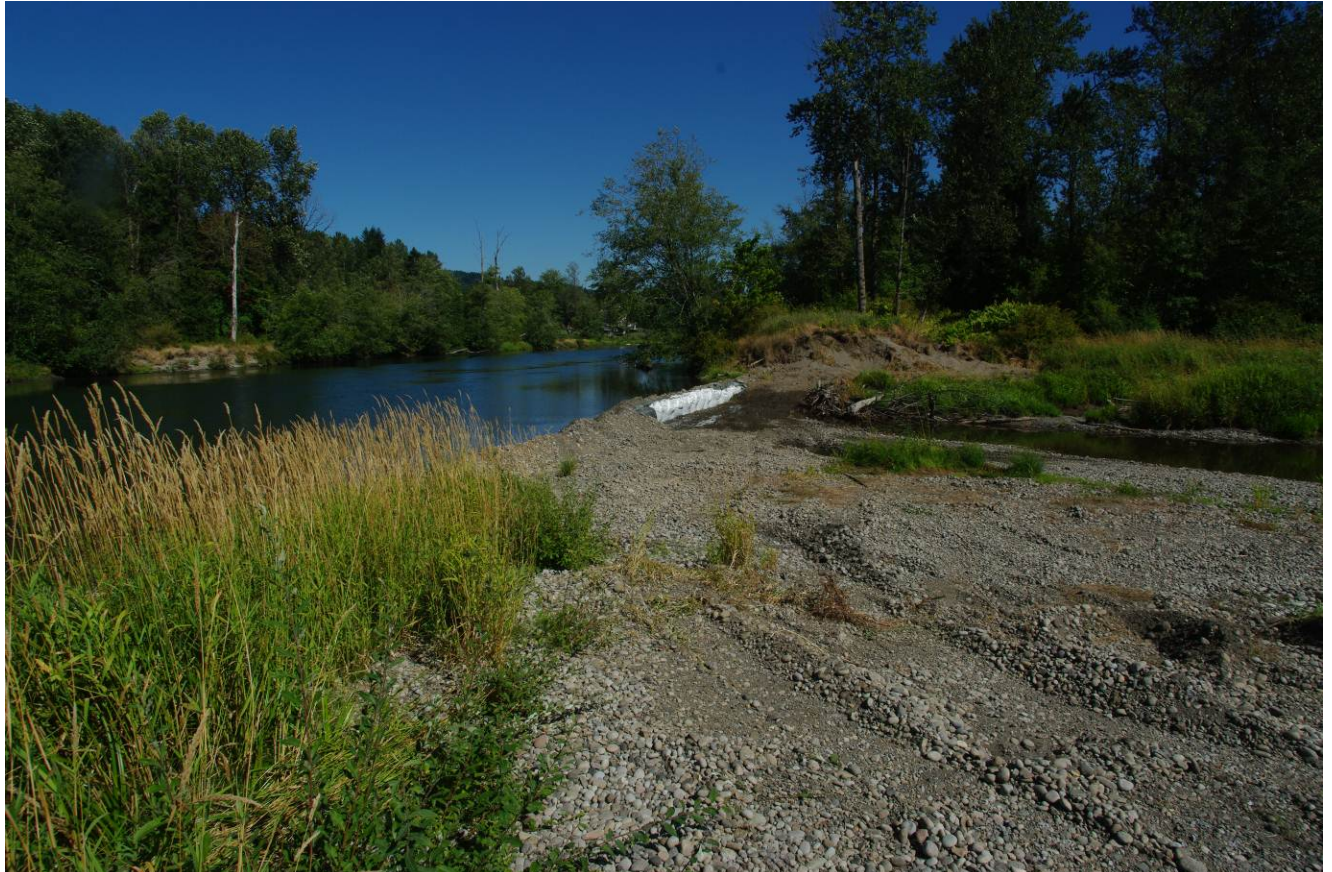
Upstream coffer dam. The entire project site was dewatered and kept from “live” water throughout the entirety of the construction phase.

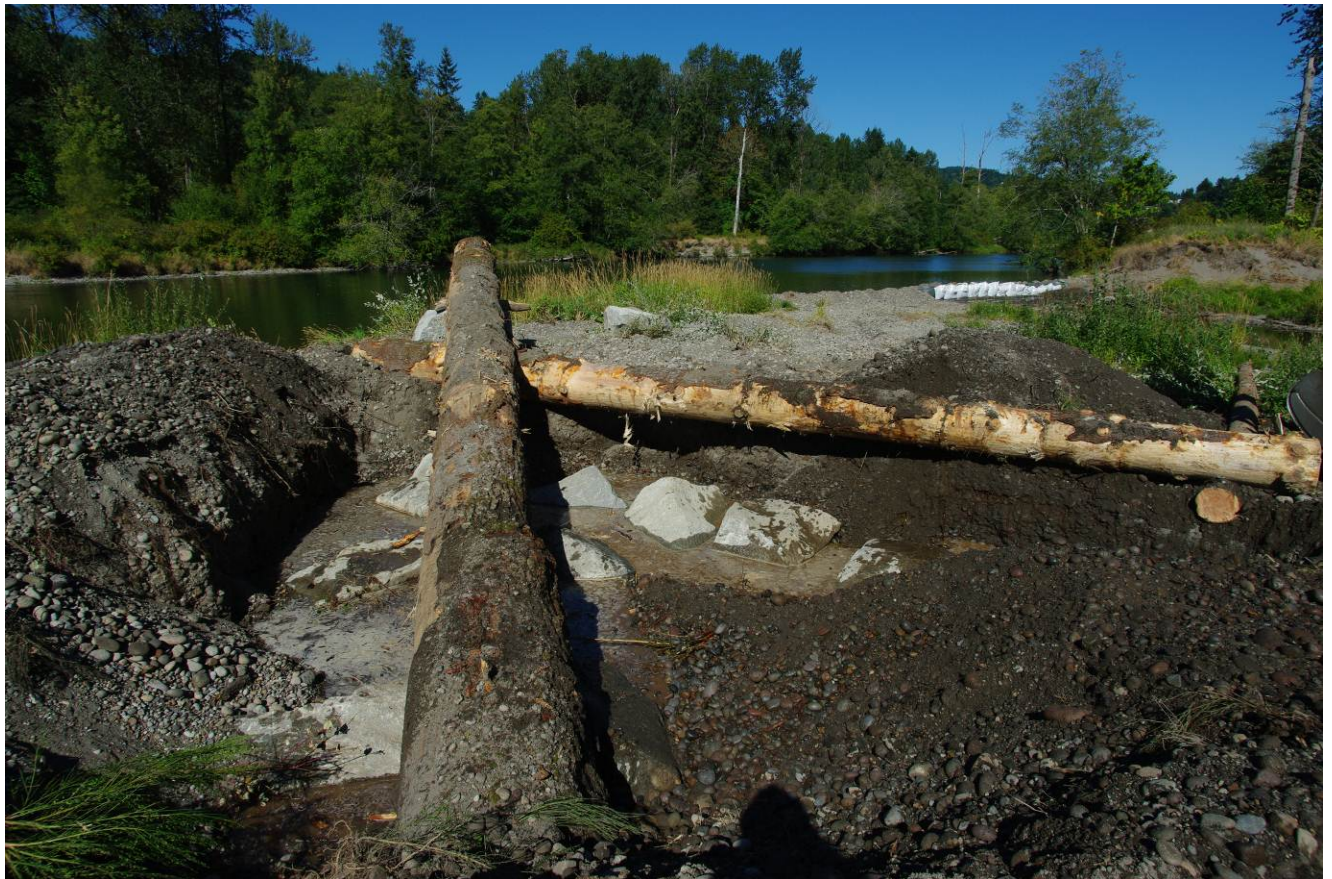
Key log structure of the apex bar jam at the head end of the project. Note the boulders loaded into the excavation in preparation of the next key elements.

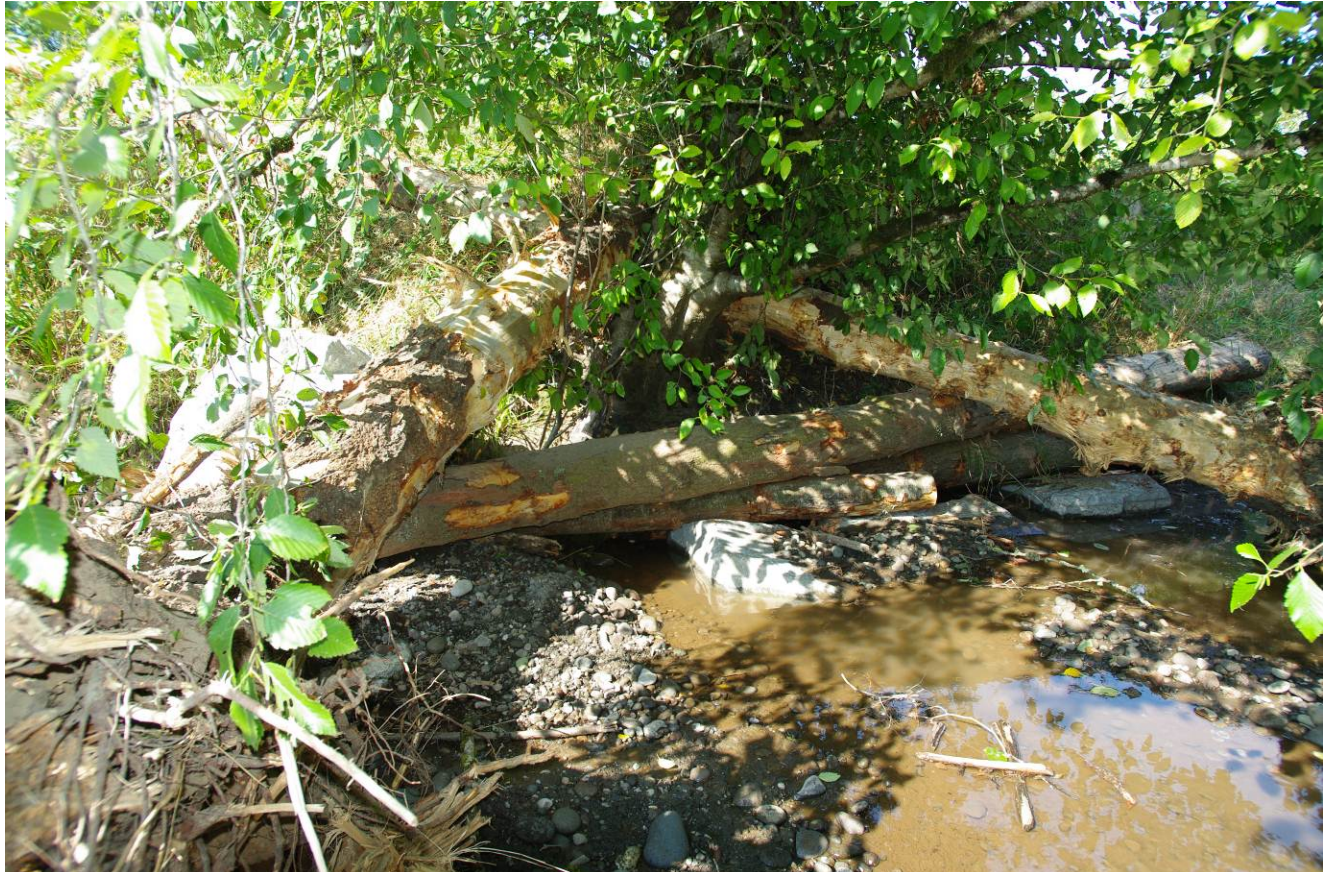
Incorporating an existing alder to make a habitat wood structure

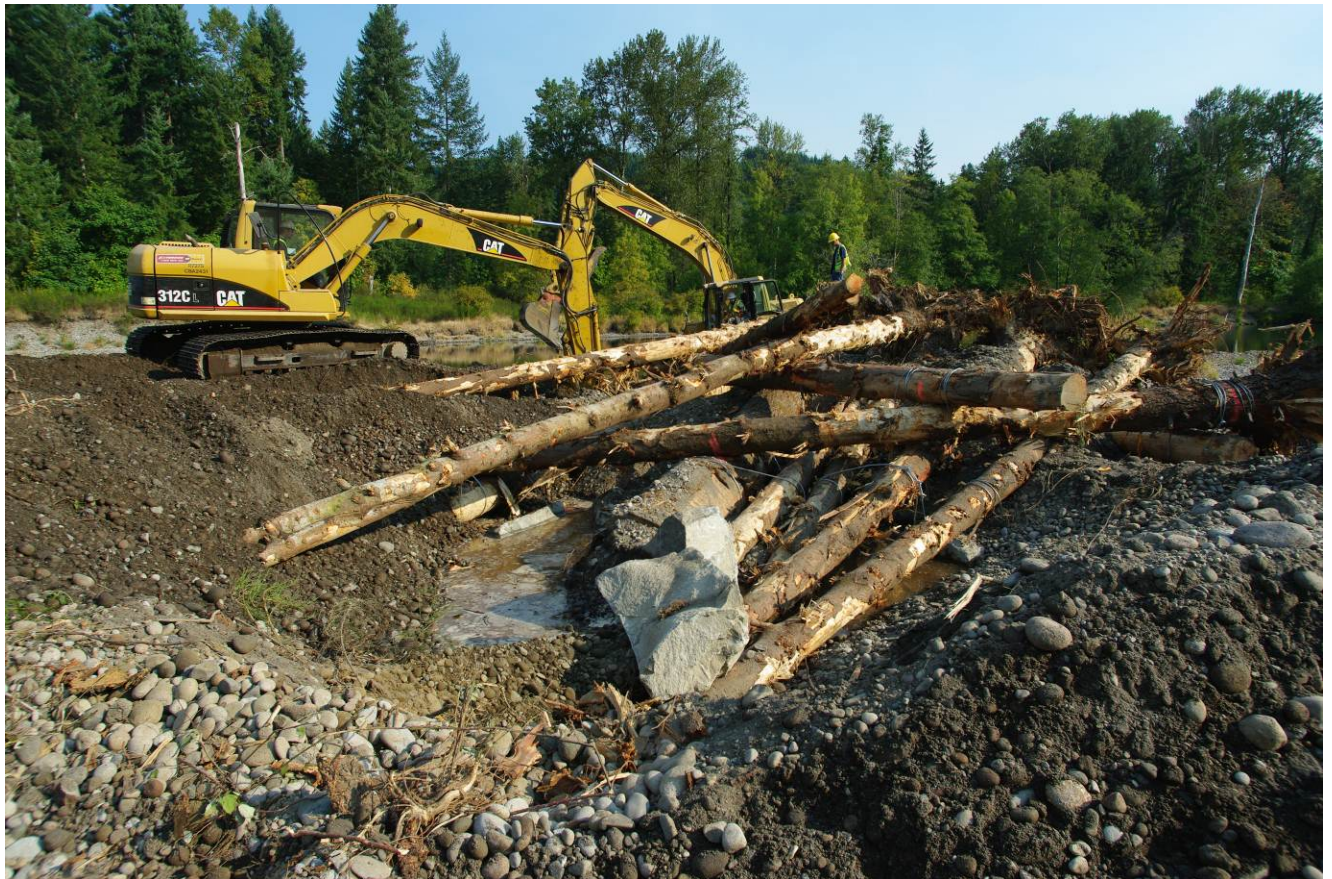
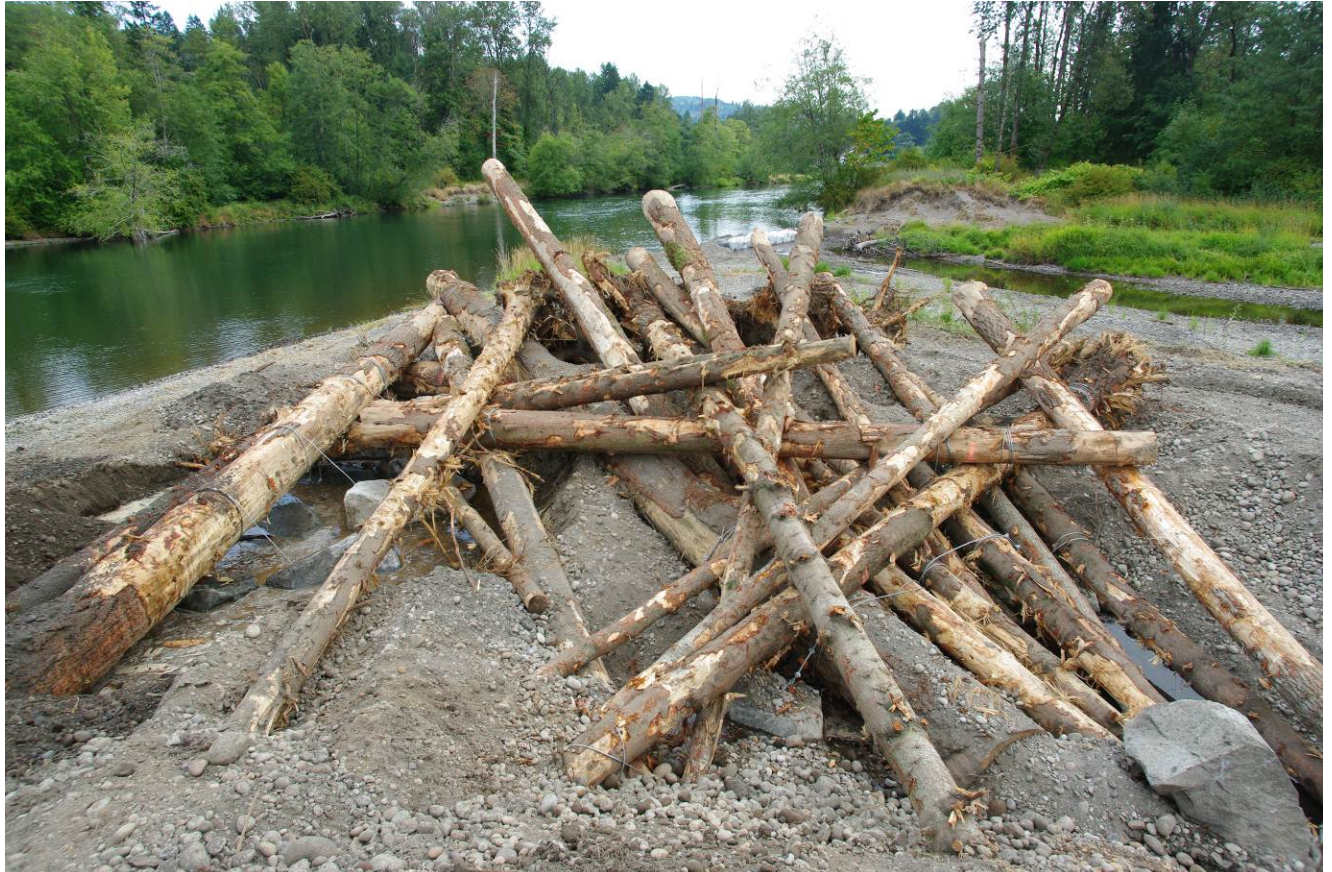
Adding wood pieces to the head end apex jam structure(above), below, looking down at the head end apex jam structure.

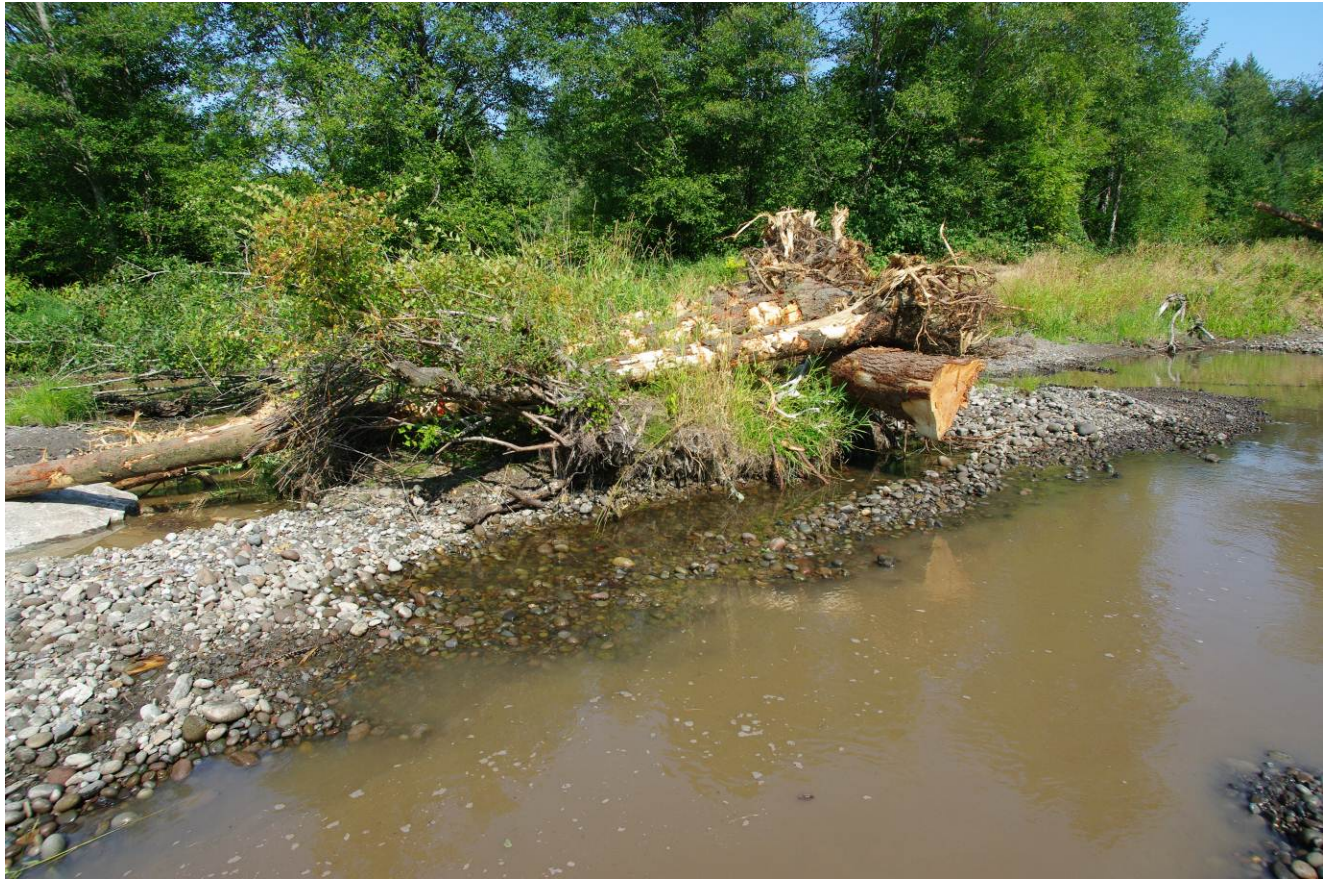
An apex bar jam structure built around an existing alder tree that had fallen

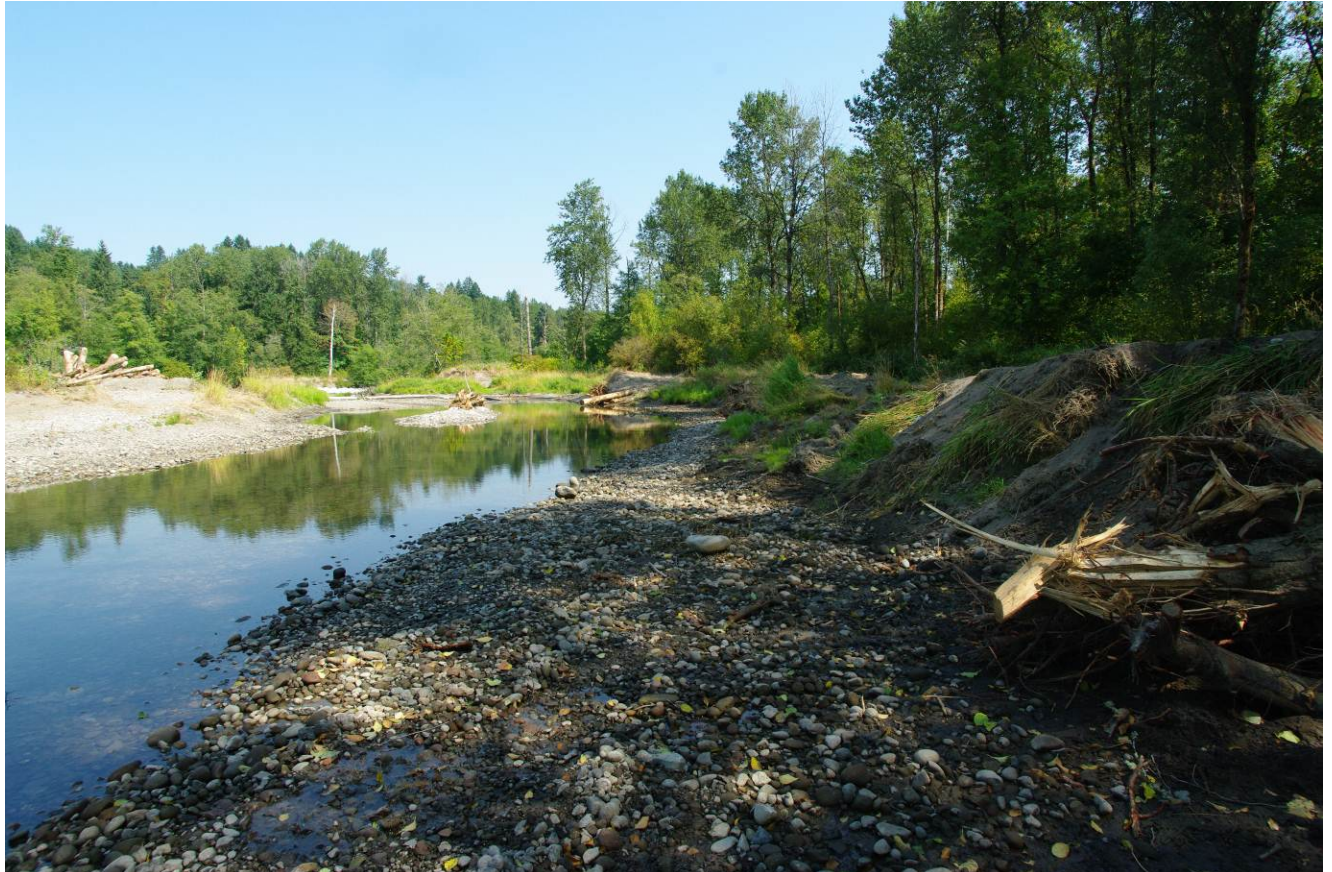
Looking upstream from the south bank of the side channel from the pre-construction photo. Visible on the right are three scour pool structures, in the center a log with rootwad anchored in place, and the head end apex bar jam on the left. Floodplain wood is not yet in place.

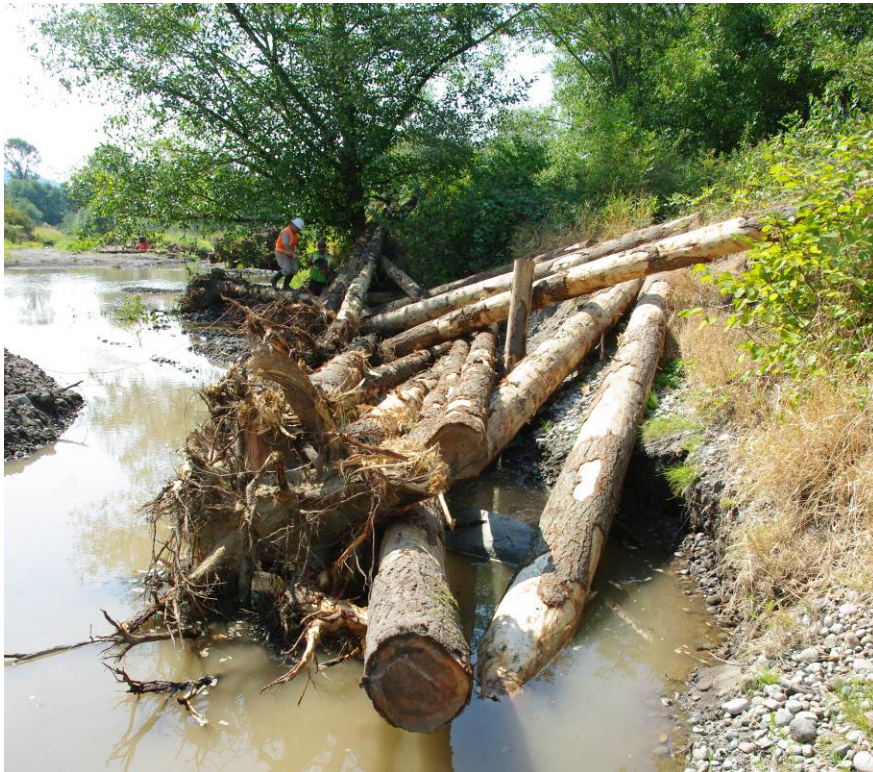
Habitat wood structure being cabled to boulder ballast (not visible in image)

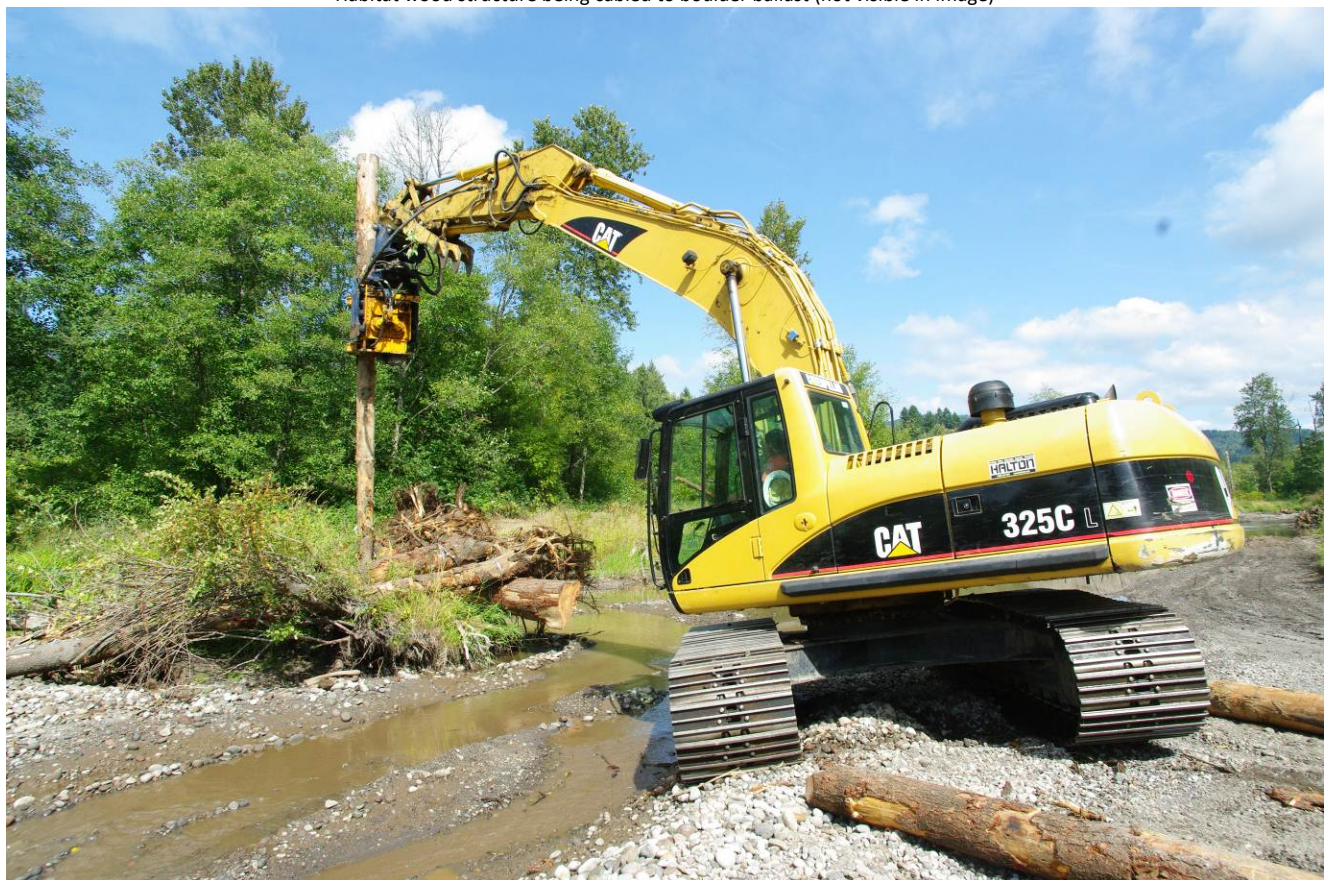
Pile being driven into apex bar jam number three. There were four apex bar jam structures built into the project.

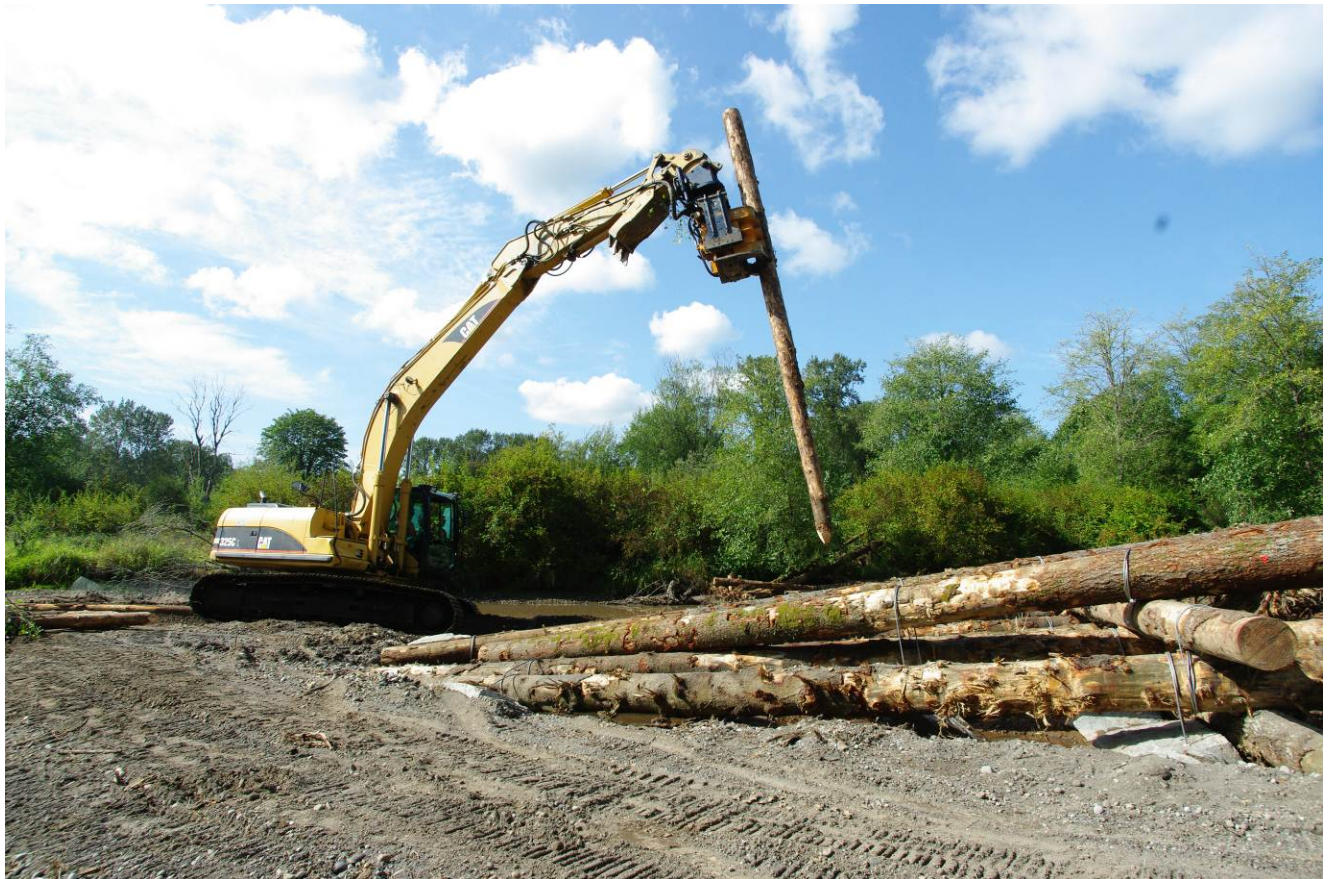
A pile being readied to be driven into apex bar jam #2. This was the typical length and diameter of the logs used as piles

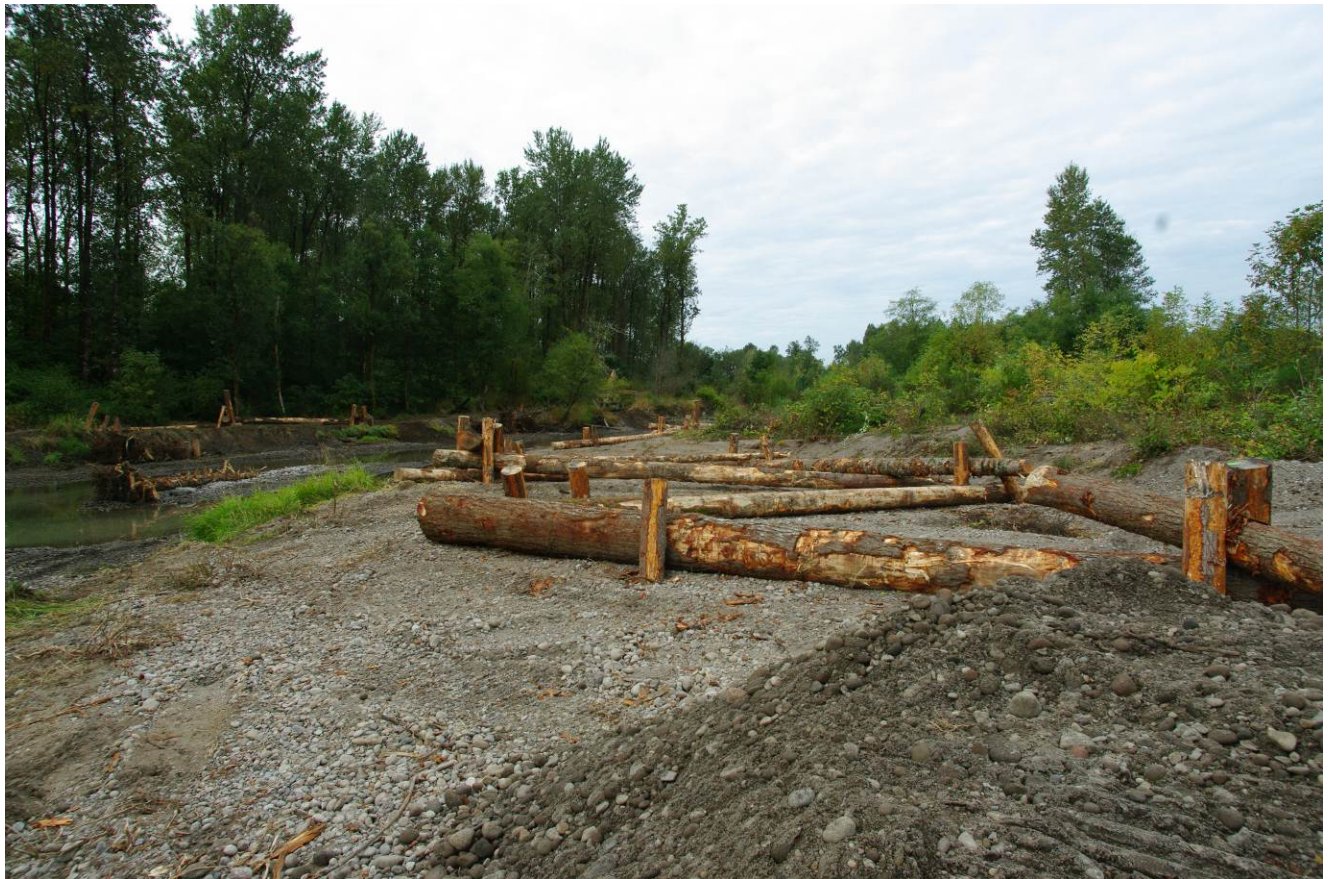
Floodplain wood structures. Consisting of approximately 90 logs, the two floodplain structures (part of the south bank structure is visible here) channel energy into the intended channel at high flows

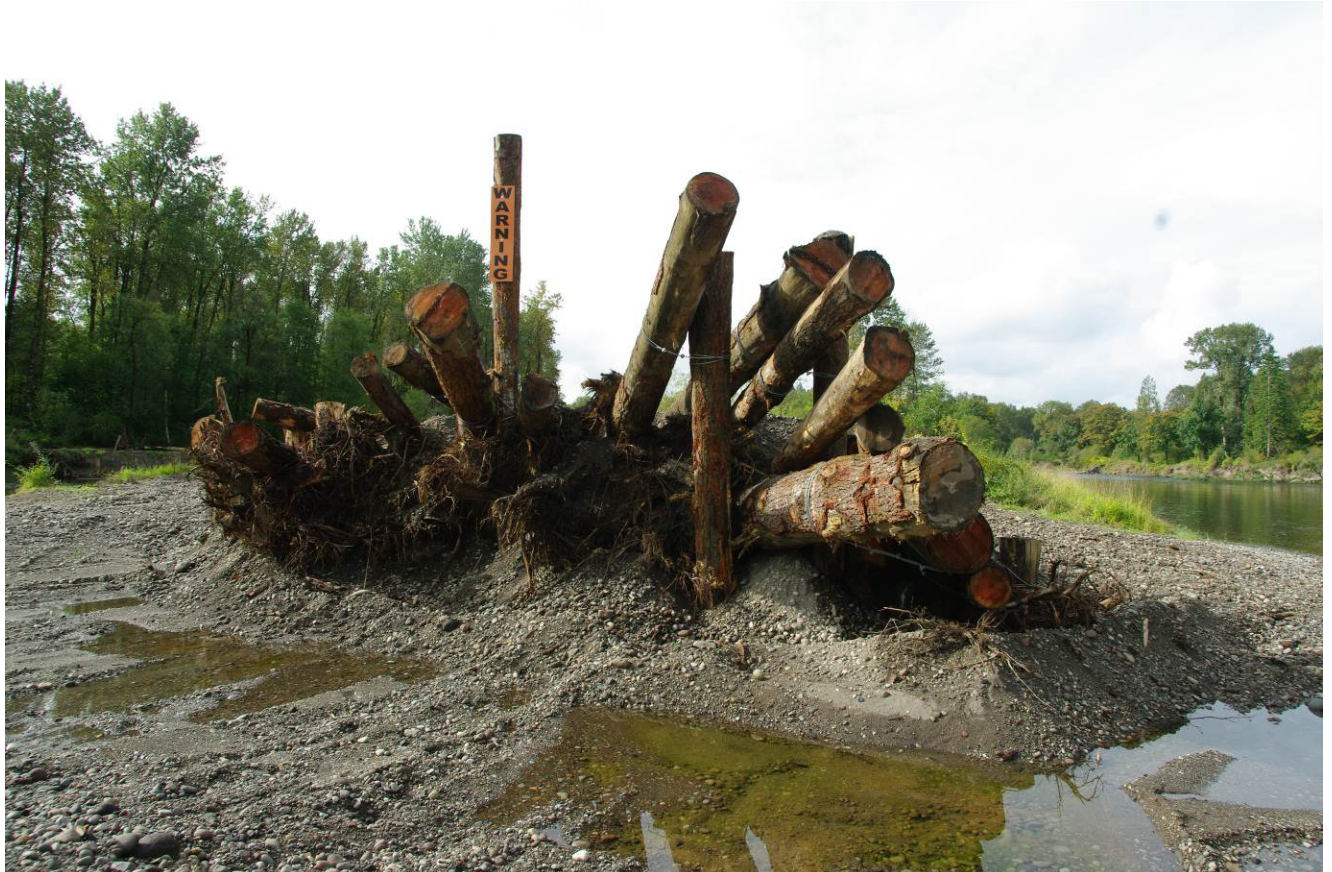
Apex bar jam structure at the head end of the project with warning sign visible. The sign uses 10inch letters and complements the detailed warning sign placed 50 feet out away from the structure.
