USFS, Gifford Pinchot National Forest

Pepper Lewis Side Channel Instream Habitat Restoration

Monitoring Report December 2012

Prepared by Abigail Groskopf
Mount St. Helens Institute
For the Mount St. Helens National Volcanic Monument
Gifford Pinchot National Forest

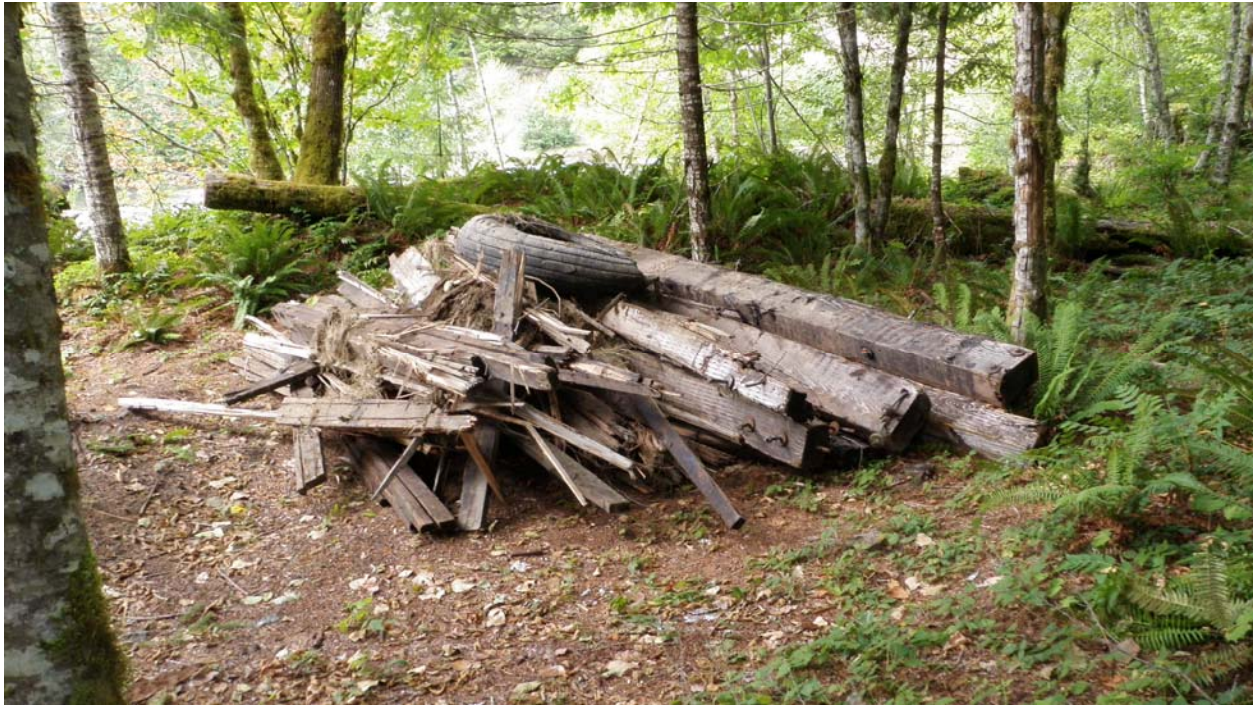
Figure 1. Picture of some of the creosote timbers removed from the logjam. Timbers were disposed of properly at a hazardous waste facility

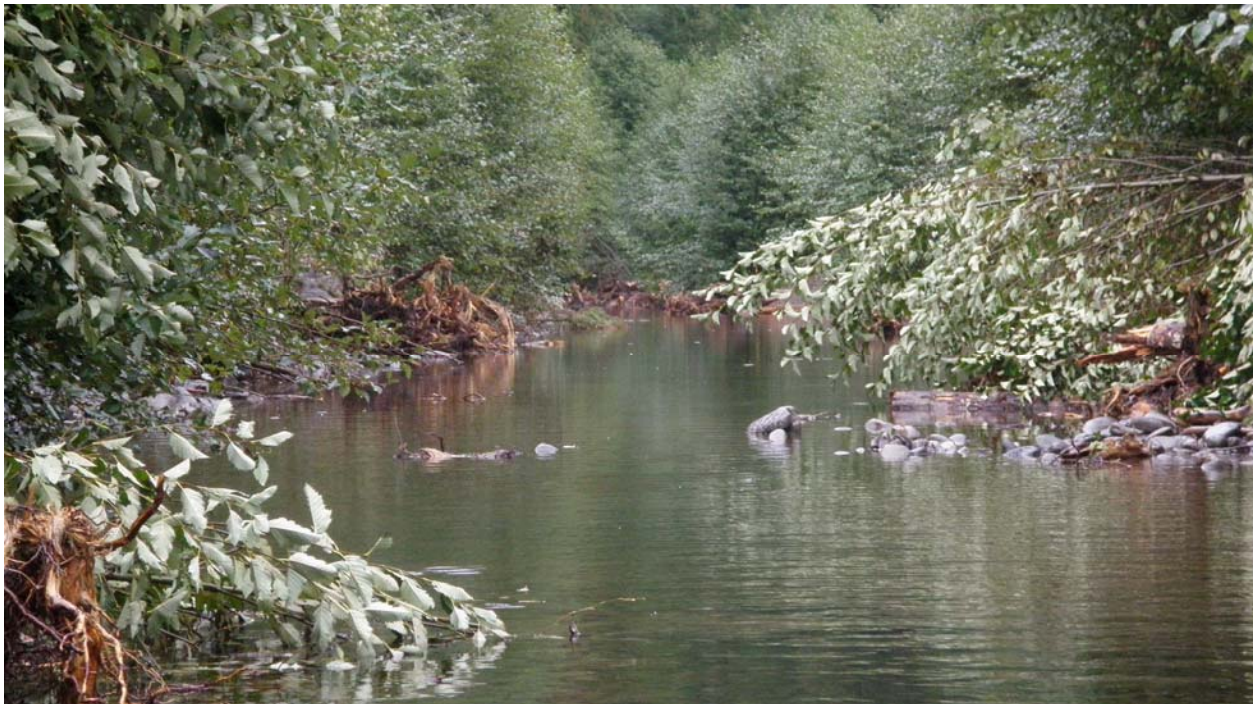
Figure 2. Section of Side Channel with installed structures.

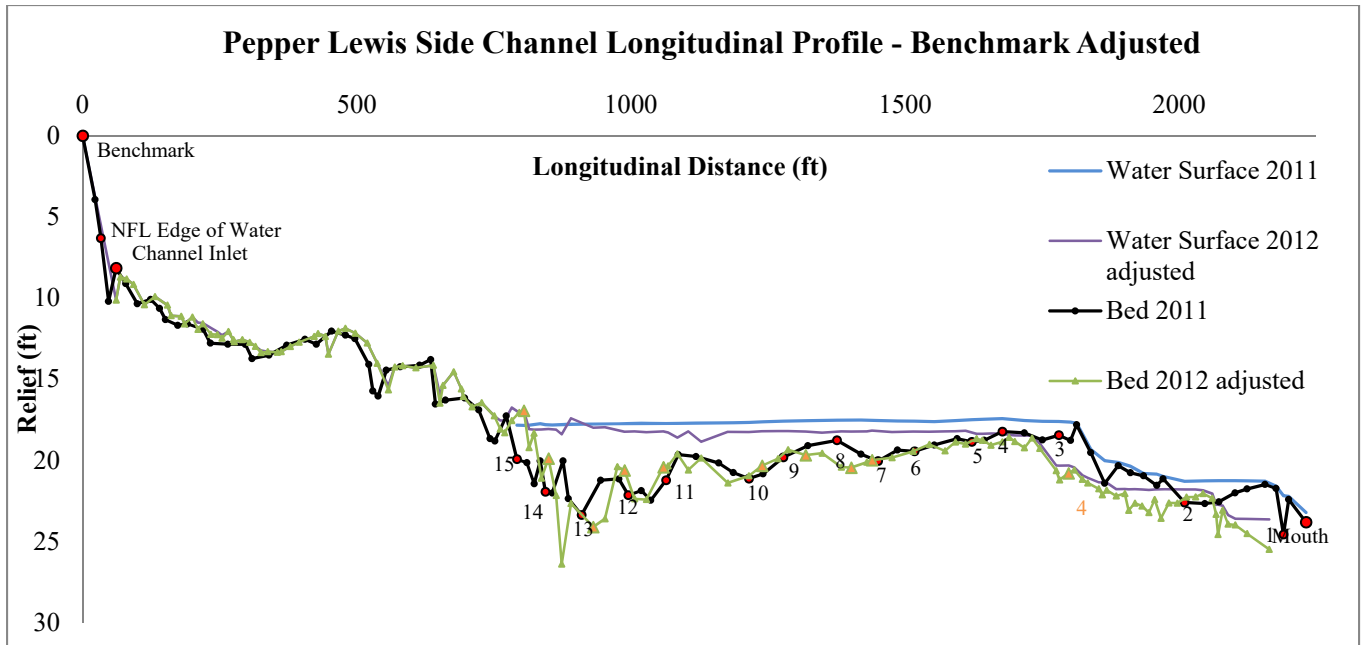
Due to a changing thalweg, the longitudinal profiles between 2011 and 2012 were not perfectly aligned; however, this shows morphological change, especially below Structure #3. Note the long run between Structure #8 and Structure #3 in Figure 1. This run may be in part due to the mouth of Pepper Creek. Also note the riffle-pool profile near the Lewis River confluence.

Figure 3: Pepper Lewis Longitudinal Profile for 2011 and 2012

Overall, there is a pool to riffle ratio of 69% pools to 31% riffle, with 949 feet of pool habitat, comprised of 21 pools, and 410 feet of riffle length. This includes the long run as a pool or slow water habitat unit. There is little noticeable change in the profile but it may take multiple years for structures to influence stream dynamics in a side channel.

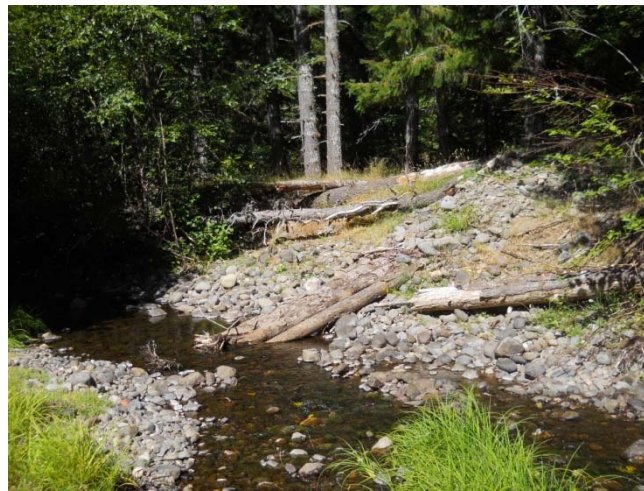
Figure 4 Above Structure #4 looking downstream to cobble riffle unit

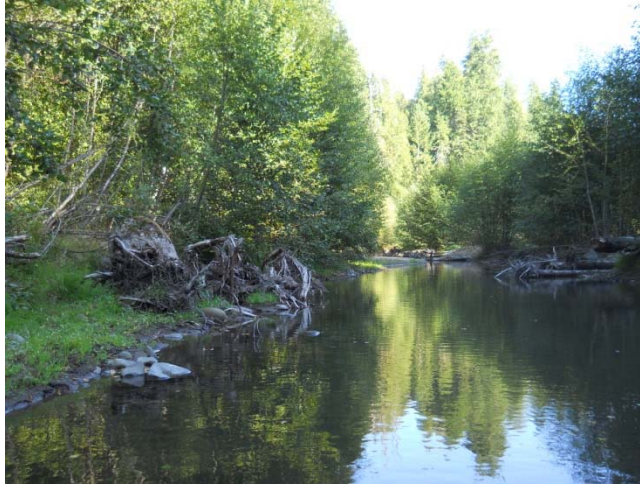
Figure 5 Above Structure 10 looking downstream at long run

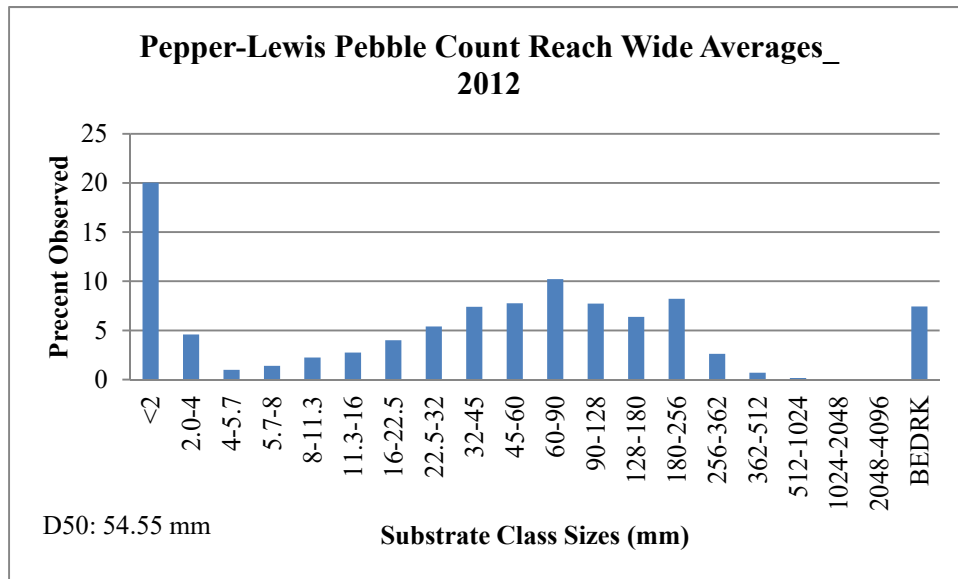
Overall, sediment median particle size is within the range of use by salmonids, with a D50 of 54.55 mm. However 20% of observed particles are fine (<2mm). In addition, observed particle sizes display bimodal distribution of fines and cobbles at 9 of 15 cross-sections surveyed. This high level of fines and bimodal distribution of sediment sizes could result in the filling of interstitial spaces potentially decreasing redd success and macroinvertebrate populations.

Figure 6 Substrate size percentages observed

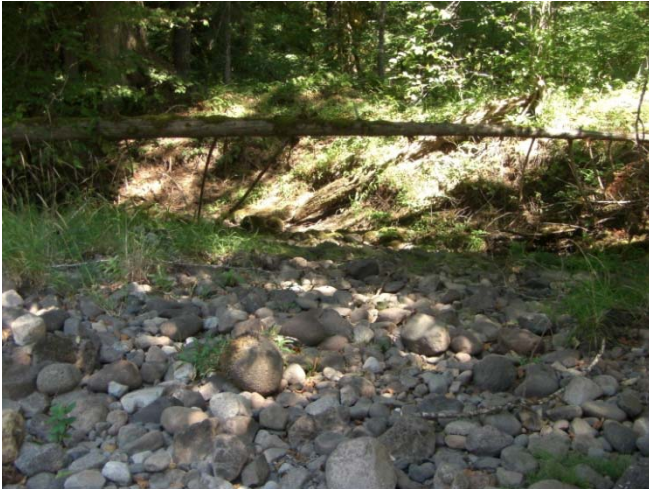
This side channel is approximately 1/3 of a mile long. During summer base flows, the upper end of the side channel is disconnected from the mainstem. With the exception of isolated pools (5 pools in 2012), the first 740 feet were dry during summer months in 2011 and 2012; during low flows the upper end of the side channel is disconnected from the mainstem, however Pepper Creek provides flows below its confluence with the side channel. Deep pools with margin structures occur for approximately 500 feet upstream from the Pepper Creek confluence. Overall the side channel is characterized by pools, runs and toward the mouth, by riffles.

Figure 9 Upper end of side channel; note dry and disconnected from North Fork Lewis River mainstem

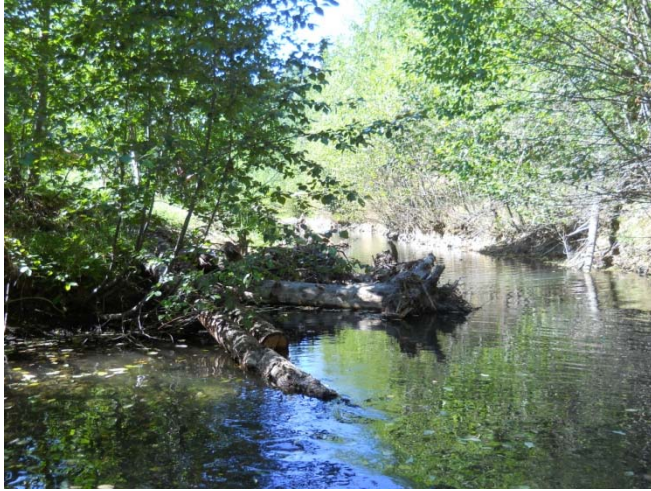
Structure 14

Figure 11 ST 14, above ST looking downstream; note deep pool

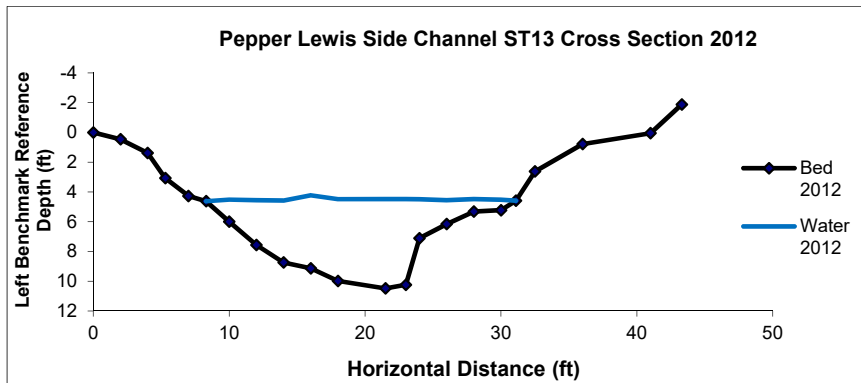
Structure 13

*No pebble count because of water depth
